Archaeological Watching Brief
Muthill Old Church
Muthill
CRIEFF
MQ01

**ARCHAEOLOGICAL WATCHING BRIEF
MUTHILL OLD CHURCH,
MUTHILL**

MQ01

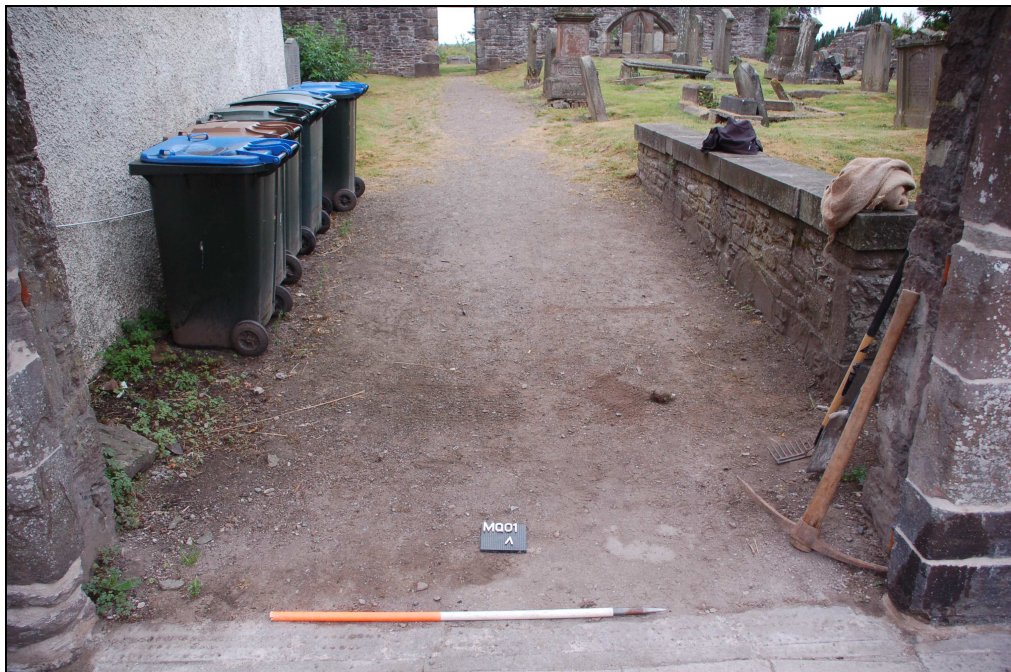
The area prior to the start of work, looking N.

A layer of tar covered by small gravel and fine dust (01) forms the surface material in the entrance way and under this is a compacted base for the tar formed of gravel and fragments of crushed rock (02). Immediately below the base is a thicker layer of makeup comprising bands of red/ brown clay mixed with darker soil (03). This

material contains small and medium stones but no larger pieces or architectural fragments.

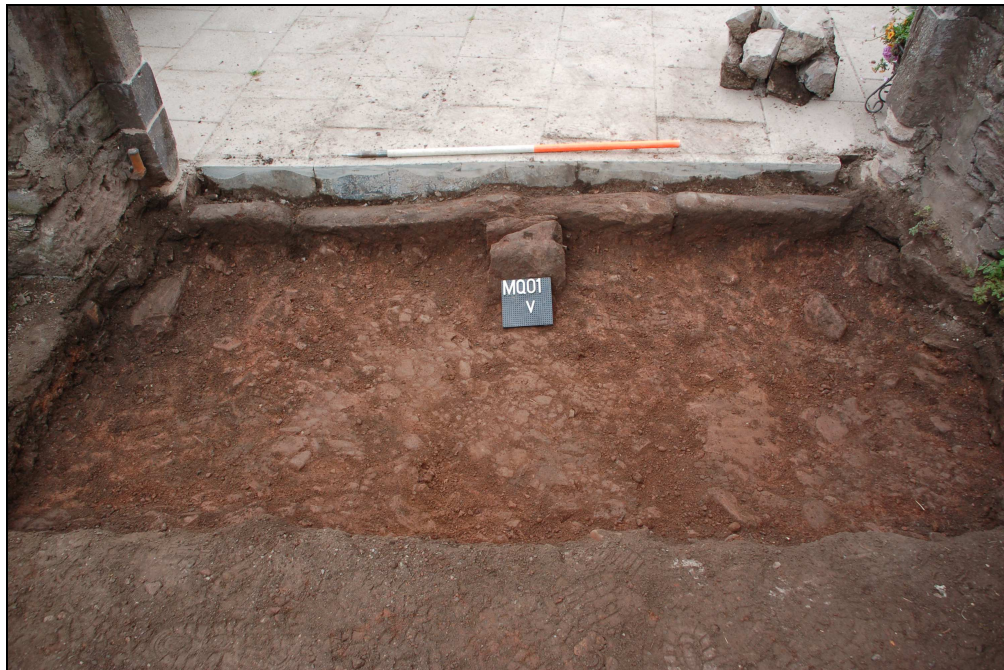
The cobbled surface (04) and sill stones (05), looking S

Below the makeup a partially surviving cobbled surface was identified (04). This deposit was identified at the formation level of the excavations (maximum depth 0.2m below modern ground surface) and as such has not been disturbed by the present development. The surface was formed of small rounded pebbles, perhaps sourced from river gravel, rather than larger stone sets. The surface has been disturbed in the area of the threshold and around the foundations for the gateway. Immediately inside the entrance four buried red sandstone sills (05) were identified. These stones are heavily worn and smoothed in places indicating heavy foot traffic over a number of years. The poor condition of the stone can also probably be explained by its exposure to the elements in the gateway. These previous threshold stones respect the dimensions of the current entranceway suggesting that the opening has been of a similar size for many years.

Immediately inside the threshold a square stone (06), originally approximately 0.25m by 0.25m, but now split into two pieces, was discovered abutting the sill stones. The small square shaped hole in the centre of the stone marks the position of a sliding drop bolt from a previous two-leafed gate arrangement.

At the base of the current excavations, and below the layers of makeup, an area of cobbles was uncovered which represents the earliest feature identified by this watching brief. The cobbled surface is located below the ground level marked by the sandstone sills and is cut away by these features and also disturbed by the foundations for the arched gateway. This suggests that the cobbled surface pre-dates the arched gateway and associated structures. This surface represents an early entranceway into the

churchyard, though the lack of artefacts discovered in the work have prevented any attempt at dating.
