Archaeological Evaluation
Glenisla Golf Course
Pitcrocknie
ALYTH
AG05

**ARCHAEOLOGICAL EVALUATION
GLENISLA GOLF COURSE
ALYTH**

AG05

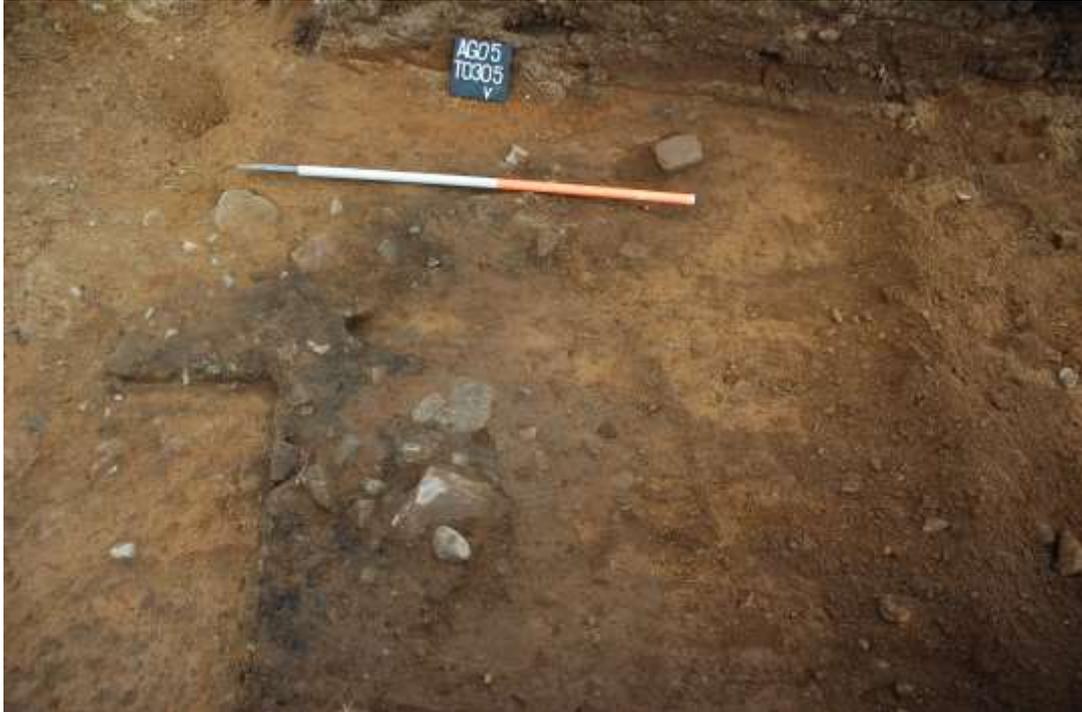
At 7.5m from the S end of the trench a feature (0307/ 0305) with better defined edges was uncovered running under the W edge of the trench. The dimensions that could be observed in the initial trench were 0.6 by 0.4m. Charcoal was visible throughout this fill (0305) and in some places there were denser patches of this poorly preserved material. The fill contained fire reddened sandstone as well as a sherd of prehistoric pottery provisionally identified as being of an Early Bronze Age fabric. Two sections were cut through the feature showing it to be very shallow with a maximum depth of 0.09m. An extension to Trench 03 was made at this point to further investigate this feature. This 4.4m long extension cut at right angles to the main trench showed that

0307/ 0305 was part of a slightly larger poorly defined feature, with ill-defined edges, containing some charcoal fragments and medium sized stone inclusions. No further evidence on the function of this shallow spread of material was uncovered in the extension trench.

Feature 0305 seen in extension to Trench 03

Trench 3 contained some very heavily truncated features surviving beneath landscaping for the golf course. It is uncertain whether these features have been truncated by the construction of the golf course or by the previous agricultural activities on the site. The presence of Early Bronze Age sherds in a deposit containing charcoal suggests that 0305/ 0307 could be the very heavily truncated remains of an urned cremation in which the bone has not survived (most likely because of soil conditions). The presence of urned Early Bronze Age cremations in the vicinity of standing stones is well attested (see discussion in Johnson 2012) although at Pitrocknie there is no evidence for the survival of a cremation cemetery within the development area.

- A limited excavation should be carried out to preserve the remains by record, and also to detect any other similar features nearby. This could be achieved by an excavation of approximately 20m by 20m (400m²) incorporating the part already seen in trench 03 and its extension. The fragmentary and insubstantial nature of this prehistoric archaeology does not lend itself to being investigated by means of a watching brief on groundworks for the proposed development.

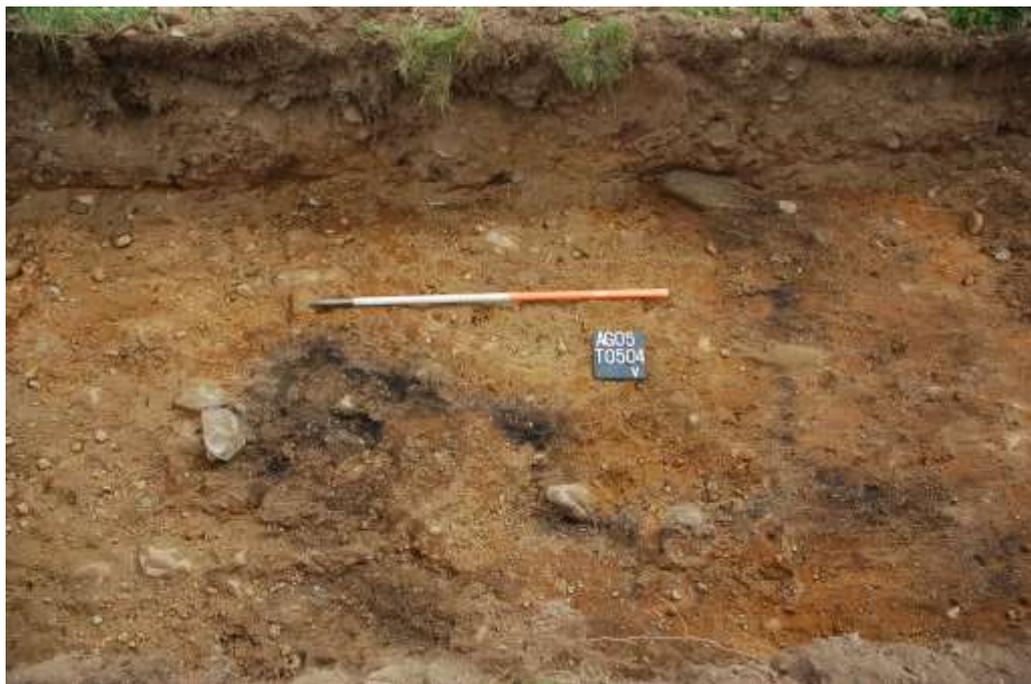
Also located on the rough, this NE-SW trench aligned terminated close to the W boundary of the site. Moderately compact topsoil (0502) over glacial gravel was the deposit profile identified along the length of this trench. At the SW end of the trench a curving feature (0504) with irregular ill-defined edges was uncovered. Patches of charcoal were visible in places though none of these looked to be well preserved. The poorly defined edges of this feature together with its very irregular shape suggests that this feature may be the result of natural processes such as tree throw disturbance rather than cultural activity.

Feature 0504 in Trench 05

Feature 0306 in trench 03 and 0504 in trench 05 are more difficult to attribute to cultural activity because of their irregular shape and poorly defined edges. It seems likely that these features are the result of natural processes such as tree-throw disturbance. The charcoal in 0504 may also have had a natural origin rather than as the result of cultural activity.
