**18 Ritchie Street, Millport, Isle of Cumbrae:
Archaeological Watching Brief**

Data Structure Report

by Rebecca Shaw

4th August 2008

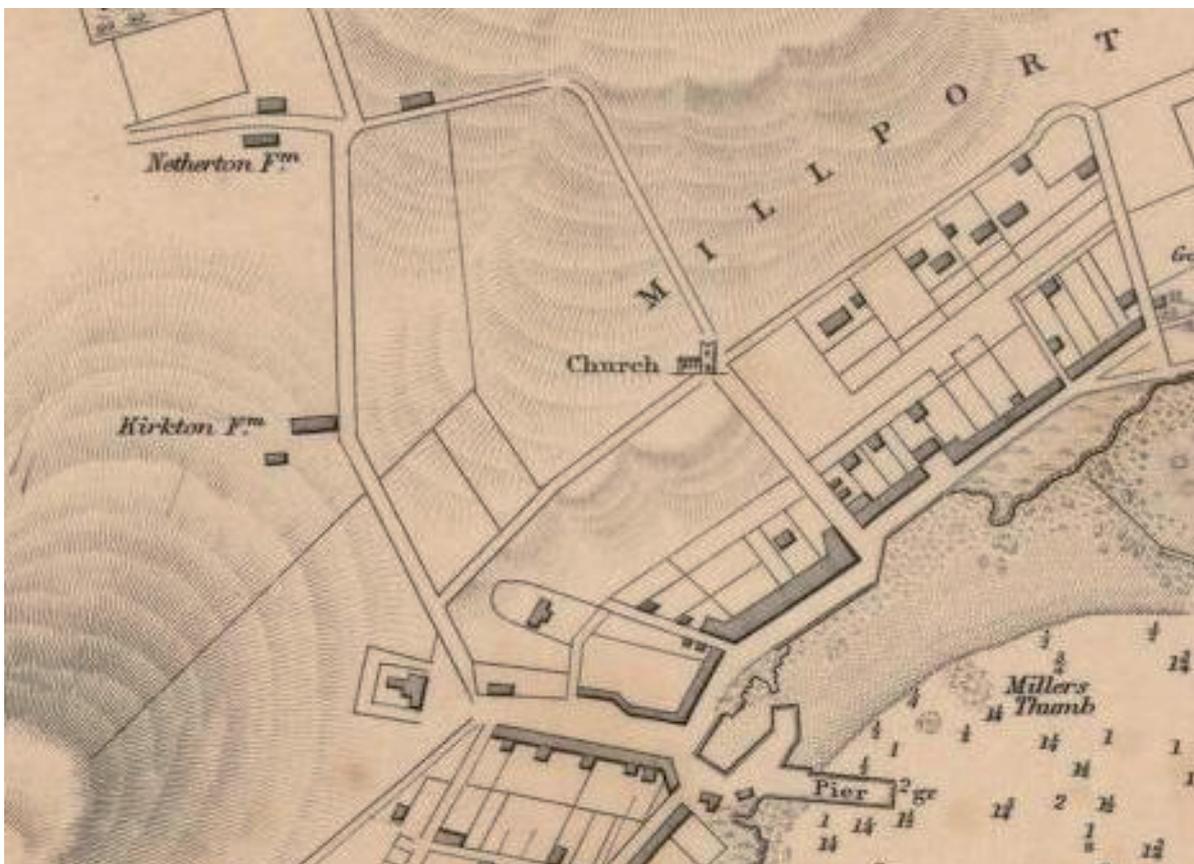
Figure 1b – Admiralty Chart of Scotland (1845-47)

The Admiralty Charts of Scotland undertaken in 1845-47 indicate that there was possibly one small square structure on the development site at this time (Figure 1b). The first sound mapping that we have dates to the mid 19th century and denotes two structures within the development site; a long rectangular one and a square one (Figure 2a). At this time the street does not appear to have a name but close by there is a well called '*Mrs Ritchies Well*' which is presumably where the street gets its name.

From cartographic sources we know that the rectangular structure is standing by 1856 (Figure 2a) but did not exist in 1845 (Figure 1b). Between 1856 and 1896 (Figure 2b) the structure appears to have become slightly longer but apart from that seems to have changed very little between its construction and demolition. Locals only seem to remember a timber boat shed being on this site.

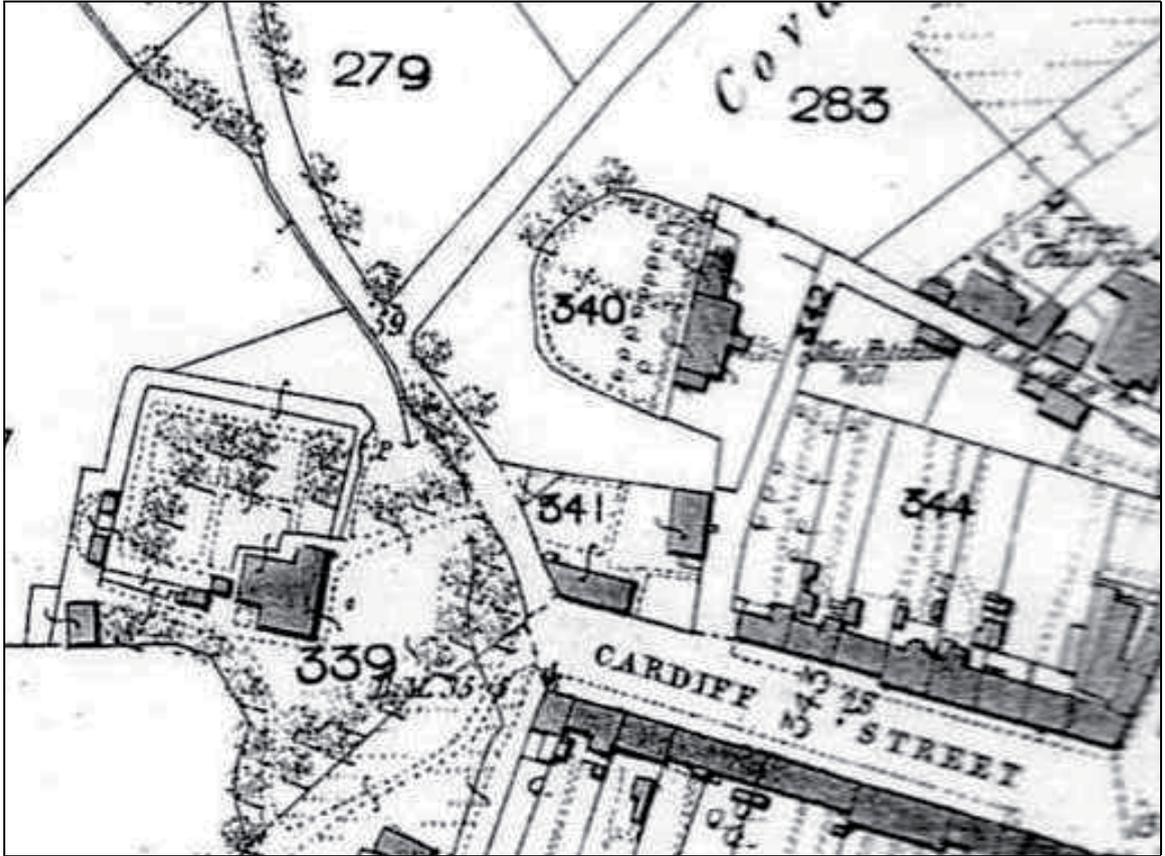
Figure 2a – 1st Edition Ordnance Survey (1856)

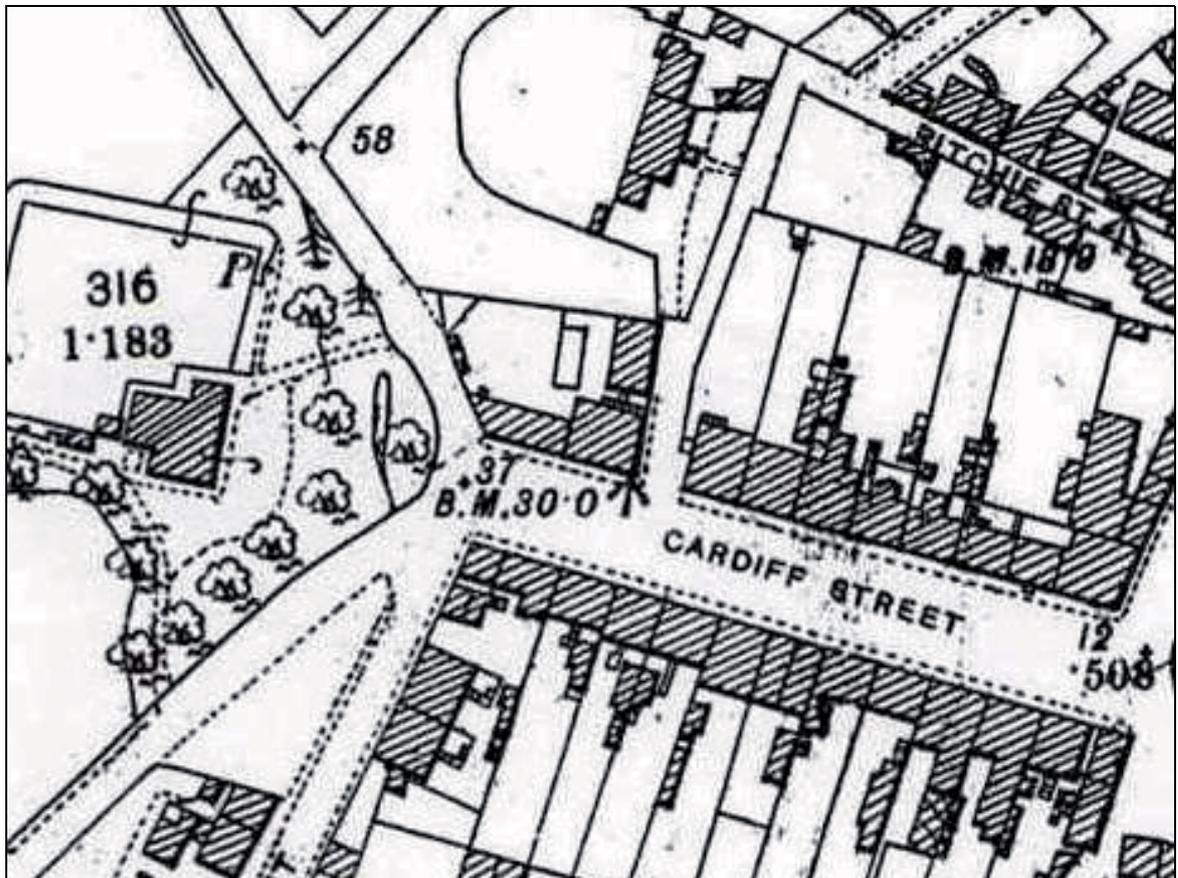
Figure 2b – 2nd Edition Ordnance Survey (1896)

The 2nd edition Ordnance Survey undertaken in 1896 shows little change to the development site with both a roofed square and rectangular structure still being depicted (Figure 2b), the street is now named Ritchie Street. The next map, which was surveyed in 1966, only depicts the rectangular structure, with the area where the square structure previously stood shown as open ground. Various locals mentioned that in the 1920's the small square structure was in use as a bakery and prior to that was a pottery. The rectangular structure, which was demolished recently, comprised a wooden boat shed with a concrete floor and a yard.

Deposit [107] was midden-like in nature and was possibly bought in from elsewhere as build up material to level the ground after the demolition of the small square structure. Cartographic sources denote that a square building stood in the northwest corner of the site from about 1845 (Figure 2b) and was it still there in 1896 (Figure 2b), however, by 1966 the structure was no longer marked. Local knowledge indicates that the square structure was still standing in the 1920's when it was in use as a bakery and prior to this was a pottery.

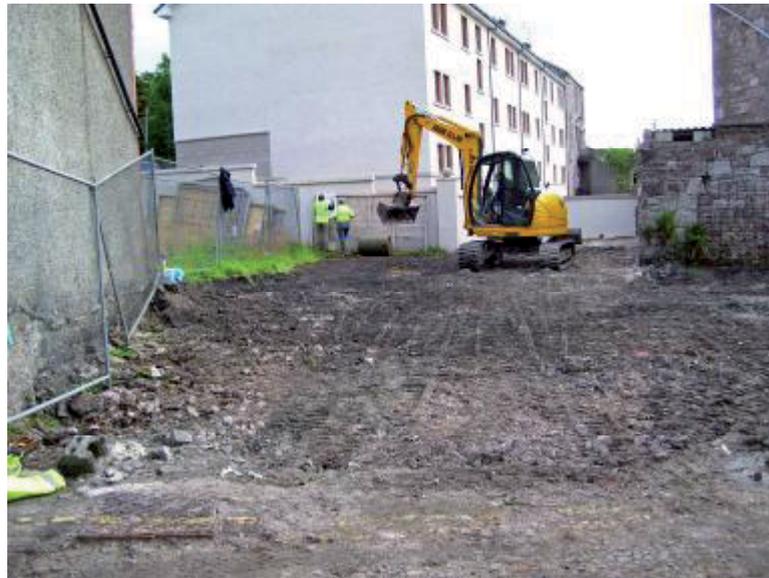
Figure 3a – dwelling site after removal of concrete

Removal of the upper surface of concrete and vegetation [101] revealed a layer of demolition debris comprising irregular shaped sandstone blocks, glass and general rubbish [102]. In some areas within this section bedrock was very close to the surface (Figure 3a).

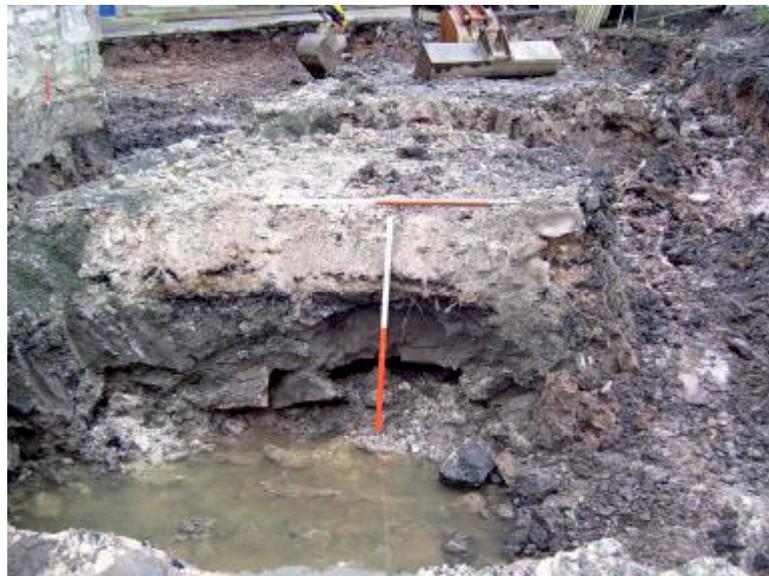
Figure 3b – northern end of site

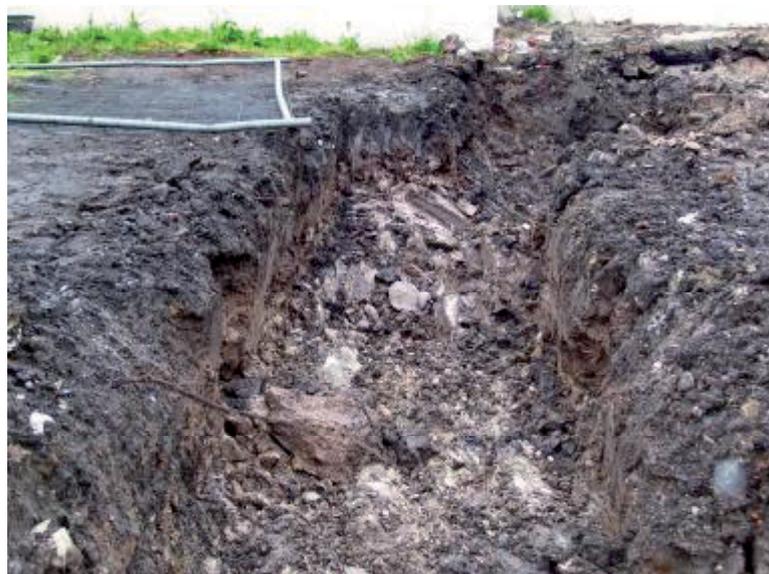
Figure 3c – showing bedrock close to surface

Excavation of the foundation trenches revealed a subsoil which comprised either bedrock [103]; a pinky red clay [104] or a yellowish /orange sand [105], both the width and depth of the founds trenches varied. There was an in-use water pipe [106] running roughly north/south across the site which was encased in concrete with fine pea-gravel on top, it measured 600mm in width (approx). The southwest corner area was left unexcavated as it is to be a parking area.

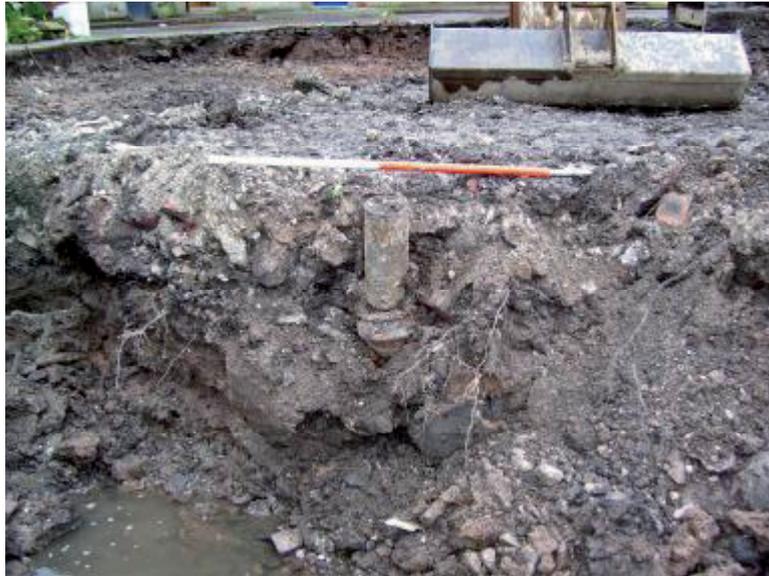
The subsoil in this area was mostly a sandy clay [108]. Along part of the eastern edge of the site (visible in section) were the remains of what appeared to be a sandstone wall [109]. A similar looking wall was also visible in the southern section (below the road). Within the eastern half there was the *in-situ* remains of an upright pipe (Figure 4a) as well as the fragmented remains of a saltglaze pipe aligned roughly east/west.

Figure 4a – *in-situ* pipe from sink of timber boat shed

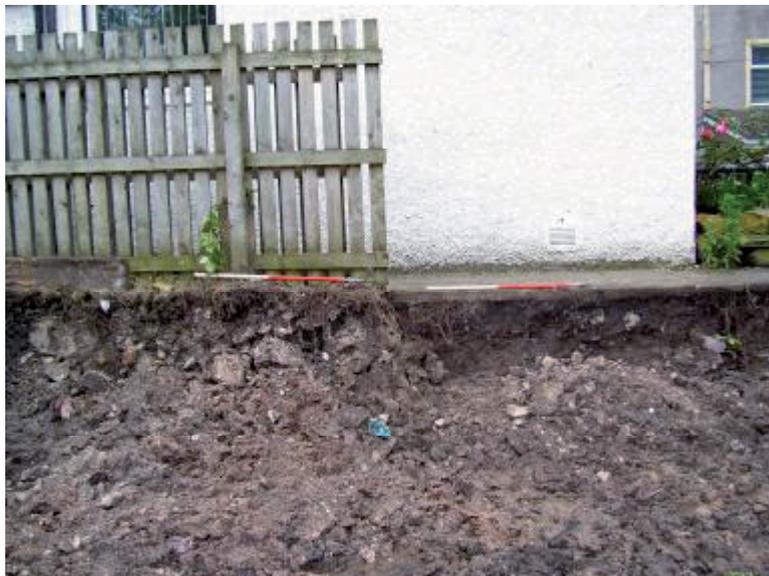
This therefore gives us a demolition date for the square structure of between roughly 1925 and 1966, which is in keeping with material bought in to level up the ground. It is presumed that the two partial sandstone walls visible in the east and south sections are the remains of this square structure (Figures 4b and 4c). The wheel-like sharpening stone may have come from elsewhere but it could also have been used in either the pottery or bakery for sharpening tools or knives.

Figure 4b – section showing remains of wall in east

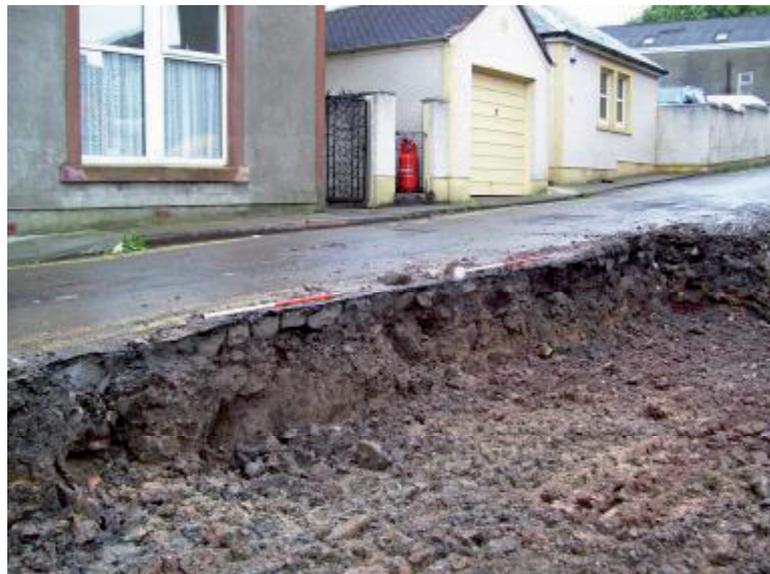
Figure 4c – section showing remains of wall in south
