**Site to the North of Arnabost Cottage (1), Isle of Coll:
Archaeological Watching Brief**

Data Structure Report

by Rebecca Shaw

5th May 2008

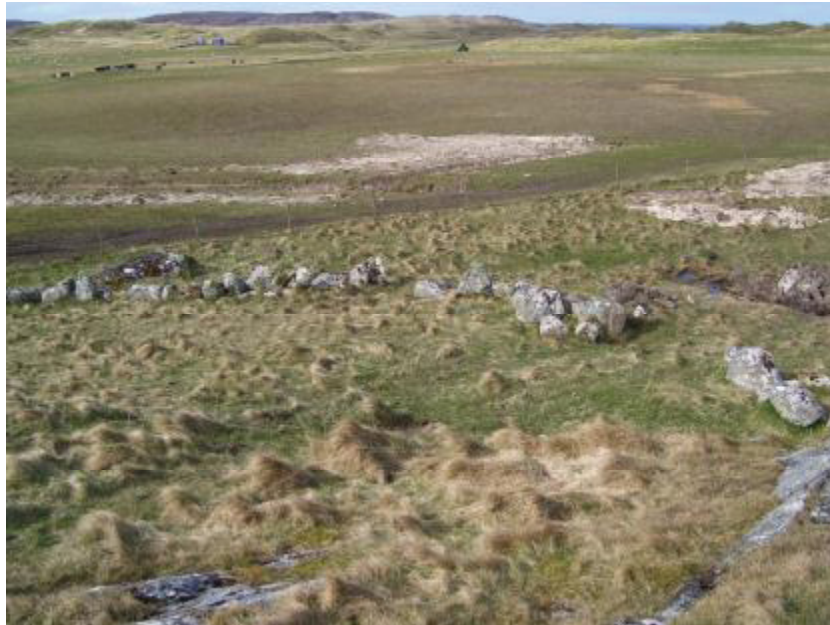
However, it is worthy of note that the large amount of rocky outcrops as well as general availability of large rocks on the Isle of Coll has led to the utilising of both for enclosures. Examples of this type of enclosure were noted on the periphery of the development site (front cover) with some of the stones being displaced where the access road terminated at the dwelling site.

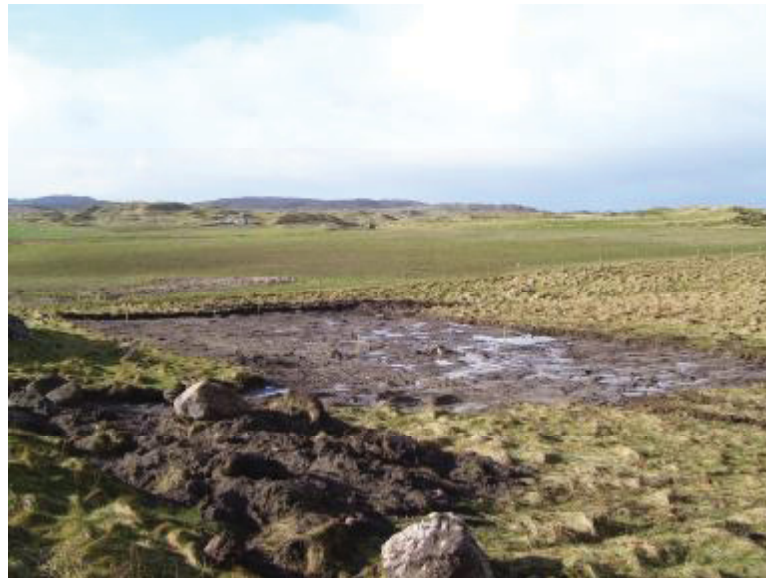
Figure 3a – dwelling site after topsoil removal

The dwelling site measured roughly 13.5m by 12m (at most – including protrusions for utility room and porch areas) Removal of the turf and topsoil (Figure 3a) revealed a mid brown fairly fine sand with occasional (some very large) rocks [007]. The foundation trenches (Figure 4c) measured 600mm in width and averaged 400mm in depth. In general all the trenches exhibited context [007] below which was either a mix of red & grey clay [008]; a mix of dark grey & brown coarse sand [009] or a mix of boulder clay & sand [010]. Bedrock was visible in some sections as well as patches of a dark brownish / black 'gravel' [011] which was possibly degraded bedrock.

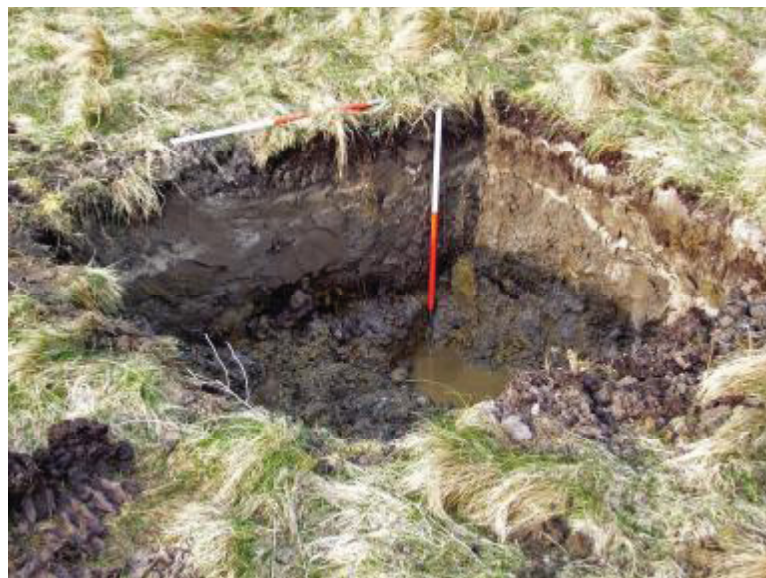
Figure 3b – septic tank

The area of the septic tank measured roughly 2.2m by 2m and was excavated (under monitoring) to a depth of just below 1m. Immediately below the turf was a warm dark brown peat-like topsoil [003] with an average depth of 250mm, this came down onto a fine grey sand [004]. The sand which contained lenses of whiter sand throughout appeared to be an undisturbed windblown sand (Figure 3b). Below [004] was an orangey grey much coarser sand [005]. At roughly 1m in depth the ground became very wet. The drain that was excavated from the existing field drain (re-excavated) (Figure 4b) to the septic tank was roughly 35m in length with a width of 600mm and an average depth of 750mm. The stratigraphy was more or less the same as the septic tank, though in some sections of the base a reddish / orange clay was apparent [006] (Figure 4a).

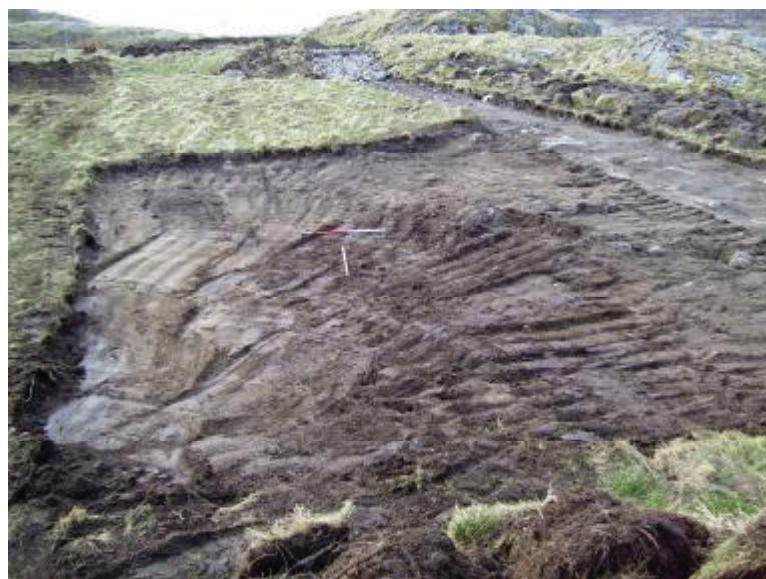
The access measured roughly 220m in length and was excavated from the existing main road to the dwelling site. Below the turf the topsoil was a mid to light brown very fine silt with a small to moderate percentage of sand [001]. Bracken roots were observable in some areas and bedrock was occasionally visible at the surface, large sub-angular rocks were also prevalent. Although in most sections only the turf and topsoil were removed, the depth was on occasional up to 500mm which revealed a pale brown fairly fine sandy subsoil [002]. The car park area measured 11m by 10m and also comprised topsoil [001] (Figure 3c) – though occasional shells were visible as well as an occasional to moderate amount of sub-rounded

Figure 3c – car park area

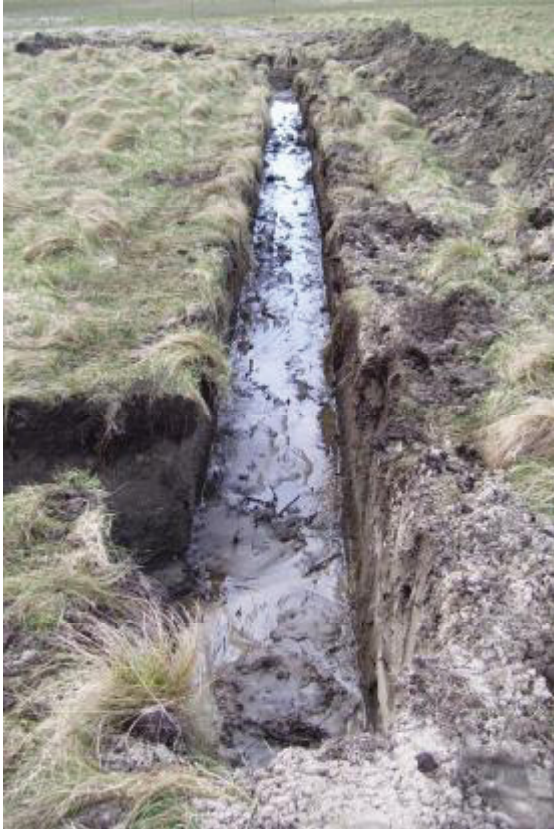
Figure 4a – new drainage for septic tank

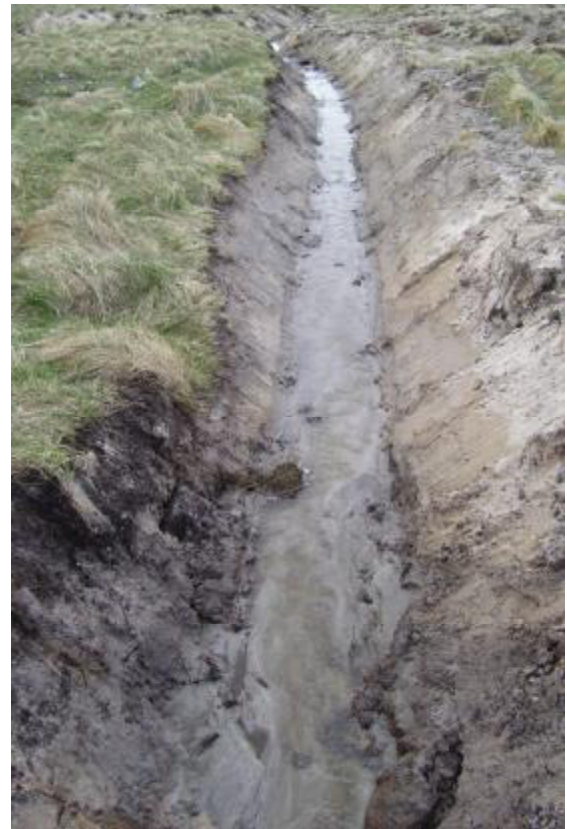
Figure 4b – old drain re-excavated

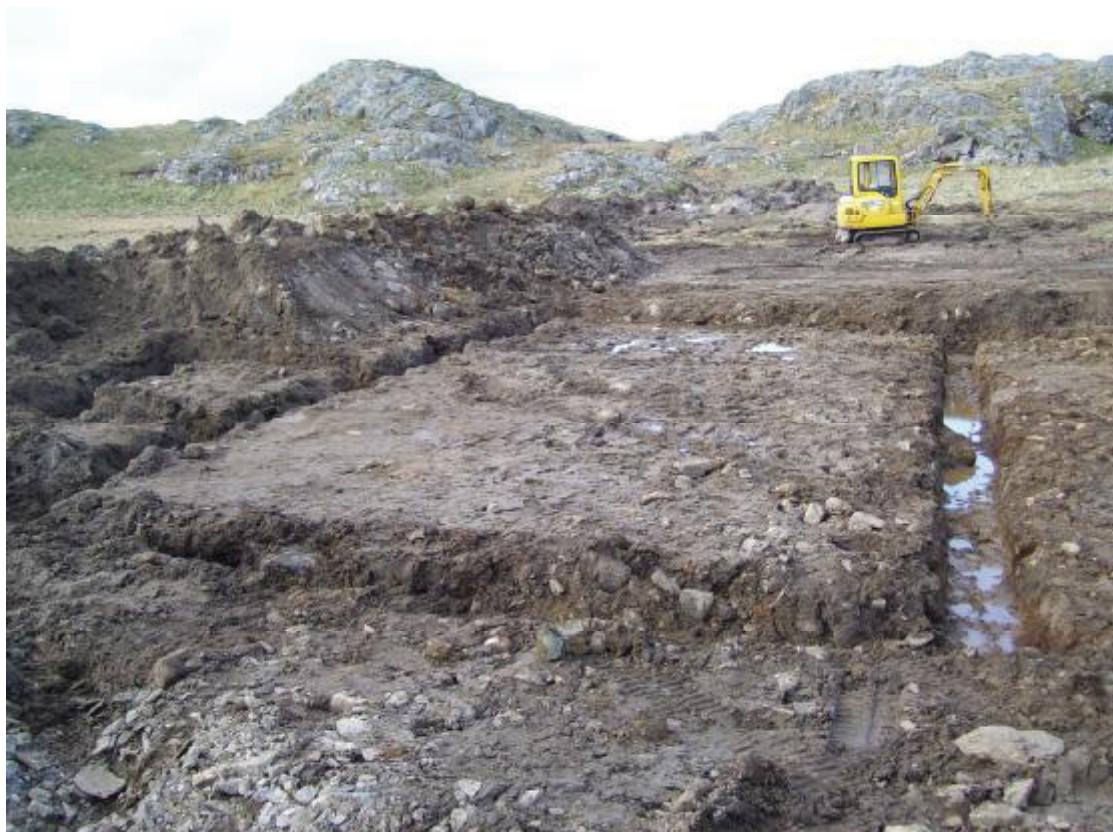
Figure 4c – general post-ex showing foundation trenches
