**19 Market Street, Stranraer
Historic Building Recording and Evaluation**

Data Structure Report

by Rebecca Shaw

6th June 2008

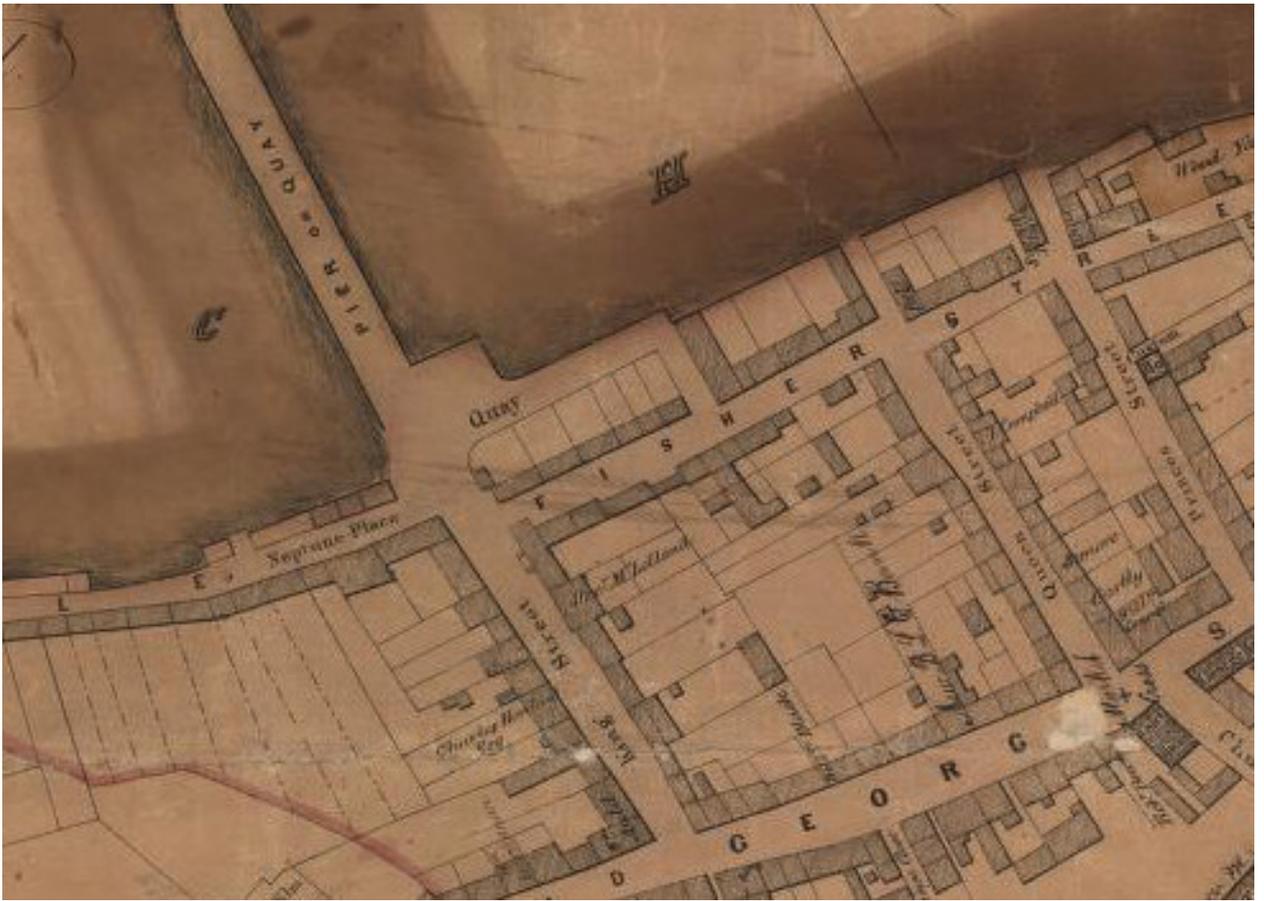
Figure 1a – Woods (1843)

The earliest definitive cartographic source we have for the area the site is on is John Woods town plan of 1843 (Figure 1a) on which depicts a building frontage on Fisher Street with a yard or garden behind it running down towards the Quay. As well as the long roofed rectangular building along the frontage on Fisher Street there is also a smaller roofed rectangular structure fronting onto King Street. By the time of the ordnance survey town plan only a few years later (1847) the small structure on King Street has disappeared and Market Street has been established running adjacent to the Quay (Figure 1b). There is still a rectangular building fronting onto Fisher Street but there is now also a roughly rectangular shaped building with an internal dividing wall fronting onto Market Street. There is a yard between the two structures which is accessed from King Street.

From cartographic sources it appears (Figure 1a) that in the early 1840's there was a dwelling fronting onto Fisher Street with a backland / garden area running north behind the structure towards the quay. There is also a small structure to the west which is most likely an ancillary building related to the property on Fisher Street. However, by the late 1840's the small ancillary structure and the backland / garden area had gone and been replaced by two buildings; one still fronting onto Fisher Street and the other fronting onto the newly built Market Street (Figure 1b) with a yard area between them.

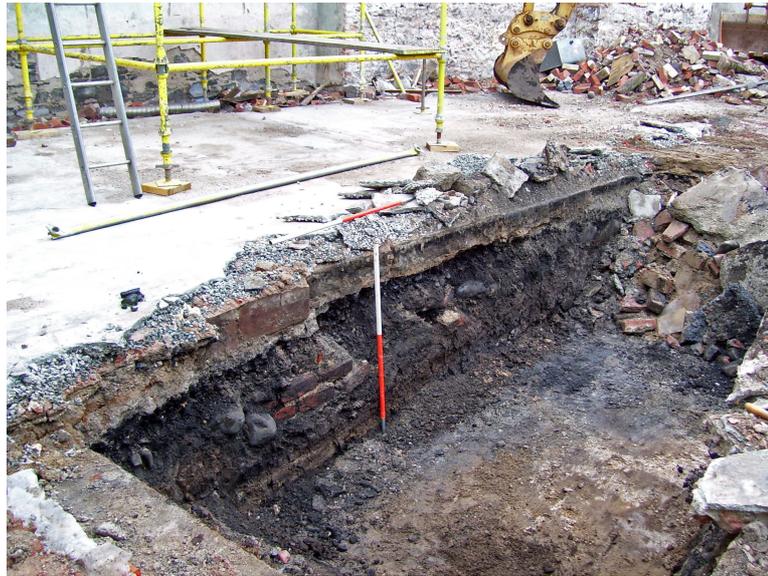
Figure 2a – Trench 1

In Trench 1 there was a very strong smell of a diesel-like substance at the subsoil level (about 1.10m down from the top of the upper surface). The sandy subsoil [105] was also stained darker in this area further suggesting ground contamination. Above subsoil [104] and [105] was a mid to dark brown fairly clean slightly clayey silt [112] which was between 190mm and 370mm in depth.

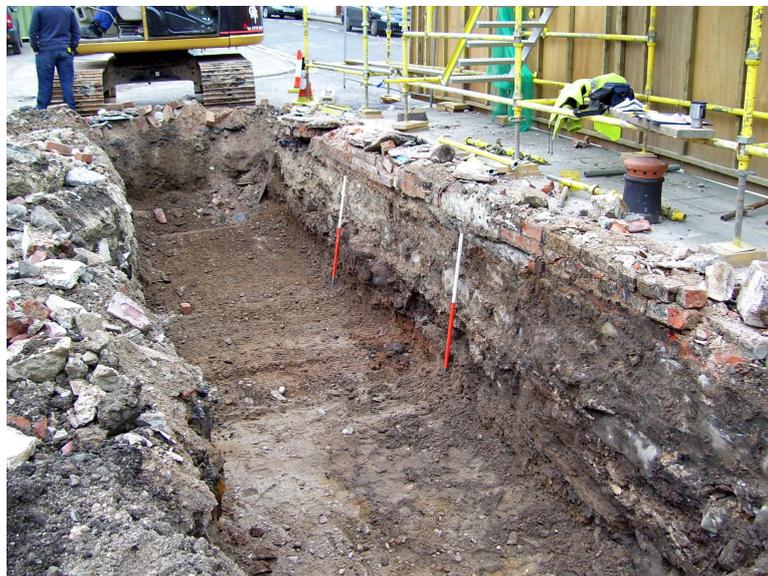
Figure 2b – Trench 4

All the trenches had an upper floor surface made of concrete with either a sandy or pebble / gravel subsoil which appeared beach-like in its composition (Figure 3c and 2b). Trenches 2, 3 and 6 all exhibited *in-situ* cobbling [204] [306] [605] and [607] at a depth of between 300mm to 400mm below the upper surface (Figures 3a-b). The cobbling comprised various sized, mostly sub-angular stones set on their ends (Figure 2c). Above the cobbling (and in some cases within the cobbles) was a black clinker-like material containing ash & coke [203] [304] and [608]. With the exception of one or two shards of green bottle glass, there were no obvious finds on within or on the cobbled surface.

Trench 4 had the slight remains of an earlier wall [405] situated immediately below the red brick wall [404] that formed the western elevation (King St) of the structure that had been demolished. The wall comprised large angular, sub-angular and sub-rounded stones bonded together with a pale yellowish white sandy mortar. The foundations [406] for the earlier wall (Figure 2b) protruded slightly and were made of very large rounded stones. The wall measured 450mm in height (at most) and the foundations 350mm.

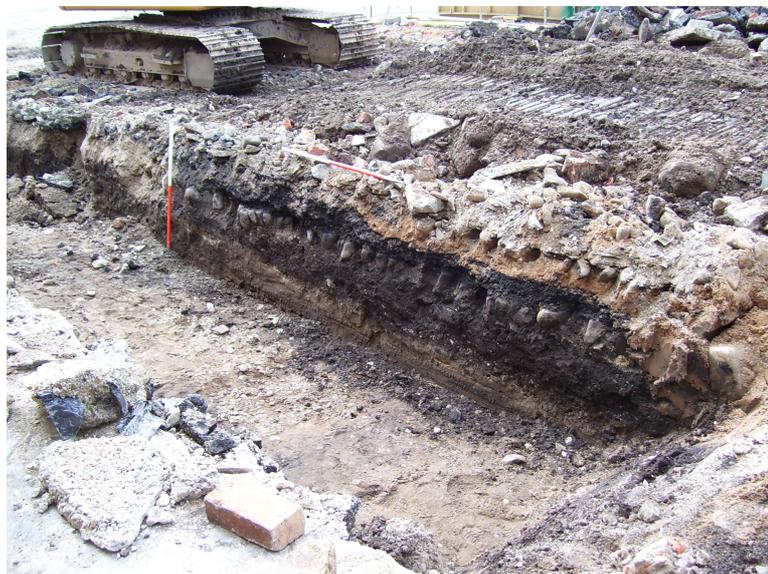
Figure 2c - Trench 6

At the northern end of Trench 6 (about 760mm from the top of the upper surface) there was a discreet layer of flint & chalk deposits with some burning waste [614] that could be waste debris related to a clamp or lime kiln (John Pickin *pers comm*). It did however, appear to form part of a deliberately laid even spread rather than a random dump.

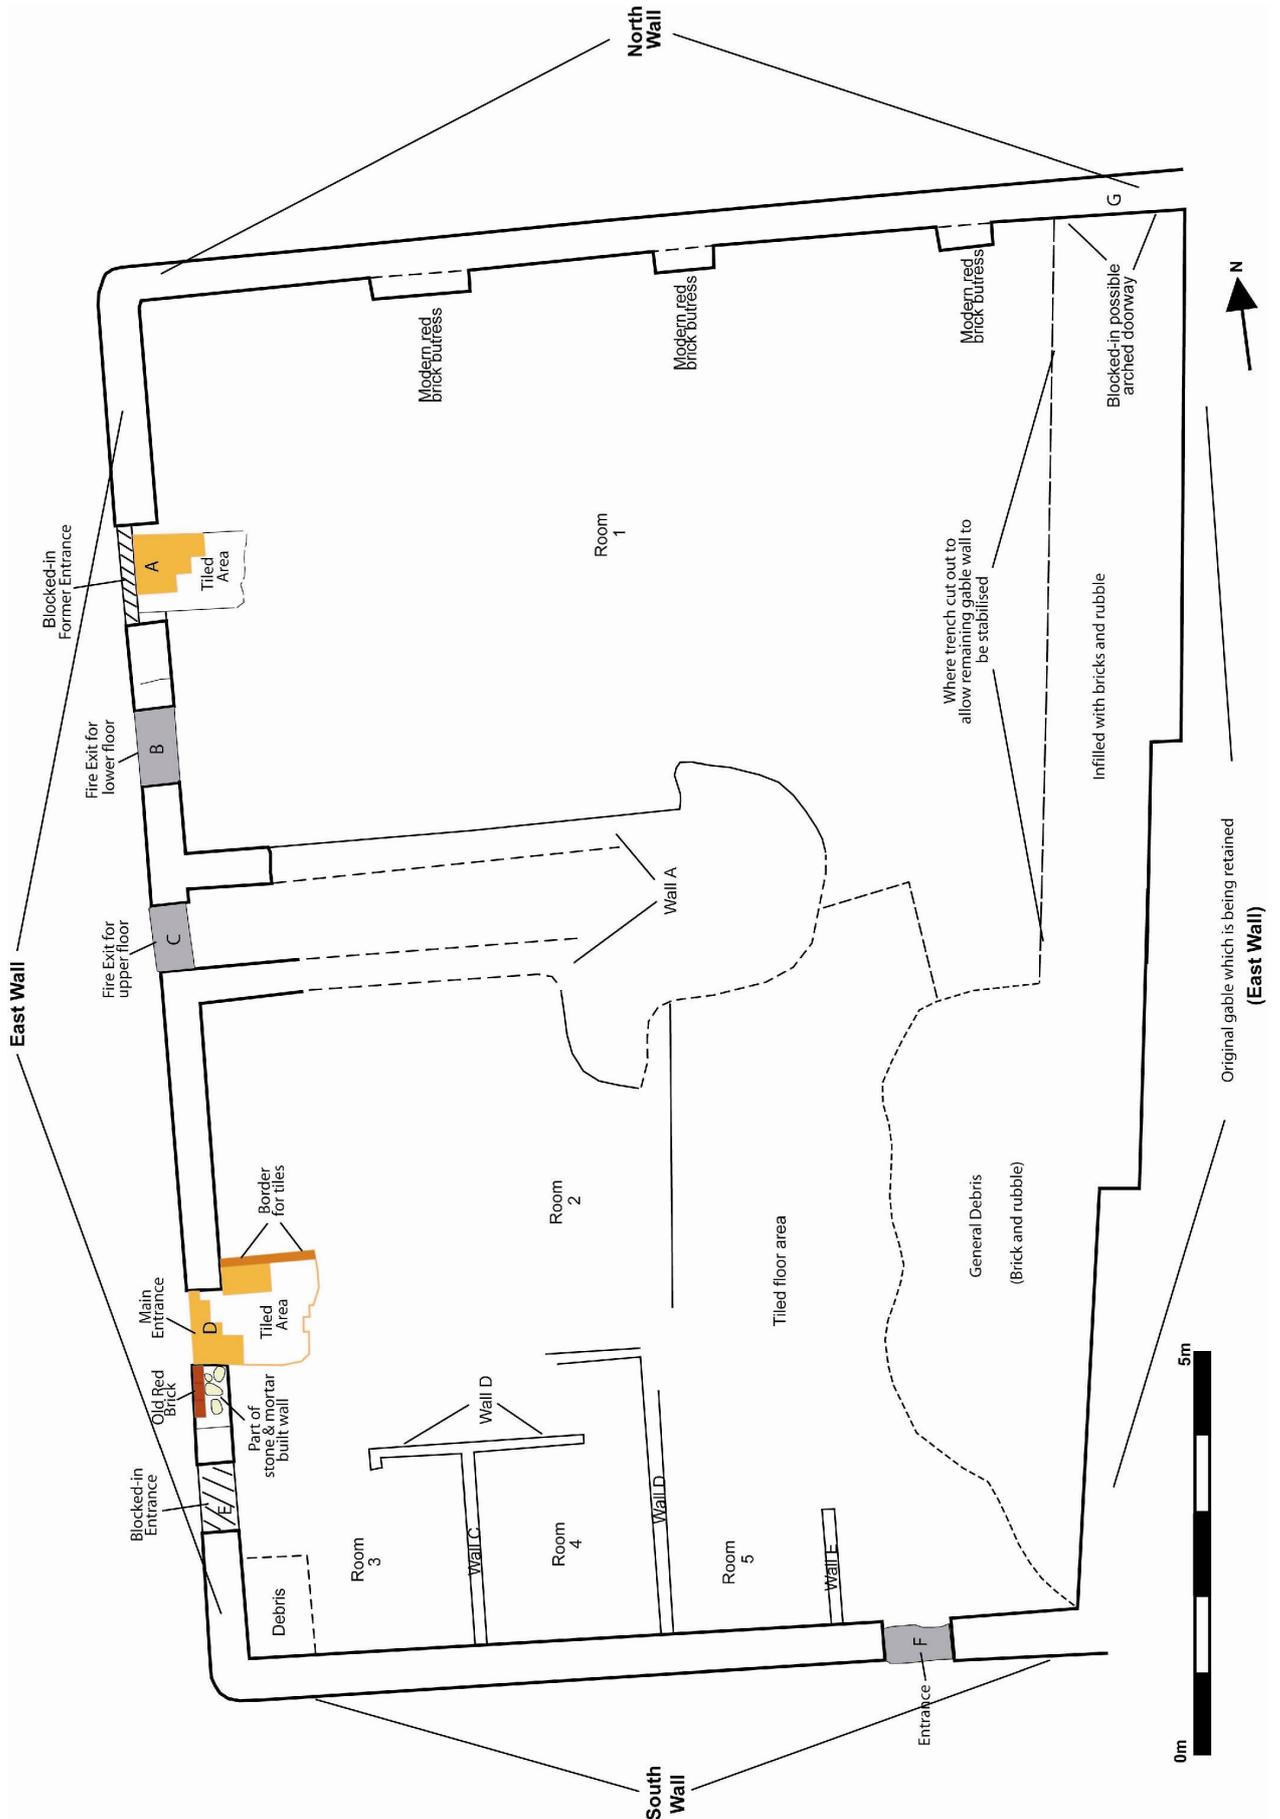
Figure 4 – Ground Floor plan

Within the interior of the building all of the visible features were relatively modern relating to its use as a pub (The Break) such as internal walls for toilets, cloakroom, dance-floor, tiled floor etc. There were indications of where new entrances had been added or older ones blocked-in and where windows had been latterly inserted into walls. The addition of the stair leading to the upper floor also appeared to have been added at a later date.

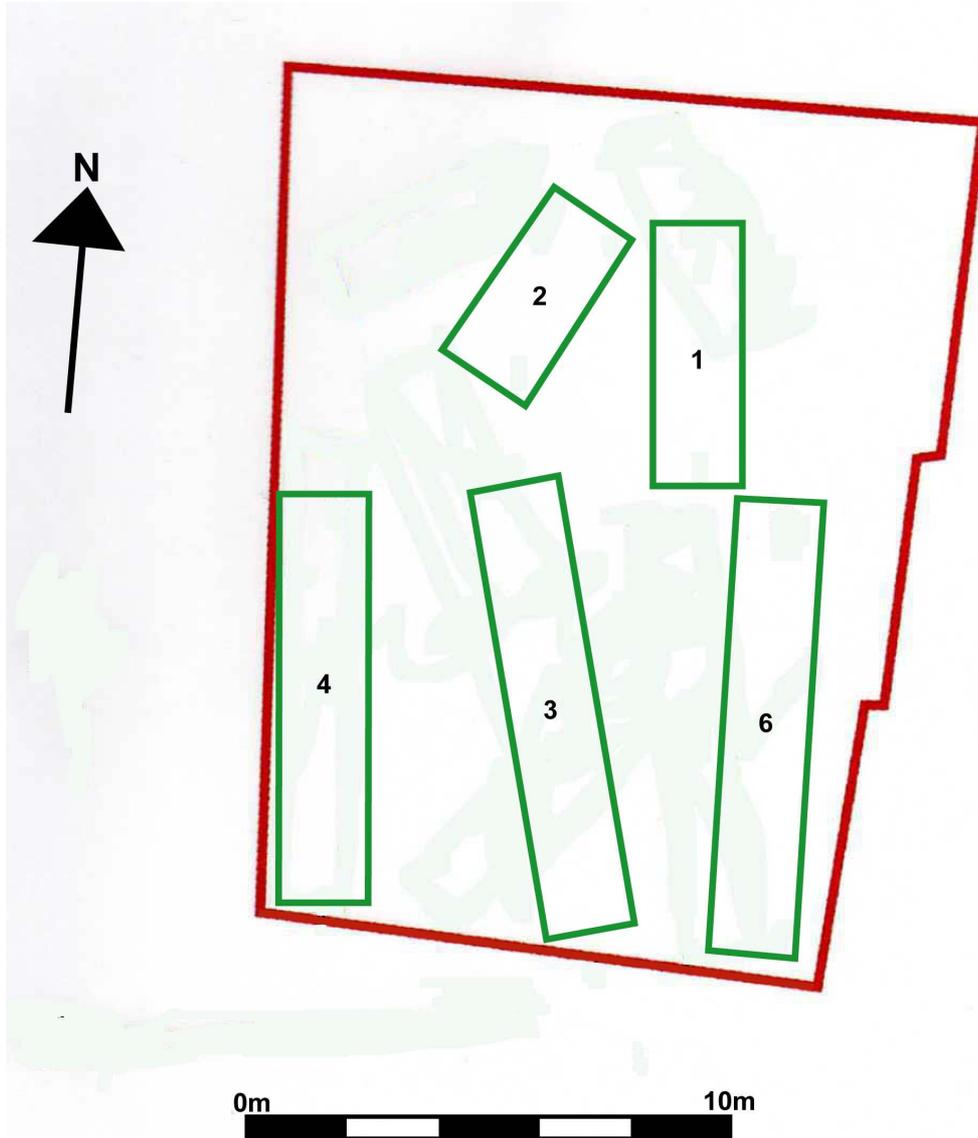
Figure 5 – Plan showing actual location of trenches

The locations of the five trenches are shown in (Figure 5) and the findings are detailed within the appendices:

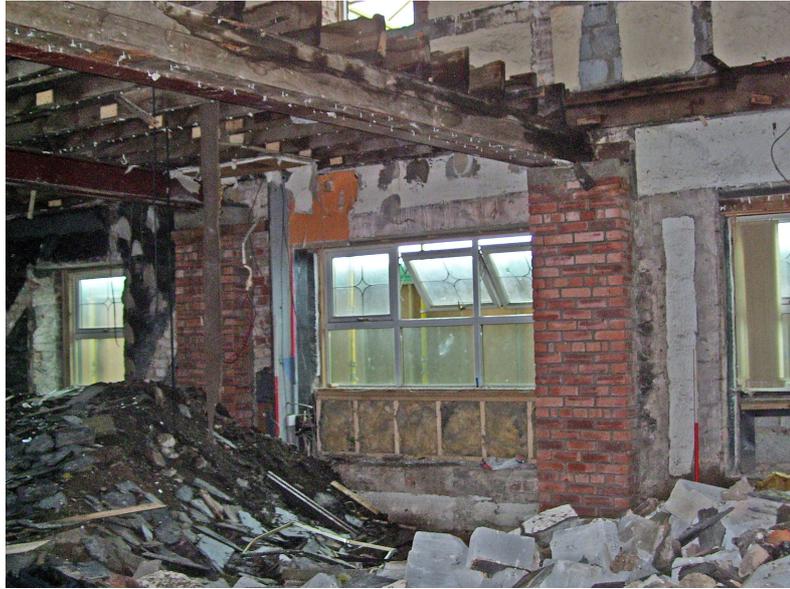
Figure 9a – buttresses in northern wall

The northern wall (Market Street elevation) also comprised Victorian redbrick with three lower windows and four upper windows, at the eastern end of the wall there was an entrance blocked in with grey block (G). However, a large section of the wall was inset here and it is possible that at one time there was a very large entrance here, made smaller latterly then finally totally blocked up. Three newer looking red brick square pillars/butresses protruded from this wall which held up the steel floor beams inserted to support the snooker tables. Like both the northern and western walls the southern wall (Fisher Street elevation) comprised Victorian red brick, it contained two small windows on the upper floor and one doorway (F). A number of vents were visible on this wall

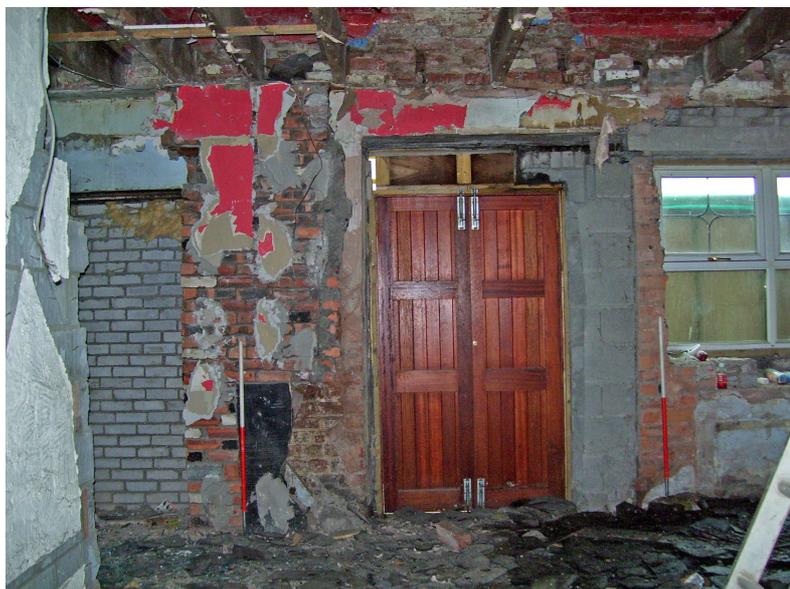
Figure 9c – main entrance (D)

The west wall (King Street elevation) comprised Victorian redbrick with two windows on the lower floor and four on the upper floor. There were two large doorways (B and D) and one small doorway (C) as well as one large blocked in doorway (with grey block) (A) and one small blocked in doorway (grey brick) (E) (the blocked in doorways were only visible on the interior). Later repairs such as the narrowing of the main entrance (D) and repairs around the window (Figure 9c) were also done with grey brick and block.

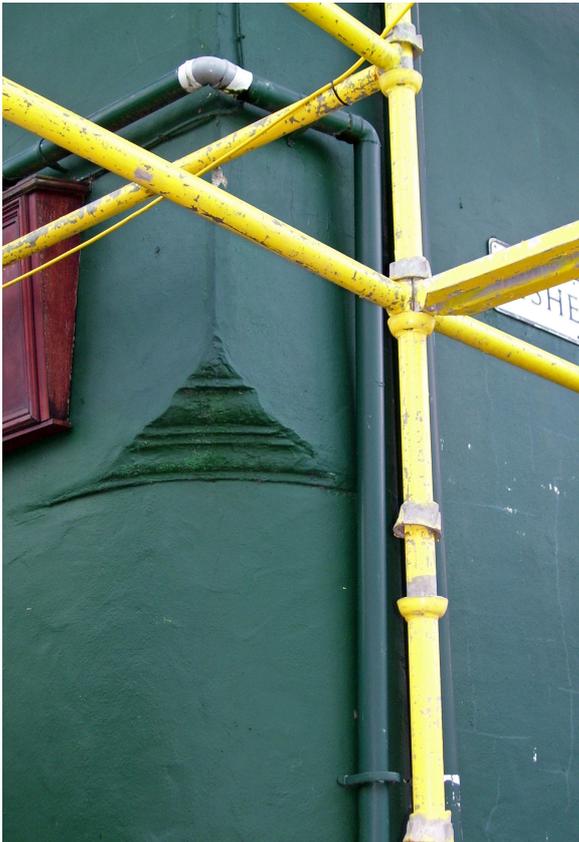
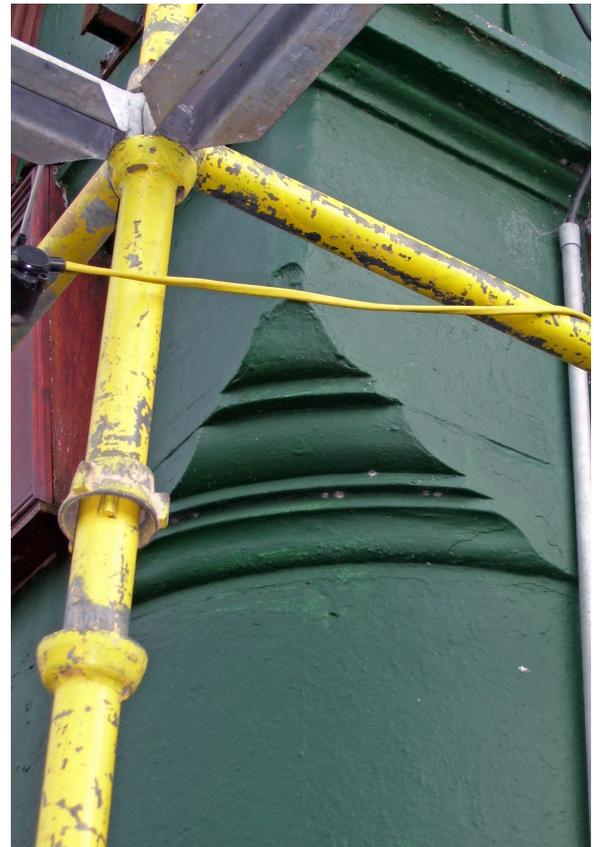
At both the northwest and southwest corners of the exterior of the building the lower halves of the corners were rounded and topped with a moulded protrusion (Figures 10a and 10b) – the corners above the moulding were angled and the mouldings were the only decorative features on the exterior of the structure.

Figure 10a – moulding SW corner

Figure 10b – moulding NW corner

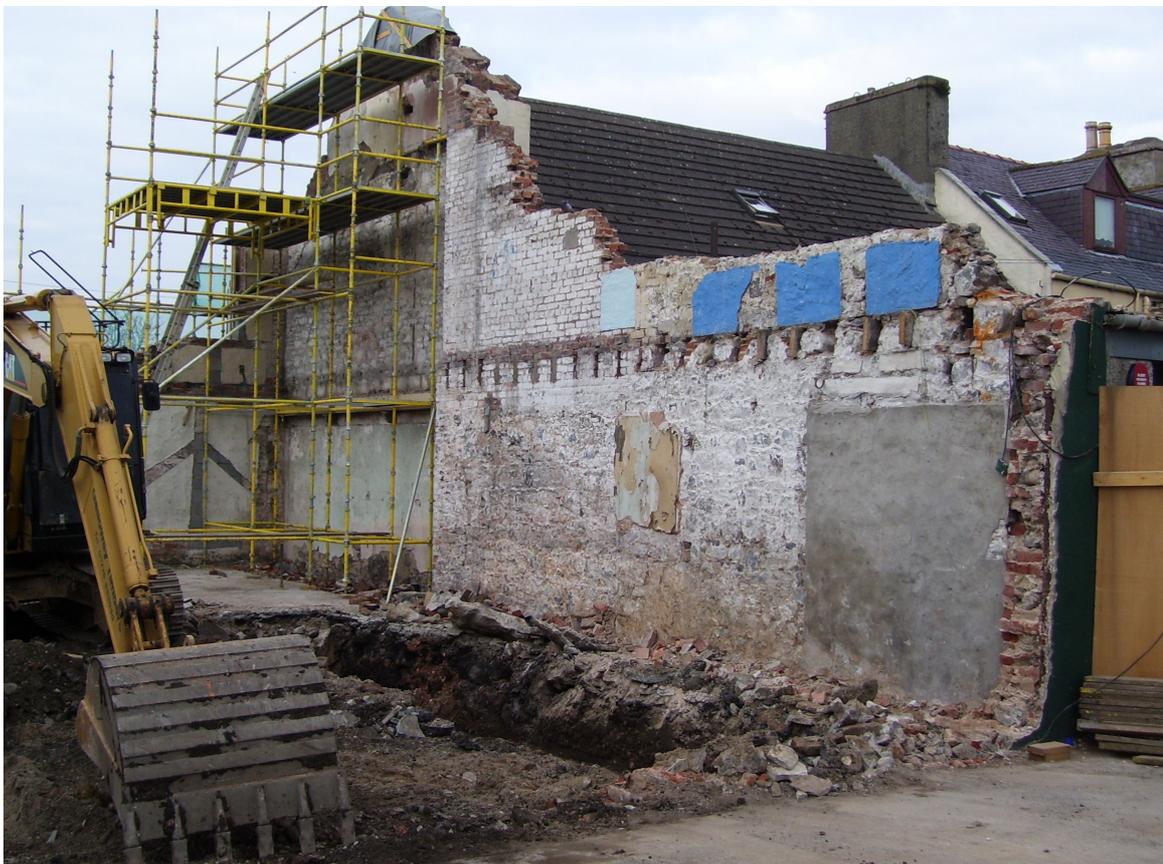
Figure 10c – eastern wall showing gables

The eastern wall of the structure (which has been retained as it is also the supporting gable for the adjoining house, differed to the other three walls in that it was made of stone. The gable in fact comprises 'three' sections measuring 6.8m (northernmost) 5.5m (centre) and 5.3m (southernmost). The sections are not in alignment and comprise stones of various sizes and shape which have been roughly mortared and plastered. In both the northernmost and southernmost gables this composition is apparent their entire height but in the centre section the upper half is constructed of red brick (Figure 10c).

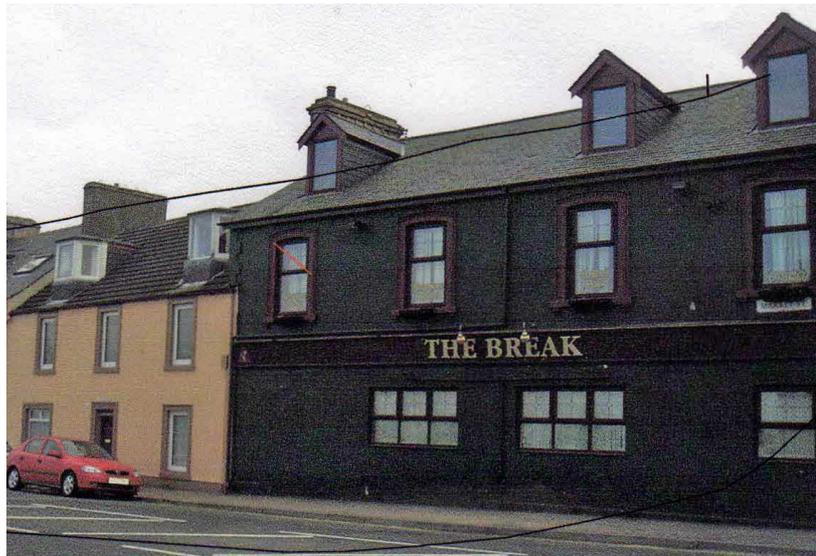
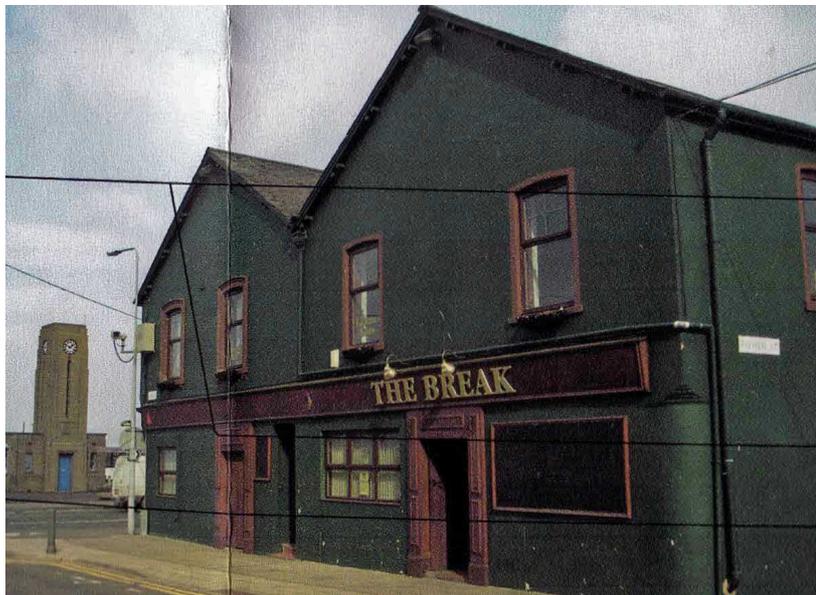
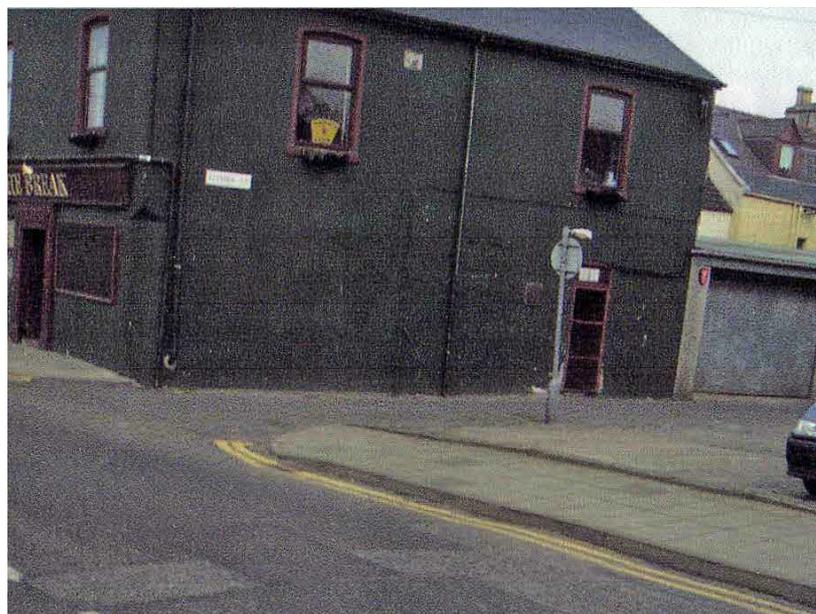
Prior to demolition the structure comprised a roughly rectangular shaped two storey gabled building with a tiled roof. Three dormer windows were observable on the roof with fifteen various sized windows on the main structure and four doorways. The exterior of the structure had a smooth render and had been painted dark green. The name 'The Break' was on signs on both the northern and western faces. Before building recording works were undertaken a scaffold had been put up around the exterior of the structure as well as boarding to protect pedestrians. This meant that it was not possible to get scaled photographs of the exterior; however, Galloway Timbers Ltd did pass on some photographs they took before the scaffolding was put up and these are included in the general building recording photographs at the end of the report (Figures 11a-c).

Figure 11a – northern elevation (Market St)

Figure 11b – western elevation (King St)

Figure 11c – southern elevation (Fisher St)
