Seal Bay, Kildonan, Isle of Arran: Archaeological Investigative Works

Data Structure Report

issued 4th December 2009

Rebecca Shaw Archaeological Services

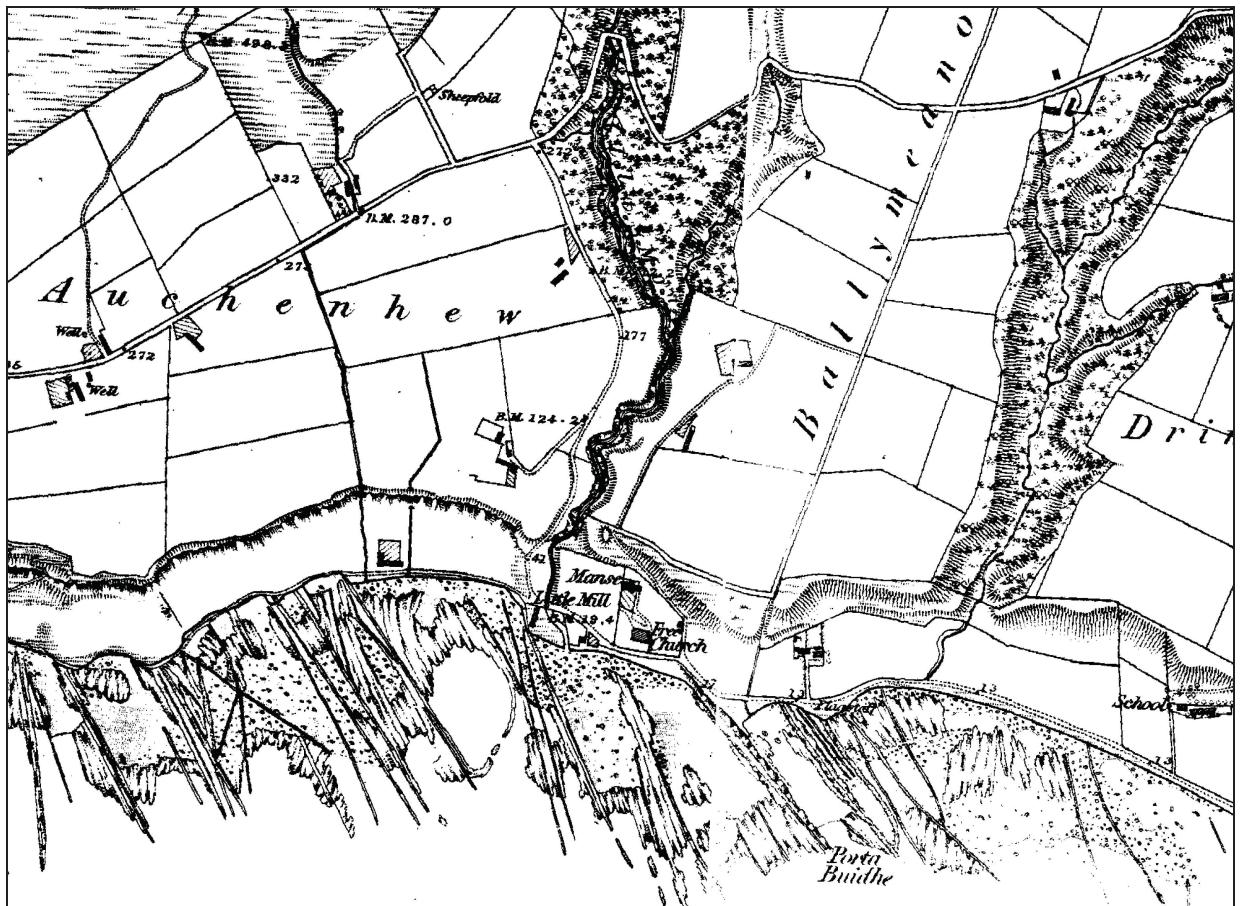
Figure 2a – 1st Edition Ordnance Survey (1869)

Early cartographic sources indicate that the proposed development area (Figure 1) has always been open ground (Figures 2a and 2b) which has only been used for agricultural purposes. Old pictures (sourced at Ocean Breeze Bed & Breakfast next to the site) show that although the site was often in grass it was also used to grow crops (possibly potatoes) as well as hay stacks are visible in one of the pictures.

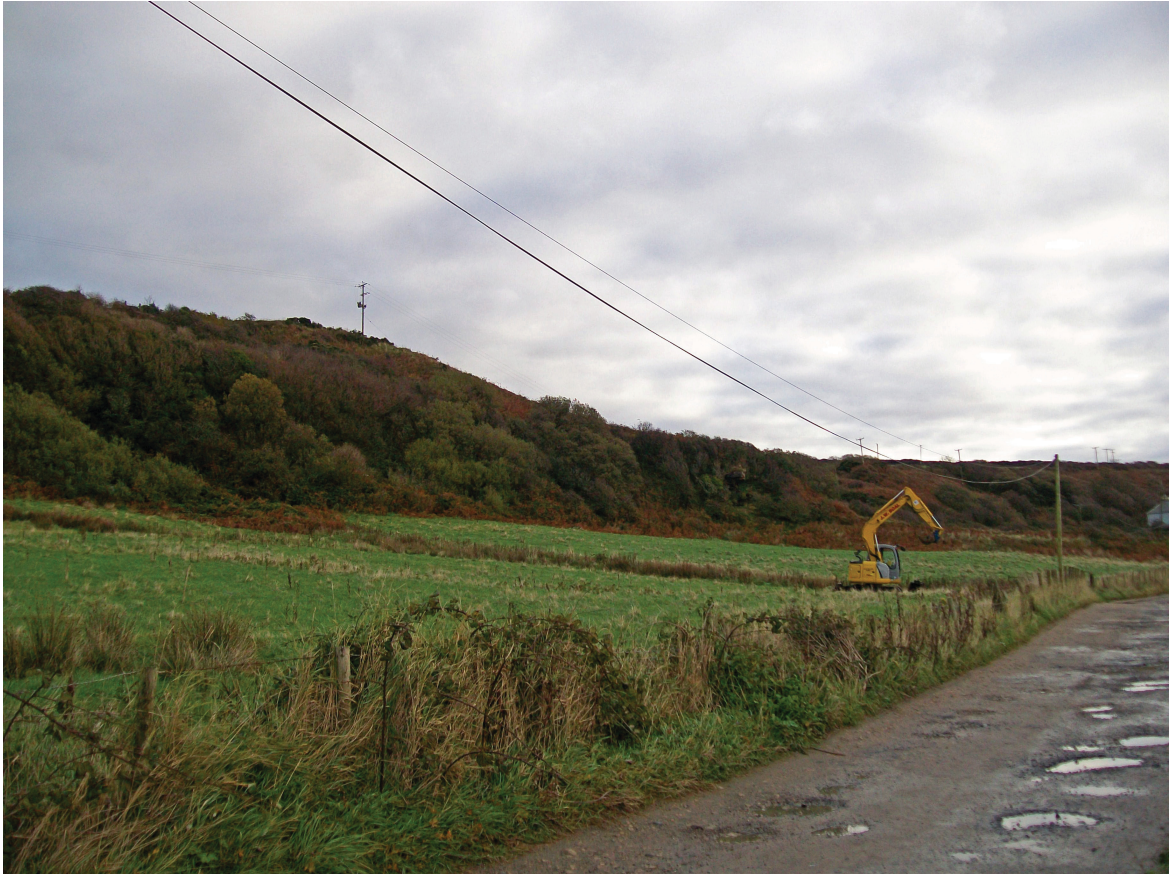
Figure 3a – Pre-ex of site

The site slopes from north to south (Figure 3a) with steep cliffs (Figure 3b) located at the northern end before flattening out at the very southern end as it heads towards the sea. In general the topsoil was deeper at the northern end of the site at the base of the cliffs.

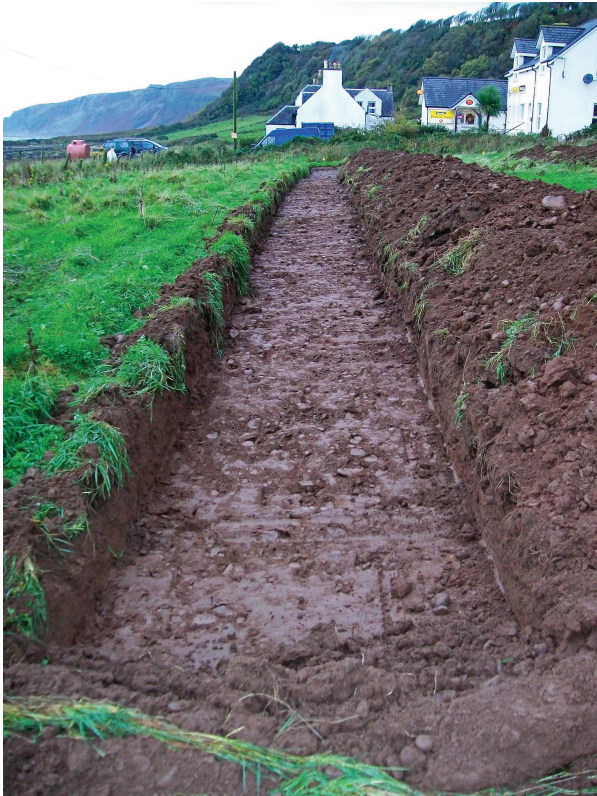
Figure 4a – Trench 14

The subsoil (Figures 4a – 4d) varied from a mid brown coarse gravelly sandy silt containing numerous small sub-rounded and sub-angular stone; to a brownish orange clay with occasional stones and a gravelly clay with very frequent sub-rounded stones with occasional areas of silt and very occasional very large stones. Bedrock was visible at the base of trench 9 and trenches 1, 4, 5, 6, 8, 9 and 12 all contained rubble drains.

Subsoil character: Mid brown silty clay containing a moderate to frequent amount of sub-angular and sub-rounded stones [1402].

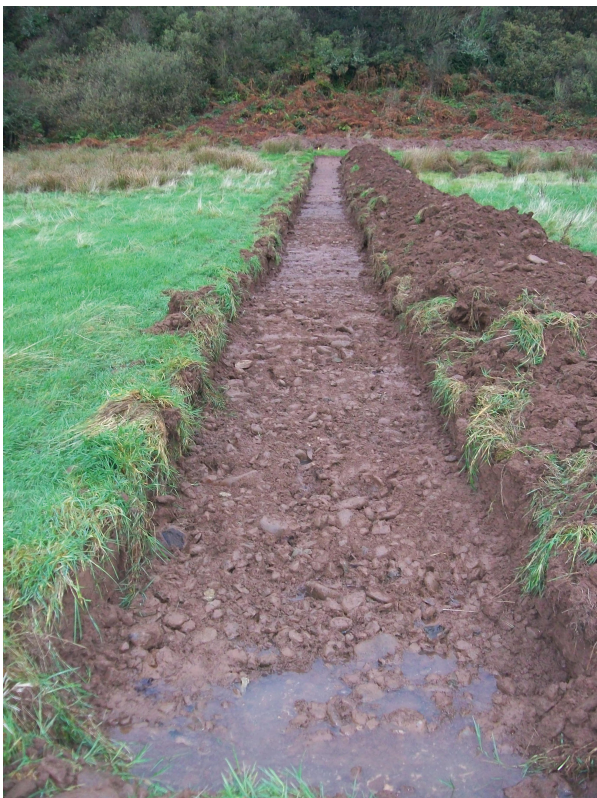
Figure 4c – Trench 12

Orientation:	North to South
Size:	44m by 1.8m (79.20m ²)
Subsoil character:	Brownish orange stony clay with occasional very large rocks [1202]. From 16m to 23m the subsoil comprises a mid to dark brown slightly gravelly clay containing an occasional to moderate amount of small stones [1204]. From 23m to the end of the trench the subsoil is a mid brown gravelly silt with frequent small angular and sub-angular stones [1205].

Modern features: Rubble drain [1203].

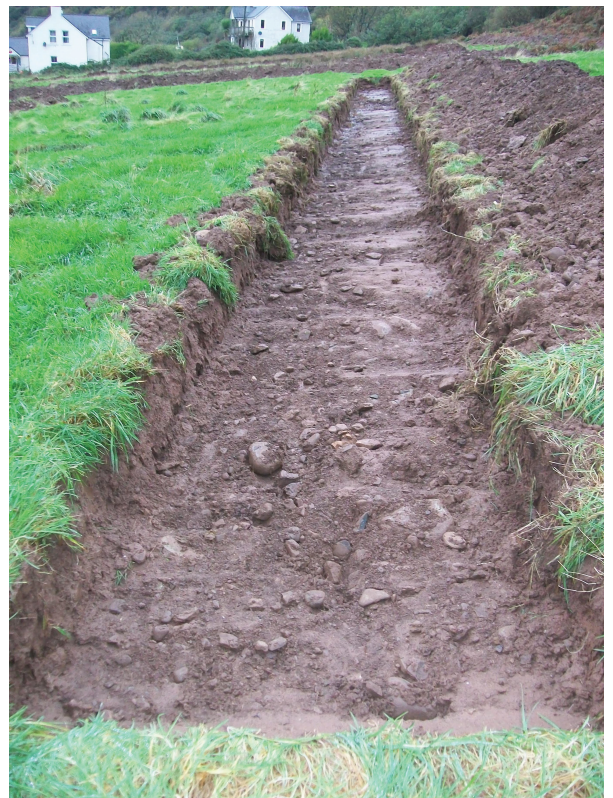
Figure 4d – Trench 4

Orientation:	West to East.
Size:	39m by 1.8m (70.20m ²)
Subsoil character:	Brownish orange clay with occasional small stones [402].
Modern features:	Rubble drain.
Significant features:	None
Artefacts:	None.
