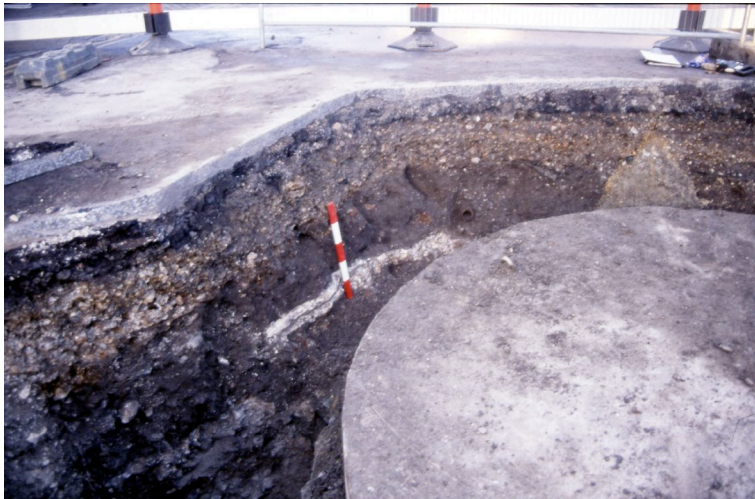
Plate 2: Chalk floors of post-medieval building with Roman road gravels in lower left foreground

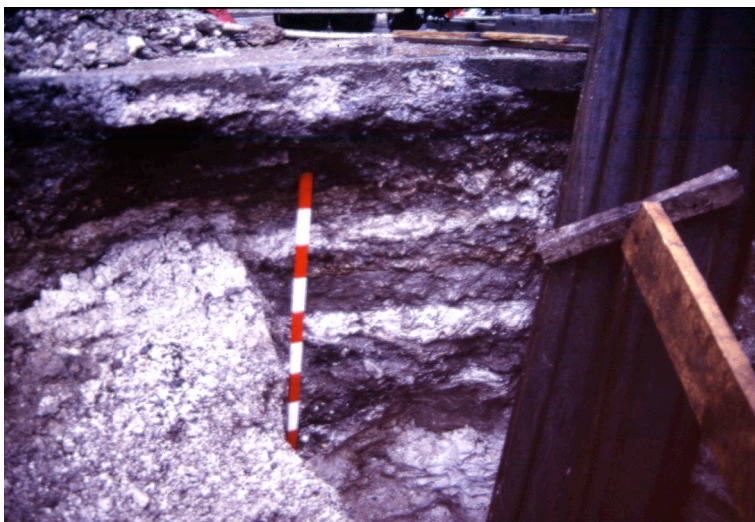
Plate 3: View of south section, showing Roman road gravels

Context	Description	Interpretation	Depth / Thickness
	Filled with 21. Cut from base of 2		
Contexts exposed in South Section (Figure 5)			
1	Modern tarmac	Existing road surface	0.20 m
2	Compact flint gravel	Sub-base for 1	0.28 m
26	Unconsolidated chalk rubble in very dark grey silty matrix	Uncertain-modern	0.08 m
27	Very compact redeposited chalk	Make-up	0.07 m
28	Very compact greyish-brown flint gravel	Make-up	0.09 m
29	Compact strong yellowish-brown flint gravel	Make-up	0.05 m
30	Firm brownish-grey silty loam with rare flint fragments up to 0.06 m	Soil layer	0.14 m
31	Compact redeposited chalk with rare flint fragments up to 0.08 m	Make-up	0.15 m
32	Very compact brownish-grey flint gravel including small quantity silty clay loam	Make-up	0.19 m
33	Dark brown silty clay loam with common small sub-angular chalk pieces up to 0.02m	Fill / layer	0.08 m (E. side)
34	Chalk rubble, small sub-angular to sub-rounded pieces up to 0.04 m	Fill / layer	0.11 m (E. side)
