## **A650 Bingley Relief Road**

### **Archaeological Evaluations, 1999**

Overall summary of results

BTI 004383 March 2000

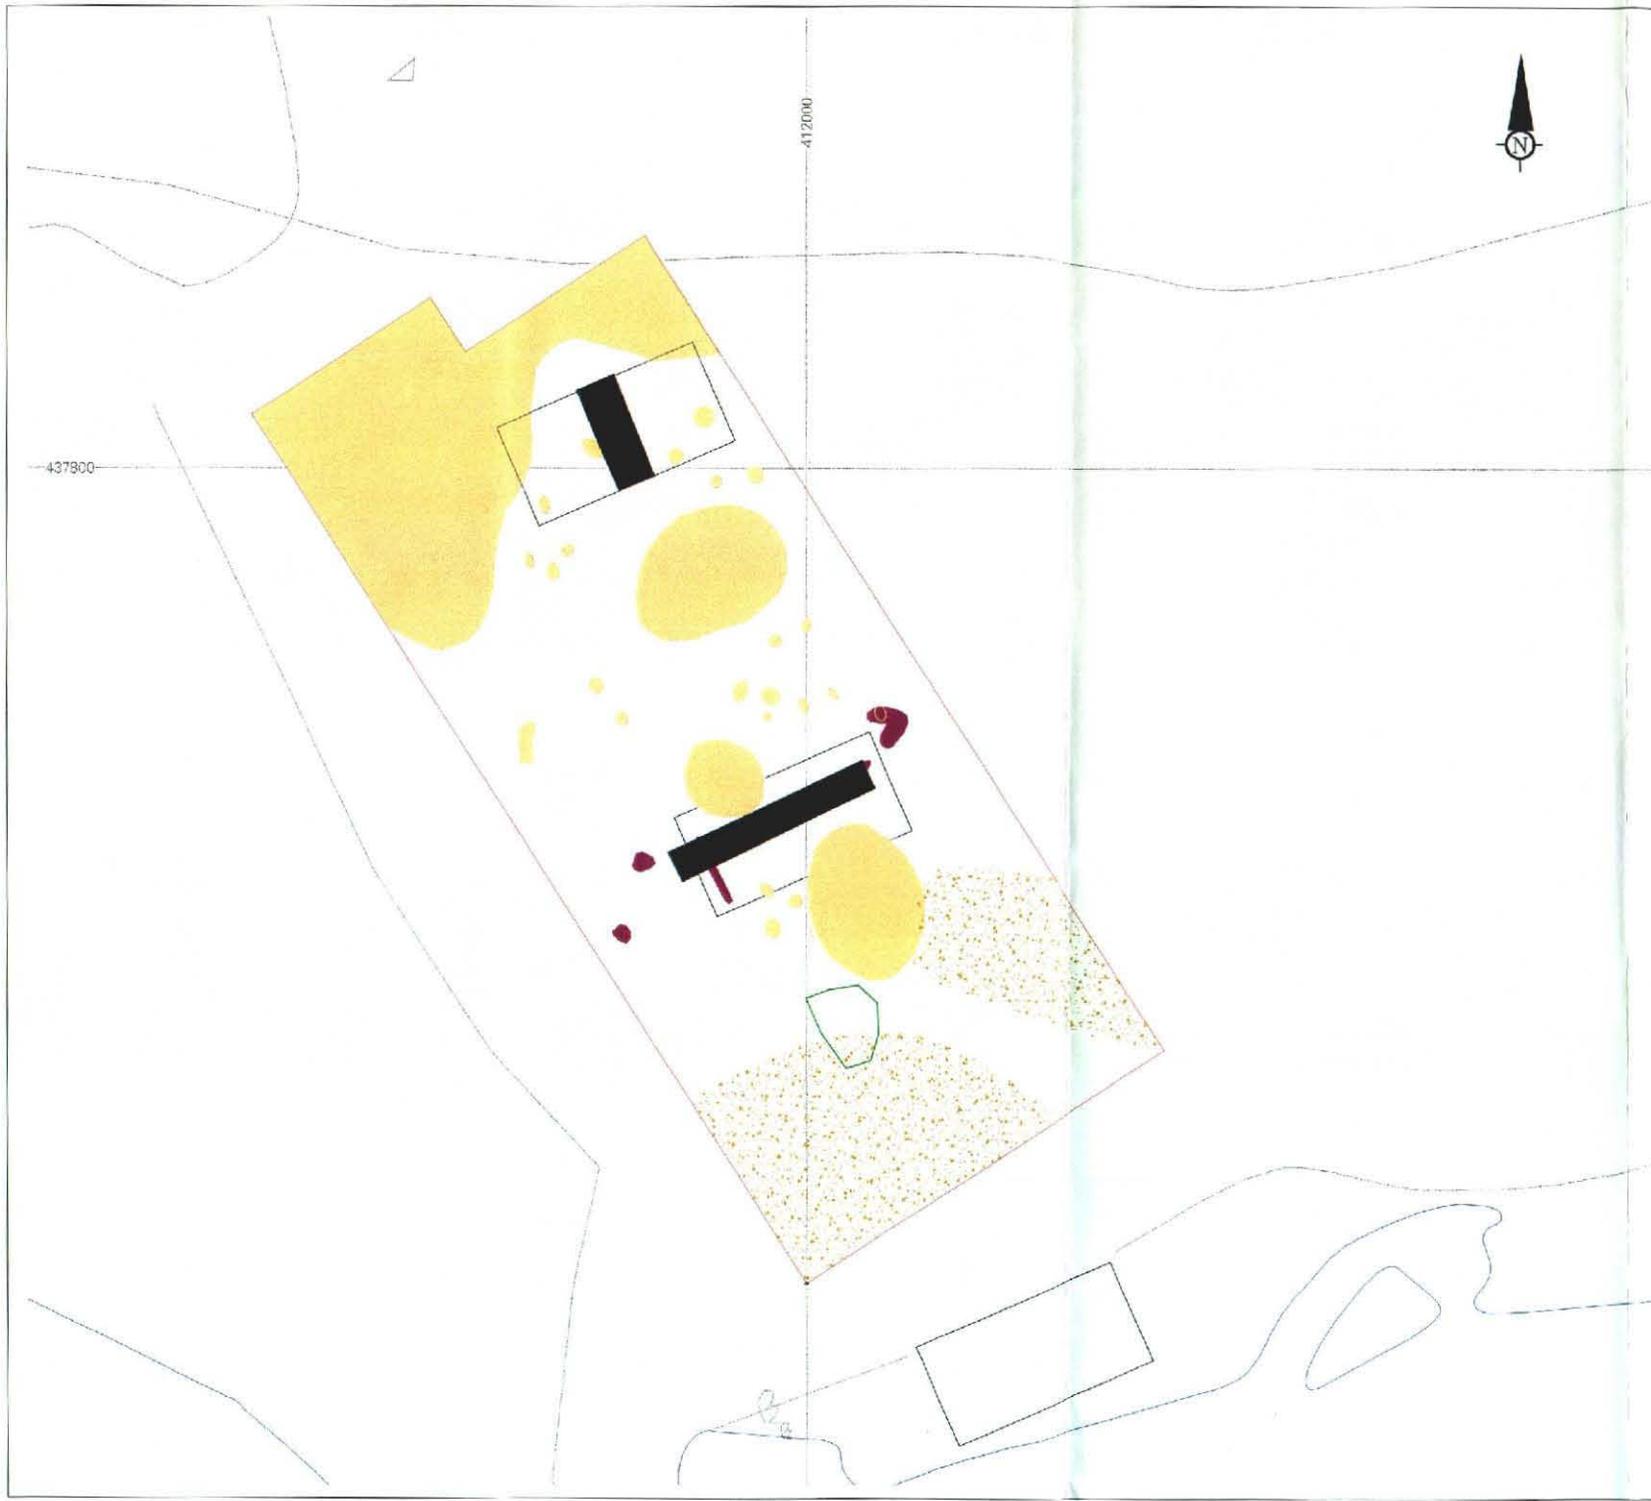
Client	Highways Agency		
Project	A650 Bingley Relief Road		
	Figure 2 - Site 6 : Trench Locations and Geophysical Survey Results		
Drawing No.	BTI 04383/125/14		
	1:500	Date	Jan 00
	Drawn	Checked	Approved

- 3.1.2 Geophysical (gradiometer) survey over an area of about 0.5 hectares identified large areas of ferrous disturbance at the north-west and south-east ends of the survey area, with smaller patches of ferrous responses scattered throughout the area. A small group of amorphous anomalies in the centre of the survey area, close to one of the viaduct piers, were tentatively identified as of possible archaeological origin. No clear interpretation of the anomalies was possible, and it is equally likely that they were of natural origin.

- 3.1.3 Sample excavation of two trenches totalling 120m<sup>2</sup>, one located at each viaduct pier, failed to identify any archaeological remains. Topsoil and subsoil were stripped by mechanical excavator, followed by hand-cleaning of the exposed surfaces. No archaeological remains were identified at this level. Mechanical excavation in smaller sample areas demonstrated that the subsoil of undifferentiated fine alluvial deposits continued to at least 1.5m below ground level in each trench, well below the maximum depth at which gradiometer survey would be expected to detect archaeological remains.

### 3.1 **Site 6 (Flint scatters and other finds along the River Aire) - Figure 2**

4.1.1 The sample excavations indicated that it is unlikely that any archaeological remains are present at the locations of the viaduct piers. While there were some magnetic anomalies of possible archaeological origin in the area, nothing was recognised in the trenches. A larger area of magnetic disturbance in the southern part of the site could be of industrial or natural origin; it was not investigated by sample excavation as it lay away from the viaduct piers.

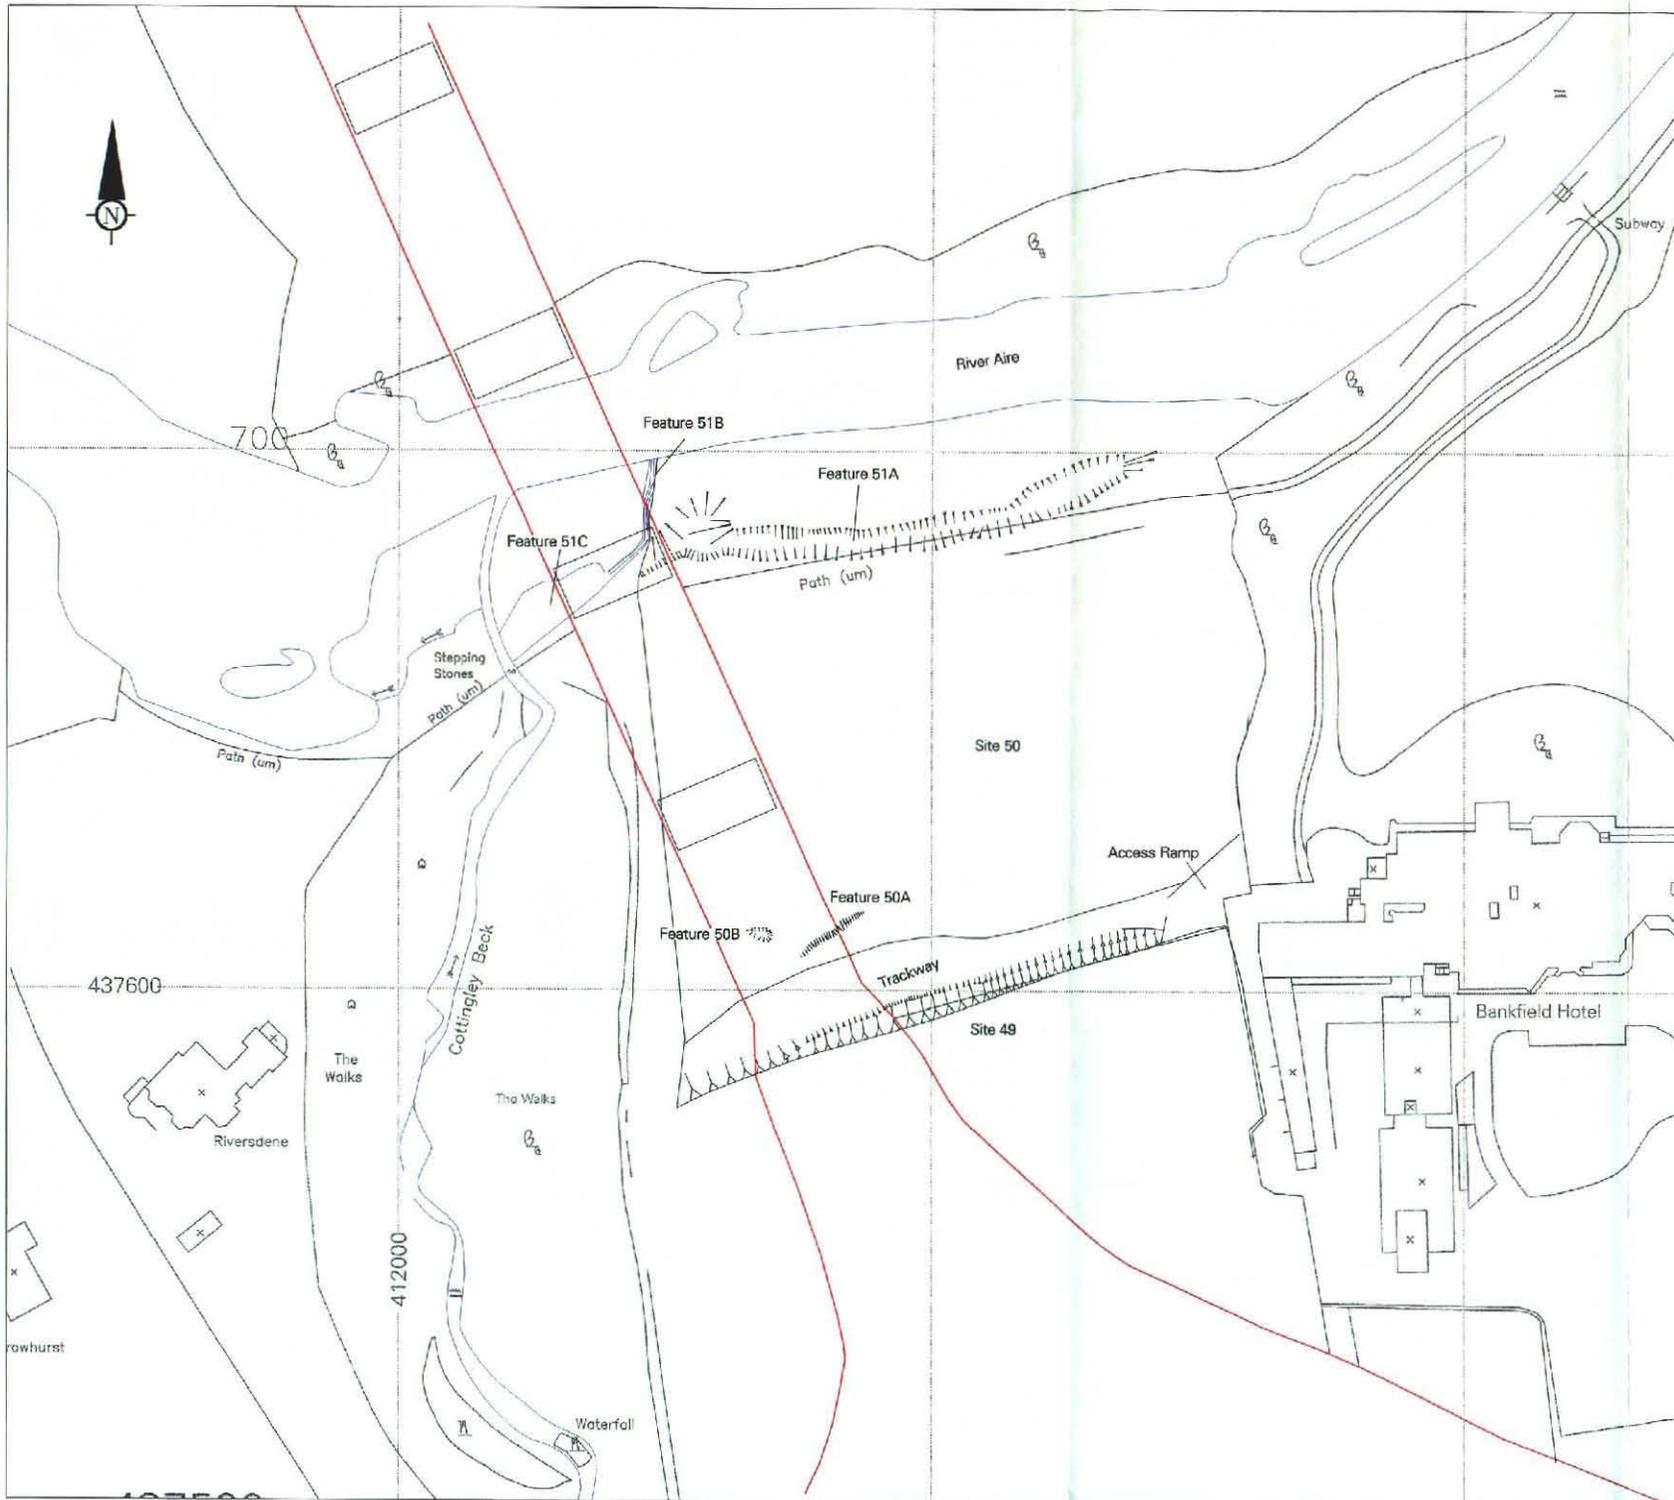
Client	Highways Agency
Project	Bingley Relief Road
Title	Figure 3 - Earthwork Survey of Site 49, 50 and 51

**3.4.2** The lynchet was recorded by earthwork survey. It was up to 1.2m high and 2.7 - 3m wide, orientated approximately east to west with a modern fence and hedge on its top edge and face. It is marked as a boundary on the Ordnance Survey map of 1852. Stone is visible in the face of the lynchet, and it has a break of slope on its face. Dumps of dressed stone are visible on this feature, but do not appear to be directly associated with it. The trackway was recorded as a relatively level area at the base of the lynchet. It is unclear whether it is of man-made origin, although it could have been partially terraced into the slope; its up-slope edge is obscured by the presence of the lynchet. The 'trackway' is partially overlain by a modern access ramp into the field. After consultation with WYAS-AS, no sample excavation was undertaken in Site 49.

**3.4.3** In Site 50, earthwork survey identified the remains of a low grass-covered stone bank, 0.3m high and 1m wide orientated south-west to north-east with stone visible. An oval depression is located 8m to the west of this feature. Although individual pieces of large rubble are scattered around the field, no other terraces or wall footings were present. Gradiometer survey identified two magnetically strong anomalies which could represent burnt or fired structures, although they were more likely to result from modern ferrous objects. Two larger areas of magnetic disturbance and some weak linear trends could also have archaeological origins, although again they were considered more likely to have modern or natural origins. Resistivity survey identified two large areas of high resistance in the southern (up-slope) part of the site. These anomalies were likely to be caused by topographic changes, although one was partly bounded by a band of low resistance and coincided with an area of magnetic disturbance, and could therefore be of archaeological origin.

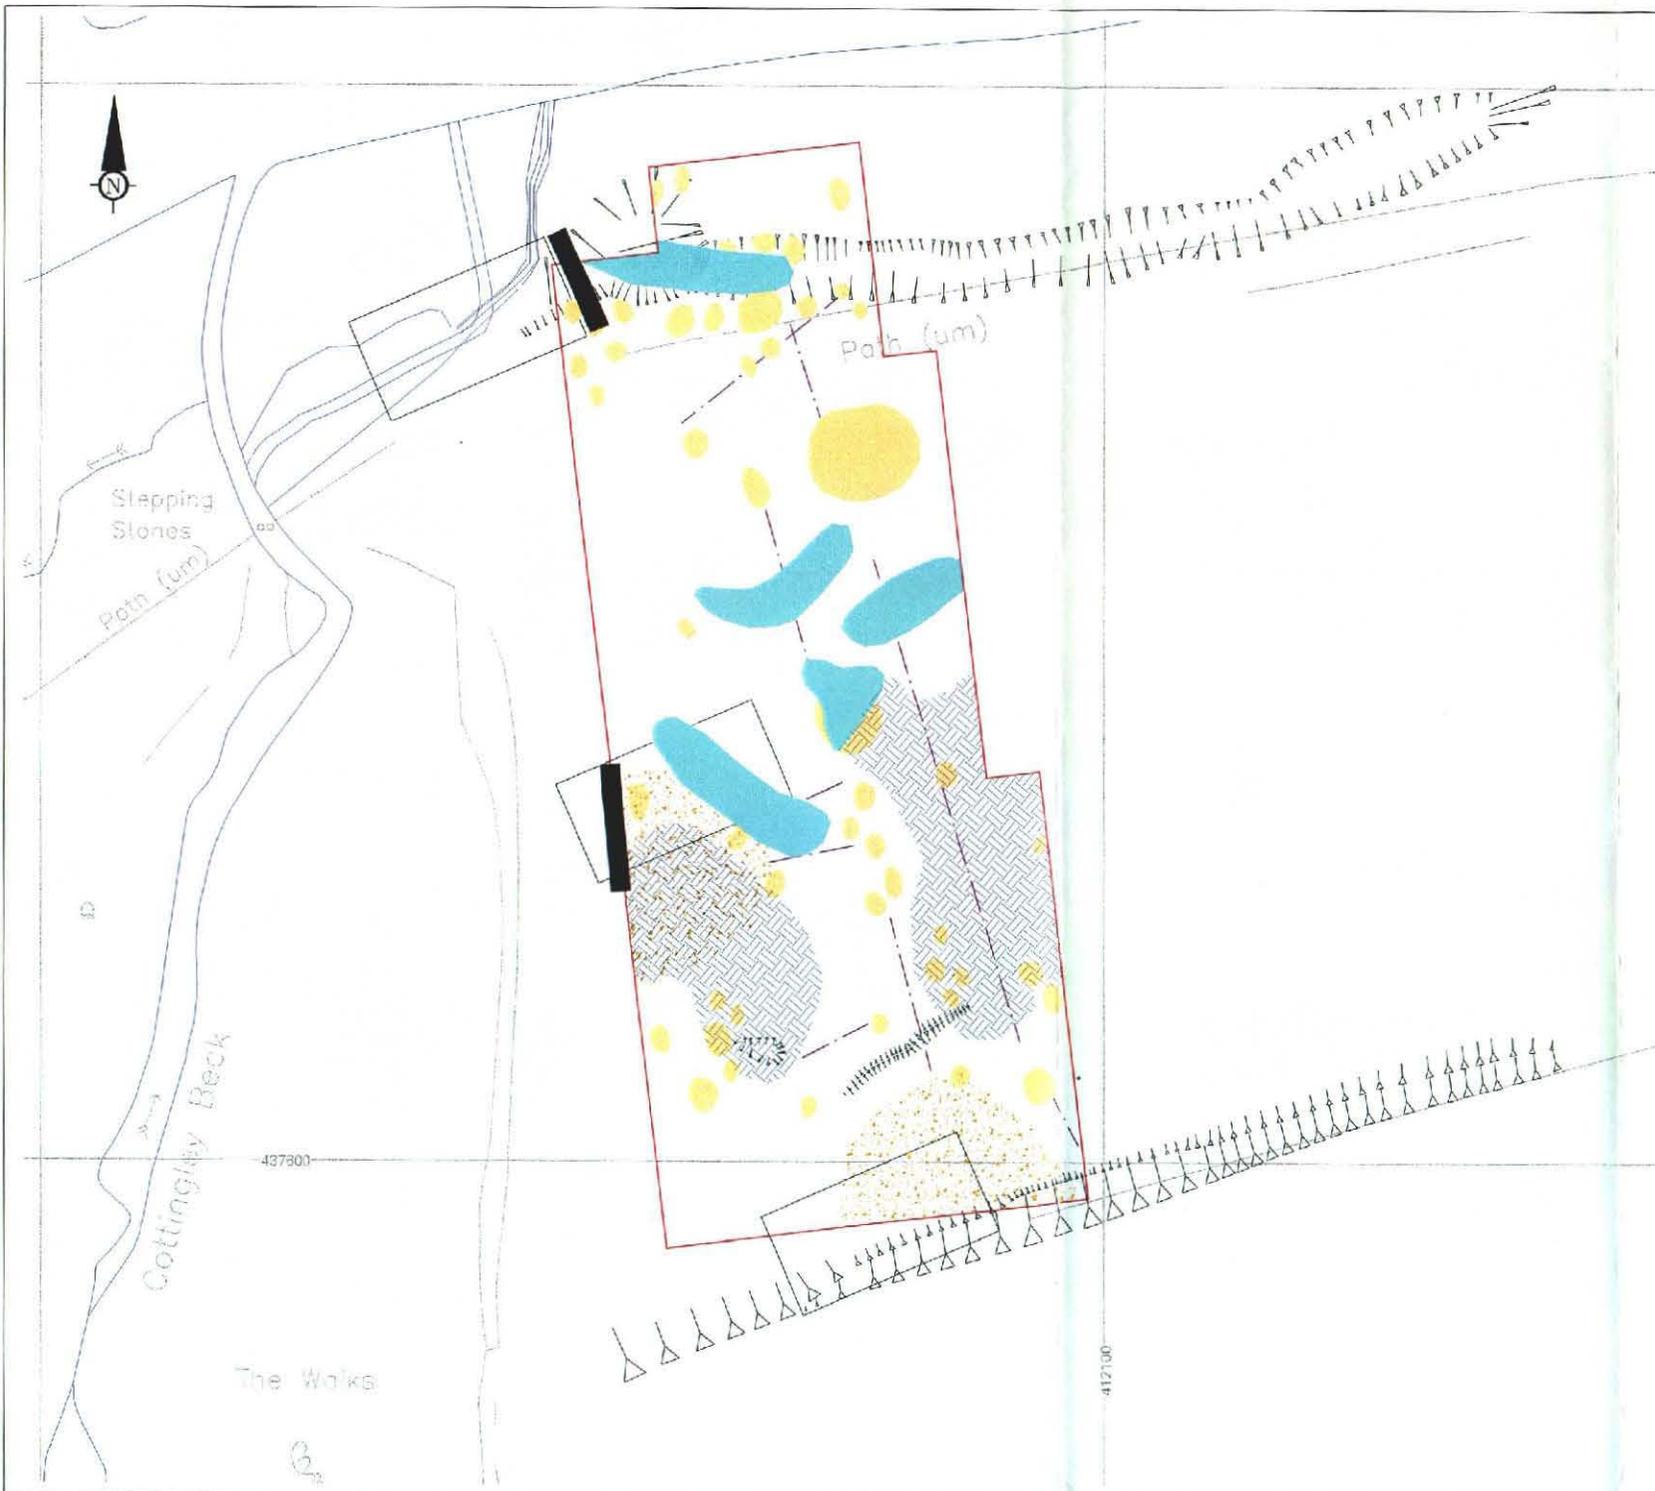
Client	Highways Agency		
Project	A650 Bingley Relief Road		
	Figure 4 - Sites 49,50 and 51 - Trench Locations, Geophysical and Earthwork Survey Results		
Drawing No.	BTI 04383/125/13		
	1:500	Date	Jan 00
	Drawn	Checked	Approved

**3.4.4** The proposed pier location in Site 50 did not coincide with any earthwork features, but did overlap with an area of magnetic and resistivity anomalies. Sample excavation of one trench of some 24m<sup>2</sup> at this location identified no archaeological remains, although 5 sherds of 17<sup>th</sup> to 19<sup>th</sup> century pottery were recovered.

- 3.4.5 The channel in Site 51 was 6m wide, 0.7m deep and approximately 100m long. Orientated east to west, it has a gentle U shape in profile and at its western end it has been eroded away by the river and cut by a drain. The channel could not be traced beyond this point. To the east the feature becomes wider and shallower and appears to peter out near the east edge of the field. Resistivity survey identified a band of low resistance flanking one of high resistance which could relate to the channel.

- 3.4.6 The proposed pier location in Site 51 lay partly in an area where erosion has partly destroyed the earthwork features. Trial excavation of one trench totalling 20m<sup>2</sup> adjacent to the east end of the pier examined the surviving features, showing them to have been heavily disturbed by previous erosion episodes and filled with dumped material containing 44 sherds of 17<sup>th</sup> to 19<sup>th</sup> century pottery. No evidence for a man-made origin for the feature was found. Parts of the feature lying further east, away from the area of impact, appear from the earthwork remains to be better preserved.

#### **3.4 Sites 49, 50 and 51 (earthworks near Bankfield Hotel) - Figure 4**

**4.4.1** The only significant feature clearly of man-made origin was the lynchet in Site 49. The 'trackway' could be of natural origin. No significant earthwork features were recognised in Site 50 and, despite the presence of geophysical anomalies, no archaeological features were found by trial excavation in Site 50. The geophysical anomalies themselves could be explained by natural phenomena. Although a water-channel was recognised in Site 51, it has undergone at least two separate phases of truncation and erosion in the area which would be affected by construction, and it cannot be shown from evidence in this area to be of man-made origin. Most of the part of the feature which would be affected has already been destroyed.

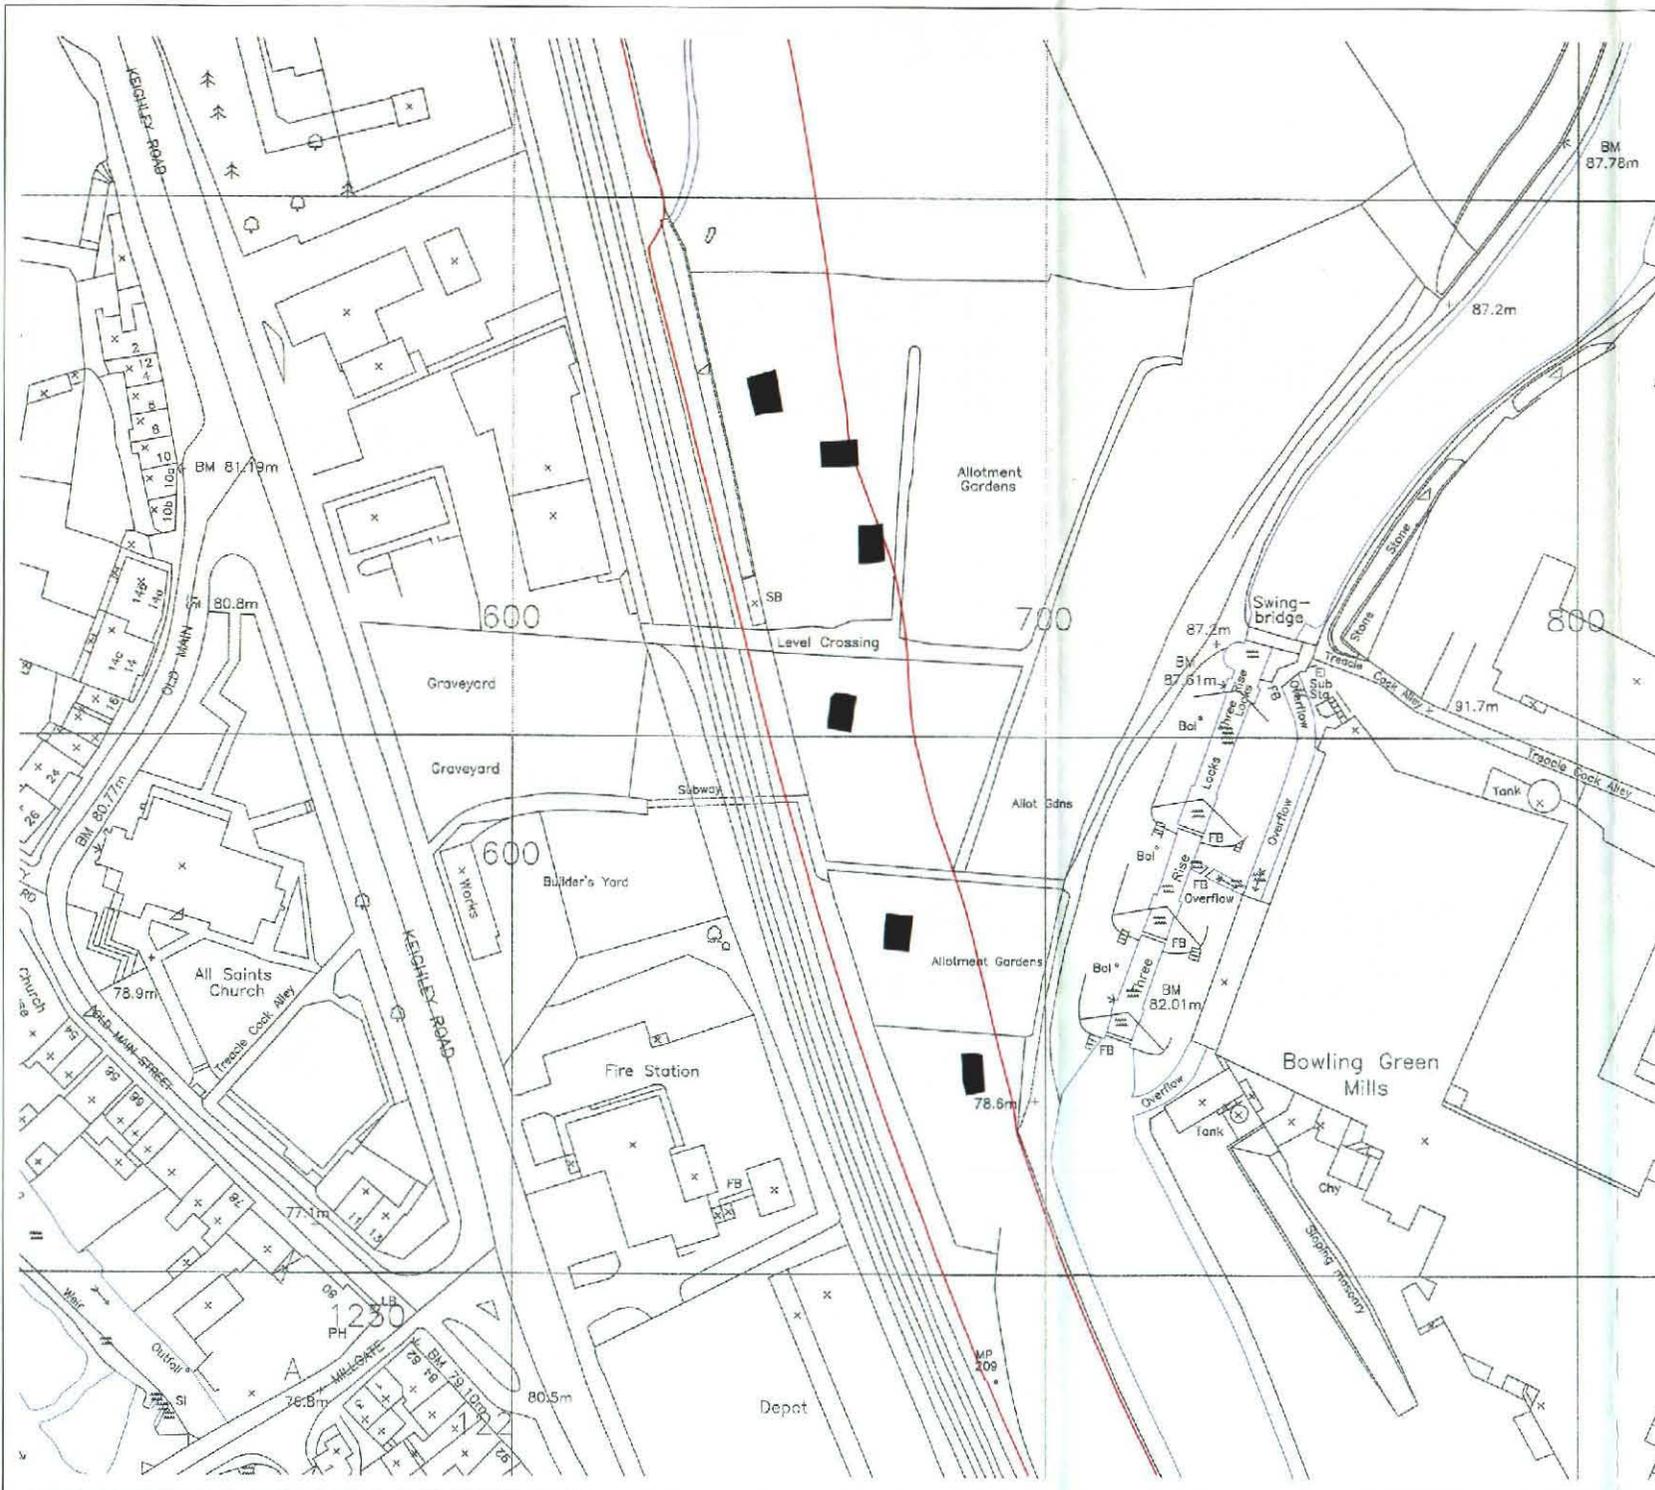
Client	Highways Agency		
Project	A650 Bingley Relief Road		
Title	Figure 5 - Evaluation Trench Locations at Site 52		
Drawing No.	BTI 04383/125/16	Date	Jan 00
Scale	1:1000	Drawn	JD
		Checked	DAJ
		Approved	DAJ

- 3.5.2 Trench A, at the south end of the allotments, was excavated to a depth of 3m. The base of the sequence consisted of thin layers of natural peat, subsoil, topsoil and buried turf, totalling approximately 0.5m in thickness and overlying natural clays. Because of health and safety considerations at this depth, only a very small area of these deposits was exposed. The buried turf and topsoil contained 18<sup>th</sup> to 20<sup>th</sup> century pottery. These basal deposits were overlain by a sequence of dumped deposits totalling a least 2.5m in thickness, probably associated with the construction or maintenance of the adjacent canal (opened 1775) and/or railway (opened 1846/7).

- 3.5.3 In Trench B, some 23m north-west of Trench A, topsoil directly overlay undisturbed natural, which occurred at an elevation 2.7m higher than the equivalent deposit in Trench A. Several features of modern or natural origin were identified, together with two post-holes which could

**3.5.4** Trench C was located 35m north of Trench B. The only features found were a large stone-capped drain and an apparent alignment of very large cobbles of unclear origin. There was no direct dating evidence associated with the features, but unstratified material in the trench included pottery of 13<sup>th</sup>-14<sup>th</sup>, 16<sup>th</sup>-17<sup>th</sup> and 17<sup>th</sup>-18<sup>th</sup> century date.

**3.5.5** Trench D, located some 25m north of C, contained no identified archaeological remains.

**3.5.6** Trench E, a further 11m to the north, identified two small stone-capped drains containing 18<sup>th</sup> century and residual 13<sup>th</sup>-14<sup>th</sup> century pottery. One of the drains was subsequently incorporated into a crudely-built wall of possible 18<sup>th</sup> century date, whose collapse scattered rubble across the area. The rubble was subsequently covered by a thin silty deposit, which was itself cut by another stone- and brick-lined drain.

**3.5.7** Trench F, located 10m north-west of E in the north-western corner of the allotments, identified peat deposits forming the south edge of Bingley North Bog. The peat was overlain by a clay make-up deposit containing 17<sup>th</sup>-18<sup>th</sup> century pottery, itself overlain by a silt deposit containing pottery and clay pipe bowls of a similar date. Although the excavator suggested that the pottery in the clay could be residual, the presence of similar material in the overlying silt makes this less likely. These layers were cut by a linear feature filled with lime plaster, sandstone fragments and clay, containing 17<sup>th</sup>-18<sup>th</sup> century pottery; the plaster itself is of a probable pre-19<sup>th</sup> century type. This feature appears to have been a foundation trench for an insubstantial structure, probably of 18<sup>th</sup> to early 19<sup>th</sup> century date.

- 3.5 **Site 52 (Three Rise Allotments) - Figure 5**
- 3.5.1 Site 52 was identified by WYAS-AS as a possible part of the early medieval core of Bingley. The site is located in an area of allotment gardens between the Airedale railway line and the Leeds and Liverpool Canal, just east of the late/post-medieval core of the town. Current land use meant that non-intrusive surveys were not suitable. Sample excavation of 6 trenches (A to F) totalling 210m<sup>2</sup> identified only minor features, largely of post-medieval date, with no evidence for urban occupation.

**4.5.1** Only a thin scatter of minor archaeological features was identified. Although all the dated features were post-medieval, undated features were recognised, the most substantial being a stone-lined and capped drain. Assemblages of medieval pottery were found unstratified or in residual contexts in several trenches, suggesting some medieval activity in the area; this could be expected, given the proximity of the site to Bingley. Some of this unstratified medieval pottery was found in the same trench as the undated drain. There is therefore some potential for the presence of scattered medieval features, although no evidence to suggest that any part of the site formed part of the medieval core of Bingley.
