**BOLTON BRIDGE BYPASS**

**ARCHAEOLOGICAL MONITORING AND RECORDING**

**NAA 94/13**

**February 1994**

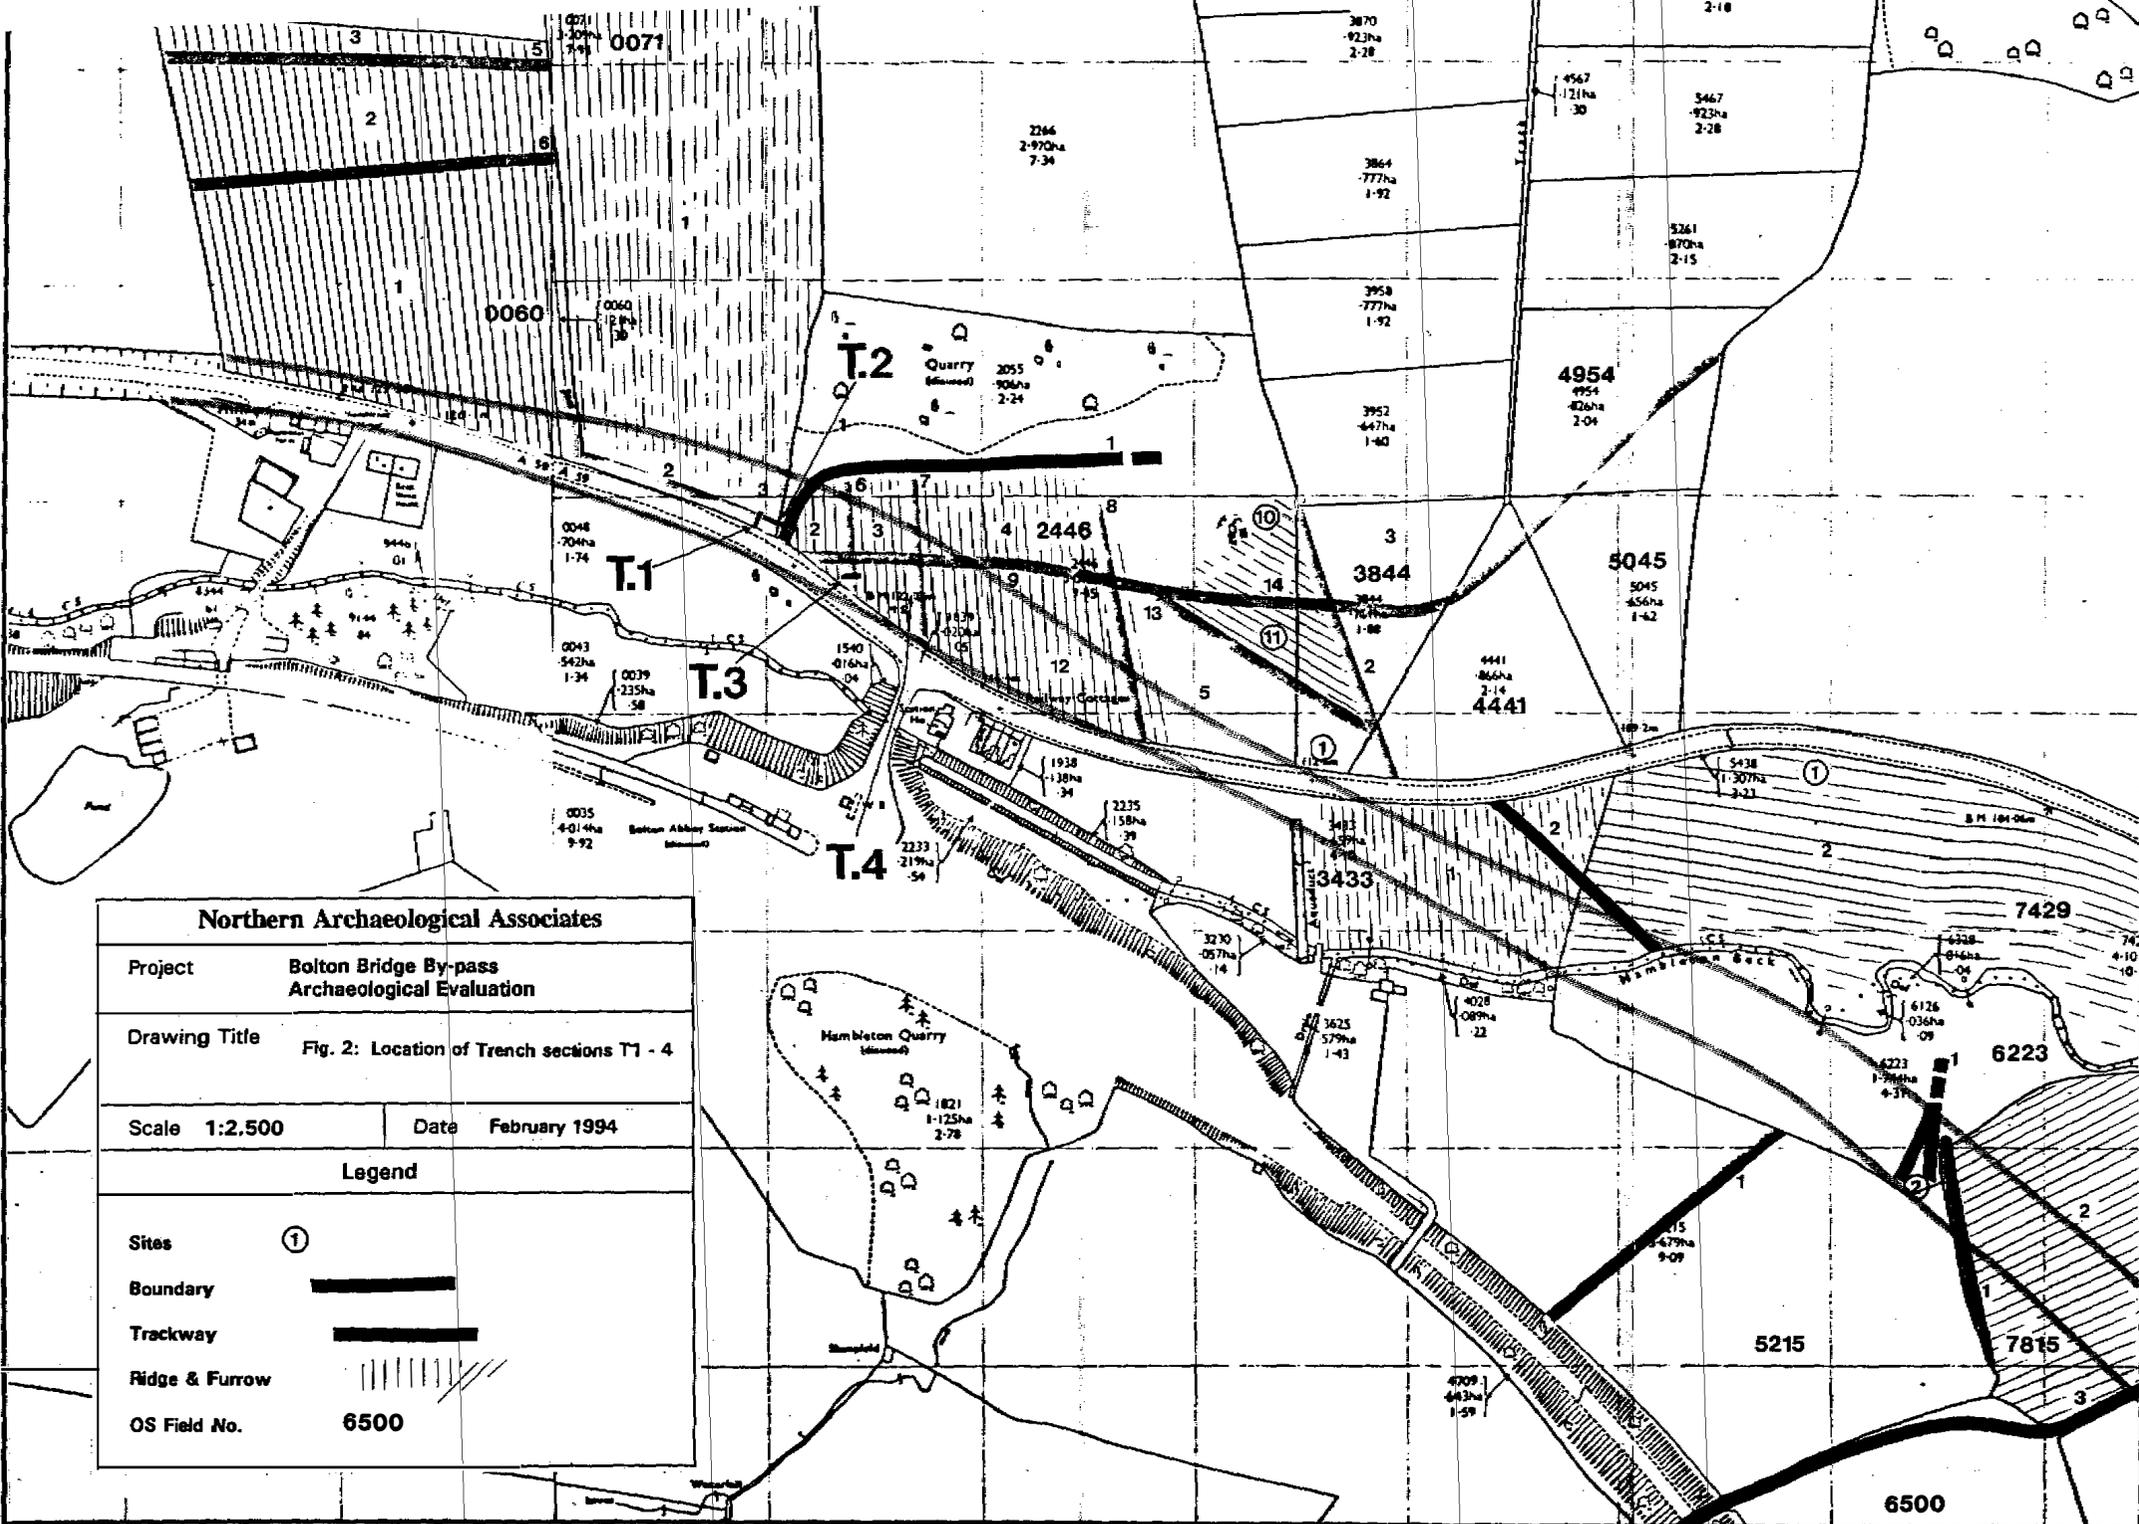
<b>Northern Archaeological Associates</b>	
Project	Bolton Bridge By-pass Archaeological Evaluation
Drawing Title	Fig. 2: Location of Trench sections T1 - 4
Scale 1:2,500	Date February 1994
<b>Legend</b>	
Sites	①
Boundary	—————
Trackway	—————
Ridge & Furrow	
OS Field No.	6500

This work was carried out during March 1993 (fig. 2). Trenches were excavated across a sunken linear feature in OS field 0071 (trench 1); across the extant boundary between the

two fields, extending to include two adjacent possible archaeological features (trench 2); and transecting two linear earthworks in OS field 2446 (trenches 3 and 4). Two potential archaeological features which were probably field boundaries, identified in the desktop study [1] in OS field 2446 as features 8 and 9, were not recorded as those elements within the road corridor were destroyed when an initial access route was inserted.

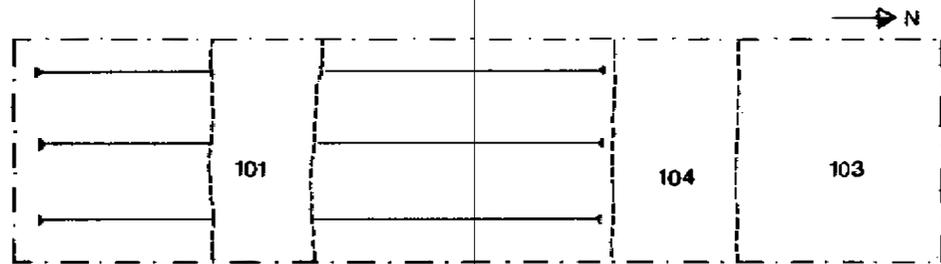
TRENCH 1

Trench 1 was located so as to transect feature 2 in OS Field 0071 [1]. It was positioned at right-angles to the existing southern field boundary 14.4m west of the south-eastern corner of the field. The trench measured 1m wide and 4.1m long. It showed that a linear depression running parallel to the existing hedge was an infilled ditch (101/102) which measured c.1.2m wide and extended for at least 90m along the southern field boundary. No dating evidence was recovered for this feature. A linear band of pea-grit (104) running parallel to the ditch on its northern edge possibly represented the base of an earlier hedgebank.

**Topsoil 100:-** This deposit was a fairly compact, dark brown sandy clayey silt. No finds were recovered. It occurred throughout the area of the trench (4.1m N-S by 1m E-W), continuing in all directions, and was on average 0.15m thick. It had an undulating profile. 100 sealed ditch fill 102 and layer 104. It was the turf and topsoil above trench 1.

**Ditch 101:-** This linear feature equated to Field 0071 Feature 2 [1]. It ran E-W parallel to and north of the extant S field boundary, between SE 0601 5352 and SE 0609 5349, for a total visible length of c.90m. A 1m segment was partially excavated within trench 1, where it was 1.2m wide. Only the top 0.1m was excavated due to difficulties experienced in distinguishing the fill 102 from the similar surrounding subsoil 103 under conditions of extremely bright sunshine. Colour enhancement effect in the photographs taken demonstrated subsequently that the feature was genuine and deeper than excavated. Ditch 101 cut subsoil 103 and was filled by 102. It either formed part of a boundary with the extant field hedge, or with a possible disappeared hedge represented by 104.

**Ditch fill 102:-** This deposit was located within ditch 101, and was excavated under the parameters noted under 101. It was a fairly compact, mid brown sandy clay, with occasional stones (<100mm) and frequent roots (from the adjacent hedge). No finds were recovered. 102 was the fill of ditch 101 and was sealed by subsoil 100.

**Subsoil 103:-** This deposit was a compact yellowish brown sandy clay, with occasional rounded pebbles (<15mm) and subangular limestone fragments (<200mm). It was not excavated. It was cut by ditch 101 and was below layer 104.

**Layer 104:-** Located running parallel to ditch 101, c.1.2m upslope of it to the N, this was a band of fairly loose pea-grit and small stones 0.56m wide lying on the surface of subsoil 103. It was not excavated. It was above 103 and sealed by topsoil 100. It possibly represented material worm-sorted to the base of a disappeared hedgebank.

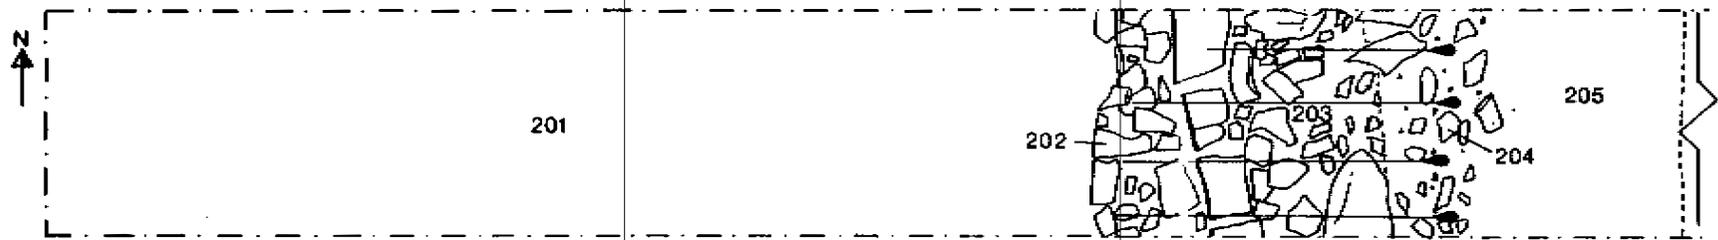
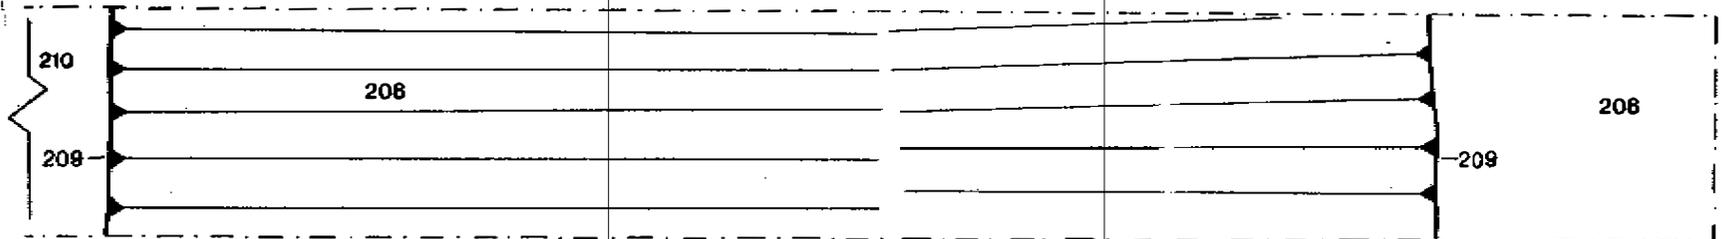
TRENCH 2

This trench was located 5.7m from the southern end of wall 203 which separated OS Fields 0071 and 2446. It was 1m wide and 14.8m long, and was orientated at right angles to the field wall (203) in order to transect possible boundary feature 3 in Field 0071 and hollow way 1 in Field 2446 [1]. The field wall had very recently been demolished to turf level. It measured 0.9m wide at the base, and extended for c.50m. It had been constructed directly upon the upper surface of the subsoil (201), within a shallow construction trench cut through the shallow topsoil (200) and backfilled with construction debris (202,204). To the west of the wall, no evidence was observed to support the presence of feature 3 in OS Field 0071 [1], the topsoil (200) being directly above a clean subsoil (201). To the east of the wall, Hollow Way 1 [1] was observed as a linear hollow (209) c.6m wide, 0.4m deep and extending for at least 200m. It cut through clean subsoil (201, 208), and the base was roughly metalled with limestone fragments (206). Two deposits of limestone (205, 210) between its western edge and the field wall either represented the robbed remains of an earlier wall or were fragments of further metalling. No dating evidence was recovered from any of these features.

**Wall 203:-** This wall formed the boundary between OS Fields 0071 and 2446 to the S of disused quarry 2055, and then continued N for several hundred metres up the hillside forming the E side of Field 0071. The stretch to the S of the quarry boundary had very recently (several days) been demolished to turf level by machine. It was 50m long N-S, 0.9m wide, and where sectioned only survived to a height of 0.3m (1 or 2 courses) below turf level. It was constructed of unworked angular limestone blocks (<0.4m) as facing stones, with a core of smaller limestone rubble in a matrix of dark orange-brown silty sandy clay with >10% pea grit (2-10mm). No finds were recovered. Wall 203 was constructed on the upper surface of subsoil 201, and was butted to the W by rubble 202 and to the E by rubble 204, which probably represented the fills of an unrecognised construction trench.

**Hollow Way 209:-** This feature was Field 2446 Feature 1 [1]. It ran NE from SE 06110 53480, at the SW corner of the field, to SE 06125 53507, then E to SE 06285 53517. It was linear, with a rounded NW corner. It had a total length of c.200m. A 1m segment was excavated within trench 2. At this point it was c.6m wide and c.0.4m deep. It had gradual breaks of slope at the top, gently sloping sides and gradual breaks of slope to a concave base. It was cut into subsoil 208 and was filled by layer 207 and surface 206. The feature was a hollow-way, with a metalled surface in the base. No indication was recovered to suggest a date.

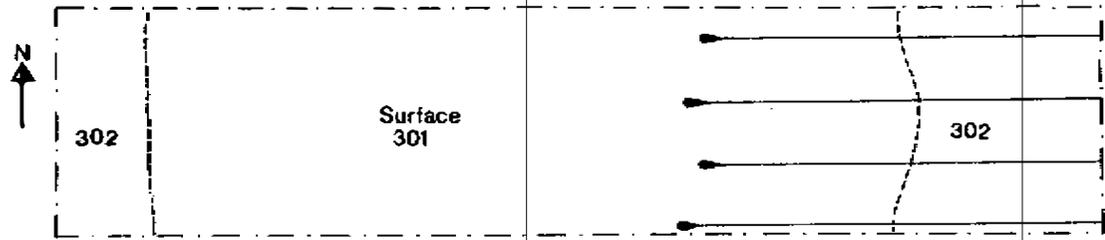
TRENCH 3

Located so as to transect a wide, low linear bank (feature 6) in OS Field 2446 [1], this trench measured 1m by 4.6m. It was located 9.3m north of the southern field boundary. 0.15m of topsoil (300) was removed to reveal a linear metalled surface (301) which was 3.3m wide and up to 0.18m thick in the centre, tailing off to each side with a shallow convex profile. It was formed of a single dump of angular limestone fragments laid directly on the surface of the underlying subsoil (302). The feature extended for c.60m north-south, and the northern end approached the entrance to a disused limestone quarry (OS plot 2055). It is interpreted as a trackway providing access to the quarry from the A59.

Trackway 301:- This feature equated to Field 2446 Feature 6 [1], and could be observed as an upstanding earthwork running for c.60m N-S between SE 0614 5345 and SE 0614 5351. It consisted of a layer of compacted angular limestone fragments (50-200mm), 3.3m wide and up to 0.18m thick where sectioned in a 1m segment. It had a slightly convex profile. No finds were recovered. 301 was pushed into the upper surface of subsoil 302, and was sealed by topsoil 300. It represented a roughly metalled trackway, probably utilising quarry debris, running from the disused quarry immediately to the N (OS block 2055) southwards to the extant A59 roadway. It possibly re-utilised a ridge from the ridge and furrow system within the field in order to achieve additional drainage. No dating evidence was recovered, but it was presumably contemporary with the quarry.

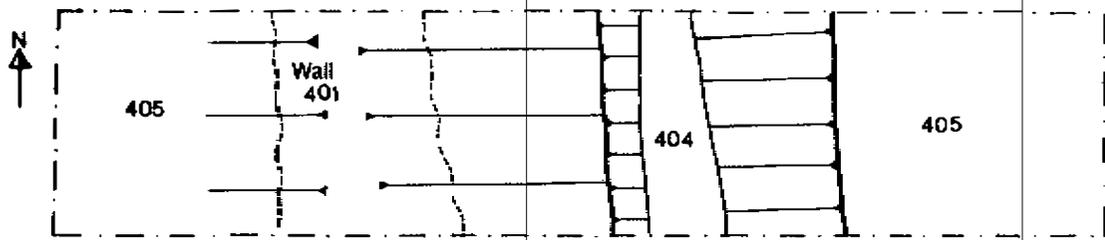
TRENCH 4

**3.4 Trench 4 (fig. 3)** This trench was located 25.3m from of the southern end of feature 7 in OS Field 2446 [1]. It measured 1m wide and 4.6m long. Feature 7 was c.75m long, orientated roughly north-south parallel to the surviving adjacent traces of ridge-and-furrow agriculture, and consisted of a low bank with a shallow linear depression along its eastern side. 0.15m of topsoil (400) was removed, revealing that the bank was the robbed footings of a drystone field wall (401), 0.6m wide and surviving to a height of 0.15m. It had been built directly on the surface of the subsoil (405). A ditch (404) was located 1.1m east of, and parallel to, the wall. It was 0.95m wide and was cut 0.33m into the subsoil. Two distinct fills were recognised (402, 403). The profile of the ditch suggested that it was contemporary with the wall, which had discouraged erosion on that side. No dating evidence was recovered to suggest a date for these features.

Wall 401:- This feature, which equated to Field 2446 Feature 7 [1], was observable as a raised linear earthwork running c.75m N-S between SE 0618 5343 and SE 0617 5351. Where sectioned, it was 0.6m wide and 0.15m thick, and consisted of c.70% subangular and subrounded limestone fragments (<150mm) and frequent small limestone fragments (<20mm) in a matrix similar to 400. It had a convex upper profile and a flat lower profile. 401 was above subsoil 405 and was sealed by topsoil 400. No dating evidence was recovered for this feature which apparently represented the robbed-out base of a field wall. It was probably contemporary with adjacent ditch 404 (see 404 for comment) and was parallel to the adjacent traces of ridge and furrow.

Ditch 404:- This linear feature was located parallel to, and c.1.1m east of, wall 401. It measured 0.95m wide E-W by 0.33m deep. Only a 1m segment was excavated, but the feature probably extended the full length of wall 401. 404 had sharp upper breaks of slope, the W side being very steep and fairly straight-sloping, whilst the E side was fairly gently sloping and slightly concave. There were rounded breaks of slope to a fairly flat linear base. Ditch 404 cut subsoil 405 and was filled by fills 403 and 402. Its N-S orientation and position suggested contemporaneity with wall 401, as did the profile, which suggested that the W side had been protected from erosion by the presence of the wall.

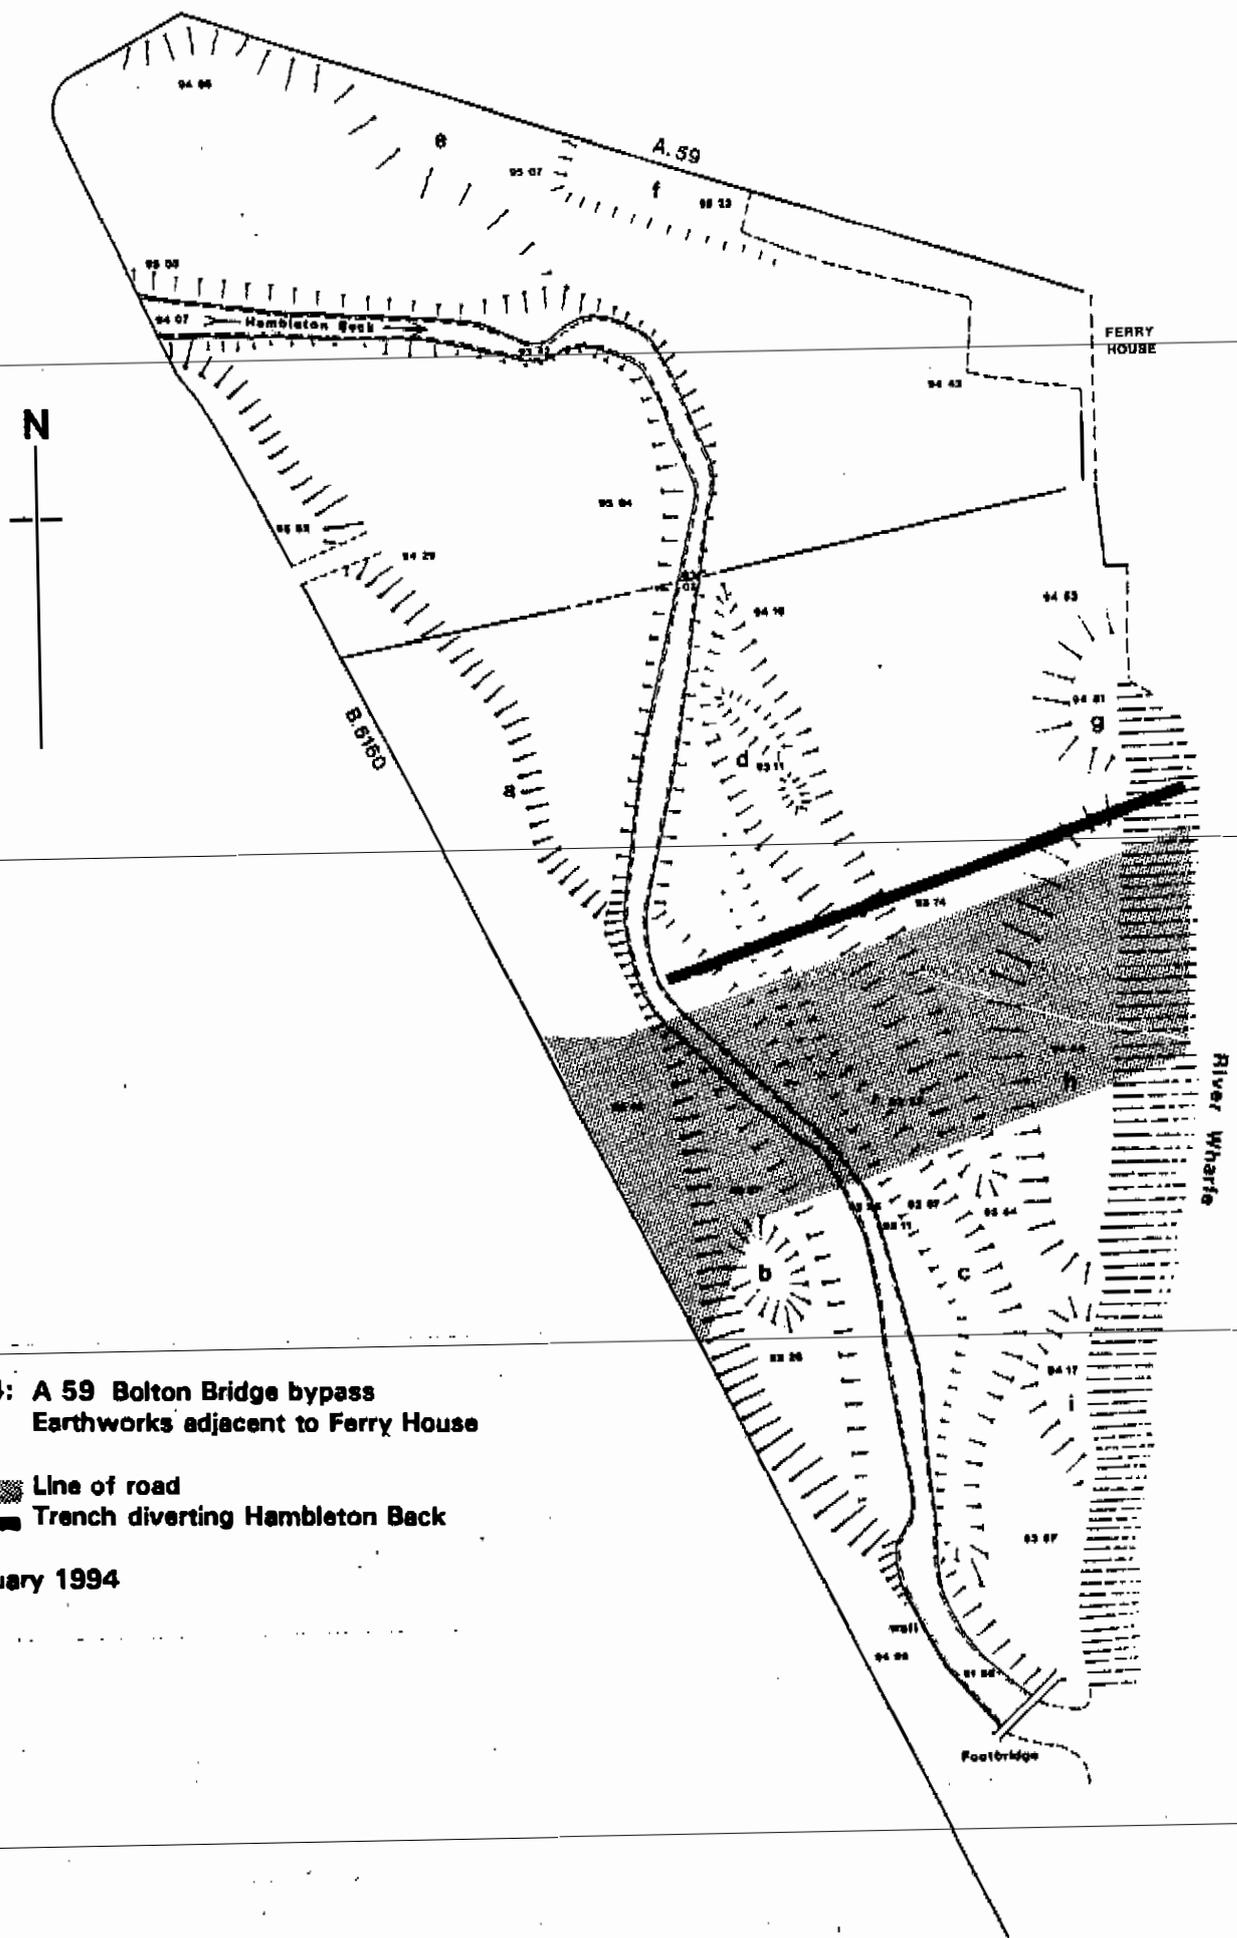
**Fig. 4: A 59 Bolton Bridge bypass  
Earthworks adjacent to Ferry House**

A watching brief was carried out during the machine stripping of topsoil on the section of the corridor between the B6160 and the River Wharfe and on the section between the River Wharfe and Beamsley Lane. With the exception of a stone wall, no features were recorded in these areas as they were topsoiled using a bulldozer, however, a section through the triangle of land between the Hambleton Beck and the River Wharfe was recorded during the excavation of a channel to temporarily divert the Hambleton Beck during construction work (fig. 4).

Within the section from the Hambleton Beck to the River Wharfe the basal layer exposed was a brown alluvial silty gravel deposit which lay up to 0.7m below ground level. A U-shaped ditch feature (50) was cut into the gravel approximately 13m west of the Hambleton Beck. The ditch measured approximately 2.9m wide by 0.7m deep and contained three distinct fill layers. The primary fill was a firmly compacted brown grey clay (6) containing patches of charcoal, which was overlain by a firmly compacted clay silt (7), which was overlain by a firmly compacted grey brown sandy silt (8), which formed the final fill of the ditch. The ditch was sealed beneath a turf and topsoil deposit (1) which varied between 0.4-0.6m in depth.

The lower course of a dry stone wall was exposed at two points sealed beneath the topsoil. It was constructed of irregular cut sandstone blocks and river cobbles of up to 200mm by 300mm by 100mm, although only one course survived. The structure was exposed in section in the temporary channel and in plan in the adjacent field to the south. It was located 5m from the break of slope to the River Wharfe and ran parallel to the river. It may have been the remains of a stock enclosure wall for the field. There was no associated dating evidence.

The contour survey carried out in the triangle of land between the Hambleton Beck and the Wharfe suggested that a number of possible earthworks were natural in origin. This was confirmed by the section revealed in the side of the drain cut to divert the beck. Only two archaeological features were identified in the section and these were probably agricultural in origin. The recovery of post-medieval finds from the bank of the beck during the survey suggested that the stream had modified the adjacent ground extensively over the last 100 to 200 years. No evidence was found to suggest the presence of wharves or other medieval features adjacent to the River Wharfe crossing.
