REPORT ON GEOPHYSICAL SURVEY

**Doultong Bypass, Somerset**

Report Number 92/02

# M11 WIDENING JUNCTIONS 8-9

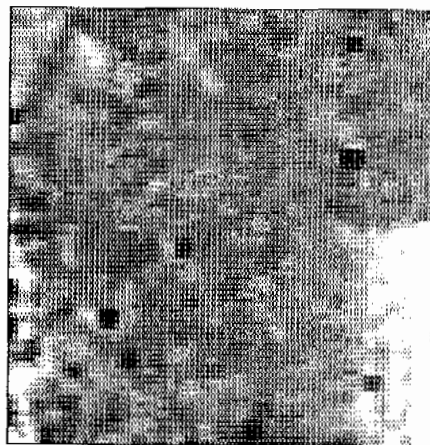
Figure 3

- 4.1.1 The level of background noise is noticeably increased by the adverse ground and weather conditions. Within the data there are suggestions of two linear responses which may be of archaeological interest, indicating an extension of the known Roman site. However, the responses are within the levels of noise and as such interpretation is extremely tentative.

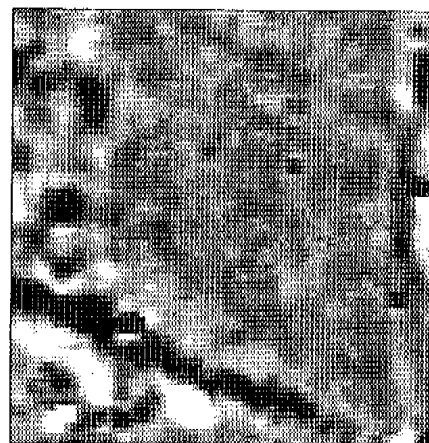
- 4.2.2 The data are dominated by a relatively strong, broad linear response orientated approximately southwest-northeast; parallel to the existing field boundaries. Given this alignment and the nature of the response it seems likely that this indicates a former field divisions, probably a drainage ditch. A second weaker linear anomaly, with the same orientation is visible in the southeast of the survey and may be of a similar modern/agricultural origin.
- 4.2.3 Along the eastern limit of the survey there are several pit type responses. While these may be archaeological their close proximity to the field edge and the presumed drainage ditch casts some doubt on this interpretation.

- 4.2.4 A curvilinear anomaly is visible along the southwestern limit of the survey. This may be archaeological, although the limited survey has made interpretation difficult. This anomaly appears to lie beyond the road corridor.
