# Lower Lime Farm, Lime Lane, Oldham

## An Archaeological Watching Brief

UMAU March 1998

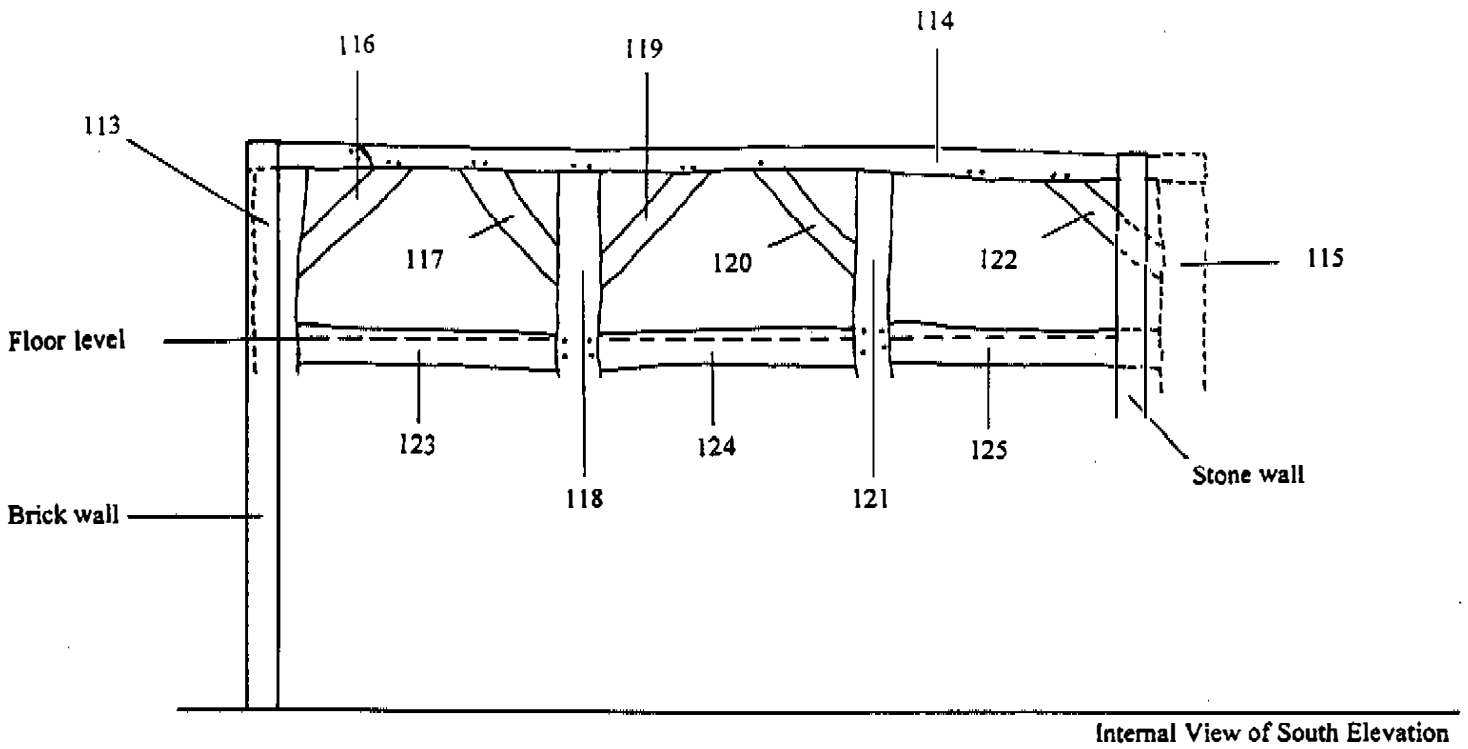
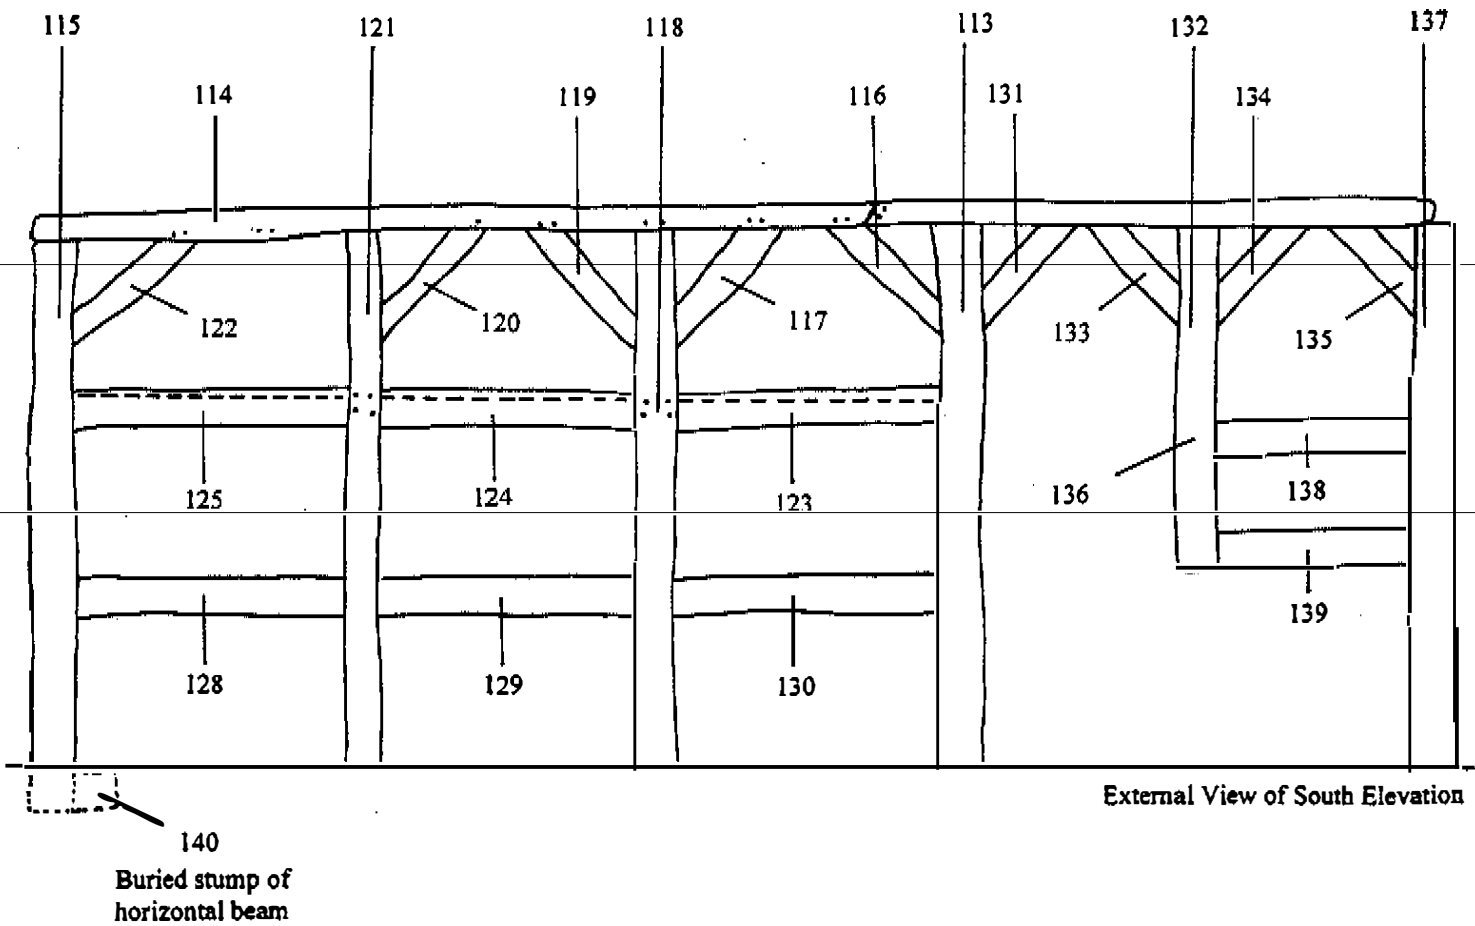
**Fig.3 Lower Lime Farm Structure No.2 Upright Section**

- 2.1 The second timber-framed structure at Lower Lime Farm is contained within a later group of farm buildings. It is a two storey building of which only a single bay remains. Most of the surviving timbers are in the upper floor and consist of a timber box-frame south elevation and a single roof truss with principle rafters and tie-beam. The west elevation is constructed of stone, while the remaining elevations are brick-built.

- 4.2 The timbers which were to be removed had previously been numbered and marked using Dymo-tape. The numbers ran in sequence from 101 to 127. This numbering sequence was recorded on to the drawings on the survey report of 1991.

- 4.4 The watching brief continued during the demolition of a brick wall, adjacent to and below the south elevation. On its removal further sections of the timber-framework were revealed which had not previously been visible to the survey team in 1991. These additional timbers were contemporary with those found in 1991 and formed a box-frame made with pegged mortice and tenon joints. A sketch of these additional timbers was made prior to removal and incorporated into the drawing of the 1991 survey report (Fig. 3). They were numbered in sequence and marked up from 128 to 140 giving a total number of 40 individual timbers for the structure. These timbers and the remainder of the timber-framed structure were removed with the minimum of damage.
