# Trewarthenick House, Tregony, Cornwall.

## Historic Building Recording

Date: November 2011

**Project No:** AC08001E

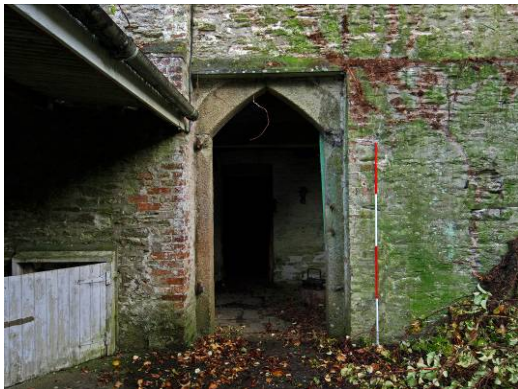
*Plate 1 Northwest Wing: doorway to Room 33, the doorway constructed from probable 16<sup>th</sup> or 17<sup>th</sup> century granite fragments*

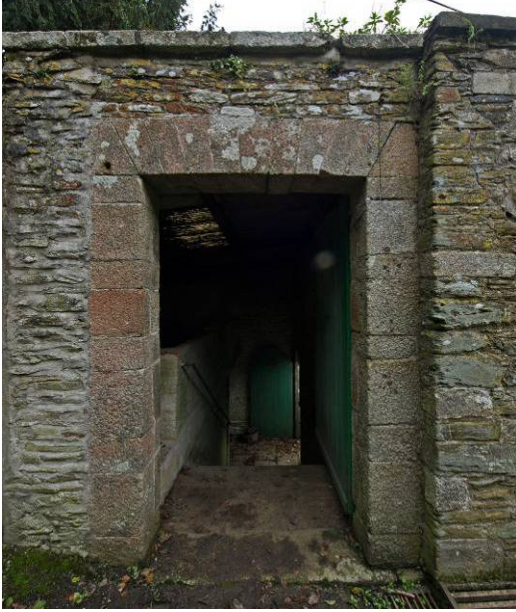
*Plate 2 Northwest Wing: doorway to Room 33 stair, not shown on 1843 map. It must have been built soon afterwards.*

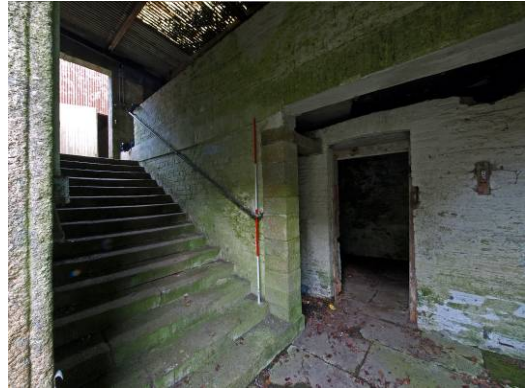
*Plate 4 Northwest Wing: granite staircase in Room 33, looking northwest, with cellar doorway, right.*

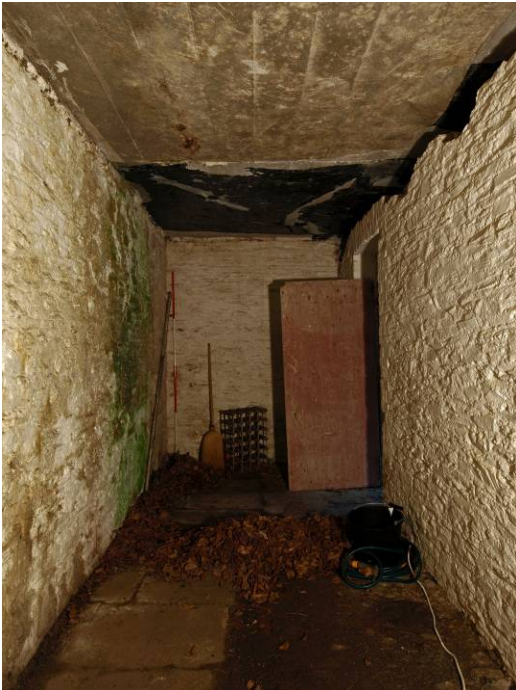
*Plate 3 Northwest Wing: Cellar (Room 34) looking east*

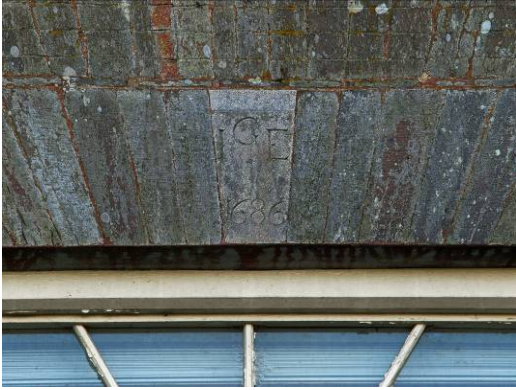
*Plate 7 Date-stone 1686 and JGE, probably for John and Elizabeth Gregor.*

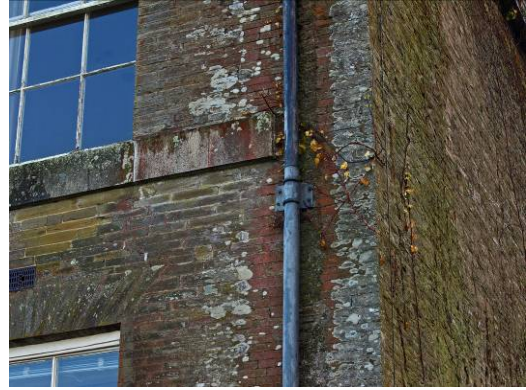
*Plate 9 Platband inserted probably in 1831*

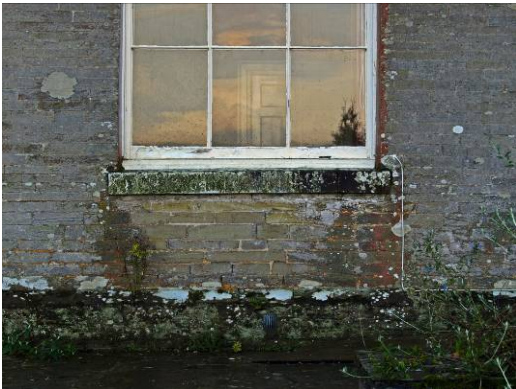
The replacement of the window sills was probably carried out when stonework was cut away behind the jambs to accommodate hidden sash boxes. If this alteration was part of the 1831 Harrison scheme it means that none of the present windows pre-date that scheme. The sashes without horns and with very thin glazing bars (central bays) are an important survival from this time and represent the height of fashion in the early 19<sup>th</sup> century.

*Plate 8 Window sill right of doorway*

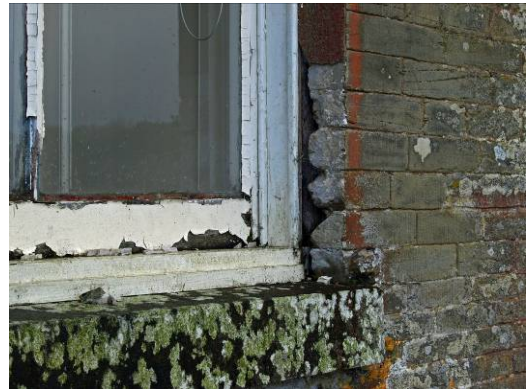
*Plate 10 East Front, window jamb far right showing jamb stonework cut back*

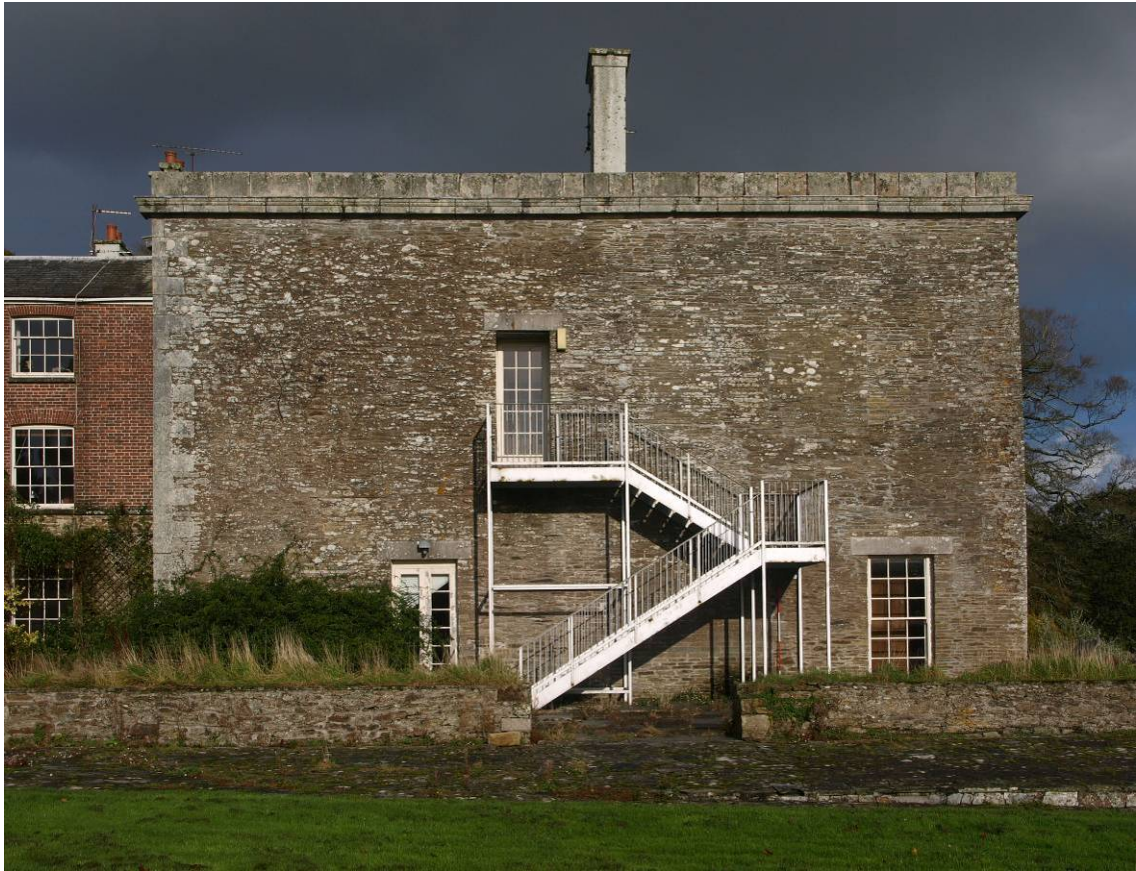
A blocked window opening at first-floor, right, is a former inserted opening dating from some time in the 18<sup>th</sup> century and is shown in a c1790 painting by Repton. A patch of walling to the right of this opening may relate to an earlier opening but the character of the stonework suggests that it is part of 1925, or later, repairs since the Harrison wing was demolished.

The dressed stone parapet masonry with moulded cornice is reused from the former Harrison wing in 1925.

*Plate 11*      *South end of East Range*

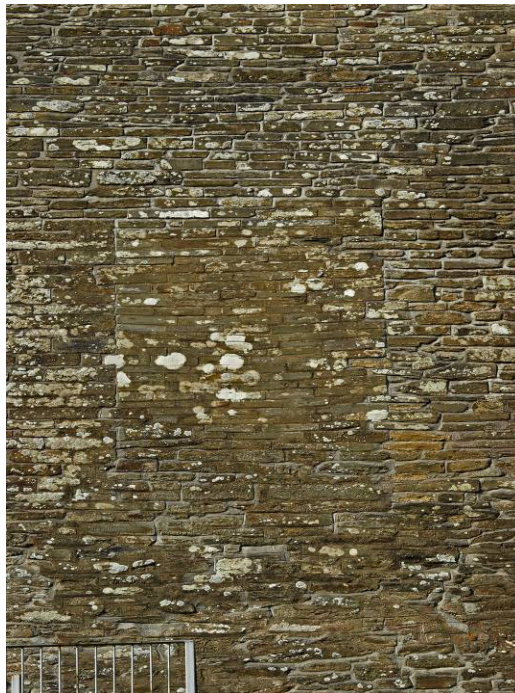
*Plate 12*      *South end of East Range detail showing blocked first-floor window.*

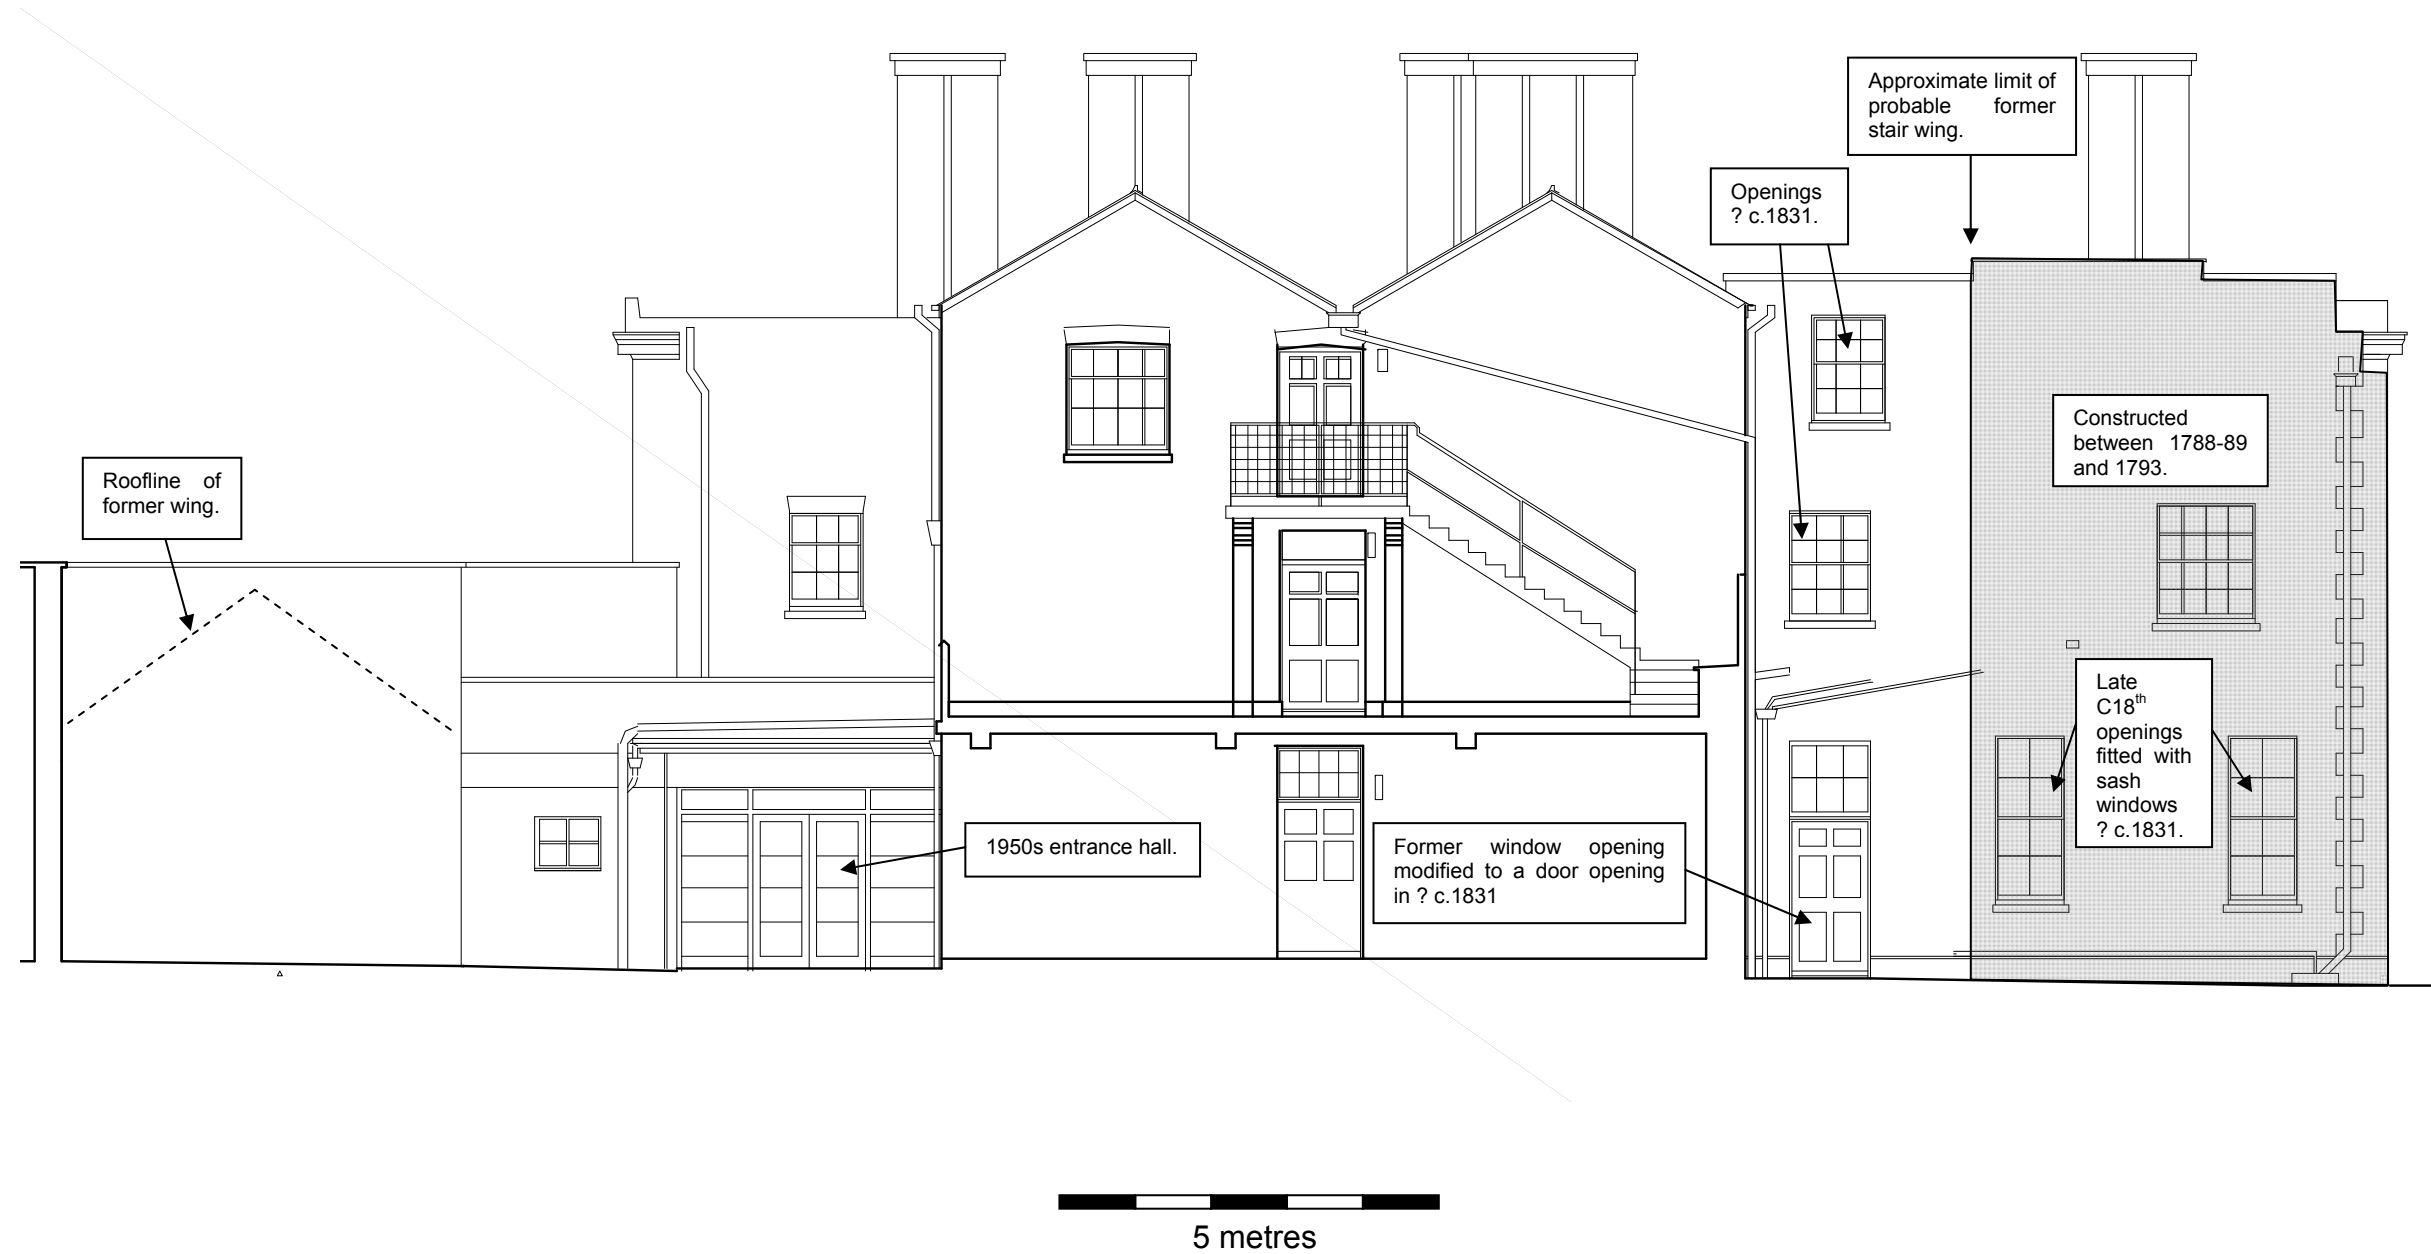
Figure 13 West elevation of the main house and courtyard with annotations

North of the 1950s entrance is the two-storey high stone rubble North Range wall. This includes a first floor brick repair where the two-storey building was reduced to a single storey probably in 1831 as well as a scar for the single-storey roof line.

The north wall of this range was retained to its full height to screen the service courtyard from view when approaching the house from the north.

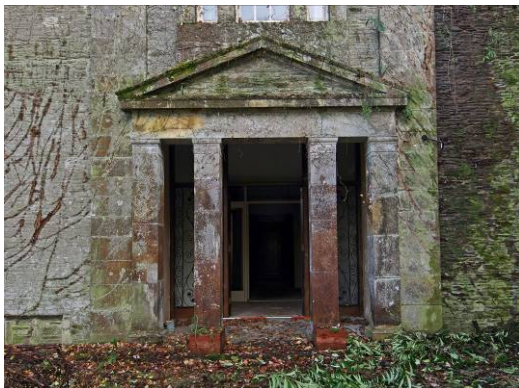
*Plate 16 North portico, re-sited from 1831 Harrison wing that was demolished in 1925*

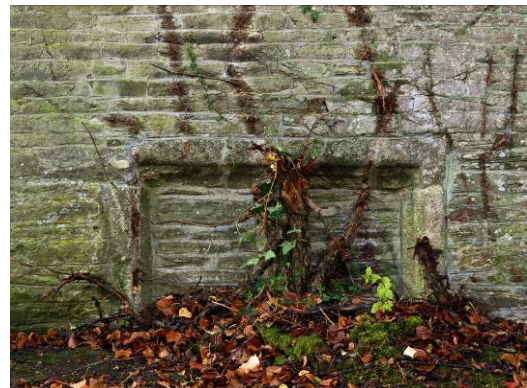
To the east of the north portico, a blocked doorway in the north wall gave access to the pavilion added c1790. This doorway is flanked by blocked two-light mullioned windows. These windows may have previously lit the cellar. Based on the construction of the windows it appears that they are made from reused masonry fragments, from a 17<sup>th</sup> century phase of the house or earlier structure.

*Plate 18 Mullioned window in north wall of East Range, one of two similar windows, probably reused from an earlier phase of the house*

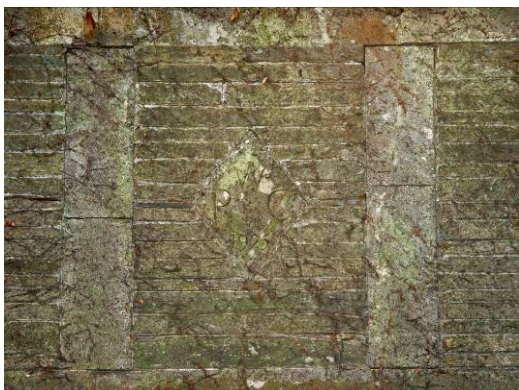
*Plate 17 1925 date-stone inscribed WPC on blind bays above north portico*

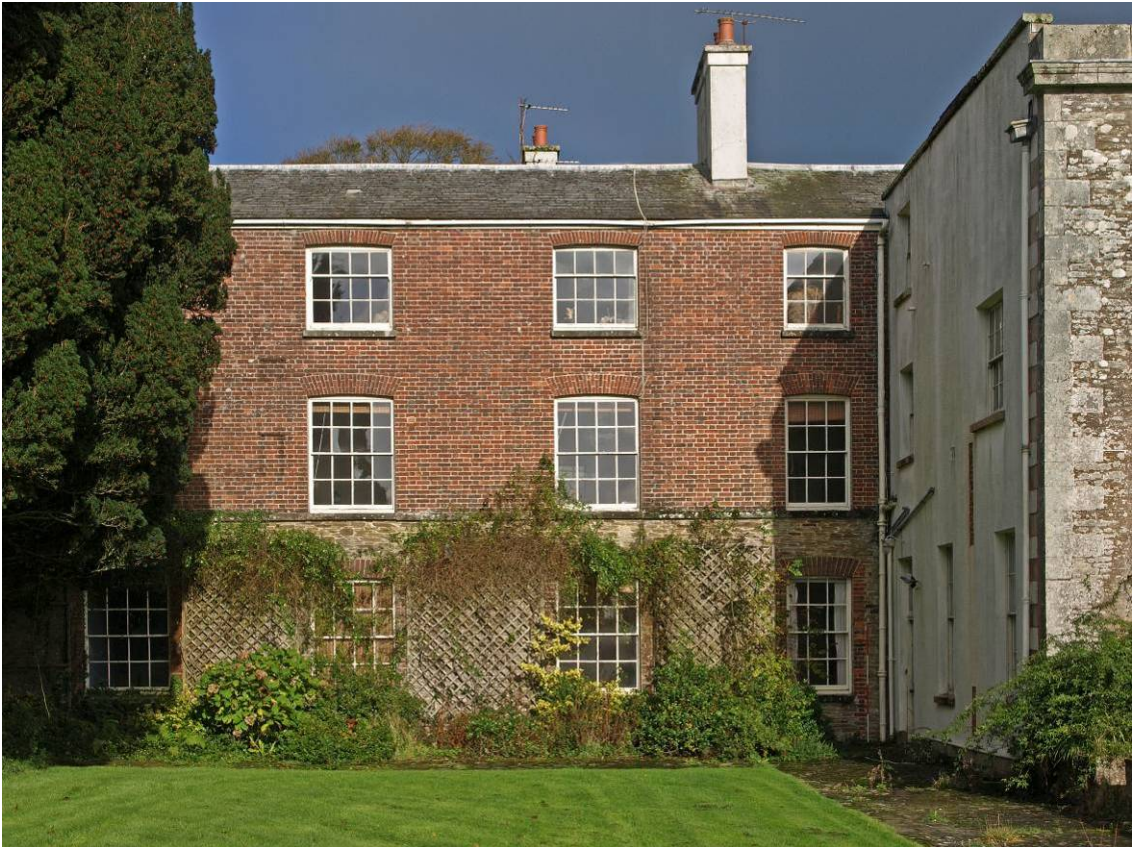
The hornless 12 and 16-pane sash windows in most of the openings to this elevation are original to the c1831 phase of this Wing. These windows are a rare survival in their own right. The only replacements are two horned sashes to the second-floor westernmost room.

Following the truncation of the west end of the rear wing, the projecting ground-floor was covered with a flat roof serving as a forecourt to the upper floors.

*Plate 19 Rear Wing, south elevation.*

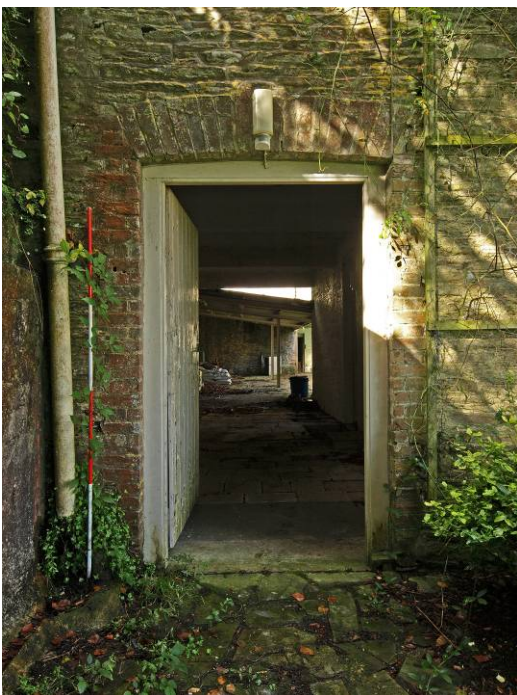
*Plate 20 Rear Wing, south wall:  
doorway re-modelled from former  
window.*

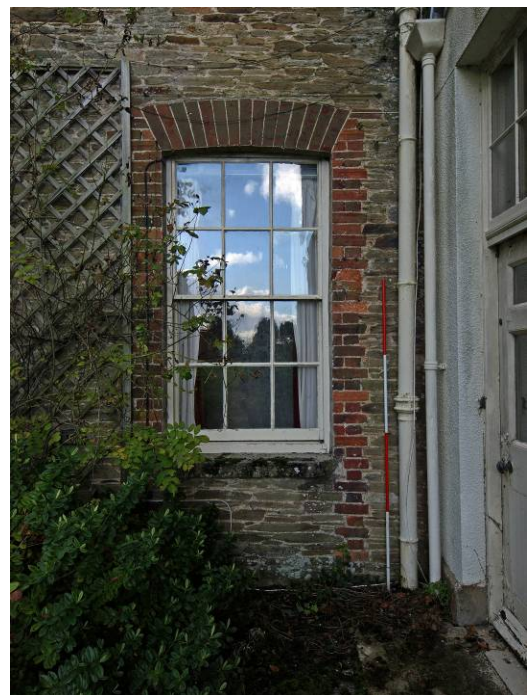
*Plate 21 Rear Wing, south wall:  
former doorway*

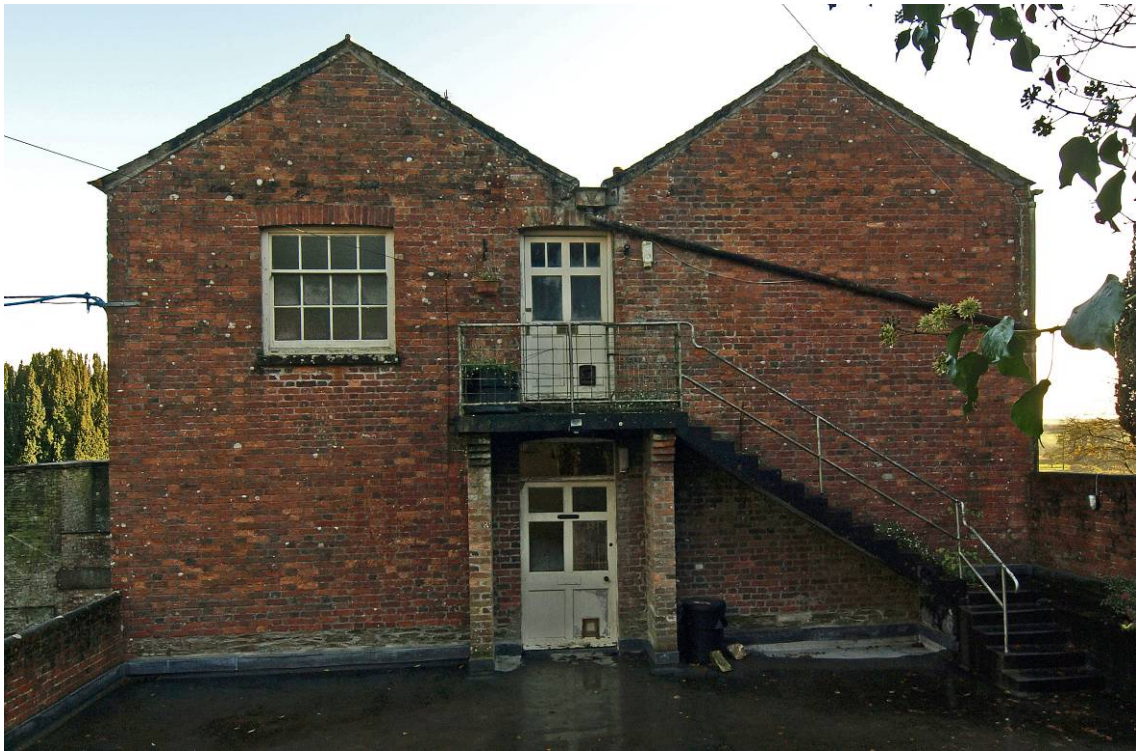
*Plate 22 Rear Wing, west elevation (rebuilt when the wing was truncated probably in 1925)*

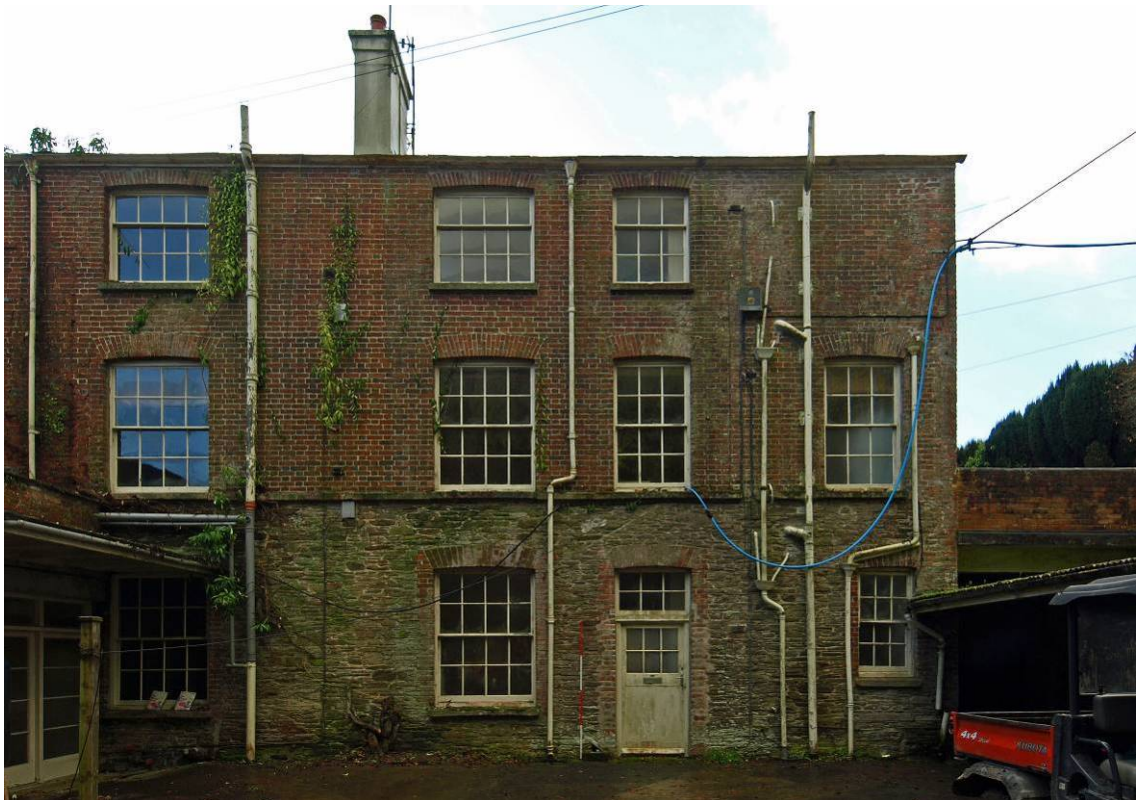
*Plate 23 Rear Wing, north elevation*

The only replaced window is a 12-pane horned sash at the west end of the ground-floor in an opening that was reduced in width when the Wing was truncated. The ground-floor doorway is a replacement of the original door which accessed a probable entrance hall. Above the doorway is the weathered remains of a former hipped roof porch shown on the 1879 and 1906 OS maps and on the map extract of the 1921 sale particulars.

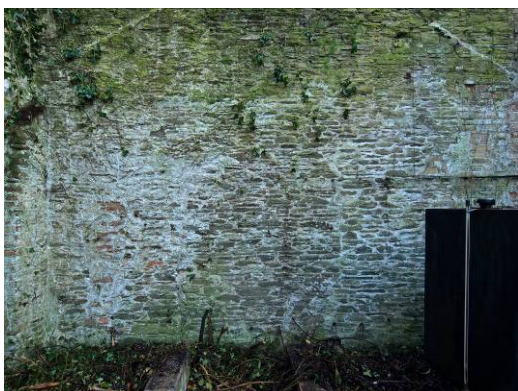
*Plate 24 Courtyard east side, evidence of former openings and former roof line*

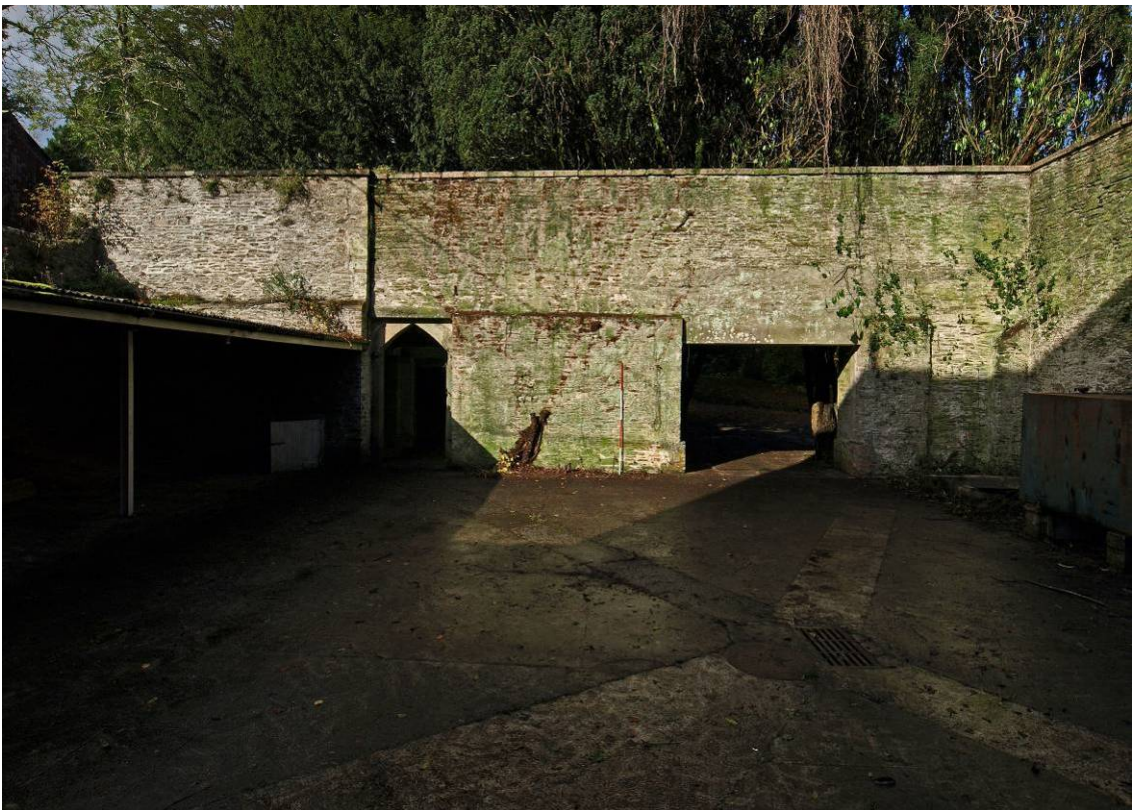
*Plate 26 Courtyard, north wall (remains of north range)*

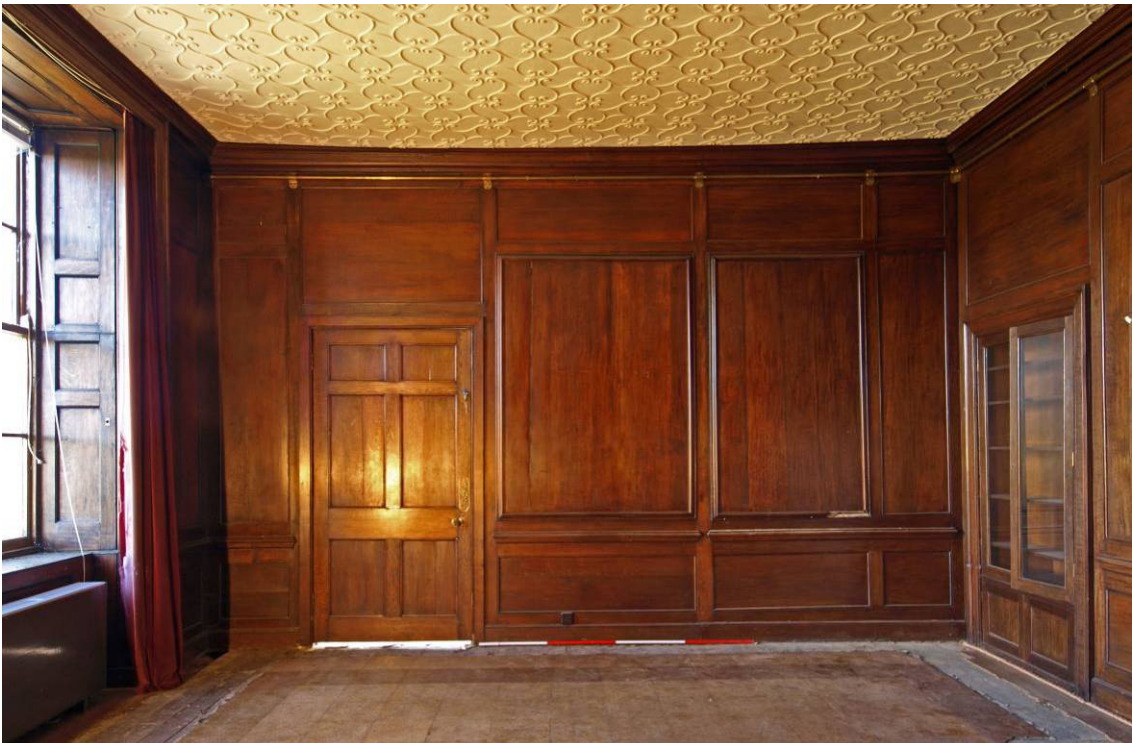
A doorway that was created in the late 18<sup>th</sup> century is the only opening in the south wall. In 1831 this doorway probably become an internal communicating door or was used as a cupboard recess. Since the 1831 Harrison wing was removed in 1925 the doorway became an external doorway again and its glazed door and window shutters must date from then.

*Plate 30 East Range, South Reception Room 3, south wall with inserted doorway.*

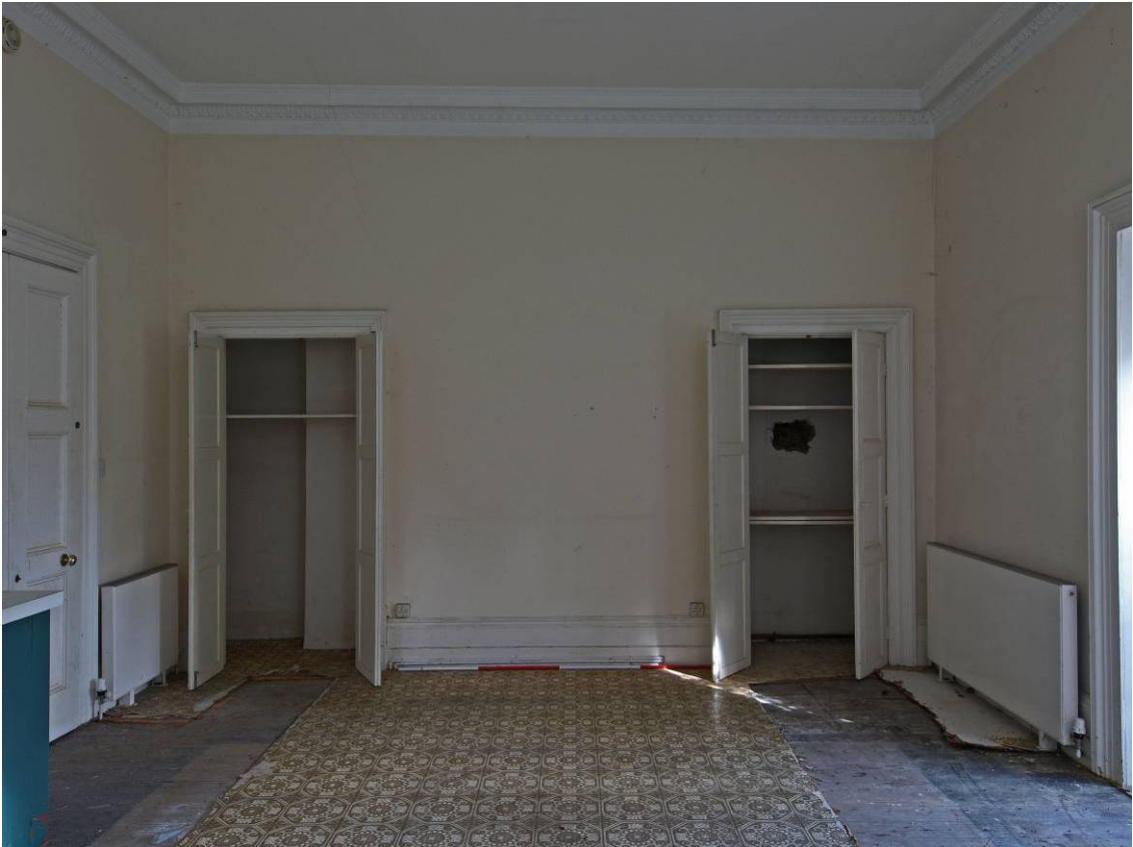
This room was created in the late 18<sup>th</sup> century when the East Range was extended at the rear. The moulded ceiling cornice (with bead and reel and egg and dart enrichment) and panelling under the windows probably date from this period (Plates 31-32). The panelled entrance door, the cupboard doors to the east and south walls including their architraves, and the eight-pane sash windows at the west end of the room probably all date from 1831. The existing windows probably replaced late 18<sup>th</sup> century 12-pane sashes.

*Plate 31 East Range, Rear South Room 4, created c1790*

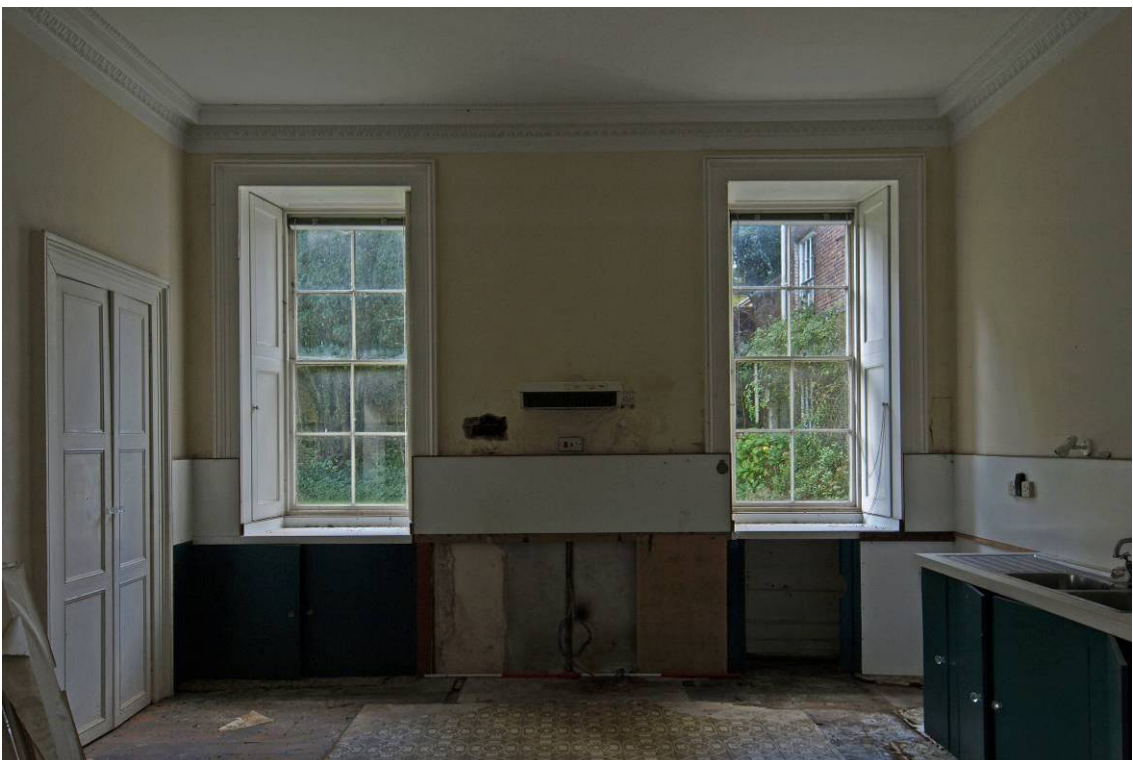
*Plate 32 East Range, Rear South Room 4, west windows probably replaced in 1831*

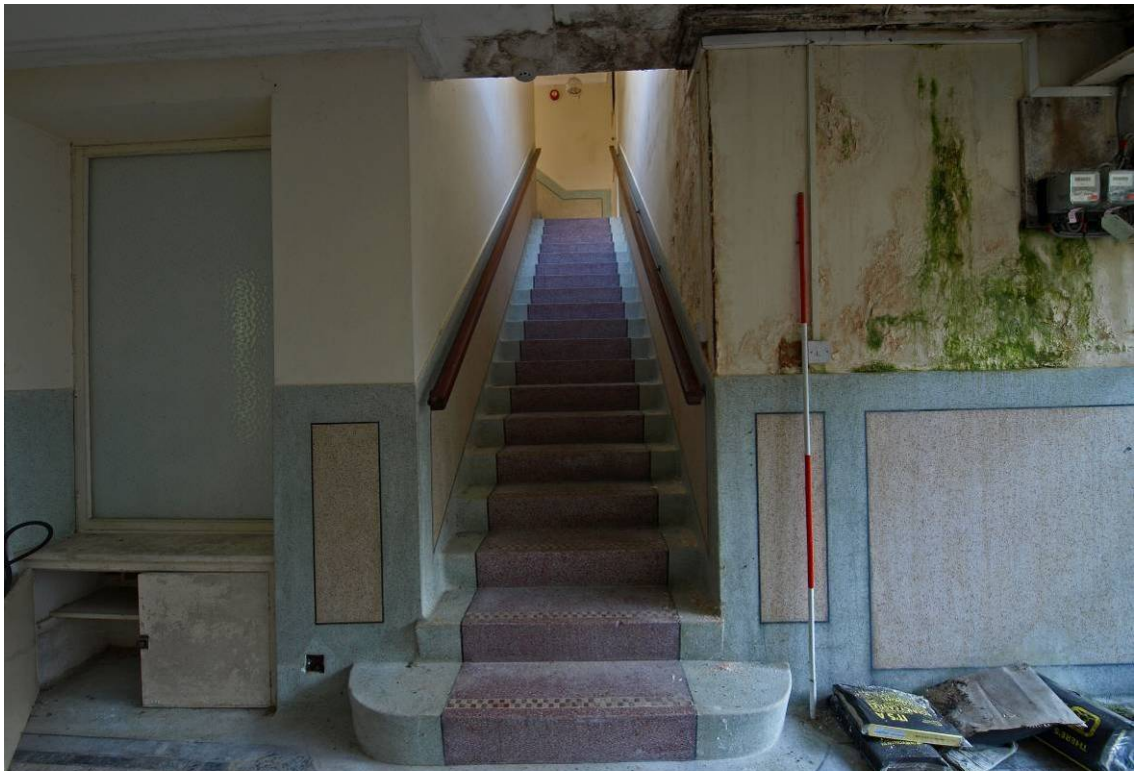
The rear entrance hall was constructed under a flat roof in the 1950s in the southeast corner of the courtyard (Plate 36). This room has terrazzo finishes including a scheme to a straight-flight staircase that rises from the south side of the room in the probable location of a former c1831 service/guest staircase. At the north side of the hall is a straight-flight staircase that gives access to the cellar below the East Range.

*Plate 36 East Range, 1950s rear entrance hall (Room 9) with terrazzo detail.*

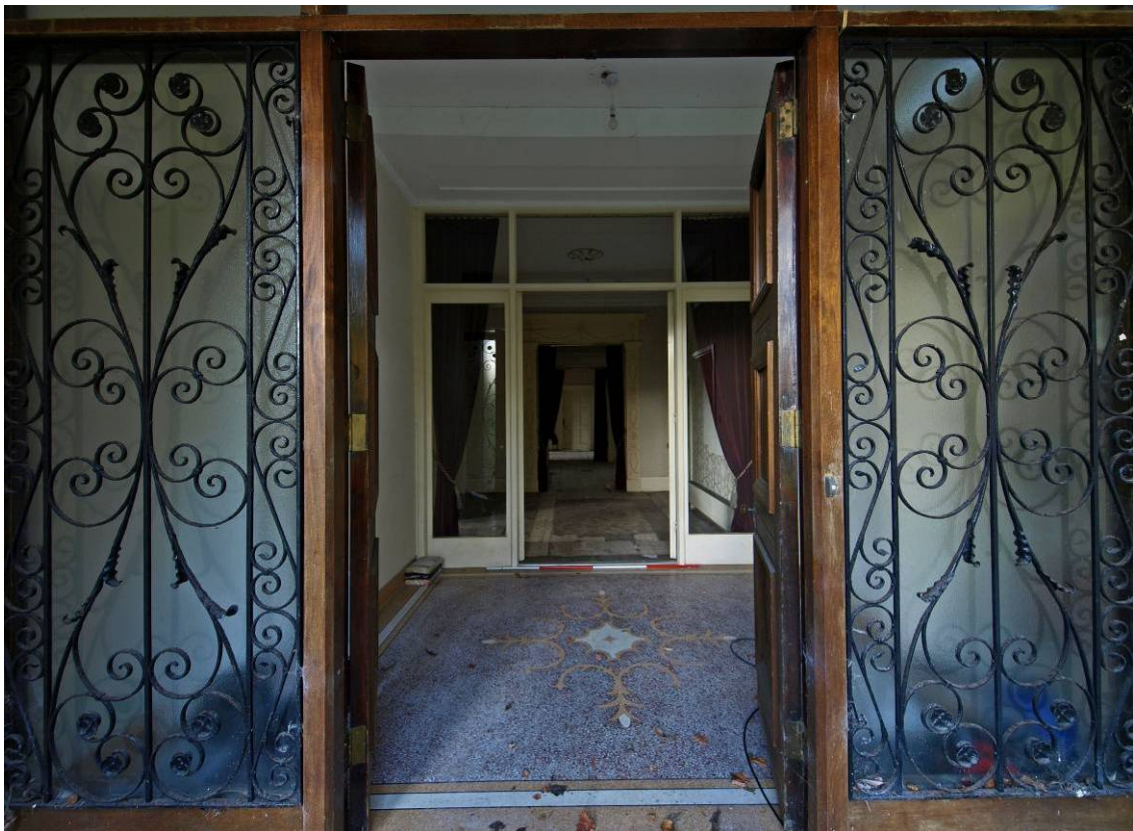
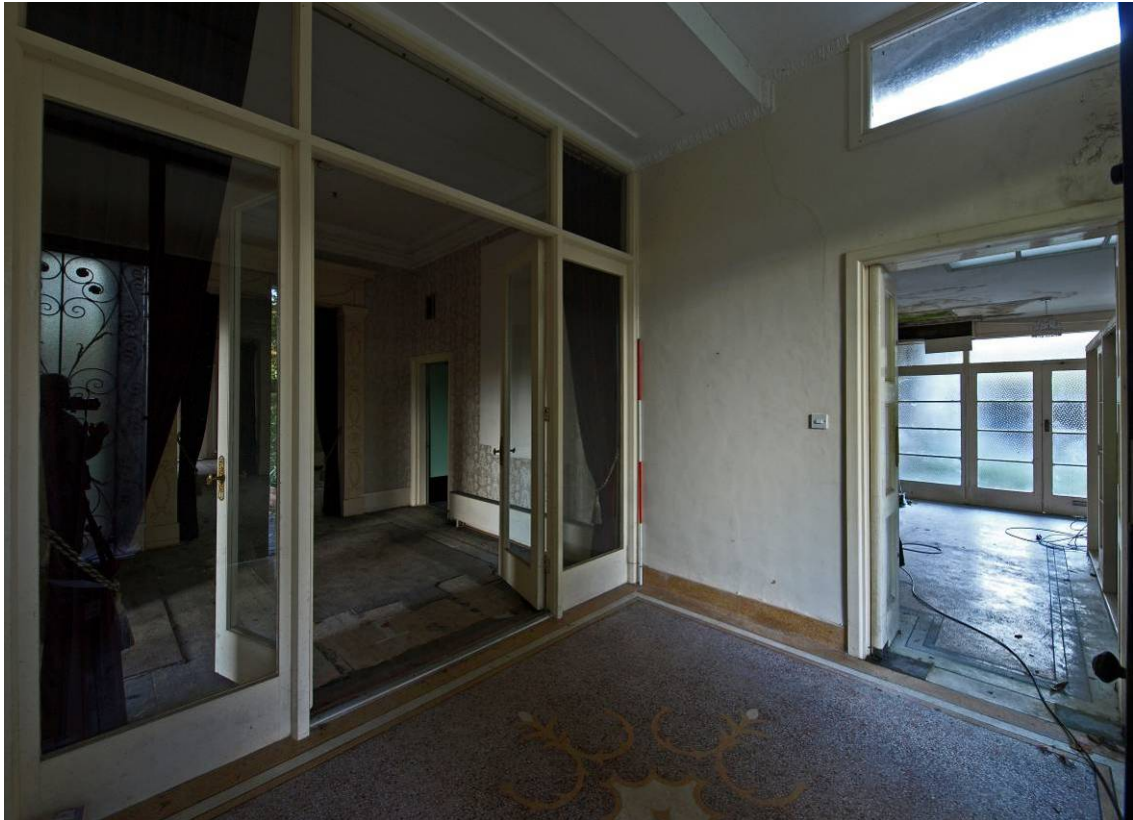
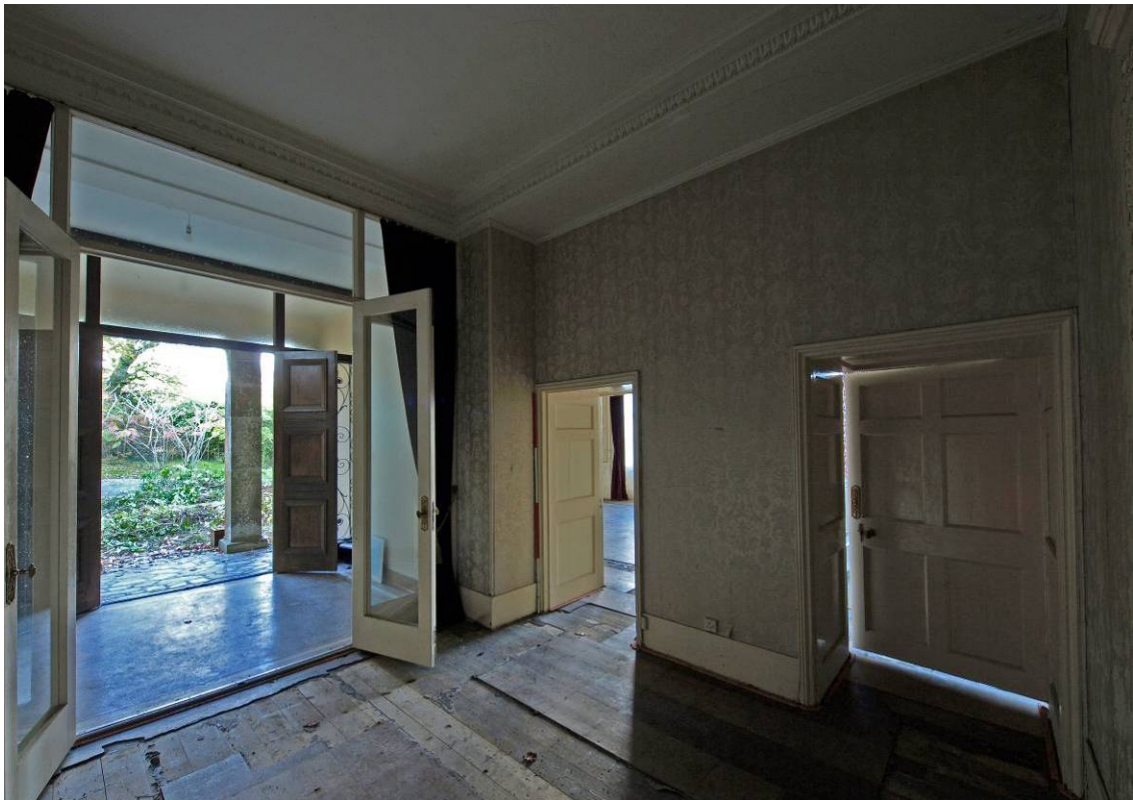
The north vestibule (Plates 37-9), must have existed at least in part since the early 18<sup>th</sup> century as it gives access between Rooms 1 and 2. Since the 1950s this vestibule has been subdivided by a glazed doorway and the north area provided with a Terrazzo floor.

Egg and dart cornice detail at the north end is modern but the moulded cornice with egg and dart detail in the larger area to the south may be genuinely 18<sup>th</sup> century, similar to the late 18<sup>th</sup> century ceiling in Room 5. The ceiling rose also looks genuinely historic.

*Plate 37 East Range, north vestibule (Room 12) looking south.*

*Plate 38 East Range, north vestibule (Room 12) looking southwest.*

*Plate 39 East Range, north vestibule (Room 12), looking northeast.*

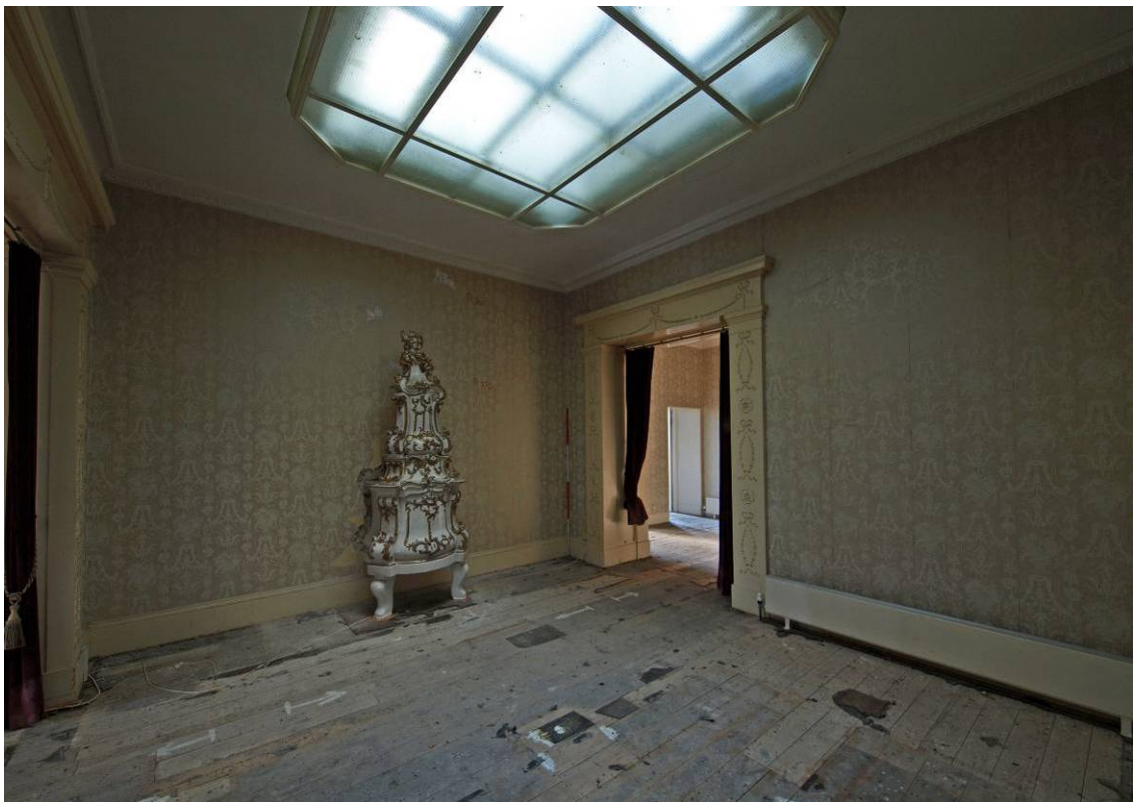
The moulded ceiling cornice with egg and dart detail appears to be genuinely 18<sup>th</sup> century and significantly is similar to the probable late 18<sup>th</sup> century ceiling cornice in Room 5 and to the ceiling cornice in the north vestibule, all of these apparently belonging to the same phase. The doors that lead off this space are probably replacement features from the time of the 1831 Harrison scheme.

*Plate 40 East Range, central hall- 1831 stair hall (Room 13)*

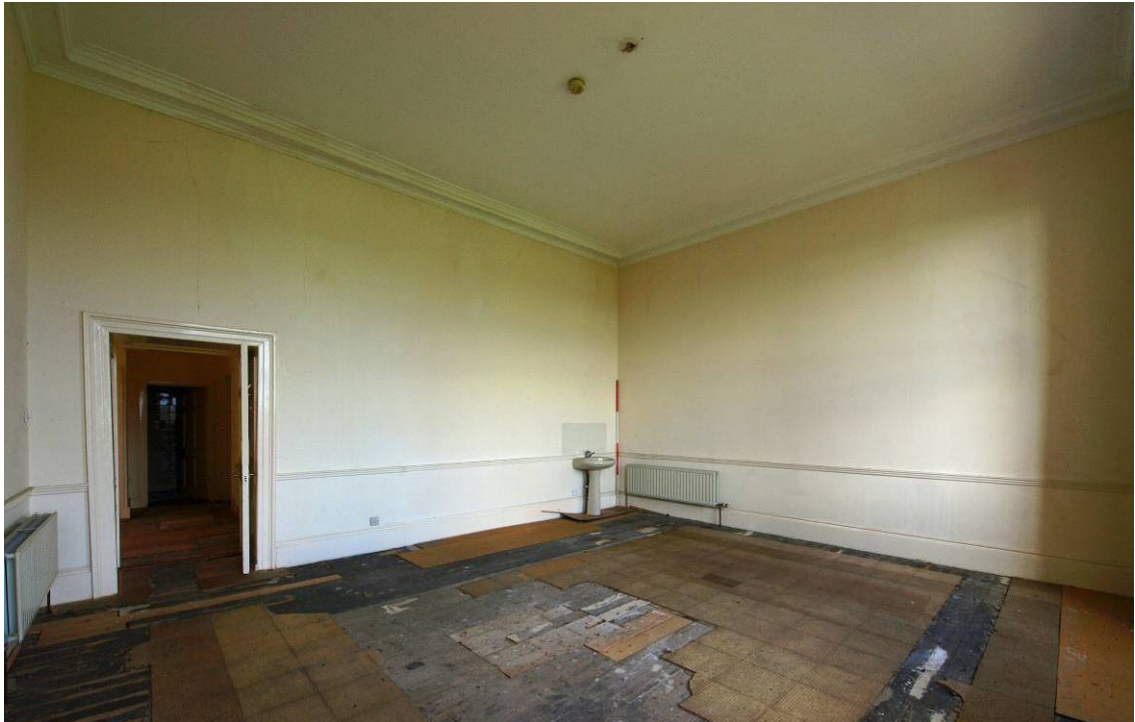
*Plate 42 East Range, north bed chamber (Room 40) looking northwest.*

This room has what appears to be an 18<sup>th</sup> century chair rail. The skirting board, panelled window shutters, panelled reveals to the door and the six-panel door probably date from 1831 (Plate 42). The moulded ceiling cornice appears to be modern. The fireplace has been blocked in but its location central to the west side of the room can be identified by straight joints in both the skirting board and the chair rail. An inspection panel in the floor reveals the original floor constructed with joists connected into axial beams at two levels with mortise and tenon joints.

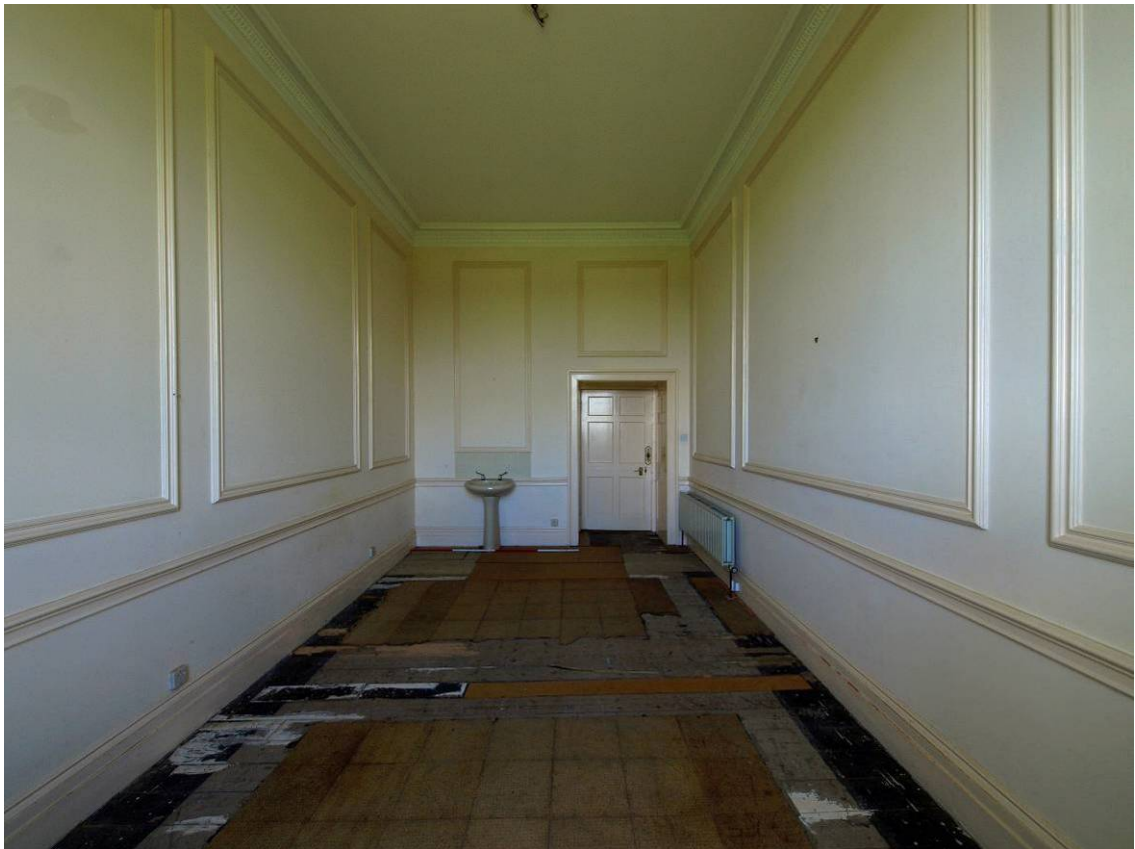
*Plate 43 East Range, dressing room (Room 41) early 18<sup>th</sup> century scheme*

Room 41 (Plate 43) is a dressing room ensuite to the principal bed chamber (Room 42). Rooms 41 and 42 retain original early 18<sup>th</sup> century panelled plastered walls together with moulded chair rails and moulded ceiling cornices. This is a rare and important scheme, particularly as it survives in two related room spaces.

The window shutters and sash windows with very thin glazing bars and the six-panel door probably belong to the 1831 Harrison scheme.
