# Trewarthenick House, Tregony, Cornwall.

## Historic Building Recording

Date: November 2011

**Project No:** AC08001E

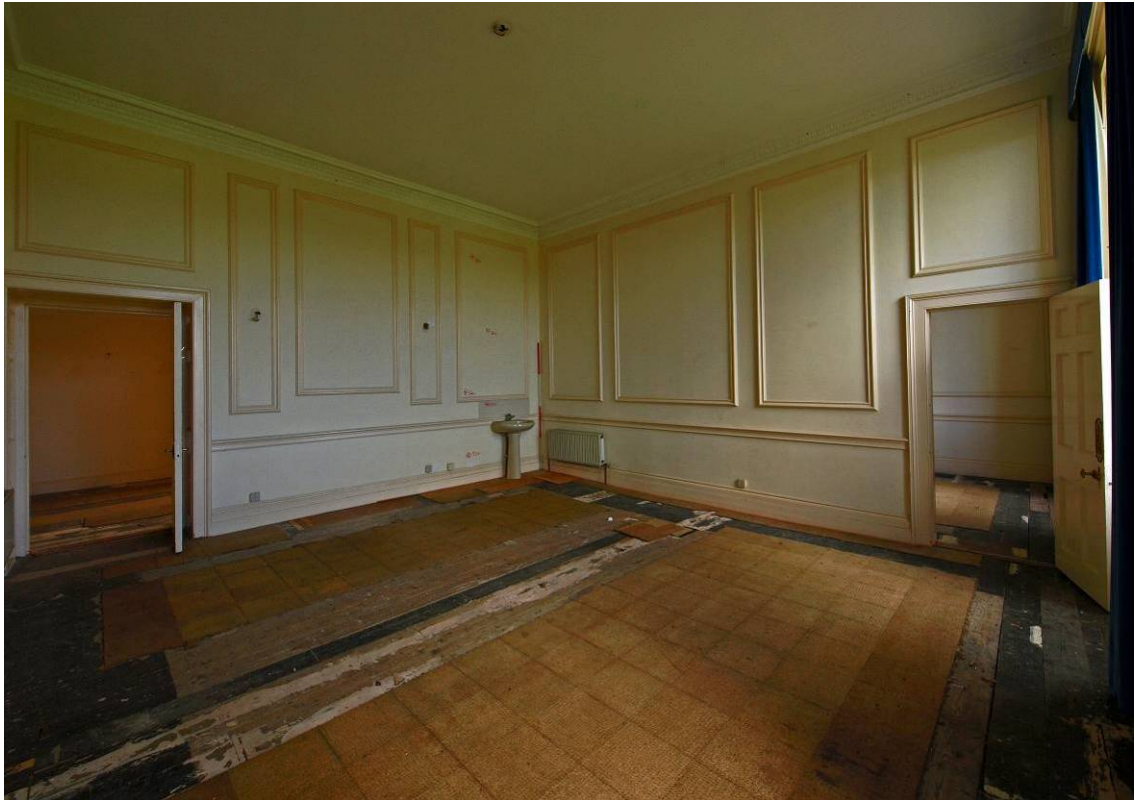
*Plate 44 East Range, bed chamber (Room 42), part of an important early 18<sup>th</sup> century scheme.*

The fireplace is now blocked but its former location can be identified central to the west side of the room by the arrangement of wall panels and by the survival of the hearthstone in the floor (Plate 44).

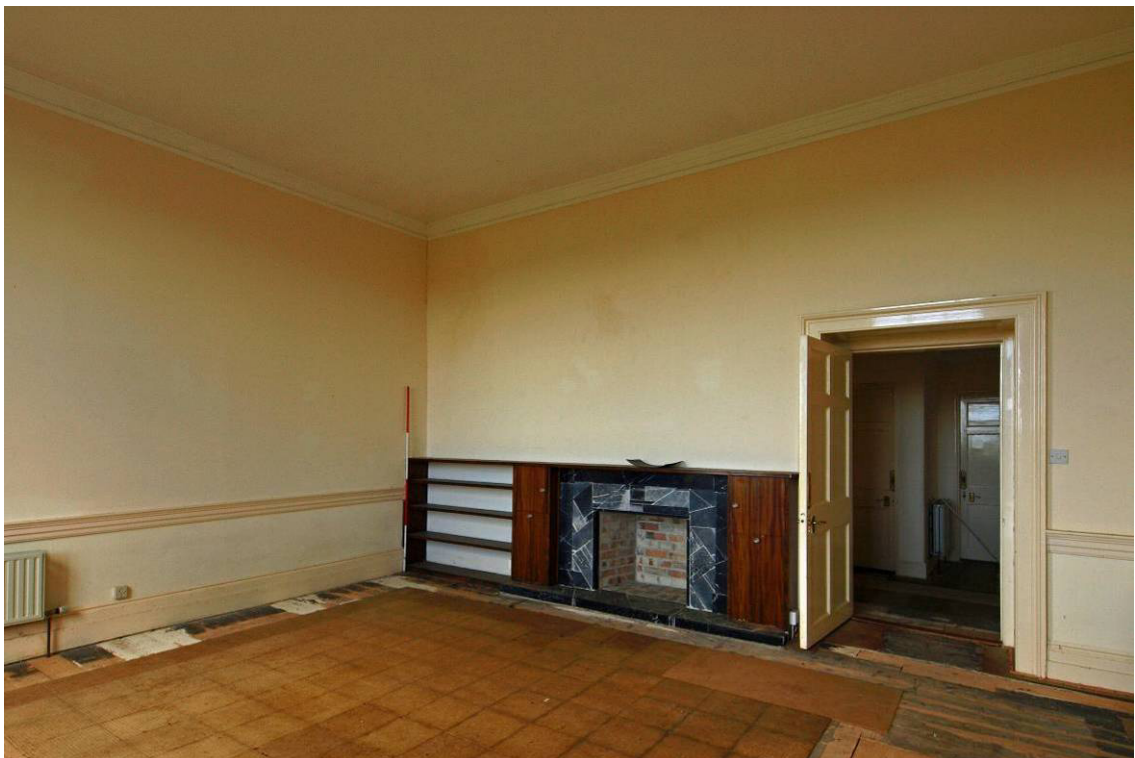
*Plate 45 East Range, south bed chamber (Room 43), much altered.*

Room 43 is at the south end of the East Range. The moulded chair rail belongs stylistically to the 18<sup>th</sup> century but other historic features including panelled window shutters, skirting boards, panelled doorway reveals and the six-panel door probably belong to the 1831 Harrison scheme (Plate 45). The moulded ceiling cornice may be much later, possibly part of the 1925 scheme.

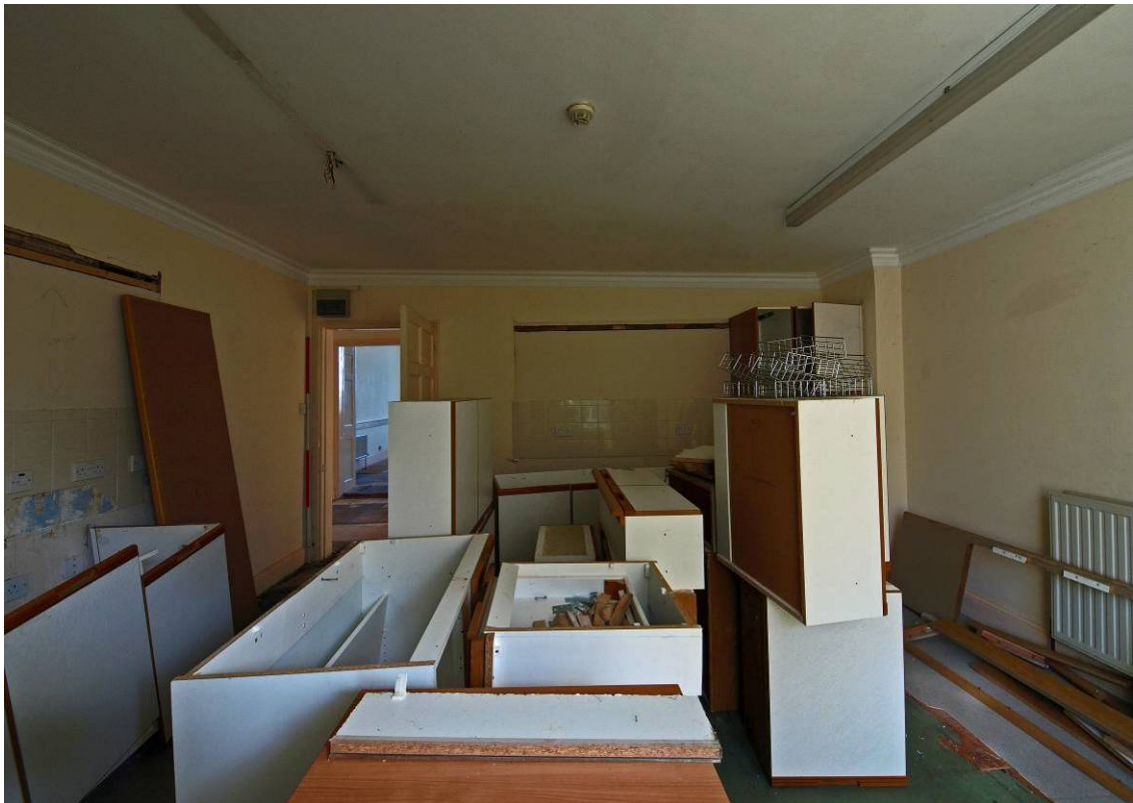
*Plate 46 East Range, rear bed chamber (Room 45), added when the East Range was extended c1790*

This bed chamber must date from when the southwest corner of the East Range was extended between 1789 and 1793. The moulded plaster ceiling cornice and the panelled window shutters probably date from this time, and possibly the door architraves, but the panelled door, like so many others in the house, probably dates from the Harrison scheme (Plate 46).

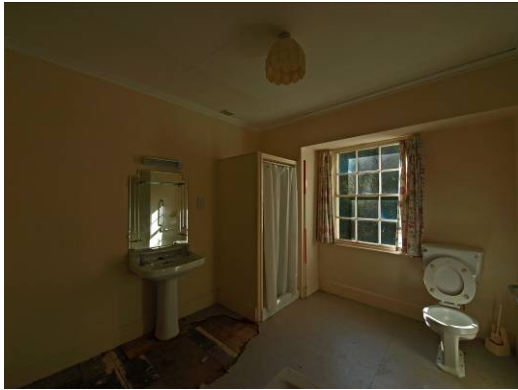
*Plate 47 Bathroom (Room 46) in probable former stair wing.*

This small room probably replaced a staircase removed as part of the 1831 Harrison scheme. The moulded ceiling cornice, the door architrave and panelled door, the 12-pane hornless sash window fitted to the west wall, all probably date from 1831.

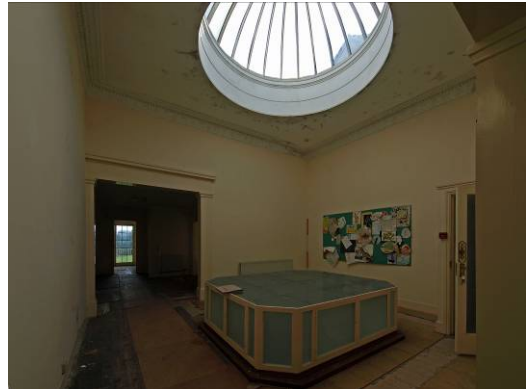
*Plate 50 Former principal stair hall (Room 50), probably part of the 1831 scheme by Henry Harrison.*

This former principal stair hall is one of the principal elements of the 1831 Harrison scheme for re-ordering the house. Until the late 18<sup>th</sup> century this space is shown as an open courtyard. It is in-filled by about 1790 and may have contained a staircase from that time but the moulded and carved ceiling cornice with band and the fine oculus roof light (Plate 52) are an important part of the Harrison scheme. The cornice and oculus suggest that the staircase that must have filled this space until probably the 1950s was the principal 1831 staircase.

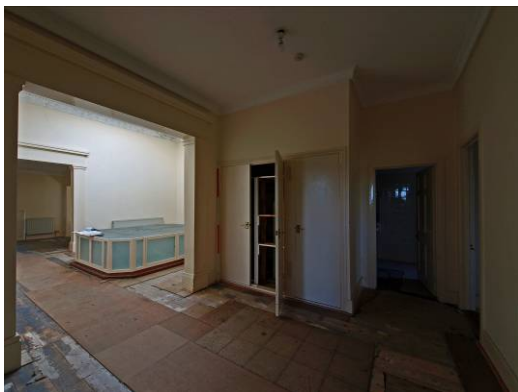
*Plate 48 North landing vestibule (Room 49), to southwest and former principal stair hall.*

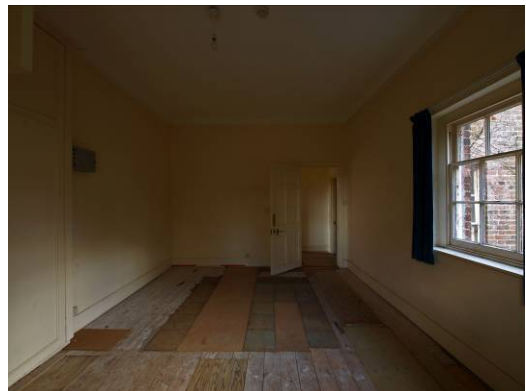
*Plate 51 Unheated bed chamber (Room 48) located above north vestibule.*

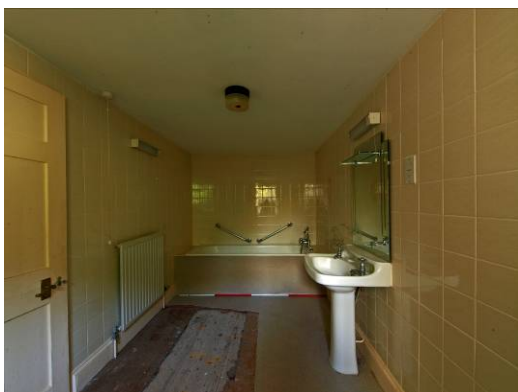
*Plate 49 Bathroom (Room 47) behind north landing in probable location of former service stair.*

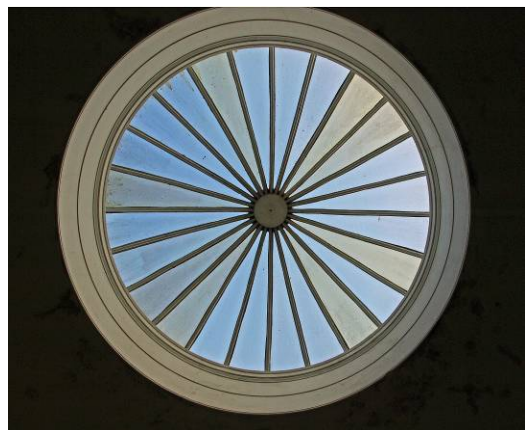
*Plate 52 Former principal stair hall (Room 50), roof oculus detail.*

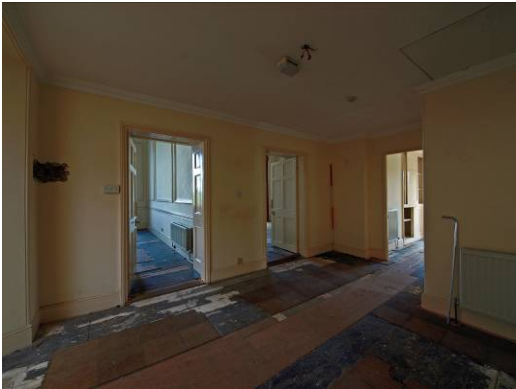
*Plate 53 East Range, south landing vestibule (Room 51) looking southeast with doorways of rooms 42, 43 and 44.*

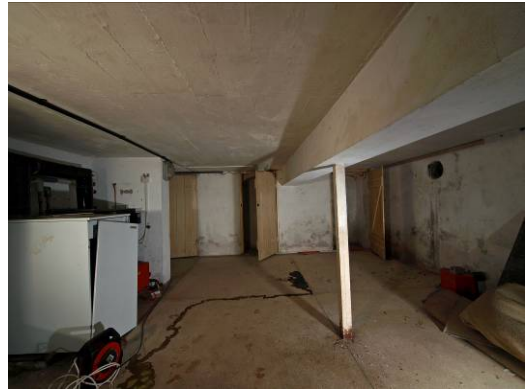
*Plate 56 East Range, original basement (Room 31) looking north.*

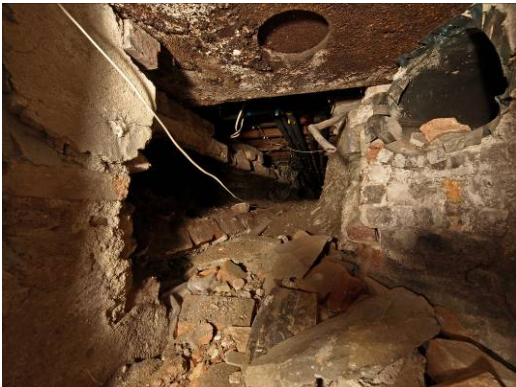
*Plate 54 East Range rear basement (Room 30), inserted brick and copper flues looking south.*

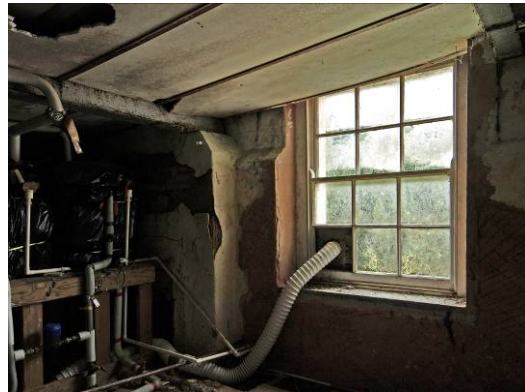
*Plate 57 Attic (Room 70) above southwest corner of East Range, looking southwest.*

This attic space (now under a low-pitched modern roof) survives from when the house used to have a double-pitched roof over the rear wing (Plates 57-58). The west wall contains a fireplace, clear evidence for this floor having been a proper living area of the house. There is a 12-pane sash window north of the fireplace that is an approximate horned copy of the former 1831 hornless sash window that it replaces. Variation in the thickness of the wall right of the fireplace is further evidence of a radical alteration to this former probable stair wing probably in 1831.

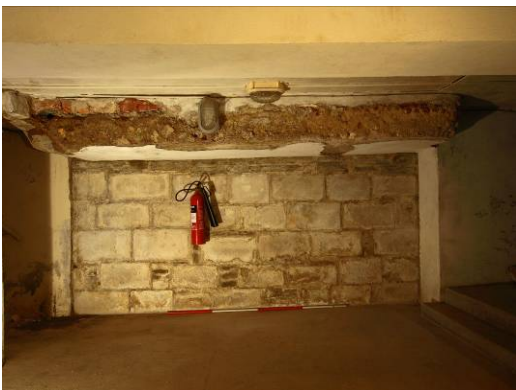
*Plate 55 East Range basement (Room 30), stone ashlar walling under probable remains of original floor level.*

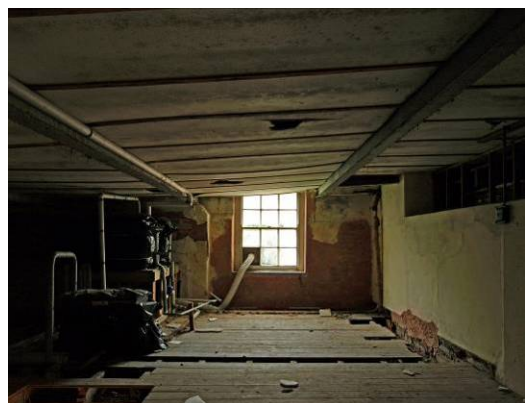
*Plate 58 Attic (Room 70) above southwest corner of East Range, looking west.*

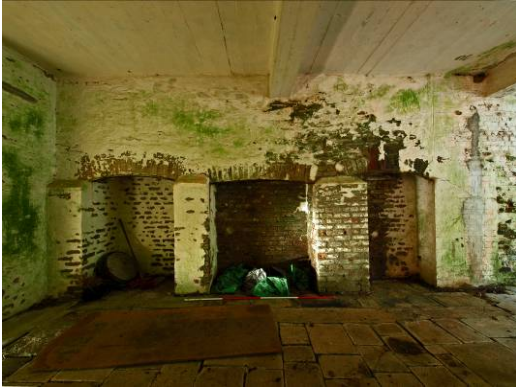
*Plate 59 Former Kitchen (Room 15) at west end of Rear Wing, truncated probably 1925, the fireplaces surviving under 1950s flat roof*

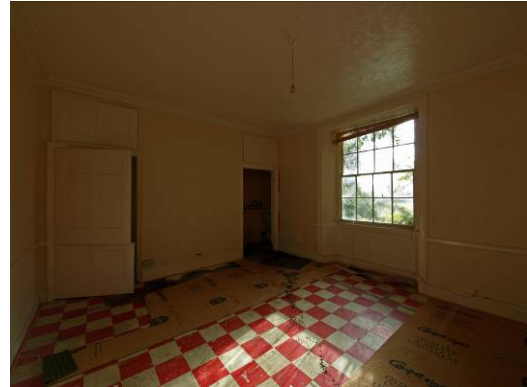
*Plate 62 Rear Wing, ground floor, Room 21, looking southeast showing panelled cupboards flanking blocked fireplace and c1831 sash window*

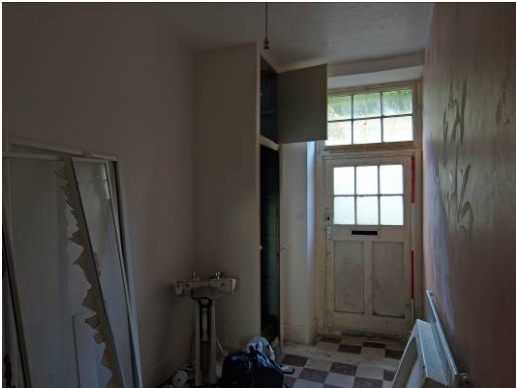
*Plate 60 Rear Wing lobby (Room 17), looking north.*

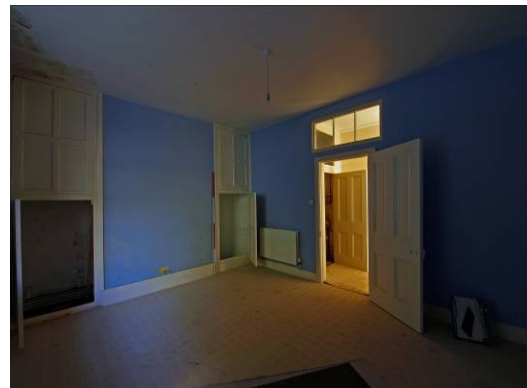
*Plate 63 Room 19, looking southeast showing panelled cupboards flanking blocked fireplace and later 19<sup>th</sup> century four-panel door.*

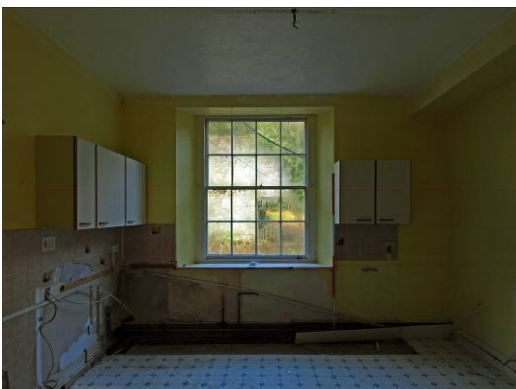
*Plate 61 Rear Wing, Room 18 with c1831 sash window*

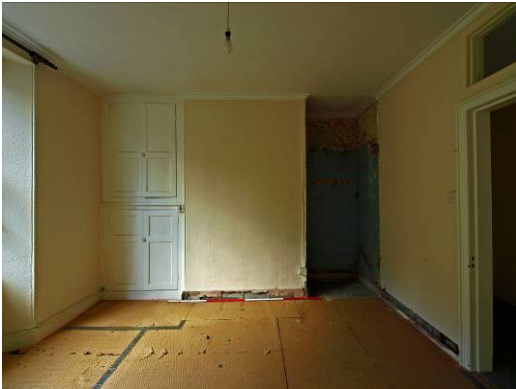
**Plate 65** Rear Wing, first floor, bedroom (Room 55) looking east showing cupboards flanking blocked fireplace

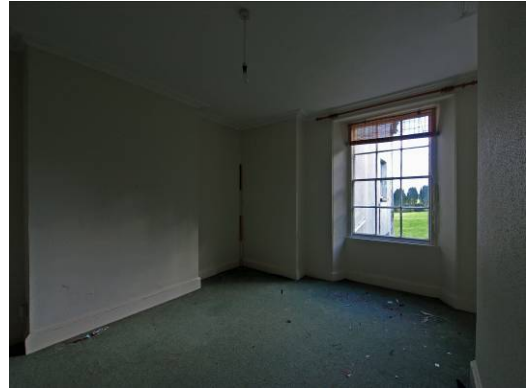
**Plate 68** Rear Wing, first floor, Room 56 looking southeast showing blocked fireplace, c.1831 sash window, ceiling cornice, and pre-1831, thicker walling left of window

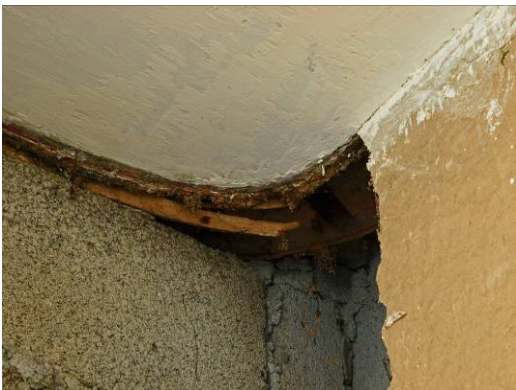
**Plate 66** Rear Wing, first floor, Room 55 looking southeast showing curved ceiling detail from former c.1831 stair hall to east.

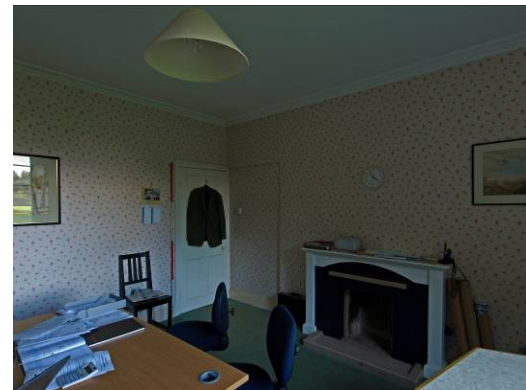
**Plate 69** Rear Wing, first floor, Room 57 looking northeast, showing c.1831 ceiling cornice and 1950s fire grate.

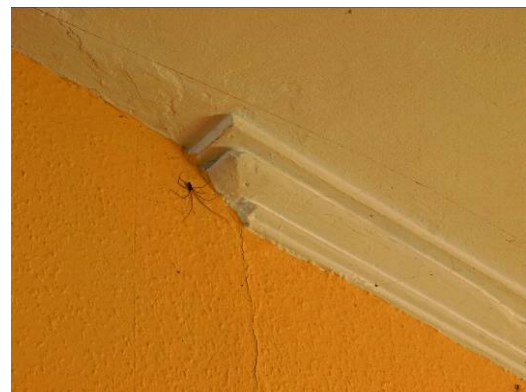
**Plate 70** Rear Wing, first-floor service passage (Room 59), c.1831 ceiling cornice detail

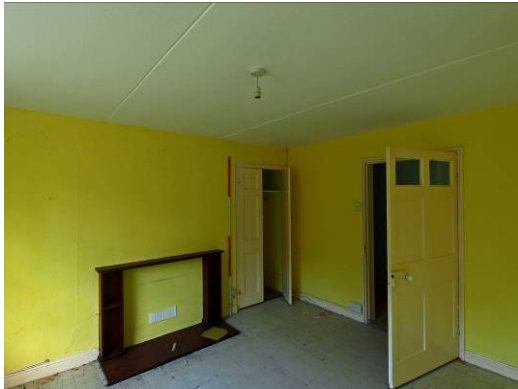
*Plate 71 Rear Wing, second floor, Room 62, looking southeast showing fireplace, and c.1831 panelled cupboard and door.*

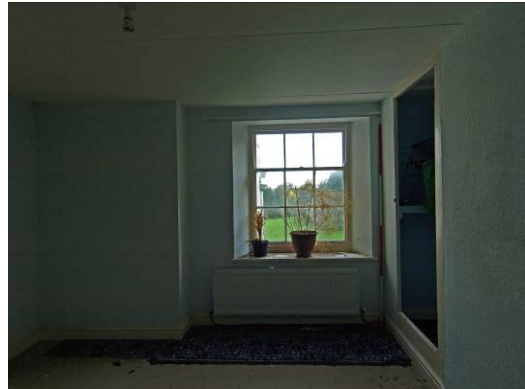
*Plate 74 Rear Wing, second floor Room 65 looking south showing c.1831 sash window, and earlier thicker, walling to left.*

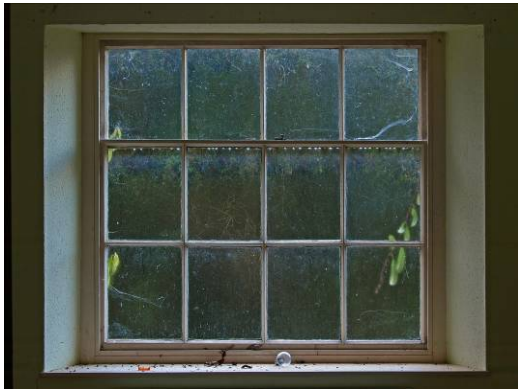
*Plate 72 Rear Wing, second floor Room 63 north window c.1831 four over eight-pane sash.*

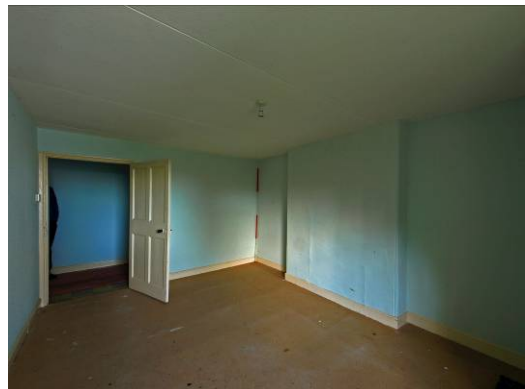
*Plate 75 Rear Wing, second floor Room 65 looking northeast, showing panelled door and blocked fireplace.*

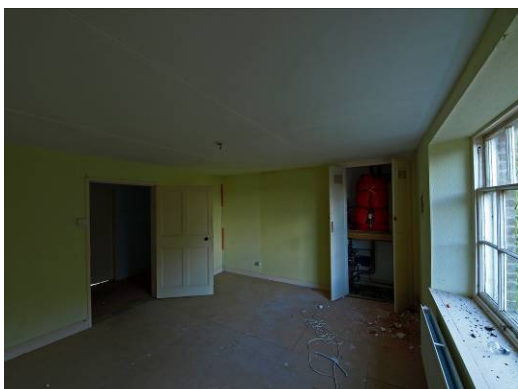
*Plate 73 Rear Wing, second floor Room 64 looking west, showing c.1831 panelled doors and sash window.*

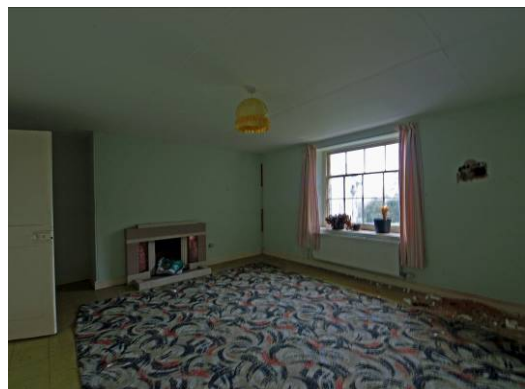
*Plate 76 Rear Wing, second floor Room 66 looking southeast showing c.1831 sash window and 1950s grate.*

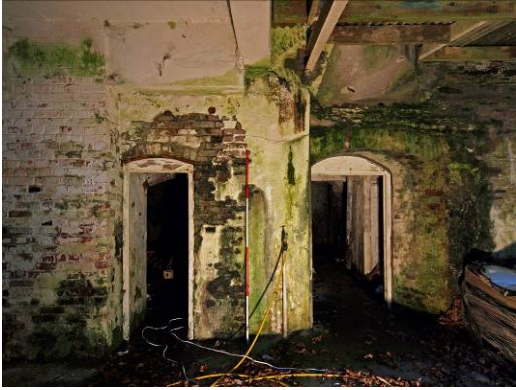
*Plate 77 Coal Cellar doorways looking west*

Each cellar was filled by chutes, located in the west wall of Cellars 36 and 37 and in the east wall of Cellar 38. Thick encrustation of coal deposit survives on parts of the cellar walls. Cellar 38 has slots in its doorway for presumed baffle boards.

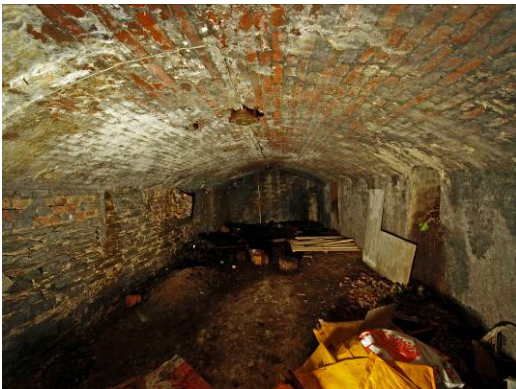
*Plate 78 Coal Cellar (Room 36) looking south*

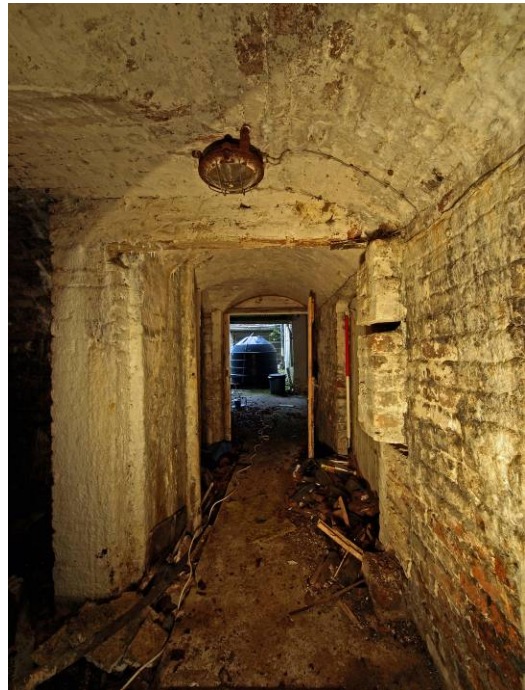
*Plate 81 Coal Cellar passage (Room 25) looking east.*

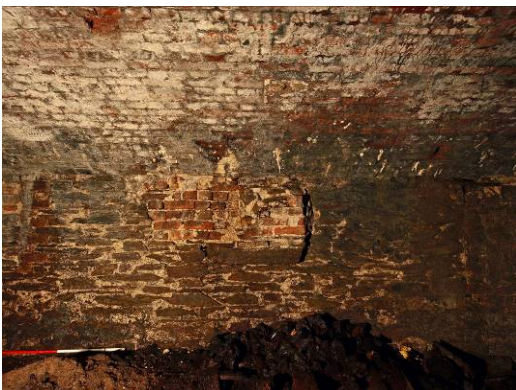
*Plate 79 Coal Cellar (Room 36) looking east, showing blocked remains of probable oven.*

The east wall of Cellar 36 has three areas of re-facing, each area relating to a kitchen fireplace to the east. The central blocking includes what appears to be the threshold stone of a former oven.

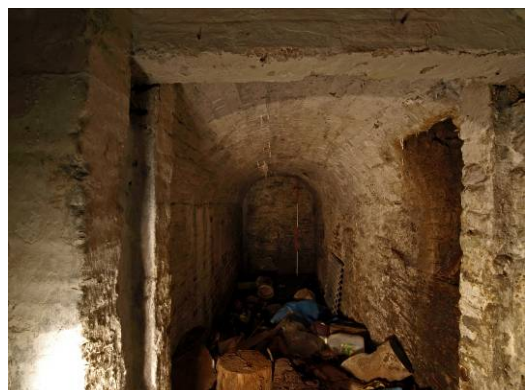
*Plate 82 Coal Cellar (Room 38) looking north*

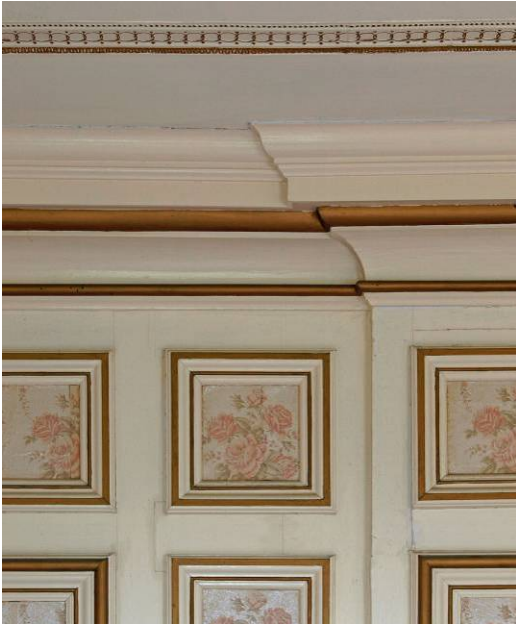
*Plate 83 East Range, North Reception Room 1.*

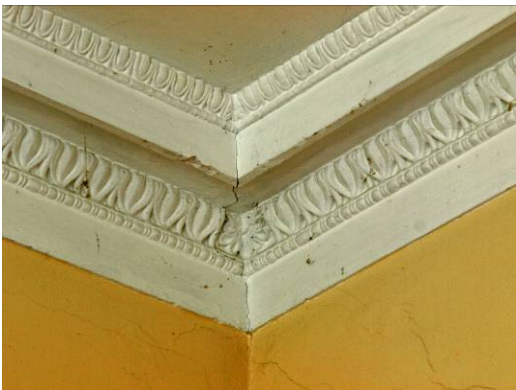
*Plate 84 Room 4 c.1790.*

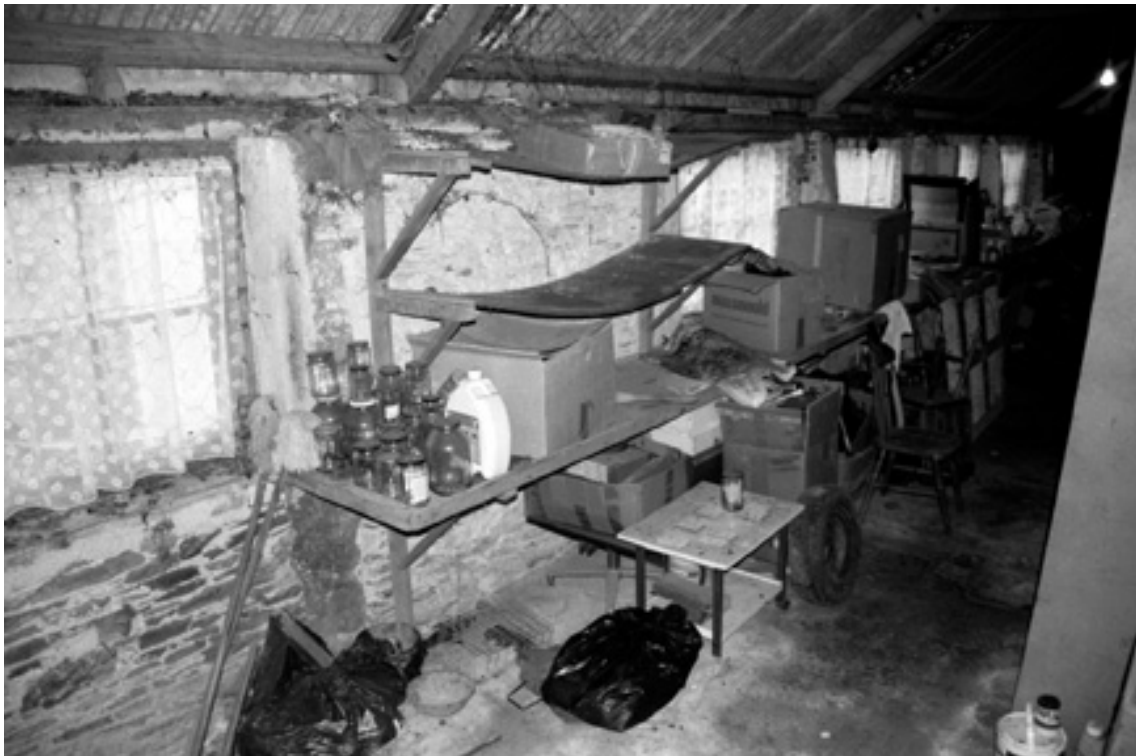
The original form of the workshop with a low roof, continuous rear wall and open east elevation punctuated by evenly spaced granite pillars indicates the building was designed as a cart shed. The north end of the building may have been a working room or storage area. The amalgamation of the two buildings sometime after 1921, appears to have involved a new floor and the moving of the granite pillars further east to accommodate the new roof.

*Plate 101 The interior of the workshop looking southeast*

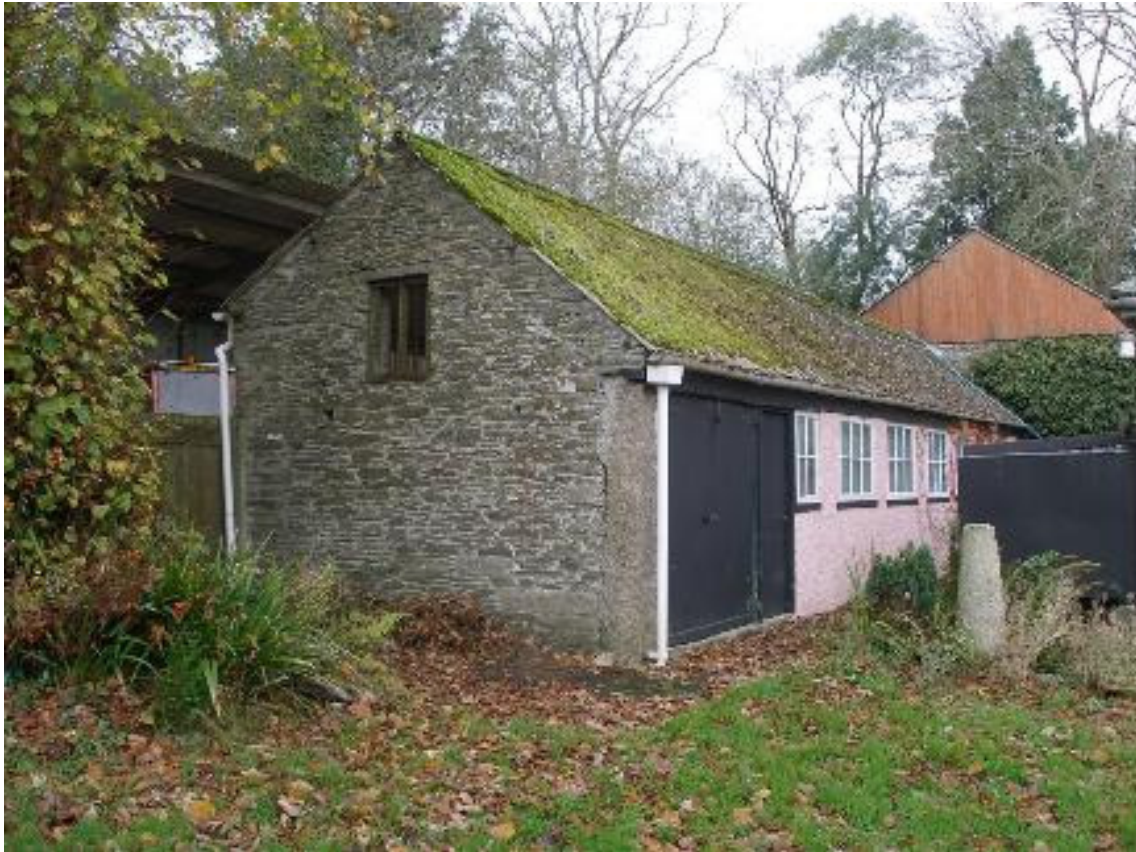
The floor of the workshop was concrete throughout, although the northern end had a raised floor level. The walls were primarily constructed using local shale, bedded on its broad side and bonded with lime mortar. The eastern side of the building was supported by wedge split granite pillars, generally c.2m apart (Plate 101). The wedge marks suggest that the granite was split sometime before the 19<sup>th</sup> century, though it seems the pillars had been repositioned.

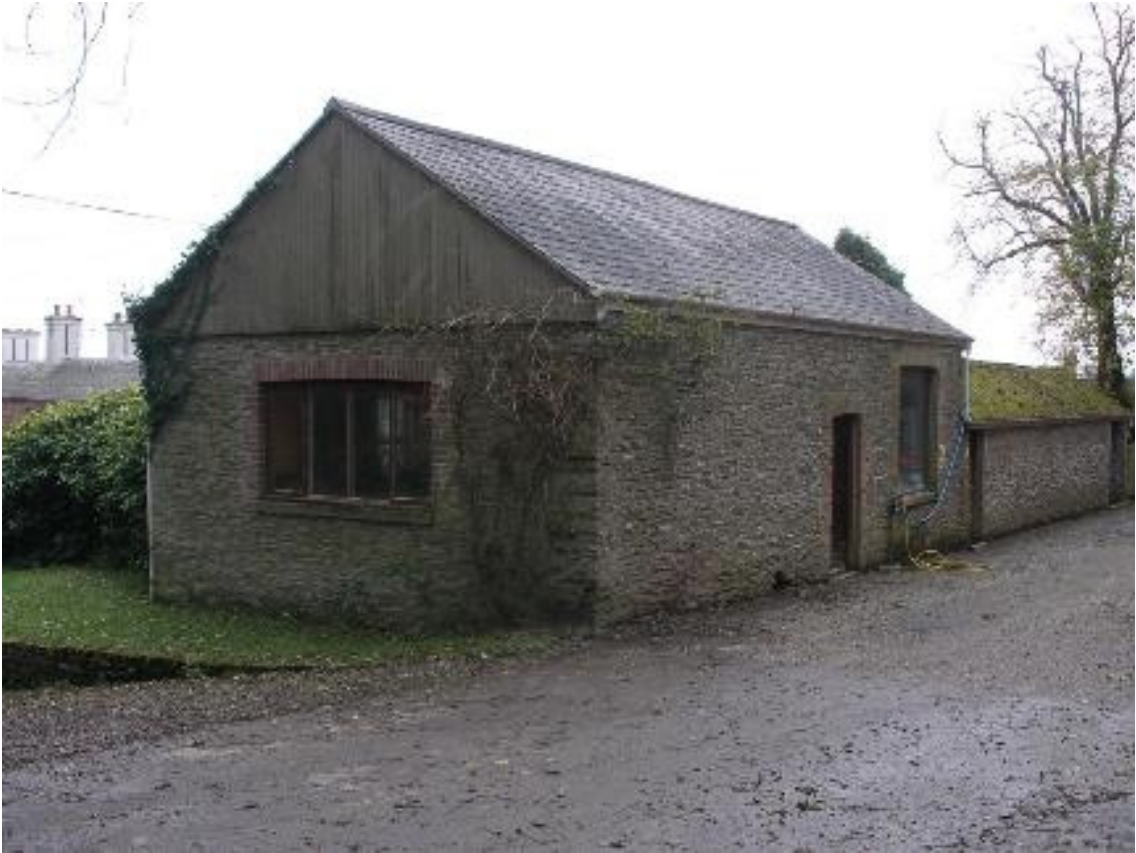
Repair work to the walls in local slate or shale and brick and the insertion of brick lintels suggest that at least four of the windows and the doorway were inserted into the pre-existing fabric. A surveyor's bench mark was inscribed onto the repaired stonework resulting from the insertion of the exterior doorway. The windows, doors, roof and interior are modern.

*Plate 103 The office looking southeast*

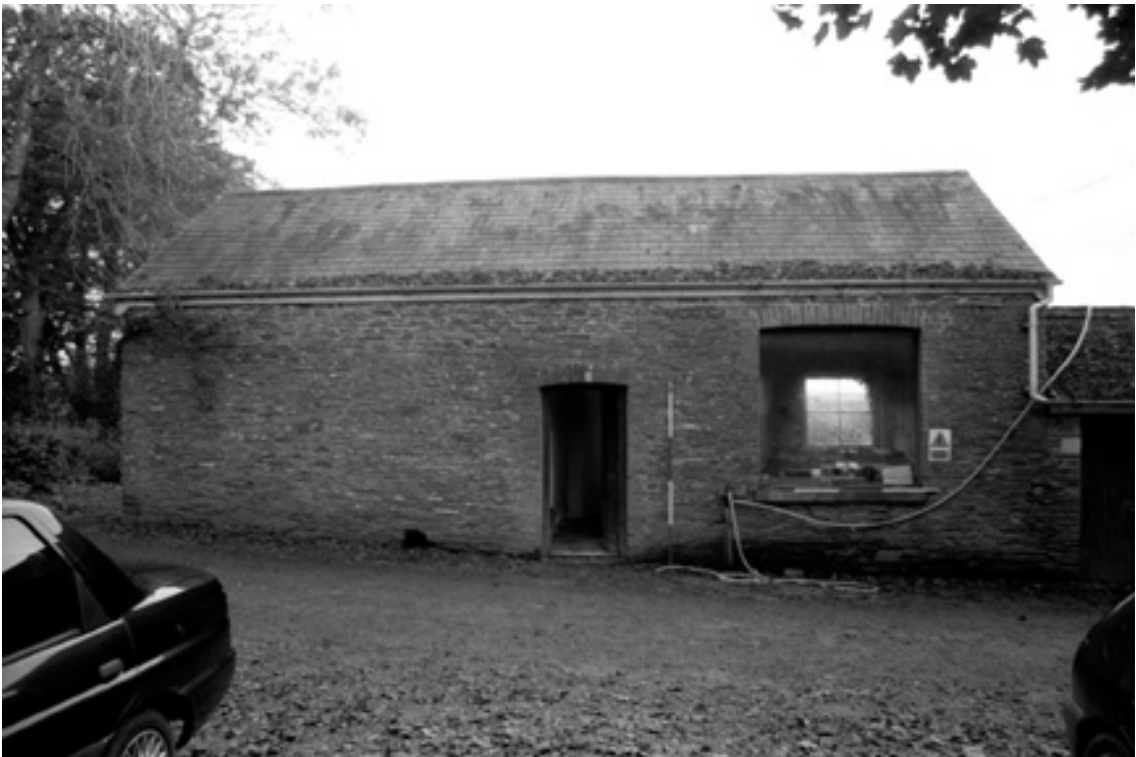
The Office was an amalgamation of two slate or shale built buildings forming a rectangular building measuring 11.30m north to south by 5.95m east to west (Plate 103). Two buildings are first visible on the 1843 Cornelly parish tithe map (Figure 7). The 1879 1<sup>st</sup> edition Ordnance Survey map more clearly shows two buildings divided by a narrow space.

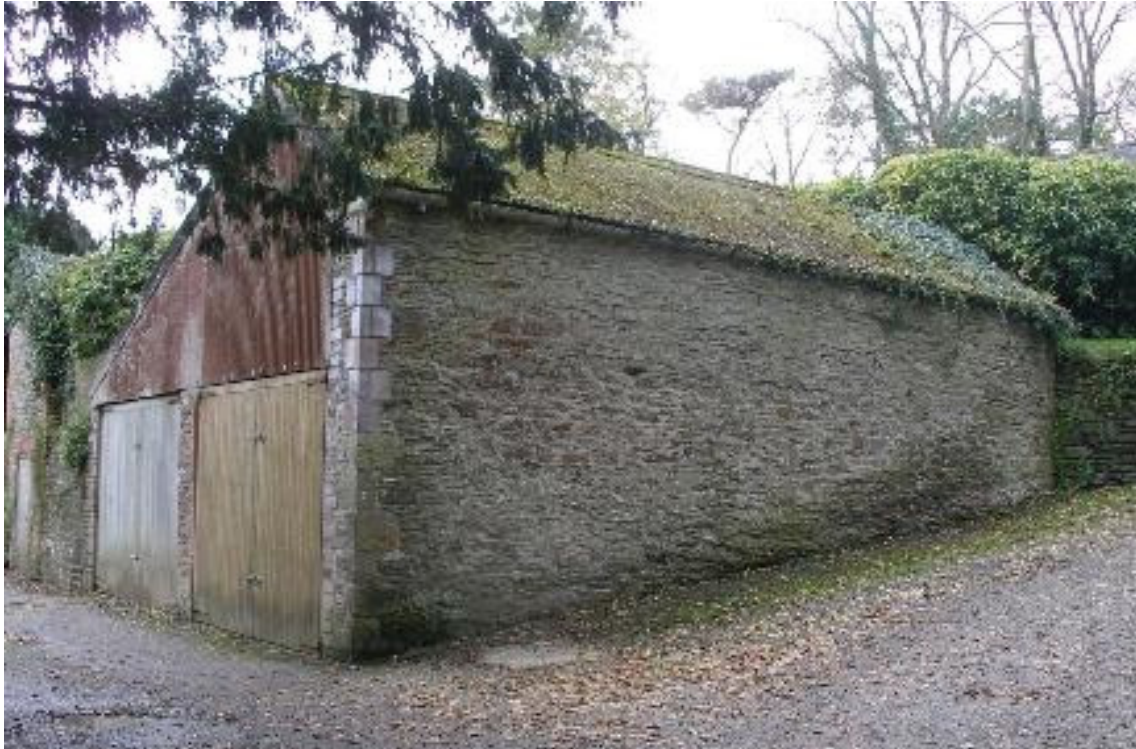
*Plate 105 The garage looking southwest*

The garage was constructed principally using local slate or shale and lime mortar. The upper part of the east elevation and the roof were corrugated fibre cement. The doors were made using modern softwood timber planking (Plate 105). The garage was divided into two bays by a central internal wall.

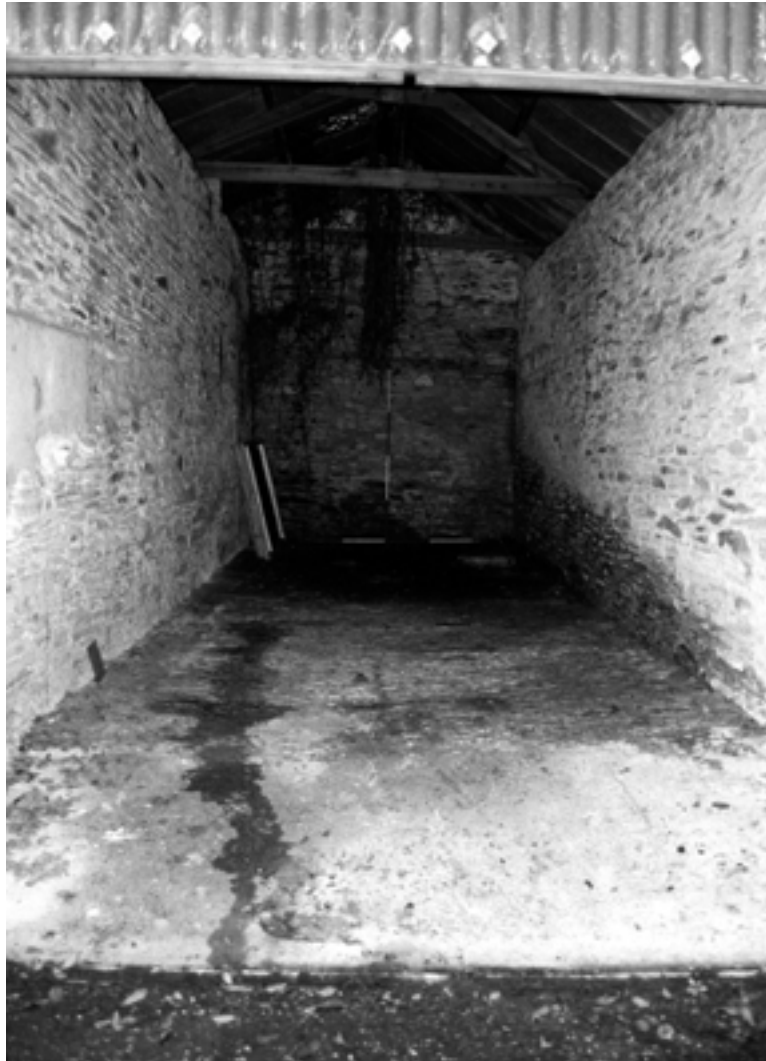
*Plate 106 The interior of the northern bay of the garage, looking west*

The floor in the northern bay sloped upwards slightly from the level of the exterior access road before becoming level (Plate 106). The level area of floor in this part of the garage was cobbled using local slate or shale bedded on its side and running across the width of the room. Red bricks and slate or shale bedded on their sides ran along the edges of the room, defining the extent of the cobbling. To the west a line of c.1m wide slabs of fine dark-grey slate ran along the width of the room. A shallow drain c.8.5cm wide was cut into the slates. Joist sockets at the west end of the northern bay showed the position of a former floor. Parkes (2008, 119) suggests the building may have been a firehouse for large vehicles with a water tank in the loft space.

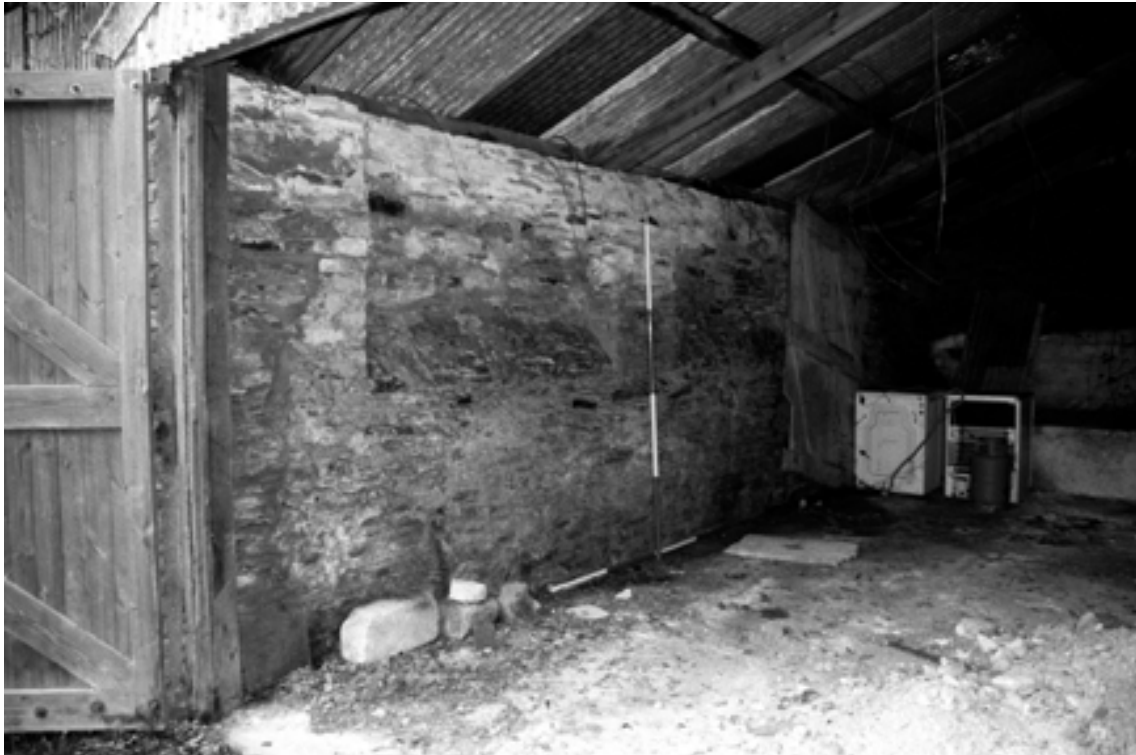
*Plate 107 The interior of the southern part of the garage, looking southwest*

The southern bay of the garage was cut into the natural subsoil, areas of which were not retained using walling. The south wall was not visible externally as it was below ground level. The inside of this wall revealed three large blocked windows (plate 107) indicating that the exterior ground level was previously lower. Below these an iron and a lead pipe had been inserted through the wall.

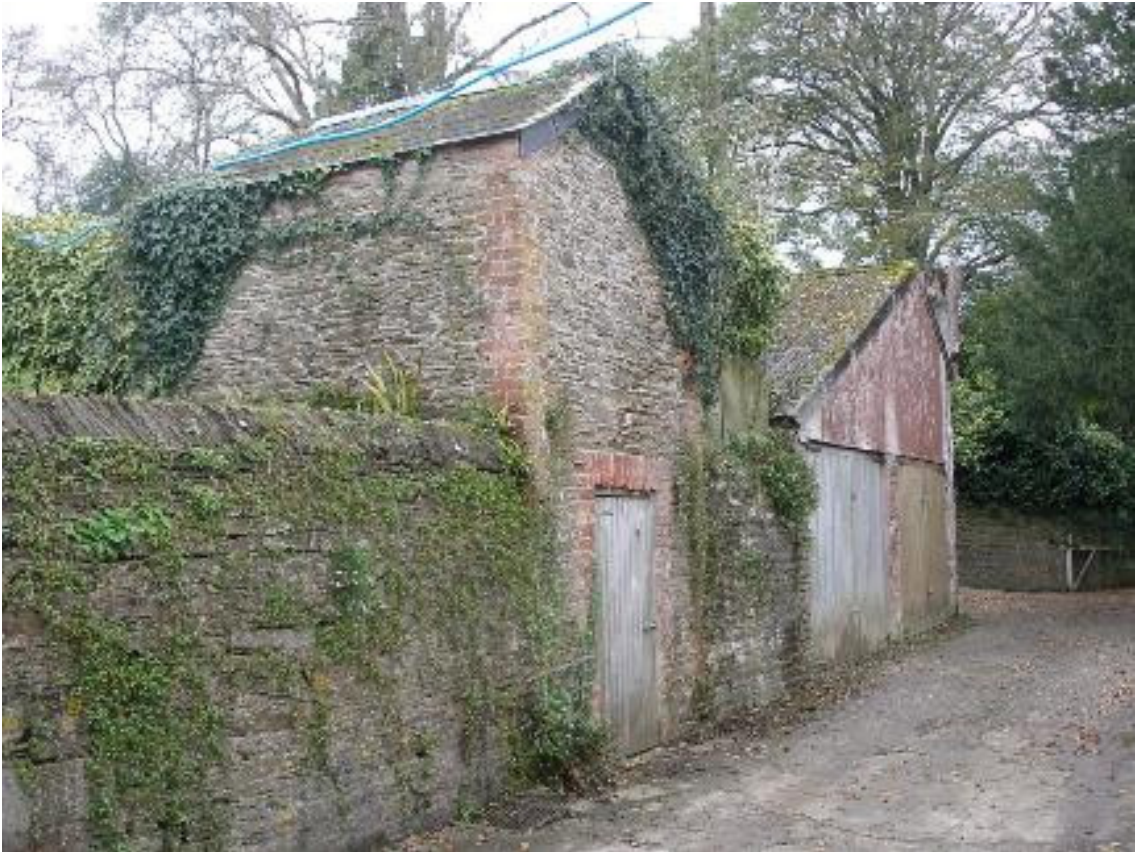
*Plate 108 Woodside outhouse looking northwest*

The Woodside Outhouse was a small two storey building measuring c.2.70m north to south by c.3.05m east to west (plate 108). This building is first visible on the 1843 Cornelly parish Tithe Map (Figure 7). Its first floor doorway ties in with the present raised level of the ground, suggesting that the door must post date the blocking of the south windows of the garage, unless a retaining wall or steps were provided.

The Woodside outhouse was constructed using local slate or shale with red brick details. The brick had sizeable quartz inclusions. The walls were bonded with a lime mortar with granitic inclusions and partially re-pointed at a later date using Portland cement. The replacement roof was constructed using thin mid grey slates, with black glazed ceramic ridge tiles. The woodwork of the roof and first floor was modern sawn timber.

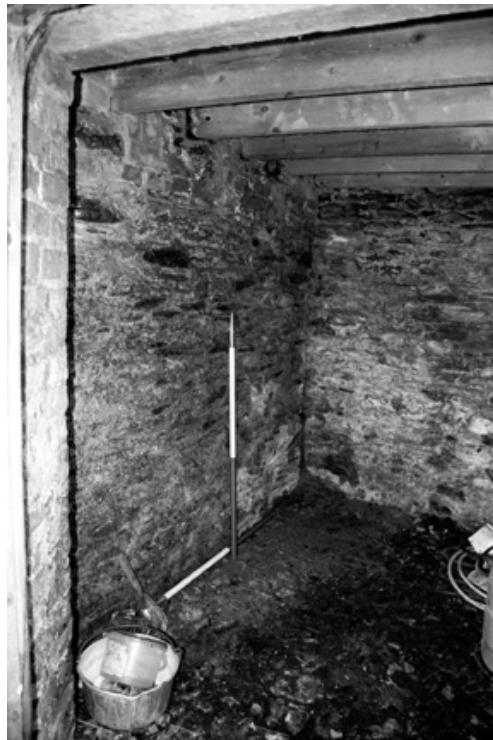
*Plate 109 The ground floor interior of Woodside outhouse looking southwest*

The ground floor of the building had a floor cobbled using sub-rounded granitic stones and occasional pieces of local slate or shale (Plate 109). The doorway had a splayed entrance with brick quoins and shallow relieving arch. The door itself was made from treated tongue and groove timber planks. Inside, repairs using Portland cement were evident for the replaced first floor and roof.

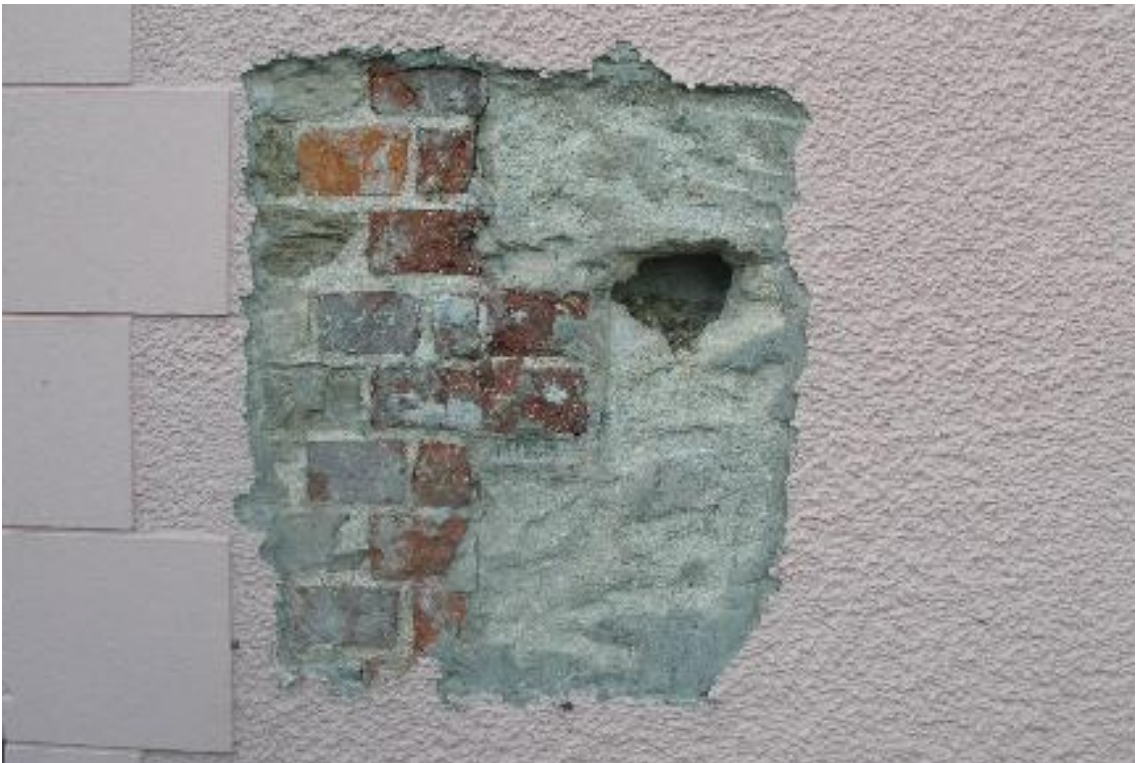
Plate 111 *Detail of Woodside building fabric, east elevation.*

The northern part of the building was rendered in pebbledash, although a small area of exposed fabric showed that it abutted the earlier building to the south and was built using concrete (Plate 111). Four UPVC windows were visible in the north and west elevations and a chimneystack had been provided on the north side of the building. There was presently a flat roof.

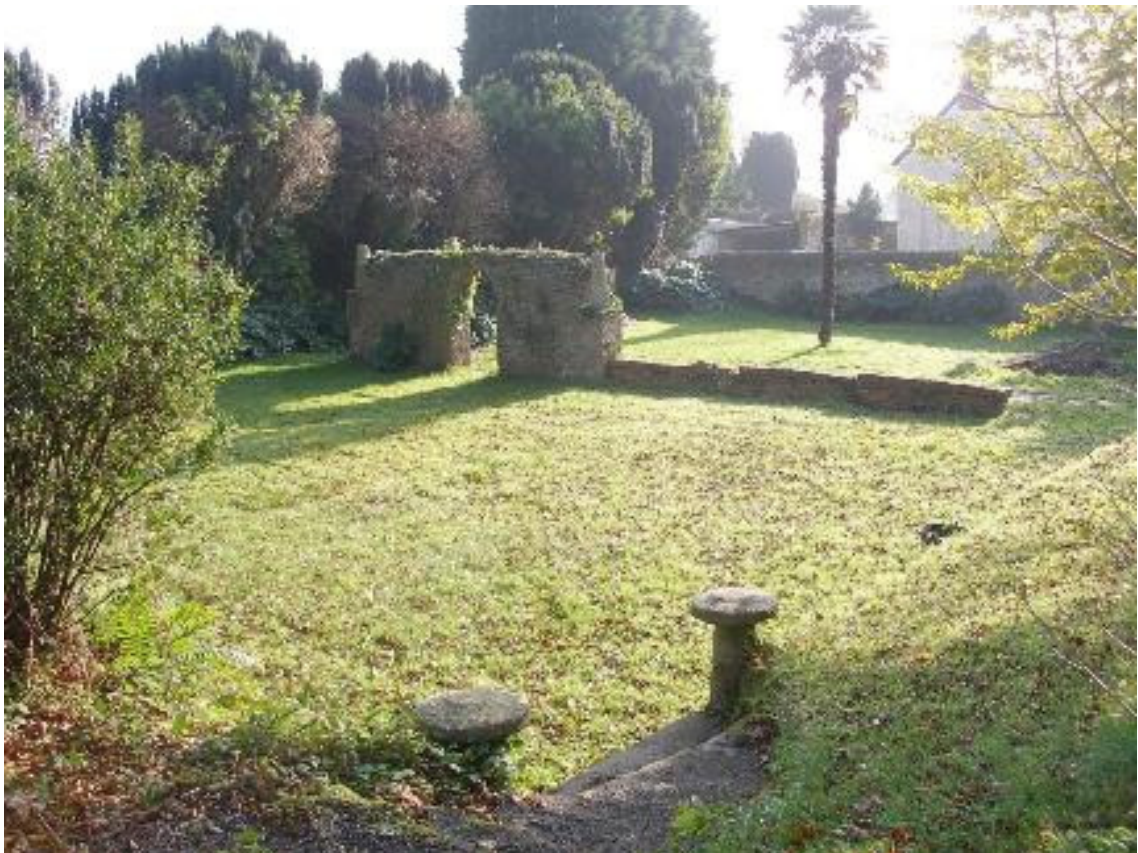
The southern terraced area of the walled garden was delineated by the north wall of two former buildings shown on the 1843 Cornelly Tithe Map. The eastern building appears to have been largely demolished by 1879 as it is not shown on the 1<sup>st</sup> edition Ordnance Survey map. The western end of the wall was constructed using red brick, whilst the eastern end was constructed using local slate or shale with brick details including a doorway with a brick relieving arch (Plates 112, 117 & 118).

The ground surfaces within the walled garden were predominantly grassed (Plate 112) although a path running east to west in the south terrace reused stone flags set in brick (Plate 113).

*Plate 112 The Walled Garden looking southeast, showing the north wall of the buildings depicted on the Tithe Map of 1843.*
