# Trewarthenick House, Tregony, Cornwall.

## Historic Building Recording

Date: November 2011

**Project No:** AC08001E

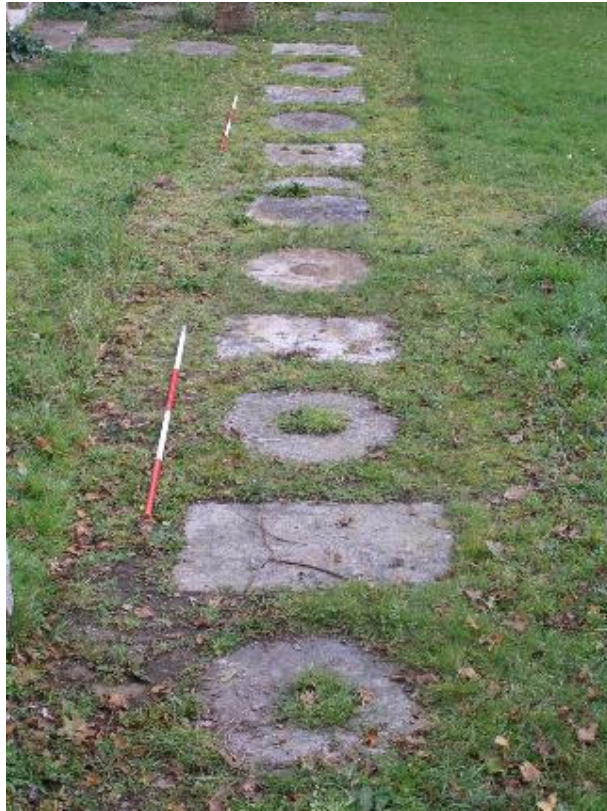
The ground surfaces within the walled garden were predominantly grassed (Plate 112) although a path running east to west in the south terrace reused stone flags set in brick (Plate 113).

*Plate 113 Brick path somewhat overgrown with grass, with decorative stone work, in the Walled Garden, looking east*

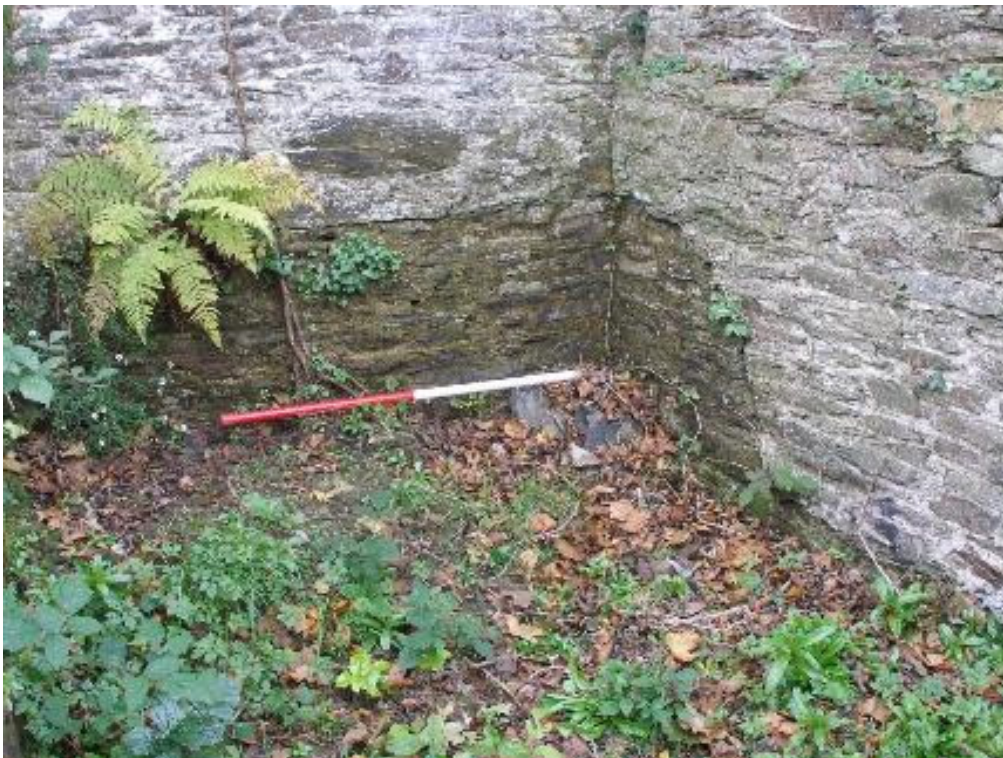
*Plate 116 Different phases of walling and traces of lime wash in the Walled Garden, looking northwest*

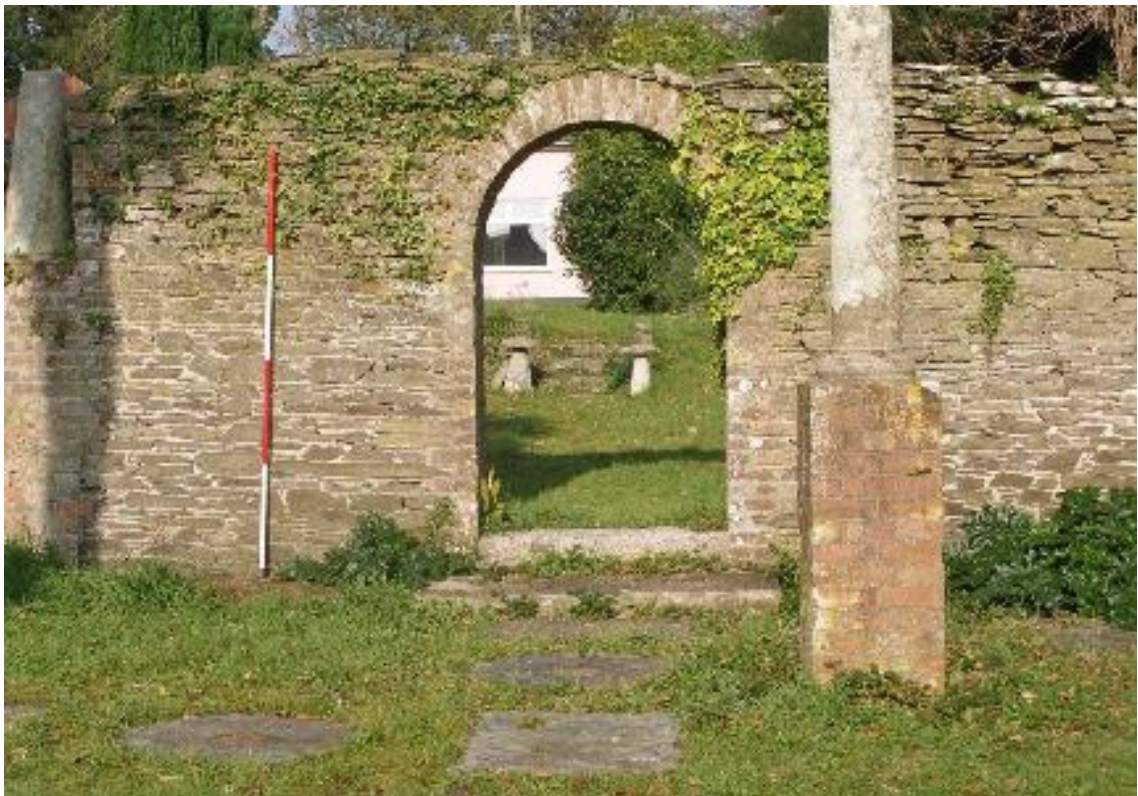
*Plate 118* Brick relieving arch, part of a building shown on the Tithe Map of 1843, in the Walled Garden with granite pillar reused from the pond area.

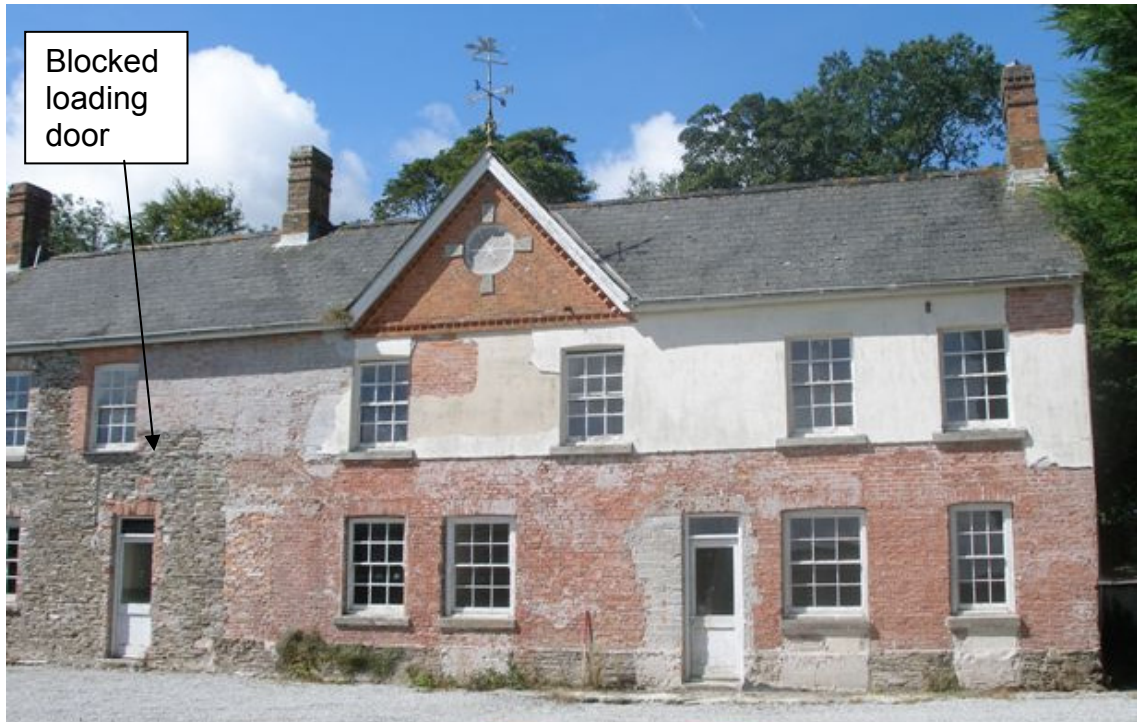
There were eleven windows and two doorways in the east elevation as well as a blocked circular oculus within a gabled dormer (Plate 120). The oculus was set in a triangular brick pediment set slightly off-centre in the elevation. The opening was constructed using two concentric circles of radiating red bricks with four evenly spaced granite key stones. The main face of the pediment was built in red brick using Flemish bond and defined at its extremities using dog-toothed brickwork, matching the chimneys. At the apex of the pediment there was a painted iron weather vane with a Pegasus motif and compass points (Plate 124). The steeply pitched pediment and central oculus appear to echo the form of the east elevation of the main house, prior to its alteration in c.1831, though the brickwork looks more recent.

**Room 17** had a carpeted floor. The skirting appeared modern and there was no cornice. The ceiling adjacent to the top of the stairs was sunken below the level of the main extent of the ceiling apparently reflecting the height of a blocked first-floor loading door visible on the east elevation (Plate 120). There was a type 1b window in the west wall. The staircase was made of painted wood and of a mass-produced design of the late 20<sup>th</sup> century. It is likely the ceiling in this room was lowered to accommodate the proportions of this inserted staircase.

*Plate 120 East elevation of the Bothy Building with Flemish bond brickwork, common from the 18<sup>th</sup> century onwards.*

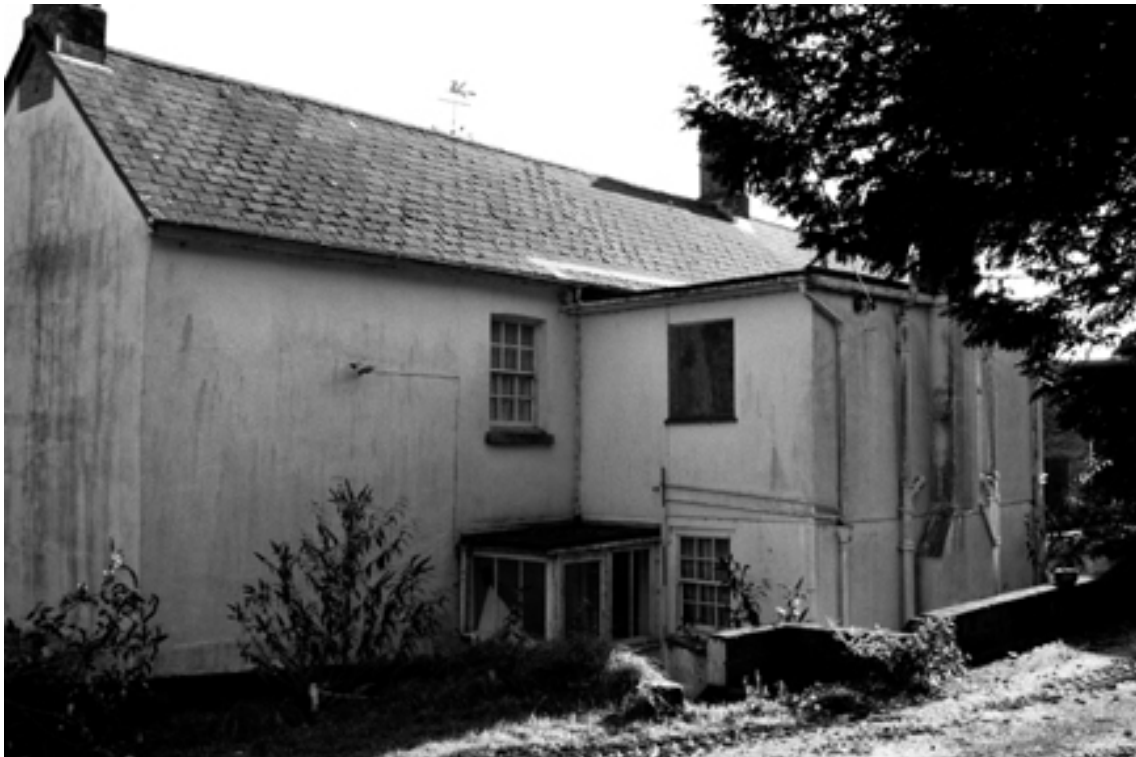
*Plate 121 The Bothy Building looking southeast showing western extension.*

The Bothy Building was rectangular in plan measuring 21.10m north to south by 6.05m east to west at its foundation course (Plate 120). An extension measuring 6.93m north to south by 3.82m was located centrally on the western side of the building (Plate 121). At the time of recording, the Bothy Building was divided internally for use as two separate dwellings. The Law survey of 1788-9 and Red Book plan of 1793, show an 'L' shaped building, which may have served as a stable block. The yard to the east was previously cobbled. The western part of the building had been taken down by 1843 (Figure 7) and the

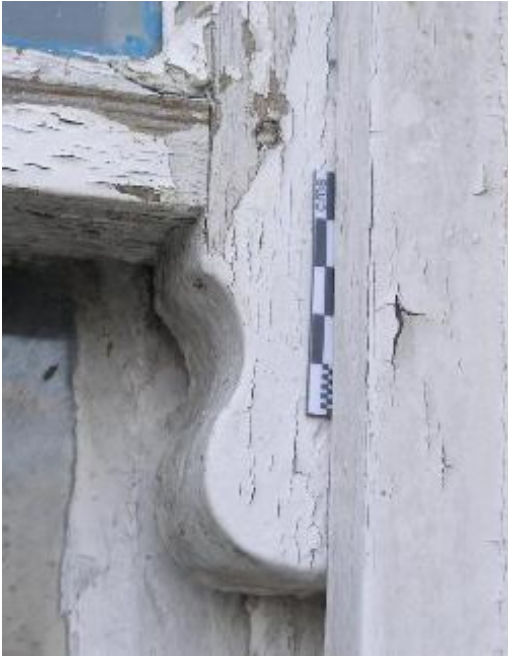
*Plate 122 Detail of a horned sash window type 1*

Three principal types of window frame were observed (Plates 122 & 123):

- 1a – Rounded horned sash windows with six panels over six panels. These had thick wooden glazing bars and float glass. Late 19<sup>th</sup> century or early 20<sup>th</sup> century.
- 1b – Replacement of type 1a in the same style. Late 19<sup>th</sup> century or early 20<sup>th</sup> century.

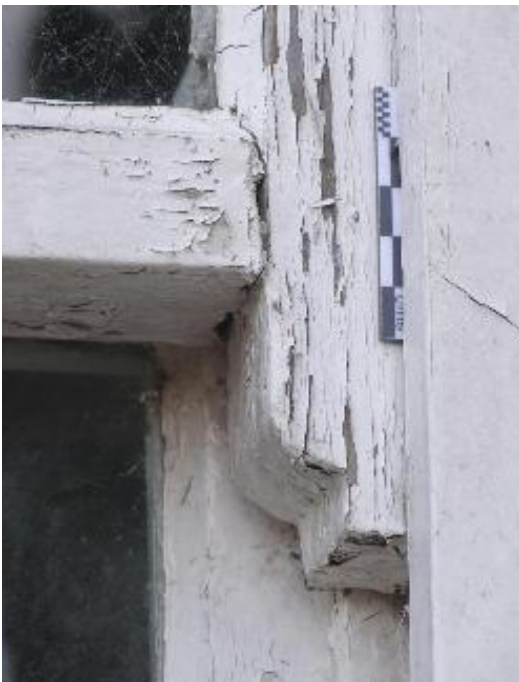
*Plate 123 Detail of a horned sash window type 2*

- 2 – Crude replacement windows with more angular horned sash windows with thinner glazing bars. Late 20<sup>th</sup> century.

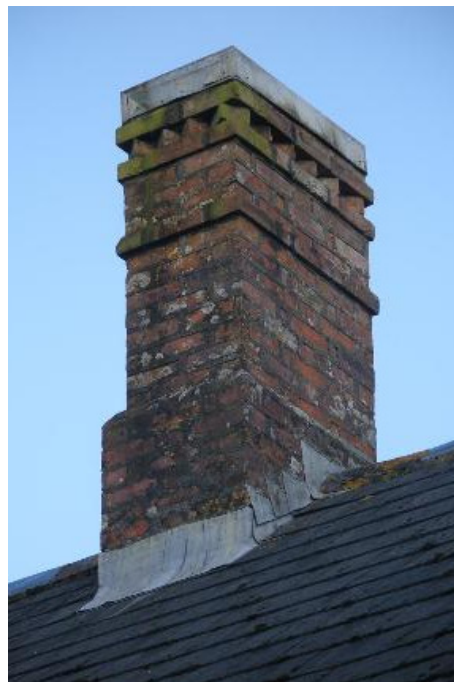
The roof was covered with regular slates or fibre cement/asbestos slates and ceramic ridge tiles. Three chimneystacks were constructed with red brick using Flemish bond, their tops decorated using dog-toothed brickwork, matching the pediment (Plate 125).

*Plate 125 Detail of chimneystack with dog-toothed brickwork.*

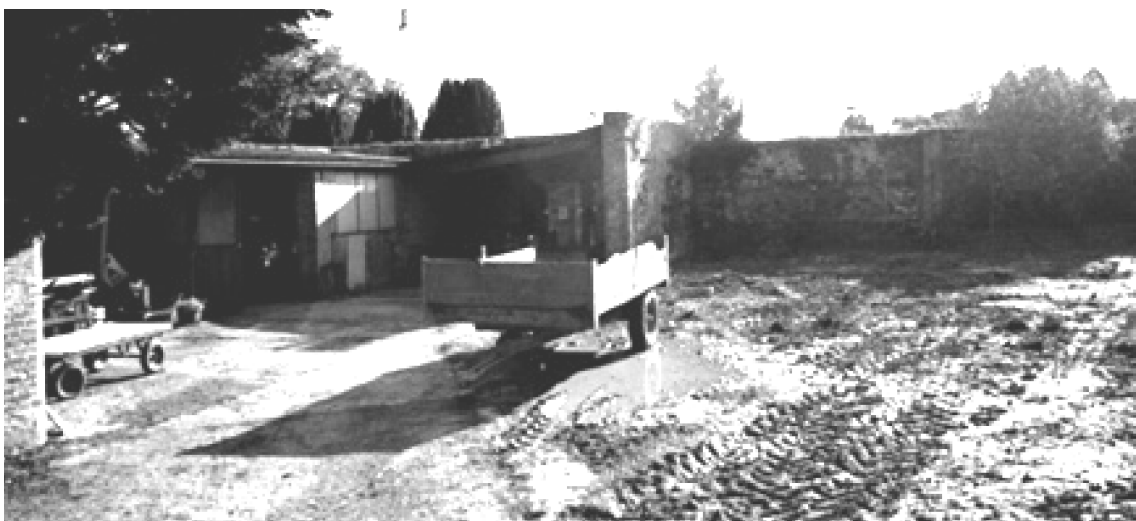
*Plate 126 Workshop and Stores, looking southeast*

The workshop and stores was an L-shaped building comprising two open-fronted bays to the east of the Bothy Building (Plate 126). Its maximum measurements were 12.15m north to south by 11.15m east to west. This building is shown on the 1788-9 survey. The east wall also served as a garden wall shown on the 1788-9 survey.

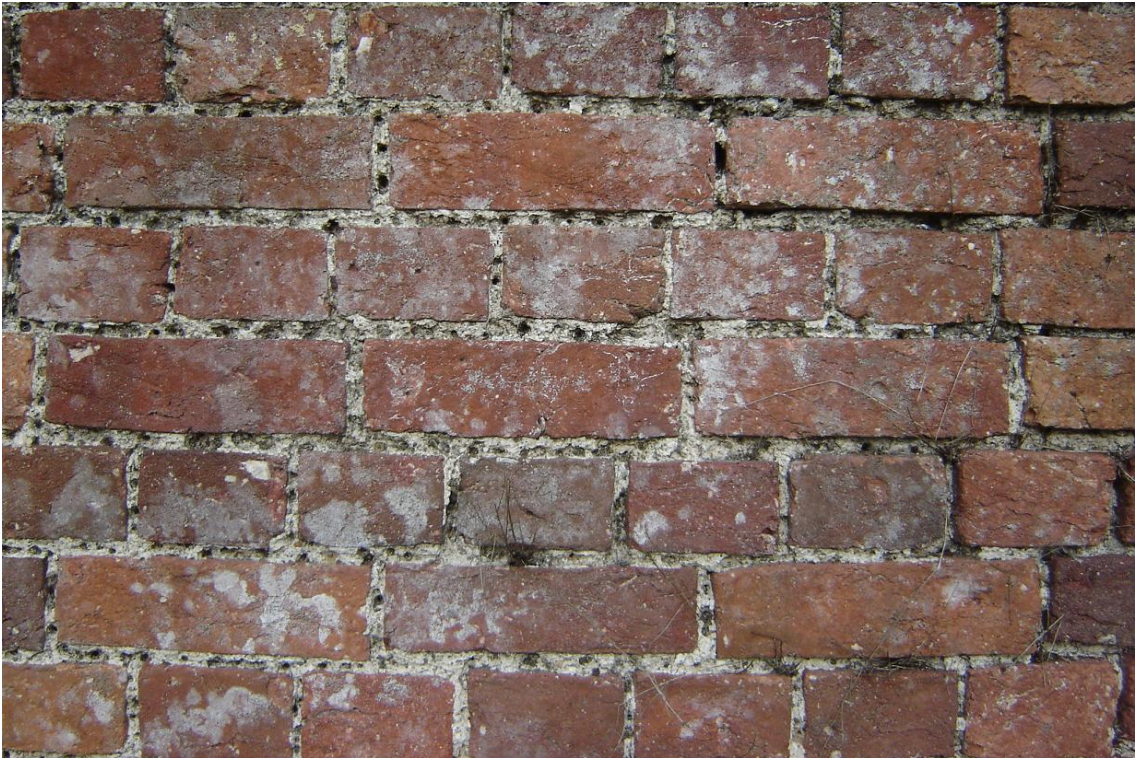
*Plate 127 South elevation of the Workshop and Stores building. Detail of English bond brickwork with numerous holes where plant ties have been removed.*

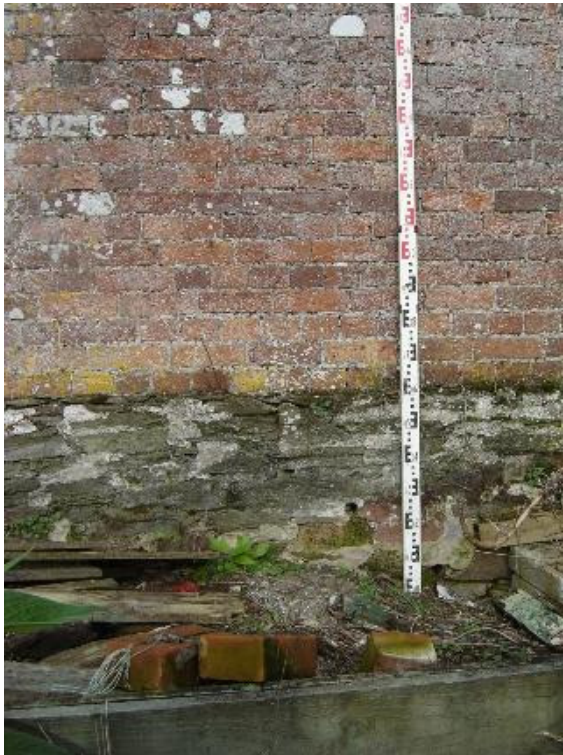
*Plate 128 Foundation of the Workshop and Stores, south elevation*

The local slate-shale wall foundations were surmounted by red bricks with lime mortar laid in English bond (Plates 127 and 128). The coursing was somewhat rough so that what started out as English bond, in places became closer to English cross bond. English bond was commonly used until the end of the 17<sup>th</sup> century, with its use often superseded by Flemish bond, though in Cornwall notably brick was considered a prestige material even in the 18<sup>th</sup> century. On

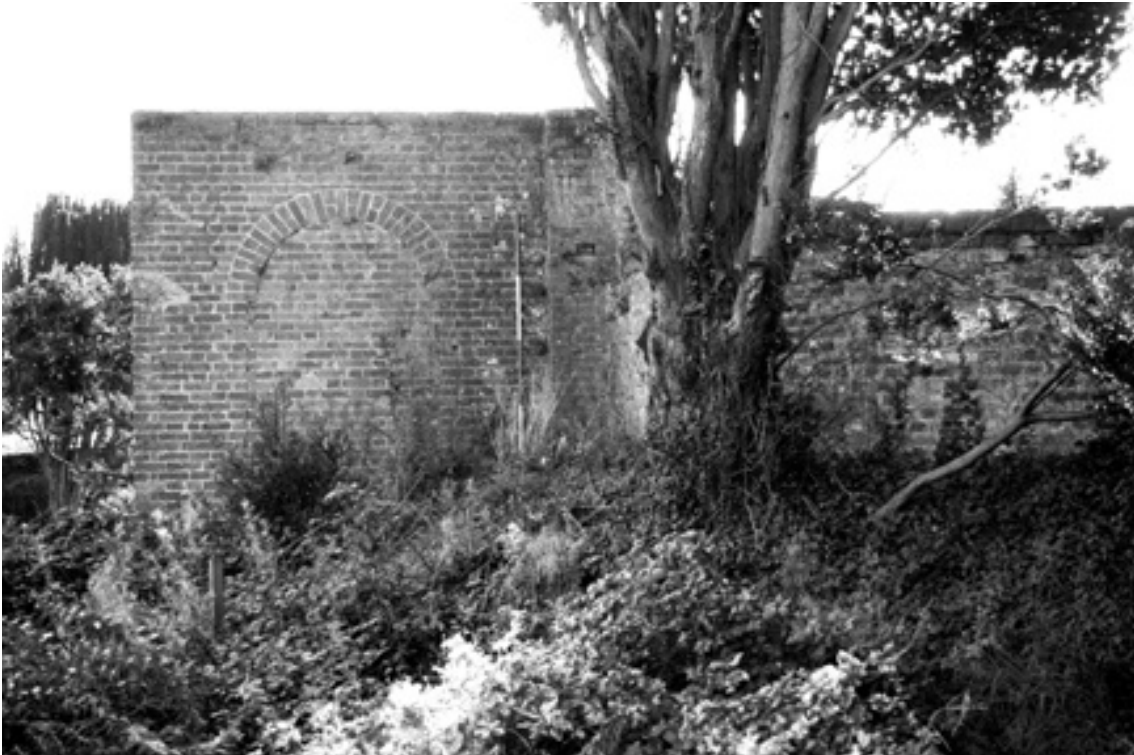
*Plate 129 Blocked arched opening in the Flemish bond rebuilt walling of the north elevation of the Workshop and Stores building.*

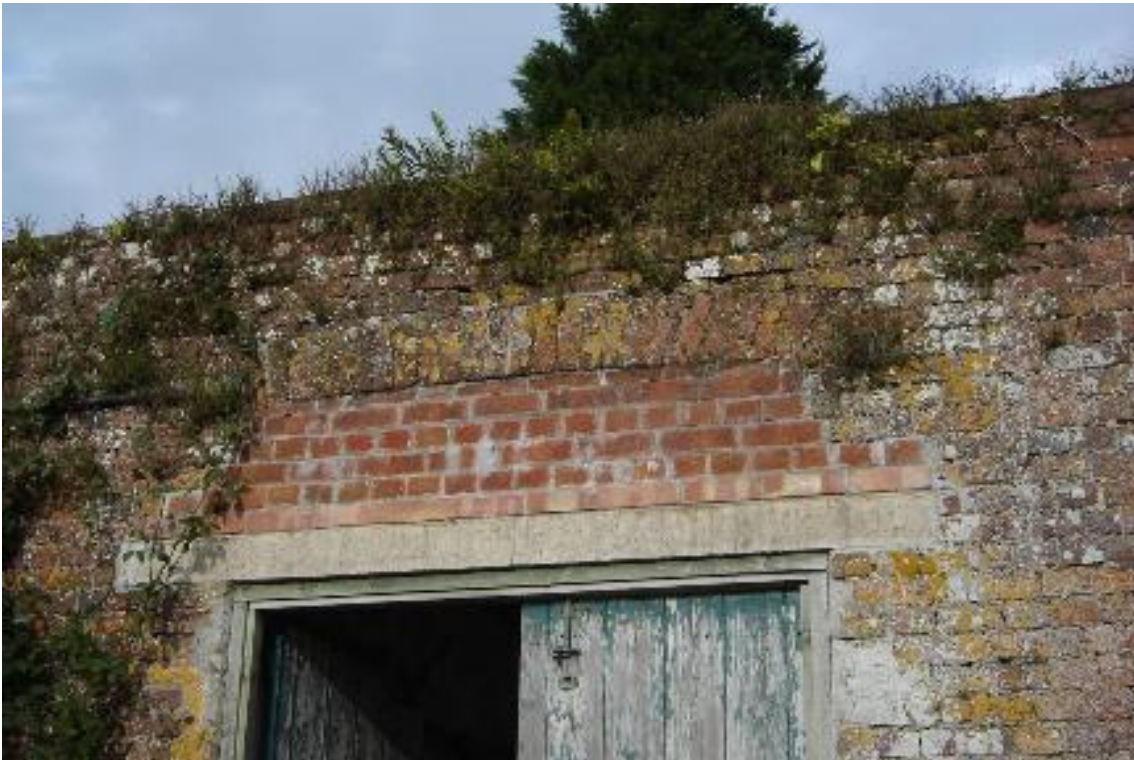
*Plate 130 Additional lintel with arch head infill repairing an opening in the south elevation of the Workshop and Stores building.*

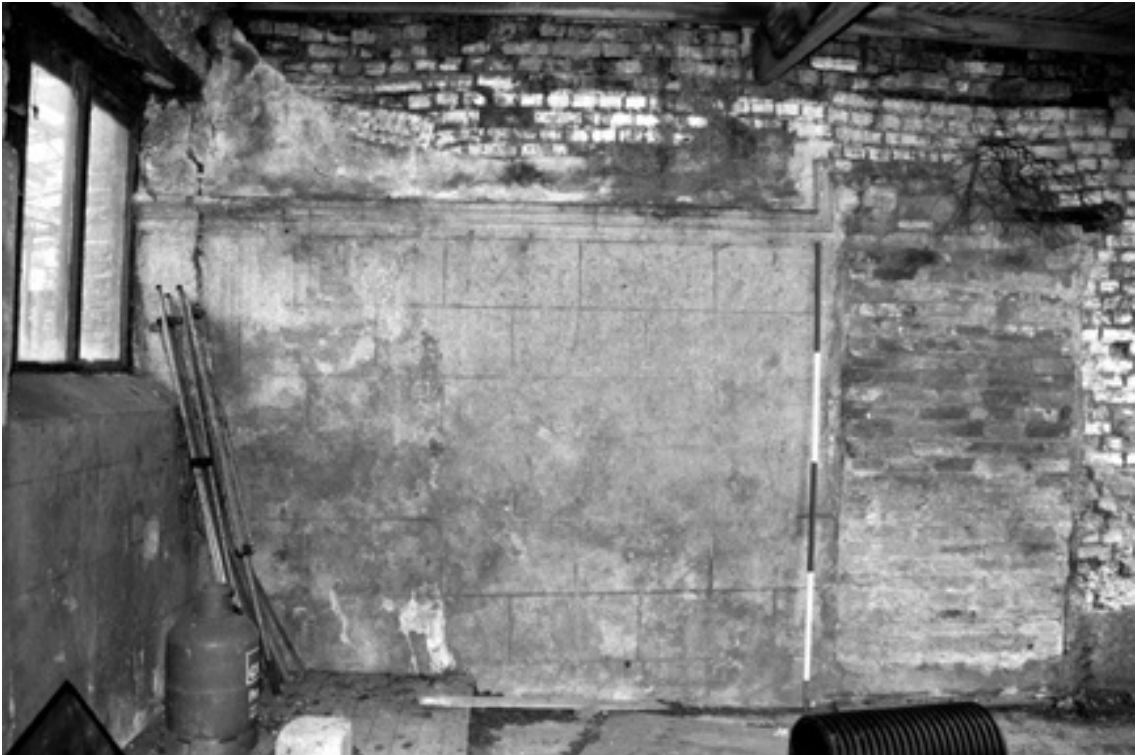
*Plate 131 Render in the Stores building, masks the southwest door and frames a more recently blocked doorway (right) looking west*

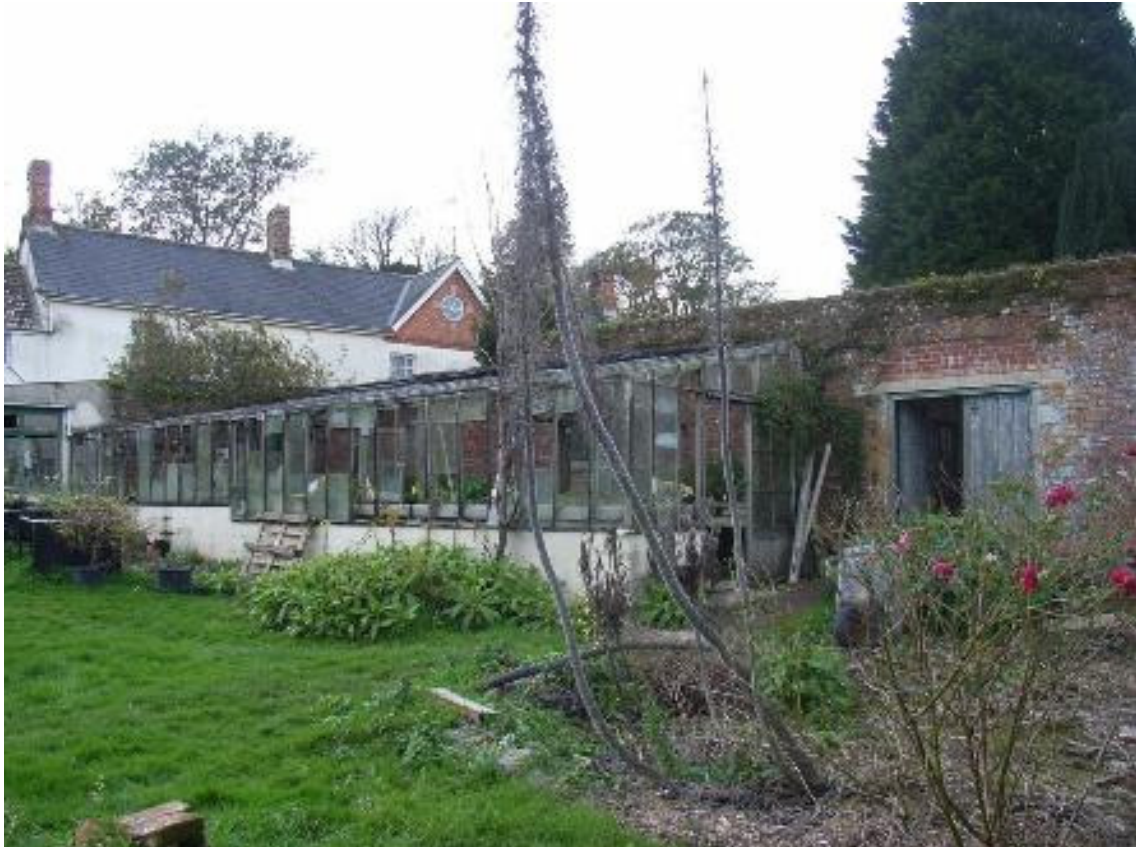
*Plate 133 The Greenhouse, looking northwest*

The Greenhouse measured 14m east to west by 4m. It abutted the lower Walled Garden wall to its north and the lean-to to its west, post-dating the 1921 Sales Particular map (Colvin and Moggridge, 2006, Vol 2 Figure 15D).

It had a lean-to roof sloping gently down to the south. The wall and roof were built from glass panels within a timber frame (Plate 133).

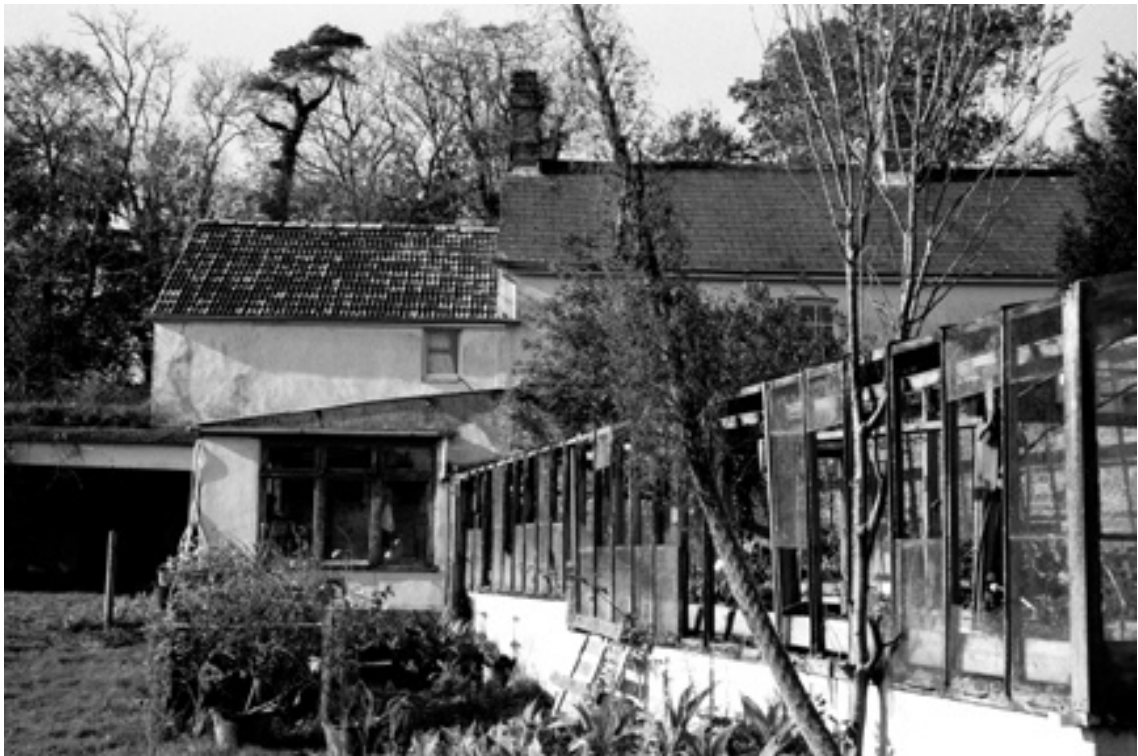
*Plate 134 East elevation of the Lean-to building with Greenhouse in the foreground*

The main part of the Lean-to building was of two-storey height but there were no visible holes for first-floor joists. It was externally painted and rendered on its east elevation (Plate 134). Its north elevation was built of uncoursed local slate-shale rubble, with slate barging below the eaves. There was a gable roof with ceramic pantiles and ridge tiles. There was a doorway in the north elevation

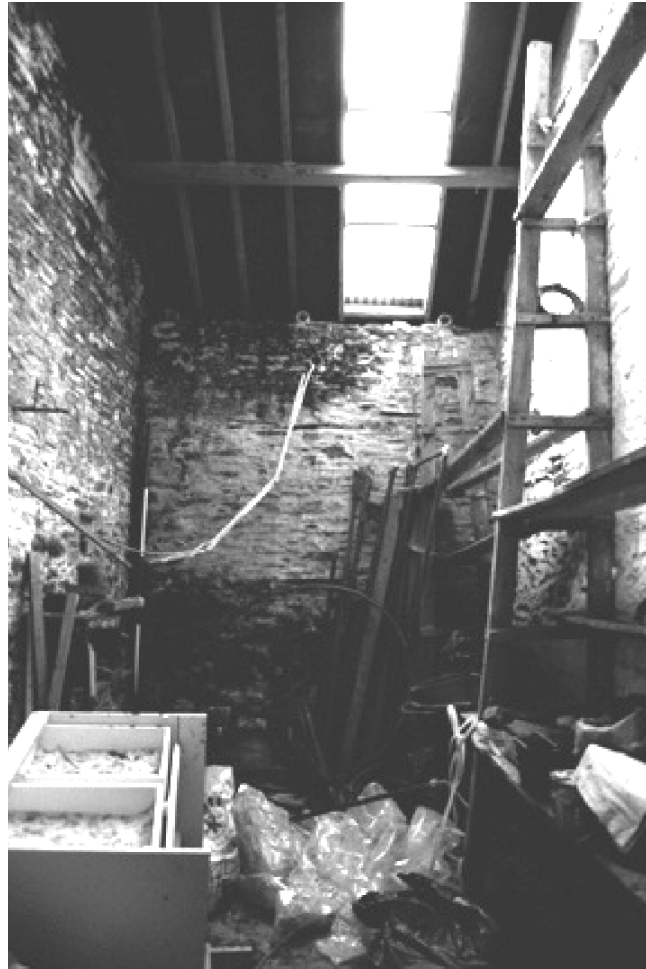
*Plate 135 Interior of the Lean-to, looking west*

The main part of the Lean-to building was sub-divided, presumably some time after its construction to form two narrow, tall rooms running east west (Plate 135). The walls were provided with full height wooden shelving and two small square ventilation shafts had been provided in the south wall. Inside there was a concrete floor with a concrete machine base with inset metal hold-down bolts, possibly for an apple press. The adjoining extensions to the east of the Lean-to were built using concrete blocks after 1921.

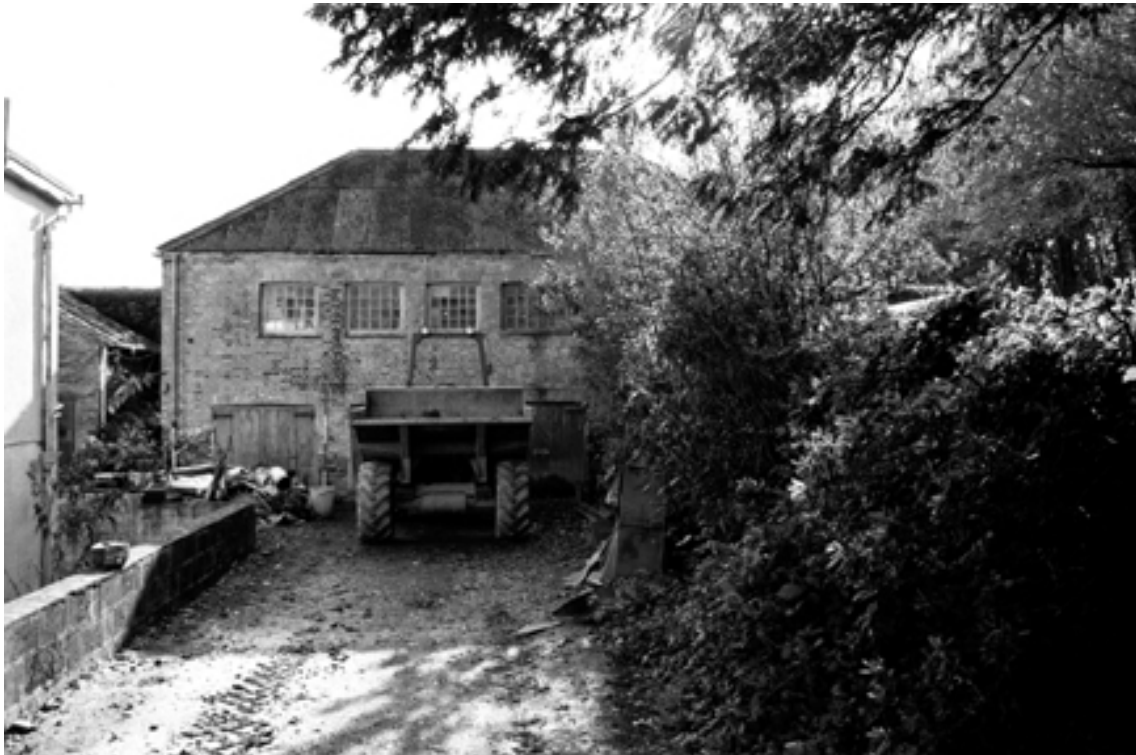
*Plate 136 North elevation of the Motor House*

It was constructed primarily of red brick in a Flemish bond (Plate 136) on a local slate-shale wall foundation, visible on the west and south elevations. The openings were spanned with shallow relieving arches of red brick to the exterior and wooden lintels to the interior. The building appeared to have cut through the English bond garden wall to its south (Plate 137).

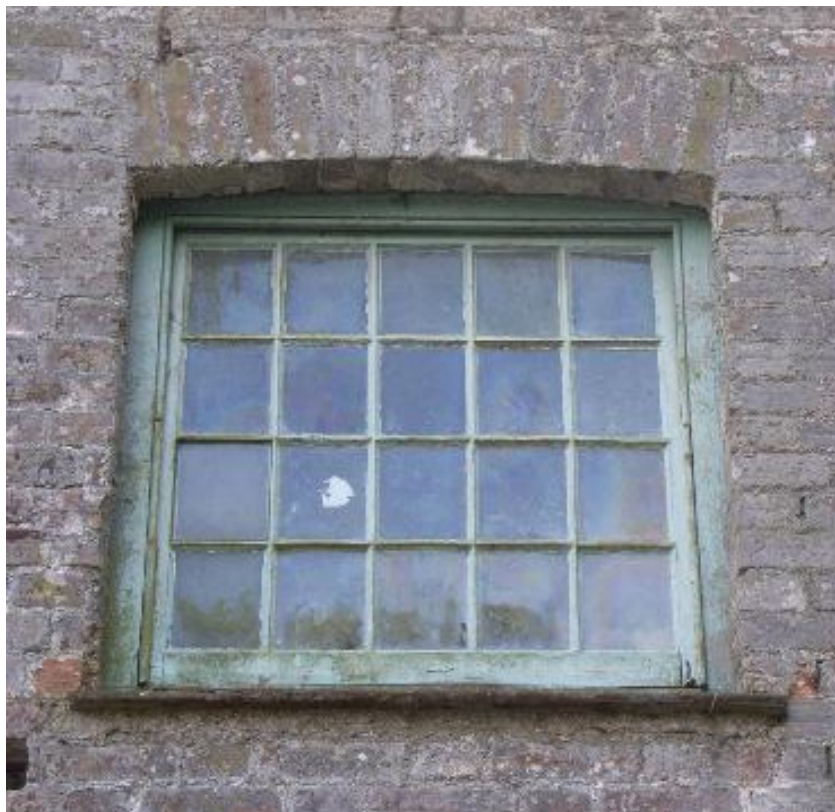
*Plate 138 Detail of tilting window, north elevation, Motor House.*

The building was cut into the slope, so that access to the first-floor was at ground level on the western side of the building. The windows on the first-floor were wooden 20-pane tilt windows with float glass (Plate 138). The widest of these windows replaced a former loading door. Three blocked windows were recorded in the south wall (Plate 139) as well as an inserted telephone hatch. The hatch had a small door in the south elevation allowing access to the telephone from the first-floor of the motor house and the upper walled garden to the south. Handwritten names and phone numbers were visible on both sides of this door and the frame (Plate 140).

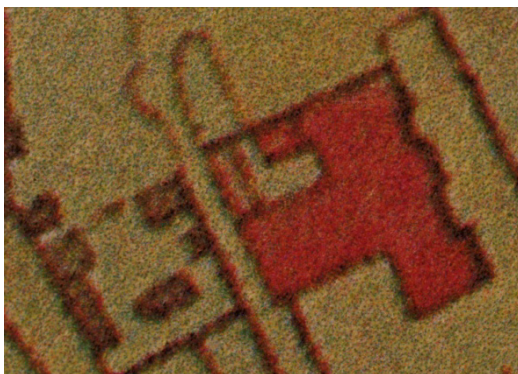
*1843 Cornelly Tithe Map extract: This post-dates the 1831 Harrison scheme with extensions flanking the East Front and shorter North Range. The West Range is shown differently since heightening of the rear wing.*
