# Bilberry Dry

Roche, Cornwall

## Historic Building Recording

Report Date February 2012

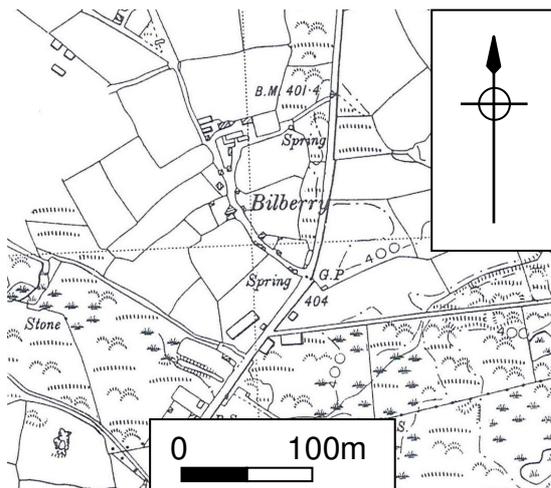
*Figure 4 1938 Ordnance Survey Map*

The first confirmation for the construction of Bilberry Dry is on the 1938 OS map (*Figure 4*) where a rectangular building in the same position and alignment is depicted. No chimney or settling pits are recorded. Interestingly, to the north west of the dry location there are breaks in field boundaries forming a sub-circular void that is not present on earlier maps and becomes an extraction pit on later maps. The simplistic portrayal could be due to the scale of the map.

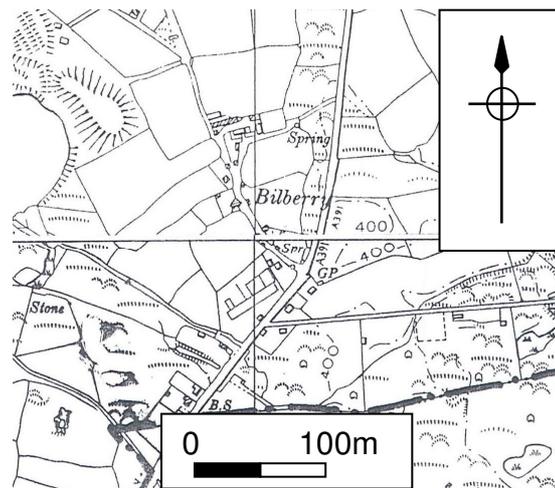
*Figure 5 1963 Ordnance Survey Map*

By 1963 the industry was in decline and greater technological advances were changing the design of kilns. These later OS maps, dated 1963 (*Figure 5*), 1971-76 and 1985-92 demonstrate a catalogue of inconsistencies in style of delineation. For example, 1963 lacks a chimney but is otherwise more detailed than the 1938 and 1985-92 maps of the same scale.

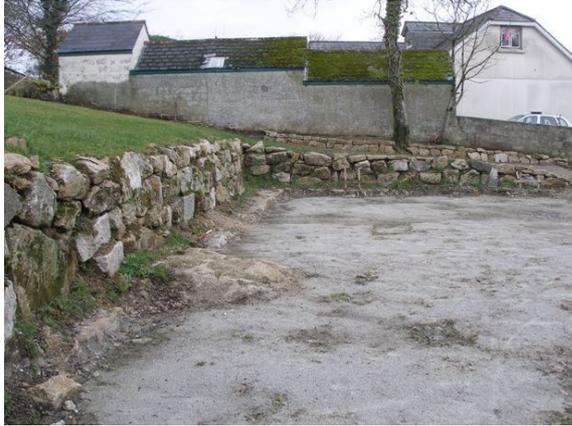
**B1** (Plate 1) measured 43m northeast to southwest by at least 27m and was surrounded by varying extents of earth bonded and faced granite walling with Portland cement repairs. The remains of two further walls, previously divided it into at least three settling tanks, each provided with an opening to the southeast. To the northwest a modern revetment, with traces of original walling at the base, held back the natural ground that rose 3.5m to the northwest. The northeast wall was 21.90 metres long by 0.80m average width. It survived to its full height of 2.05 metres at its southeast end. The majority of the southeast wall survived to its full height of 2.05m with a considerable batter to the southeast side so that the base of the wall was 0.9m average width and the top was 0.45m in average width. This wall had four openings with granite quoins, each opening providing for a settling tank. Two of these measured 1.2m wide whilst the others had recently been widened. These openings had concrete floors and rebates for shuttering to control the flow to the drying floor. The southwest wall was at least 27 metres long by 0.8 metres wide, though this included a 10 metre extension to the northwest. Within these walls fragments of the original granite block flooring survived laid on sand levelling.

*Plate 1 B1 settling tank and retaining wall, looking north*

The highest area at Bilberry occupied by areas **B1** and **B7-10** consists of rectangular spaces and can be interpreted as settling tanks (*Plate 1* and *Plate 13*). Subdivision within **B1** could have related to insertion of filter presses but no evidence for this was found. Tank **B10** is similar in size to **B1** but in construction style to **B7-9**. The 90° protrusion 15.6m along the length of the wall indicates that extension has occurred. **B10** would originally have been the same length, and age, as the other tanks (**B7-B9**). All the tanks have openings controlling the clay slurry issue to the dry (**B3**) below. Below the dry, the linhay **B4** had large openings suitable for vehicular access probably allowing carts to be loaded directly from the dry and taken to the station one kilometre away at Bugle (*Plate 6*). The ideal was to transfer the clay directly into the carts from the drying floor but contemporary sources suggest that transportation was so inefficient clay had to be stored in the linhay. This indicates why it was important for the linhay to have a roof.

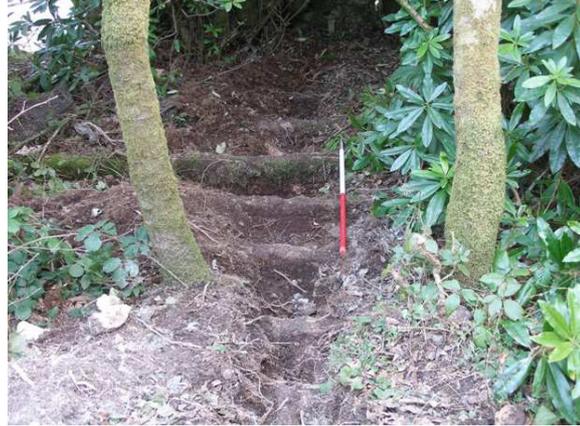
*Plate 4 Section through B3 drying floor showing flues and granite supports for floor, looking southeast*

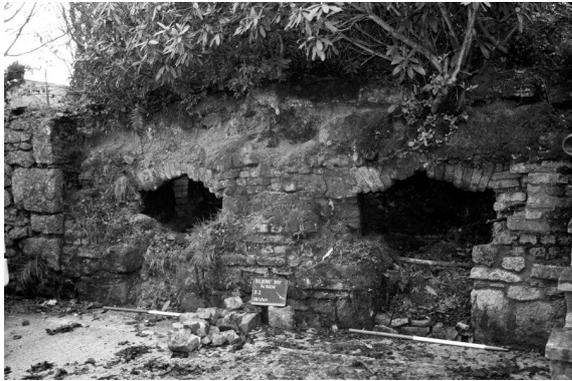
*Plate 2 Furnaces, looking south*

The furnaces are a particularly important part of the kiln complex and although well preserved, are in a fragile state. It is recommended that a railing is erected across the entrances to the furnaces to prevent access and resulting damage. This would also provide protection from any debris that may come loose from the brick arches above the openings where the bricks are already significantly eroded. The restriction of access to the area above the furnaces should also be considered.

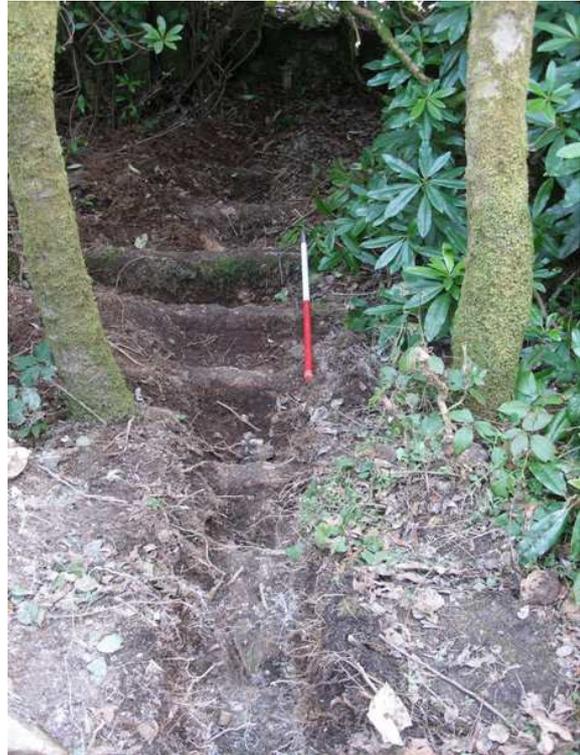
*Plate 5 Section through B3 drying floor also showing wall dividing dry and linhay, looking southeast*

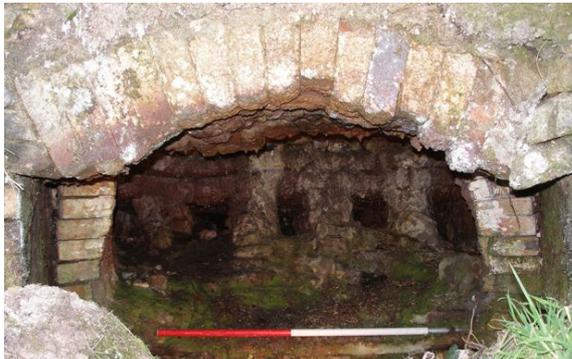
*Plate 3 Eastern furnace showing flues, looking southwest*

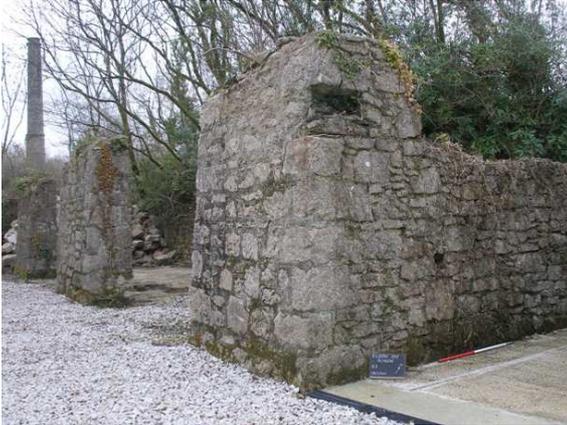
*Plate 6 B4 linhay with openings for vehicles, looking west*

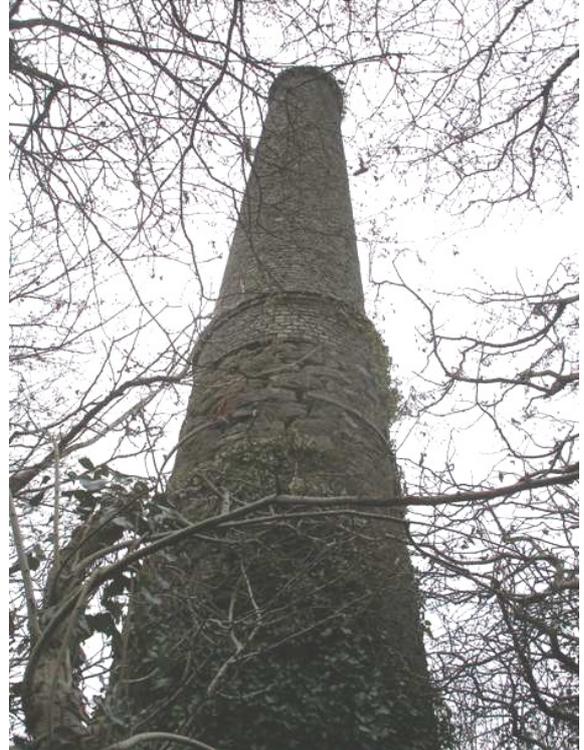
*Plate 9 Chimney B6 showing granite and brick construction*

The archaeological recording of the chimney noted that there was significant damage to the brickwork on the north side of the stack. The facings of the brick had decayed, there was little pointing remaining and an iron retaining band had broken. This could lead to ingress of water causing further structural deficiencies thus destabilising the structure. It is recommended that regular monitoring and a structural survey of the chimney is undertaken to assess how far this has occurred and to advise on future management to ensure the structural integrity of the chimney.

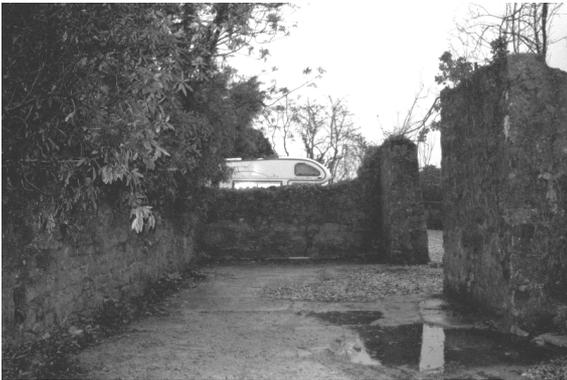
*Plate 7 Internal view of B4 linhay, looking northeast*

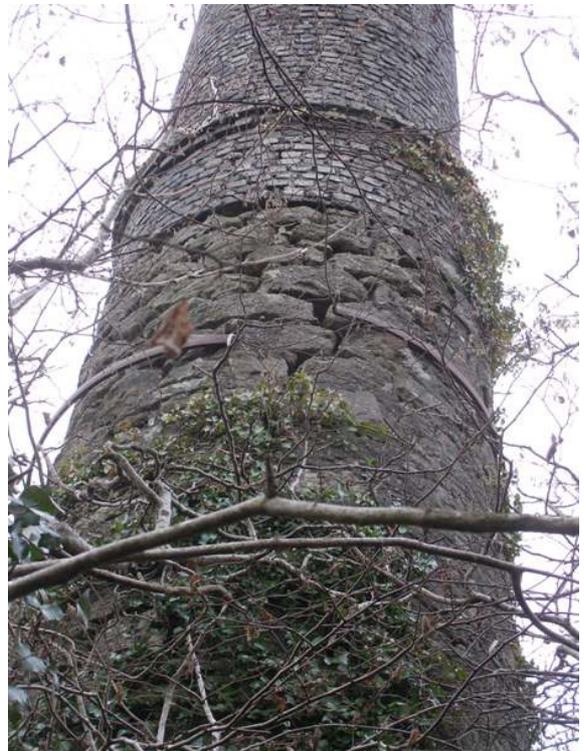
*Plate 10* and *Plate 11*) was constructed of lime mortared granite blocks up to a height of approximately 11.5m with an iron brace at the top of this section. Above this the chimney was built in brick to its full height of approximately 25m. The facings of the bricks had been significantly eroded, particularly on the north face and nearer the top of the chimney. At the base the chimney was 3.2m diameter, tapering evenly towards the top.

*Plate 10 Chimney B6 detail showing change in construction, drip ring and iron retaining band*

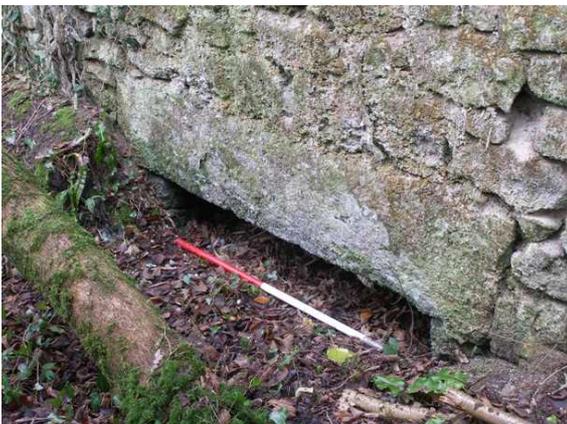
*Plate 8 Chimney flue opening at southwest end of the dry B5, looking south*

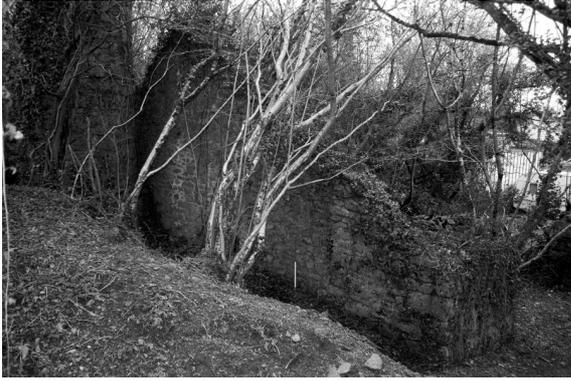
*Plate 11 Base of chimney B6 and southern external wall of B5 dry and linhay, looking north*

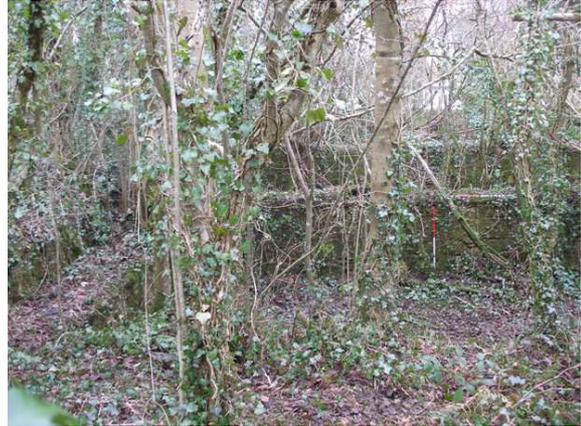
Settling tanks **B7**, **B8**, **B9** and **B10** are described together as they are similar in design and construction (*Plate 12* and *Plate 13*). All were obscured by considerable vegetation including trees with basal trunk diameters of up to 0.2m and heights in excess of 8m. The tanks increase from west to east and are divided by granite walls 0.6-0.65m wide and 1.4m high. **B7** was the smallest at 14.8m in length by 5.8m whilst **B8** and **B9** were both 15.6m in length and slightly wider. **B10** measured in excess of 29m in length although a protrusion in the wall at 15.6m suggests it may originally have been shorter. Dense vegetation precluded description of the flooring. To the north of **B7** two voids may represent an inlet pipe or channel which supplied the settling tanks.

*Plate 13 Overgrown settling tanks B7, B8 and B9, looking northeast*

Much of the site is overgrown with vegetation, specifically trees or large plants growing from the top of the walls. It would be desirable for these to be thinned and treated with systemic round up. It is acknowledged that the trees do provide privacy for the site and the root systems may in fact be holding the fabric together in many places. Complete removal is therefore not recommended but sensitive management to enable preservation of the structure as it currently is would be desirable, particularly above the furnaces on the drying floor and on the settling tank walls.

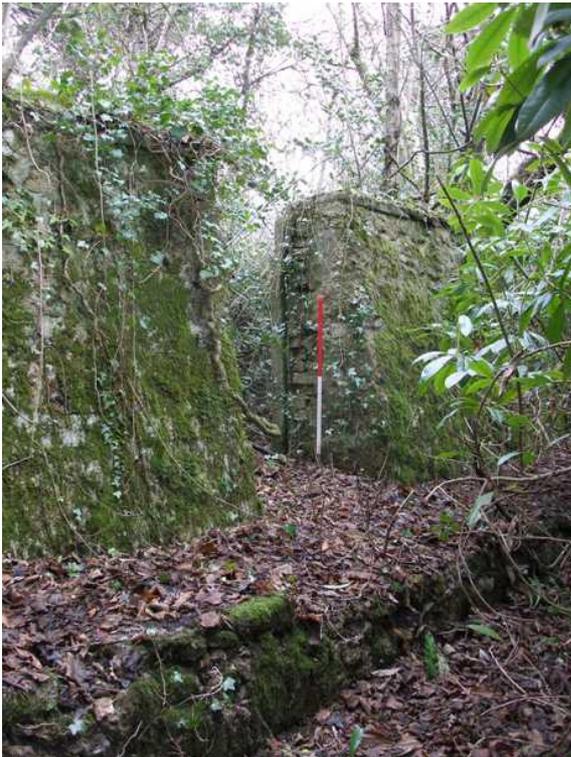
*Plate 12 Inserted concrete rebate for shutters in settling tank B8 opening and controlling flow of clay slurry to the dry, looking north*

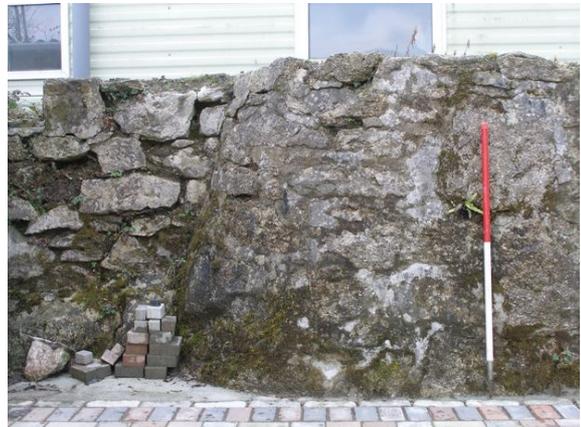
*Plate 14 Varied wall construction of B1 wall, looking southwest*

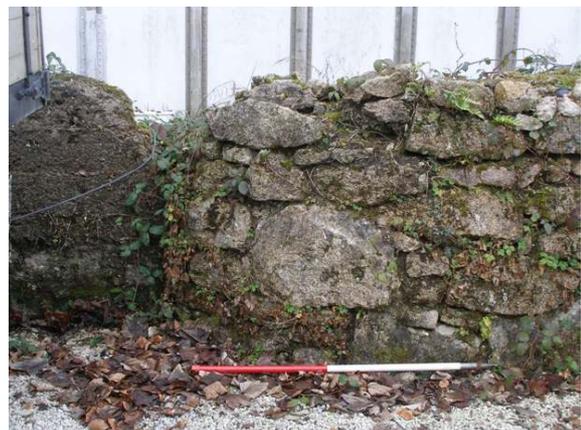
*Plate 15 Concrete wall butting up to the earlier granite construction dividing the dry (B3) from the linhay (B5), looking southwest*

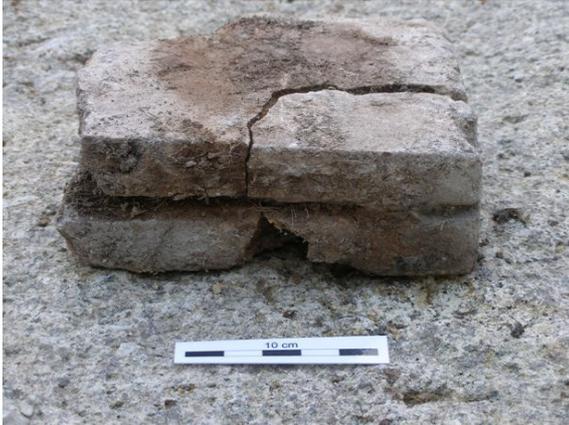
*Plate 16 Fragment of concrete from the drying floor found in area B3 close to excavated section – clearly showing the rebate presumably for iron grid reinforcement*

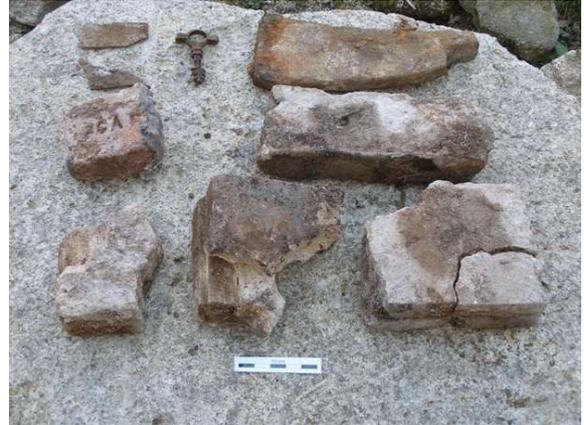
constructed in Carbis brick (*Plate 17*) and granite rubble though much of the inside had filled with organic and other debris including decayed brick from the former vaulted ceiling above.

*Plate 17 Fragments of floor, Carbis bricks and iron objects found in areas B3 and B4*

The Carbis bricks found in **B3** and **B4** are suggestive of an early 20<sup>th</sup> Century build and it seems likely that the upper brick courses of the chimney are also Carbis bricks relating to a heightening of the chimney at the same time. The Carbis China Clay and Brick Company was incorporated in 1920 (National Archives BT 31/32419/166806), being bought out by English China Clay in 1933 (London Gazette 28/6/1933). Notably the Carbis China Clay and Brick Company is also recorded as dissolving in 1948 (National Archives BT 31/32419/166806). It is tempting to associate the use of Carbis brick with the takeover of the Carbis China Clay and Brick Company by English China Clay in 1929. The buying of the site by such a large company would explain the scale of the extension as well as the use of potentially old building stock.
