Holy Trinity Church

Bolventor, Cornwall

Archaeological Recording

Report Date October 2012

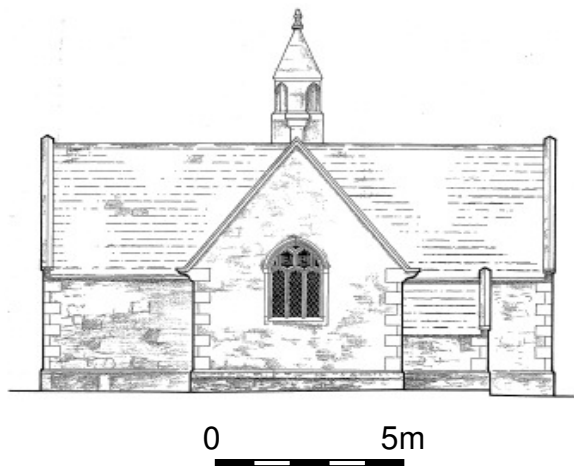
Figure 9 West elevation of church.

The west wall was discoloured below the west window with a pink hue streaked down to the ground where there was a notable absence of moss. Directly under the window along the granite ledge the staining was a rust colour, presumably from the window frame (Figure 9).

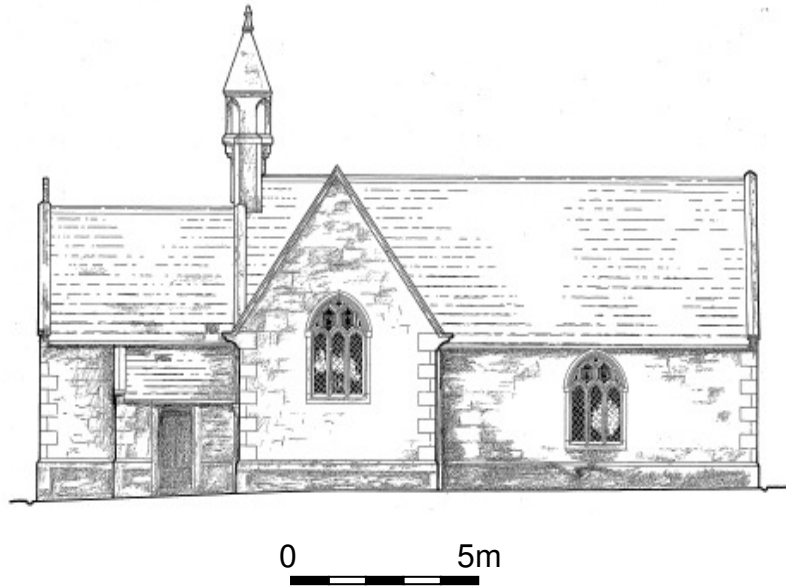
Figure 10 North elevation of church.

Water damage was evident on the north side of the church (Figure 6, Figure 10, Plate 1). Blocked down pipes and associated guttering had caused damage at the junction of the west wall of the north transept and the north wall of the nave. The mortar had been eroded, whilst moss covered the external surface and damp had penetrated to the interior. The south side of the nave was much less affected by damp.

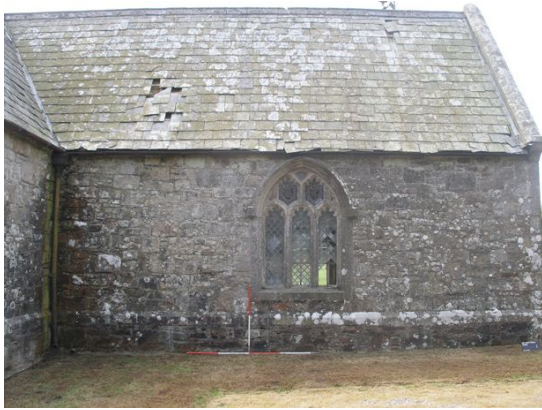
Plate 1 North elevation of nave.

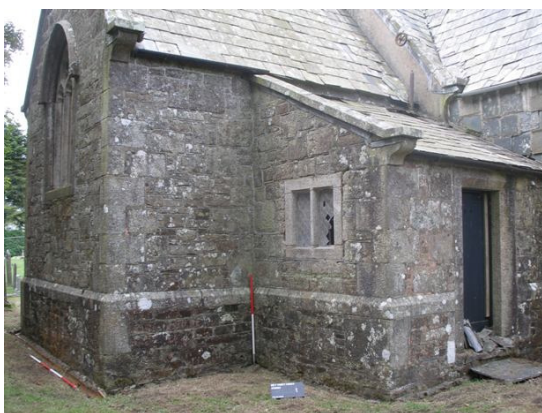
The chancel did not display any substantial signs of change or repair to any of the walls and had only one window in the east wall. The roof was slightly lower than that of the nave but otherwise of the same construction (Plate 3).

Plate 3 Chancel and lean-to vestry. Looking southwest.

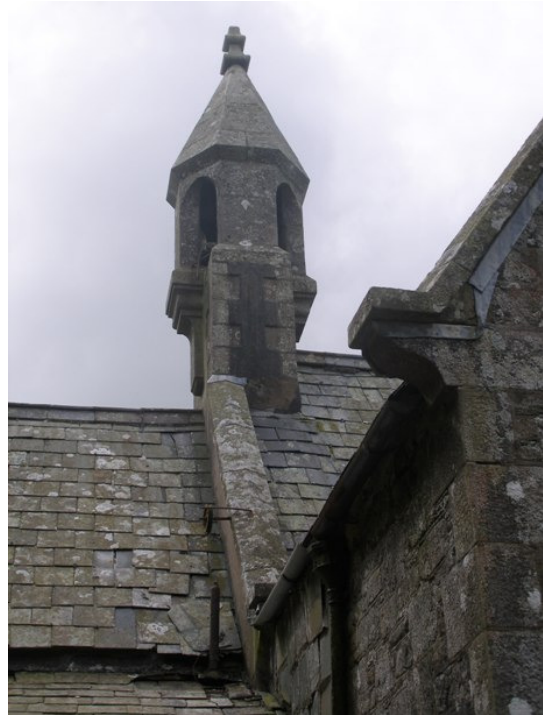
On the roof of the lean-to vestry and slightly above it is an iron reel and a tube leading down inside the building (Plate 4). On the east gable end of the nave roof above the altar and crossing is the granite bell cote. The reel and tube directed a wire from the bell to the lean-to from where the bell could be rung. The bell, although not hung due to vandalism is still complete and within the bell

Plate 4 Bellcote and bell pull system. Looking south.

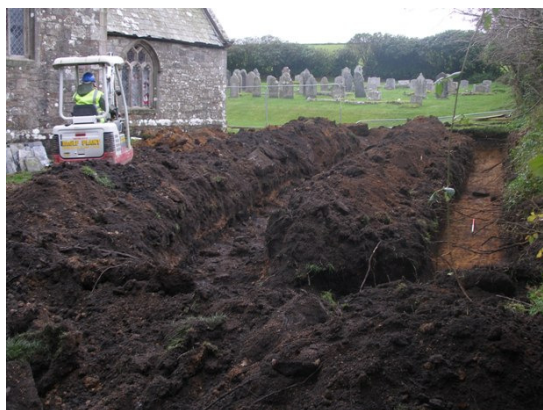
the topsoil was a dry and compact orange-yellow sandy-clay, the natural subsoil (Plate 6, Plate 7).

Plate 6 Service excavations to north of Church. Looking southwest.

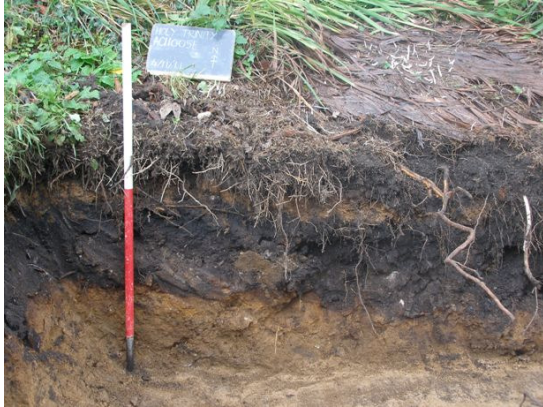
Plate 7 Section of service excavations. Looking north.

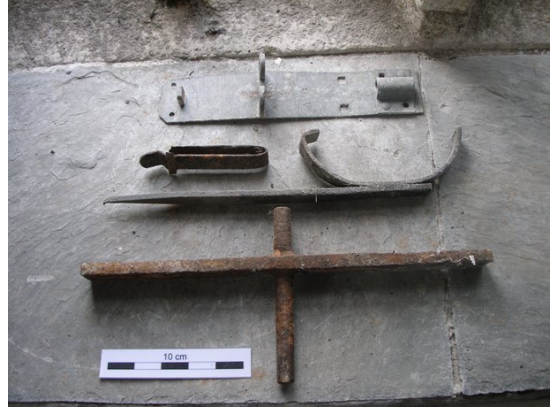
Internally, all the major fixtures and fittings had been removed or altered, only some metal objects relating probably, to the doors, were found scattered within the church (Plate 10). The floors of the nave and chancel were covered by large slate slabs whilst the crossing and transepts had concrete paving. Under these were lime mortared granite rubble sleeper walls, topped with additional slate fragments and rotten wooden beams, supporting the floor. The voids between the sleeper walls were filled with rubble and debris including 20th Century brick and electrical wiring. At the west end, close to the door, two rectangular marks

Plate 10 Metal fixings from within Church.

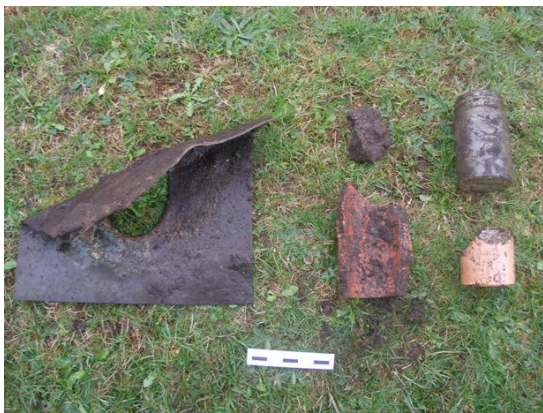
No archaeological deposits or features were found within the trenches. Five objects were recorded in the topsoil and were retained on site. These were a fragment of metal waste, a formerly rectangular metal flashing plate with a central oval hole, a white and the base of a pale-orange stoneware vessel, a glass jar and a fragment of ceramic drainpipe (Plate 8).

Plate 8 Objects recovered from topsoil during service excavations.

The flashing plate found in the topsoil during service excavations may have provided for the vestry flue or for a chimney from a stove placed on the north side of the nave behind the pews (Plate 8). The 1963 inspection records a calor gas stove and cylinder in this location and there is a replacement patch in the wooden ceiling suggestive of a chimney.

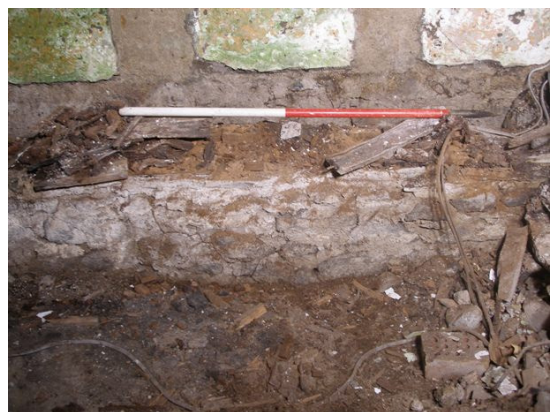
Plate 12 Sleeper wall below nave pew base. Looking north.

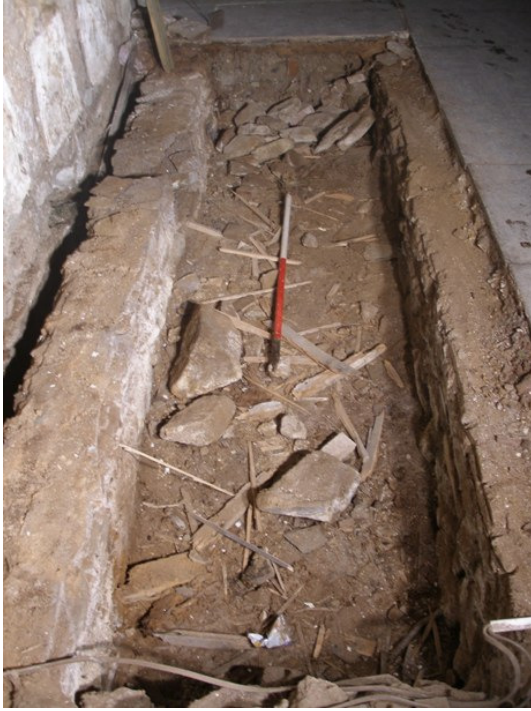
Plate 13 Sleeper walls below nave pew base, south side. Looking west

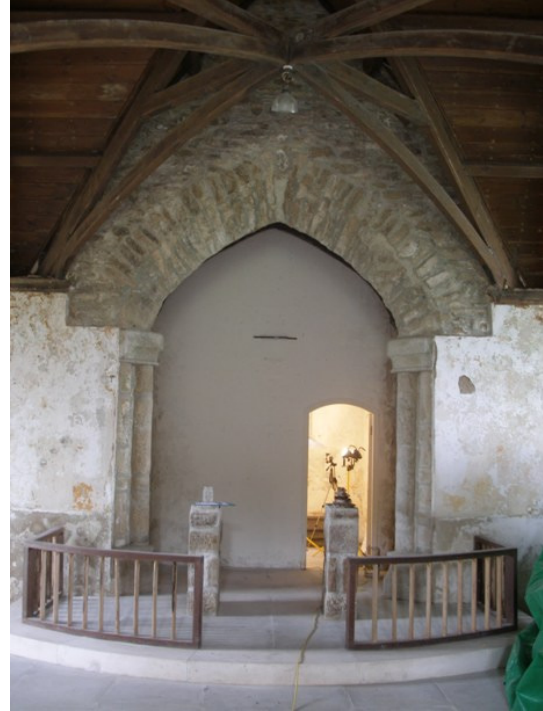
The step projecting into the crossing for the wooden communion rail and the granite altar supports are concrete. No altar table remained. The chancel arch echoes the windows in that it is of a pointed gothic design (Plate 15). It is now bare, with relatively crude granite stonework, but fragments of plaster with yellow ochre paint hint at its original finish. Such painting may have existed across the whole church but damage and damp have made this impossible to determine.

Plate 15 Crossing and chancel arch from the nave. Looking east.

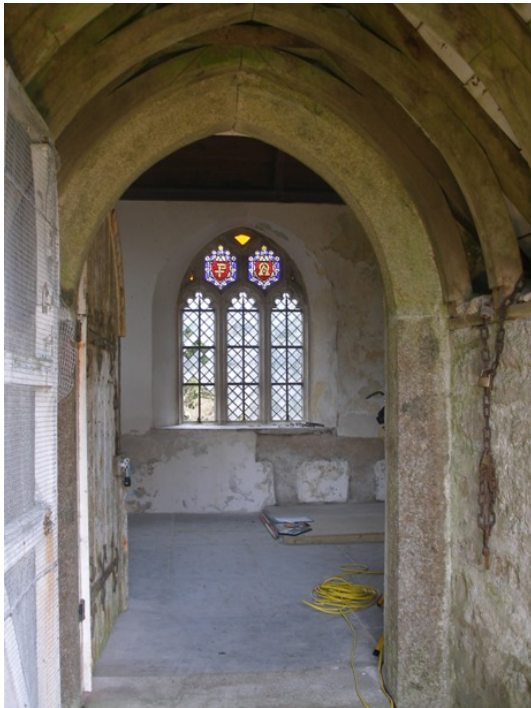
The south porch was rectangular in plan with a steeply pitched roof of similar construction to the rest of the building (Plate 14). The walls were constructed of granite blocks and although butting up to the south wall of the nave, was of the same type of construction (Figure 9, Figure 11). The outer door was a mesh covered wooden frame and is unlikely to be original. The inner door was painted wooden planks with iron fixtures including ornately decorative strap hinges.

Plate 14 Porch with north window of nave in the background. Iron stanchions in front of the replaced principal lights with original tracery-lights with chi-rho and alpha and omega monograms.

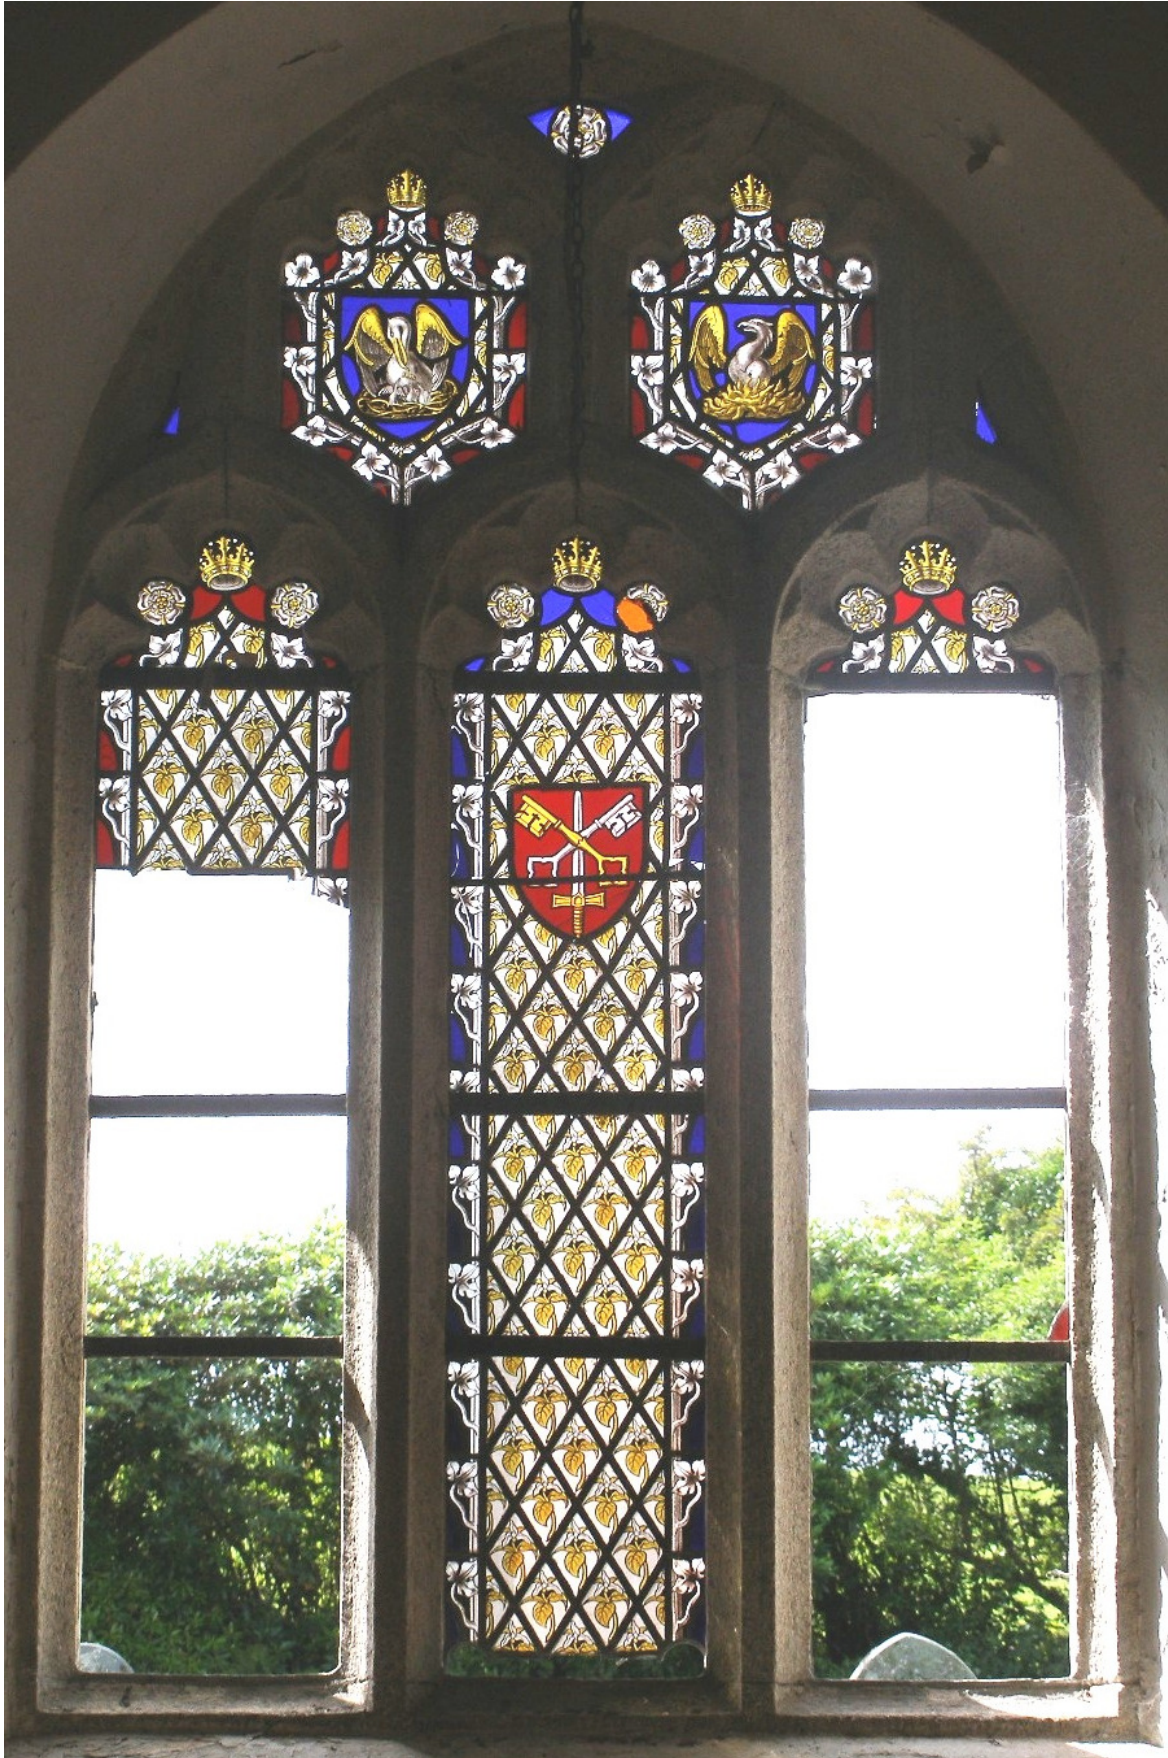
Plate 17 Vandalised west window showing the decorative quarry glass.

It is believed (David Jump pers com) that some or all of the windows were replaced in the 1960s refurbishment and the fragments of stained glass found in the chancel may support this. The colours, shape and size of the quarries match those in the west window and tracery-lights throughout the church. The lead canes are also similar, suggesting that all this glass is contemporary (Plate 11, Plate 17). The square-paned plain glass in the remaining windows has characteristically untarnished solder joints, suggesting its later date (Plate 2). Decorative quarry glass with fleur-de-lis and other floral motifs was commonly

used in early 19th Century churches (Helen Butler pers com). Quarry glass was mass-produced by moulding and printing as a cheap substitute for more traditional stained glass. When the chancel was converted for the vestry, coloured glass would not have been so important. Refurbishment would provide an opportunity for repairs and plain glass would have been a less expensive alternative though notably the Holy Trinity emblem was reused in the east window and most of the original tracery-lights survived.

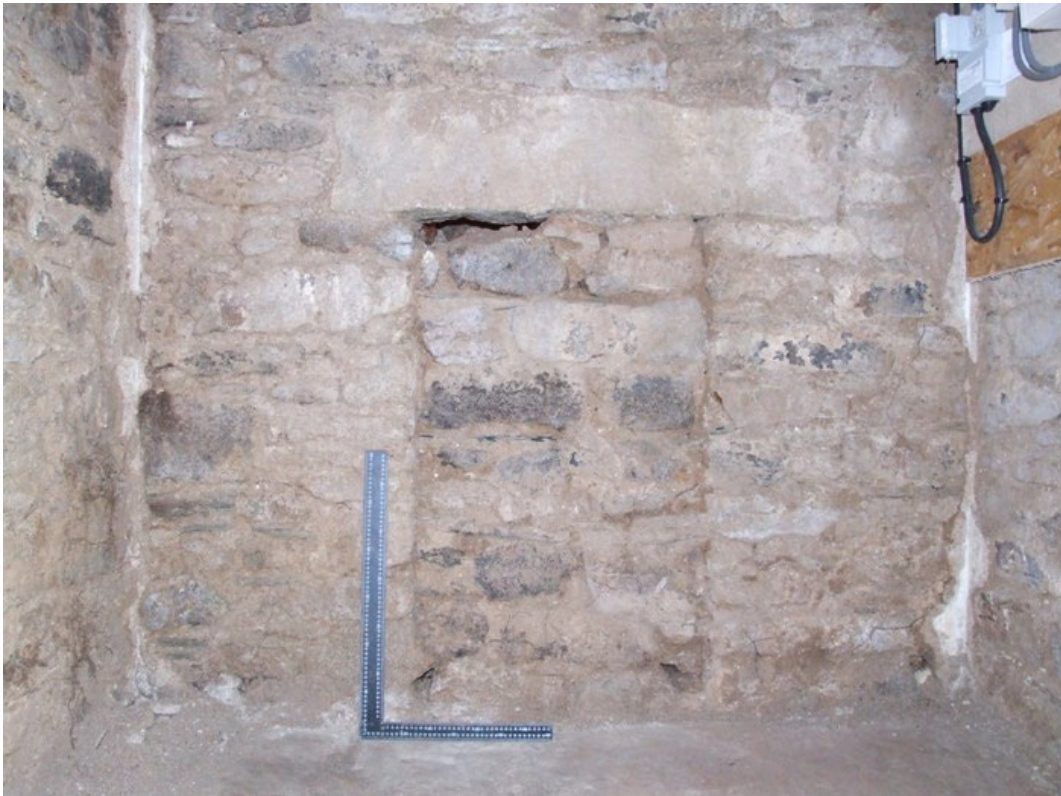
Plate 18 Blocked opening in west wall of vestry.

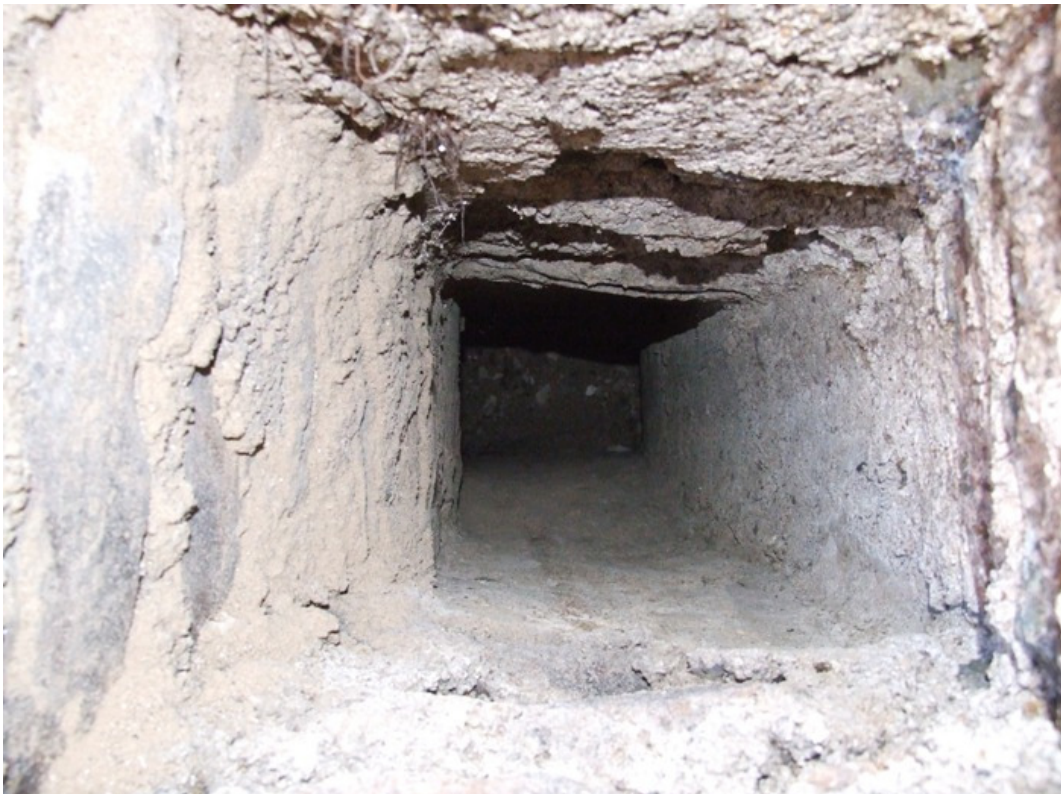
Slightly behind (east of) the arch, a wooden partition with a shallow arched doorway screens off the area to form a vestry in the far east end in what was the chancel. The most significant feature within is a cream marble plaque marking the burials of two children below the floor of the vestry. The plaque was located on marble supports approximately 2m up on the south wall but has been taken down for safety reasons. Shallow excavations for the new floor recorded orange-yellow sandy-clay subsoil but the position of the burials was not apparent (Figure 6). The vestry (Plate 3) was accessed by a door through the north wall of the chancel. Its lean-to slate roof was extremely unstable. A blocked opening was recorded during renovation work in the west wall of the vestry (Plate 18). The opening had a large granite lintel and was blocked with granite rubble similar to the surrounding wall. A square flue above the opening, had reddened stones, but no sooting (Plate 19) presumably providing originally for a cast-iron stove-pipe and stove below.

Plate 19 Reddened lining of vestry flue.
