# Fir Hill Estate

## Colan, Cornwall

### Archaeological Assessment

**Project No:** AC12006E

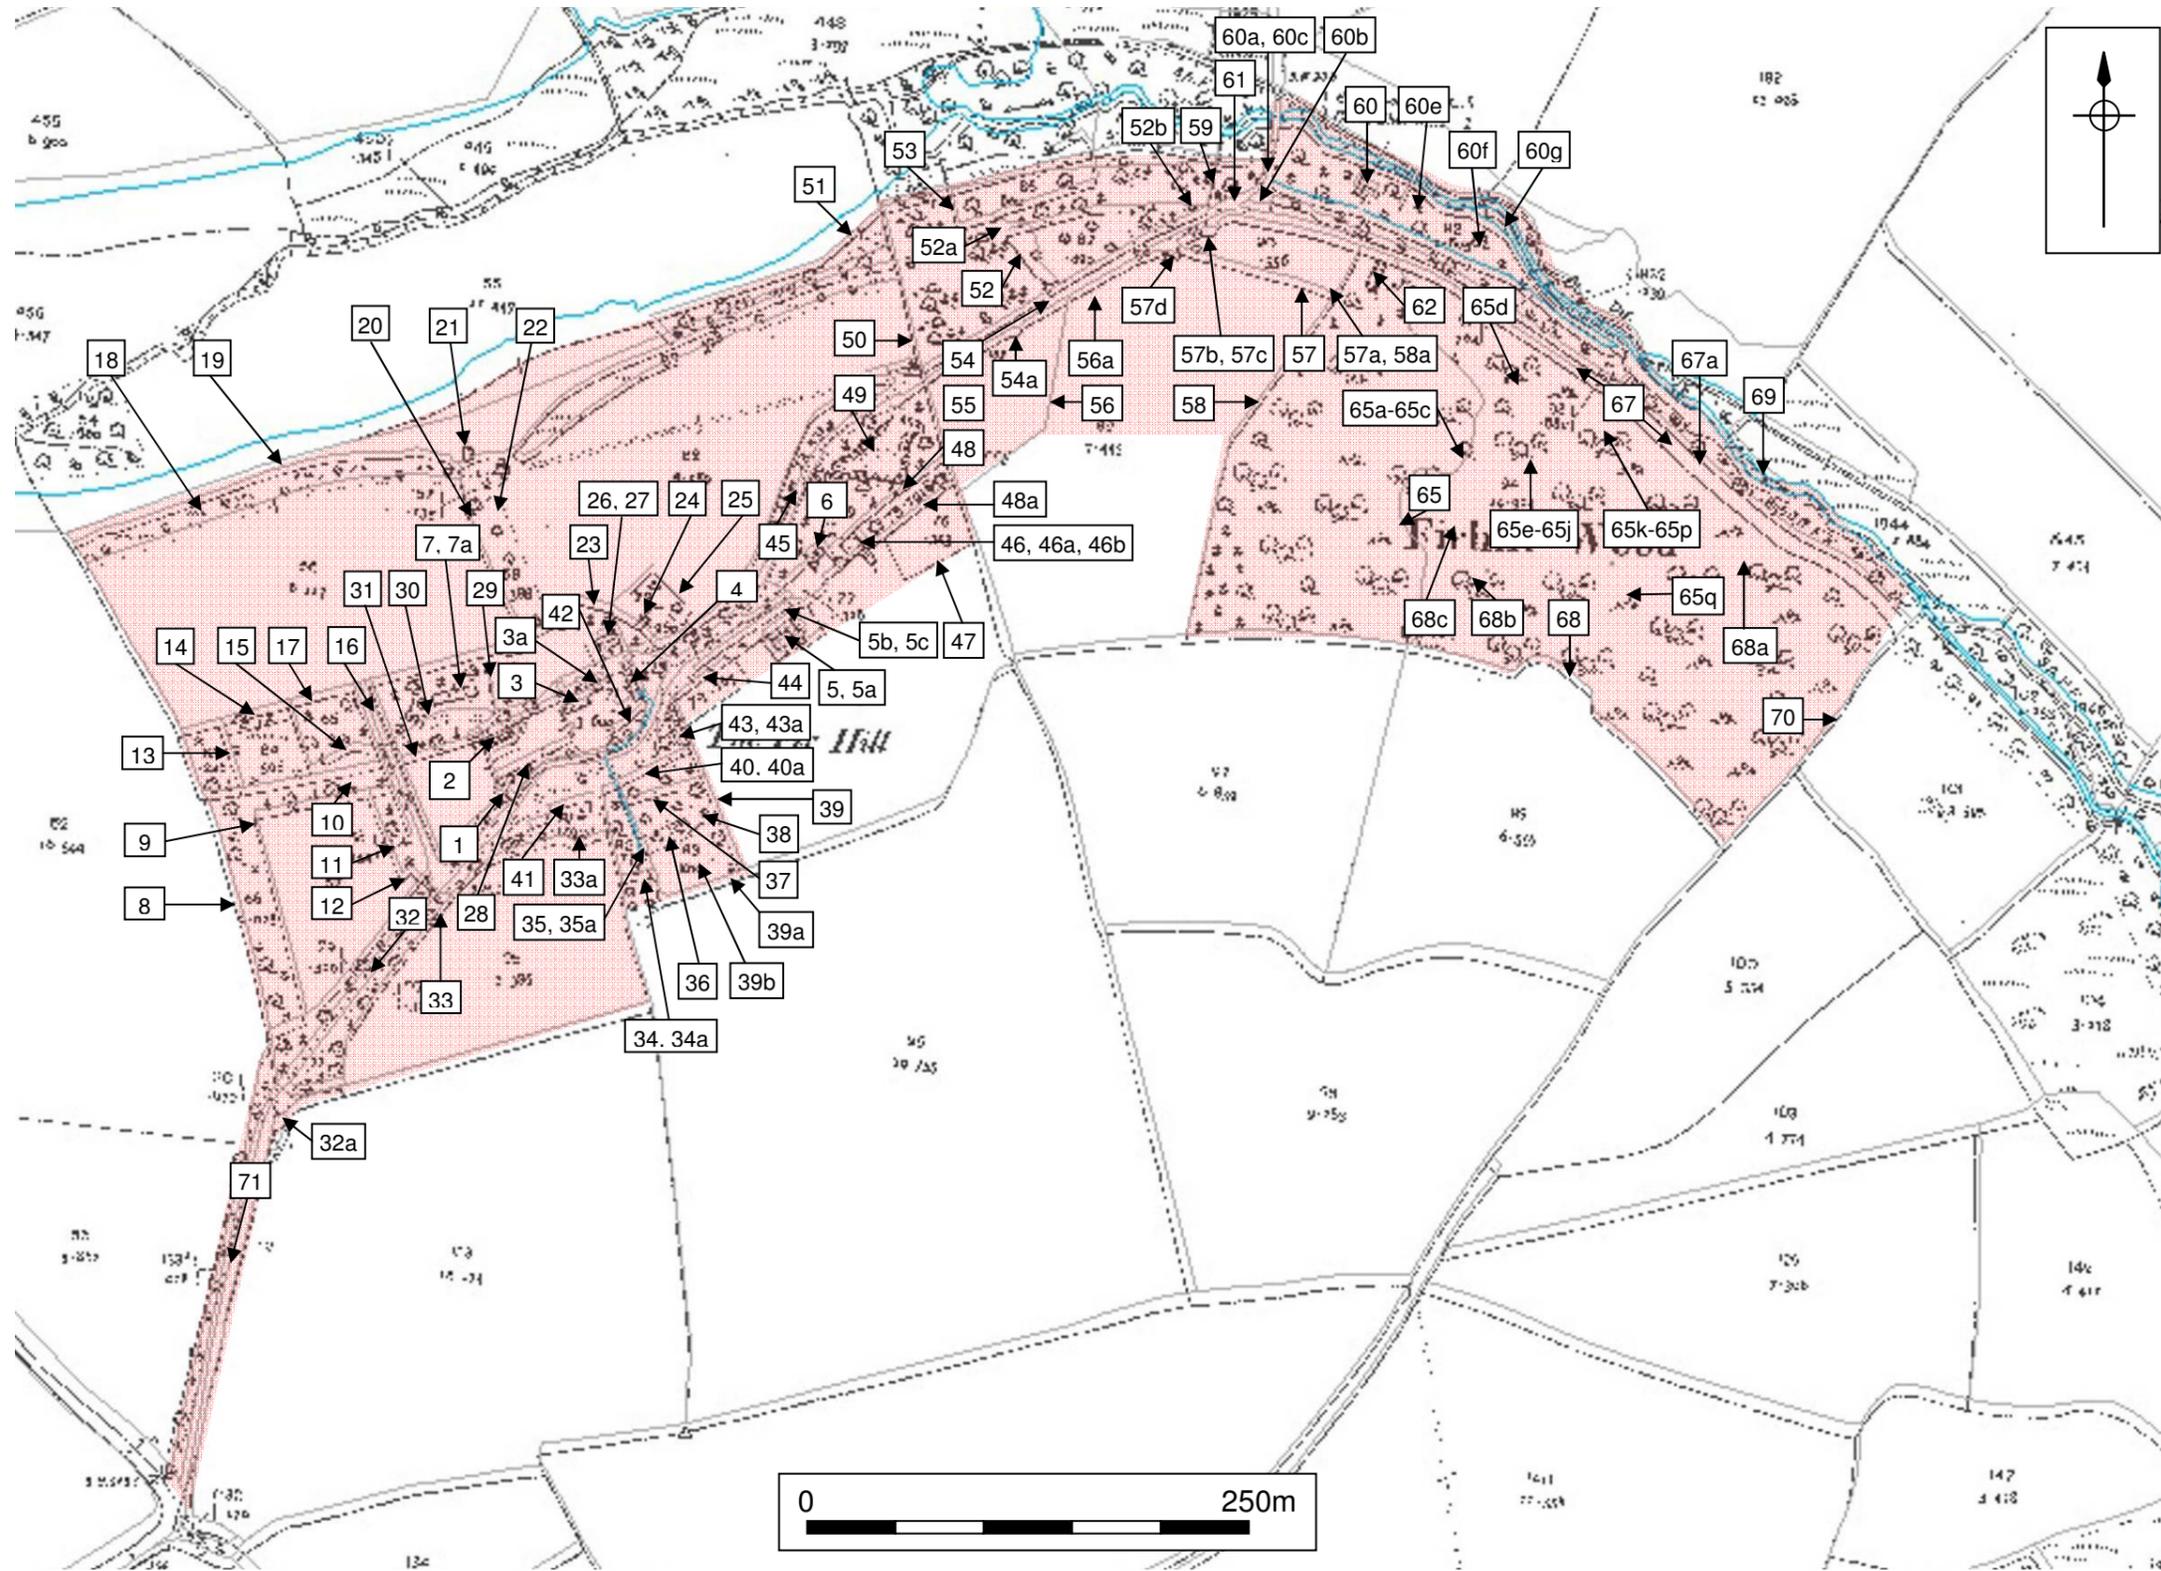
Figure 7 Locations of gazetteer sites overlaid on to 1907 Ordnance Survey map. Map courtesy of Cornwall Council.

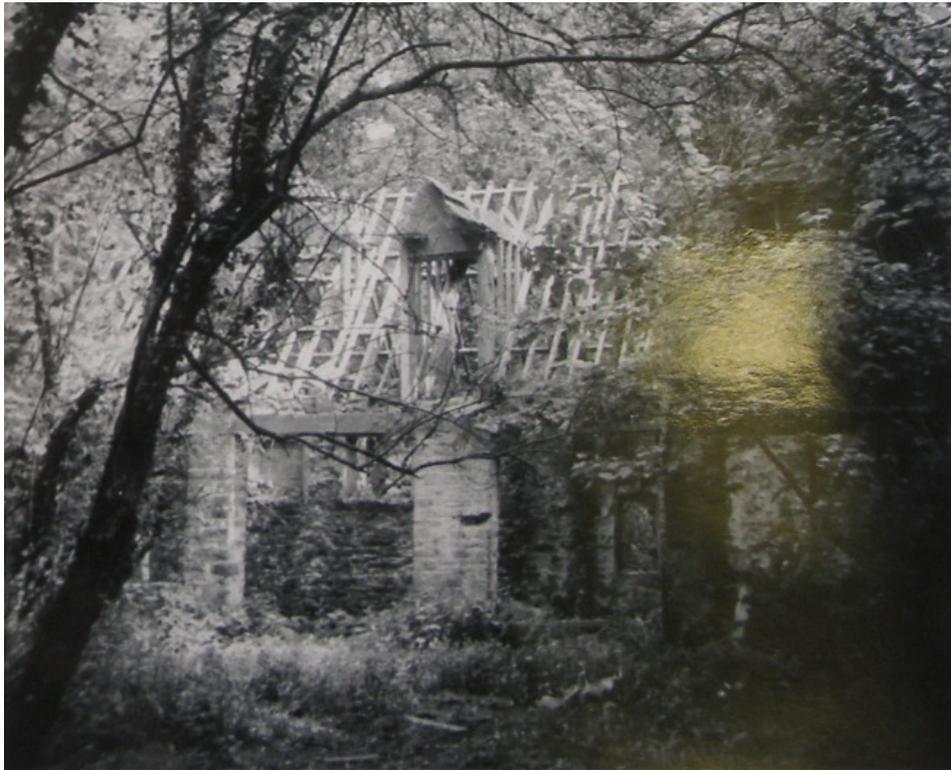
*Plate 7 The Stable Block (Building 4) with roof stripped of its tiles/slates, taken 26<sup>th</sup> May 1974. Courtesy of Newquay Old Cornwall Society Archive.*

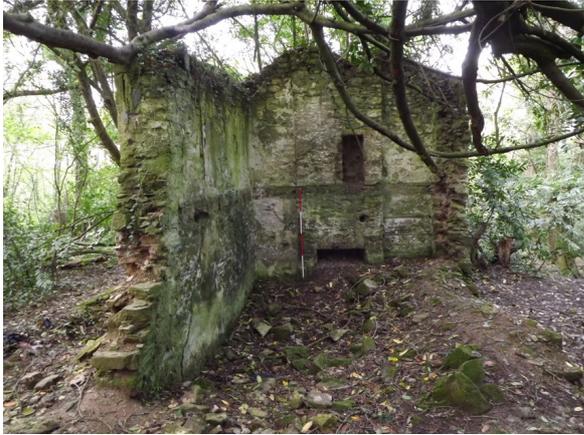
*Plate 8 The Cottage (Building 1) north and west walls, looking north.*

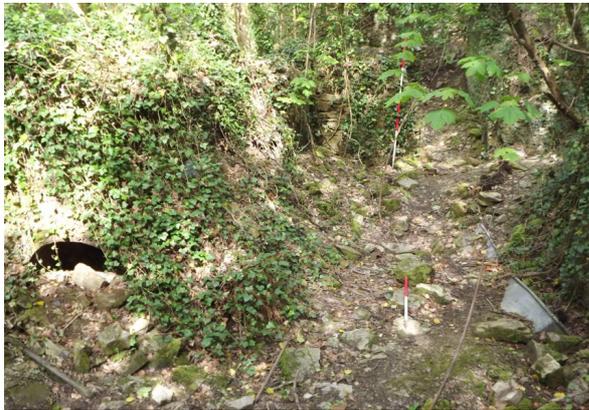
*Plate 9 Internal space of Building 2, formerly the Glass House, note the furnace on the left and irrigation pipes. Looking east.*

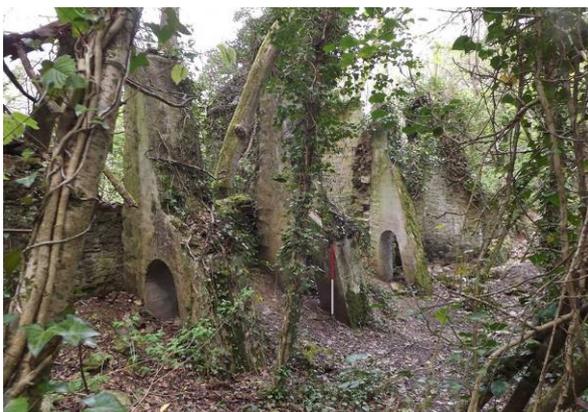
*Plate 10 Concrete buttresses on The Fir Hill House (Building 3), a 20th century addition. Looking northeast.*

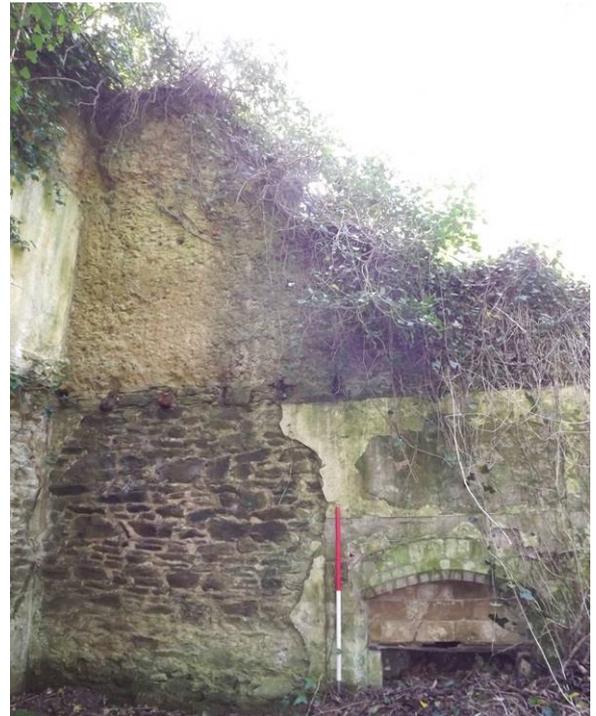
*Plate 16 Fir Hill Farm House (Building 5) internal west wall, detail of decorative brick and dressed stone arched fire surround and first floor cob wall. Looking southwest.*

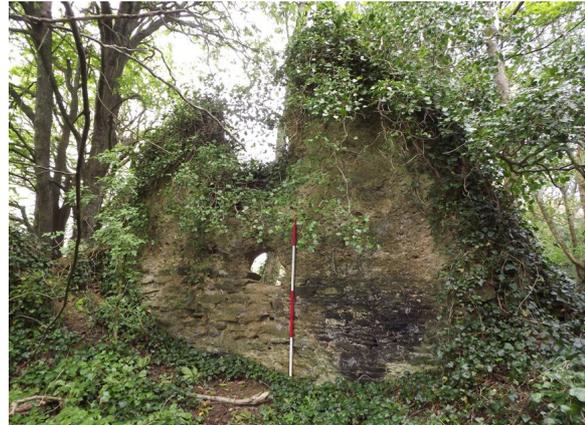
*Plate 20 East wall of Building 27 showing scorch marks and first floor doorway in cob walling. Looking northeast.*

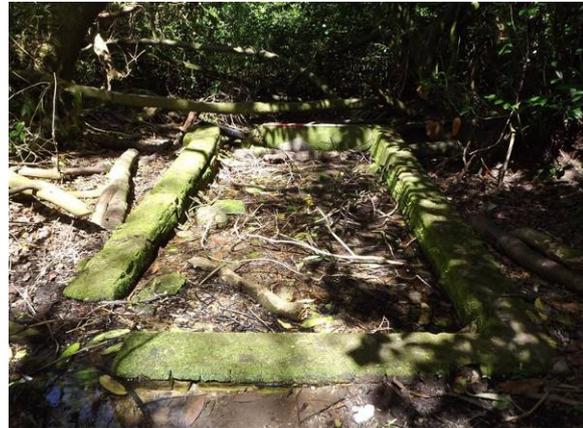
*Plate 21 Water Tank (Site 35a) connected to the Spring 34a to the south. The tank provided a head of pressure for a piped water supply to Fir Hill House down slope. Looking north.*

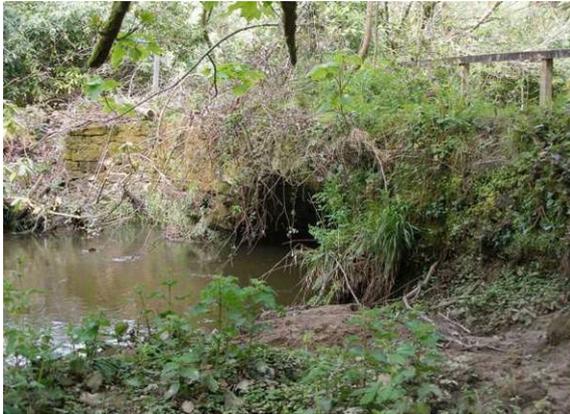
*Plate 28 Causeway/Bridge (Site 60a). Looking north.*

*The decorative but functionless cut-water on the far side of the river, emulating medieval bridge design, would have typically provided for a refuge above. The cut waters do not appear to have ever served more than a decorative purpose and seem likely to be associated with the gothic revival buildings of the Fir Hill, though a crossing is shown here on the c1813 OS map, providing for the southern approach to Nanshyden.*

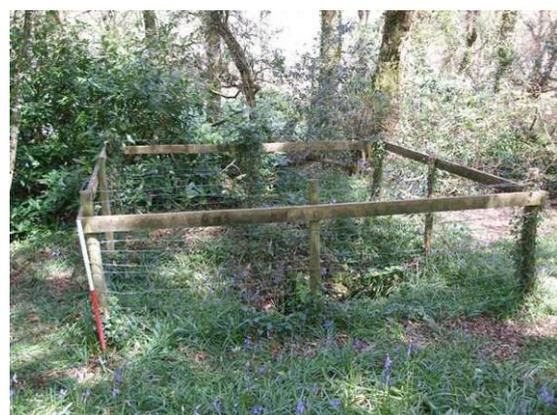
*Plate 32 Inadequate fencing around shaft (Site 65f). Looking northeast.*

- Make safe all mine workings including the capping of shafts using a conical metal frame or similar as advised by an appropriate contractor (AC can advise if required). If more substantial works are required to the mines additional documentary research into Wheal Aaron is likely to add to our understanding of ochre production at Fir Hill.
- Preliminary structural survey by a qualified contractor of all buildings identified in the gazetteer above to advise on structural integrity, hazards and priorities (AC can advise on contractors if required).

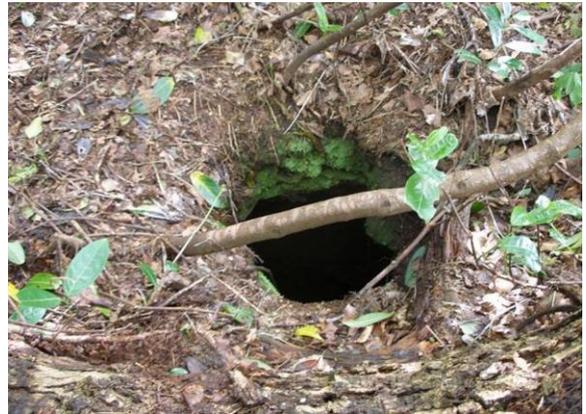
*Plate 36 Modern break into mine  
working/adit (Site 68c). Looking  
north.*

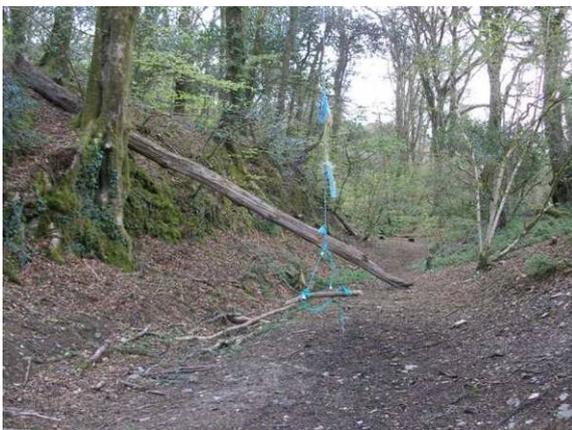
*Plate 35 Eddyvean Canal cut into  
the hillside (Site 67) with swing.  
Looking west.*
