**HATTON  
TO SILK WILLOUGHBY  
1050mm GAS PIPELINE**

**ARCHAEOLOGICAL  
EVALUATION  
& WATCHING BRIEF  
AT CAR DYKE (SAM 314)**

Prepared by  
**NETWORK ARCHAEOLOGY Ltd**

Report No. 133  
September 1999

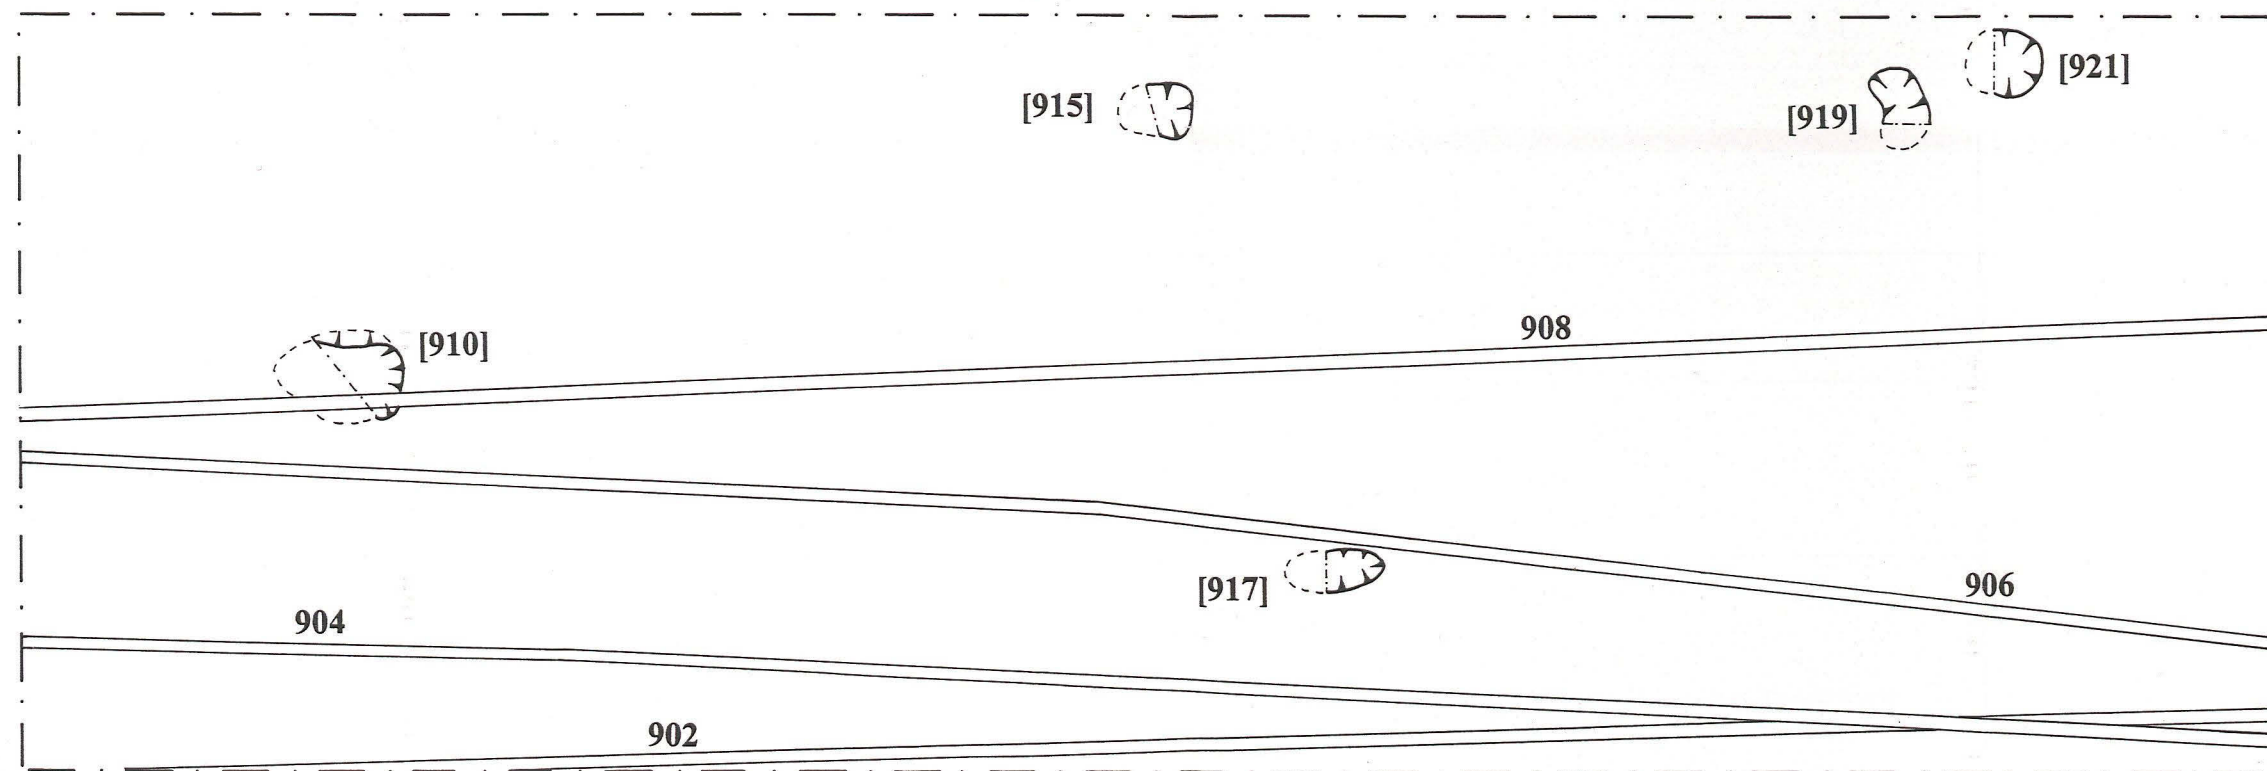
Figure 3: Plan of evaluation trench [scale 1:100]

The trench revealed two pairs of parallel land drains (Figure 3). One pair, [902] and [908], ran at an angle across the trench in a WNW-ESE direction. Drain [908] had a steep-sided cut and contained a ceramic land drain. Drain [902] was unexcavated but fragments of ceramic drain were seen in the fill. No dating evidence was recovered but this type of drain is typical of the Post-Medieval to Modern period.

The other two land drains, [904] and [906], ran at a slightly different alignment to [902] and [908], running roughly NNW-SSE. Drain [904] cut drain [902] and is therefore a later feature. The relationship between [906] and the other features remains undetermined. Neither [904] nor [906] were excavated and thus their form is unknown. However, the large quantity of flint and limestone gravel visible within the fill of the features suggests that they were both gravel-filled drains.

Five further features, [910], [915], [917], [919] and [921], were investigated but have been interpreted as tree/plant holes. All were between 0.13m and 0.53m deep and had indistinct, irregular edges (See Appendix 1 for full details). One of these, [910], was cut by land drain [908] and therefore pre-dates that sequence of drains. The other tree/plant holes were isolated features containing no datable material and as such their relationship to each other and to the land drains is undetermined.

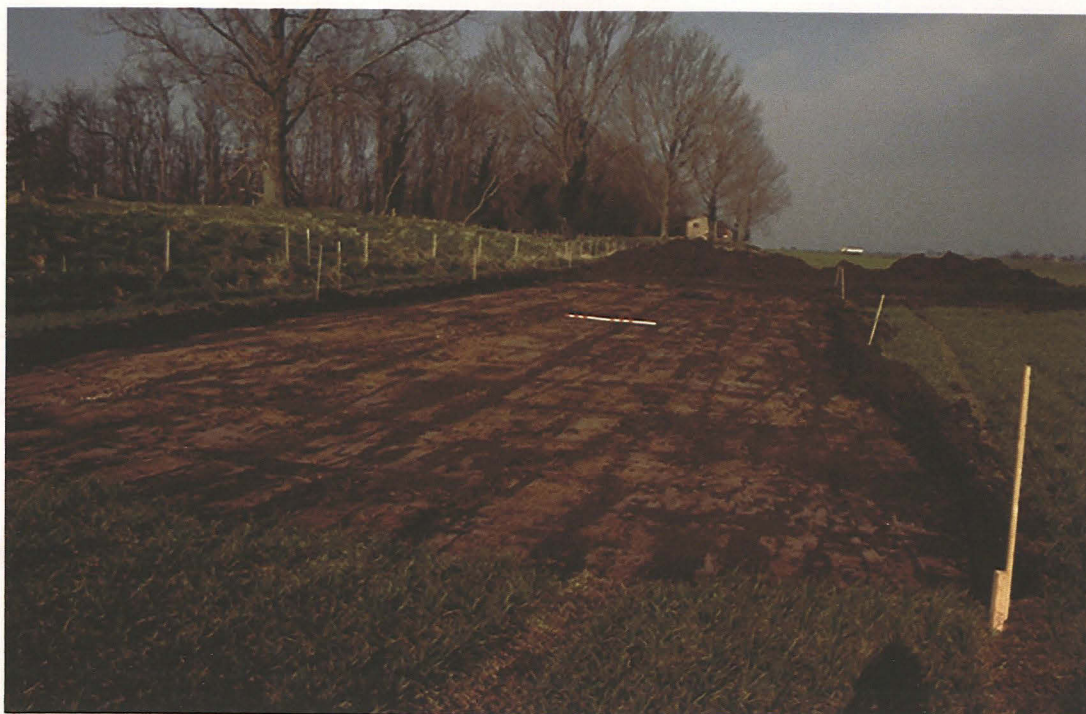
Plate 1: Evaluation trench to the north of Car Dyke

In February 1998 an evaluation trench measuring 30m long by 10m wide, was opened up to investigate the archaeological geophysical anomalies to the north-east of Car Dyke. This did not include the area of potential ridge and furrow. The pit-like anomalies were found to be tree and plant holes. Several post-medieval land drains were also identified.
