Candlesby to Trusthorpe Hall Gas Pipeline

ARCHAEOLOGICAL WATCHING BRIEF

Report by
NETWORK ARCHAEOLOGY Ltd
for
Transco

Report No 146

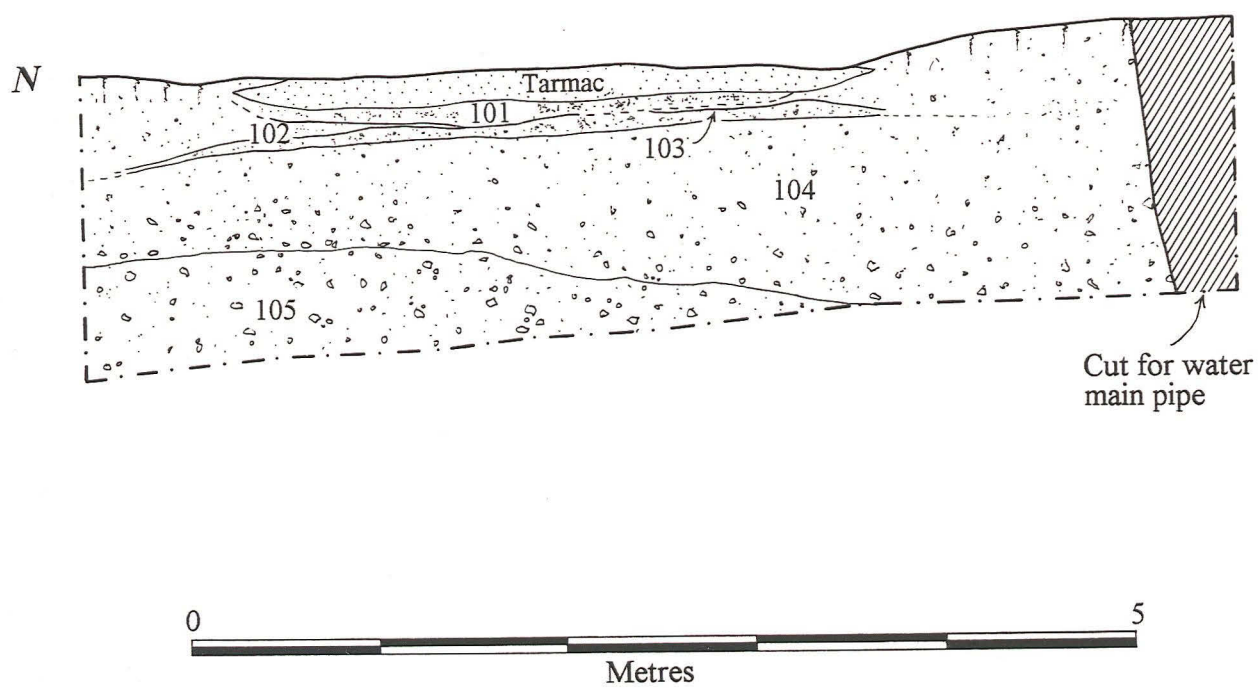
Figure 3: Section through line of Roman Road

A section through the farm track is shown in Figure 3. The modern tarmac surface could be seen to be lying immediately above a layer of crushed chalk, up to 120mm thick (101). A thin layer of reddish silty clay (102), separated this from a second layer of crushed chalk (103), which lay over a thick silty clay layer (104). In the lower part of the section, this became increasingly chalky and the base of the trench was cut into more or less pure chalk (105). The interface between these two lower layers was very irregular, the depth of the chalk varying considerably along the length of the trench. The lower silty clay presumably represents completely weathered-down chalk.

West-facing section

Although no dating evidence was found, it is possible that the lower chalk layer (103) is the remains of the Roman road. It is likely to be part of the original road surface, but could be the severely eroded remains of the foundations. The overlying silty layer (102) may have accumulated after the Roman road was abandoned and perhaps robbed, possibly as a ploughed headland as the roadside verge was formed.

No roadside ditches, usually associated with Roman roads, were seen within the pipe-trench. However, the trench was extremely narrow and the trench had been disturbed to the south by the construction of a water pipe.

Part of the make-up for the Roman road may survive as a crushed chalk layer beneath the tarmac and a more recent chalk layer of the farm track.

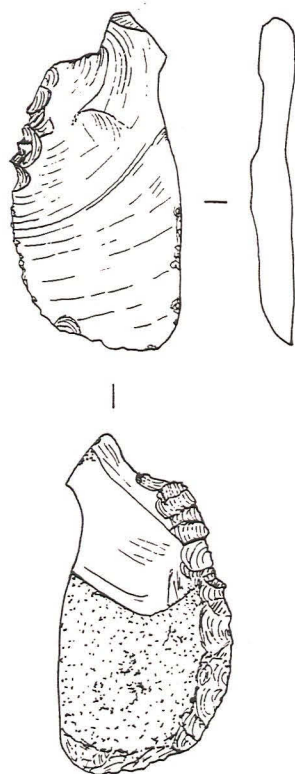
Figure 4: Late Neolithic/Early Bronze Age flint knife blade

At the bottom of the slope, centred on a point approximately 150m from the northern boundary of this field, twelve worked flint fragments were found (Appendix 2). These include a broken knife-blade, made from re-touching the edge of a struck flake (Figure 4). Apart from one piece retrieved from the spoil heap, these flints were all found in the top of the subsoil layer. They were spread over more than 100m, and the low density makes it questionable whether they could be considered as a single assemblage, rather than a concentration of background finds. If it is all of a common origin, two pieces typical of the Late Neolithic or Early Bronze Age provide a general date. The other fragments would be consistent with that

period but could not be so closely dated. The presence of probable scrapers and piercers suggest a range of tool-types and could have been derived from a domestic settlement nearby.

If it were assumed that the cropmark enclosure is the site of the settlement associated with this flint assemblage, it would provide a Late Neolithic or Early Bronze Age date for that cropmark feature. However, no flint was recovered from the point at which the pipe is closest to the cropmark, or for a considerable distance beyond. Because of the slope of the ground, erosional creep or plough disturbance might have moved them downhill. It is more likely that they derived from a ploughed-out feature within the area where they were found. This could, of course, have been contemporary with the cropmark feature and be associated with it.
