**An Archaeological Watching Brief  
during groundworks at Back Lane,  
Skillington, Lincolnshire  
(SK 8965 2576)**

**Jennifer Browning**

**University of Leicester  
Archaeological Services**

Report 2000/05 © 2000

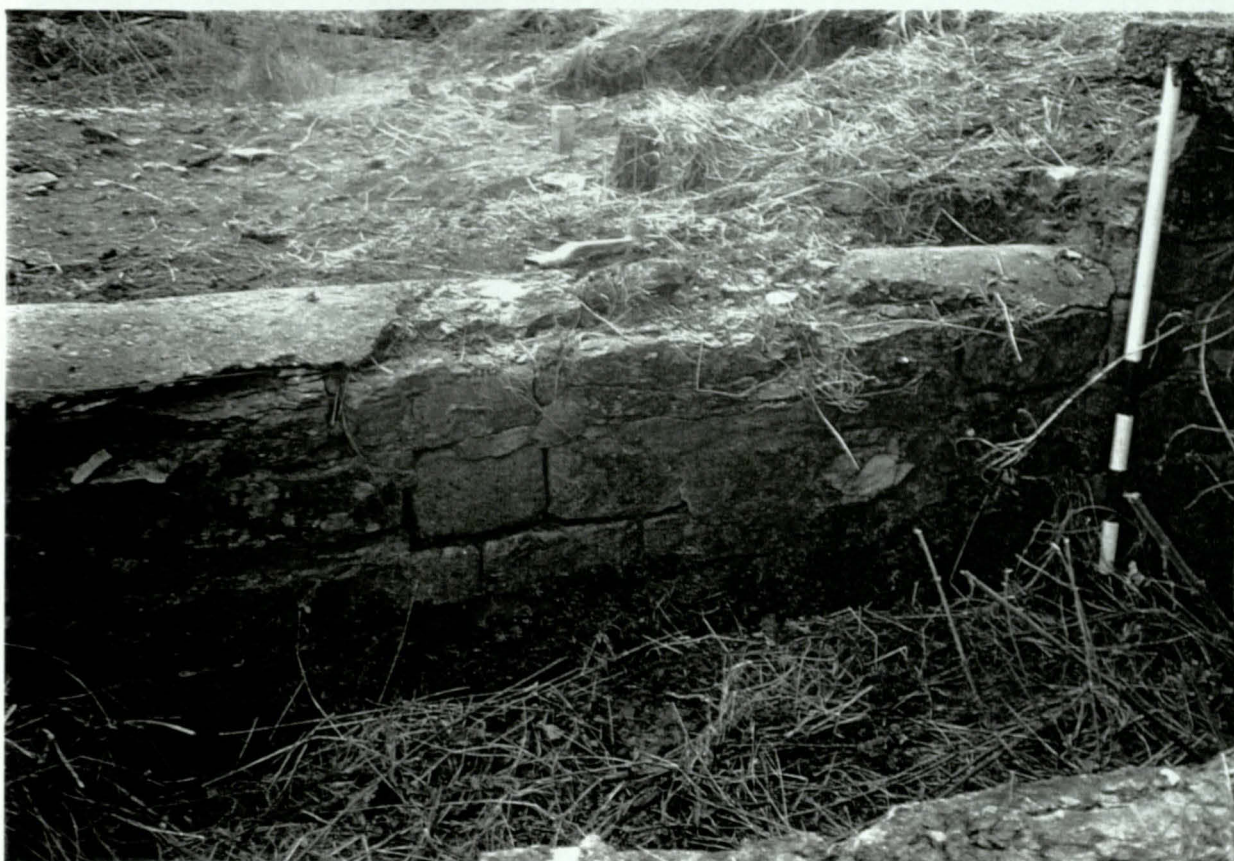
The structure is built of blocks of stone (mostly limestone) mortared together. It consists of a sub-circular well with an adjoining rectangular "trough" (*figure 6 & plates 1-4*). A stone wall projects out to the north at right angles to the trough, curving round towards the fence. It is topped by a course of blue engineering bricks. The "trough" is about 0.6m deep from the top of the south eastern wall and has a solid base. However, due to weed cover it was not possible to see from what the base is made, and it seemed likely that it has been filled with rubble. A layer of concrete tops the south eastern wall of the trough.

Plate 3: Detail of southern wall. Looking south.

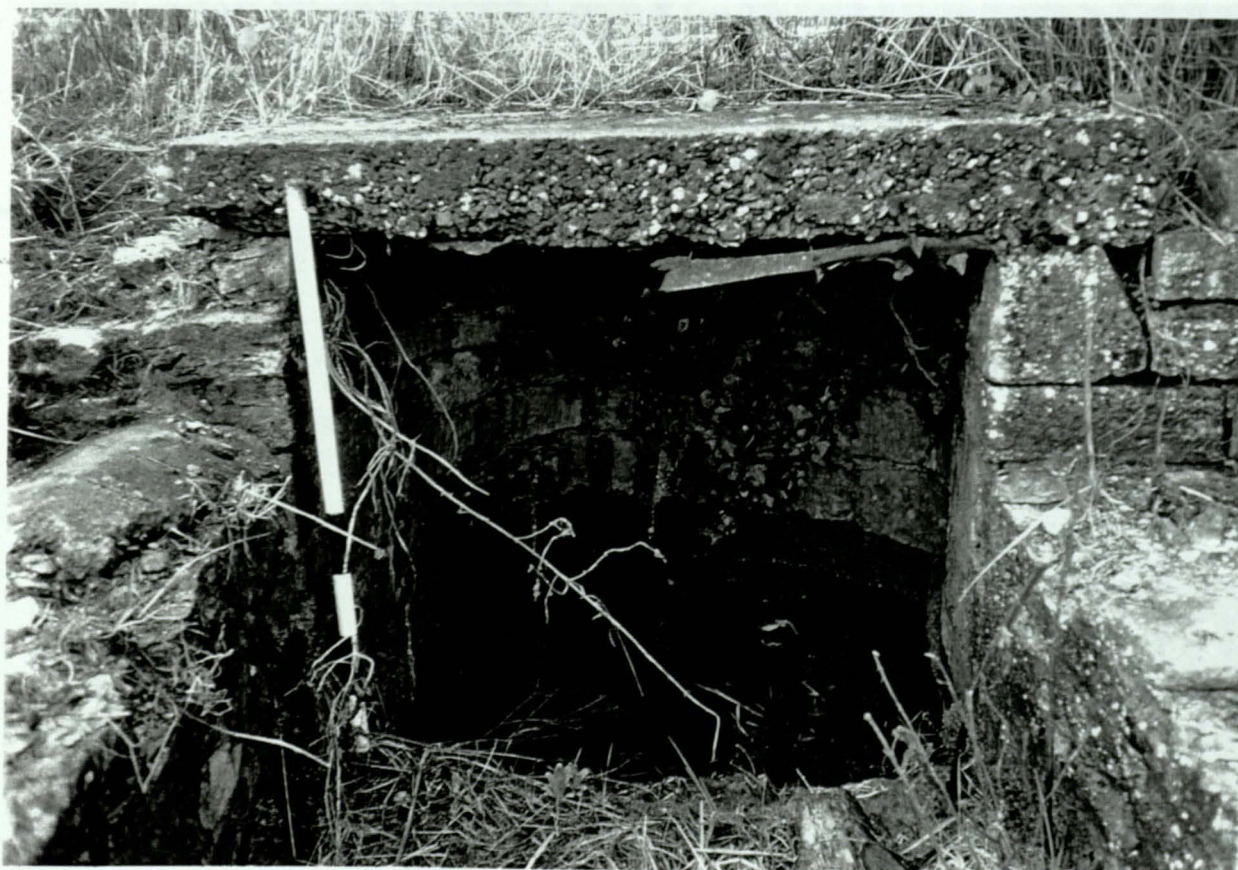
The well is capped just above present ground level by a rectangular block of coarse concrete measuring 1.42m x 1.23m x 0.15m and the water level is about 1 metre below the concrete cap. The well shaft itself is partly filled by brick rubble so it was not possible to establish the original depth. Alterations have also been made to the well using brick. The east end of the "trough" is blocked by a wall of blue bricks, similar to those of the stone wall at the western end of the "trough". The north western wall of the "trough" has been reveted using at least four courses of red bricks, which have since suffered some breakage.

Plate 4: Detail of well, looking west.

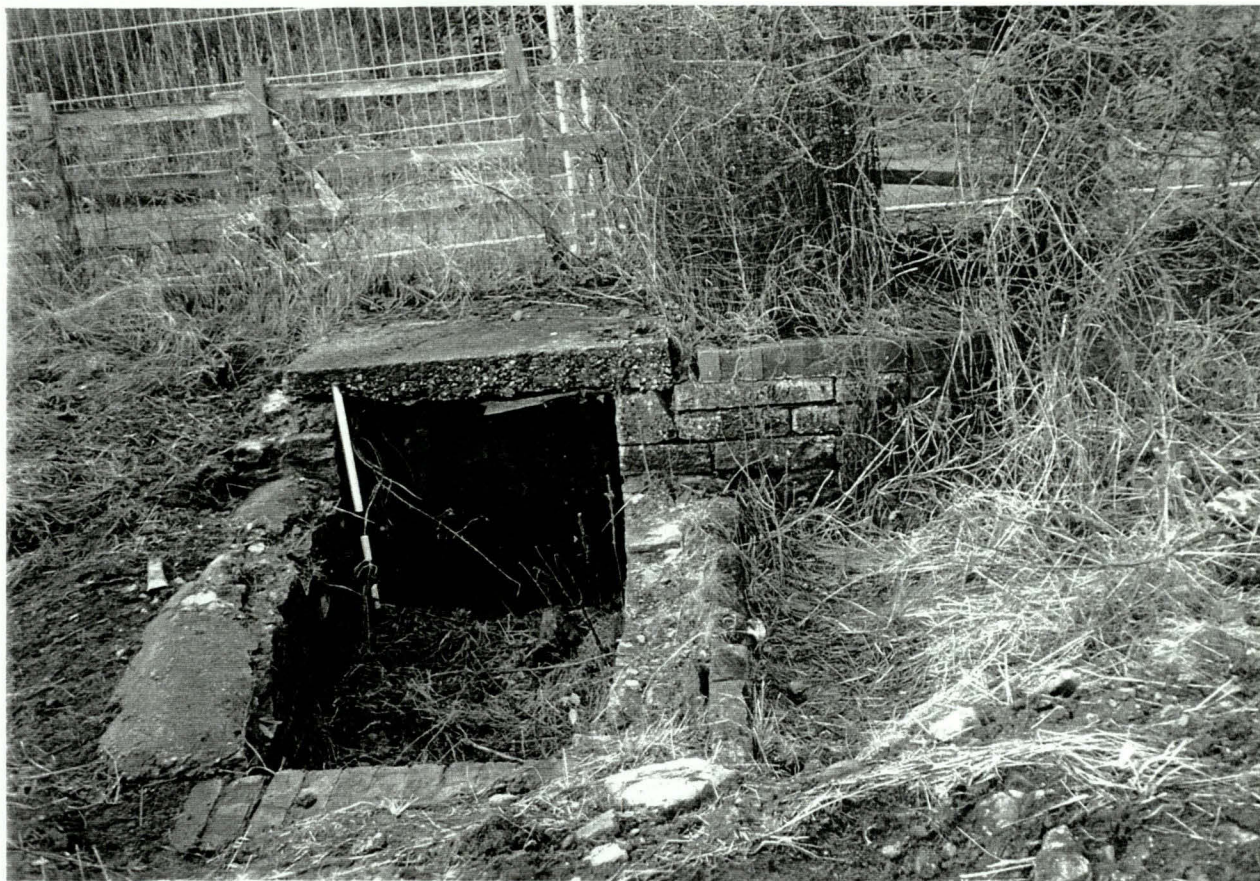
**Plate 1:** General view of well. Looking south west.

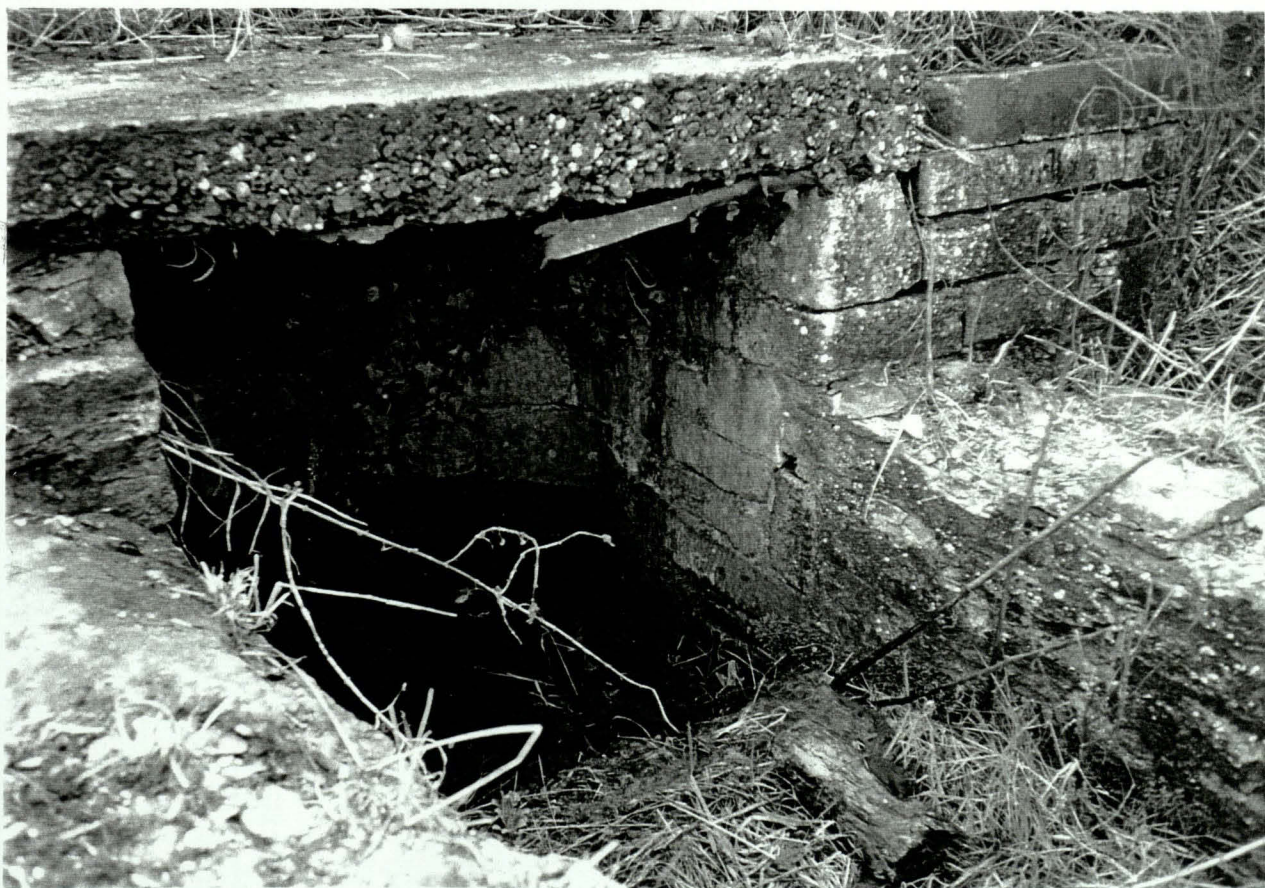
**Plate 2:** Closer view of well. Looking west.
