**ARCHAEOLOGICAL WATCHING BRIEF
OF MAINTENANCE WORK ON THE
CHURCHYARD WALL,
ALL SAINTS' CHURCH,
HOUGH-ON-THE-HILL,
LINCOLNSHIRE
(HAS 98)**

Work Undertaken For
Benton and Co. Architects
on behalf of
Hough-on-the Hill Parochial Church Council

June 2000

A.P.S. Report No. 171/00

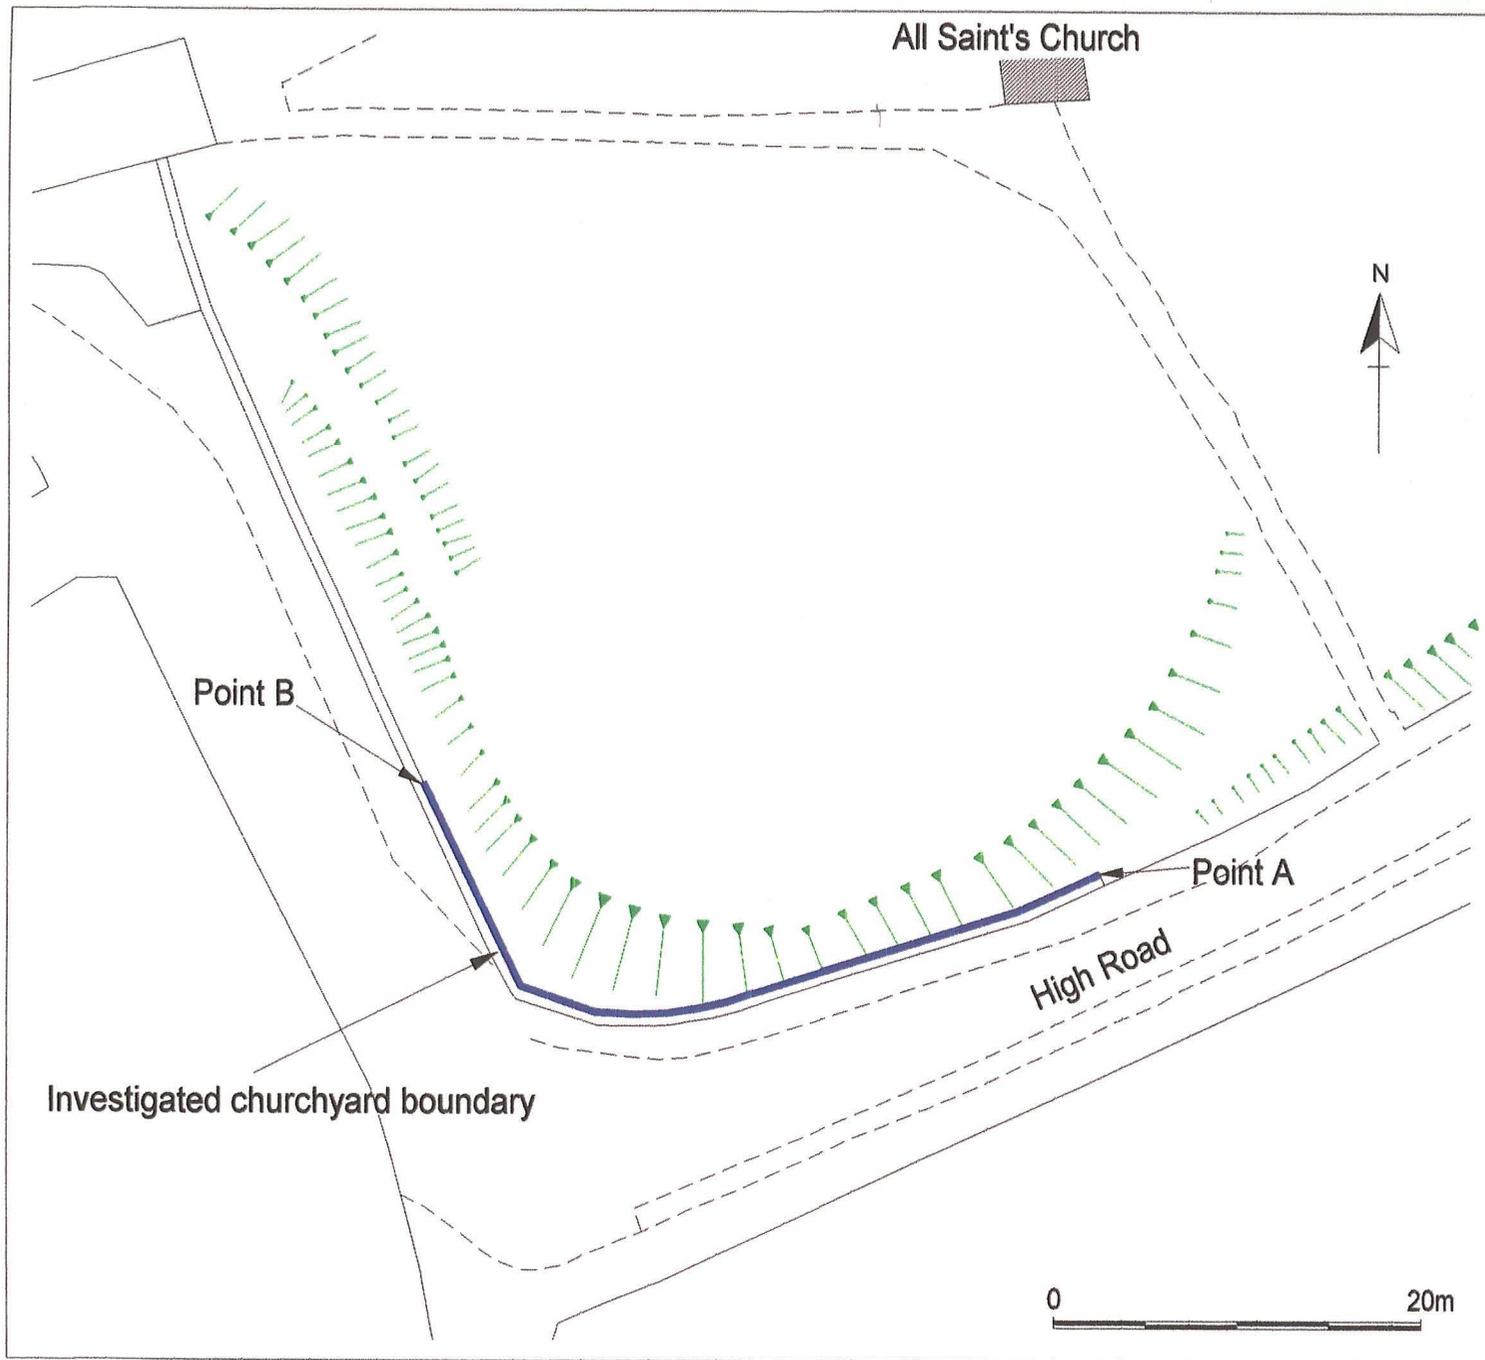
Figure 3 Investigation area

All Saints' parish church is located at the centre of the village at National Grid Reference SK 9232 4639 (Fig. 2). The repairs to the churchyard wall are along the southern and western boundaries to the churchyard (Fig. 3; Plate 1).

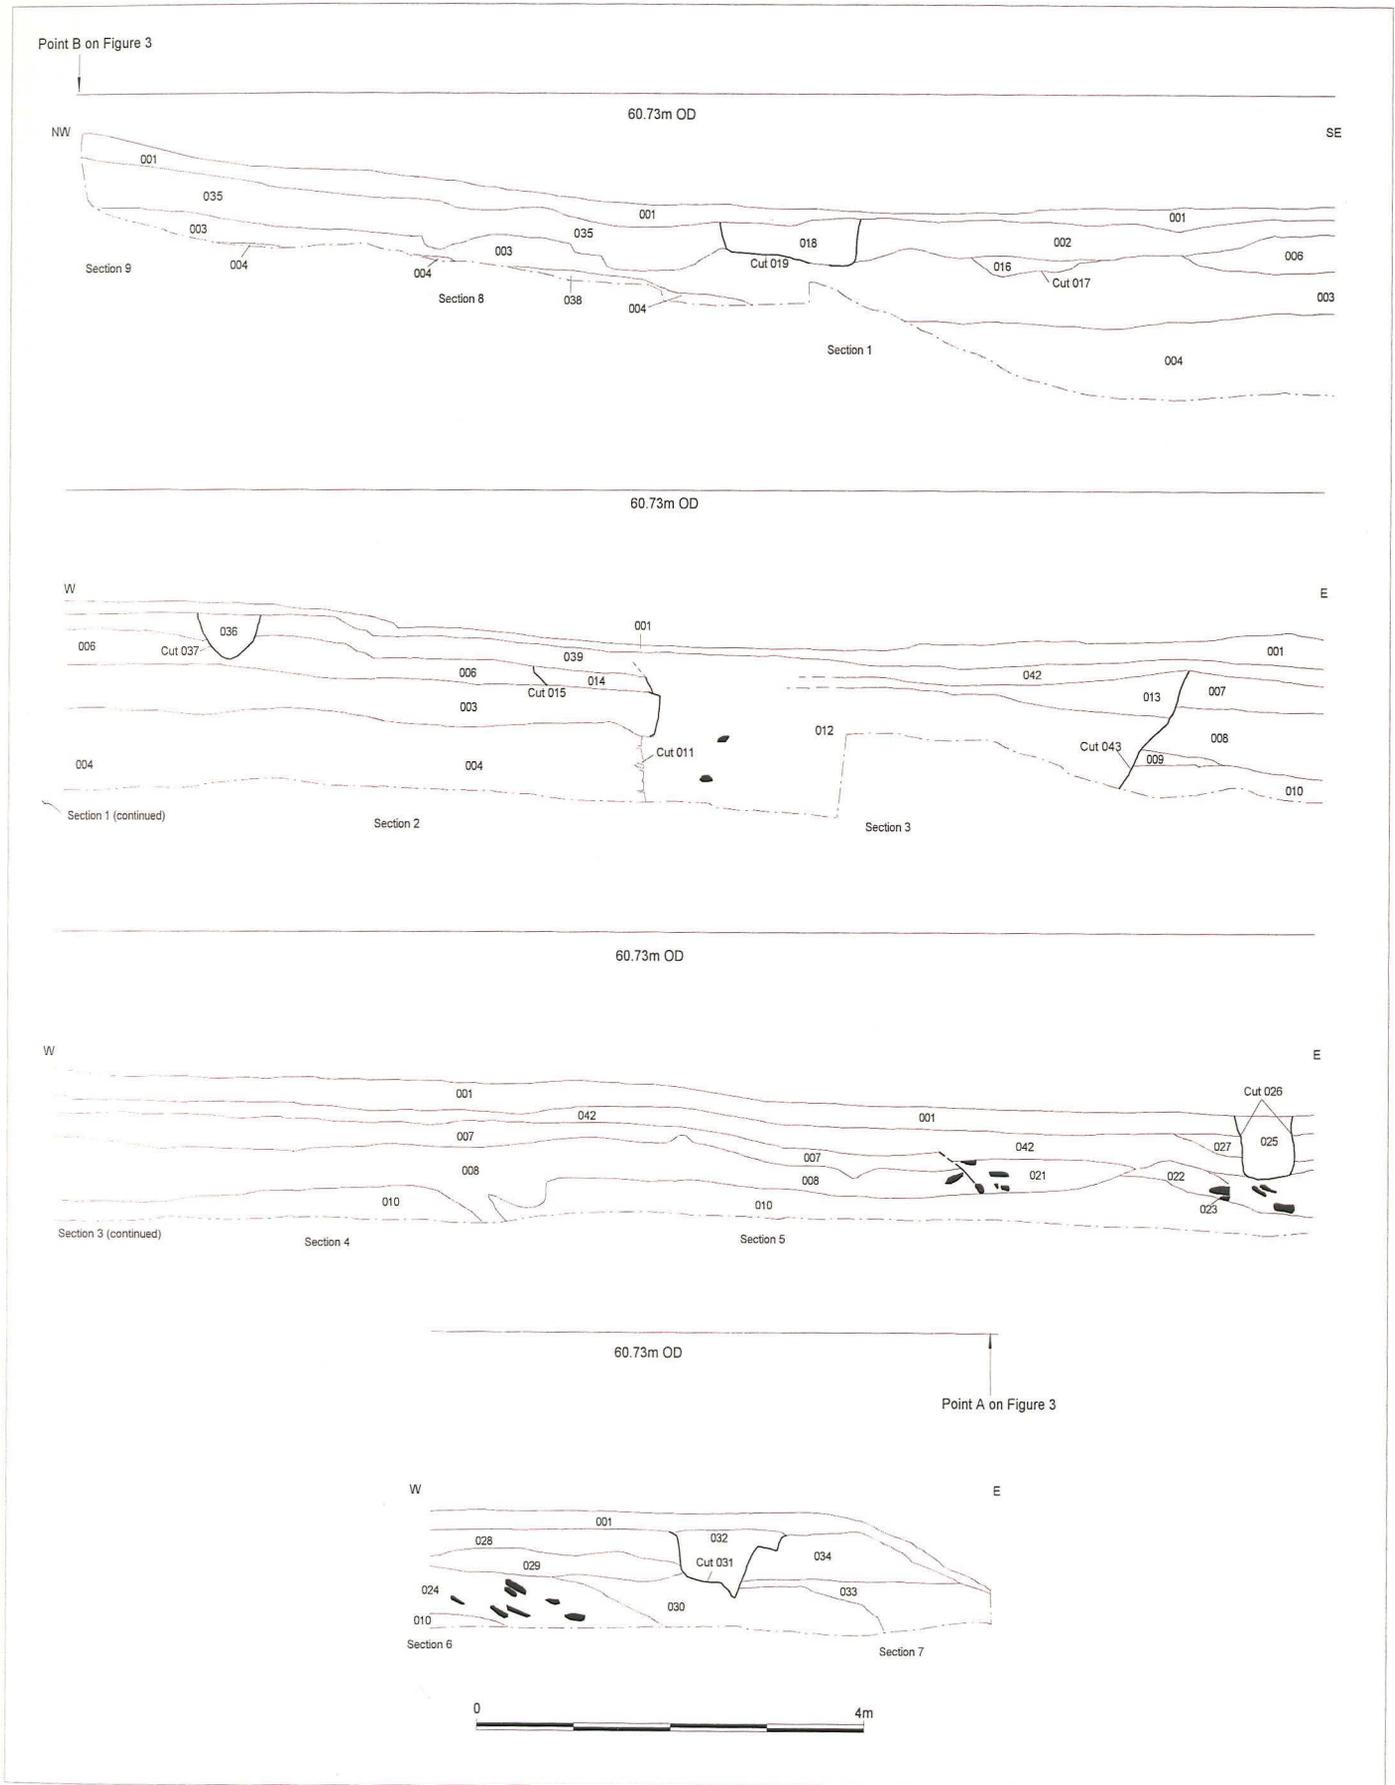
Figure 4 Continuous section of investigated area

Toward the west end of the wall (Fig. 4) the natural clay (003) was cut by a shallow, 0.3m

deep, 1.5m long feature (017). This was filled with yellow-grey clayey sand with abundant roots and is thought to be a gully (Plate 2).

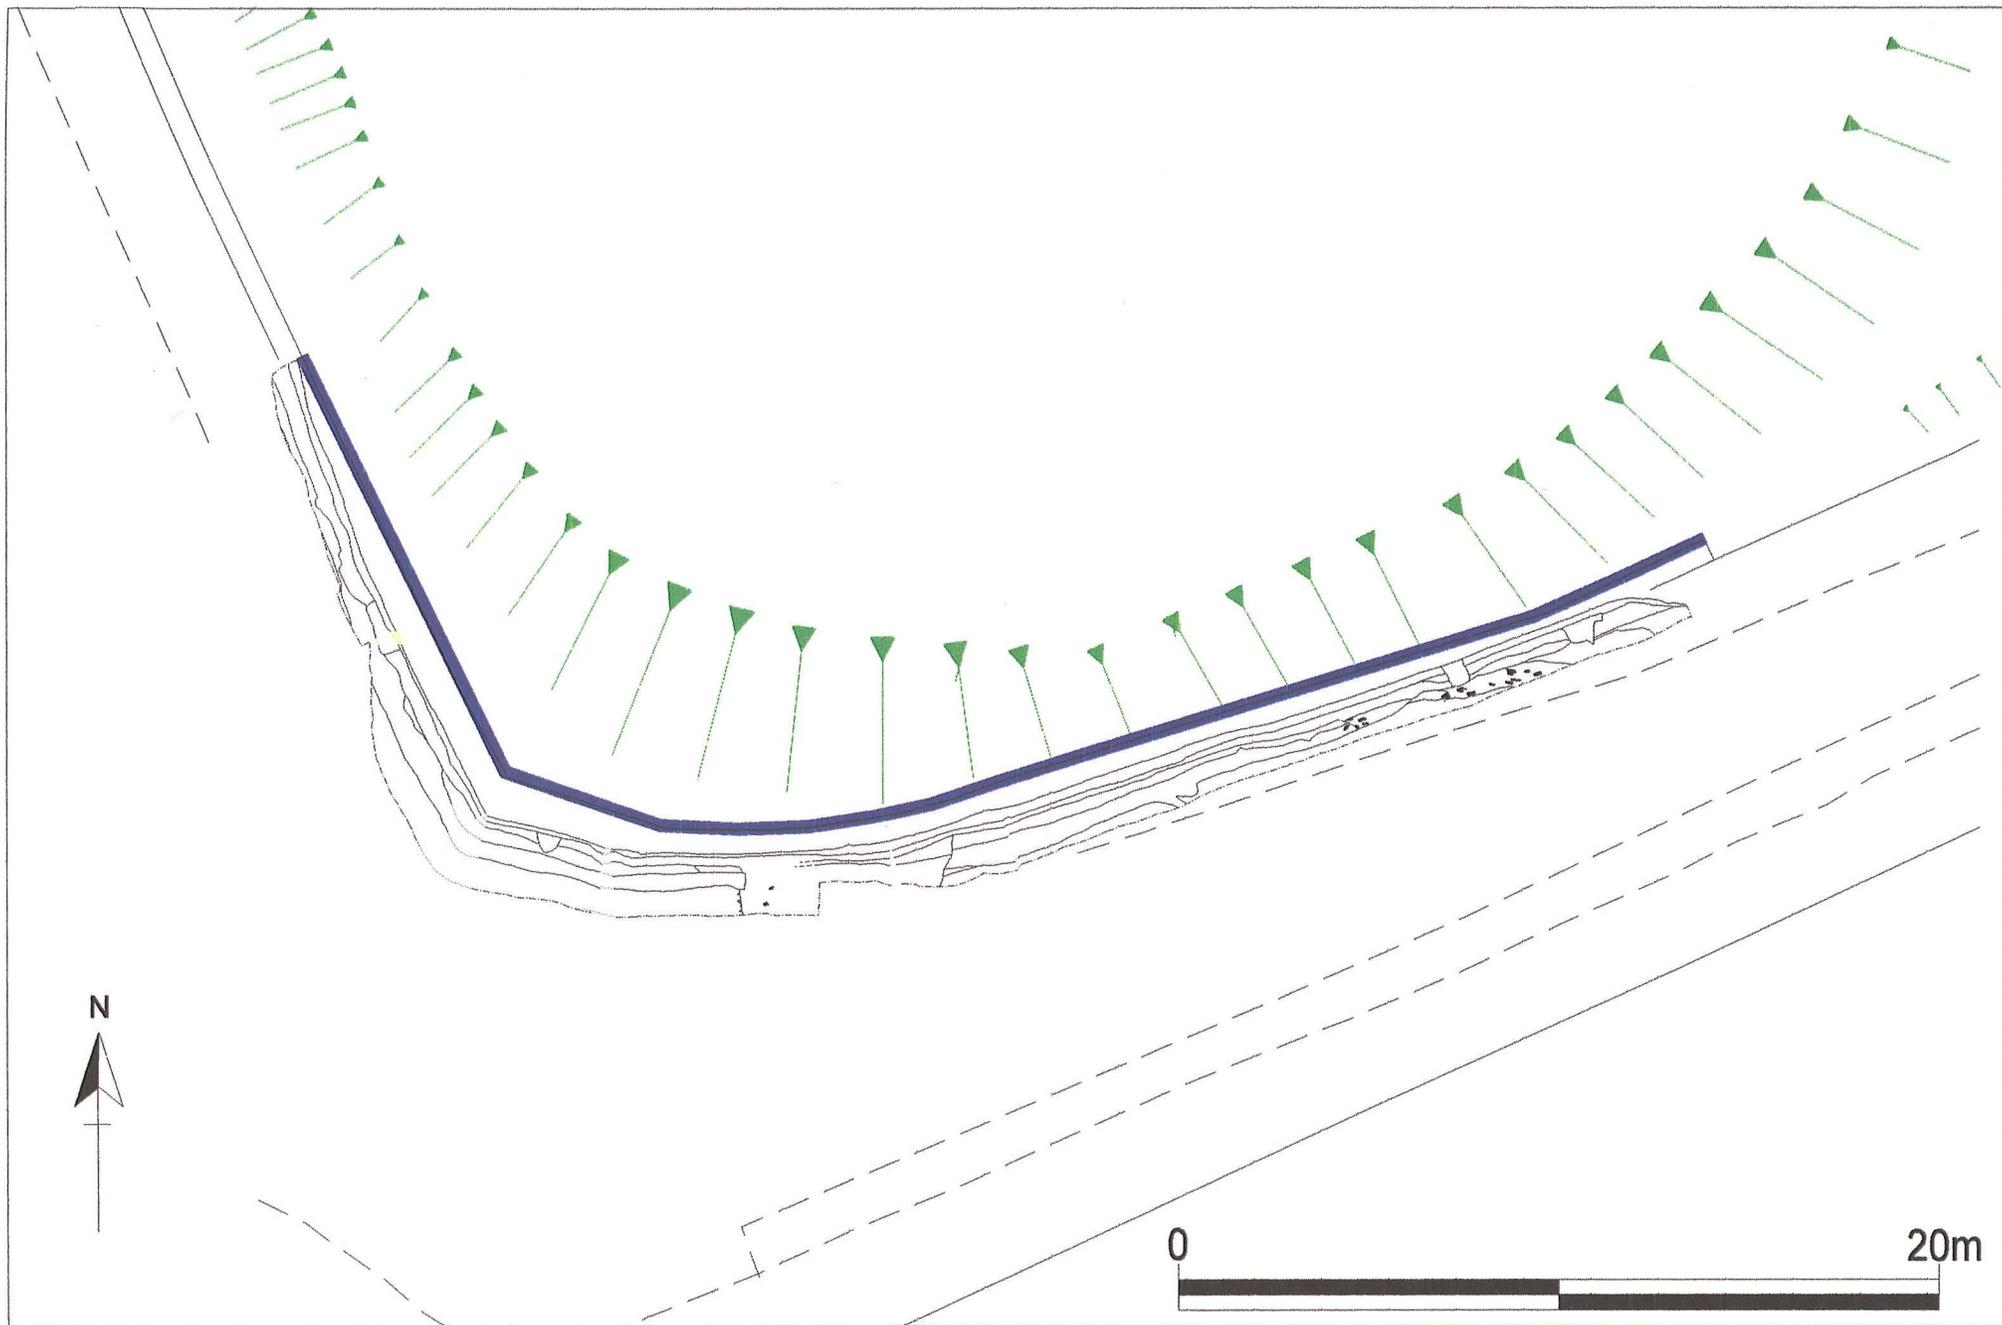
Figure 5 Investigation area. showing section tied to investigated wall length

The function of (011) is uncertain. It is broadly on the line of the postulated bailey ditch associated with the adjacent castle and may be part of that perimeter (Fig. 5). If so, then the cut may be Saxo-Norman in date. However, the feature could be later, associated with the church. The 1850 Hough-on-the-Hill tithe map (Hutchinson 1850; Fig. 6a), records that the southeastern boundary of the churchyard was different to the present alignment, with a sharp turn to the north. This was infilled by 1905, as shown on the Ordnance Survey map (Fig. 6b). However, the boundary in-turn on the 1850 map appears to be a little too far to the east to correspond with cut (011).

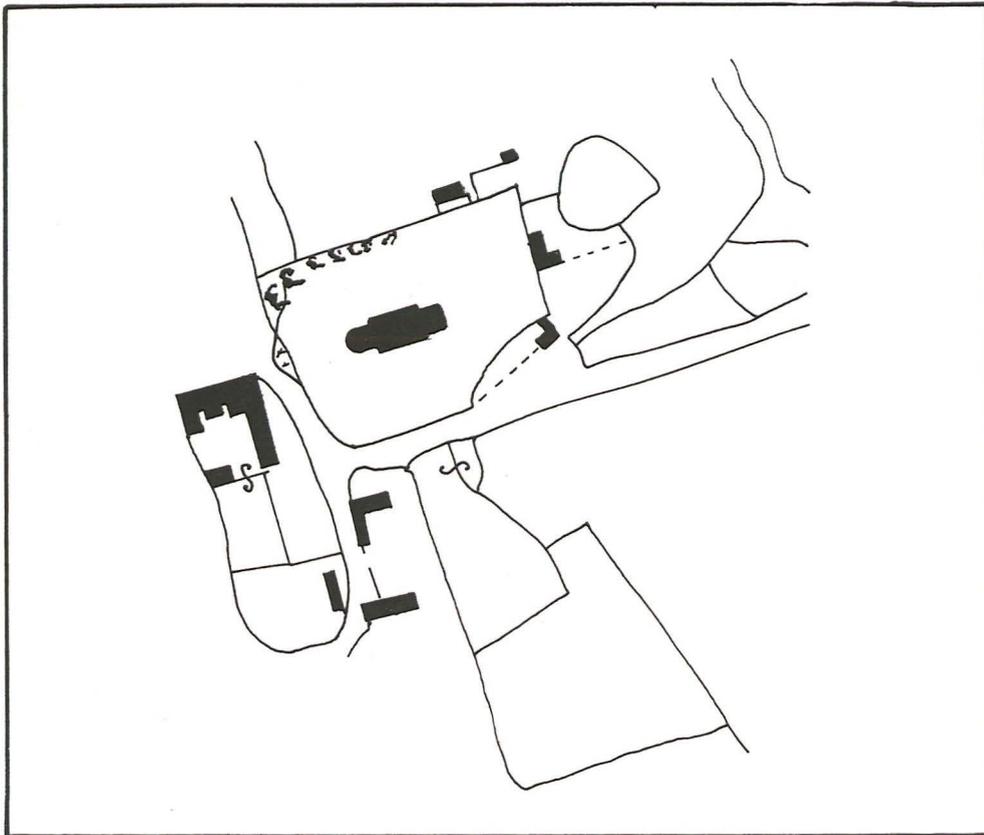
Recent deposits (Phase 3) are represented by the previous church yard wall which was taken down to facilitate the examined repairs and replacement, the present topsoil and tree planting holes. Cartographic evidence suggests that the churchyard wall was in its present form by 1905, with the examined parts perhaps as recorded in 1850 (OS 1905;

Hutchinson 1850 - Figs. 6a and 6b). An iron stay built into the rear of the wall suggests a 19th century date for its construction.

Fig. 6a: Copy of Part of Hutchinson's Map, showing site, with southern boundary different to present alignment (LAO D624)

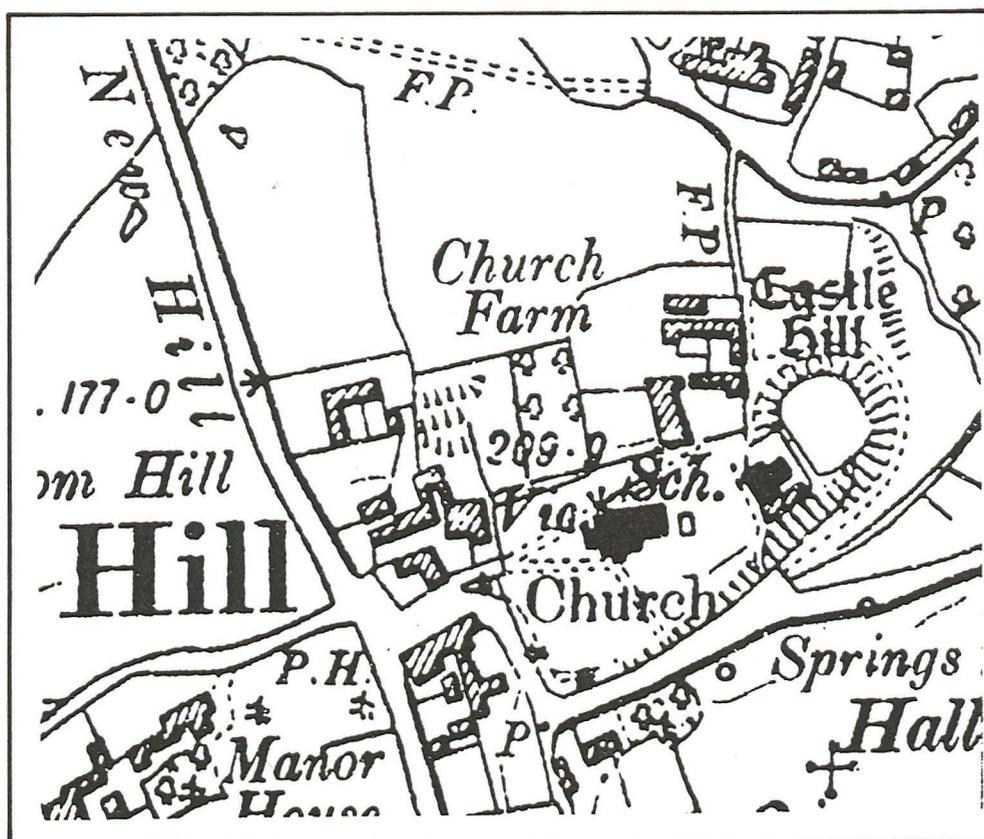
of the graveyard soils could have occurred at any period since the Late Saxon era until 1905, by which time the churchyard boundary had reached its present form.

Fig. 6b: Extract from 1905 OS Map, showing site, with southern boundary same as present alignment

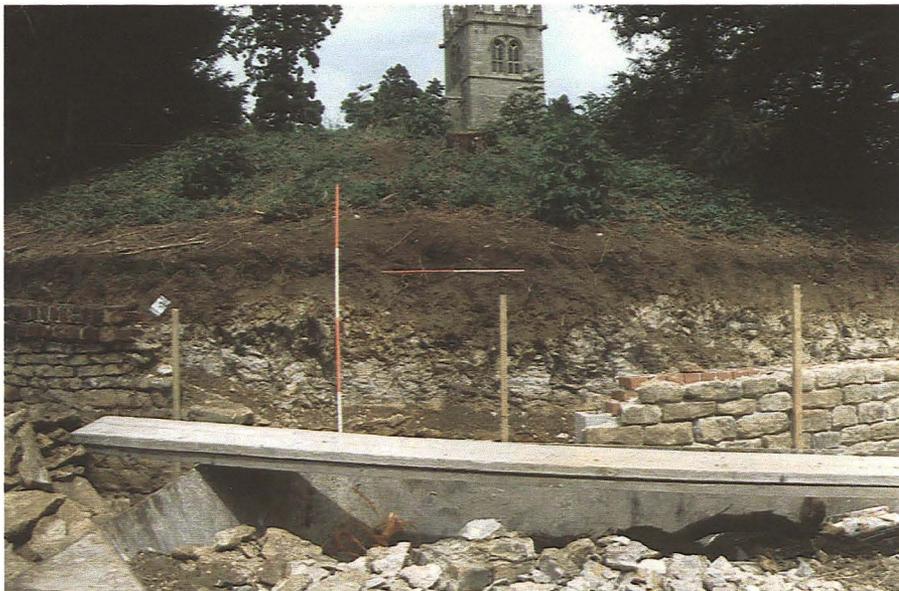
Plate 2 Cut [017], possible gully, looking north

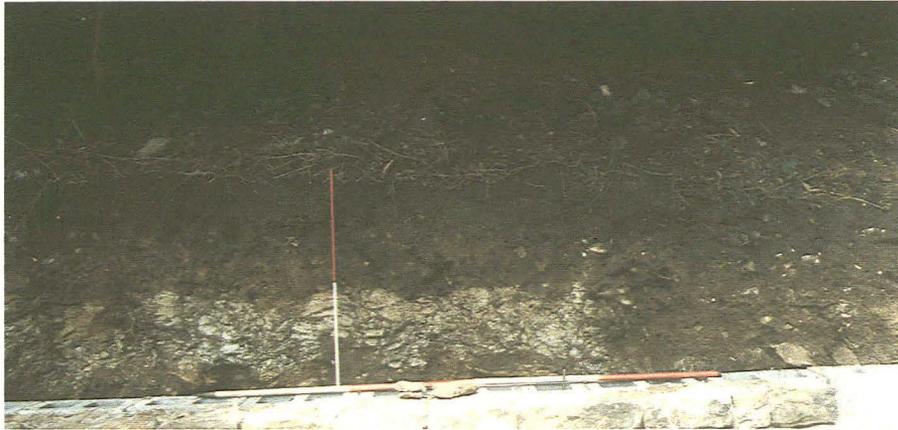
Truncating the east side of the landscaping feature (015), and possibly also cutting the subsoil, was a large feature, over 1.3m deep with a near-vertical side (011; Plates 3 and 4). This may also have been for landscaping or is possibly one side of a ditch. Approximately 3.5m to the east was a steeply sloping cut (043), over 1.1m deep and considered to represent landscaping activities. Although (043) faces cut (011), it is thought that these two features are not directly related. The area defined by the cut features (011) and (043) was filled with pebbly grey-brown and brown-orange silty sand (012 and 013), considered to be dumped materials.

▲ Plate 4 Cut [011] through natural clay (003), looking northeast

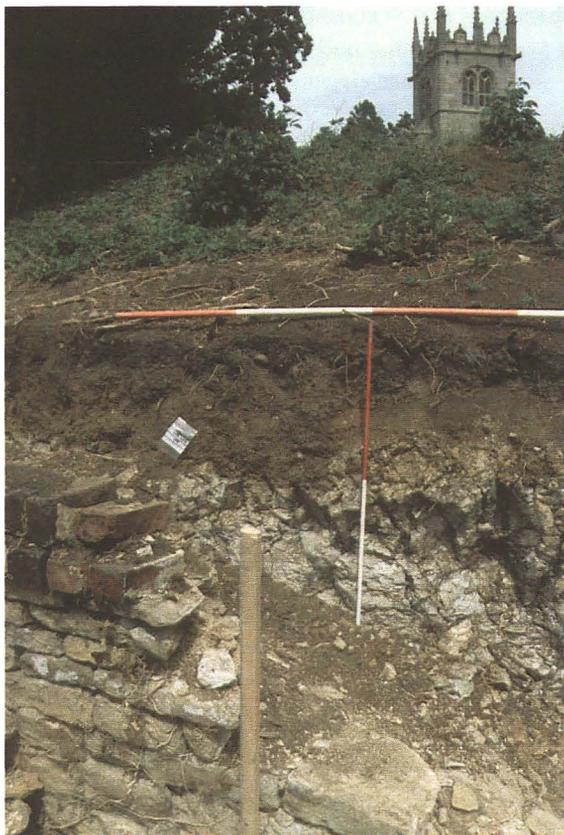
area, the subsoil (002, 035) was cut by a vertical sided, flat-based feature (019). This was approximately 0.5m deep, 1.5m long and was filled with grey-brown silty clayey sand that contained occasional bone fragments (018). The function of this is uncertain though it may be a grave (Plate 5).

Toward the west end of the site, and cutting the subsoil, a possible grave was identified. This was undated but, if the function correctly deduced, between Late Saxon and post-medieval. A probable drainage gully cutting the subsoil was also revealed.

◀ Plate 5 Cut [019], possible grave, looking north

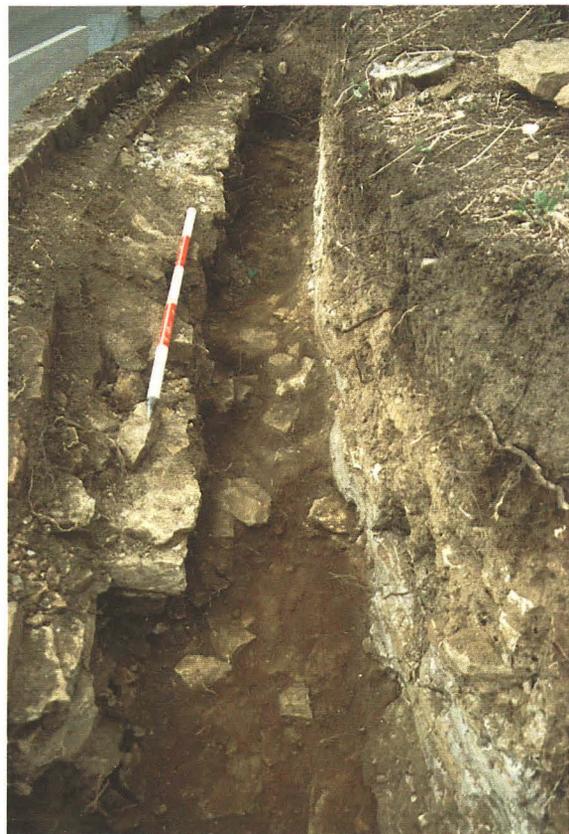
Apparently cutting through the possible grave (019) and gully (037), and also the subsoil layers (002, 035, 029), was a near-vertical foundation trench (040) for the existing churchyard wall (041; Plate 6). The wall was about 1.6m high, 0.7m thick and of coursed limestone rubble, capped with two courses of machine-made brick. The lower c.1m of the wall was in large yellow limestone blocks, the upper and rear parts in smaller grey limestone slabs. Toward the eastern end of the investigation area an iron stay was recorded protruding from the rear of the wall.

Plate 6 Churchyard wall (041), ►
prior to rebuilding

- 4.1 The existing retaining wall along the churchyard southern boundary is constructed in brick with a stone facing. It is suffering slippage and, in places, is being overturned by the retained ground behind it, a potential hazard to pedestrian and vehicular traffic.
- 4.2 Repairs will be carried out on a 45m length of the wall on the southern boundary extending west from the fence of concrete posts and metal tubular railings to a point just beyond the south-west corner where the wall height steps up. The existing wall height, along the stretch to be replaced, varies from *c.* 1.3-1.6m. A site visit is recommended before submission of your tender.
