St Bartholomew's Church, Welby, Lincs.

Archaeological Watching Brief

LAS Report No. 518

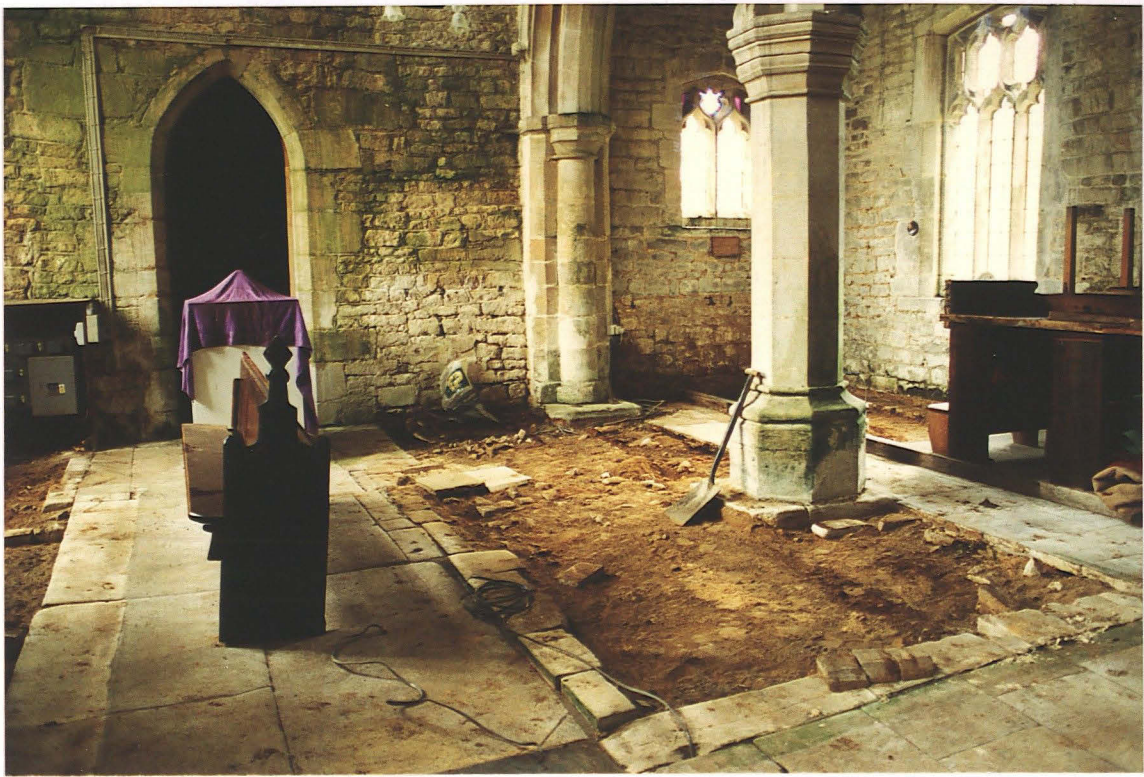
The pew platform in the north aisle had been constructed on a wooden frame resting on top of the flagstone floor (**10**). Beneath the platform the flagstones had been removed over an area 1.45m wide and 3.14m long to create a cavity 0.12 - 0.15m deep (Pl. 4). The pew platform rested on wooden sleeper beams, one placed parallel to the north wall, resting on a ledge of remaining flagstones 0.25m wide, and one along the south side of the cavity, again resting on the flagstones. These supported cross joists which were covered with 145mm wide pine boards.

A vertical post, circular in cross-section, was exposed towards the eastern side of the southern edge of this area. The post had been inserted into a rectangular posthole cut through the underlying soil. The post protruded above the floor level and was probably associated with the construction of the pew platform (Pl. 4).

Pl. 4 Area 1 after removal of upper fill with, looking west. (Scales 1m and 0.5m)

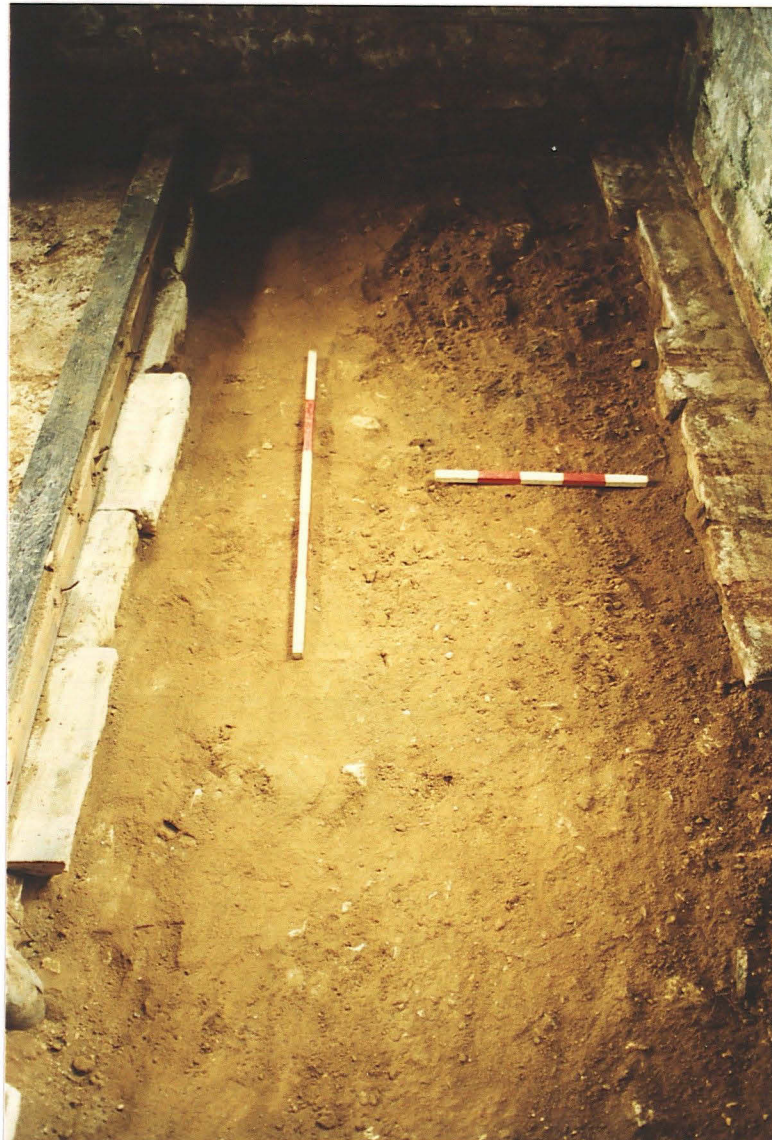
The extent cleared of pew platforms was 2.55m x 5.75m. As in Area 1, the stone flags had been removed before the platform was installed. The 0.2m thick pier bases were square, constructed with more than one rectangular stone block and stood very slightly proud of the flagged floor surface; they had escaped damage from the pew structure (Pl. 5).

Pl. 5 Area 2 Area 2, general view looking west after cleaning to reveal mortar floor 1. (Scale 1m)

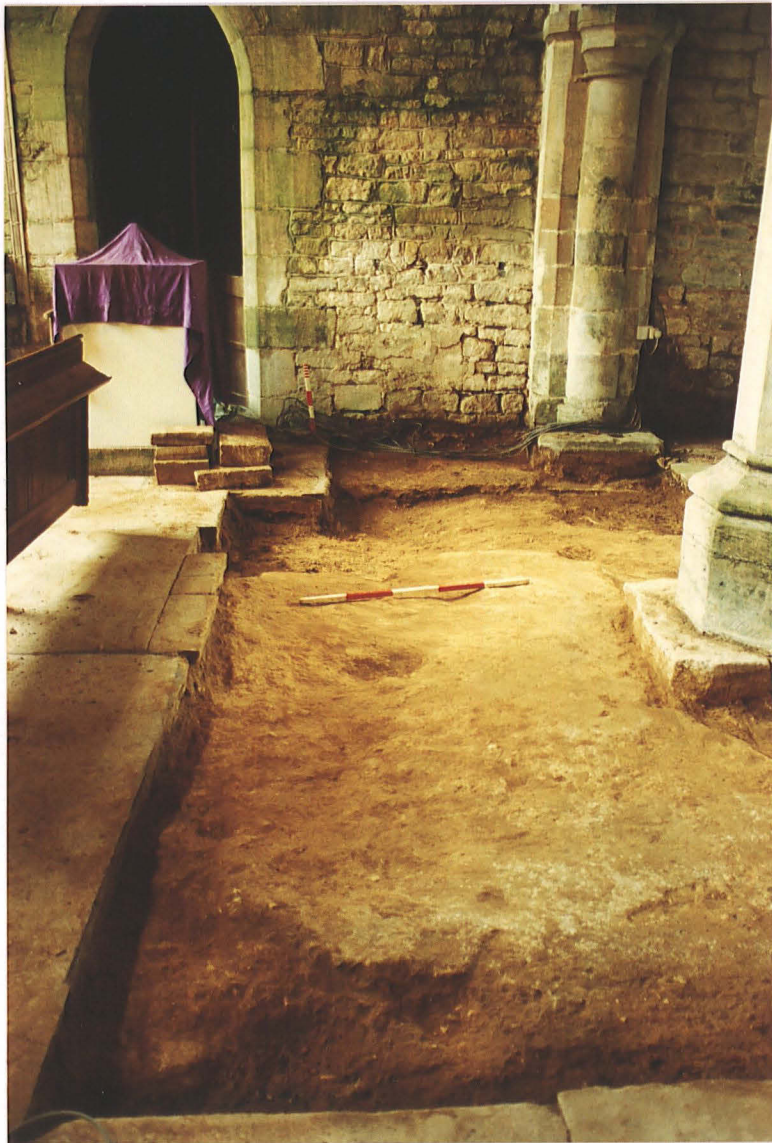
Pl. 6 Area 2 east end showing depression 17 after removal of fill. (Looking north, scales 1m and 0.5m)

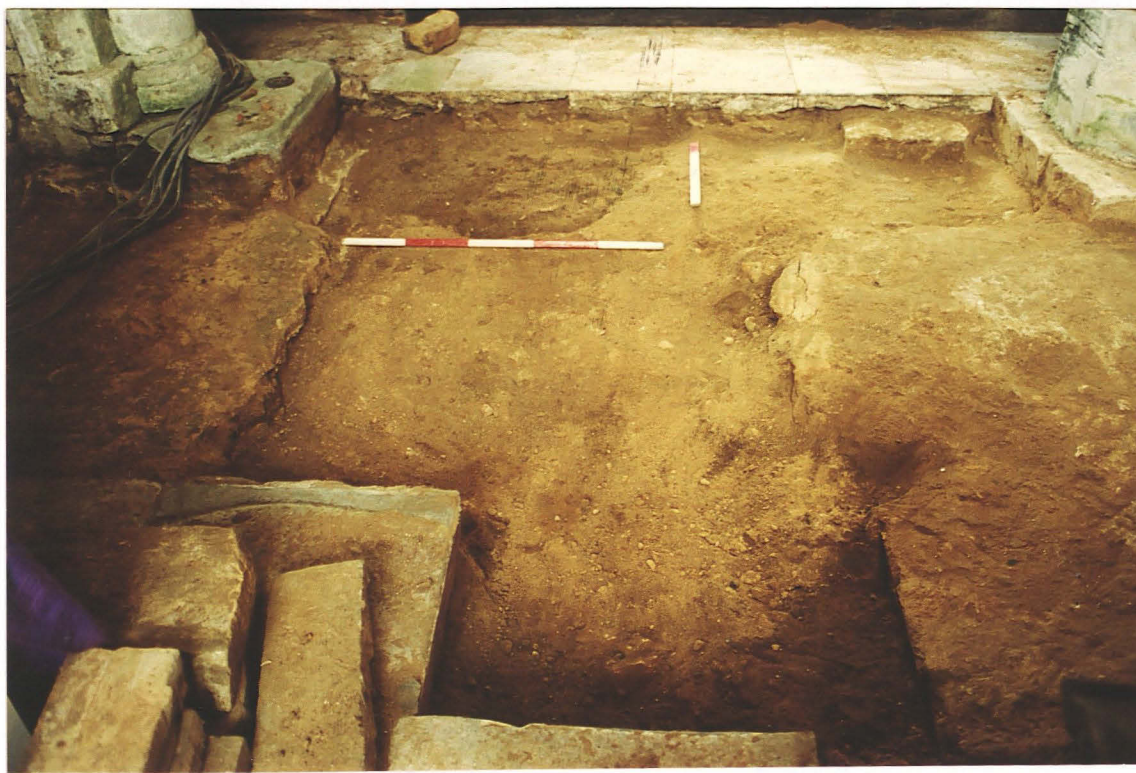
At the west end of Area 2 was an area of disturbance (**22**) approximately 1.50m x 1.50m (maximum) (Pl. 7). It contained a very loose fill (**6**) of soil mixed with mortar derived from floor surface 1. At its eastern edge were two stones (**14**) protruding from beneath the mortar floor. This material was only removed to a depth of 0.23m below the flagstone floor and there appeared to be a considerable depth of fill remaining. This is an odd shape and may represent more than one grave intercutting one another and whose fills were so similar that they were indistinguishable.

There was an area of intact mortar floor west of **22** on the south side of the respond, confirming it to be later than the construction of the aisle (Pl. 7). However, a rectangular area (**19**) at least 1.05m x 0.74m in size had been dug away on the east side of the respond, and cutting the backfilled disturbance **22**. The fill of **19** was a loose brown soil containing pieces of limestone (**4**), partially overlain by a levelling deposit of crushed mortar (**5**), which also extended over the fill **6**. This was probably a grave dug through the floor surface (Pl. 8).

Pl. 7 Area 2 west end showing disturbance 22 in foreground with mortar floor 1 to left and right. Grave 19 is to rear defined by the scales, (1m and 0.5m) Looking north.

The mortar floor surface was left intact, even where it survived above the bedding level for the new floor. The extensive disturbance 22 was lowered to enable more suitable bedding for the new quarry tile floor to be laid, but there was only limited excavation of other features which cut through the mortar floor. Disturbance to archaeological horizons was thus kept to a minimum.

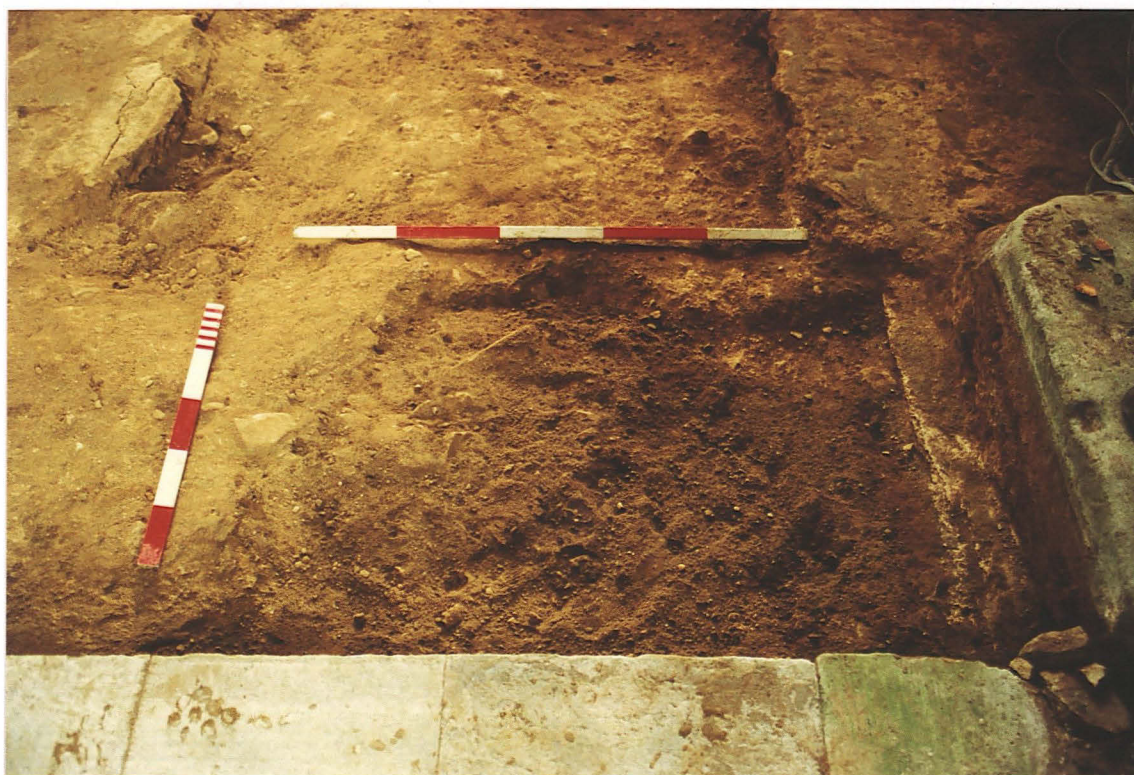
Pl. 8 Area 2. Grave cut 19, looking south. (Scales 1m and 0.5m)

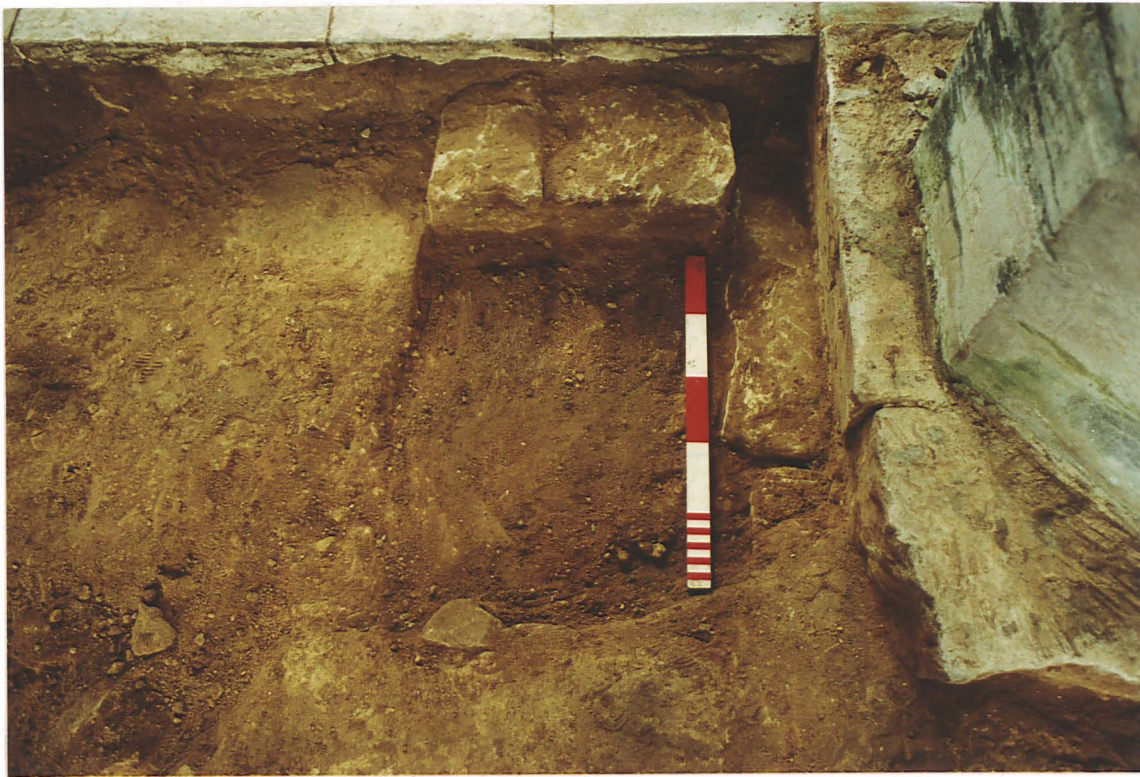
Both the west and east sides of the aisle pier had been disturbed more recently, possibly to investigate conditions beneath the pews. Hole **20**, 0.82m x 0.56m in size, on the west side of the pier cut through the mortar deposit **5** and removal of its fill (**3**) revealed the pier foundations (**7**) at a depth of 0.17m below the existing flagstone floor surface (Pl. 9). There were also two limestone

blocks (12) on the northern edge of the hole, possibly positioned to support the pew platform in an area of soft ground.

Pl. 9 Area 2. Disturbed area 20, west of aisle pier, looking north showing pier foundation to right of scale and two limestone blocks, possibly supports for the pew platform. (Scale 0.5m)

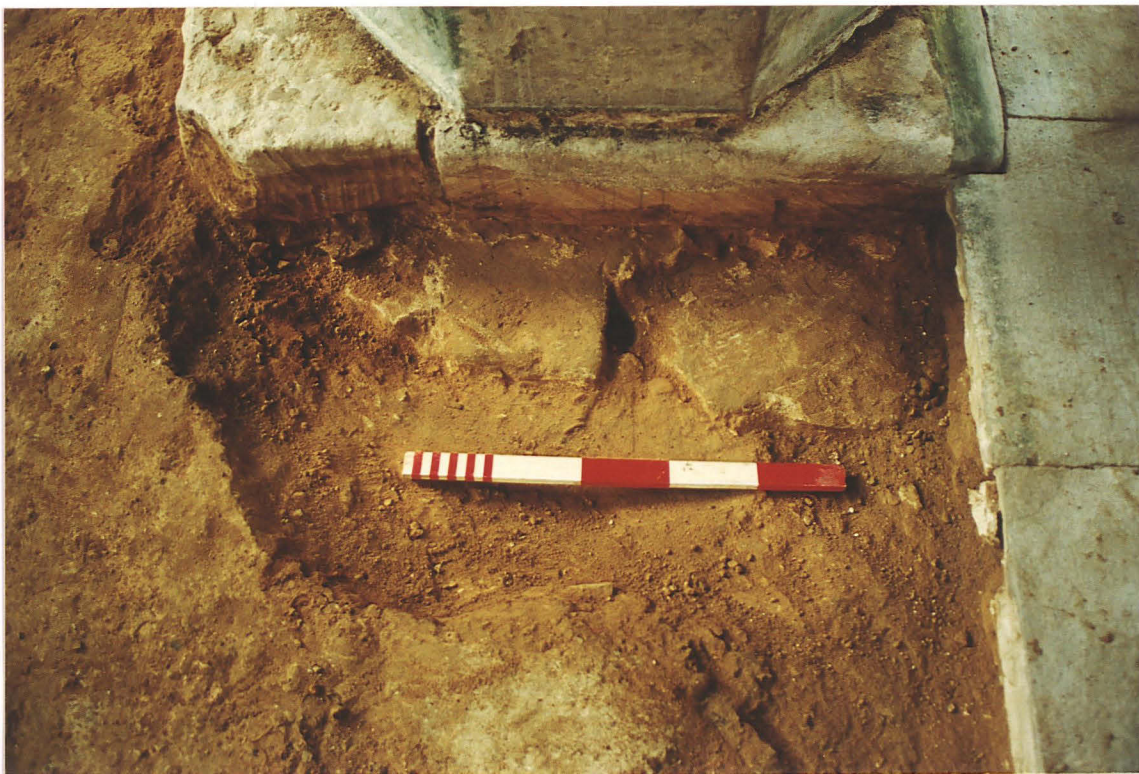
Hole 21, 0.88m x 0.5m, was dug against the east side of the pier and contained a fill of crushed chalk and plaster (2), again derived from floor surface 1. When removed the pier foundations (8) were revealed 0.20m below the flagstone floor level (Pl. 10).

Pl. 10 Area 2 Disturbed area 21, east of aisle pier, looking west showing pier foundation above scale (Scale 0.5m)

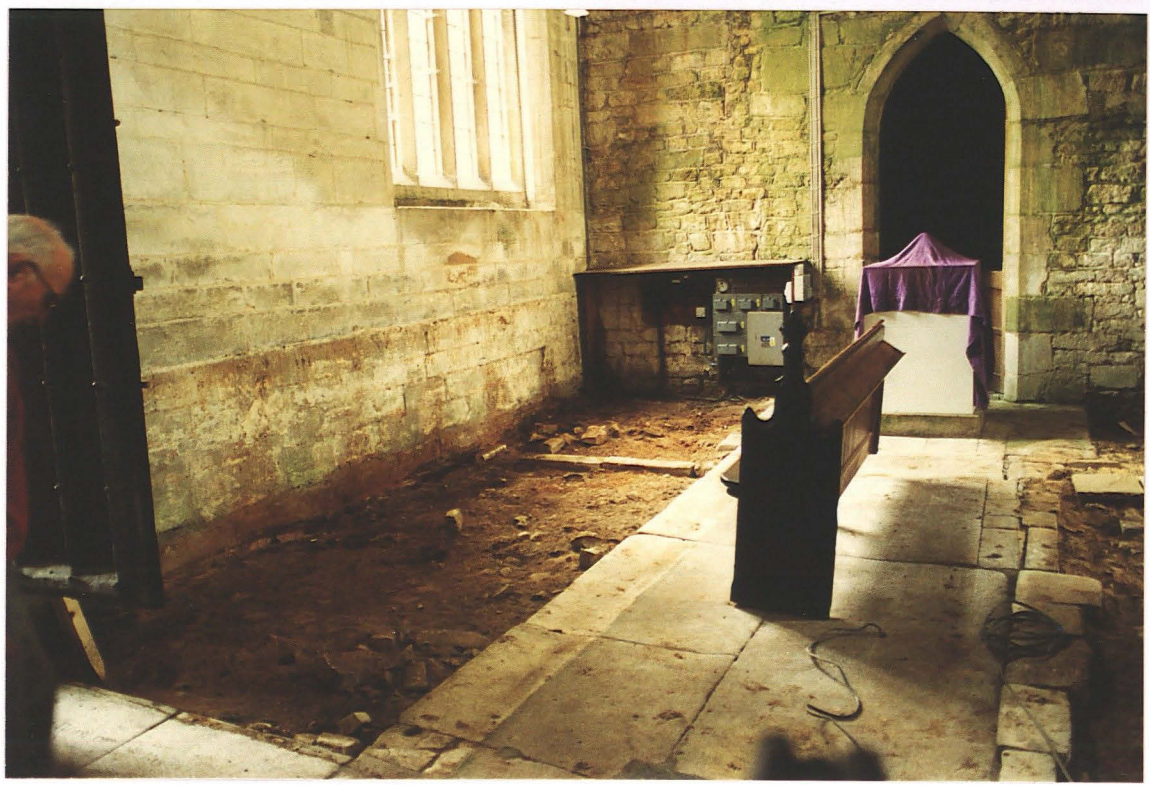
Removal of the platform across the 1.9m x 6.07m area revealed a deposit of soil, limestone fragments and rotten timber, up to 0.2m deep (Pl. 11). This material (24) was the bedding layer for the flagstone floor and contained several fragments of 17-19th century pottery and a single rim fragment from a medieval jug, probably 13th century in date. As in Area 2, it covered an uneven lime mortar floor surface 1 (Pl. 12). The highest point of the surface was in the SW corner, dropping away to the north and east with the lowest point being in the NE corner, close to the church entrance. The floor surface had been slightly disturbed in the SW corner by the insertion of electric cables. Disturbance of the surface along the northern edge may represent the edge of a grave (15) below the flagstones alongside the pews, or have been related to installation of the pew platform.

Pl. 11 Area 3 general view after removal of pew platform and before cleaning looking west

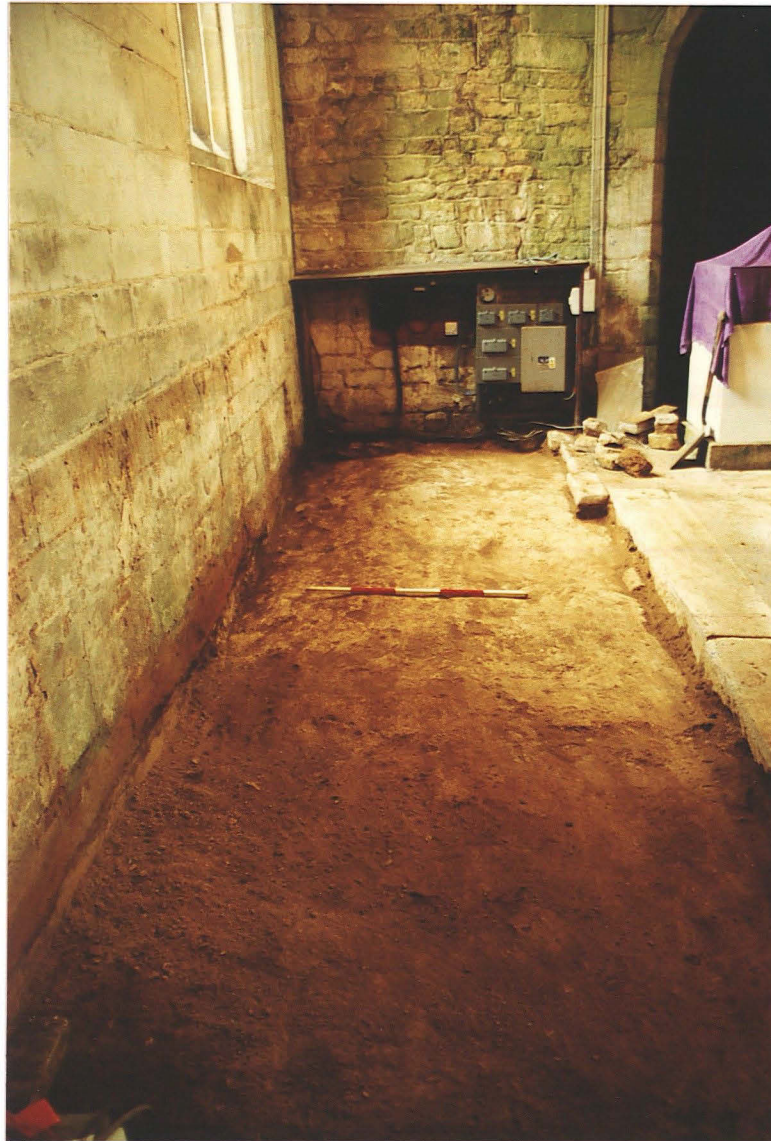
Pl. 12 Area 3 general view after cleaning looking west showing extent of mortar floor 1 (Scale 1m)
