Hatton to Silk Willoughby Proposed Gas Pipeline

ARCHAEOLOGICAL
FIELDWALKING
FIELD RECONNAISSANCE
AND
GEOPHYSICAL SURVEY

RUSKINGTON
AND
KIRKBY LA THORPE

**Report No. 150
May 2000**

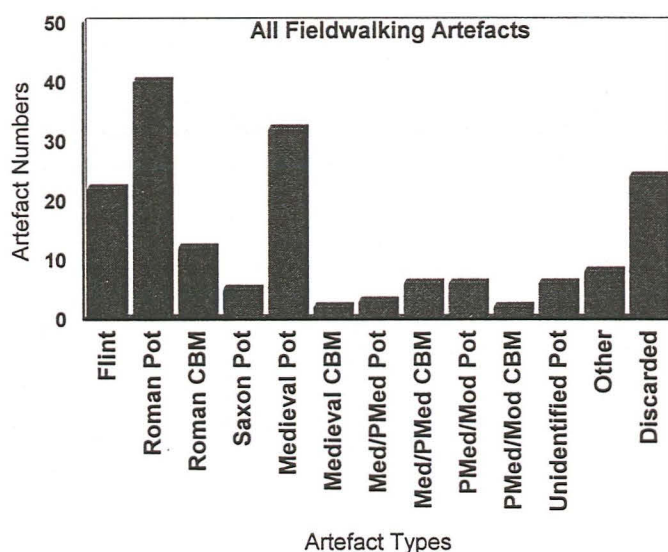
Figure 4: Fieldwalked Artefacts, Section 2

- 7.1.4 One multi-period (Late Neolithic-Bronze Age/Roman/Saxon/Medieval), one Roman and one Medieval artefact scatter have been identified. These lie in fields 22/2 (Site 2), 23/1 (Site 5) and 24/5 (Site 11) respectively. These will be discussed below under their individual site numbers.
- 7.1.5 Occasional finds of mainly Roman and medieval pottery sherds occur throughout and are probably the result of past manuring practices and/or poor ground visibility.
- 7.1.6 A concentration of Post-Medieval pantile fragments was noted in field 24/7 (Site 12) but no sample was collected.
