**RESULTS OF AN ARCHAEOLOGICAL WATCHING BRIEF:
SHEPEAU STOW COUNTY PRIMARY SCHOOL, SHEPEAU STOW, CROWLAND
LINCOLNSHIRE**

PLANNING APPLICATION REFERENCE: H02/0818/02

Site Code: **SSPS 04**

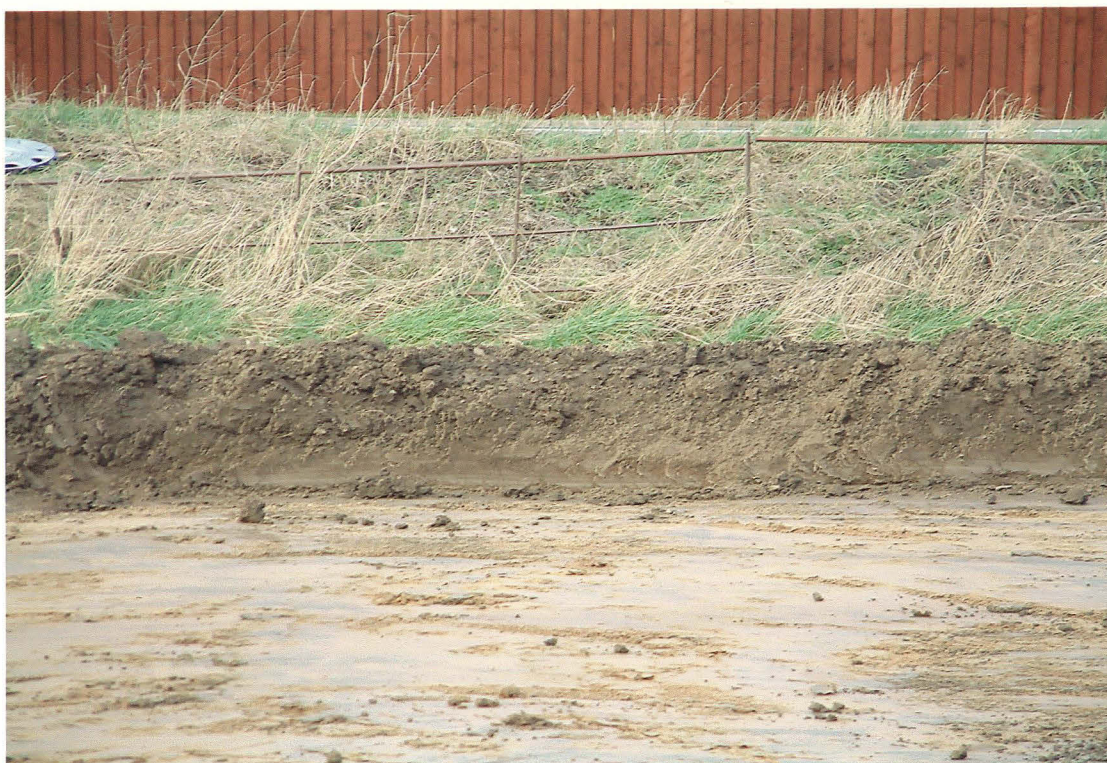
Plate 3. Showing depth of soil removal and shallow channels.

6.2 The earliest deposit exposed was the natural underlying geology, comprising a yellow orange sandy clay silt (102). The watching brief revealed the presence of a system of possible channels running across the north-eastern part of the site (Plate 2 & 3). These were amorphous in plan and on excavation were found to be no more than 0.08m in depth. The fill of these features was of topsoil and it may be that they represent natural depressions in the underlying deposits. No dating material was recovered from these features other than a single piece of blue and white glazed pottery of modern date.

Examination of the channels revealed a depth of 0.08m. These are considered to be natural in origin and may have been caused by flooding of the dykes through undulations in the silts. They contained no material of an archaeological nature although a small piece of modern blue and white glazed pottery was found. The earliest deposit recorded was a yellow orange sandy clay silt which was considered to be natural geology.

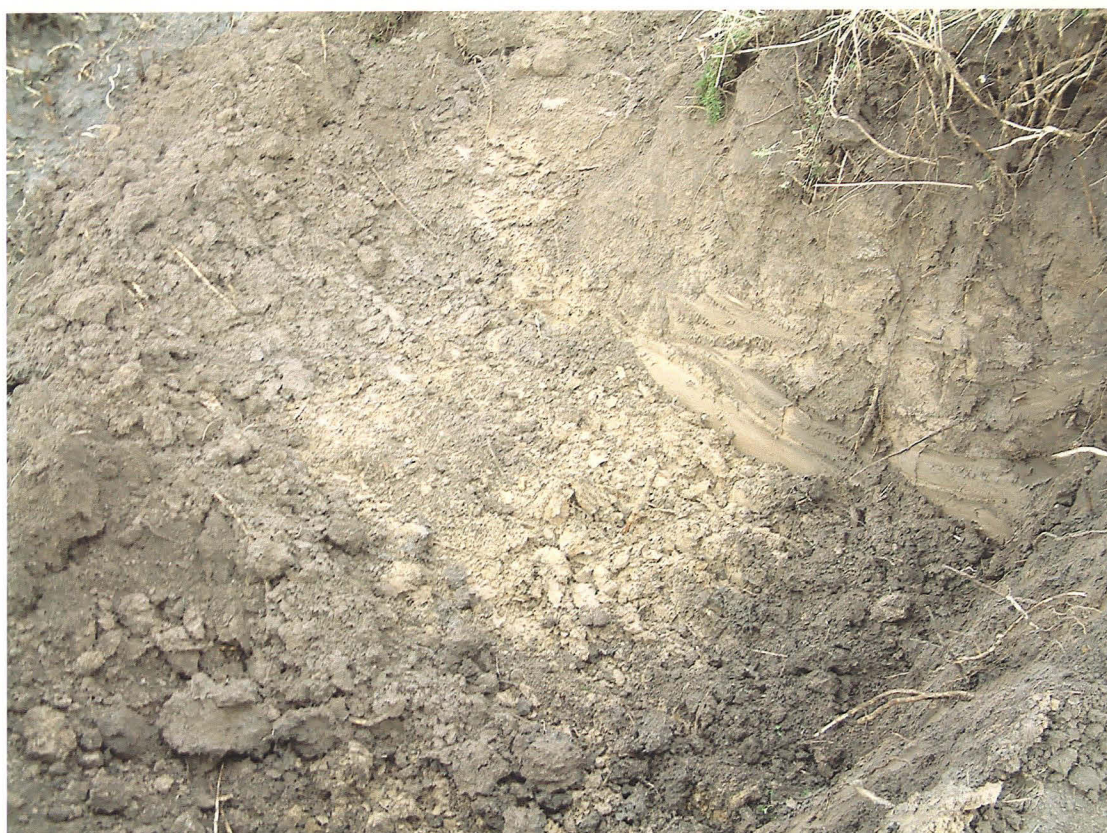
Plate 4. Showing depth of dyke removed for new entrance to car park.

6.5 A trench was excavated through the field dyke for an entrance into the new car park (Plate 4). This trench was excavated to a depth of 2.6m through the sandy silt. An old oil container of plastic was found at a depth of 0.6m and was probably buried during recent clearing of the dykes.
