**Helpringham Fen  
Lincolnshire**

**An Archaeological Watching Brief Report**

**Anglian Water Services Ltd.**

**Site Code: HLF94**

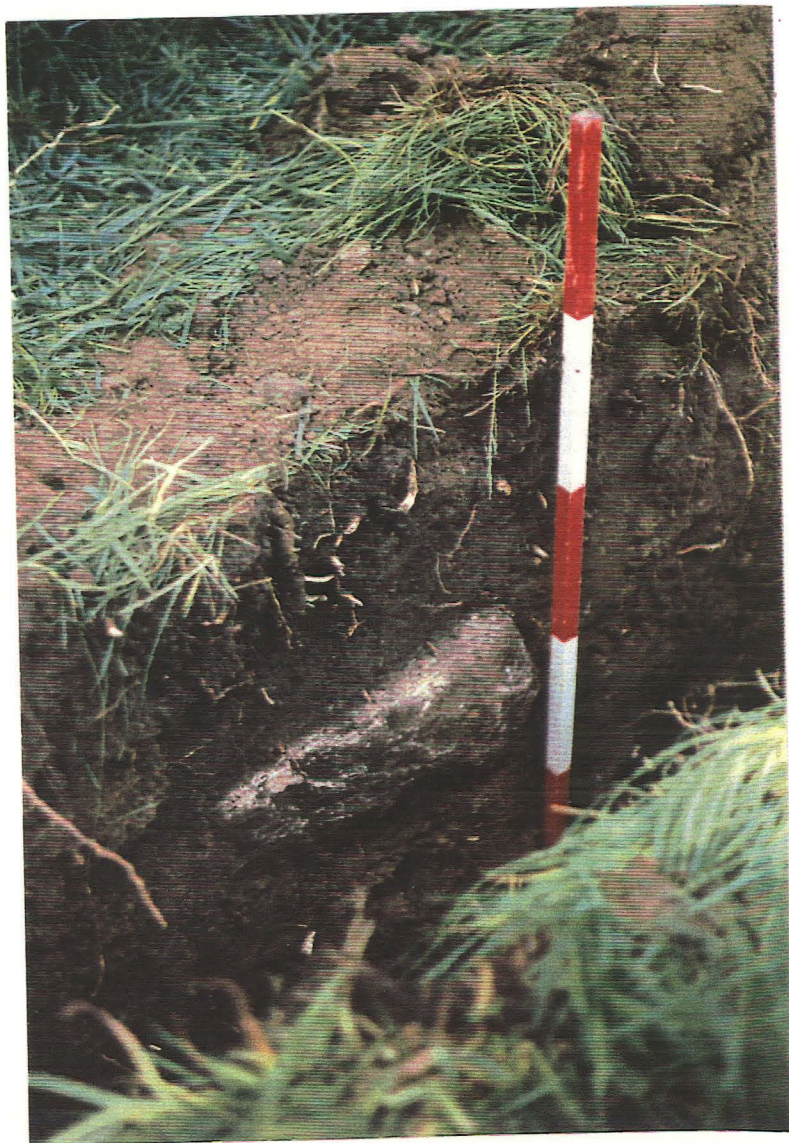
Plate 2. Large Limestone Block *in situ* TF1397 3955

occupation took place here, and secondly, in support of the aerial photographic information, Romano-British finds have been made randomly, together with an Iron Age coin (the nearest Iron Age coin to the Lincolnshire fens). There is some importance attached to these finds but, as yet, no formal archaeological investigations have taken place in or around Poor Grounds. Unfortunately, nothing was noted of any merit in the relay trench with the exception of two large pieces of limestone lying at a depth of about 25cm below the surface and alongside the water main trench (see Pl. 2). Each stone measured about 65cm x 45cm x 15cm and both were dressed on one side - the tooling marks are quite plain to see. No explanation can be given for these stones nor for their location alongside and clearly later than the original water main. On the other hand the find may be of some significance as stone is a rare commodity in the fens, especially stones as large as these, and bearing the tooling marks of a much earlier age. The find occurred at TF1397 3955.

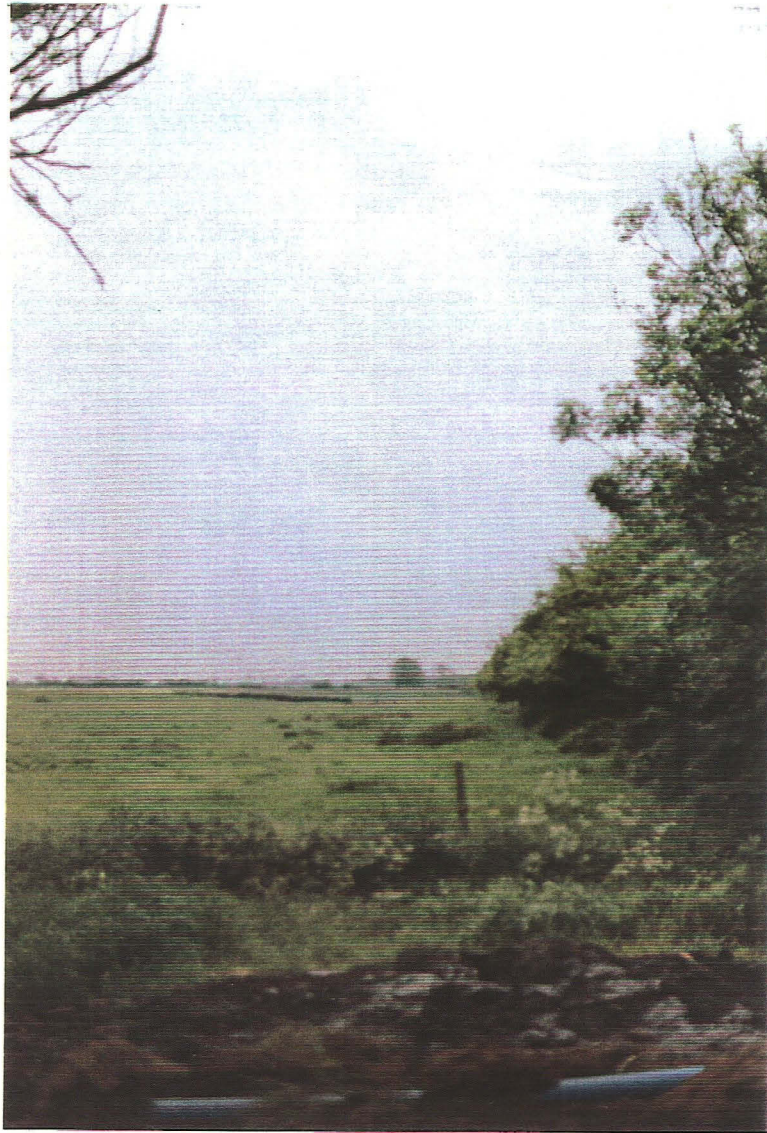
Plate 3. Remains of a Ditch and Bank, Helpringham South Fen

Beyond this point and to the Car Dyke the only finds of any merit were local changes in the subsoil. For example, at about the bridge before H. Barnes' farm is encountered (i.e. to the west of the farm), there can be seen on the road surface, and fields on either side of the road, a trace of a broad, partially filled in ditch together with a slight bank. The bank can be seen as hump in the road surface at TF1462 3931. In association with this feature and at 80cm below the modern surface occurs a heavy clay layer which may or may not have been the upcast from the digging of an earlier ditch running north-south (see Pl.3). Elsewhere it has been argued that the Car Dyke in the length running through Helpringham and Swaton Fens is an afterthought, a re-routing made by the Roman military engineers (Simmons, 1975, 30). It may be that the bank and ditch referred to here are the remnants of a putative and earlier arrangement which was superseded by the re-routing.

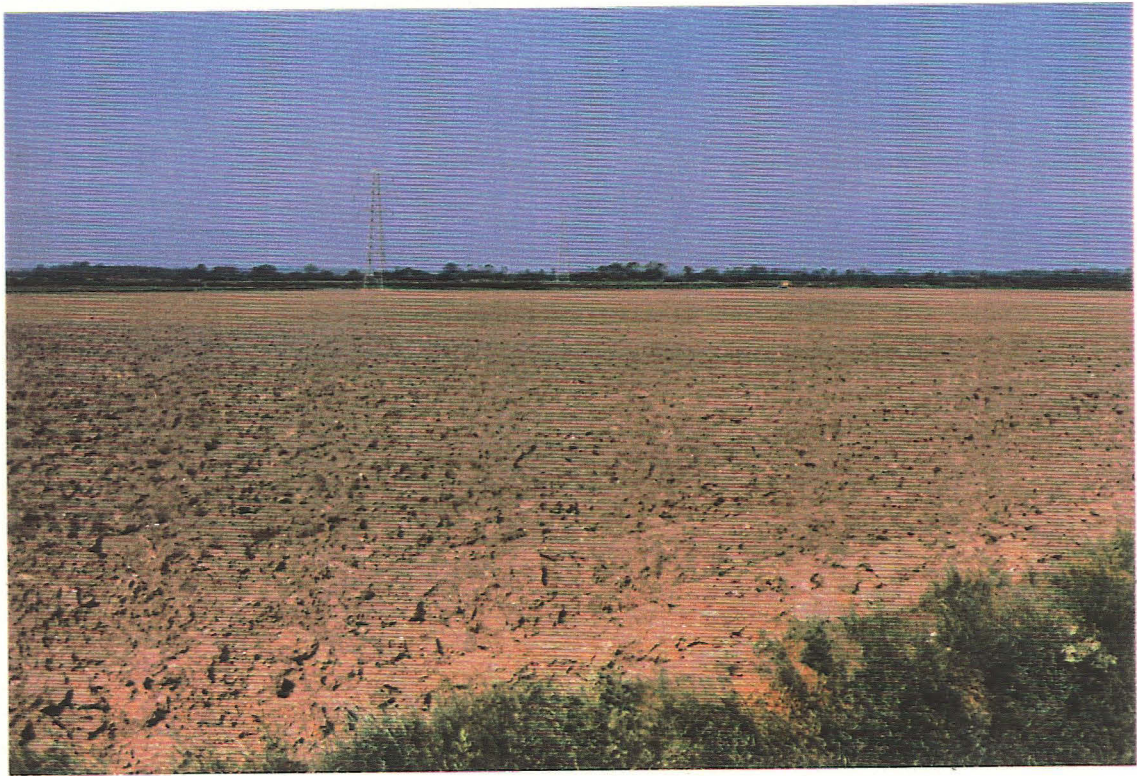
Plate 4. Ancient Creeks Seen As Soil Marks, TF150 392

At about this locality it had been seen elsewhere (Simmons, 1975, op. cit.) that ancient creeks could be observed in the fields on either side of South Drove, Helpringham. These creeks, no doubt tidal in their day, were almost certainly the ones which brought brine to the salterns and which were active during the Iron Age immediately to the east of the line of the Car Dyke and to the south of South Drove. 1994 was a particularly dry summer and once again the patterns of extinct creeks could be discerned in the fields. Plate 4 shows the contrasting dark and light coloured soils indicative of this phenomenon in this part of Helpringham Fen (centred on TF150 392). The existence of long-defunct creeks was also apparent in the stratigraphy revealed in the relay trench. Some 80-100m to the east of the eastern Car Dyke bank the usual soils gave way to gravel subsoil overlying loose clay. After a short distance the gravel and loose clays were cut by two layers of very heavy clays, one brown about 50cm thick and a lower blue one about 10cm thick. Further east along the relay trench, at about 300m from the eastern Car Dyke bank, further changes in the subsoil indicated the possibility of ancient creeks but this time with clays tending towards grey with heavy brown/orange staining occasionally appearing to be silty.
