Fulstow East Capital Scheme Archaeological Desk-Based Assessment

> Lindsey Marsh Drainage Board March 2005

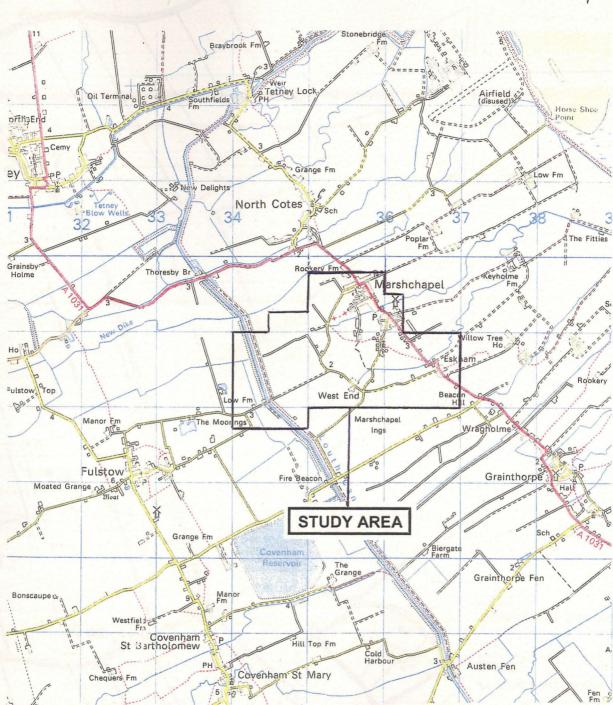
PROJECT	CLIENT			
M	Fulstow East Capital Scheme	Lindsey M	larsh Drain	age Boar	ď
	TITLE	DRAWN, BY	CHKD. BY	APPR. BY	DATE
		KRH	Hen	AB	16-Feb
	Location Plan	SCALE	PROJ. NO.	FIG. NO.	REV
		1:50,000	104L054	1

- 1.2 The site is located to east of Fulstow and the west of Marshchapel (see Figure 1). A study area of approximately 250m around the site was assessed. This was undertaken to gain an understanding of the nature of the surrounding archaeological landscape.

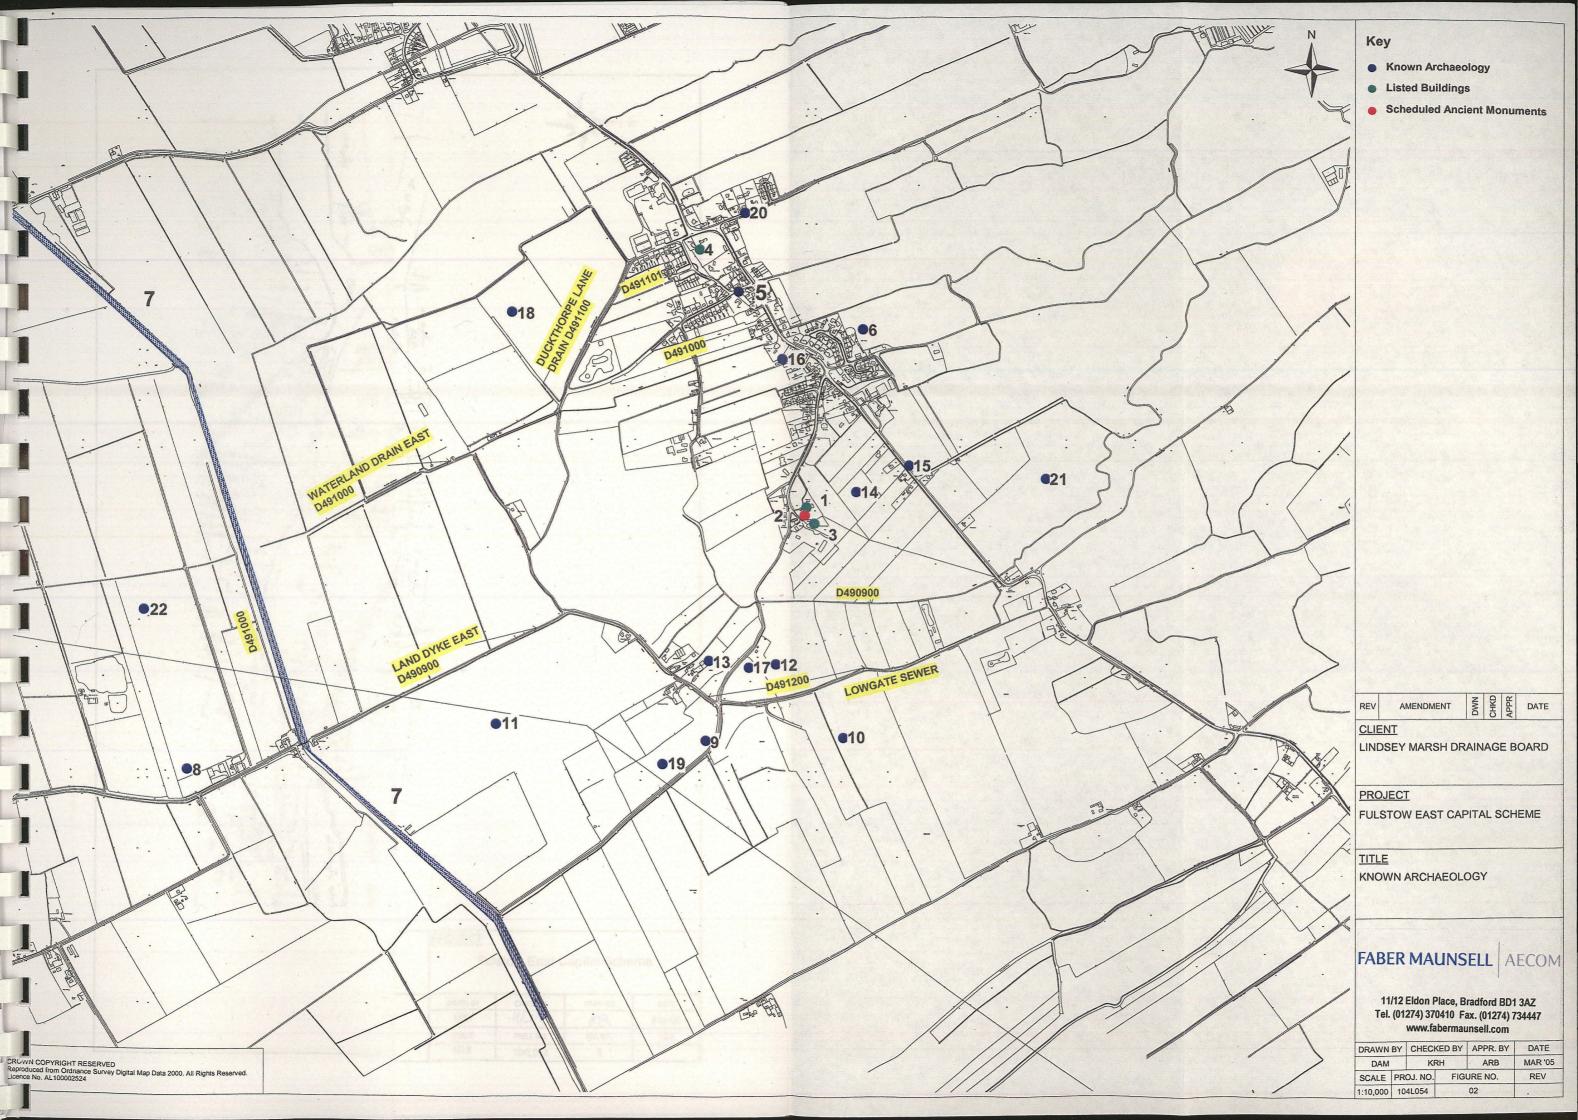
- 1.3 The proposals at this stage comprise the widening of D491100 (Duckthorpe Lane Drain), D491000 (Waterland Drain), 490900 (Land Dyke East), D491101 and D491200 (Lowgate Sewer) by 5 to 10 metres (see Figure 2). Some culverts providing road and field access will be replaced with larger capacity culverts. Regrading of drains will also take place at this time.

- 3.1 The Historic Environment Record holds information for 15 sites, whilst the National Monuments Record Centre holds details of a further 7 sites within the study area (see Appendix A and Figure 2). The numbers used to refer to sites within the text correspond to their number in Appendix A and Figure 2.

- 3.3 There are five Listed Buildings within the study area. The Church of St Mary (No. 1) is a Grade I Listed Building, the remaining four (including the cross) are Grade II Listed. The location of the Listed Buildings can be seen on Figure 2 and in Appendix A.

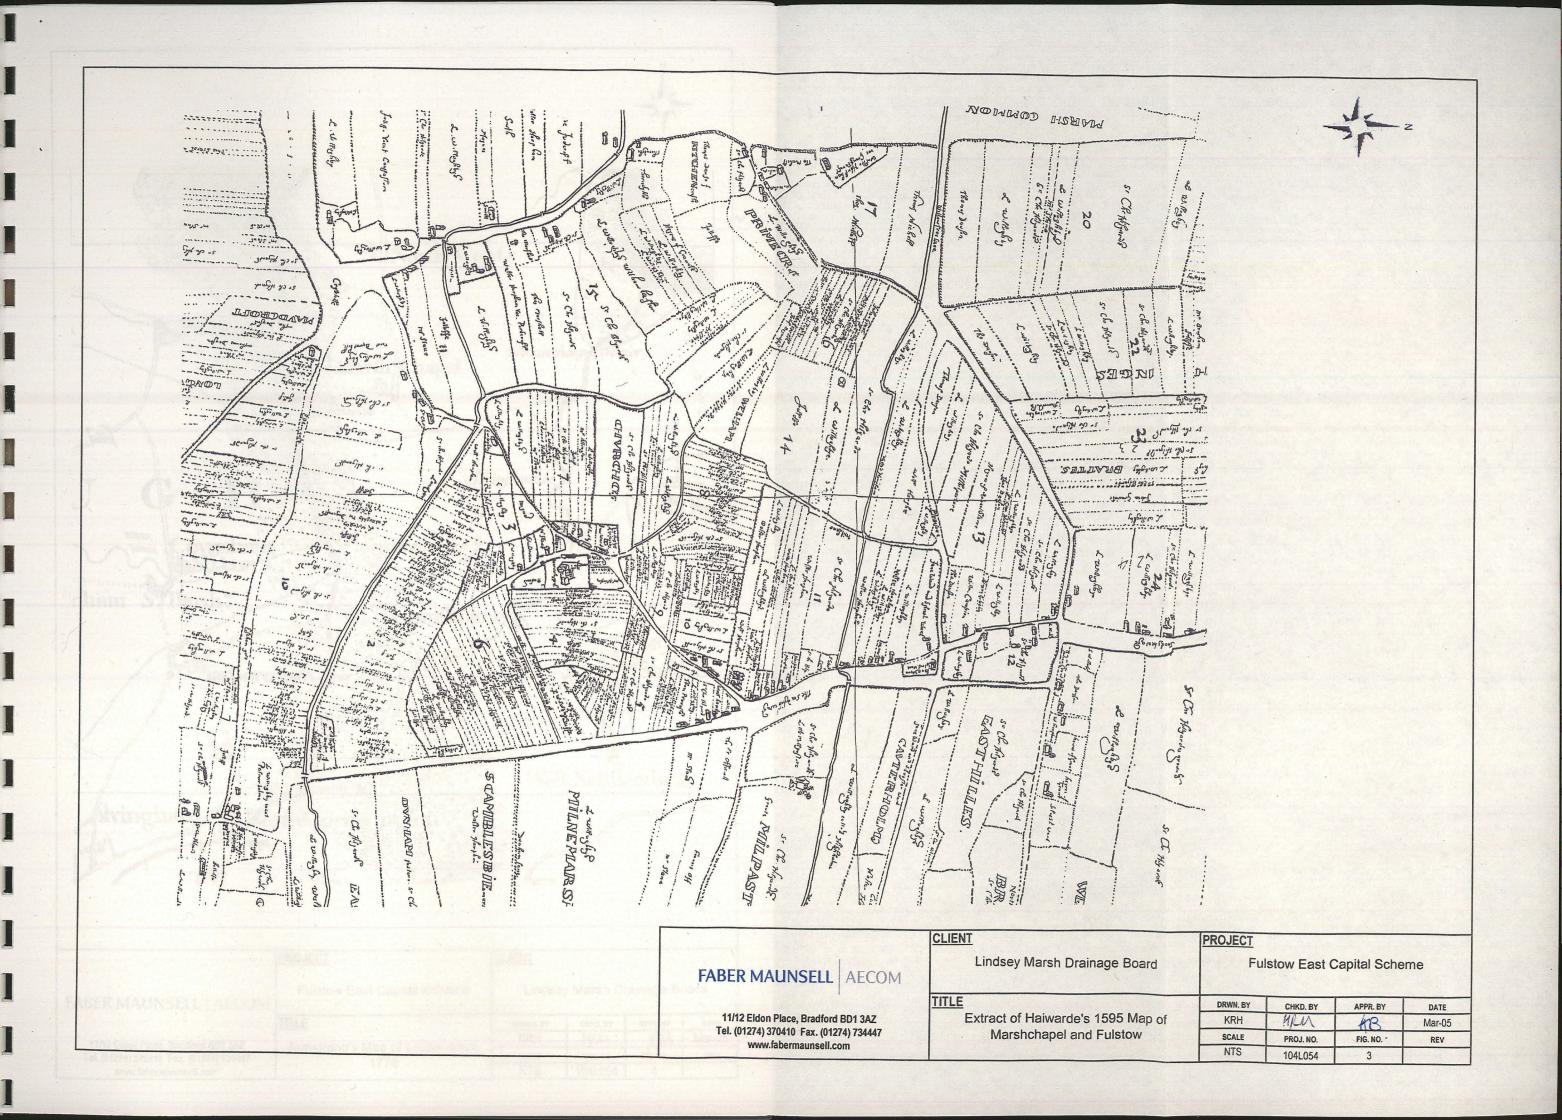
- 3.27 The historic mapping for the study area can be seen in Figures 3 9. The earliest historic map for the study area is a map of Marshchapel and Fulstow drawn by Haiwarde in 1595 (Figure 3). A full size copy of the original map was examined at Lincolnshire Archives, but the copy used to create Figure 3 was taken from a figure in the Lincolnshire Magazine (Walshaw, 1936).

- 3.28 The map demonstrates that much of the layout of Marshchapel has not changed since the late 16th century. The layout of roads and tracks are the same as the modern layout with a number of features such as the church and post mill clearly shown. The main street through Marshchapel is called Seadyke Way on this map a name that has remained to the modern day.

- 3.29 A number of the drains involved in the proposals are visible on this map. Waterland drain (D491000) is called Waterlod Sewer and drain D490900 is called Landike Sewer.

- 3.30 The land to the west of the national grid easting line TF 35 is described as Marsh Common. The land between this line and Fulstow village was predominantly common land.

- 3.37 Many of the sites described in the NMR and HER are visible on the aerial photographs examined. The most prominently visible sites are the medieval and post-medieval field system (No. 14) and enclosures (No. 15) to the south and east of the church. The different orientation of fields and ridge and furrow remains are clearly visible underlying the existing field system. The orientation of these fields is comparable with the field pattern shown in this area on the 1595 Haiwarde map (Figure 3).

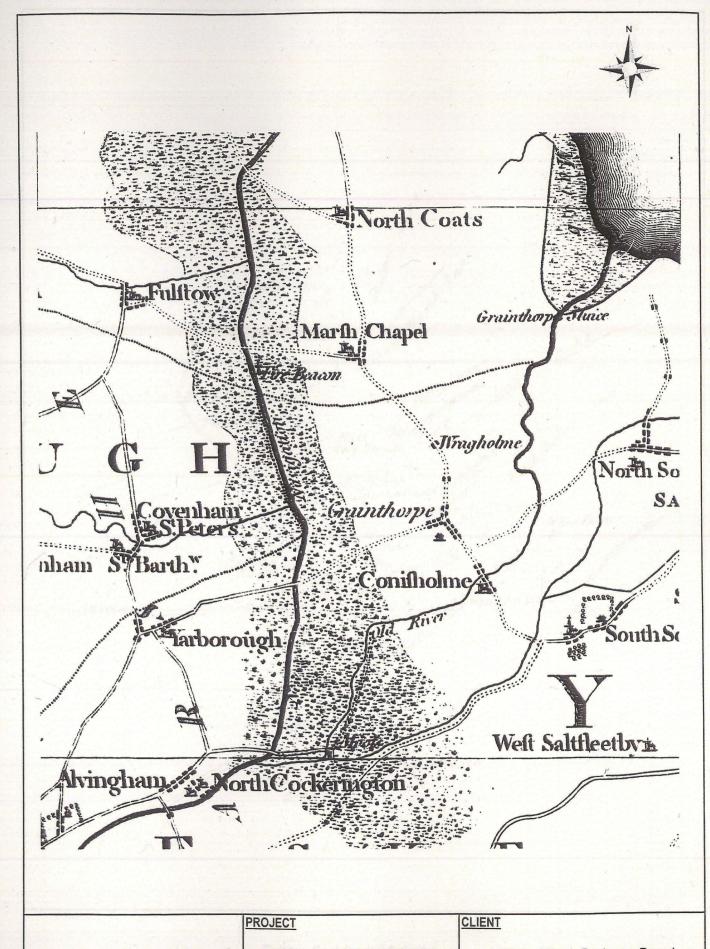
- 3.31 Armstrong's Map of Lincolnshire, 1778 (Figure 4) shows the village of Marshchapel with it's church. The Louth and Tetney Navigation is also visible by this point. Further information is not available due to the scale of the map.

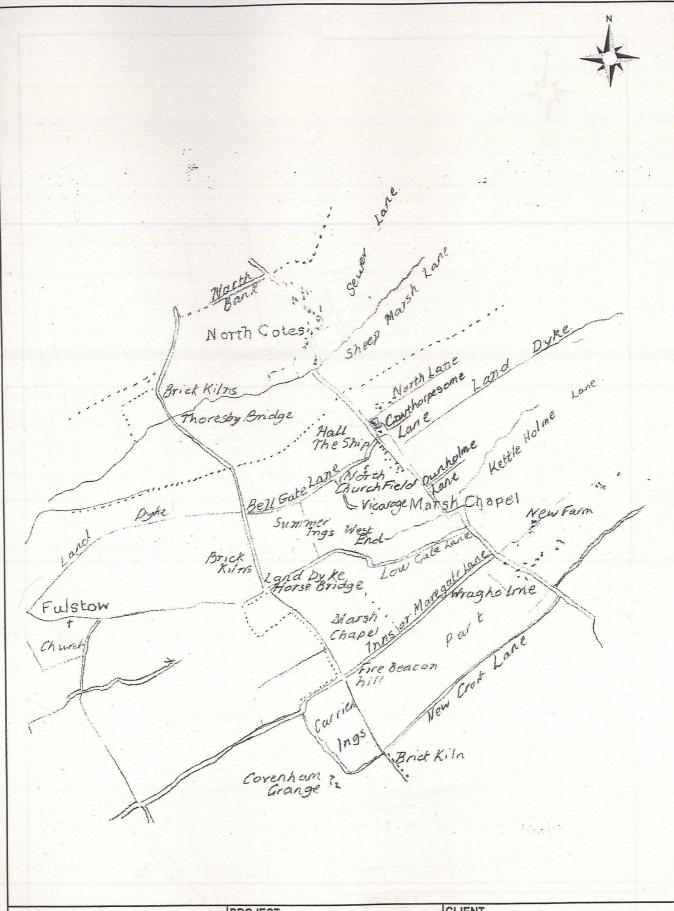
Bryant's Map of Lincolnshire, 1848

- 3.32 Bryant's 1848 Map of Lincolnshire (Figure 5) is not at a suitable scale to discern field patterns and small features. A number of field names are given such as North Church Field and Summer Ings. Brick kilns are shown to west of the Louth Navigation. They will not be affected by the proposals. Low Gate Lane is marked on the map and corresponds with the existing road and Low Gate Sewer (D49120). West End Farm is also marked at this point.
