INSTALLATION OF NEW GAS PIPE, CHURCH OF ST MARY AND ST PETER, HARLAXTON, LINCOLNSHIRE

Archaeological Watching Brief

CHURCH OF ST MARY AND ST PETER HARLAXTON, LINCOLNSHIRE

Site Code: SMPH05
LCCM Accession No.: 2005.184
Faculty No.: 1722
NGR: SK 88130 32320

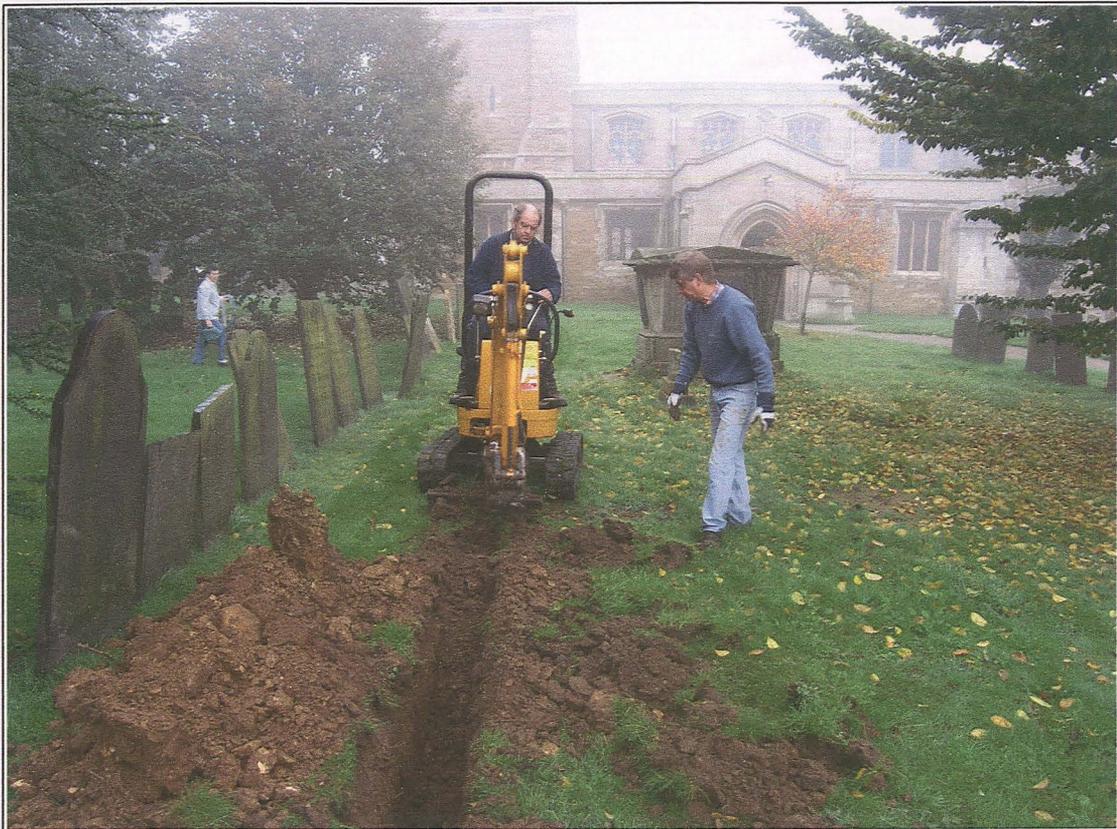
Plate 1 - View showing work in progress – south side of church, looking north.

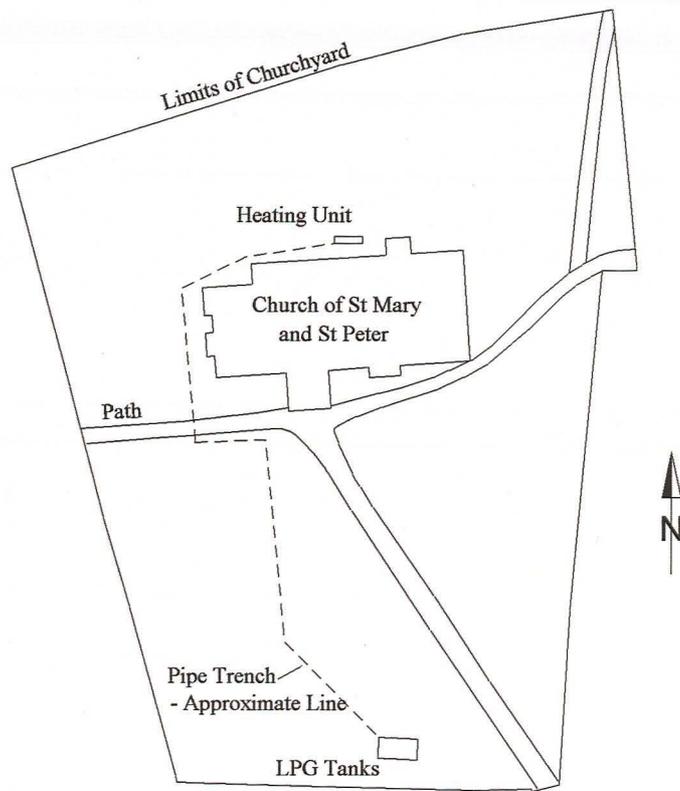
Fig.2 Site Plan - Scale 1: 1000

Deposits revealed in the southeast-northwest part of the trench, nearest to the LPG tanks, were generally loose/friable, dark grey sandy silts, with occasional patches of clayey material occurring at lower levels. Deposits became less uniform in the north-south section leading up to the line of the east-west path. Here, generally mid brown sand/silt deposits were interspersed with more mixed material, including a clay component apparently derived from the underling 'natural'. This may be taken to indicate the presence of backfilled graves. Orange-brown silty clay and ironstone, visible in patches across the trench base, probably represents the undisturbed geology.

Deposits in the area adjacent to the east-west path were noticeably drier (probably due to nearby trees and shrubs), comprising predominantly reddish brown silty sand containing frequent ironstone

fragments. Similar material extended around the church tower, to a point *c.* 2m south of its northwest corner, where stone fragments – irregular in shape and up to 200mm in size – became increasingly frequent. The stone, which occurred in a mid reddish-brown sand sealed beneath a *c.* 200mm depth of grey topsoil, did not appear to relate to a specific structure and may be interpreted as debris originating from a phase of rebuilding. The quantity of stone gradually decreased along the northern side of the church.

The only evidence for *in-situ* inhumation comprised a skull - probably belonging to an adolescent – found to the south of the church, close to the footpath at the northern end of the north-south section of the pipe-trench. The skull, which was displaced and damaged during the works, was recovered and then reburied where found. Disarticulated human bone occurred in small quantities (*c.* 20–30 fragments altogether), becoming more frequent with proximity to the church building.

Based upon plans provided by Mr K Lawry
