RESIDENTIAL DEVELOPMENT AT MANOR FARM, SUDBROOK, LINCOLNSHIRE

Archaeological Watching Brief

Site Code: MFSU06
LCCM Accession No.: 2006.81
Planning Application No.: S02/1067/02
NGR: SK 9702 4471

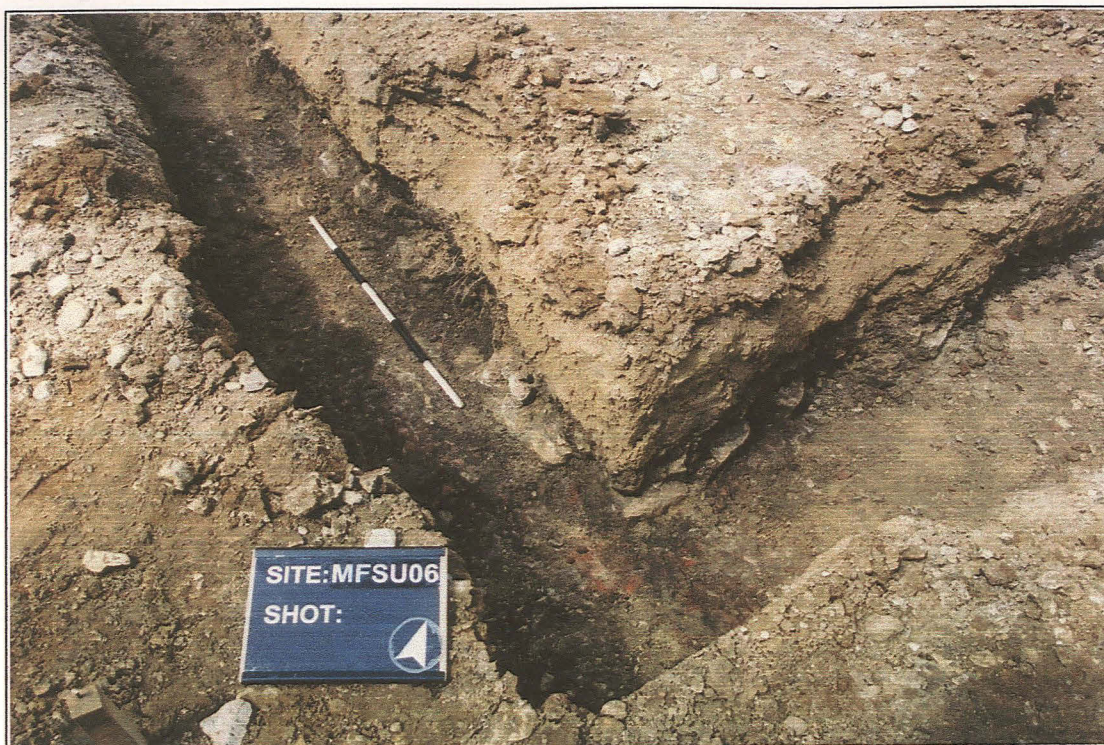
Plate 1 – Probable metallised surface (031), looking north (1m scale)

Within the associated garage plot (Section 4, Fig. 3), greyish brown silty sand, (029), at least 0.15m thick (probably late) formed the primary deposit. It was sealed by a deposit, (028), of loose mortar with frequent limestone inclusions, with a depth of c. 0.40m. The latter was in turn sealed by a band of concrete 50mm thick and crushed stone to a depth of 0.20m. Investigation at the southern corner of the garage revealed two phases of metalling at the base of the trench, the lower, (031), consisting of limestone fragments laid flat, the upper, (031), consisting of highly compacted cobbles. Fragments of tile from directly above (031) have been dated as late 18th to 20th century.

Excavations within Plots 5, 6, 7, 8 and 9 produced evidence of a metalled surface extending across much of the eastern part of the site; it is thought likely that this probably relates to use as a farmyard. Tile from immediately above the surface indicates a date of late 18th century or later. The only evidence of structures fronting on to Main Street consisted of an east-west west brick wall found in Plot 7. It is likely that this was comparatively recent in date. The probable wall found on the northern side of the development probably represents the remains of an earlier boundary wall.

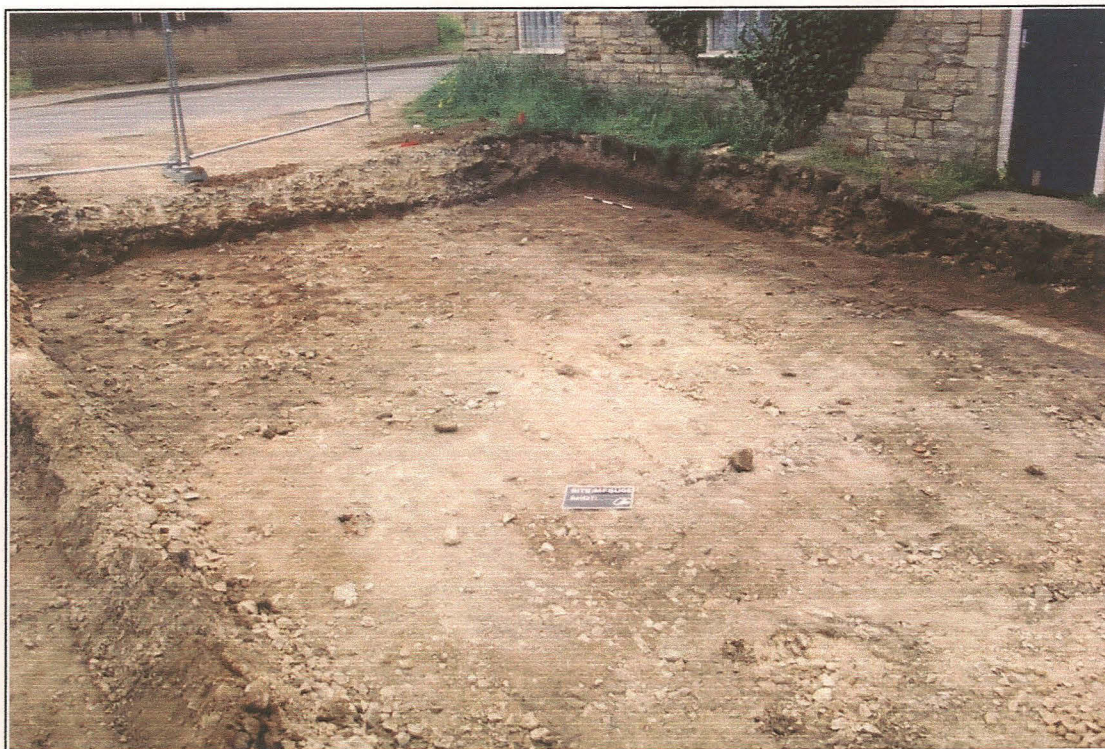
Plate 2 – View showing Section 5 and wall foundation (047) in Plot 9, looking southeast (1m scale)

Over the southern part of the area (Plots 7 & 8) more extensive excavations were required for the formation of raft foundations. This area was investigated in some detail for potential remains associated with the street frontage. The west facing side of the trench, recorded as Section 5, revealed natural sand, (049), at its lowest levels. This appears to have been cut by two linear features, [042] and [043], probably ditches, each c. 1.6m or more wide. The features were only partially removed by excavation, but appeared to extend approximately east – west in plan, running in parallel with one another to the point where they disappeared beneath later deposits. Silty sand, (041), extended throughout the upper, visible extents of both features and over adjacent deposits. It was sealed by a metallised surface, (040), composed of rounded pebbles and around 0.1m deep. The surface appeared to respect an east west aligned brick wall or wall foundation (036) at the southern end of the section. The wall, which survived to a height of two courses, was associated with a probable construction cut to the south, [038], and fill (037), while another fragment of brick-built masonry, (047), seen in plan, would appear to represent a continuation to the west. Metallised surface (040) was cut to the north, by a recent feature, [034], of uncertain origin. A topsoil-like deposit, (035), sealing the southern extent of the metallised surface and abutting wall [036] may have built up against the exterior of the wall. It was overlain by stone and mortar rubble (032) forming the modern surface.

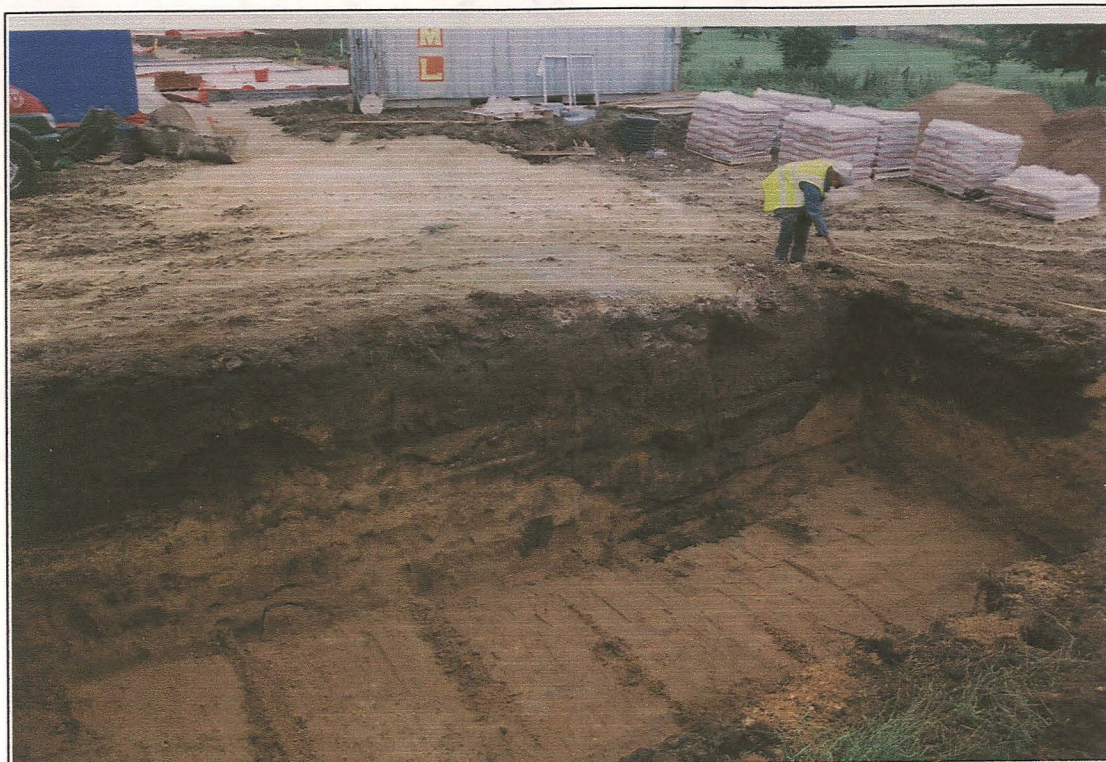
Plate 3 – Section 6 and ditch [055], looking southeast

Excavation of the sewage treatment plant revealed a broad linear cut, [055], aligned approximately southeast - northwest. Health and safety considerations prevented access to the trench for detailed recording, but trench-side observations indicated a probable recut, [053], along its northern edge. There was also ill-defined evidence of recutting (see drawing) along the southern edge of the feature, which was not dated.

The large ditch [055], and later recut [053], found during excavations for the sewage treatment plant at the western end of the development were undated but could represent an element in post-medieval or earlier land division. Another ditch, [057], found further to north, in the water-pipe trench east of the access road, aligned at right angles to [055] and could represent a related element in the landscape. The possible ditch located near the turn in the access road was on a different alignment and could belong to a different (probably later) phase of activity. Two possible ditches, running parallel with one another – [042] and [043] - were located in the area immediately west of Main Street.

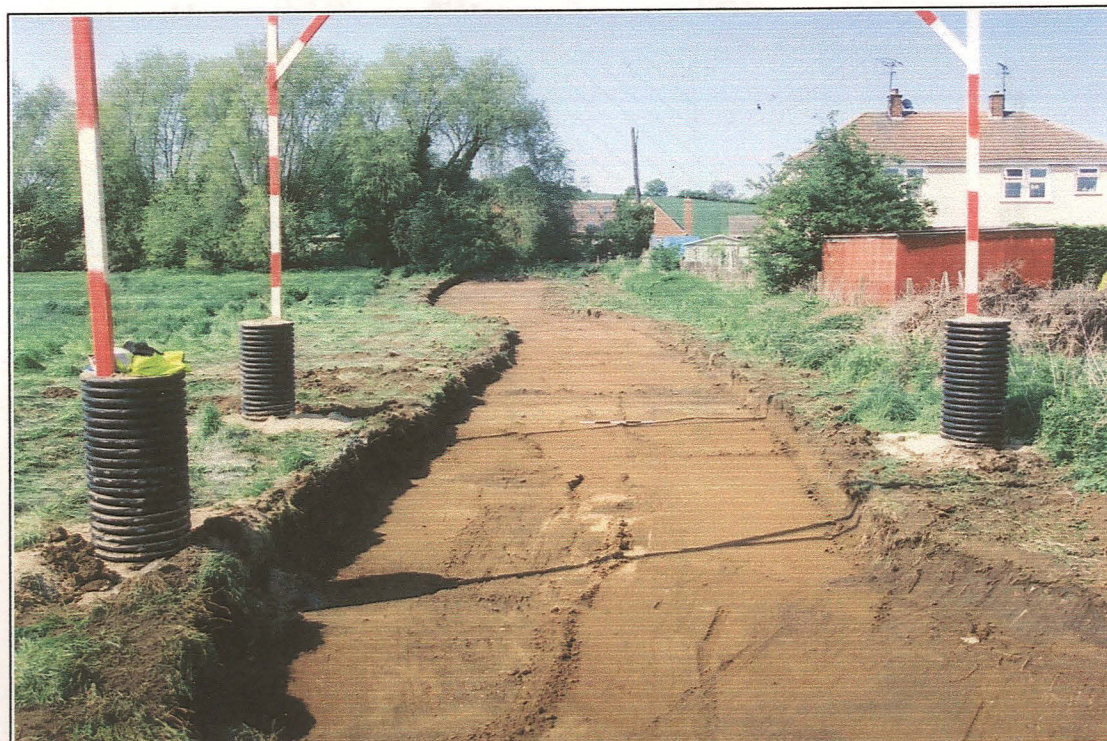
Plate 4 – North - south access road, with topsoil removed (1m scale)

Inspection of the stripped surface across the north-south extent of the access road revealed a band of sandy clay, (011), interpreted as the top fill of a probable ditch. The feature may be regarded as post-medieval or modern in date since it was cut into a subsoil deposit, (010), interpreted as probable relict plough-soil associated with medieval and/or post-medieval arable cultivation.
