**No.5, South Rise, Binbrook,
Market Rasen, Lincolnshire**

Archaeological Watching Brief

Nicola Smith Archaeological Services

Report No. 102

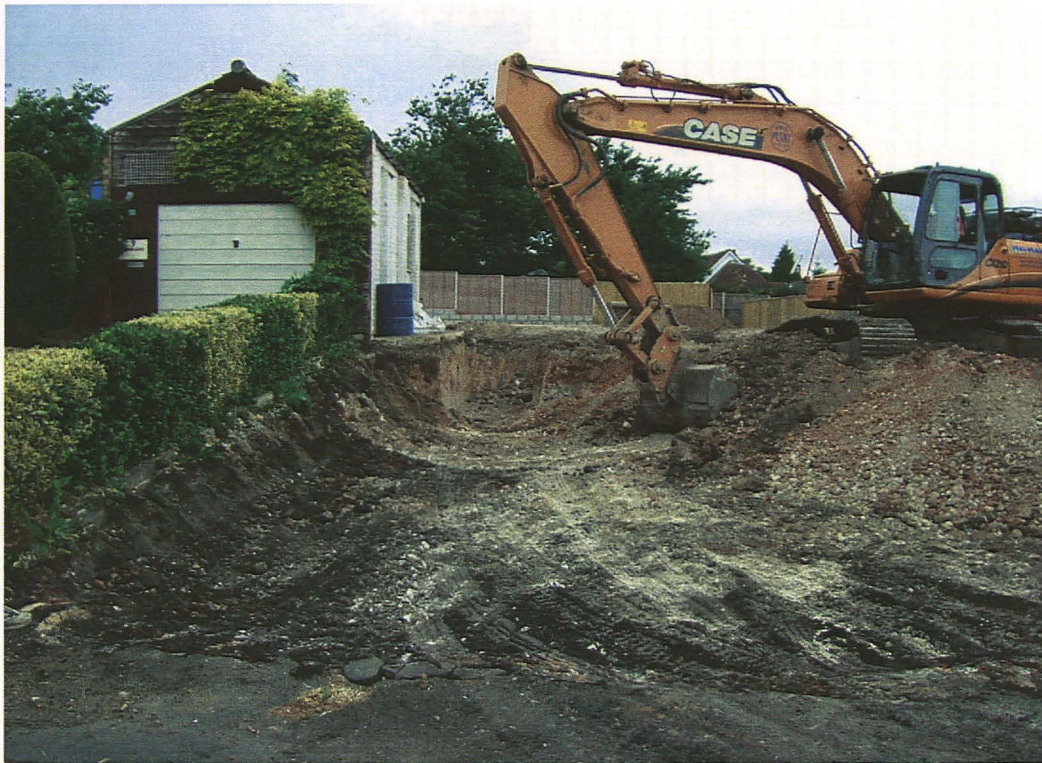
Plate 7: Entrance driveway to plot no.5 following machine excavation and removal of tarmac and underlying rubble hardcore; looking north.

- 2.21 The tarmacked area at the southern (front) end of plot no.5 sloped upwards from South Rise road until it met the concreted floor surface and brick foundations of the former warehouse building, which lay 13 metres north of the road. To the west, the tarmac was bounded by a hedge which separated the driveway from plot no.3. To the east, the tarmac was partially bounded by a low concrete wall which supported a raised area (Figure 10; Plates 1 & 2).
- 2.22 Following the excavation and removal of the tarmac (an area measuring approximately 13 x 7.5 metres), the material lying immediately below was seen to be disturbed; it comprised hardcore / loose rubble (primarily concrete, modern brick and roof tile). No finds, features or deposits of archaeological significance were encountered during the excavation of the tarmac and the area beneath (Plate 7).

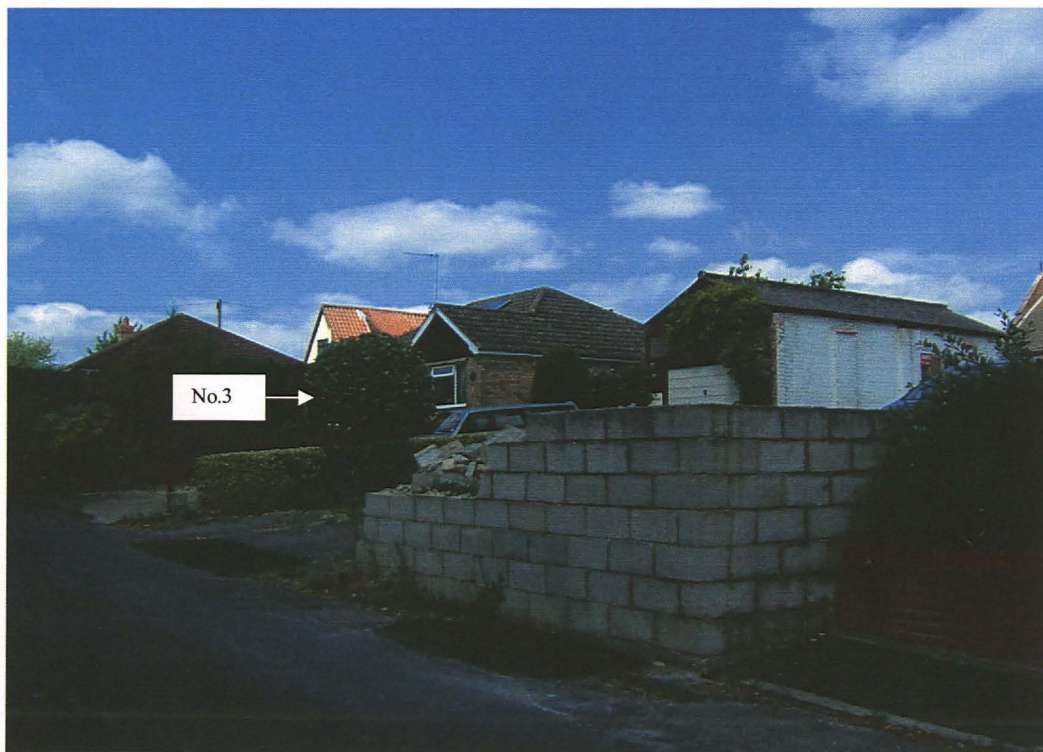
Plate 8: View from South Rise road (looking northwest) of the concrete raised area and remains of supporting breeze block walling. (The bungalow and garage building belonging to no.3, South Rise, lie in the background).

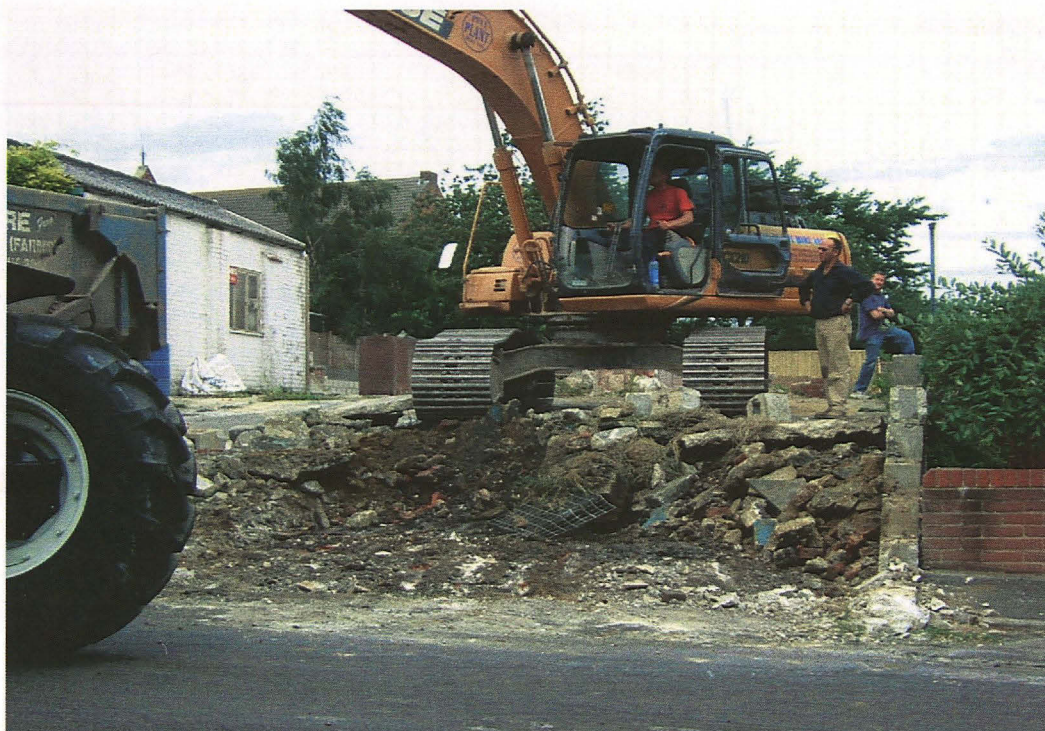
Plate 9: Levelling of raised concrete area during ground works; looking north.

- 2.32 During levelling, the raised area was found to be built up almost entirely of post-medieval and modern hardcore (largely brick, tile and fragments of concrete. No finds, features or deposits of archaeological significance were encountered during its excavation (Plates 9 - 10).

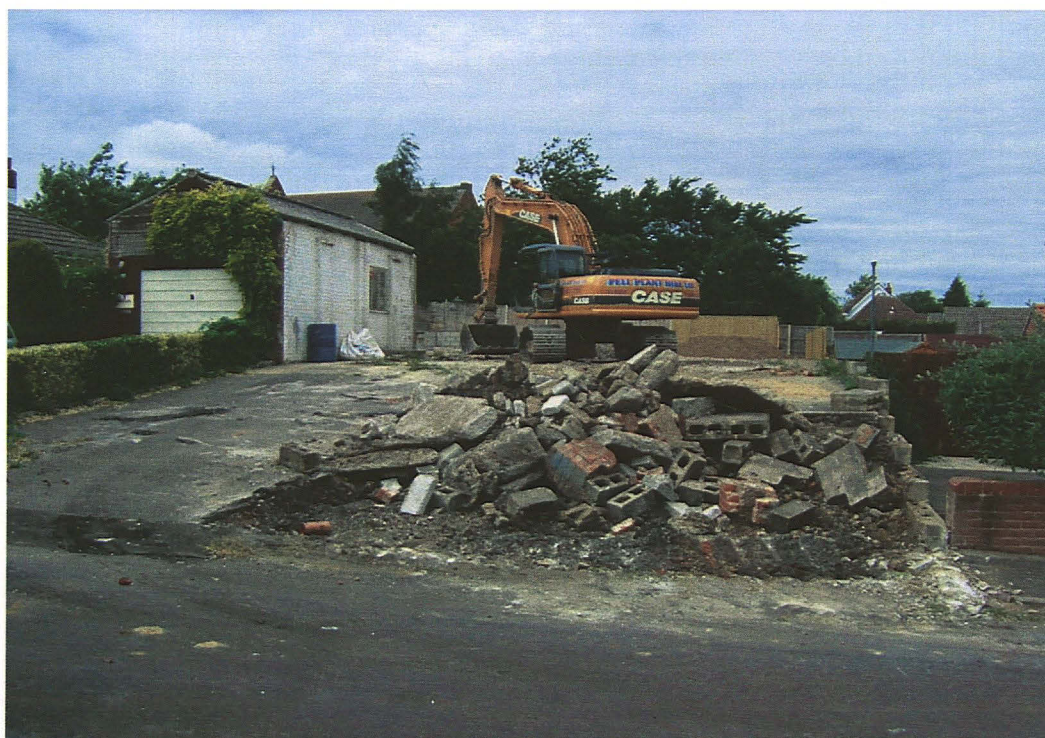
Plate 10: Rubble remains of raised concrete area following machine excavation; looking north.

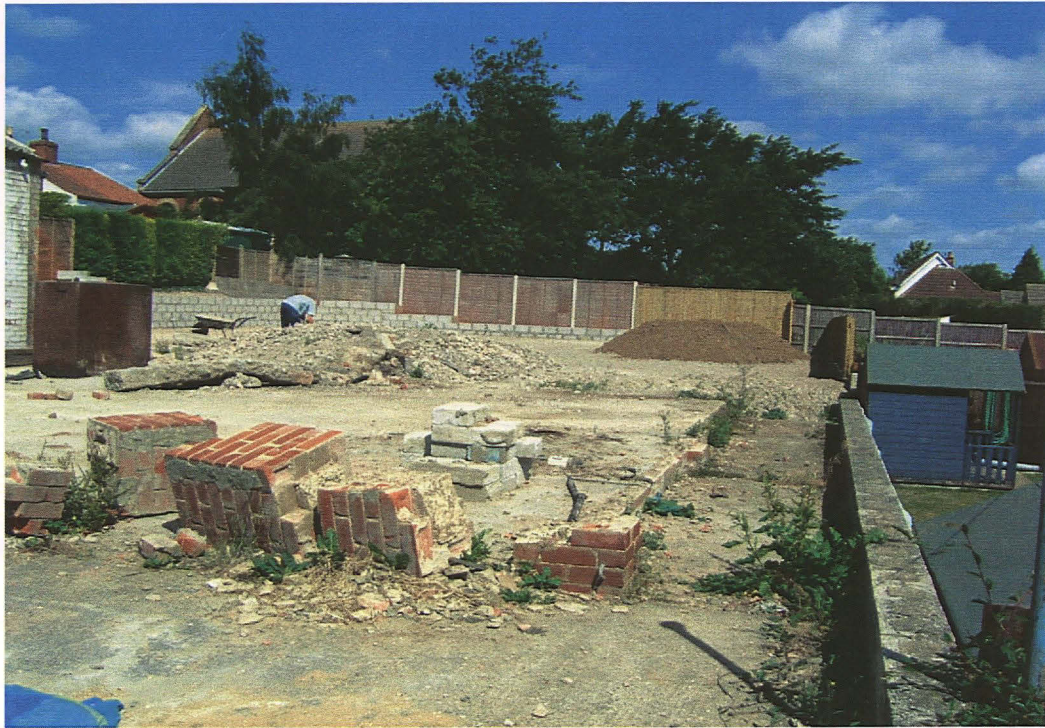
Plate 13: View across remains of warehouse structure (looking north), featuring demolished sections of warehouse brickwork.

- 2.41 The concrete floor surface of the former warehouse building (which once belonged to Marfleet's Bus Depot) measured approximately 9.20 x 9.5 metres. At the time of excavation the concrete floor was bounded to the south, north and east by brick foundations. To the south the concrete floor was met by the driveway tarmac and to the west the floor extended across as far as the wall of the garage which was located within plot no.3 (Plates 11 & 12). The top of the warehouse foundation walls lay flush with the surface of the concrete floor and also with the levelled earth surface further north. A few sections of demolished warehouse brickwork were recorded lying out of situ on top of the concrete floor (Figure 10; Plates 13 & 14).

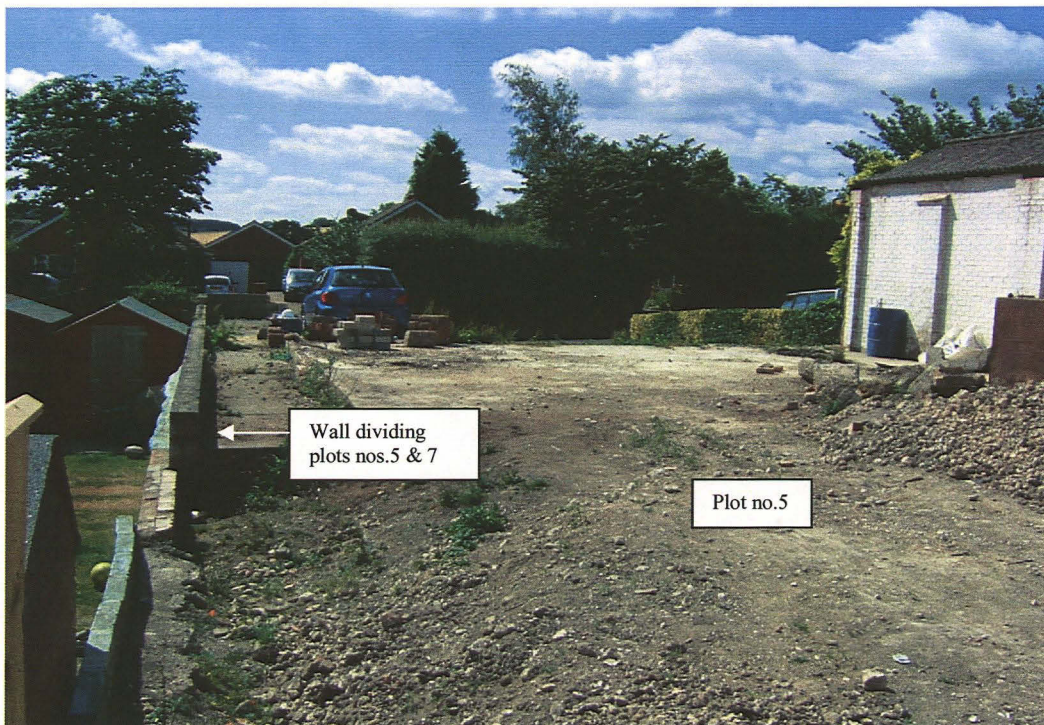
Plate 14: View across plot no.5 prior to ground works, looking south. The wall dividing plot no.5 and plot no.7 is clearly visible to the left of the shot.

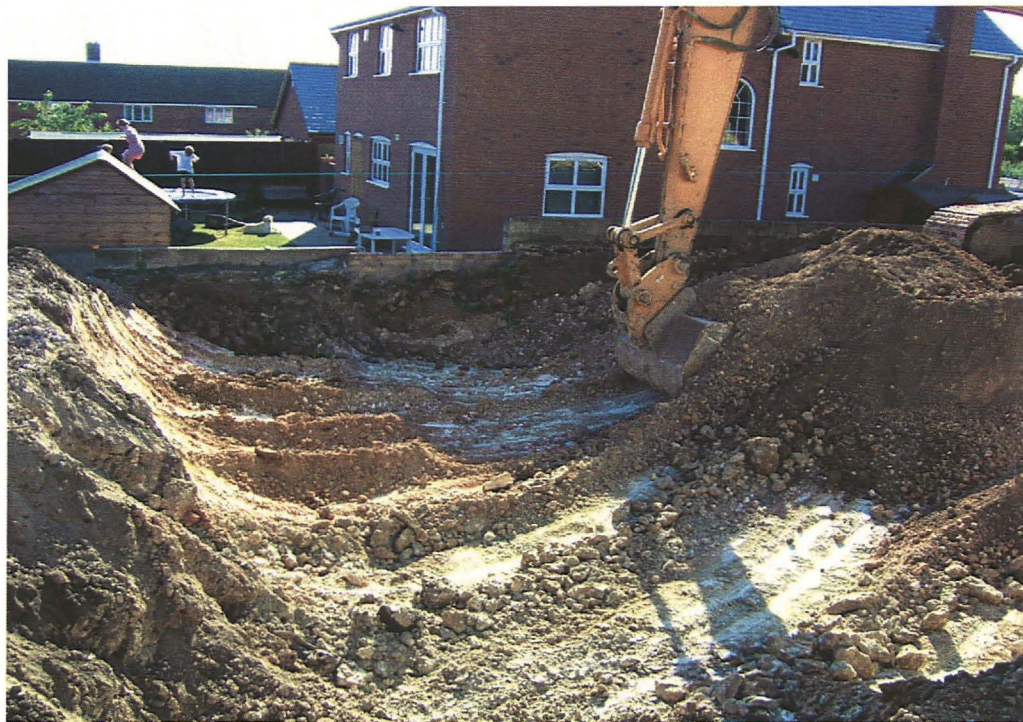
Plate 16: View across former warehouse structure following machine excavation showing the red clay subsoil and underlying chalk; looking east.

- 2.42 Following the breaking up and removal of the brick foundations and concrete floor (found to be 12 centimetres thick) during ground works, the underlying material was excavated out to a maximum depth of approximately 2.0 metres (Plate 15). Immediately beneath the concrete floor, a 30 - 45 centimetre deep band of hardcore (concrete, brick, tile) and general building demolition debris was recorded. Beneath the rubble lay an undisturbed layer of red clay subsoil and immediately below the clay, an underlying band of natural chalk (Plates 16 - 20). No finds, features or deposits of archaeological significance were identified during the removal of the concrete floor and excavation of the area immediately beneath. Similarly, nothing of archaeological interest was discovered during the removal of disturbed material from the area which lay between the eastern side of the warehouse structure and the wall which divided plot no.5 from plot no.7.

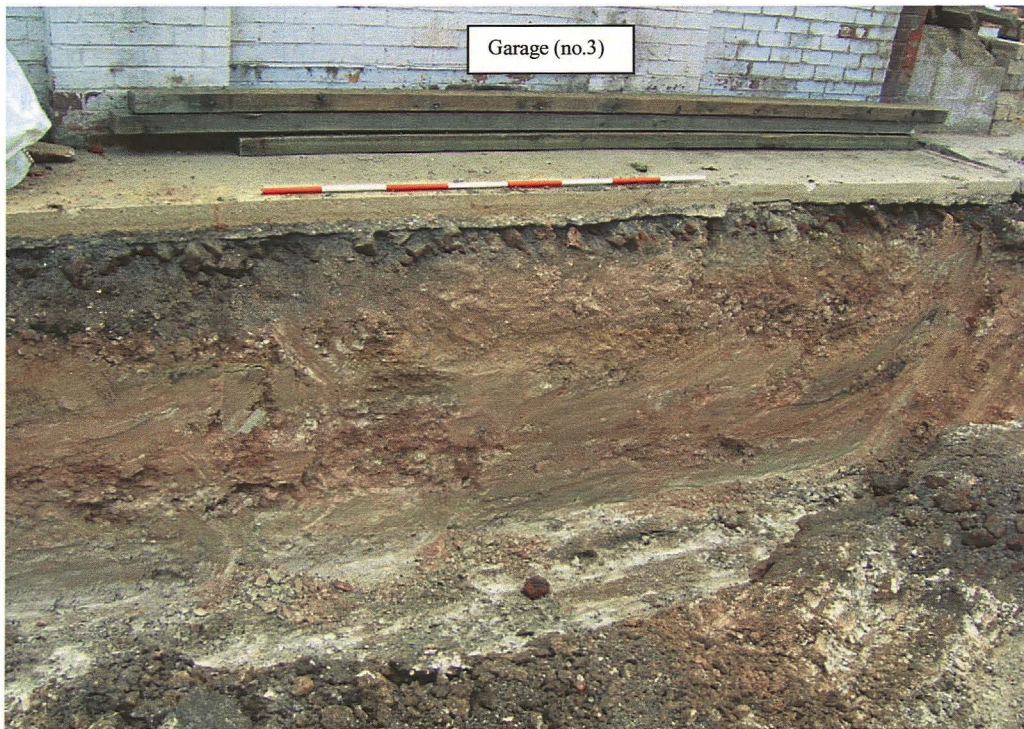
Plate 20: Section through side of trench following excavation of former warehouse structure showing stratigraphy; looking west.

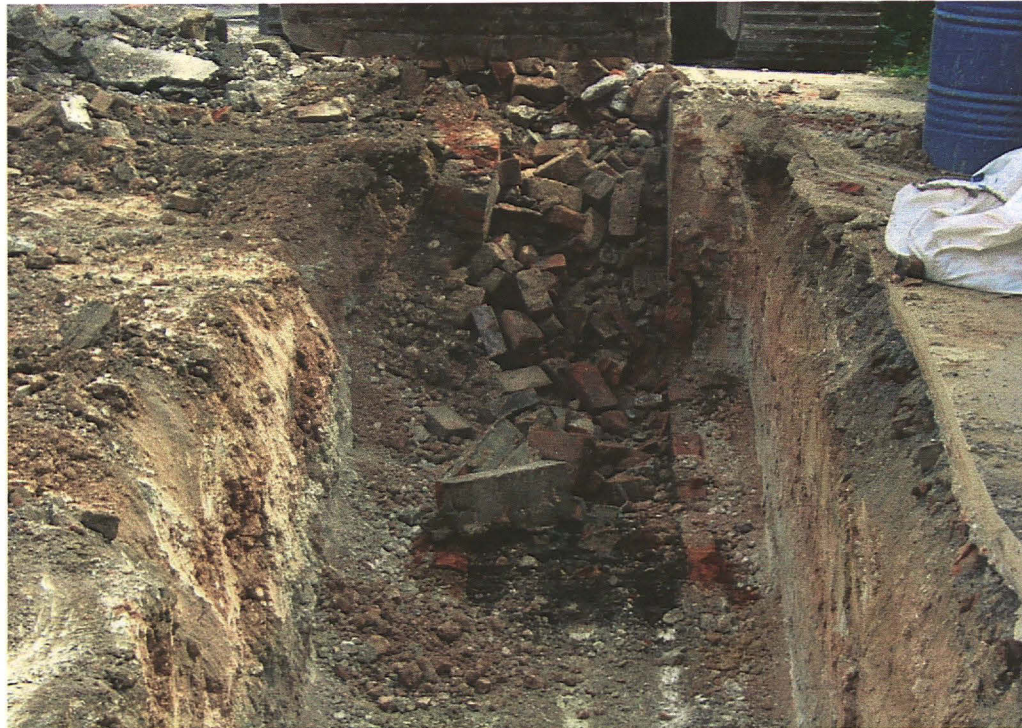
Plate 22: Excavation of brick-lined pit and removal of backfill; looking south.

2.52 The pit was found to be back-filled with rubble and building debris which almost certainly derived from the demolition of the warehouse itself. Besides containing dumps of concrete, bricks and tiles, rusted pieces of corrugated iron, bus exhaust pipes, tyres and other vehicular rubbish, the pit also produced an iron diesel tank (Plate 22 & 23).

- 3.4 The former warehouse structure with its concrete floor was originally built as part of Marfleet's Bus Depot around 1960 and was most likely used as the Depot garage. The rectangular, brick-lined pit revealed within the western side of the warehouse floor, almost certainly served as a vehicle inspection pit and appeared coeval with the building of the warehouse. Much of the backfill removed from the inspection pit during ground works very likely derived from the demolition of the warehouse itself. The rusted exhaust pipes, tyres, diesel tank and other vehicular rubbish removed from the pit most probably represent general Depot rubbish lying around the site at the time of the infilling of the pit.

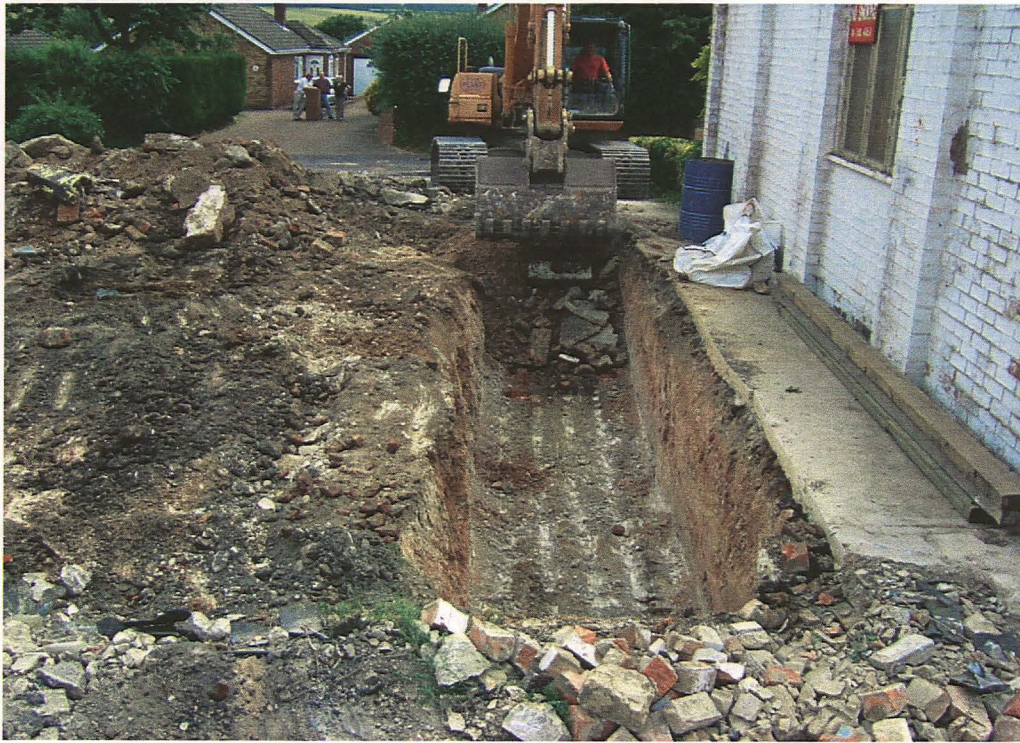
Plate 23: Shot of rectangular brick-lined pit during excavation; looking south

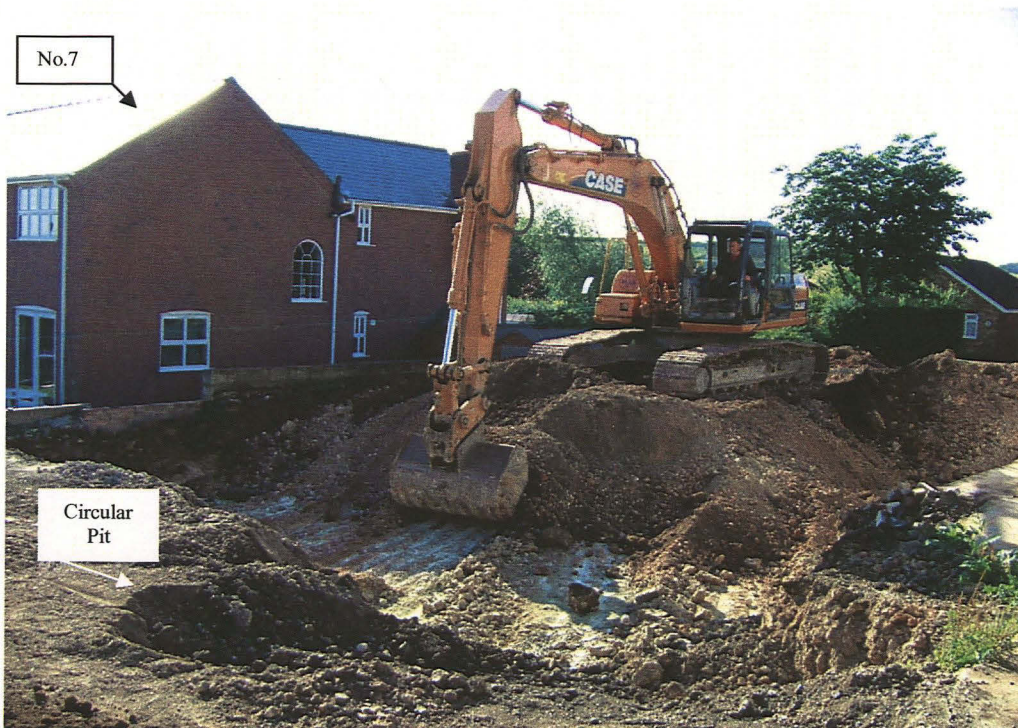
Plate 24: View across former warehouse structure during machine excavation showing partially excavated circular pit (front of shot); looking southeast.

2.61 Approximately 1 metre north of the remains of the warehouse structure a roughly circular pit (approximately 2.5 metres in diameter) was exposed during machine excavation. The lower reaches of the pit were cut through the red clay subsoil and also into the underlying natural chalk, to an approximate depth of 1.40 metres (Figure 10). The fill of the pit comprised modern rubble and building debris, rubber tyres and miscellaneous pieces of modern ironwork. Black, oily stains and deposits were recorded within the backfill material (Plate 24).

- 3.6 The roughly circular pit discovered just north of the remains of the warehouse structure very probably represents a pit which once housed a diesel tank used by Marfleet's Bus Depot. An old diesel tank was recovered from within the backfill of the rectangular vehicle inspection pit located in the former warehouse structure (see section 3.4). The black, oily deposits and staining identified within the backfill of the circular pit very likely represents the remains of diesel spillage.

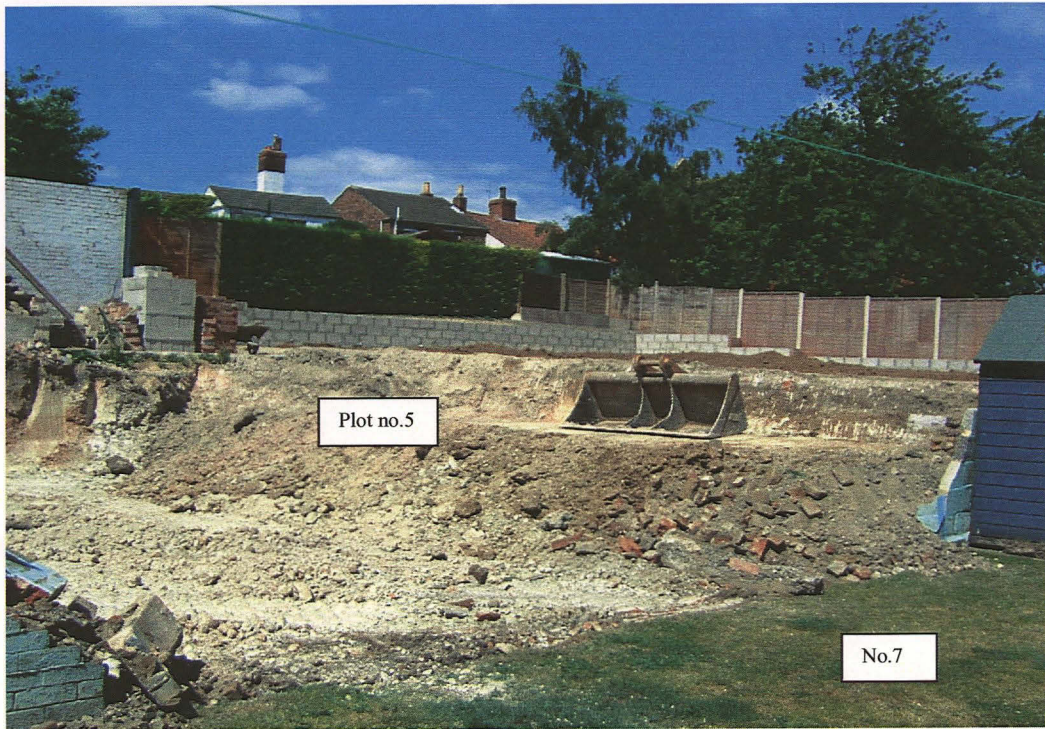
Plate 29: Looking northwest towards plot no.5 from plot no.7 during ground works, following the demolition of the dividing wall. Note the similar ground level of each plot following the excavation and levelling of plot no.5.

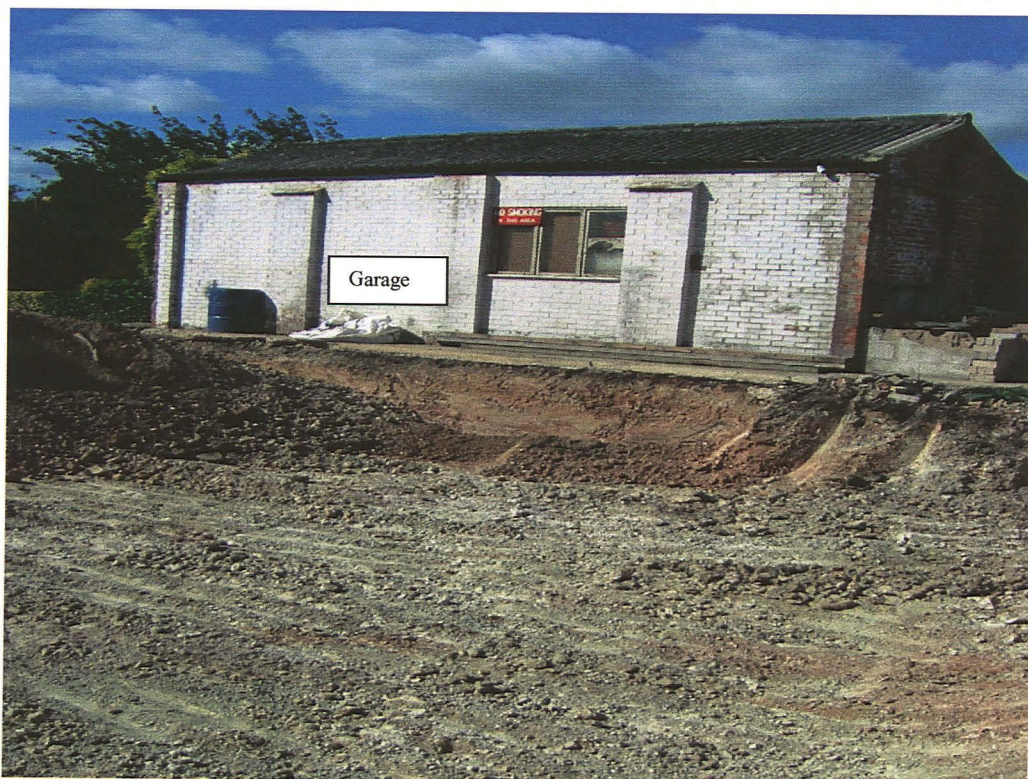
Plate 34: Looking southwest across plot no.5 towards east side of garage wall (plot no.3). This side of the garage wall almost certainly represents the west (internal) wall of the former bus depot warehouse structure.
