KETTLETHORPE HALL,  
KETTLETHORPE,  
LINCOLNSHIRE

ARCHAEOLOGICAL  
WATCHING BRIEF REPORT

Report prepared for  
Savills (L&P) Ltd

June 2008

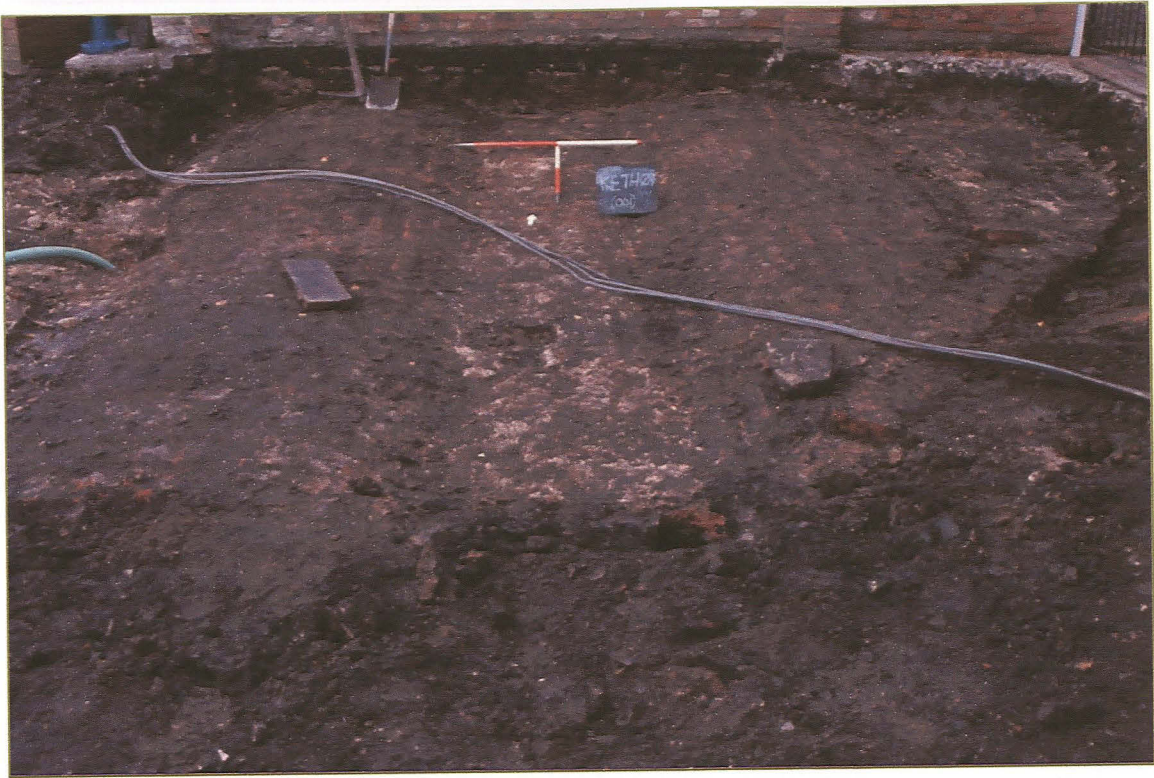
Water tanks (001) uncovered, looking north.

Adjacent to the northern perimeter of the stripped area, a vaulted brick water cistern was exposed at 0.30m below current ground level, measuring approximately 10m<sup>2</sup> in total area. The cistern comprised of two areas of brick vaulting, which were separated by a central brick arcade measuring 6.0m in length. Three water feed pipes could be seen along its eastern side, while a further pipe was visible leading northwards towards the stable block; presumably supplying it.

- (001) Brick, 9 x 2.25 x 4.25 , stretcher bond, two bay, twin vaulted with central arcade of 4 arches, aligned N/S southeast side angled 30°. Bonding material is a mid grey lime mortar. Brick built water cistern.

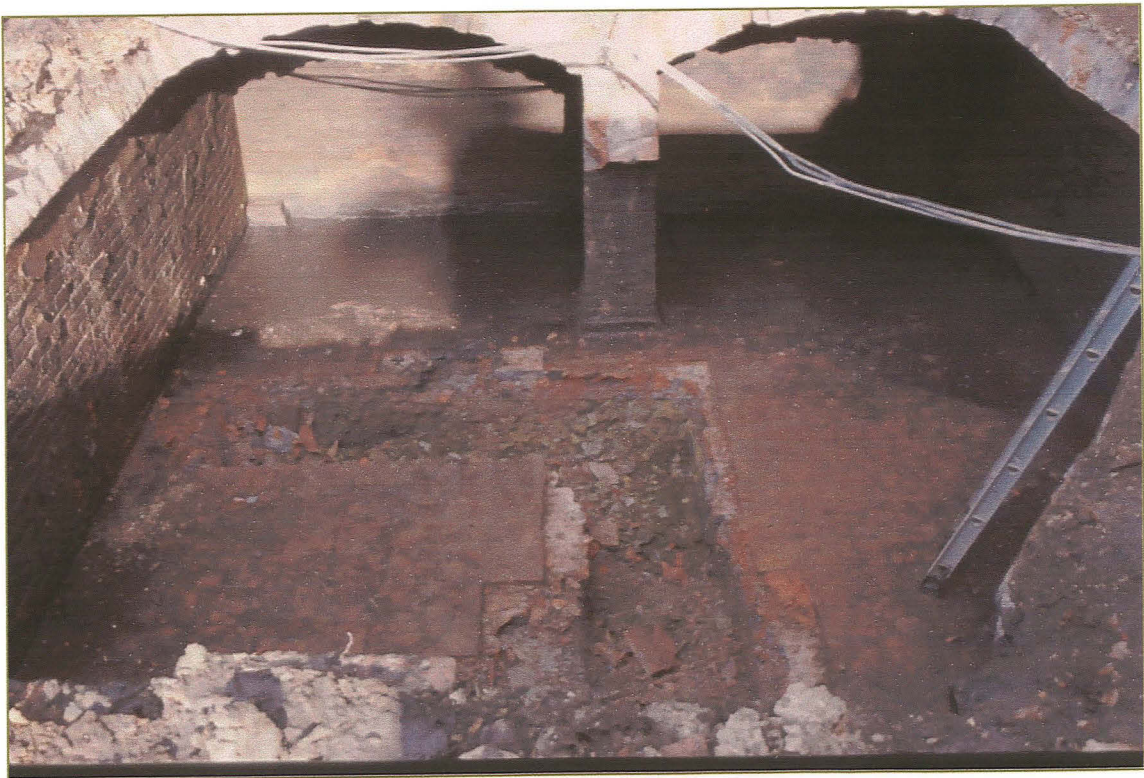
Interior view of water tanks, looking south.

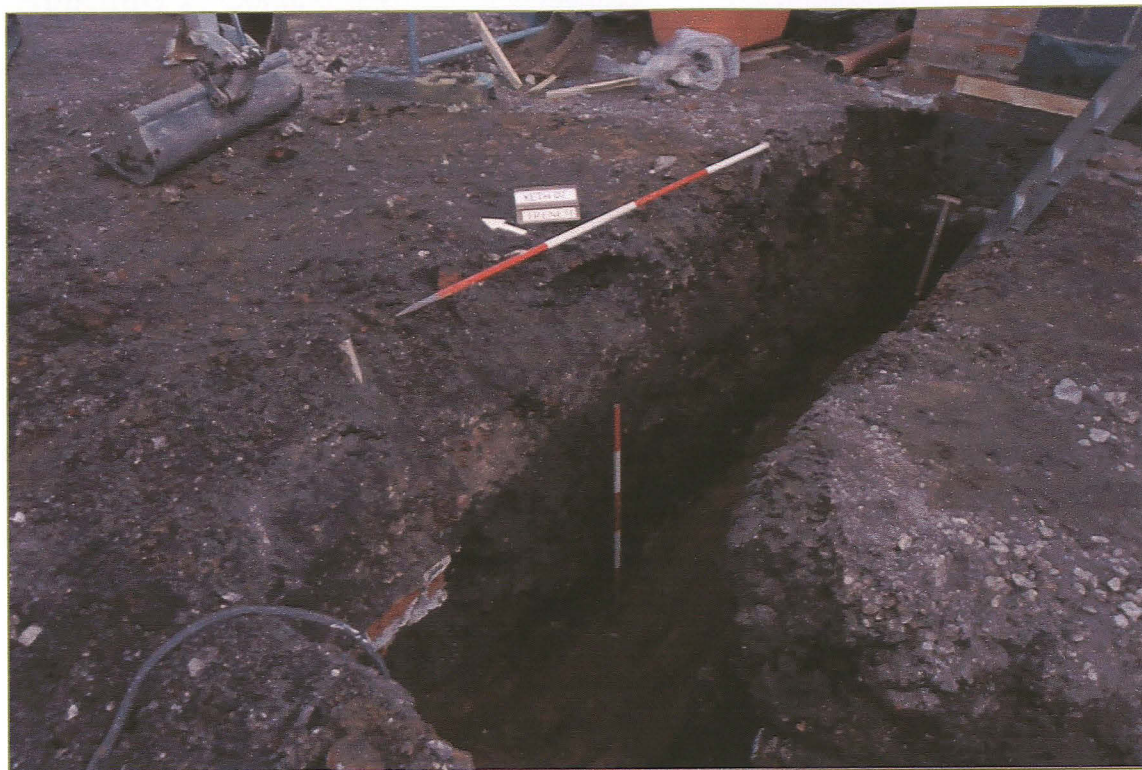
Lime slaking pit [013], looking north-east.

Truncating the above layers to a depth of 1.10m was a large pit, [013]. This contained a primary fill of slaked lime (014), sealed by (015), an ashy charcoal-rich fill from which a single 16<sup>th</sup> century pottery sherd was recovered (Appendix 3).

A number of post-medieval features were encountered within the development footprint; associated with the current (19<sup>th</sup> century) Hall. There is no reason why the lime-slacking pit was not associated with this phase of construction (producing lime on site for the mortar), although one sherd of comparatively early pottery was recovered from its fill, thus suggesting the possibility at least that the pit was associated with an earlier phase of construction.

- (011) Light greyish sandy clay. Natural.
- (012) Dark brown sand 0.04m thick. Wind blown sand.
- [013] Pit, gradual sides and base, concave base and U shaped profile. Lime slaking pit.

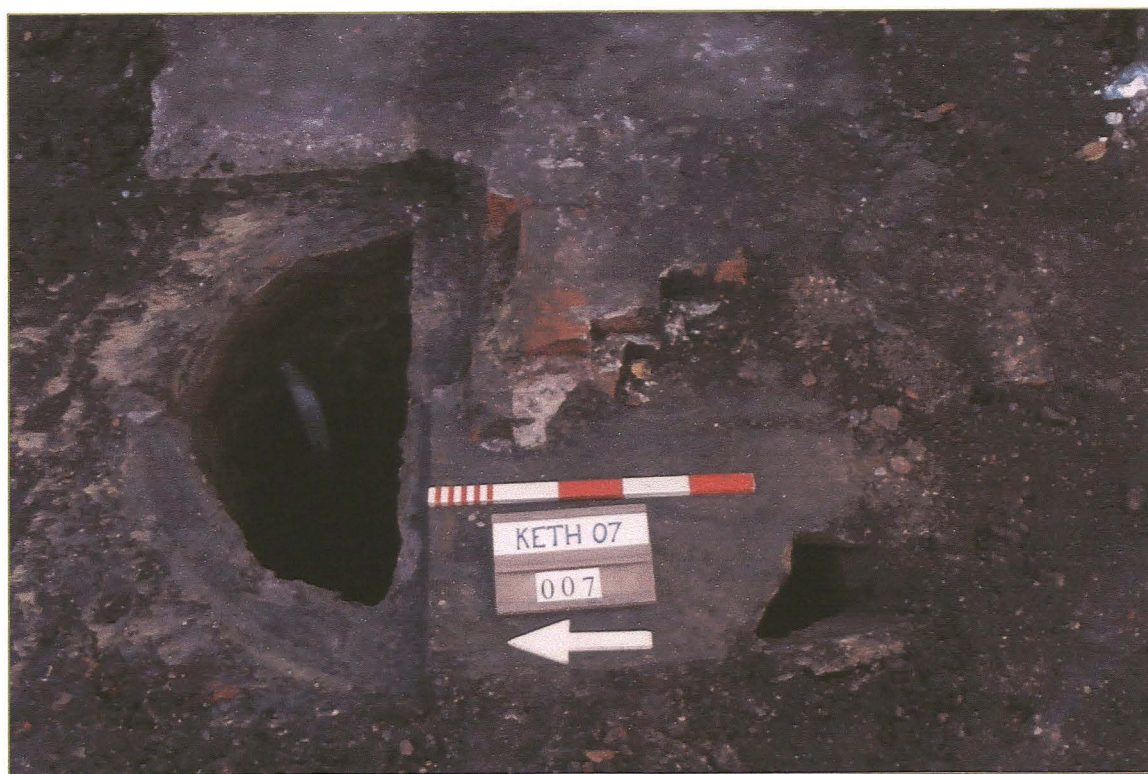
Well [007], looking east.

A brick well (007) was identified; constructed using alternating header-stretcher bond, with a lead supply pipe leading to the hall. It was capped with a York stone slab, which was sealed by a modern concrete slab associated with former outbuildings.

- (006) Contemporary wall above (001). Not recorded.
- (007) Brick, 9 x 2-2.25 x 4.25 -4.5, complex alternating header/stretcher courses. Cylindrical brick built well tapering slightly outwards. Appear dry built in places and also bonded with light grey lime mortar. Domestic well.
