**e2v Site, Carholme Rd, Lincoln
Heritage Statement**

NFAC Report No. 0921

e2v, Carholme Rd, Lincoln

Heritage Statement

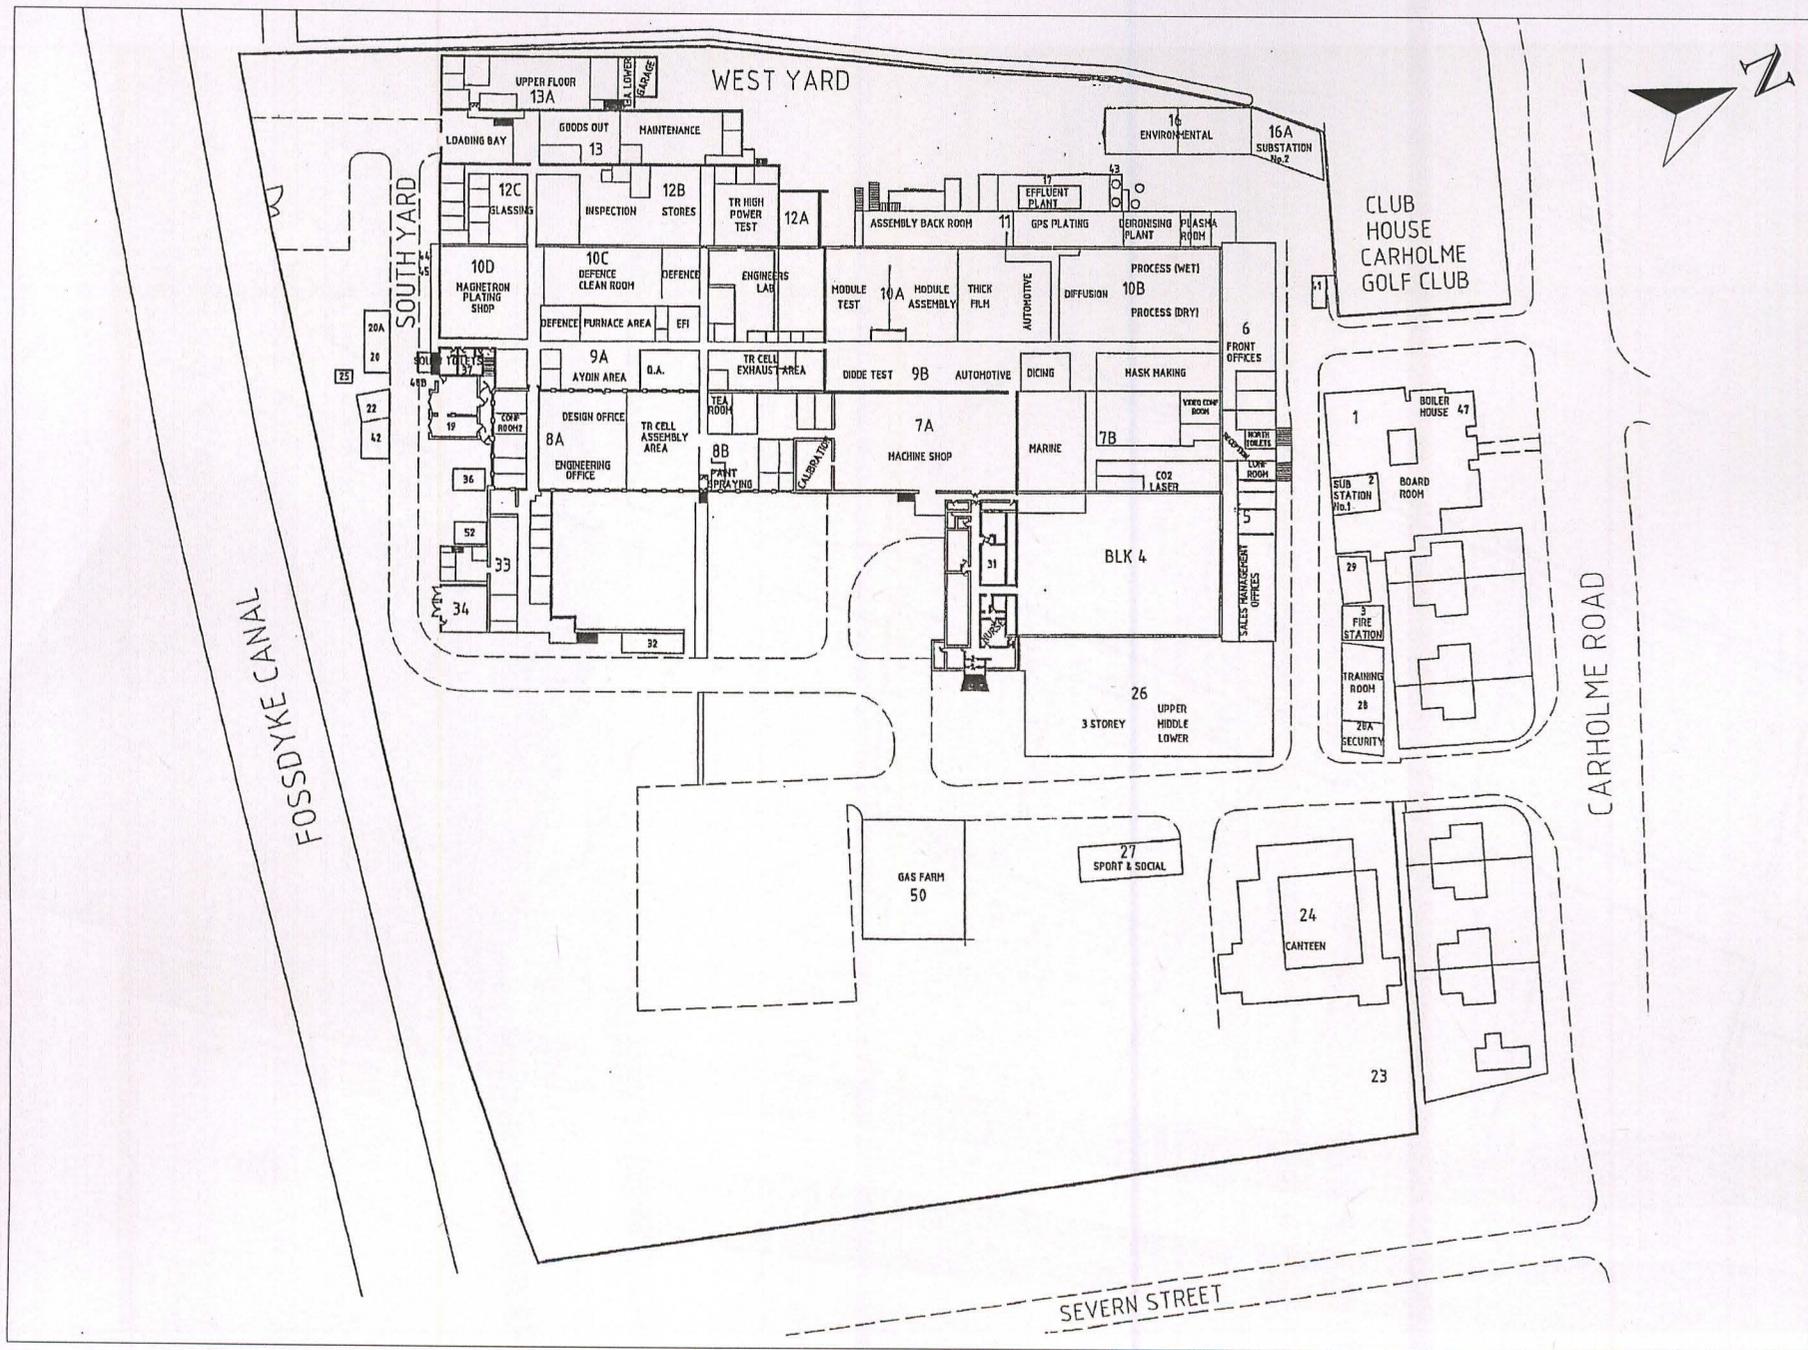
Fig. 2 General layout of existing e2v site . Plan kindly supplied by e2v Technologies Ltd

The proposed development site is currently the site of e2vTechnologies Ltd and located in the Carholme area of the city of Lincoln, 1.5km west of the historic core of the city (Fig. 1). It is situated on the south side of Carholme Road with the Fosdyke forming its southern boundary. It is bounded to the west by a drain and public foot path on the edge of the Lincoln West Common, with residential developments to the east and north. The site occupies an area of 4.8ha in extent and buildings occupy 2ha of the site. There is open ground on the east side of the site comprising a car park and grassed area (0.8ha in extent). There are additional smaller areas of hardstanding on the west and south sides of the buildings complex (Fig. 2).

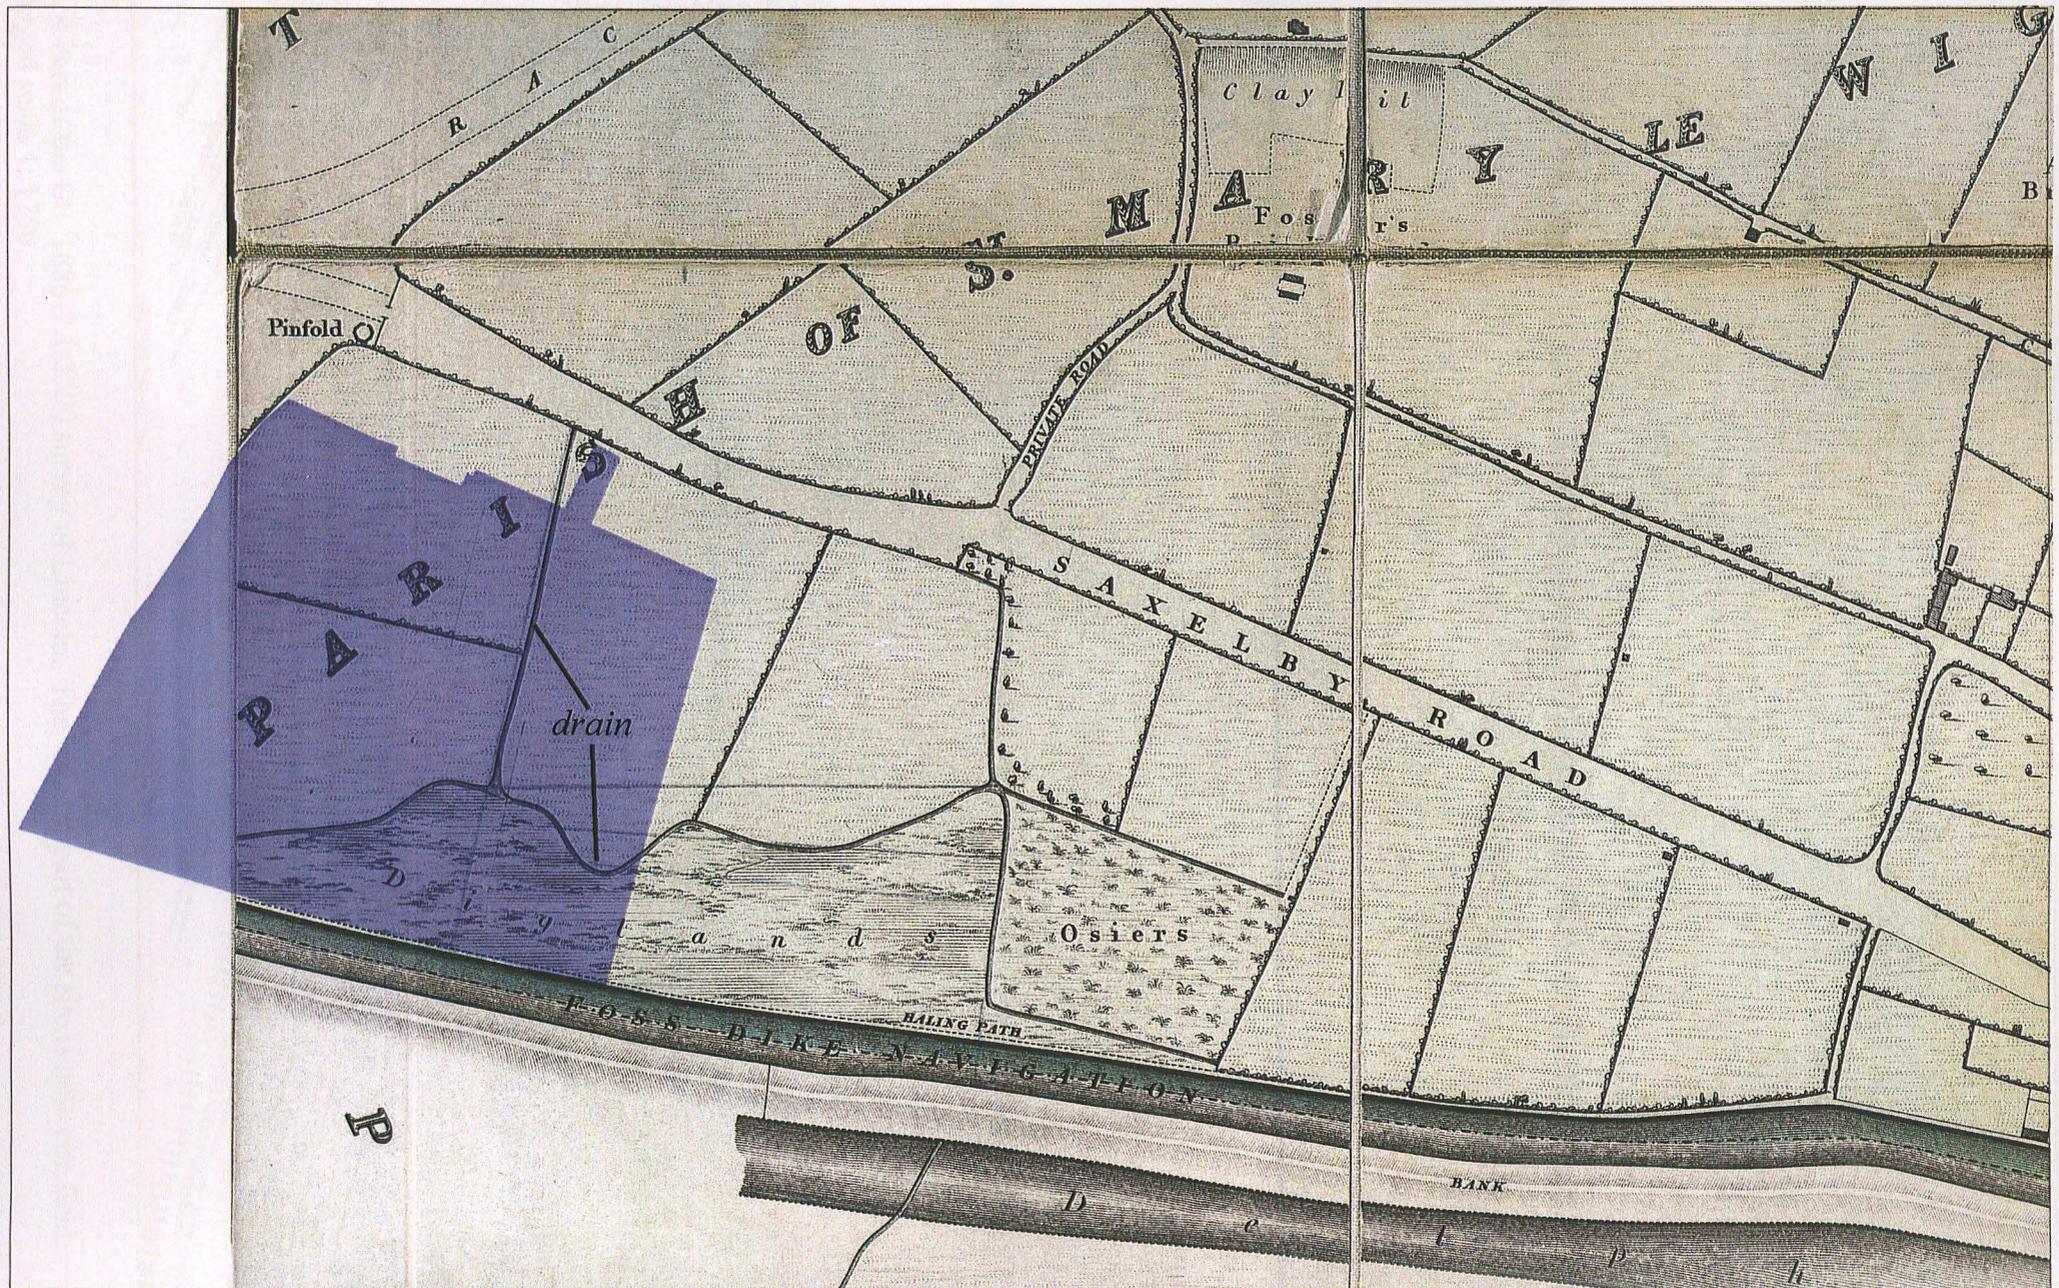
Fig. 3 Part of J. S. Padley's Survey of Lincoln, published 1842 (Scale 20" = 1 mile). The development site (lilac) straddles three enclosed fields, and an area of clay pits called the Diglands next to the Fossdyke, with drains defining some of the boundaries (Reproduced from Mills and Wheeler 2004).

Clear evidence for the use of the site can be obtained from early maps of the city although the earliest surveys by Speed and Stukely did not reach as far west. Small scale information can be seen on map of 1819. Padley's survey of 1842 marks plot boundaries, some of which are still recognisable today (Fig. 3). The site comprised an open field with a small piece adjacent to the Fosseydyke labelled 'diglands'. These may have been claypits. The main plot of land has drains running through it which have presumably been culverted. Land beyond the site, to the east, is labelled 'osier beds' which indicates that willows were growing there. This is also an indication of wet ground.

19th century cartographic evidence shows that the southern part of the site was used for the extraction of clay and the adjacent plot of land was an osier bed, an indication of wet ground. It is possible that until the land was drained the ground was too wet to be occupied in the historic era. Geotechnical investigations of the site over the past 10 years has shown that there is a built up of 'made ground' of up to 2.35m in depth. This may have been a deliberate attempt to raise ground levels to avoid seasonal flooding, as well as to fill in any of the clay pits. It is noted that asbestos and other building materials are present beneath the grassed area (ERM 2009, 42).

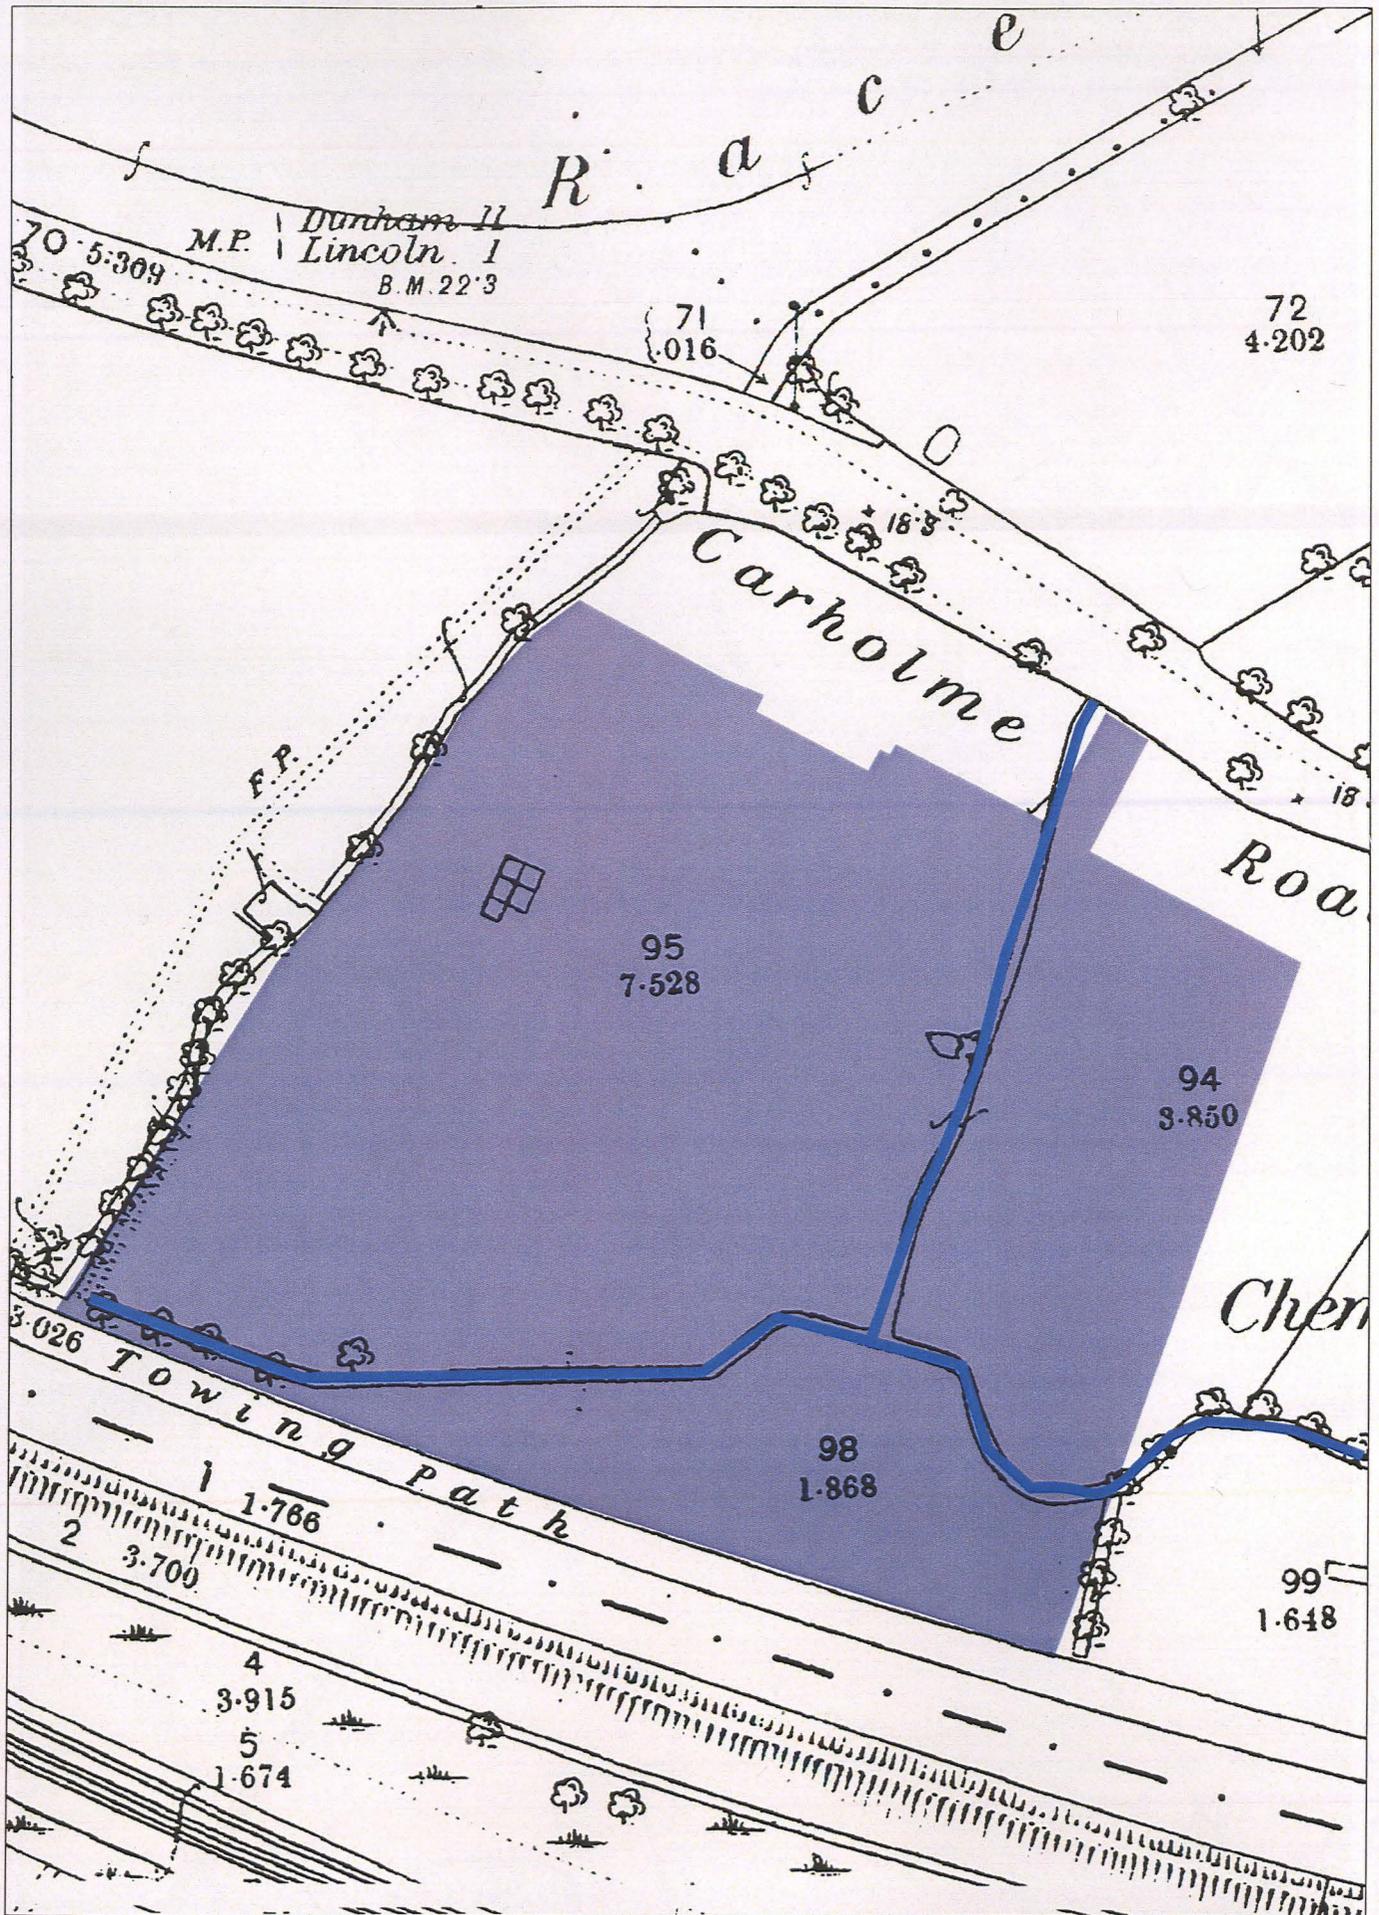
Fig. 4 Part of the OS 1886-7 1:2500 survey of Lincoln. The western part of the site is now one field. Enlarged scale 1:1750.

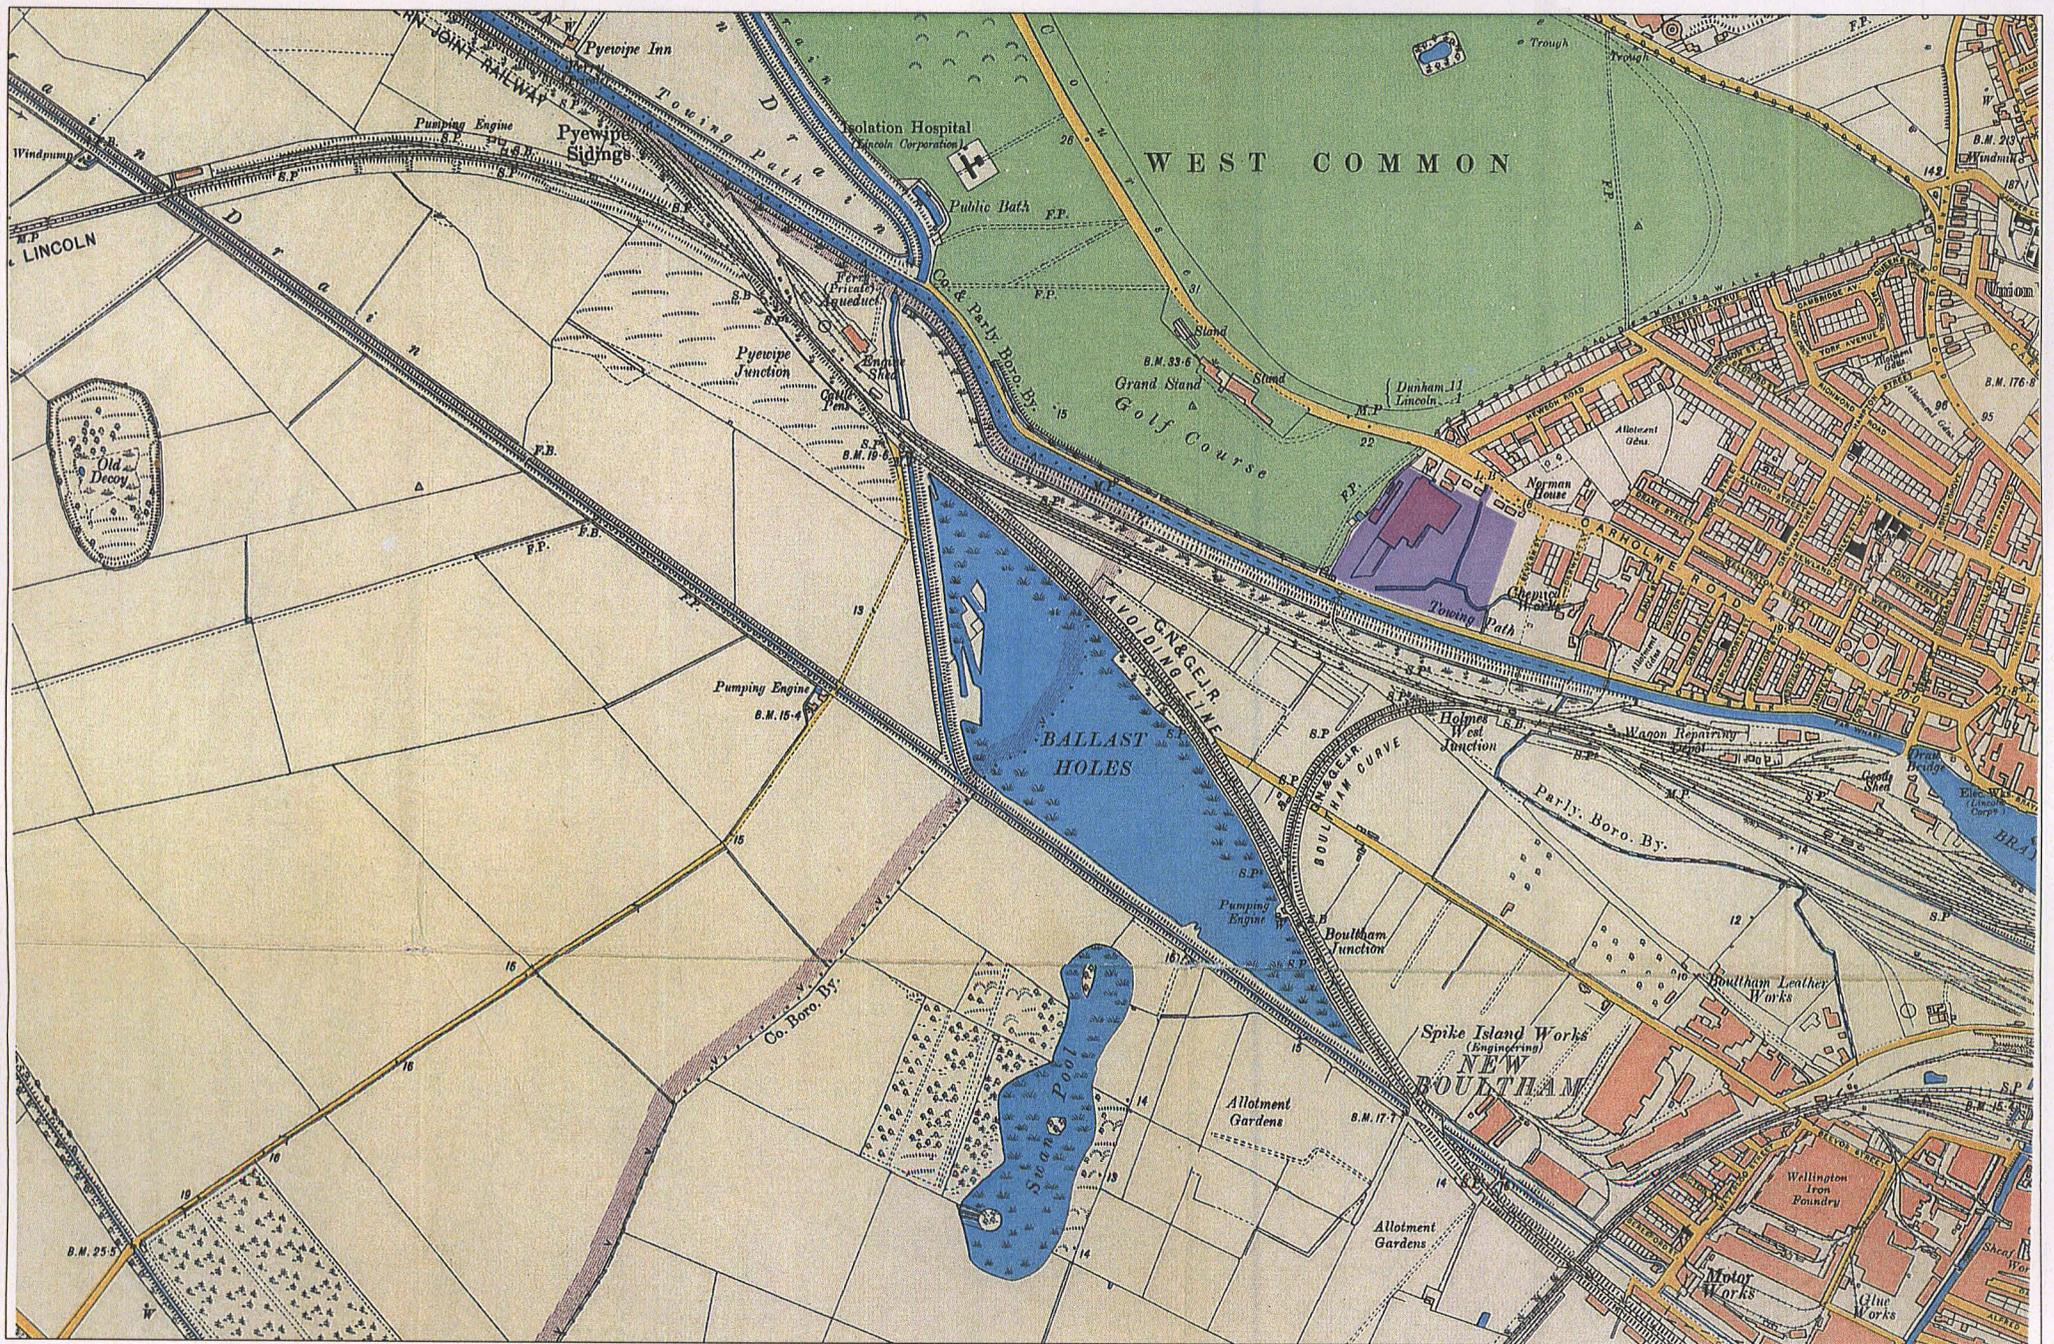
Fig. 5 Part of the OS 1920 1:25000 survey of Lincoln showing the timber yard in the western part of the site and Newsum Villas along the northern boundary. The drainage dykes recorded on earlier maps are still present. (Reproduced from Mills and Wheeler 2004) .

the 1920 OS1:25,000 map (Fig 4) and the Ordnance Survey 1:2500 maps of 1930 and 1932 (eg Fig. 5).

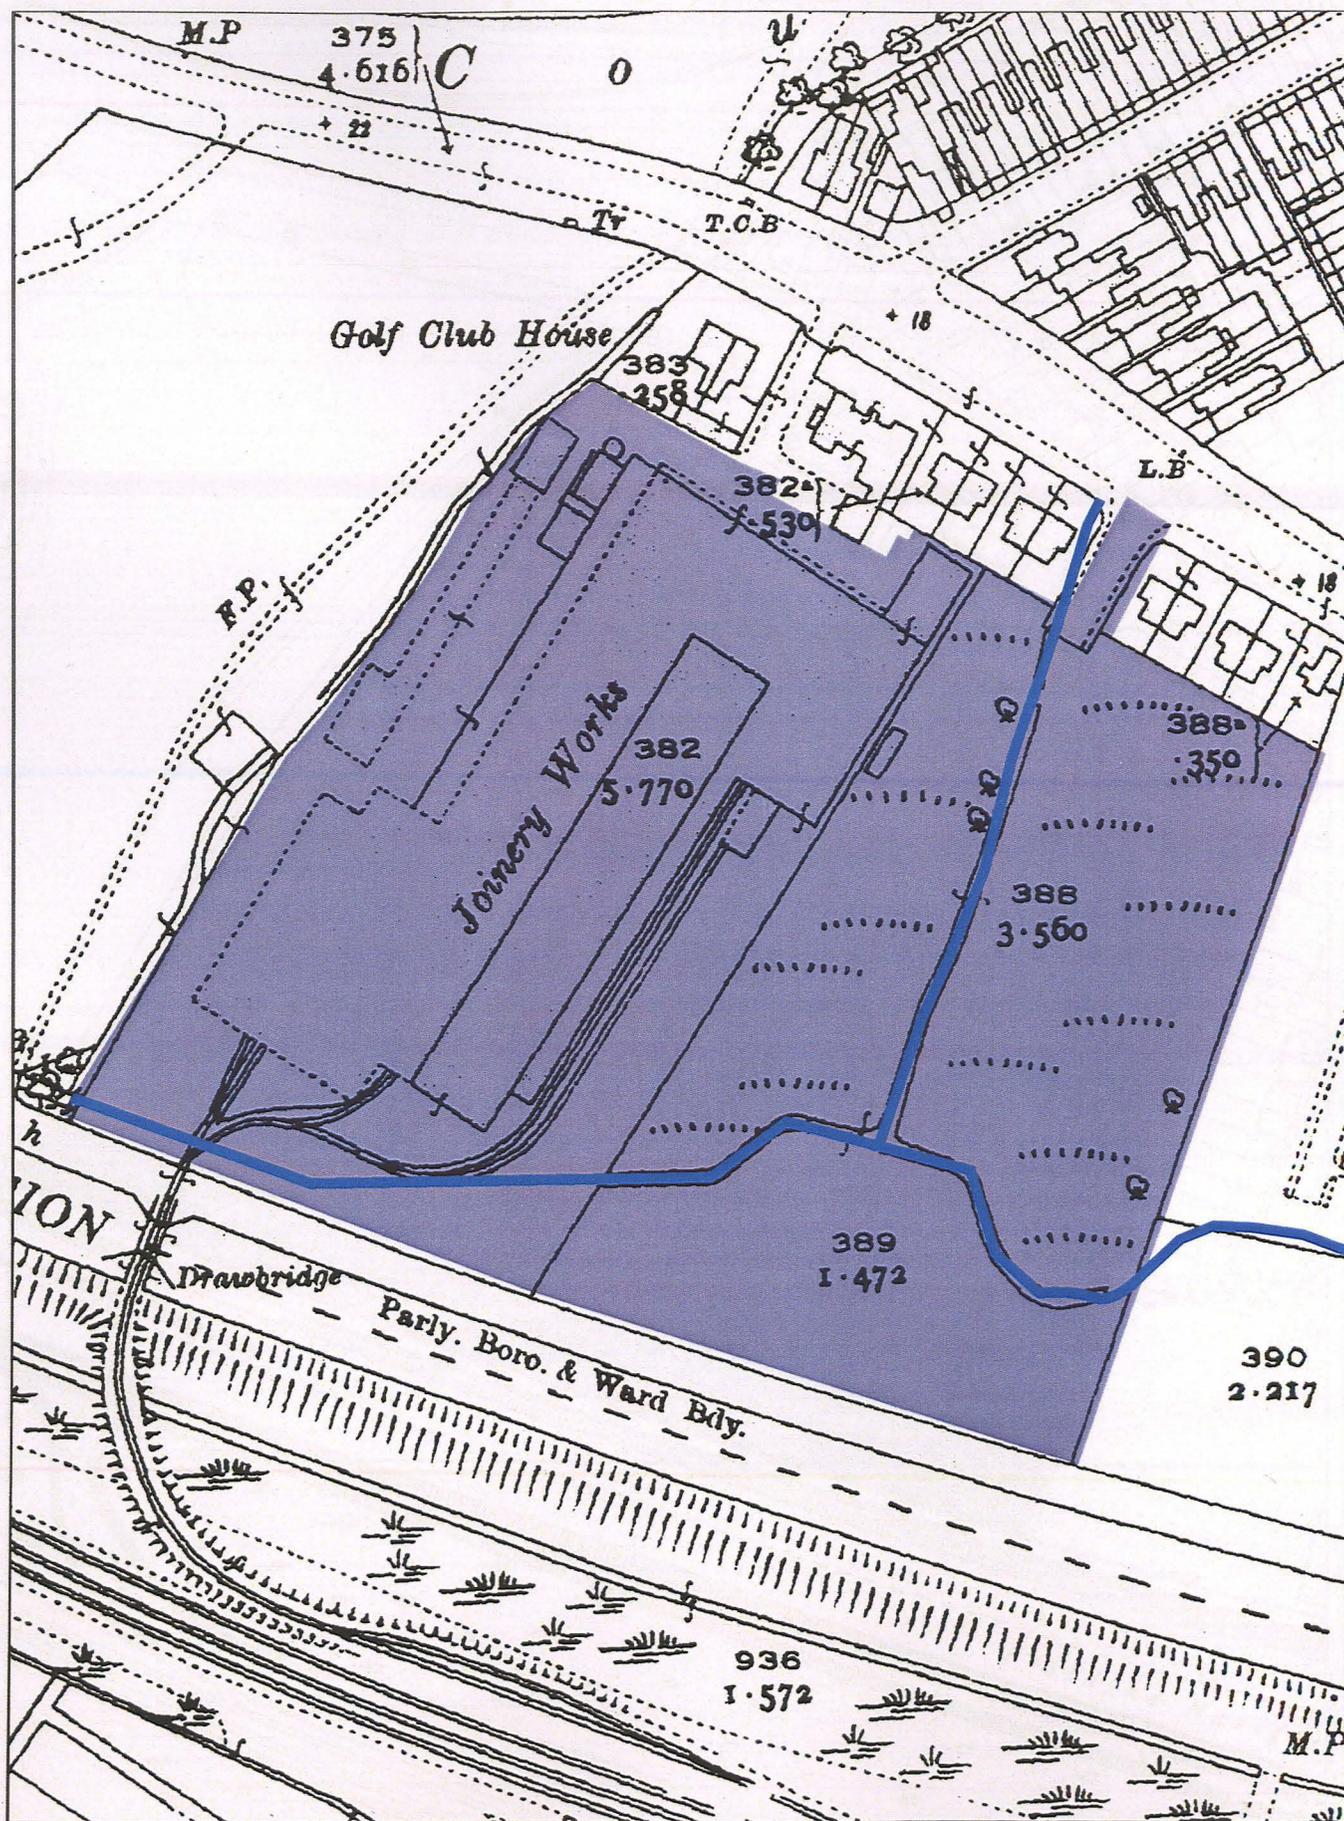
Fig. 6 Part of the OS 1930 1:2500 survey of Lincoln. This shows the railway link across the drawbridge over the Fossdyke and the three branches into the factory. Enlarged scale 1: 1750.

The works had a rail link to the LNER by a single-track railway crossing the Fossdyke by means of a drawbridge (MON6228) whose concrete footings still survive (with storage loop) curving away westwards through undergrowth behind West Holmes signal box. The line closed with the works in 1956. <http://www.photrek.co.uk/lincolnwestend.html>. There was possibly also a small dock off the Fossdyke on the north side of the bridge (BA5488).

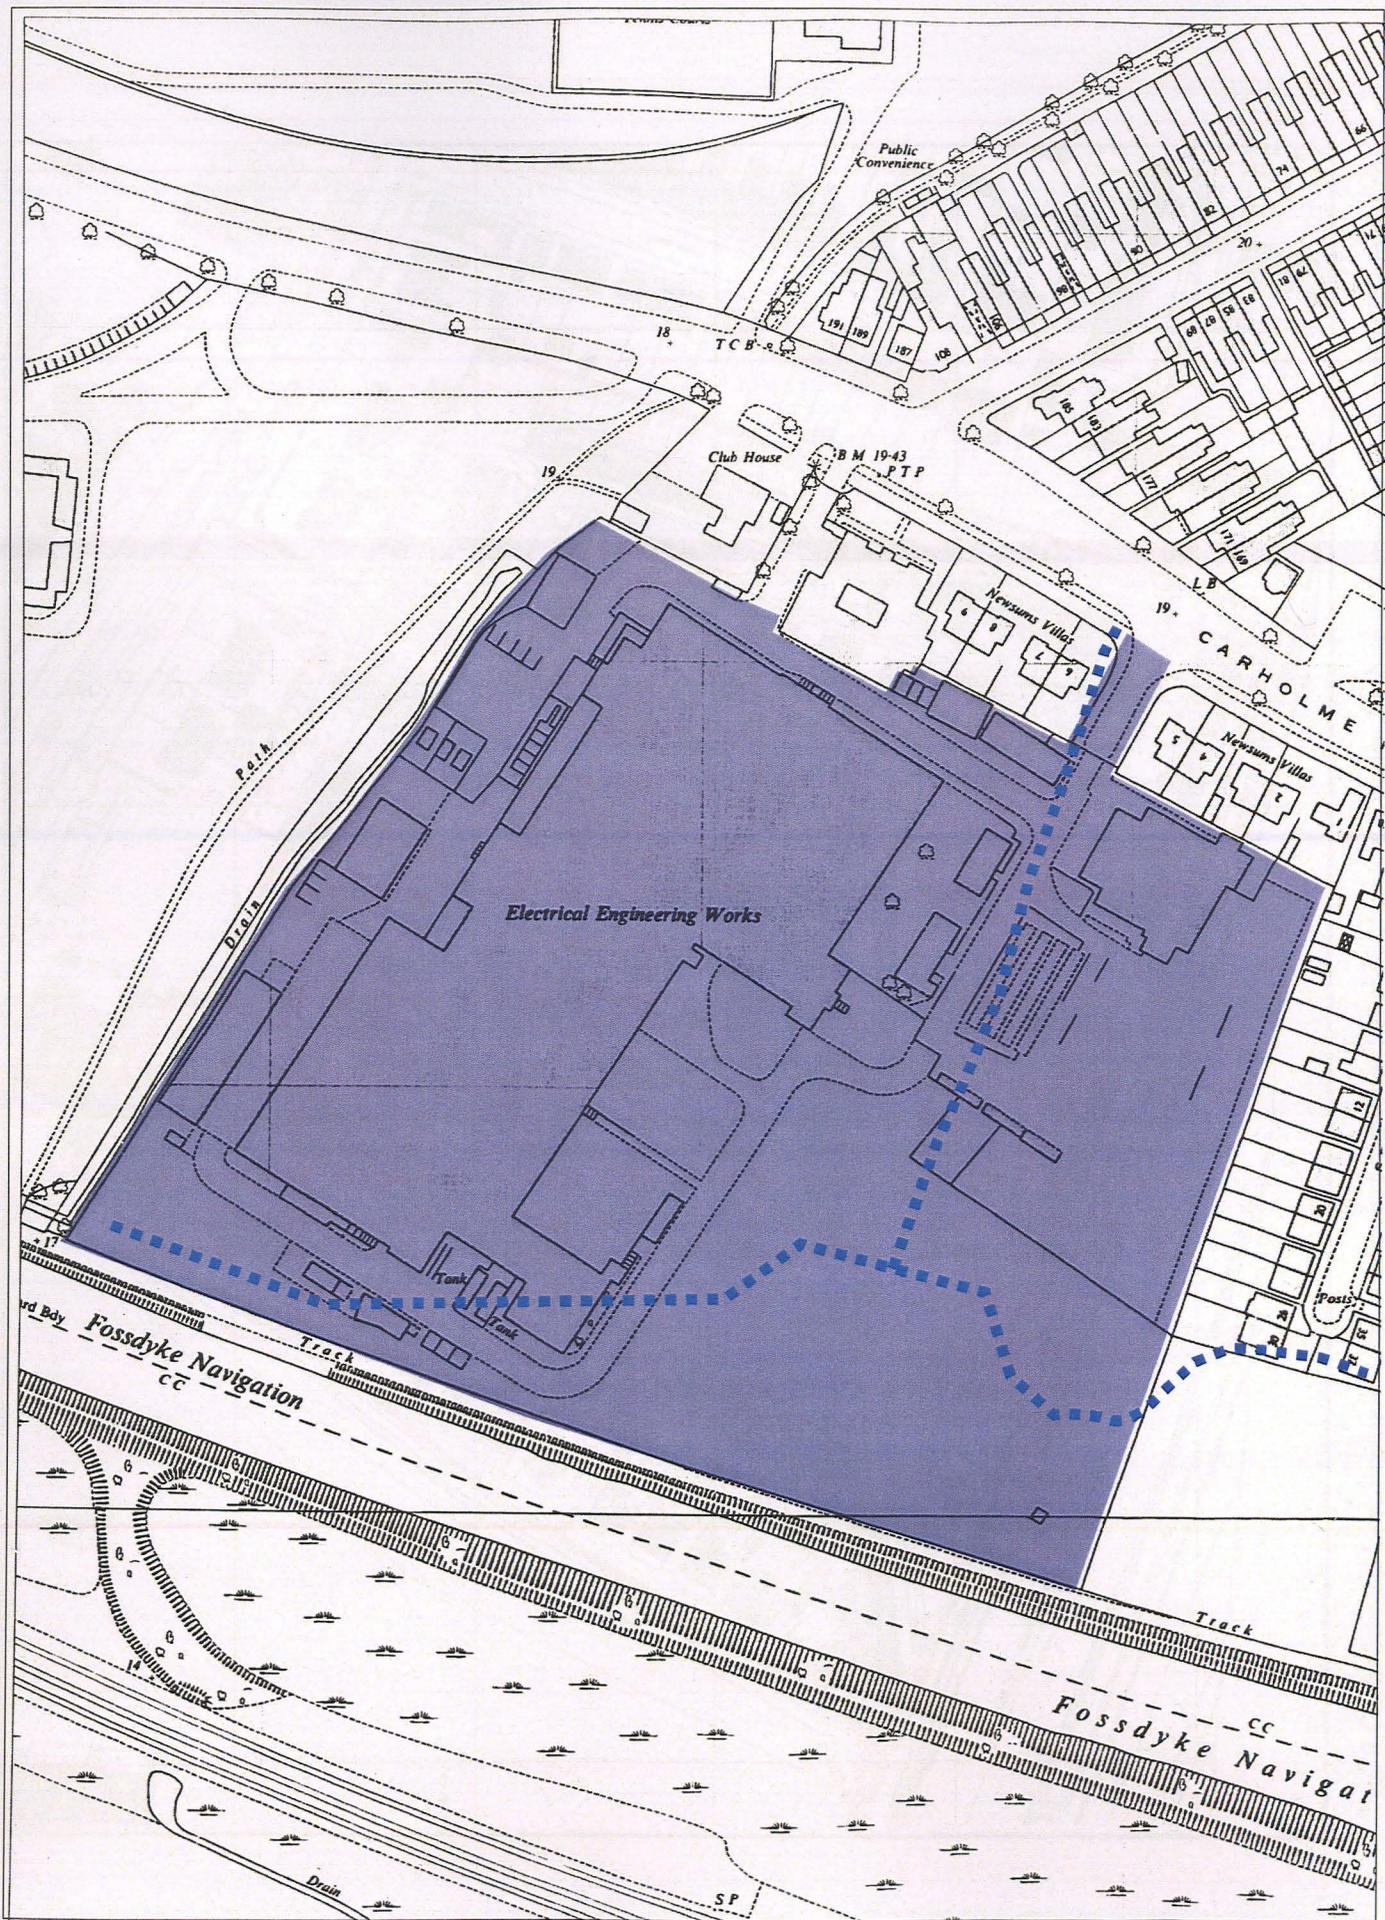
Fig. 7 Part of the OS 1966 1:2500 survey of Lincoln. The new engineering works have extended southwards and eastwards and the drains have been filled in or culverted. The railway lines and the drawbridge have gone. Enlarged scale 1:1750 Crown copyright © Reproduced with the permission of the Controller of HMSO. NFAC licence No. 1000049154.

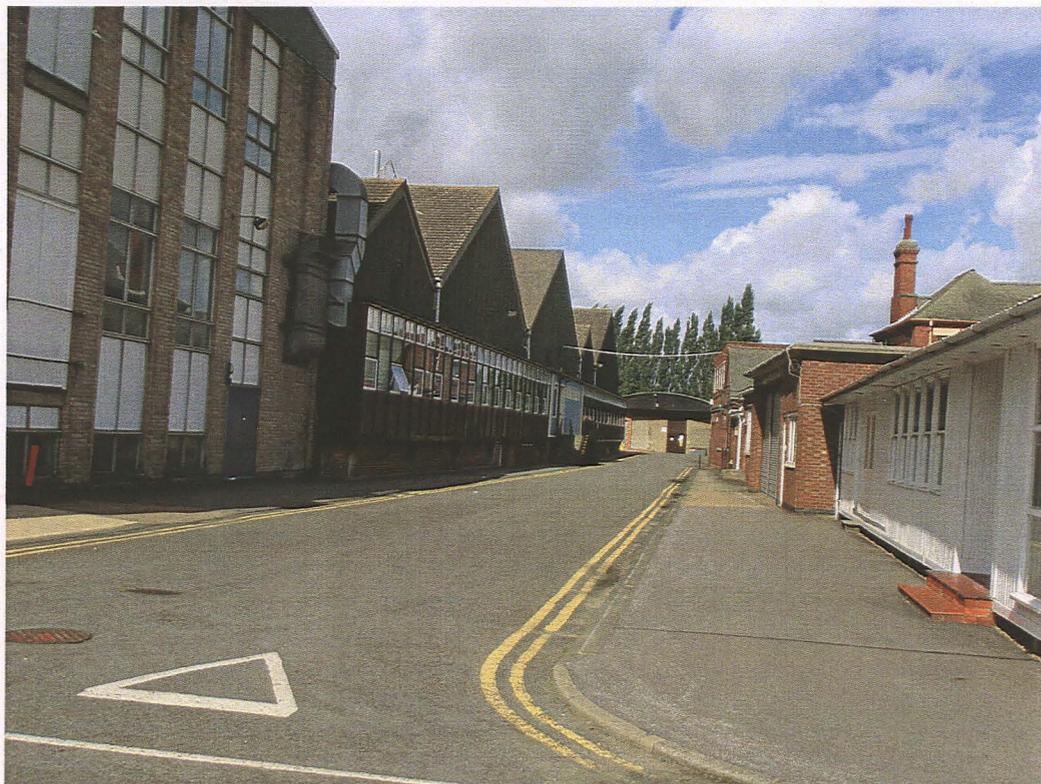
Pl. 6 View west showing, on the left, the original factory building in timber beyond the three-storey office building constructed in 1975 To the right in the background is the redundant electricity substation and Newsum's 1920 office block. In the foreground is a training room.

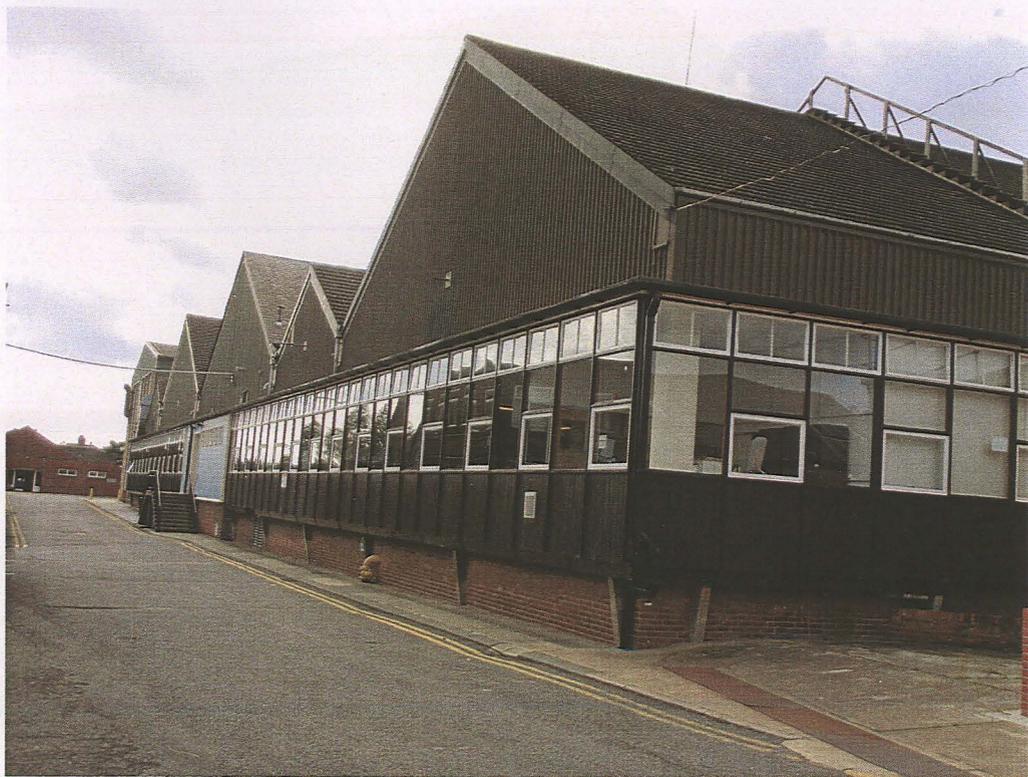
Pl. 7 Original Newsum's factory building constructed on brick stilts, looking south east.

The main production building (Pl. 7) is supported on brick stilts (Pl. 8) to raise the floor areas above the floodplain and to make it easier for loading goods onto trains that served the rear of the building. (The void beneath the building is c.1 m at the north end and falls to 2.5m at the south.) Site building services including electricity, natural gas, nitrogen, mixed gas, computer cables etc are located above ground, hanging under the production area's suspended floor. Some drainage lines and pumps are also located under the suspended floor to remove floodwater (ERM 2009).

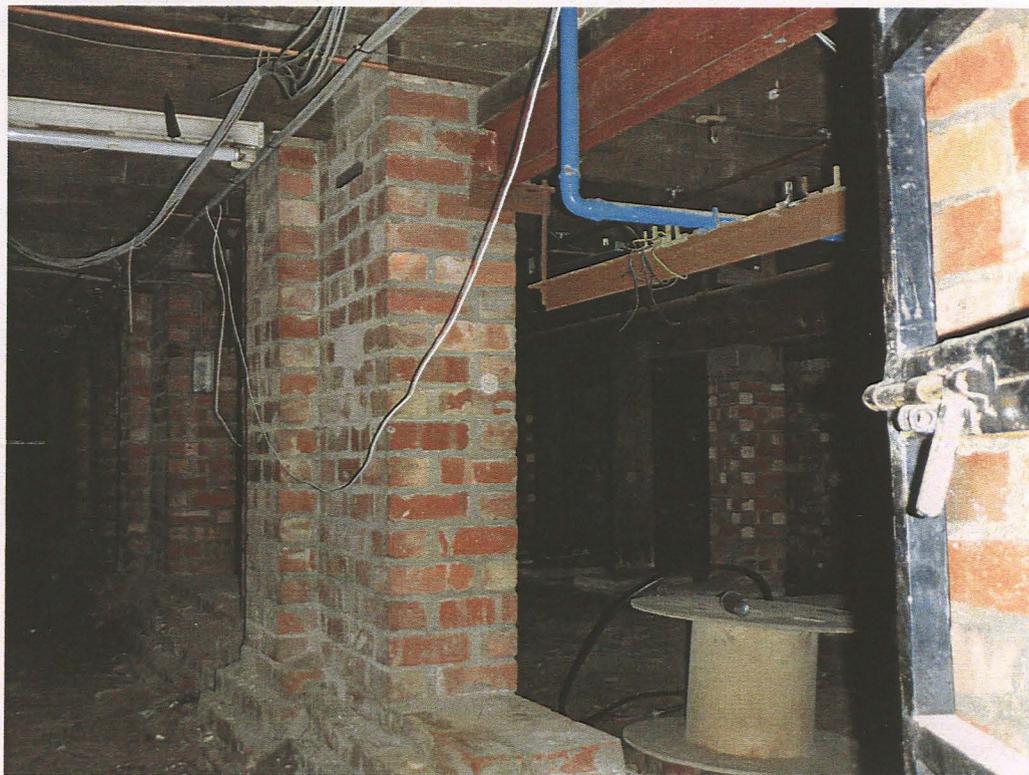
Pl. 8 Part of the area beneath the original factory building, showing services suspended beneath the ceiling

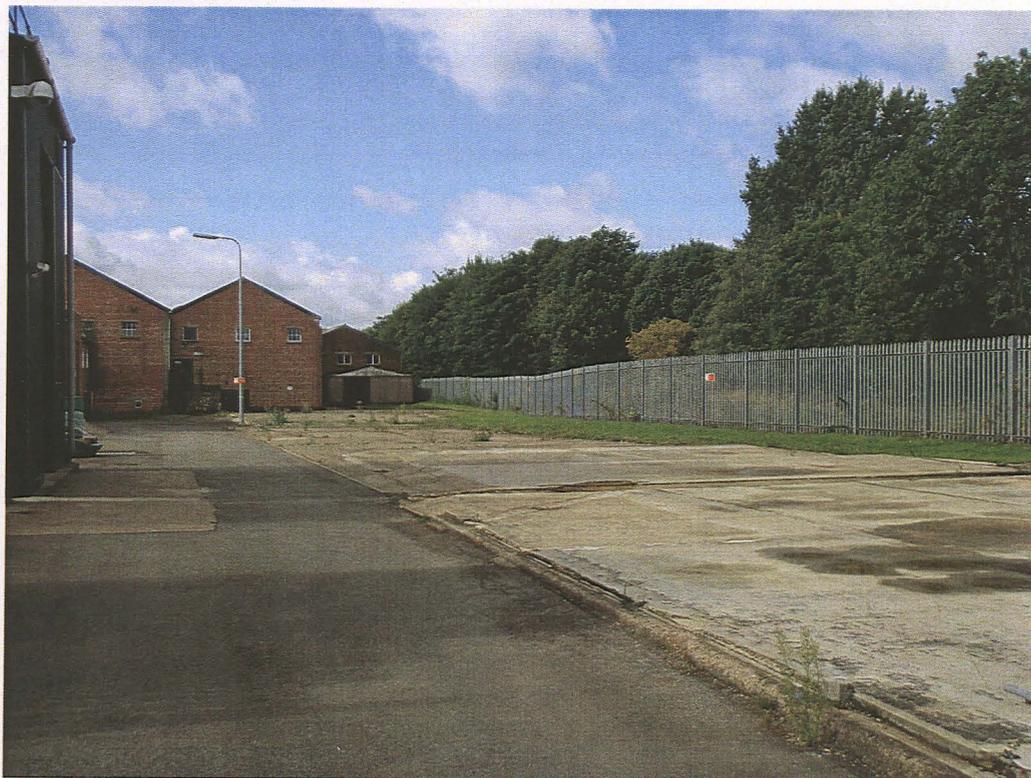
Pl. 10 West Yard showing concrete base for former buildings, with drain running along the other side of the metal boundary fence, looking south.

To the west of the main factory complex is an open area, with concrete pads along the western boundary marking the former position of outbuildings (Pls 10 and 11). There is a further open space along the southern boundary fence (Pl. 12). It is here that railway tracks are still visible, that linked to the LNER track across the Fossdyke (Pl. 13-15). The railway crossed a swing bridge to reach the site with three branches of sidings shown on the 1930 OS Map (Fig. 6). The rails from the central siding are still visible (Pl. 15). A sump in front of the white storage cabin is an example of below ground disturbance on the site (Pl. 16)

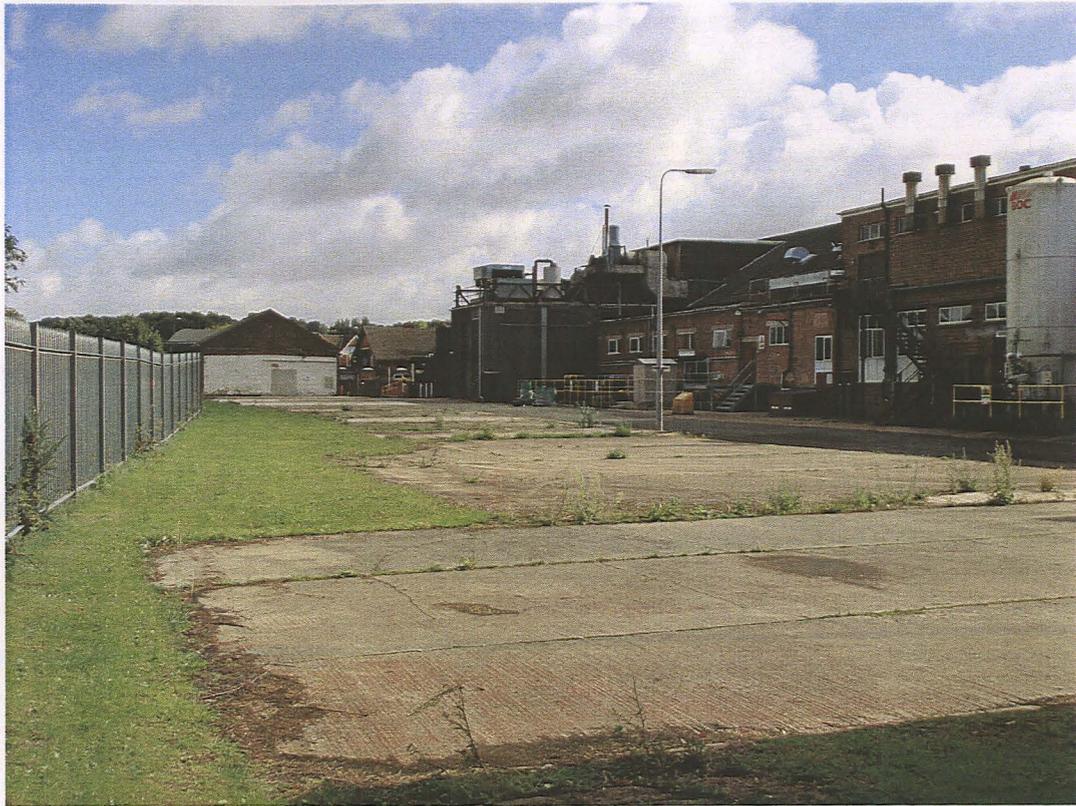
Pl. 11 The West Yard with engineering works to east, looking north.

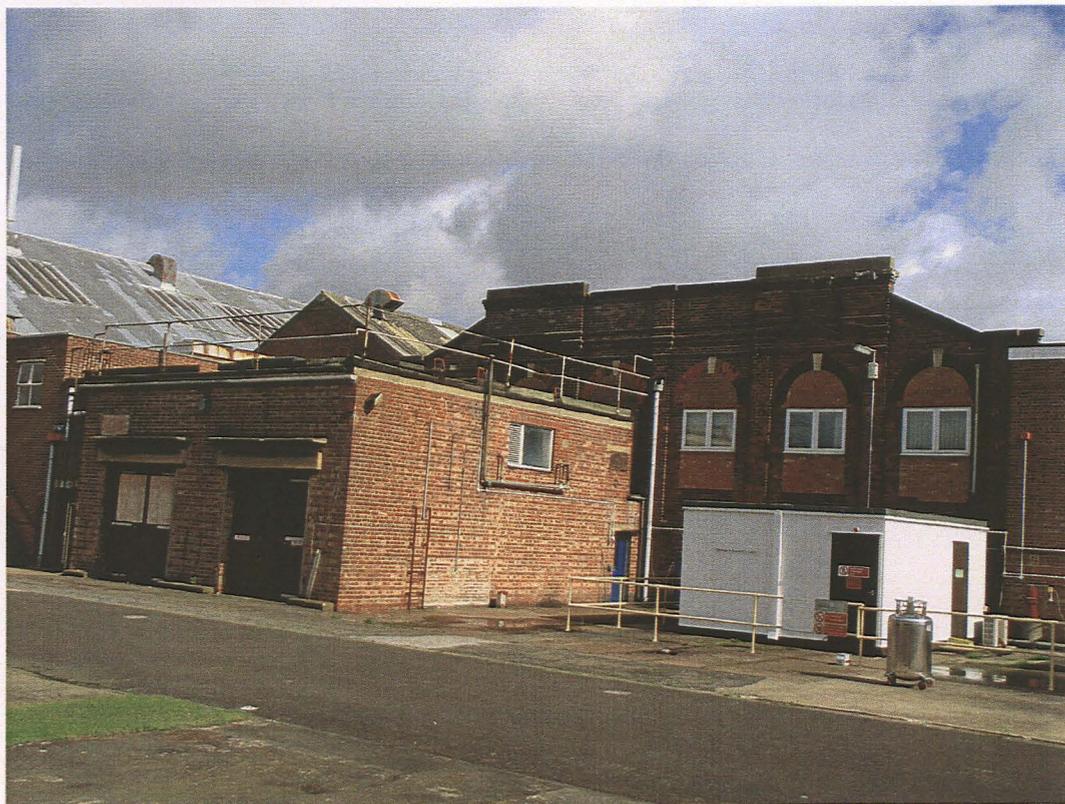
Pl. 14 The original timber works building with modern additions in front and location of railway tracks next to the white storage cabin, looking north-west

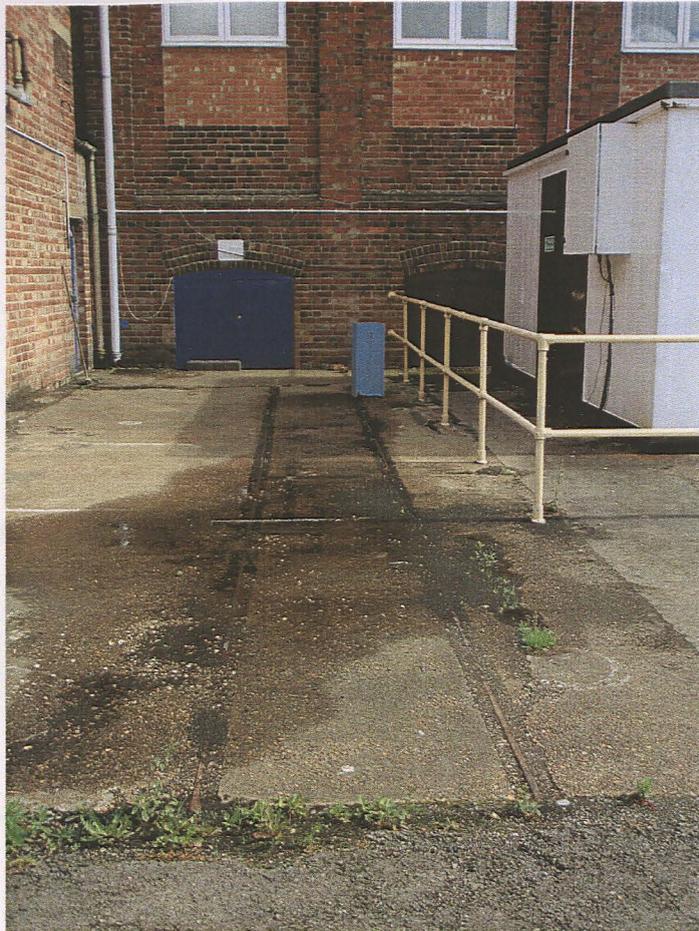
Pl. 15 One of the surviving rail tracks, looking north
