**e2v Site, Carholme Rd, Lincoln
Heritage Statement**

NFAC Report No. 0921

e2v, Carholme Rd, Lincoln

Heritage Statement

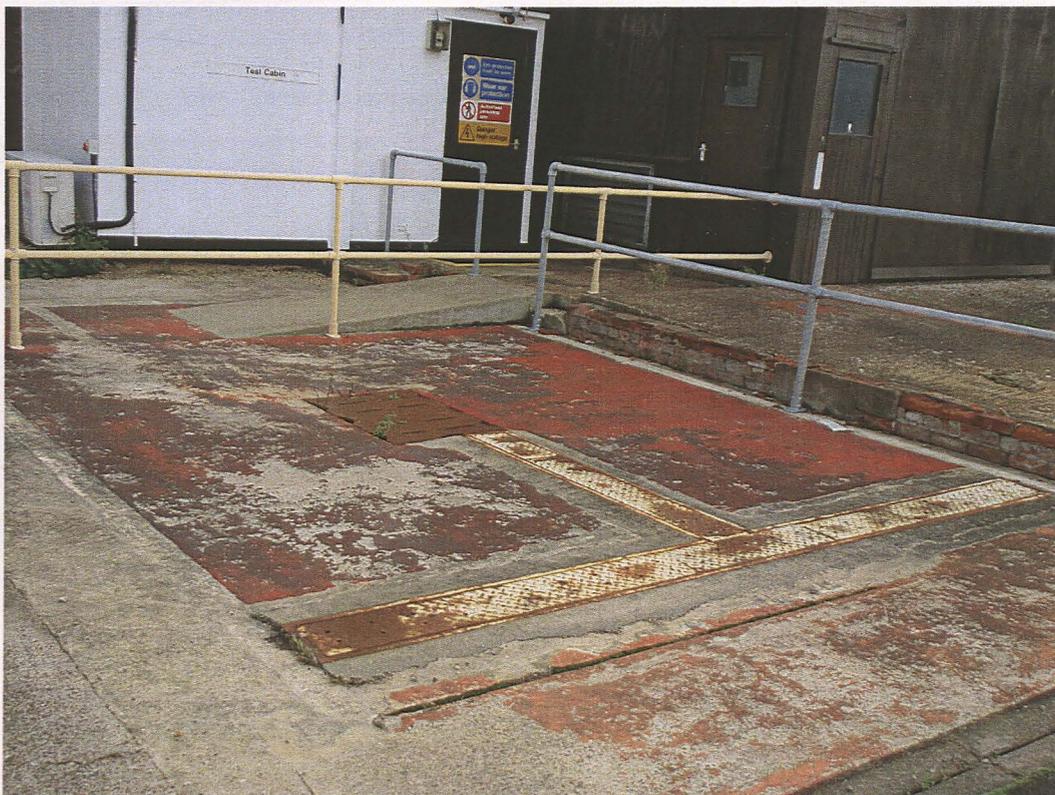
Pl. 16 Large below-ground sump, to south of main factory complex, an example of modern ground disturbance on the site, looking north-east

To the west of the main factory complex is an open area, with concrete pads along the western boundary marking the former position of outbuildings (Pls 10 and 11). There is a further open space along the southern boundary fence (Pl. 12). It is here that railway tracks are still visible, that linked to the LNER track across the Fossdyke (Pl. 13-15). The railway crossed a swing bridge to reach the site with three branches of sidings shown on the 1930 OS Map (Fig. 6). The rails from the central siding are still visible (Pl. 15). A sump in front of the white storage cabin is an example of below ground disturbance on the site (Pl. 16)

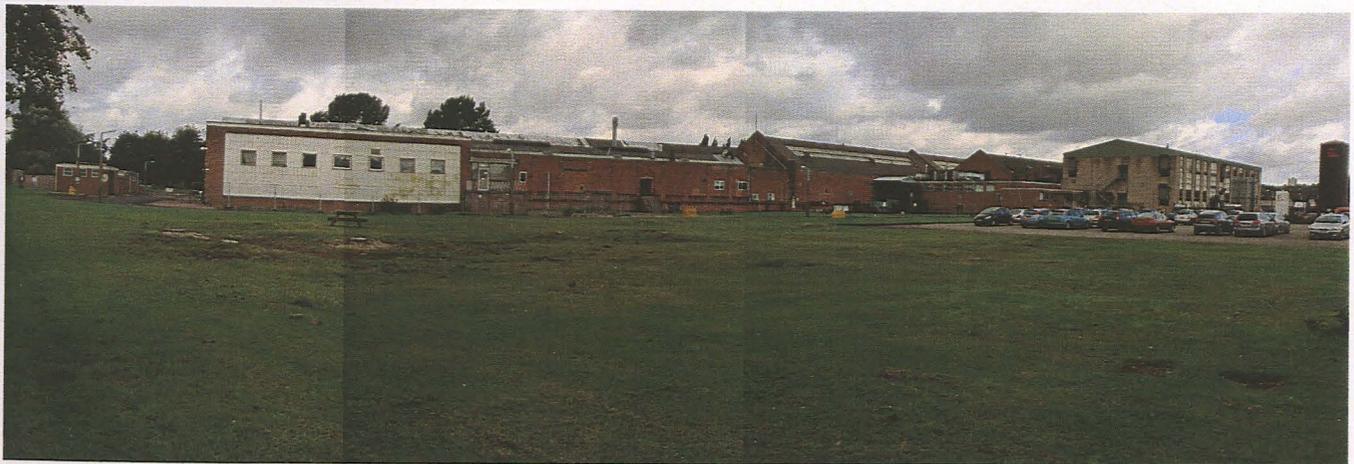
Pl. 18 composite view of the site, looking north-west showing the various phases of building construction

The large open space to the east comprises a grassed area that was until recently lined with trees along the southern boundary (Pl. 17-19). To the north is a car park with tarmac surface, and the canteen lies beyond (Pl. 20).
