LINCOLN CATHEDRAL 1992  
ELECTRICITY CABLE INSTALLATION  
*Archaeological Report (Interim)*

CLAU ARCHAEOLOGICAL REPORT NO: 30

**A Report to The Dean & Chapter, Lincoln Cathedral**

**LINCOLN CATHEDRAL 1992 ELECTRICITY CABLE INSTALLATION  
ARCHAEOLOGICAL REPORT (INTERIM)**

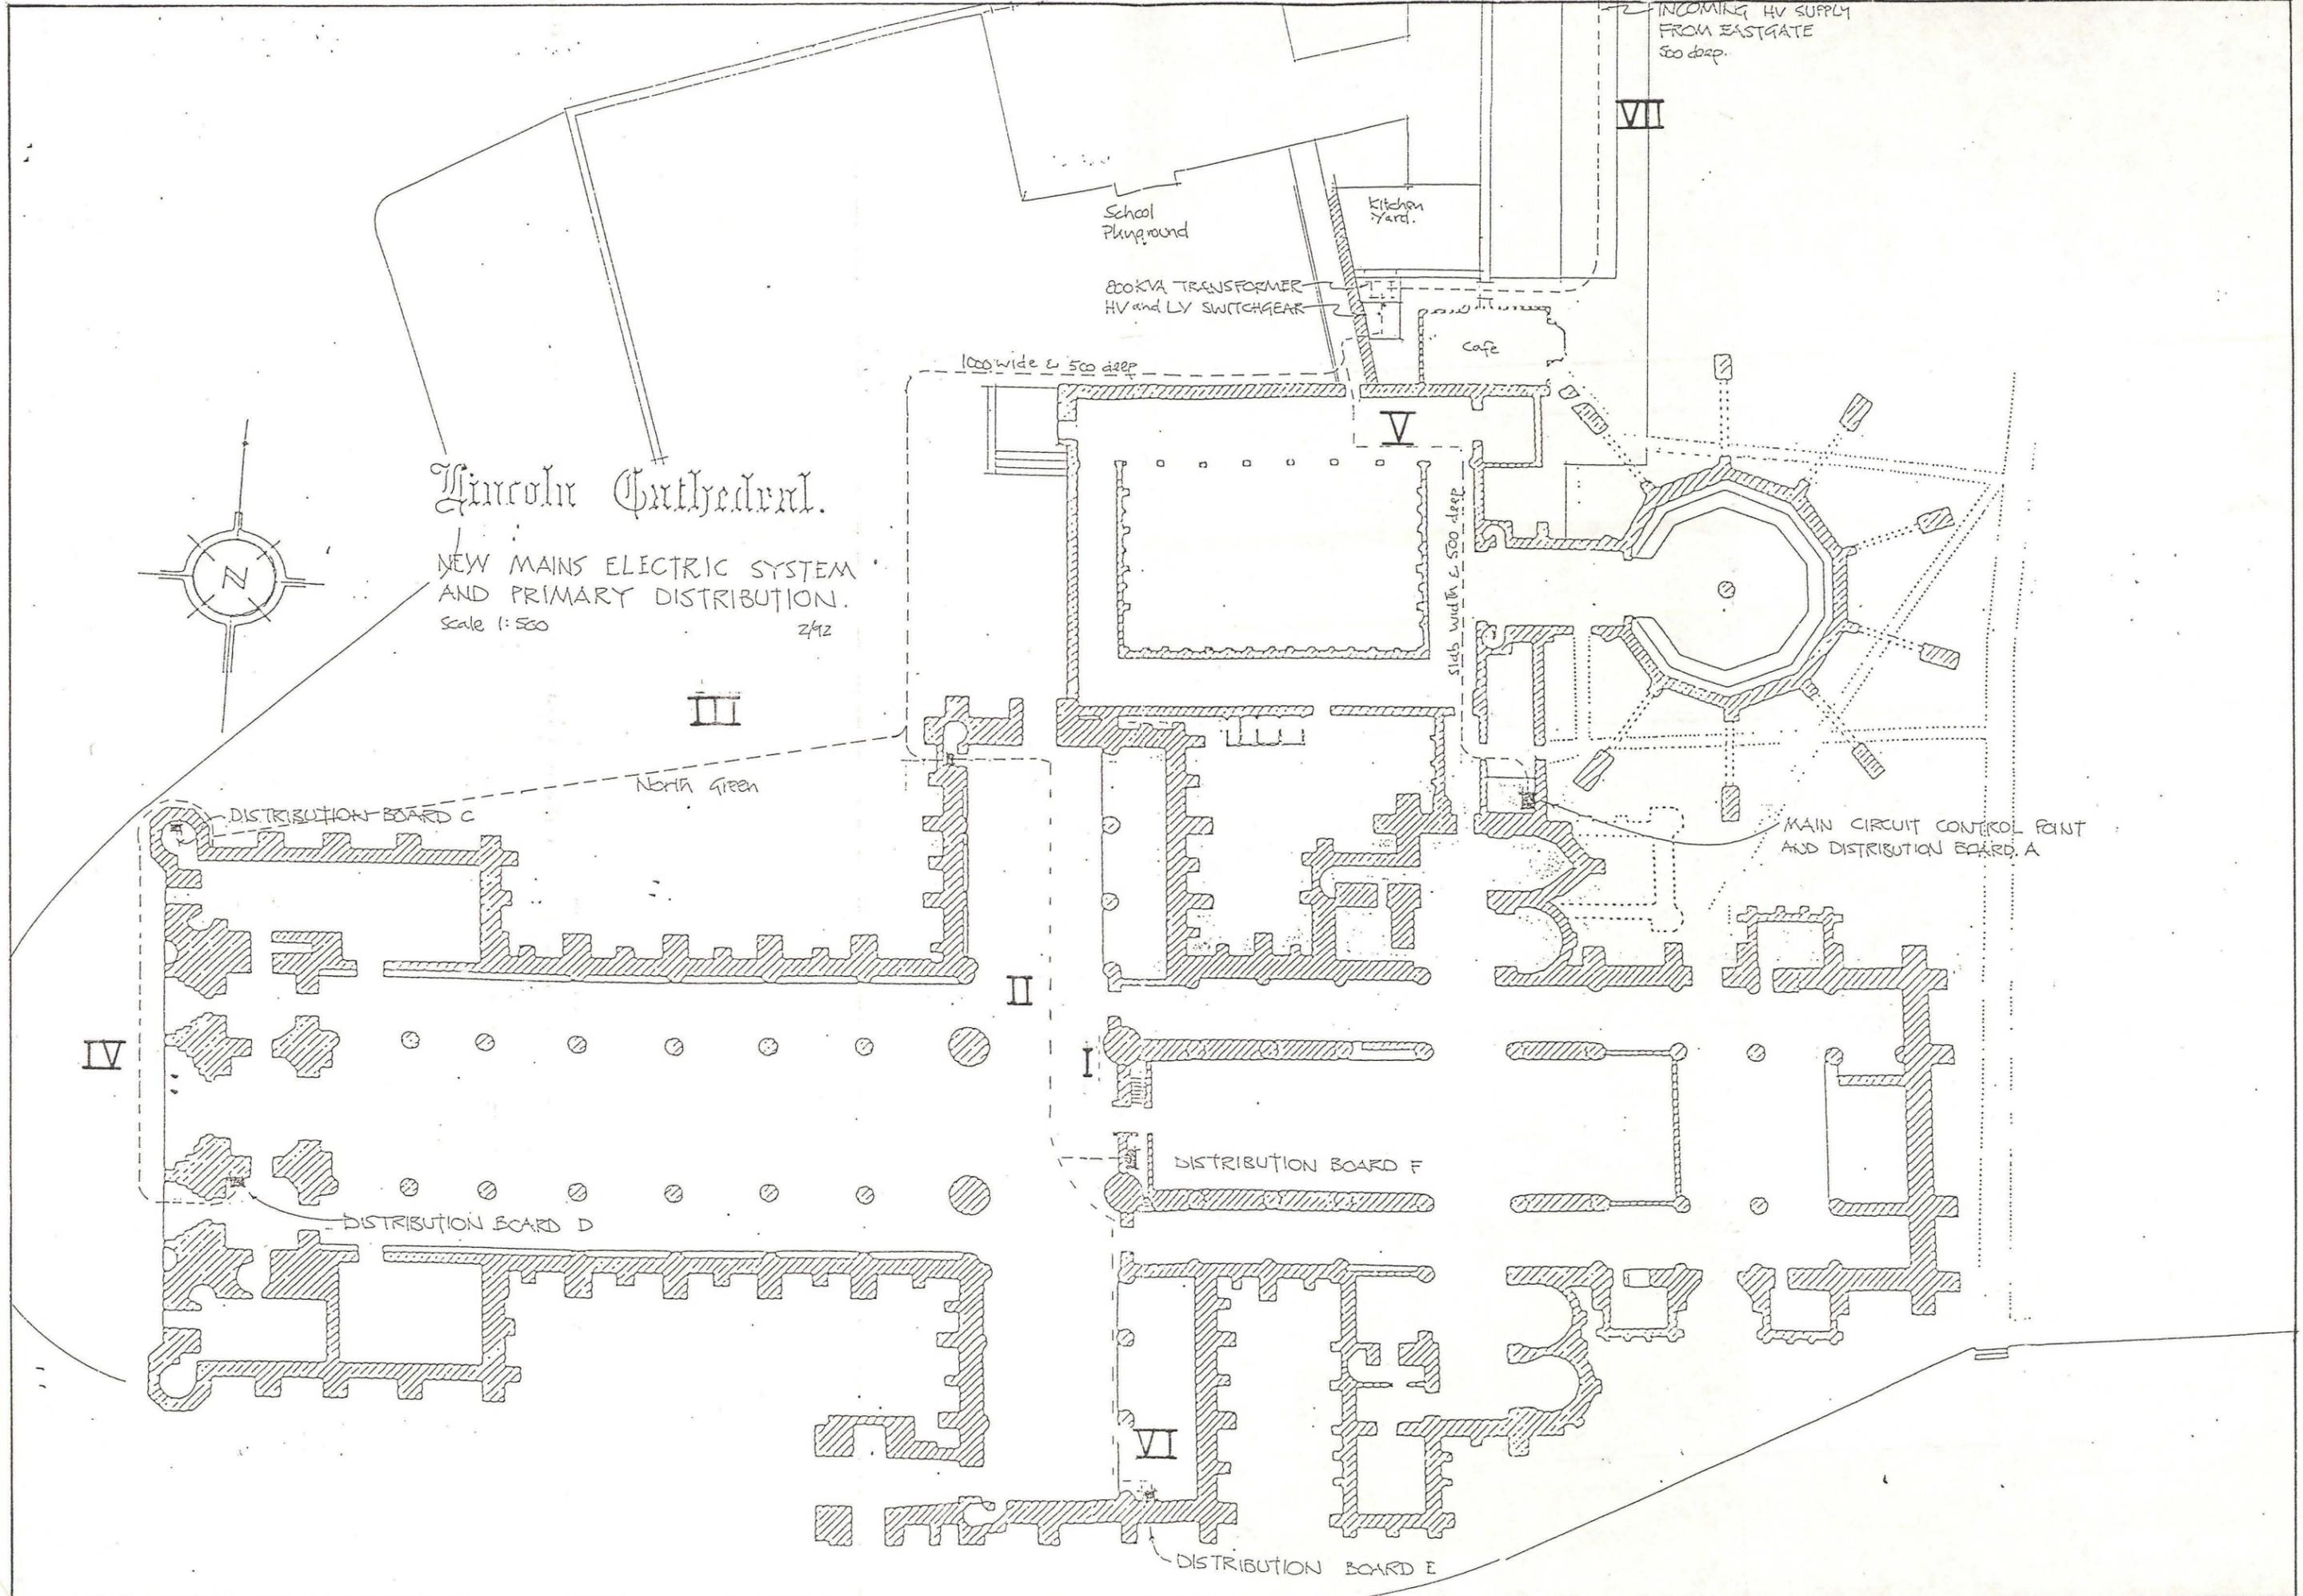
Fig.2

NEW MAINS ELECTRIC SYSTEM  
AND PRIMARY DISTRIBUTION.  
Scale 1:500  
2/42

Originally the CLAU had been asked to undertake an intermittent watching brief inside the Cathedral as the cable was to be laid in existing duct work. When this proved impractical, a more intensive watching brief was required with some excavation internally. The external trenches in the Dean's Green and Cathedral School Yard were fully excavated by the Unit. A watching brief was also carried out at the West Front and on the north-east lawn (Fig.2).

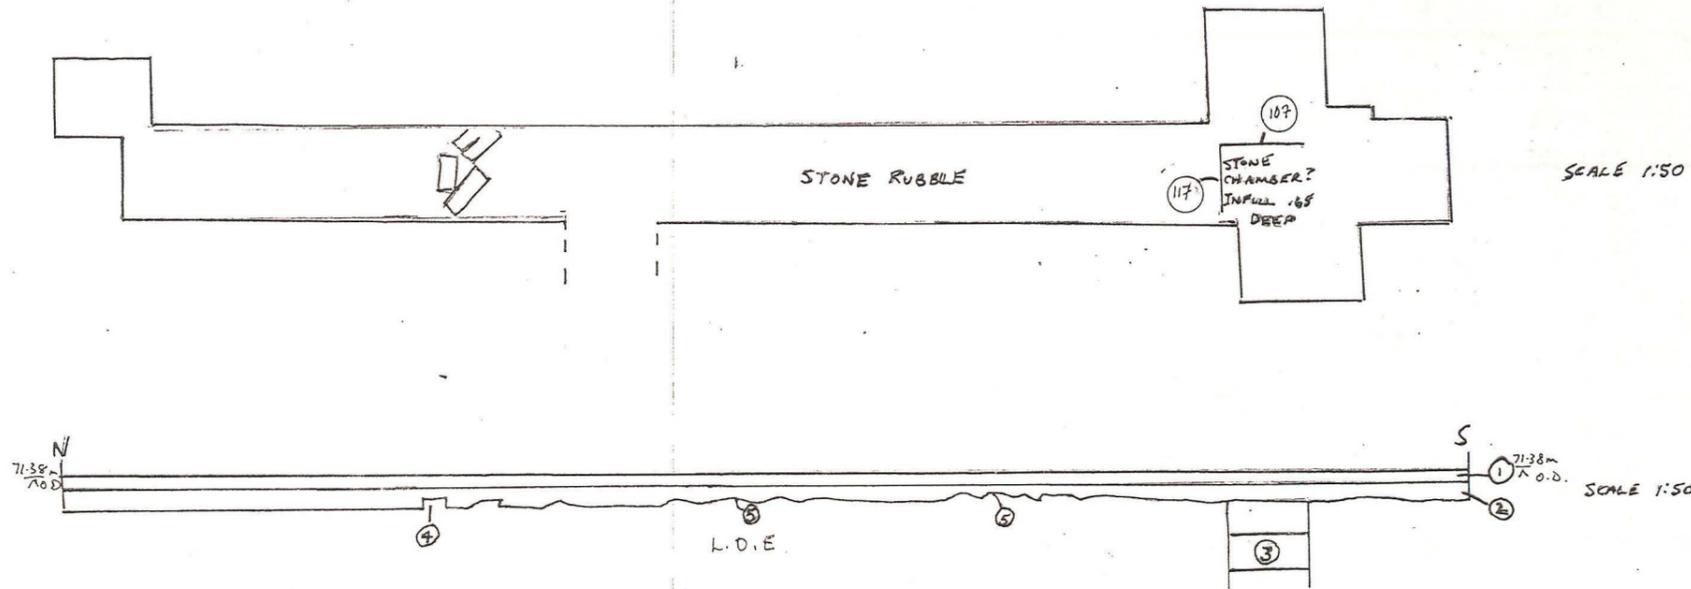
Fig.6

SITE CODE: ON 424	PLAN/SECTION NO: 2 (int.)
DESCRIPTION: REMOVAL OF SLABS AT LINCOLN CATHEDRAL TRENCH 3	
SCALE: 1:50	DATE: 17/2/92
DRAWN BY: L.G.D.	CHECKED:
ARCHIVE NO:

A trial pit and trench in Area I revealed a portion of a stone chamber directly to the NW of the steps to the Angel Choir(Fig.6) This was not investigated further and the final trench was subsequently sited further to the W.

A trench was cut through the doorway at the N wall of the Cloister to lay internal cable which would link the external electricity cables to an existing duct located at the E. side of the Cloister. The 'L' shaped trench revealed only a layer of light brown soil(334) which was overlain by bedding material(335) for the present slab floor(336)(Fig.6).

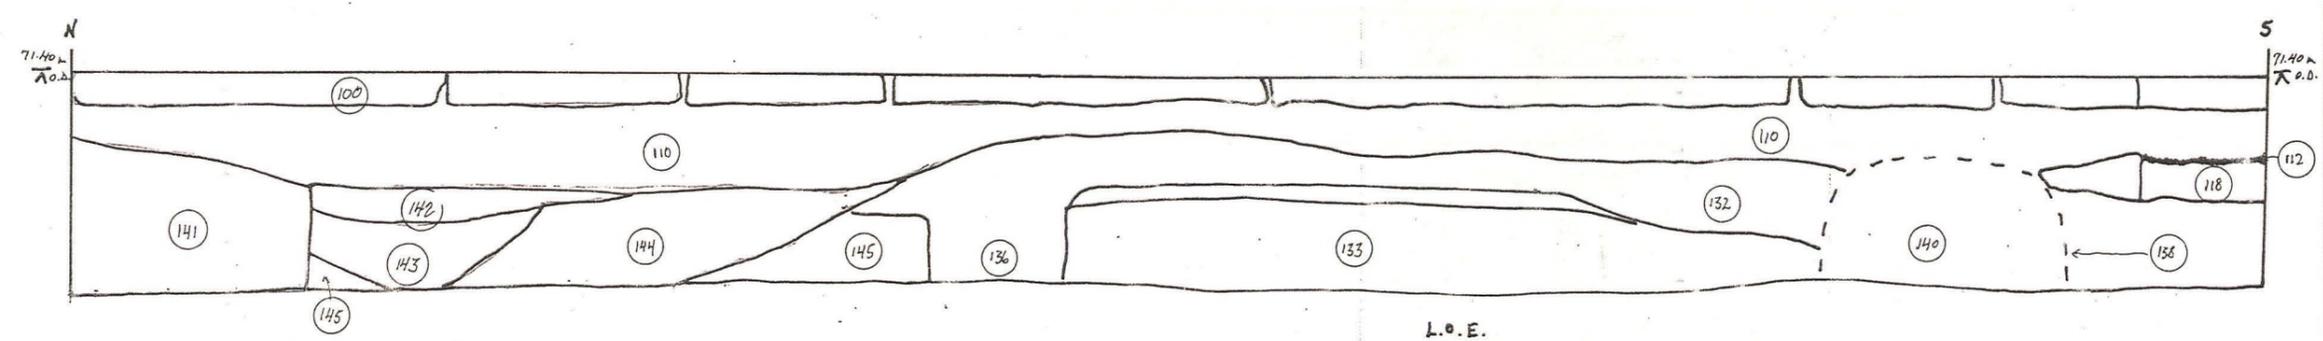
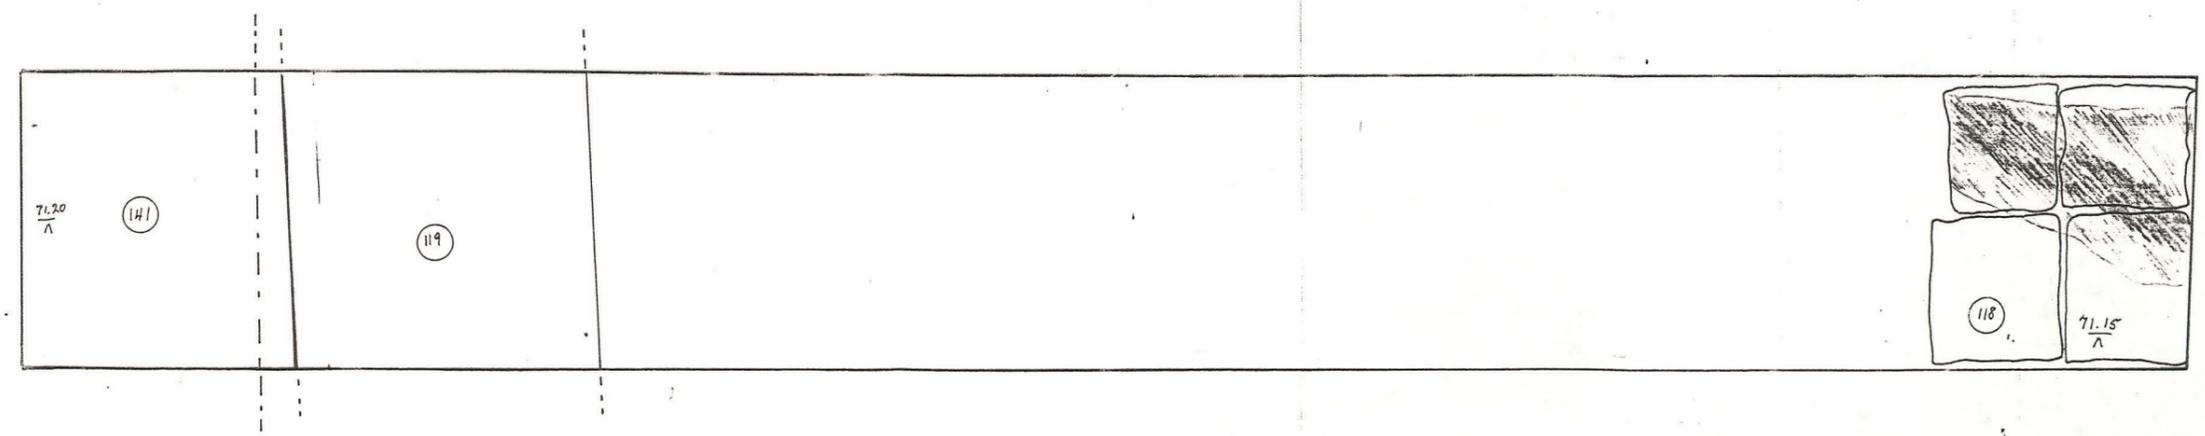
Fig.7

CITY OF LINCOLN ARCHAEOLOGY UNIT		
SITE CODE: COW 92	PLAN/SECTION NO: 5a (wr.)	
CLIENT: LINCOLN CATHEDRAL		
DESCRIPTION: W. FACING SECTION / PLAN OF 112 / 119 / 141		
SCALE: 1:20	ARCHIVE NO:	
DRAWN BY: 490	CHECKED: 490	DATE: 4/2/92

been placed directly into (126). There were no grave goods visibly associated with this burial(Figs.7,8).

Lying to the N. of (126) were the remains of a stone flagged floor(118/125). The floor was constructed of well made regular limestone slabs measuring 400mm. x 400mm. x 200mm. Floor(118) was sealed by a layer of burnt material(112). Also sealing this feature was a deposit of lead(113) which had resolidified and which filled the joints between the floor slabs. Flooring(125) to the N. had also been sealed by burnt material(112), the burning having marked and reddened the stone. After clearing the floor the burnt pattern appeared to have represented a beam lying N-S on the slabs. There was no trace of the beam itself(Fig.7).

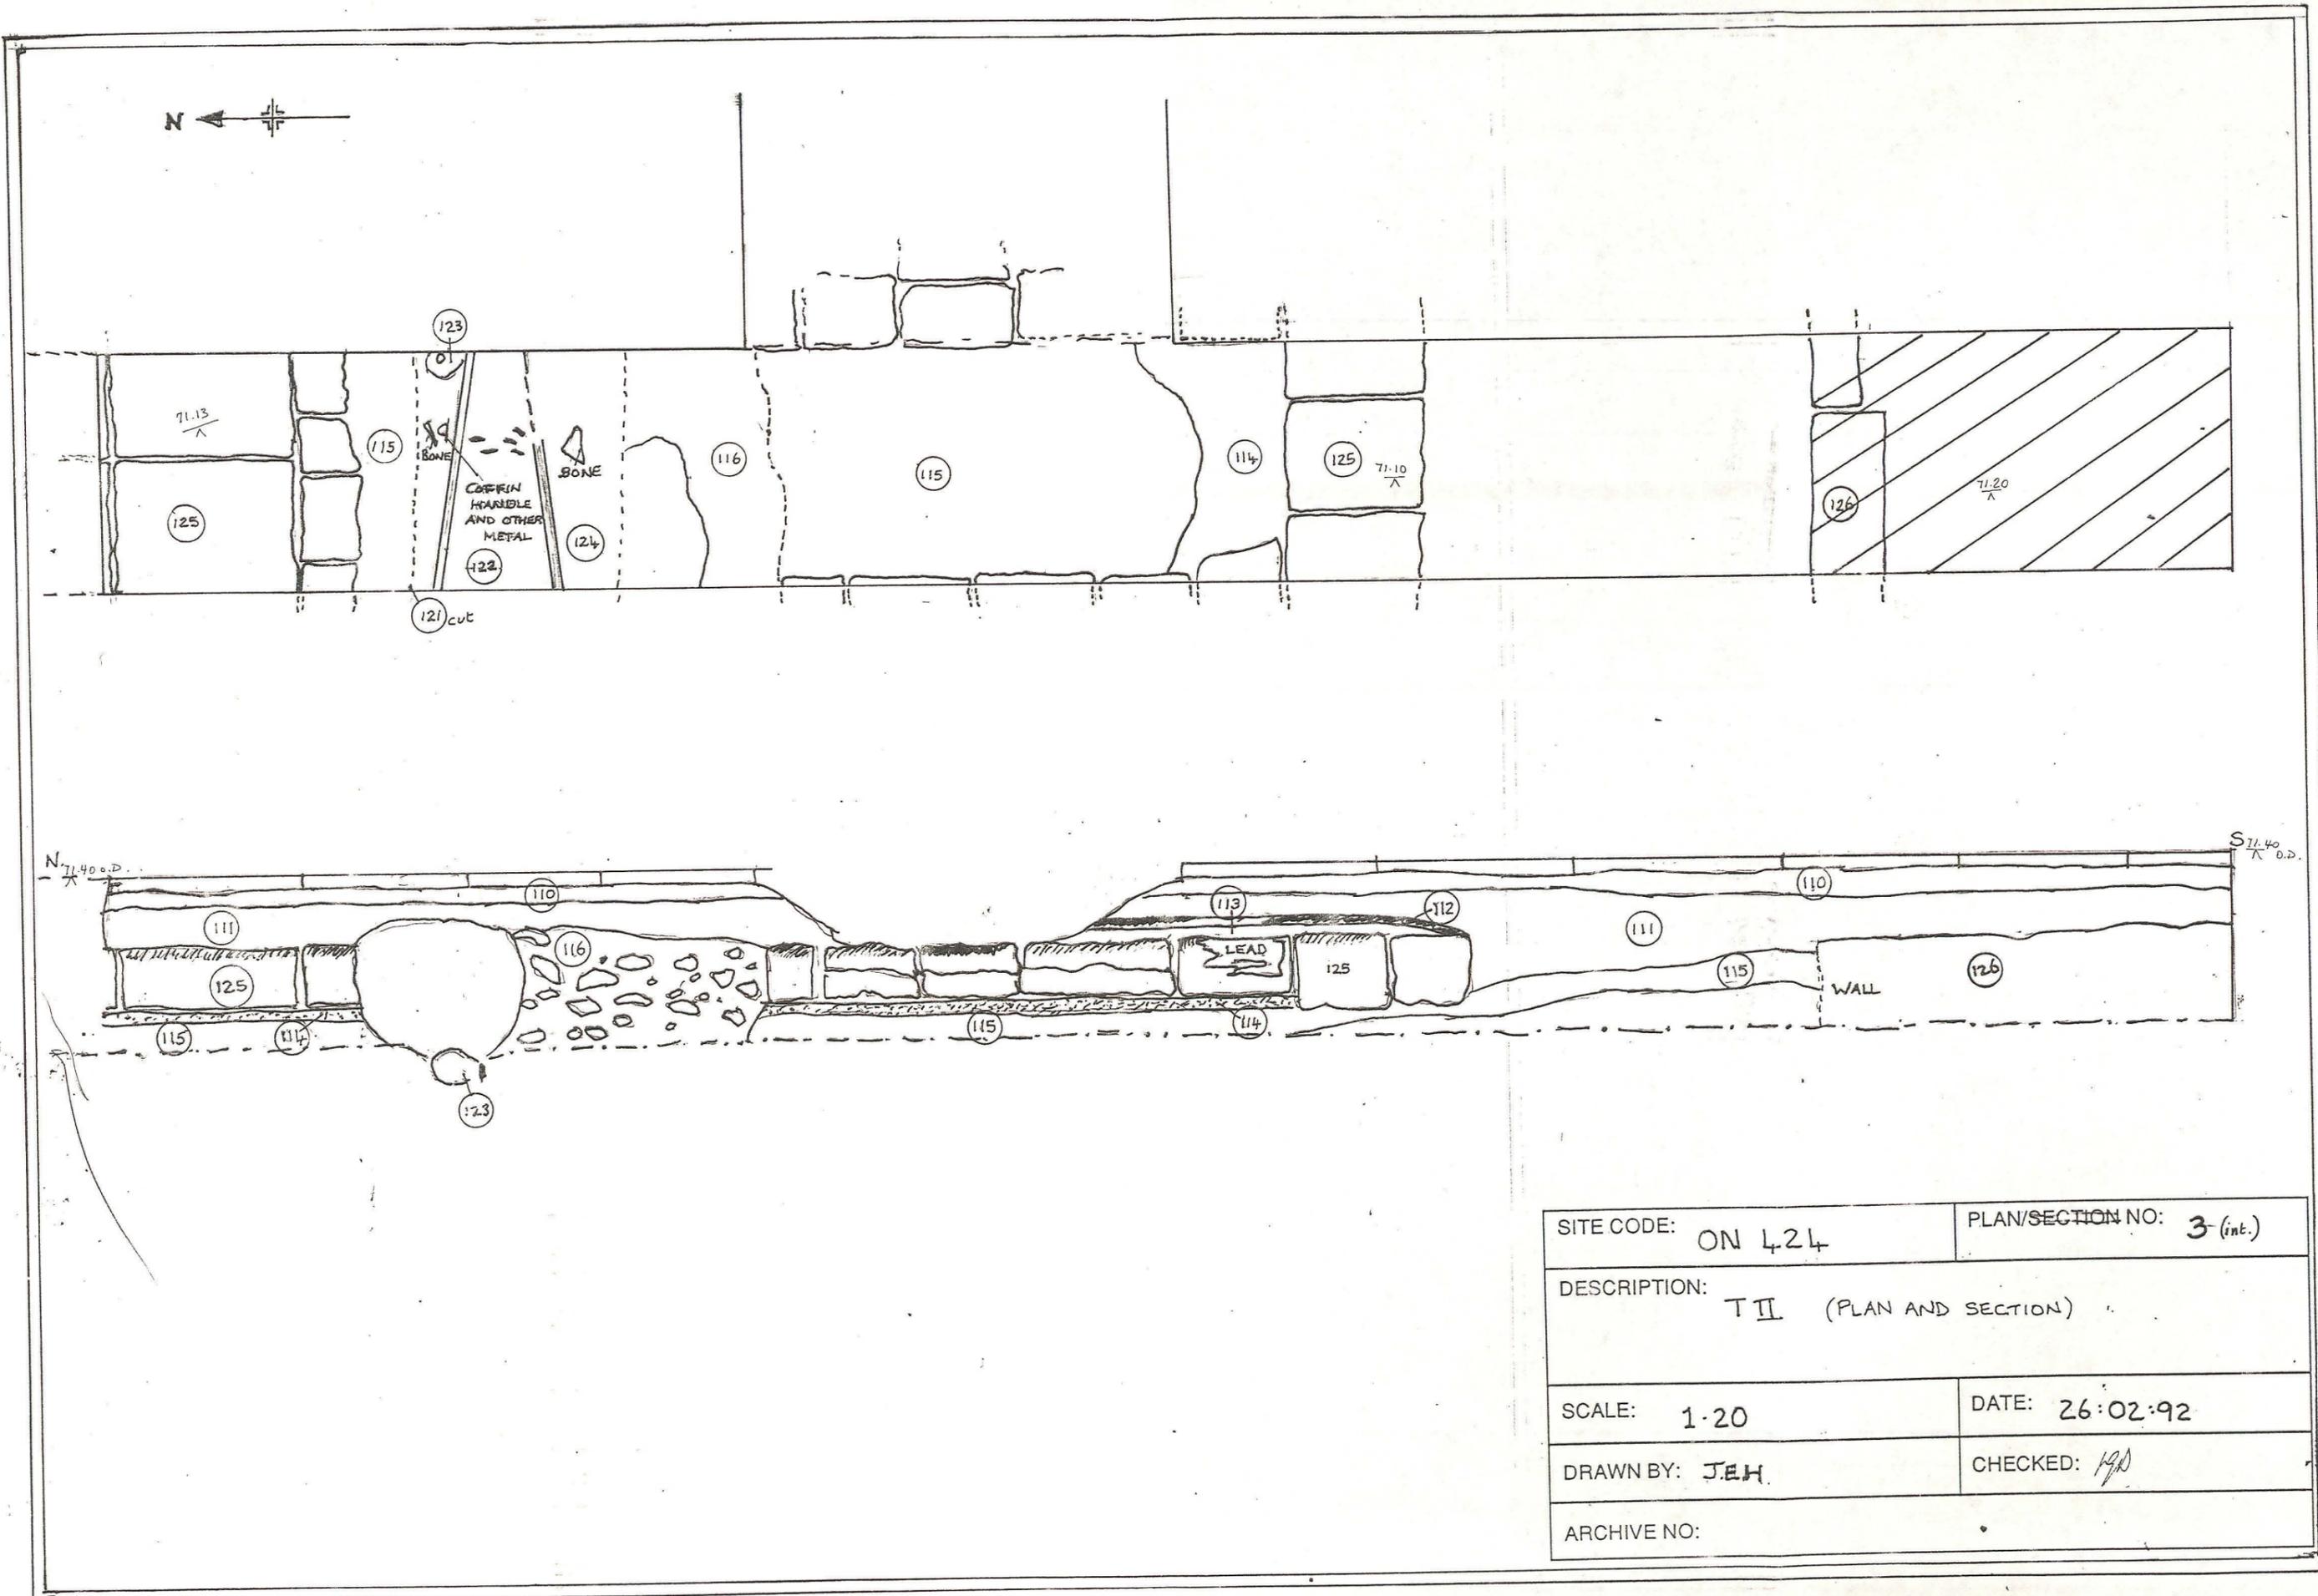
Fig.8

SITE CODE: ON 424	PLAN/SECTION NO: 3 (int.)
DESCRIPTION: T II (PLAN AND SECTION)	
SCALE: 1-20	DATE: 26-02-92
DRAWN BY: J.E.H.	CHECKED: J.E.H.
ARCHIVE NO:

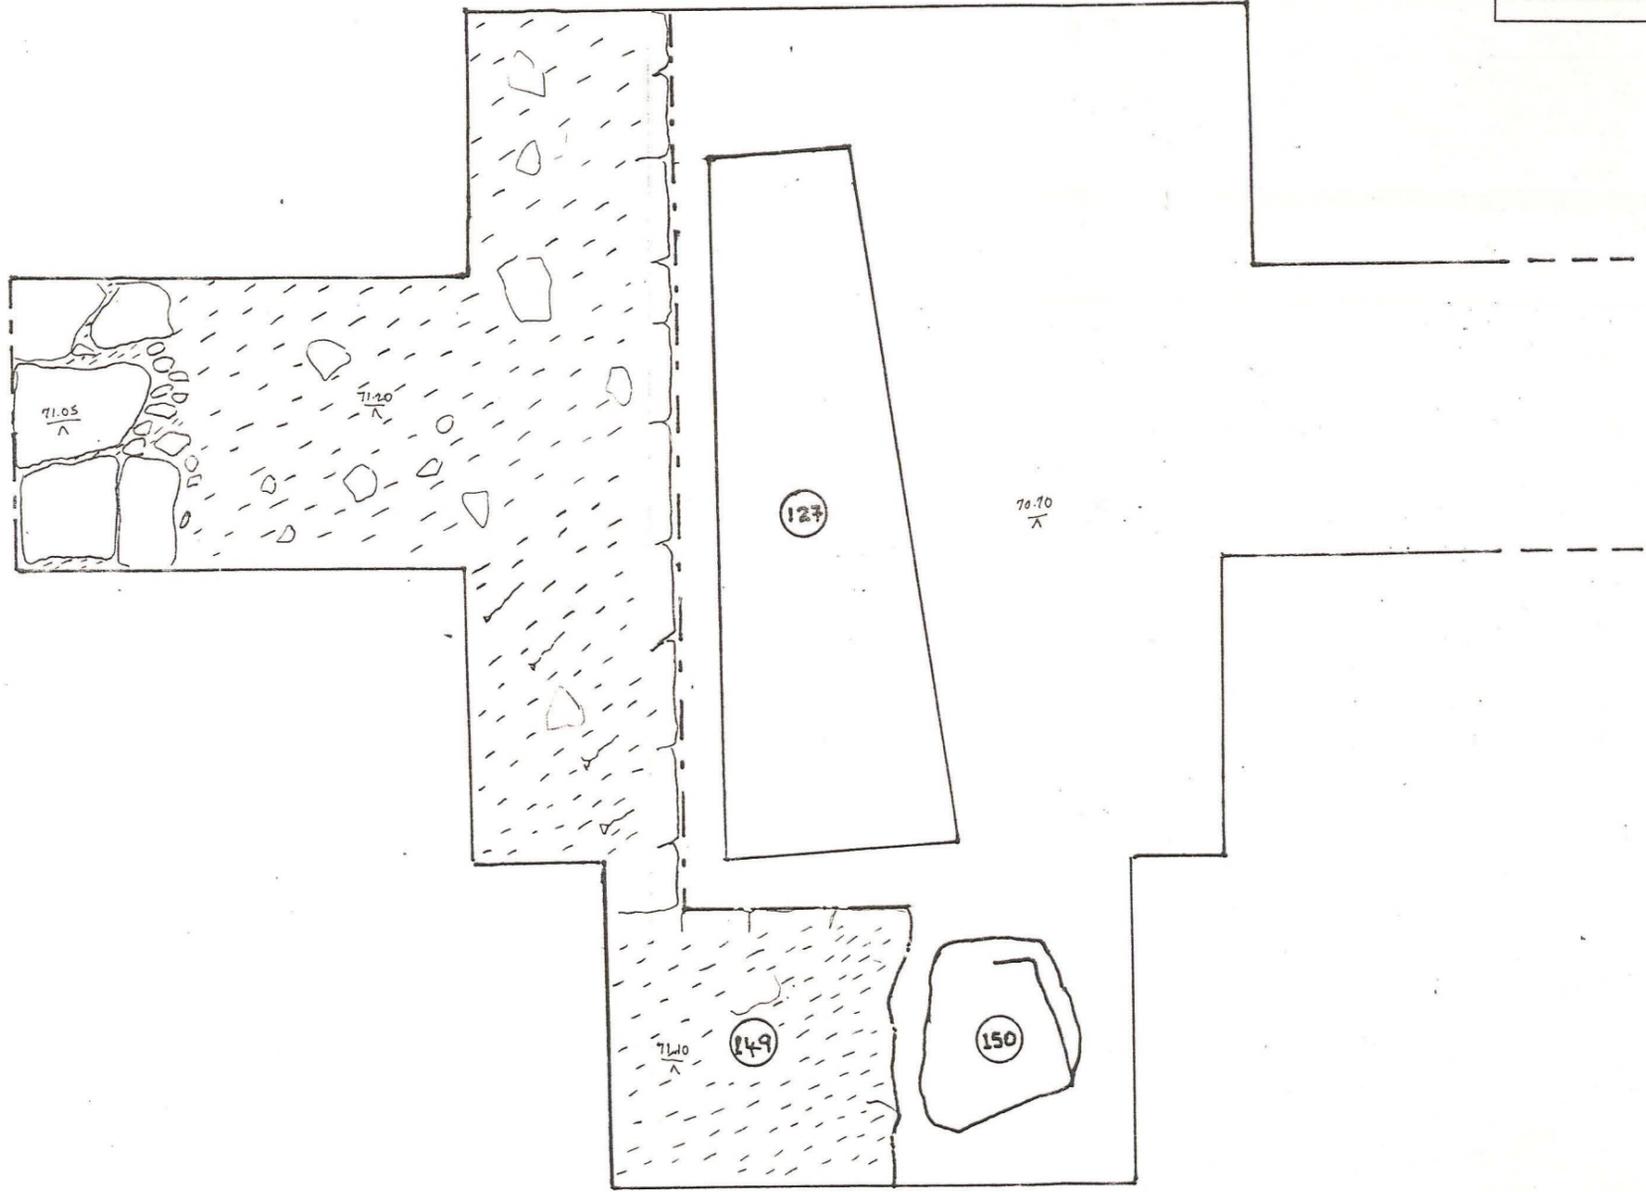
Fig.9

SITE CODE: COW 92	PLAN/SECTION NO: 9 (int.)
DESCRIPTION: E/W WALL (141) STONE FEATURE (149) STONE COFFIN (127) AND L/S BLOCK (150)	
SCALE: 1:20	DATE: 12:03:92
DRAWN BY: J.E.H	CHECKED: LPH
ARCHIVE NO:

Approximately 4.57m to the N. of floor(118/125) was another wall(141), running E-W across the trench. The wall, c.2m wide, showed a well made S. face composed of two courses of well mortared regular limestone blocks whereas the N. face was composed of rough, large, less well mortared limestone blocks. It is possible that this represents an enlargement of the wall at some point in time, though there was no dating evidence associated with (141). To the west was an extension(149) running southwards which may have formed part of a step at the entrance to the C12th N. transept. The eastern side of the wall had been cut by a modern family tomb. The size of the trench limited any real investigation and analysis of this portion of wall(Fig.9).

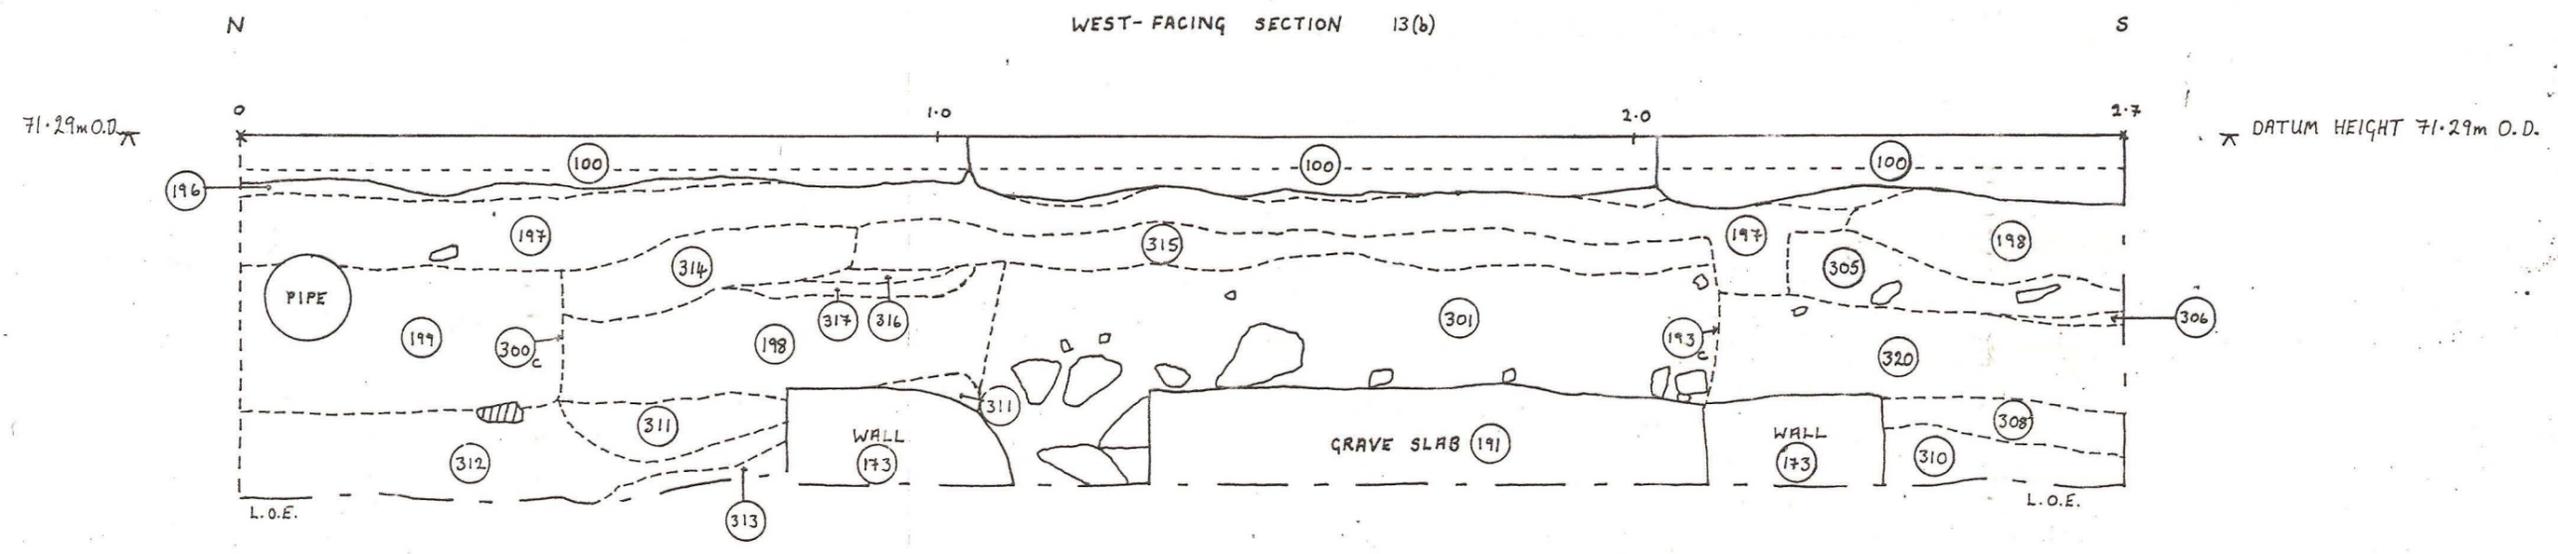
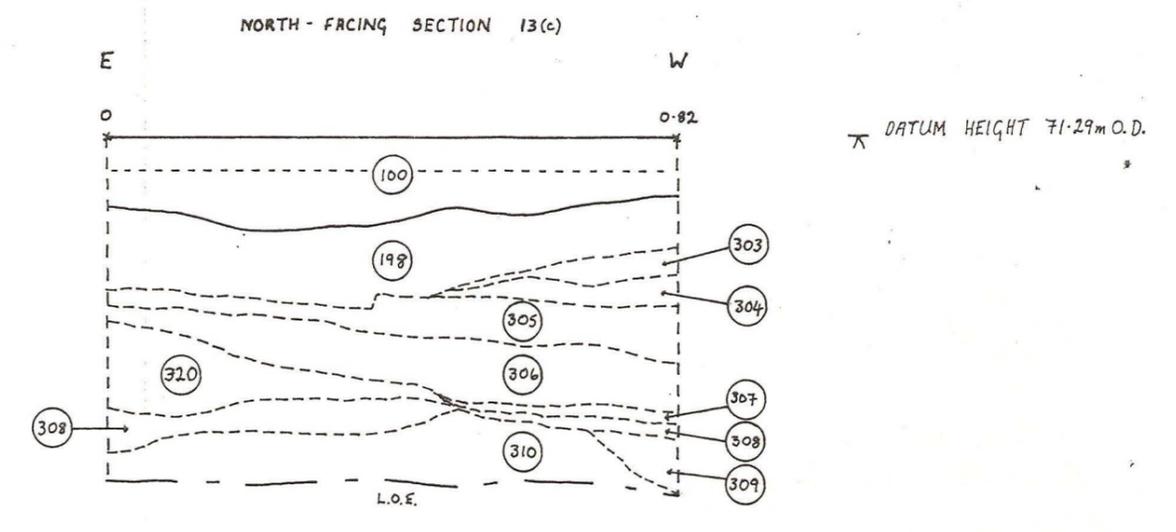
Fig.11

CITY OF LINCOLN ARCHAEOLOGY UNIT		
SITE CODE: COW 92	PLAN/ELEV/SECTION NO: 13 (b) + (c) int.	
CLIENT:		
DESCRIPTION: WEST AND NORTH FACING SECTIONS		
SCALE: 1:10	ARCHIVE NO:	
DRAWN BY: Y.R.	CHECKED: 19D	DATE: 15-06-92

area it is impossible to say how many courses remained of this feature. It had, however, been cut into by an inhumation burial which included the insertion into its core of a full stone coffin(318). There was no evidence of a grave slab, the burial having been covered by irregular limestone blocks mortared into place. Fragments of early floor (332) were also uncovered lying to the SE of feature(173). Floor (332) is another fragment of floor (118/125) which was uncovered in the N. transept. The area directly to the W. of the Angel Choir steps had been completely disturbed by five inhumations; four in stone coffins, the fifth in a lead coffin placed into a wooden coffin. Although the floor was no longer present, there was evidence of a continuous layer of burning(331) which sealed a possible surface(194) which may have been associated with the earlier floor. This layer and the surface had been cut by the stone coffins(see Burials). The lead coffin, however, appeared to have been sealed by surface(194)(Figs.11,12).

Burial (191) cut into stone feature (173) (Fig. 11). Orientated E-W with the head to the west, the skeleton lay in a stone coffin which had been placed in a cavity cut into the core of the stylobate. This had then been covered by limestone pieces mortared into place. A gap in the cover allowed a limited view of the skeleton beneath. The skeleton appeared intact with good preservation, as well, of textile and leather material. A chalice lay on the right shoulder. It was not investigated in detail as the ducting would cause no disturbance to the burial (Fig. 11).

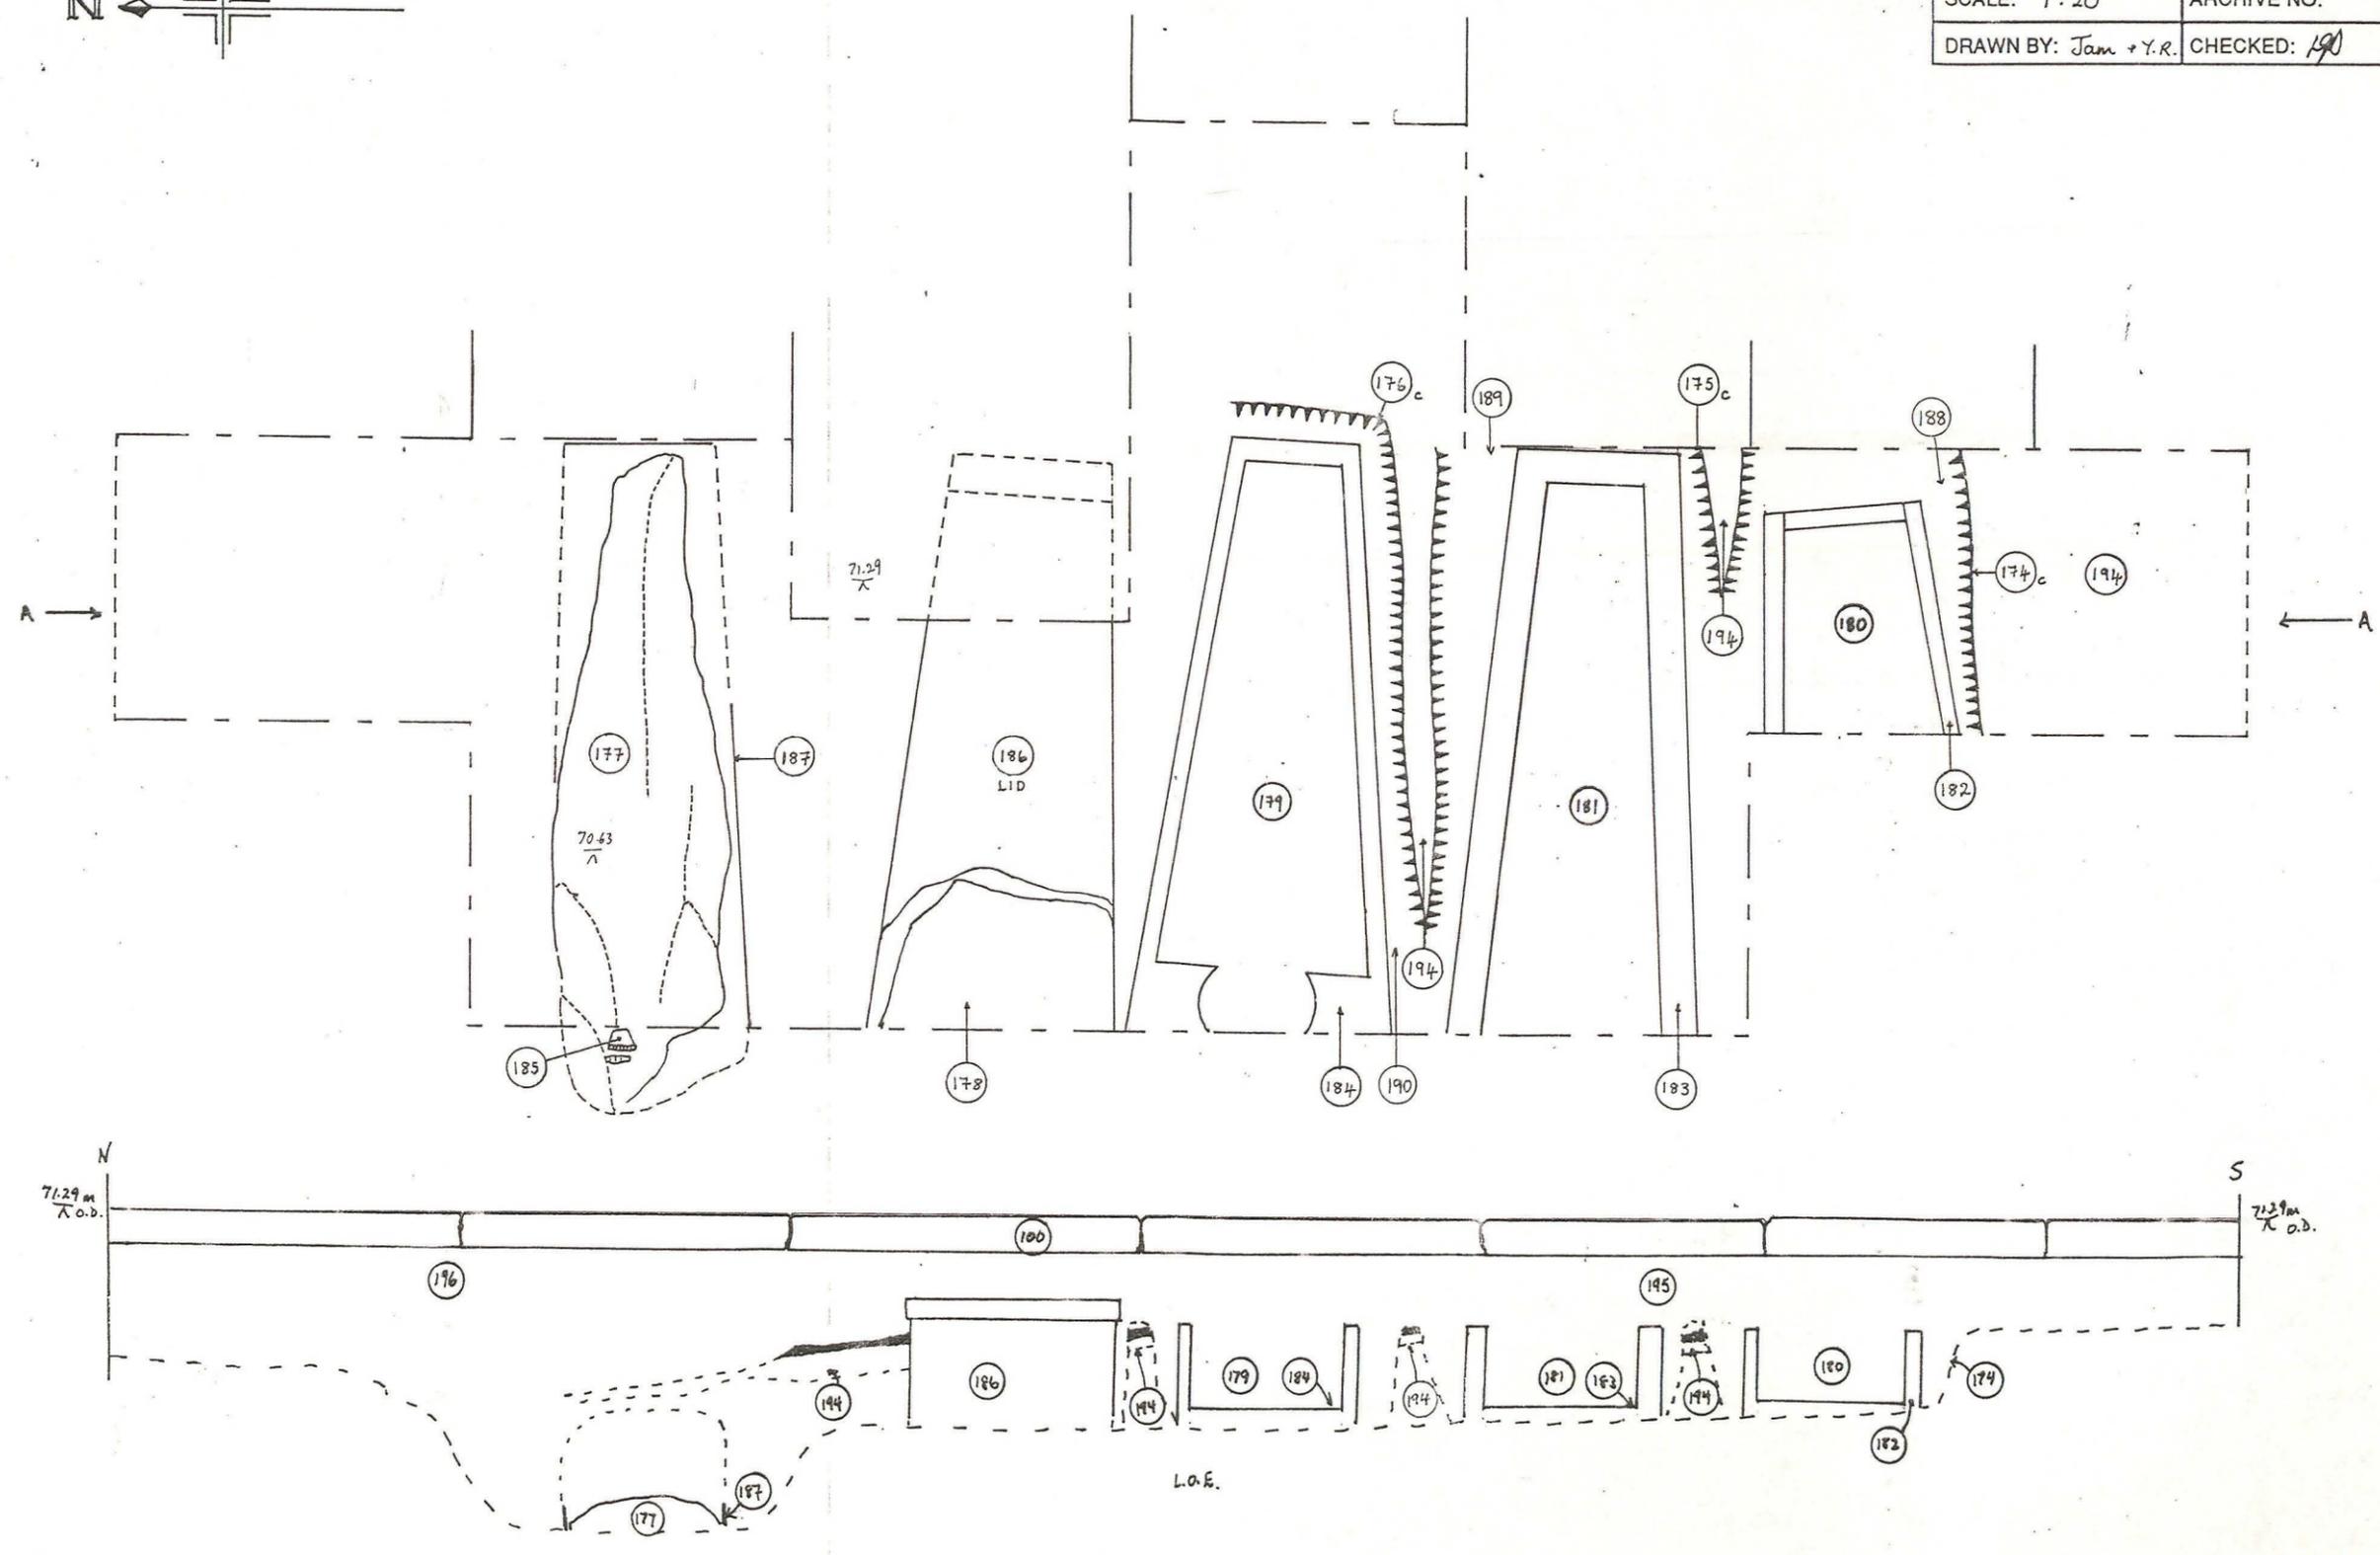
Fig.12

CITY OF LINCOLN ARCHAEOLOGY UNIT		
SITE CODE: COW 92	PLAN/ELEV/SECTION NO: 14 int.	
CLIENT:		
DESCRIPTION: SERVICE TRENCH ACROSS NAVE. LOCATION: PLAN OF COFFINS		
SCALE: 1:20	ARCHIVE NO:	
DRAWN BY: Jan + Y.R.	CHECKED: 190	DATE: 13-06-92

However, between the steps and stone feature(173) a series of stone coffin burials and one lead coffin burial was uncovered. Because the burials lay on what was then the line of the ducting and it was expected that they would have to be lifted, it was decided to investigate them as thoroughly as possible in the short time allowed before any disturbance occurred. Subsequently it was decided that the cable would be laid over the graves. After consultation with the Cathedral Archaeological Consultant, two of the burials, with coffin coverings intact were retained without any archaeological investigation(fig.). The lead coffin was uncovered during the original excavation work in an attempt to bore beneath the stone coffins(Figs.1,12).

Burial (196) lay to the N. of coffin (179) (Fig. 12). It was also orientated E-W with the head to the west. However, since the slab was virtually intact, it was not touched, the decision having been made to run the cable over the coffin rather than below it. Nevertheless, it was possible to see inside through part of the broken slab to the corpse beneath. Although the head area was covered in infill material, the rest of the skeleton appeared to be intact with vestiges of textile and embalming material evident as well as a pair of leather shoes.

Burial (177) lay to the N of the group of stone coffins (Fig. 12, 14). The body had been interred in an anthropoid lead coffin placed inside a wooden coffin. This burial appears to have been sealed by surface (194) which would then suggest an earlier context than the stone coffins which cut (194). However, one opinion on the lead coffin has dated it to the C16th. The fact that there was no continuation to the N. of the same stratigraphic sequence and because the coffin was retained in situ, coupled with the restricted nature of the trenching and the lack of firmly dated layers, the dating of this burial is left as highly questionable. There are several options presented: 1) the burial is earlier; 2) the understanding of the stratigraphy is incorrect, primarily due to the lack of dating evidence; 3) the stone coffin burials were reburials in
