LINCOLN CATHEDRAL 1992  
ELECTRICITY CABLE INSTALLATION  
*Archaeological Report (Interim)*

CLAU ARCHAEOLOGICAL REPORT NO: 30

**A Report to The Dean & Chapter, Lincoln Cathedral**

**LINCOLN CATHEDRAL 1992 ELECTRICITY CABLE INSTALLATION  
ARCHAEOLOGICAL REPORT (INTERIM)**

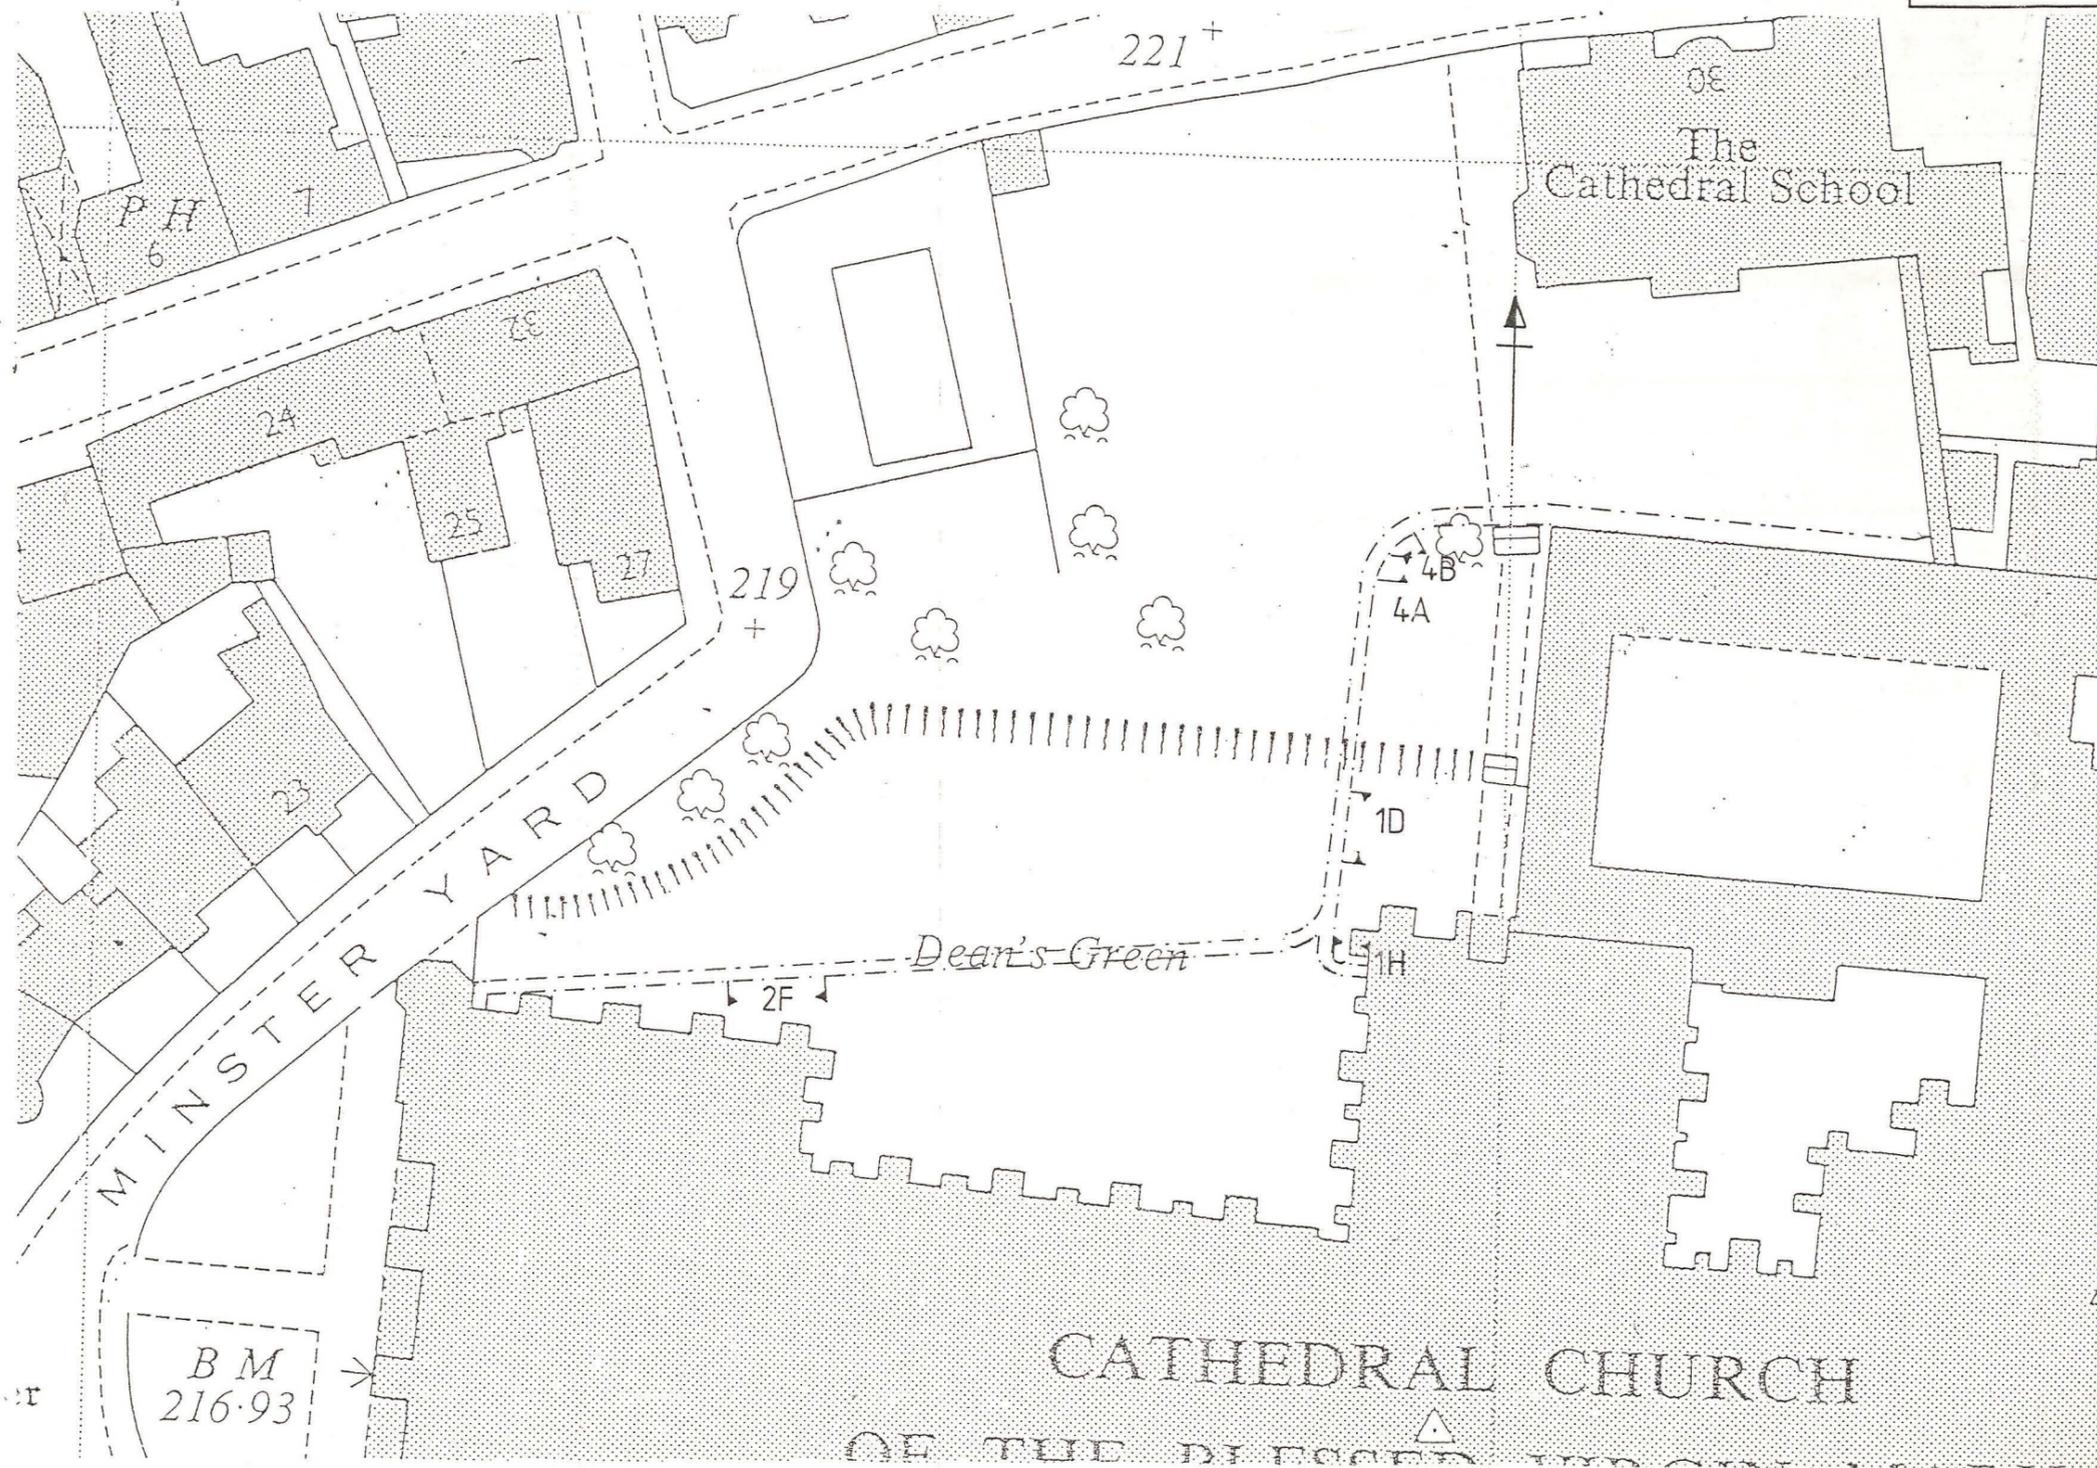
Fig.18

CITY OF LINCOLN ARCHAEOLOGY UNIT		
SITE CODE: COW 92	PLANE/ELEV/SECTION NO: FIG 18	
CLIENT: CATHEDRAL		
DESCRIPTION: AREA III GROUND PLAN SHOWING SECTION LOCATIONS		
SCALE: 1:500	ARCHIVE NO:	
DRAWN BY: K.W.	CHECKED:	DATE: 12/10/92

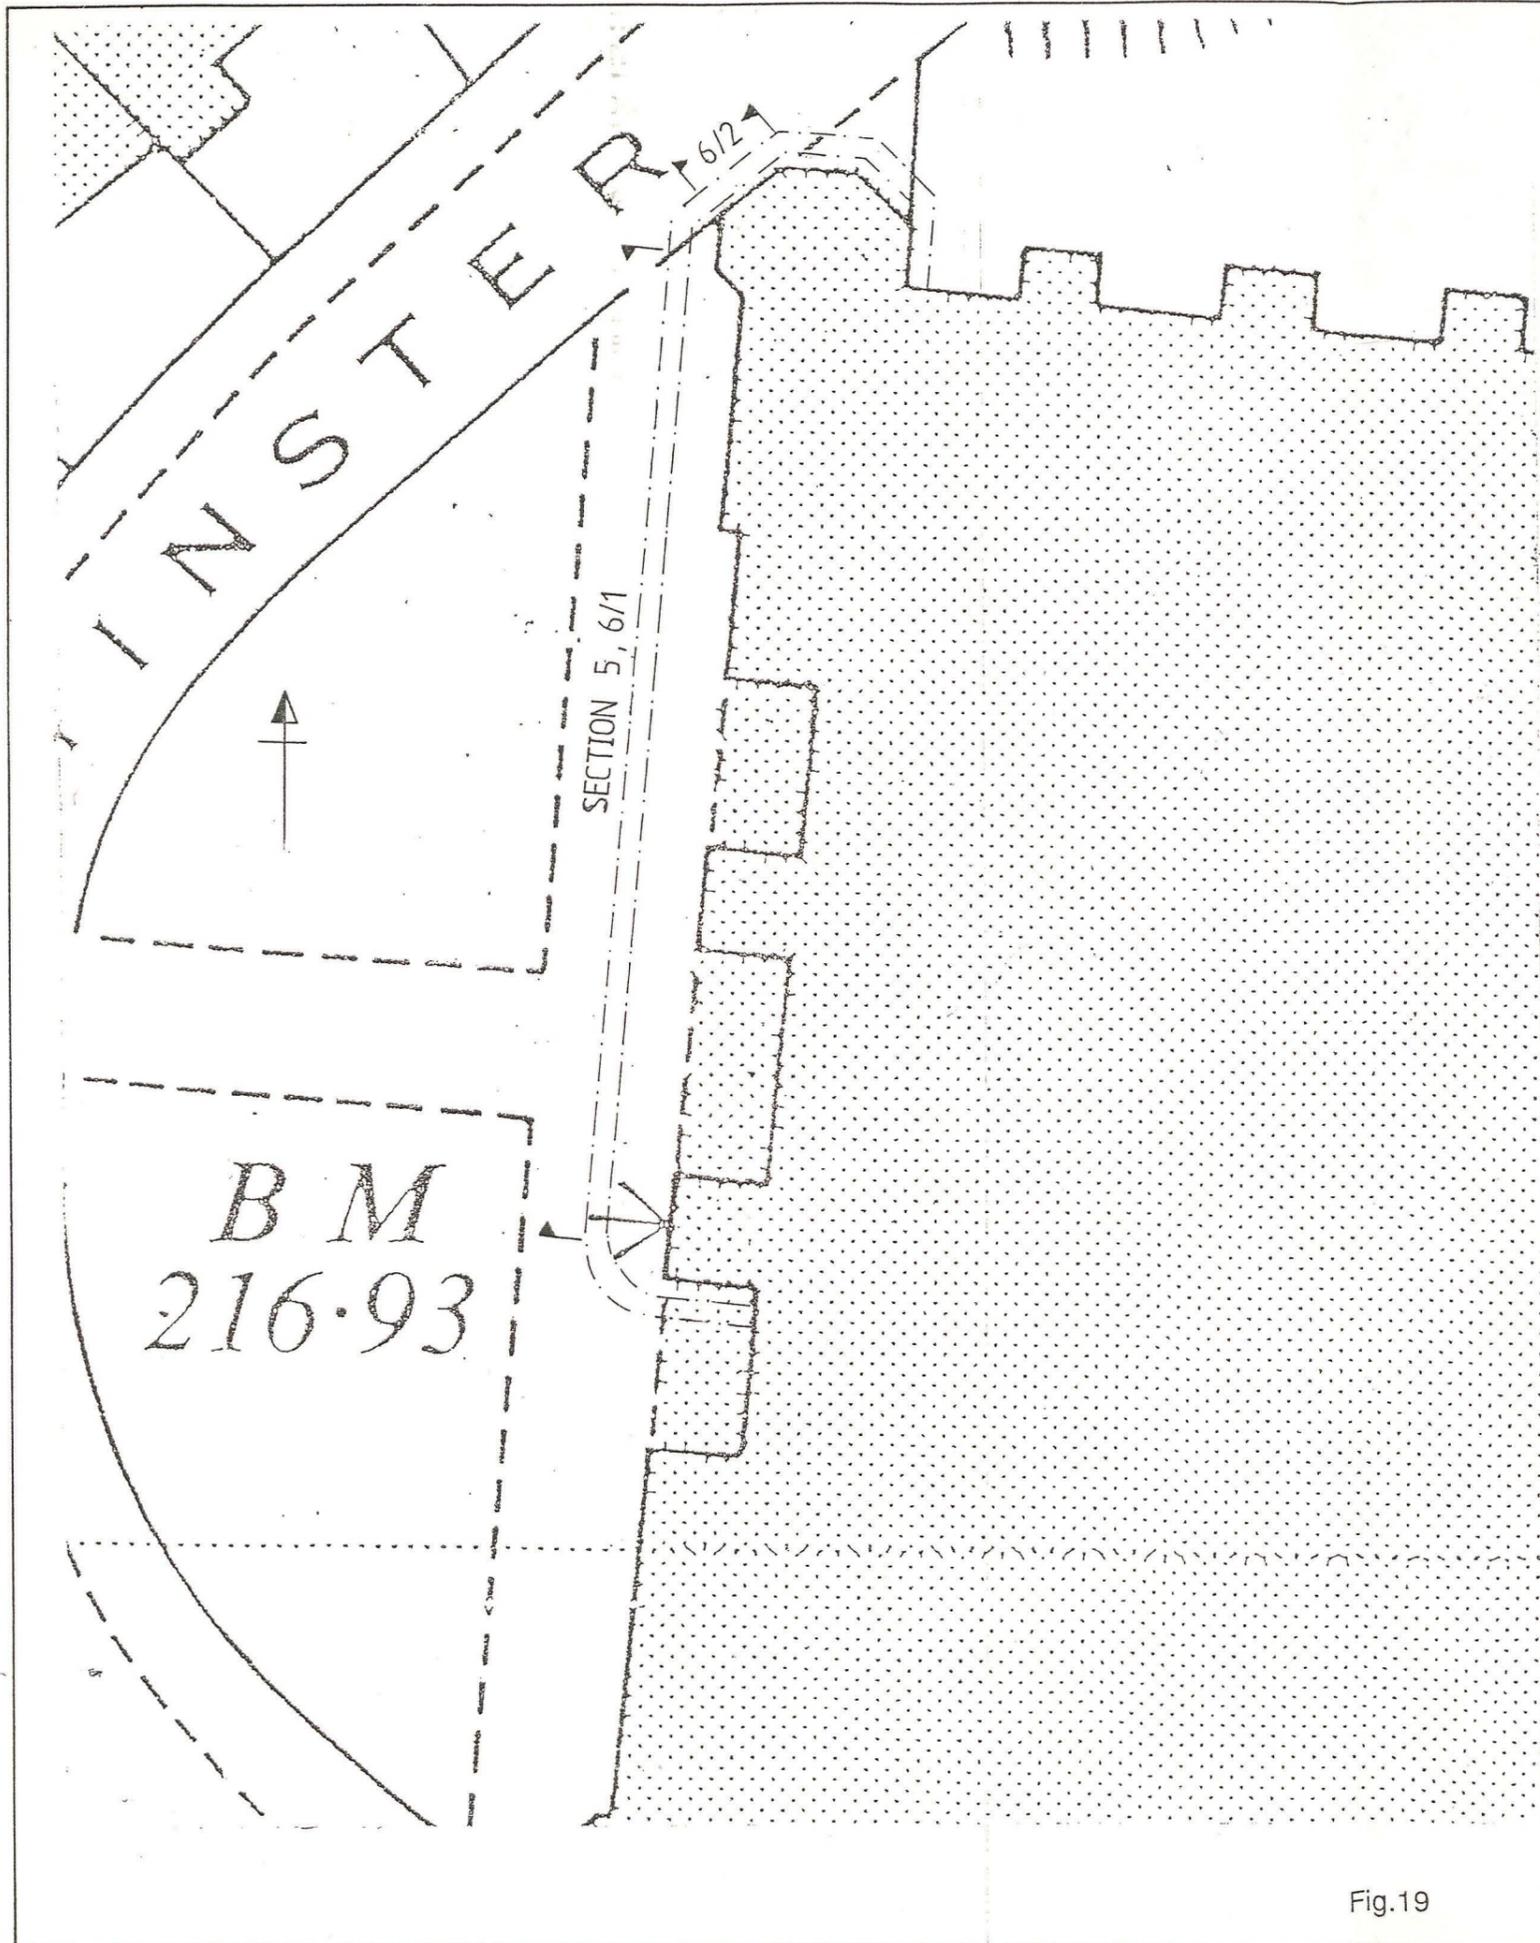
Fig.19

CITY OF LINCOLN ARCHAEOLOGY UNIT		
SITE CODE: COW 92	PLAN/ELEV/SECTION NO: FIG 19	
CLIENT: CATHEDRAL		
DESCRIPTION: AREA IV		GROUND PLAN SHOWING SECTION LOCATIONS
SCALE: 1:200	ARCHIVE NO:	
DRAWN BY: K.W.	CHECKED:	DATE: 12/10/92

The stratigraphy encountered along the west front of the Cathedral (see fig.19. for ground plan) was markedly different from that seen towards the north (area III). Earliest features recorded were three concentrations of limestone. Of these, [289] was a large unworked slab standing on edge, oriented E-W and cut by both sections. [291] was a concentration of approximately 15 large blocks lying randomly at L.O.E., and the final group of stones, [276], was an apparently linear feature, oriented E-W, forming a possible channel, topped with broken stones/slabs.

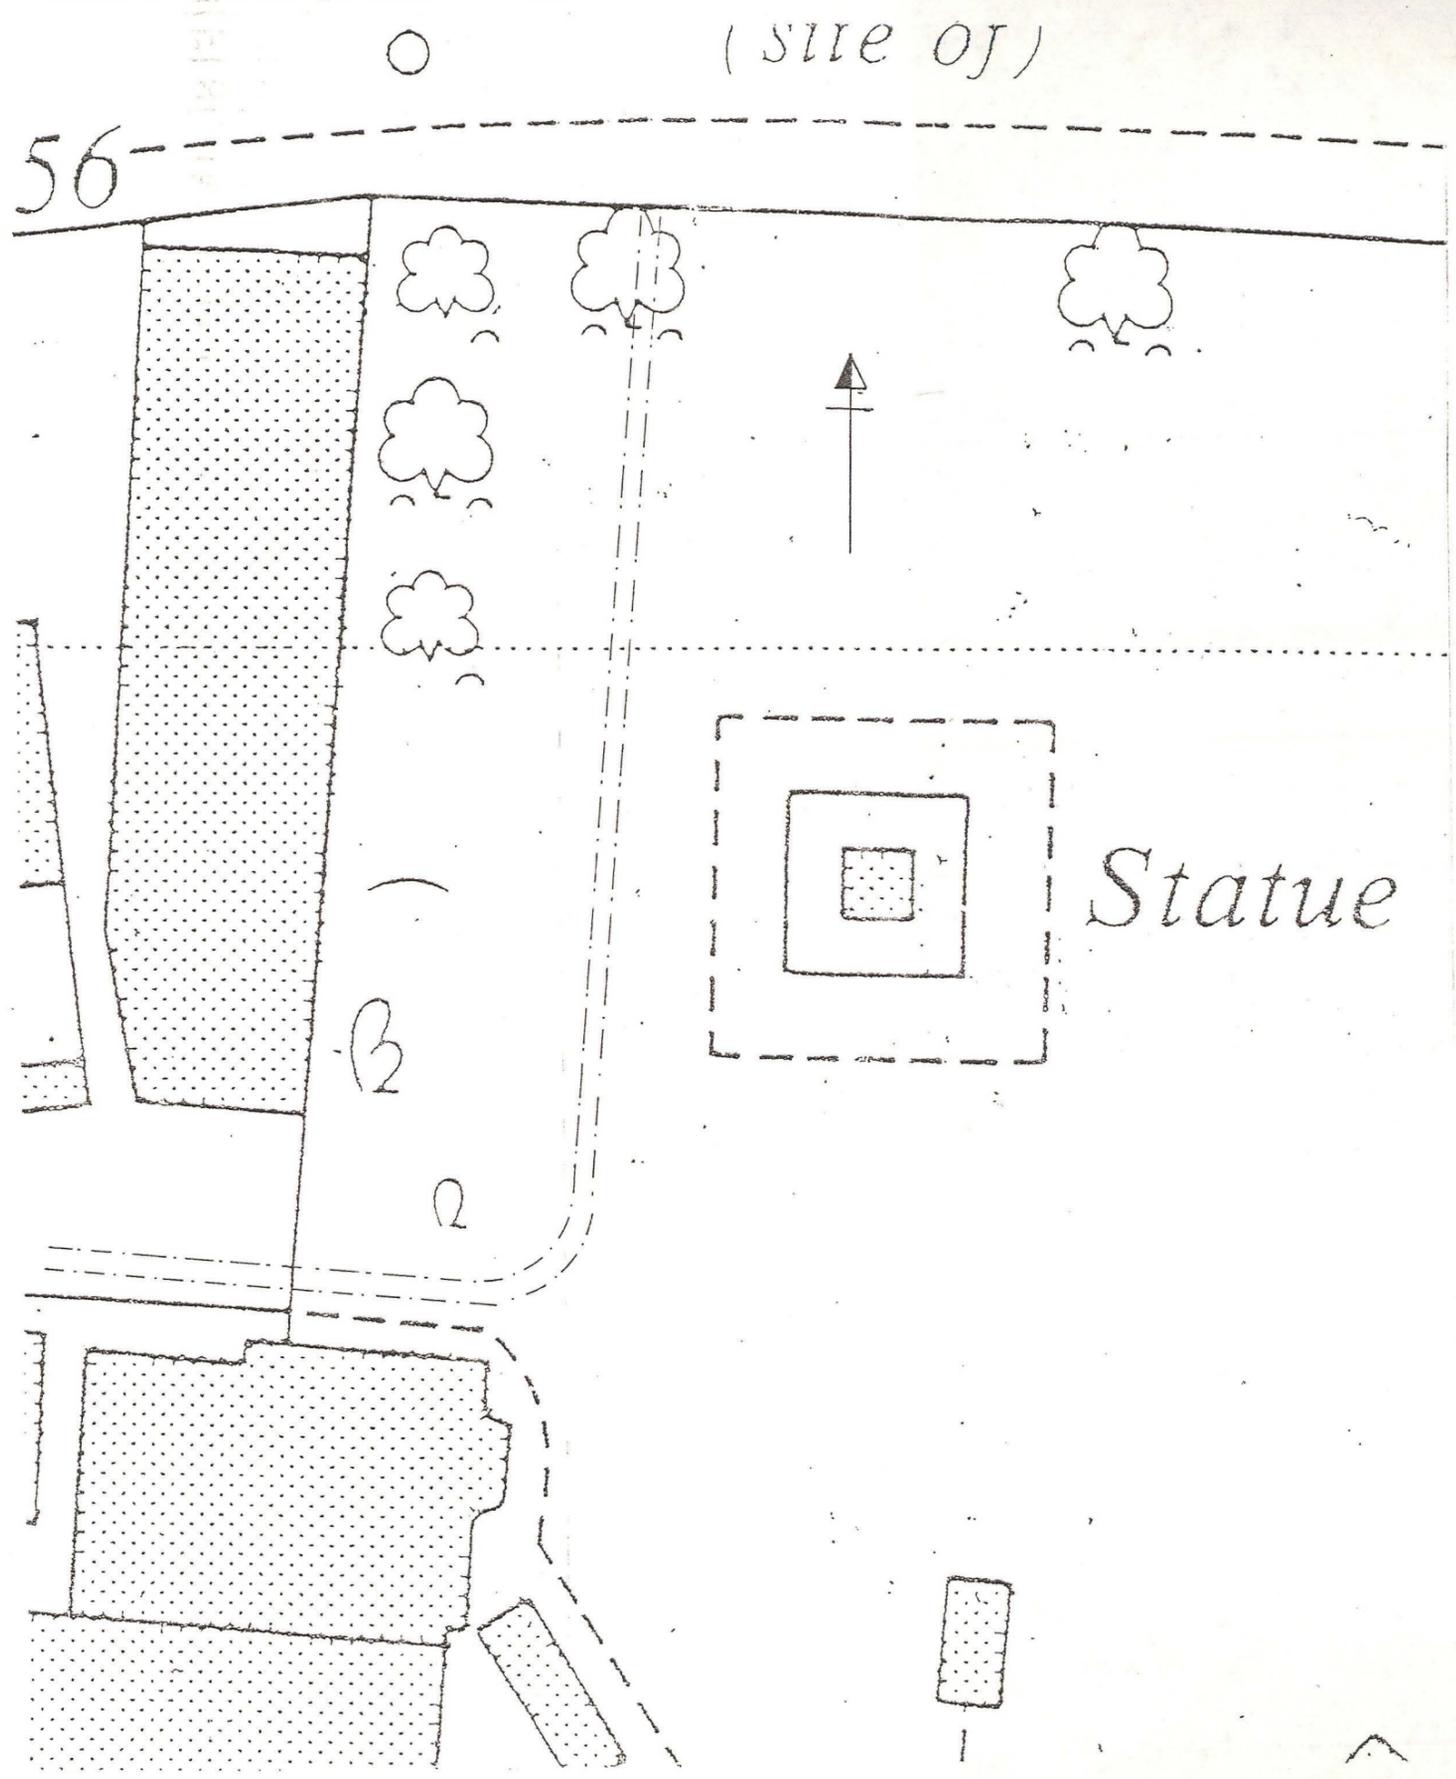
Fig.20

CITY OF LINCOLN ARCHAEOLOGY UNIT		
SITE CODE: COW 92	PLAN/ELEV/SECTION NO: FIG 20	
CLIENT: CATHEDRAL		
DESCRIPTION: AREA VII GROUND PLAN		
SCALE: 1:200	ARCHIVE NO:	
DRAWN BY: K.W.	CHECKED:	DATE: 12/10/92

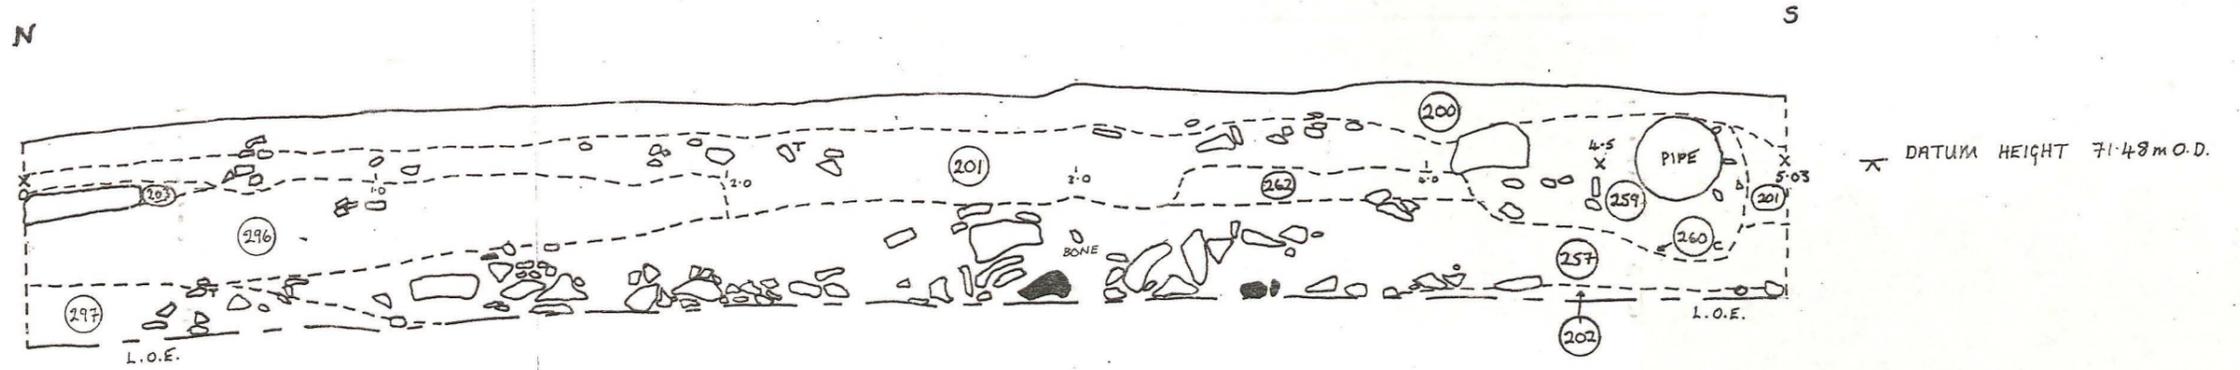
Fig.22

CITY OF LINCOLN ARCHAEOLOGY UNIT		
SITE CODE: COW 92	PLAN/ELEV/SECTION NO: 1D	
CLIENT: CATHEDRAL		
DESCRIPTION: WEST FACING SECTION SHOWING 157 LAYER CONTAINING BURIALS		
SCALE: 1:20	ARCHIVE NO:	
DRAWN BY: M.W./Y.R.	CHECKED: K.W.	DATE: 18/05/92

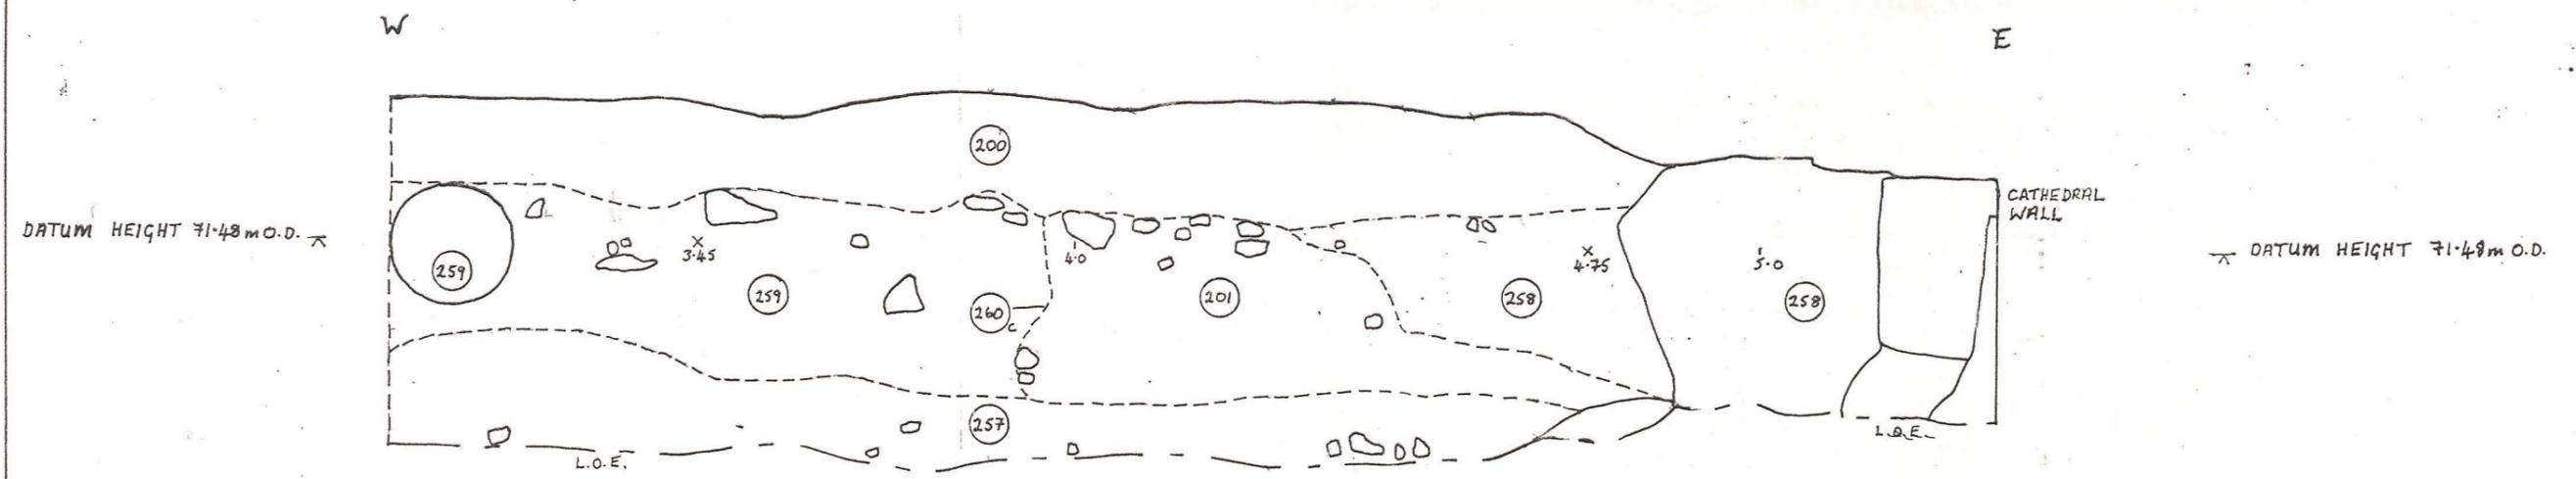
Fig.23

CITY OF LINCOLN ARCHAEOLOGY UNIT		
SITE CODE: COW 92	PLAN/ELEV/SECTION NO.: 1H	
CLIENT: CATHEDRAL		
DESCRIPTION: S. FACING SECTION		
SCALE: 1:10	ARCHIVE NO:	
DRAWN BY: Y.R.	CHECKED: K.W.	DATE: 29/05/92

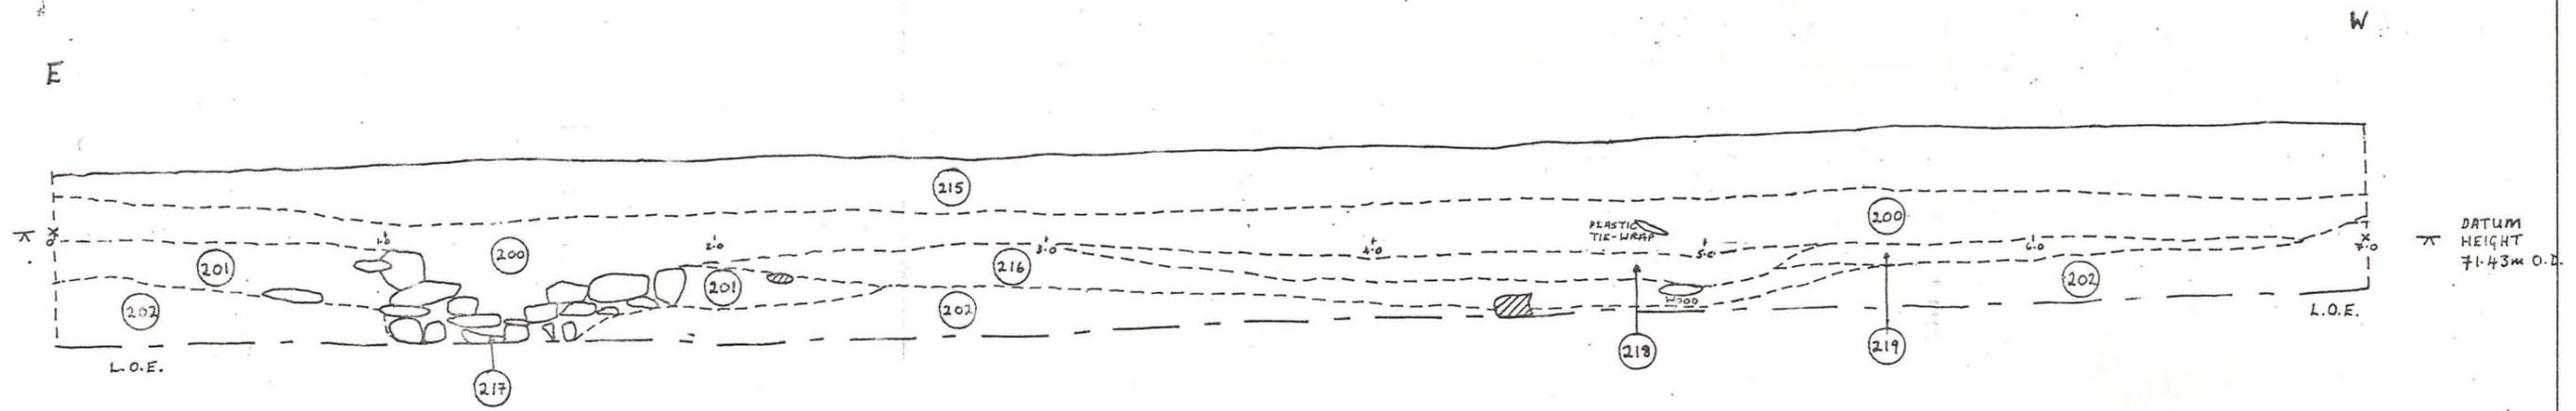
Fig.24

CITY OF LINCOLN ARCHAEOLOGY UNIT		
SITE CODE: COW 92	PLAN/ELEV/SECTION NO: 2 F	
CLIENT: CATHEDRAL		
DESCRIPTION: NORTH FACING SECTION (Part 6)		
SCALE: 1:20	ARCHIVE NO:	
DRAWN BY: K.W.	CHECKED:	DATE: 22/05/92

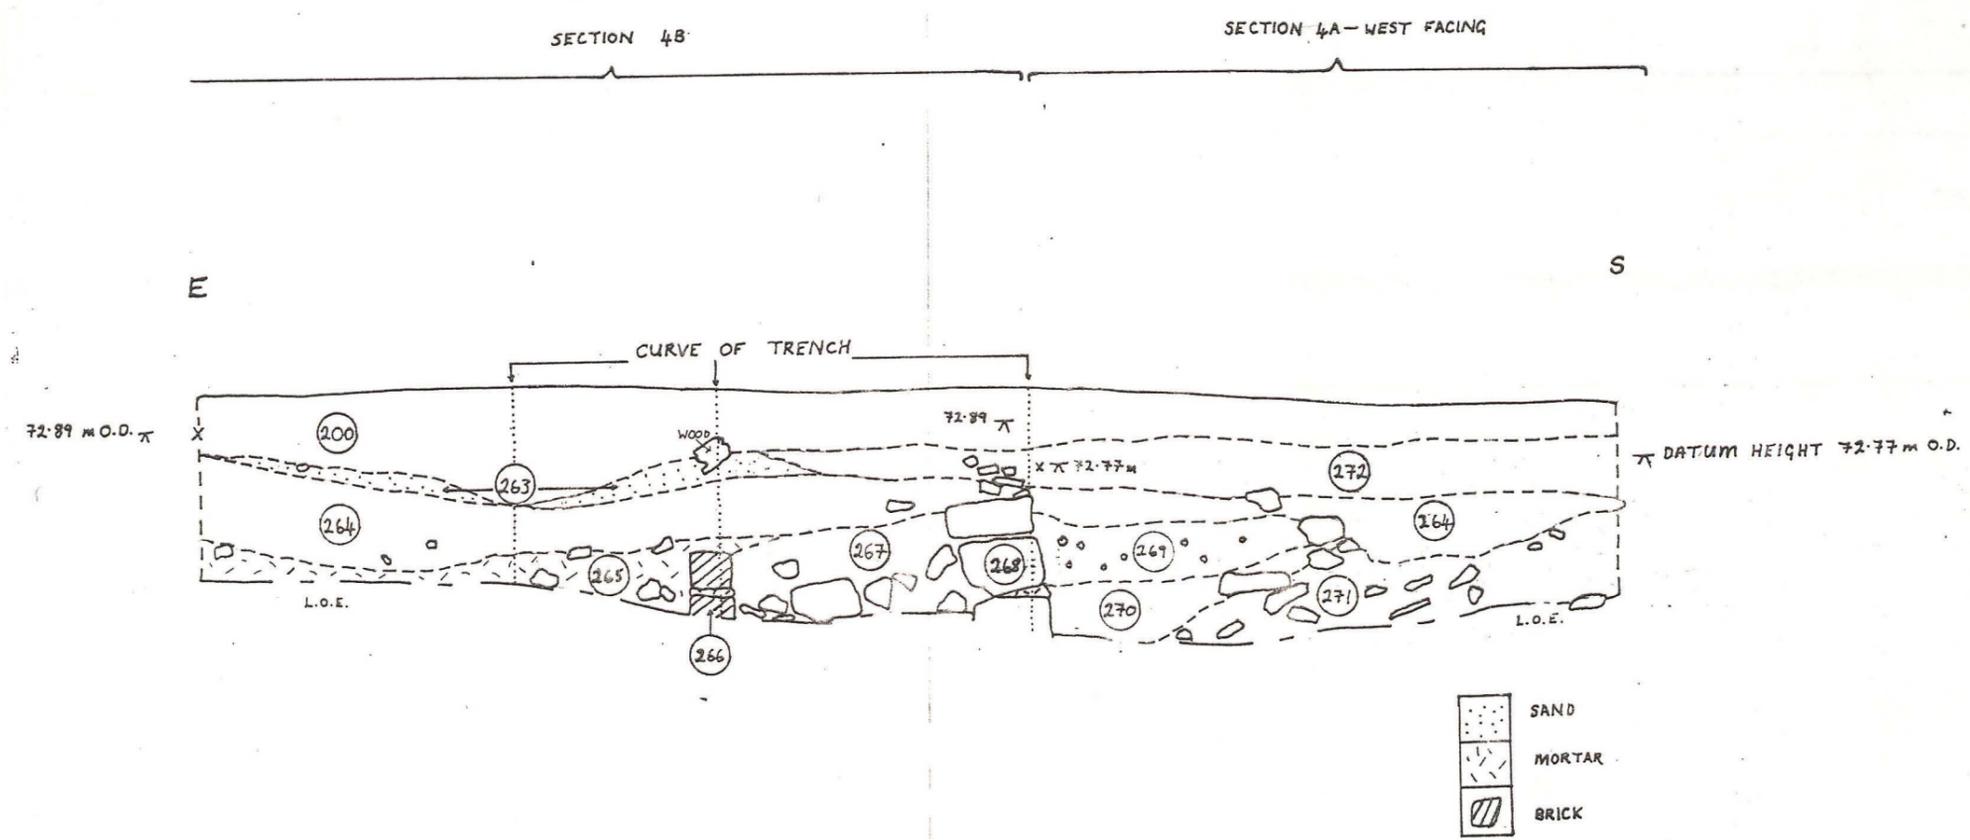
Fig.25

CITY OF LINCOLN ARCHAEOLOGY UNIT		
SITE CODE: COW 92	PLAN/ELEV/SECTION NO: 4A/4B	
CLIENT: CATHEDRAL		
DESCRIPTION: N. AND W. FACING SECTIONS (ROUND CORNER OF TRENCH)		
SCALE: 1:20	ARCHIVE NO:	
DRAWN BY: H.G.	CHECKED: K.W.	DATE: 29/05/92

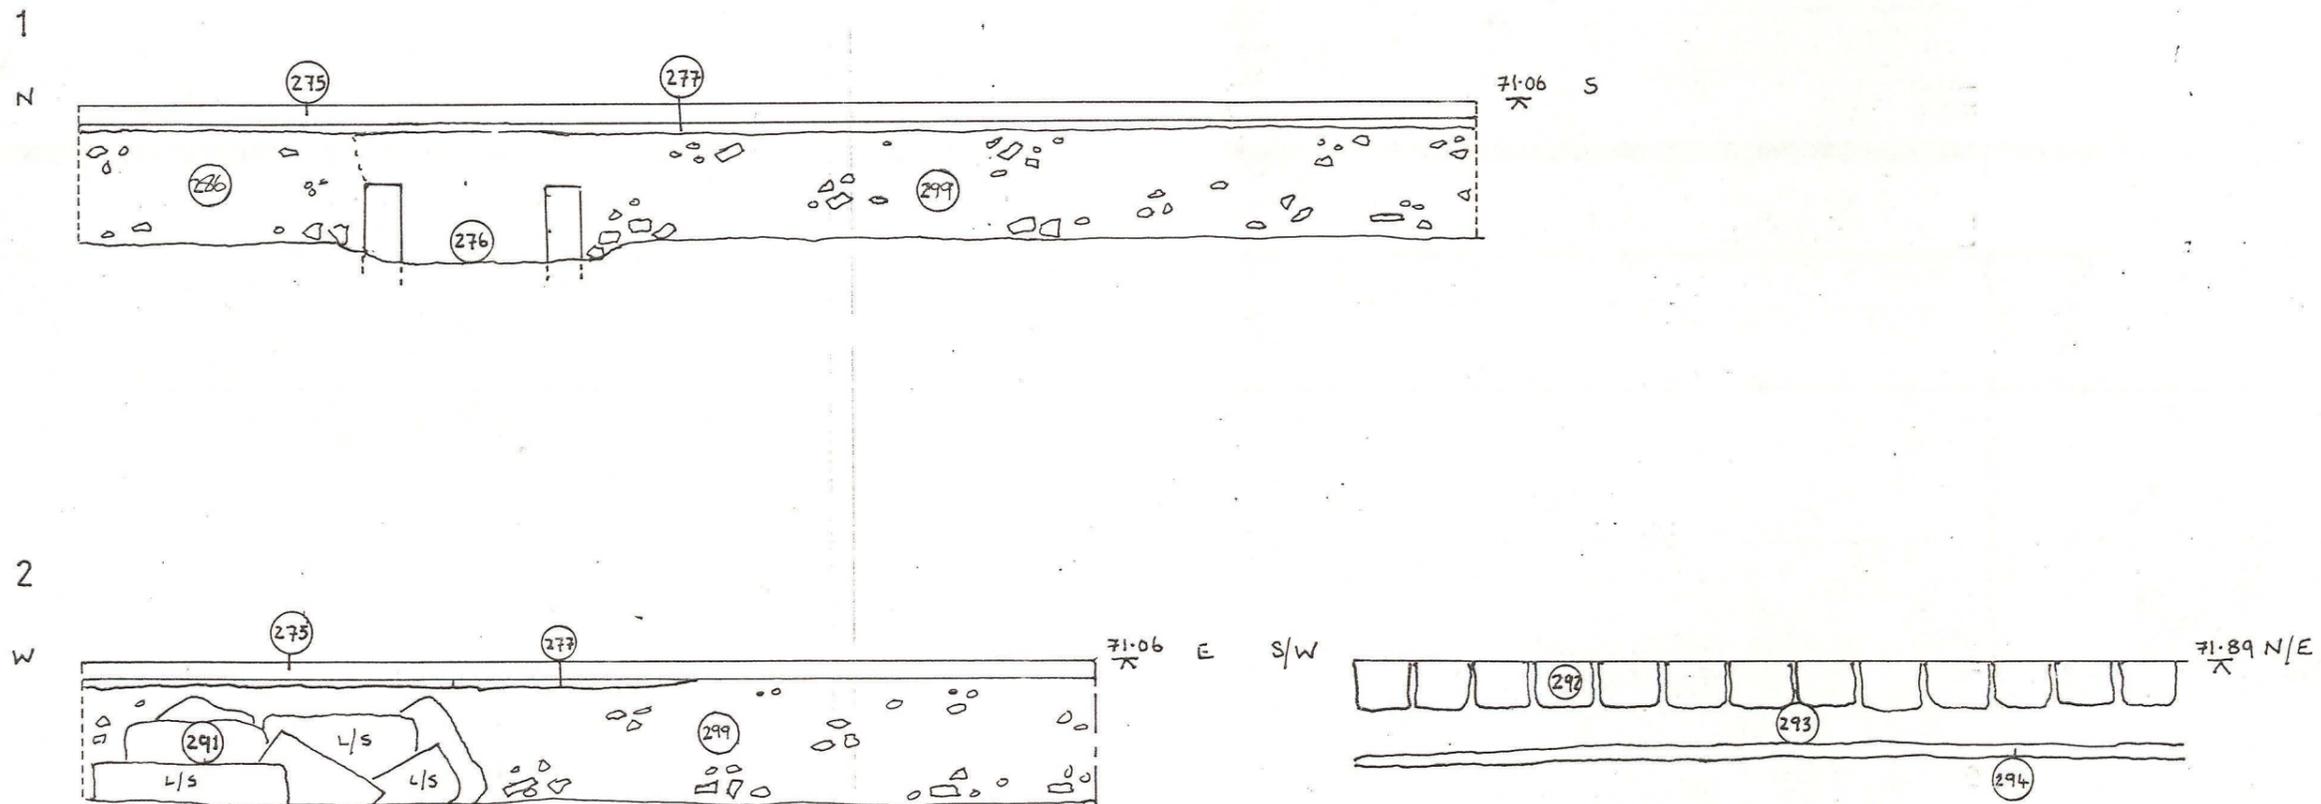
Fig.27

CITY OF LINCOLN ARCHAEOLOGY UNIT		
SITE CODE: COW 92	PLAN/ELEV/SECTION NO: 5	
CLIENT: CATHEDRAL		
DESCRIPTION: WEST FACING SECTION WEST FRONT TRENCH		
SCALE: 1:20	ARCHIVE NO:	
DRAWN BY: JEH.	CHECKED:	DATE: 21:07:92

GENERAL SECTION OF TRENCH AROUND N. BUTTRESS
