# LINDSEY ARCHAEOLOGICAL SERVICES

## ARCHAEOLOGICAL MONITORING

SUTTON-ON-SEA to MABLETHORPE RISING MAIN

Oct/Nov 1992

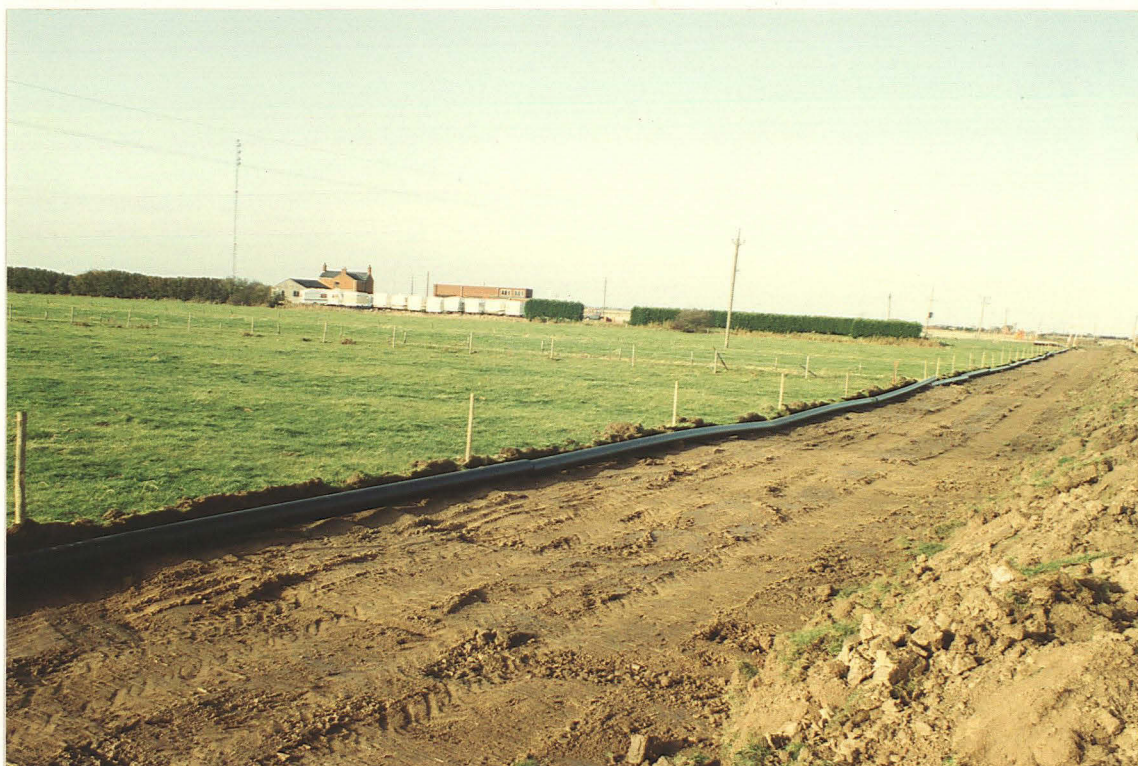
Pl. 1 Field 4. Earthwork remains of ridge and furrow

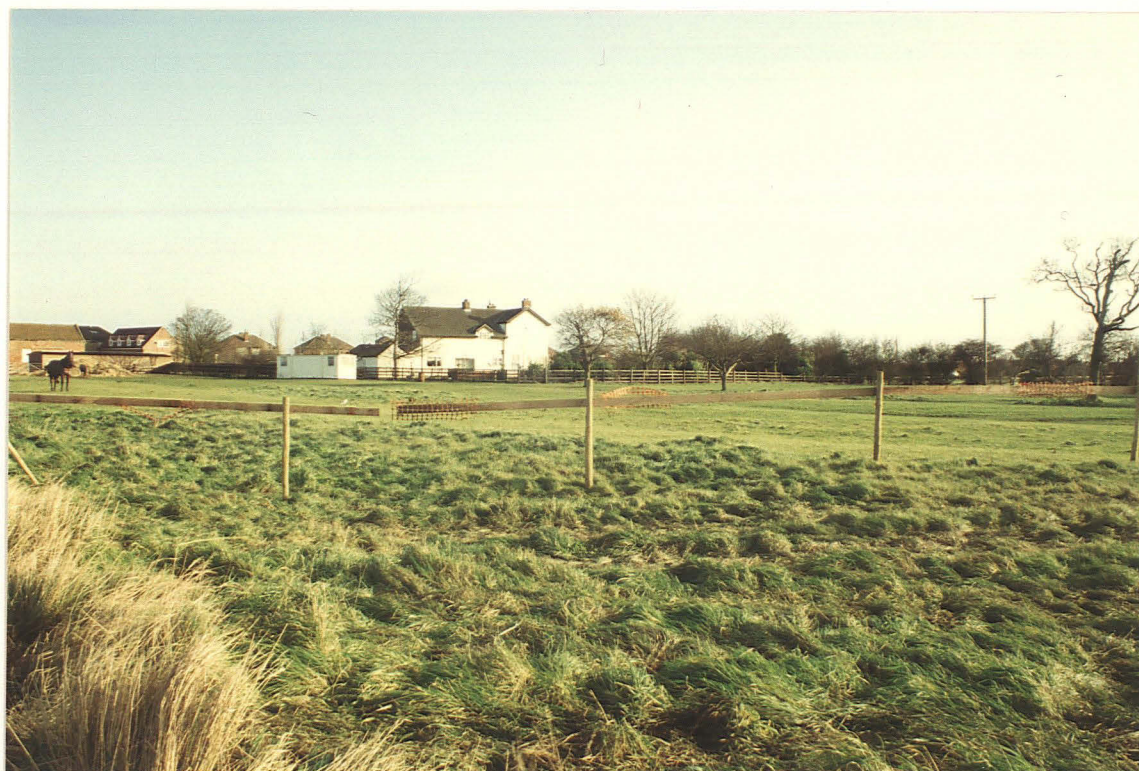
Pl.2 Field 6. Earthwork remains of ridge and furrow

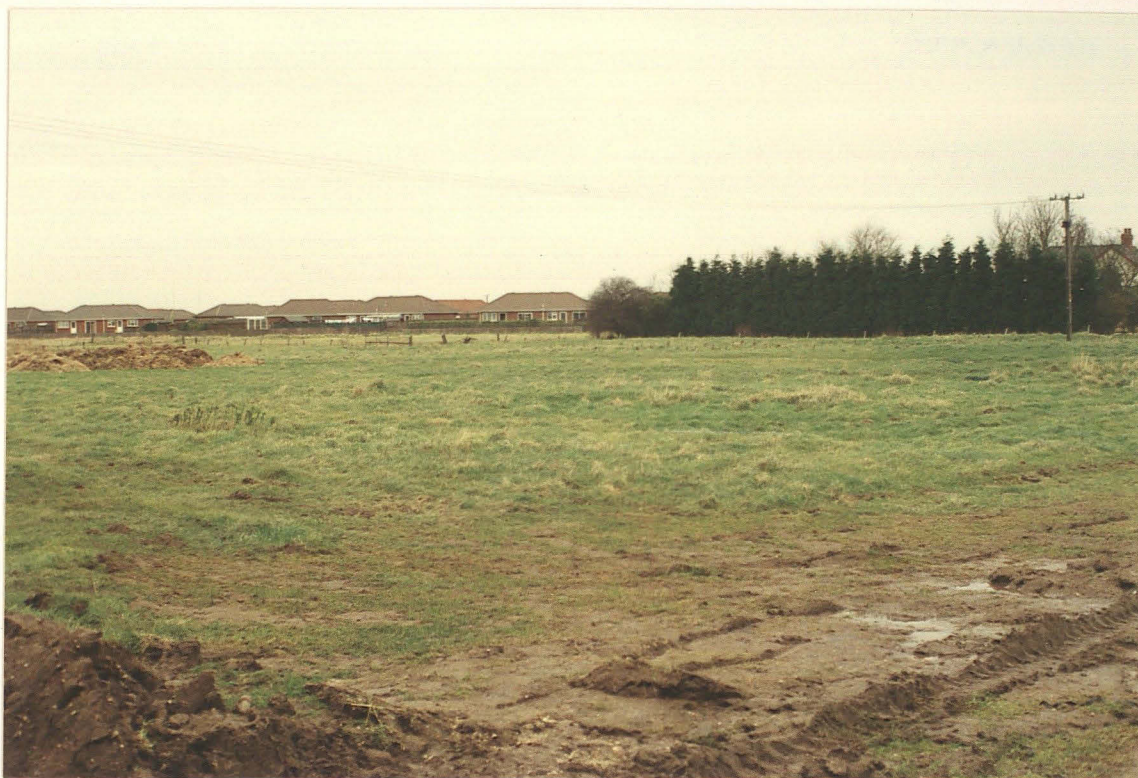
Pl.3 Field 9. Vestigial remains of earthworks east of the easement

Vestigial physical traces of archaeological features other than cultivation furrows were noted from the ground during the watching brief, both on the easement and in land immediately beyond. Most of these were in Fields 9 and 10 and were investigated within the pipe-trench area by excavation (Plate 3). An area of depressions and possible slight platforms was observed to the N of the easement in Field 25, between Trusthorpe Pumping Drain and the farm buildings (Plate 4). A single sherd of late-medieval pottery was found here and it is considered unlikely that the depressions are the remains of medieval dwellings. A more probable cause might be works for the construction or maintenance of the two Drains.

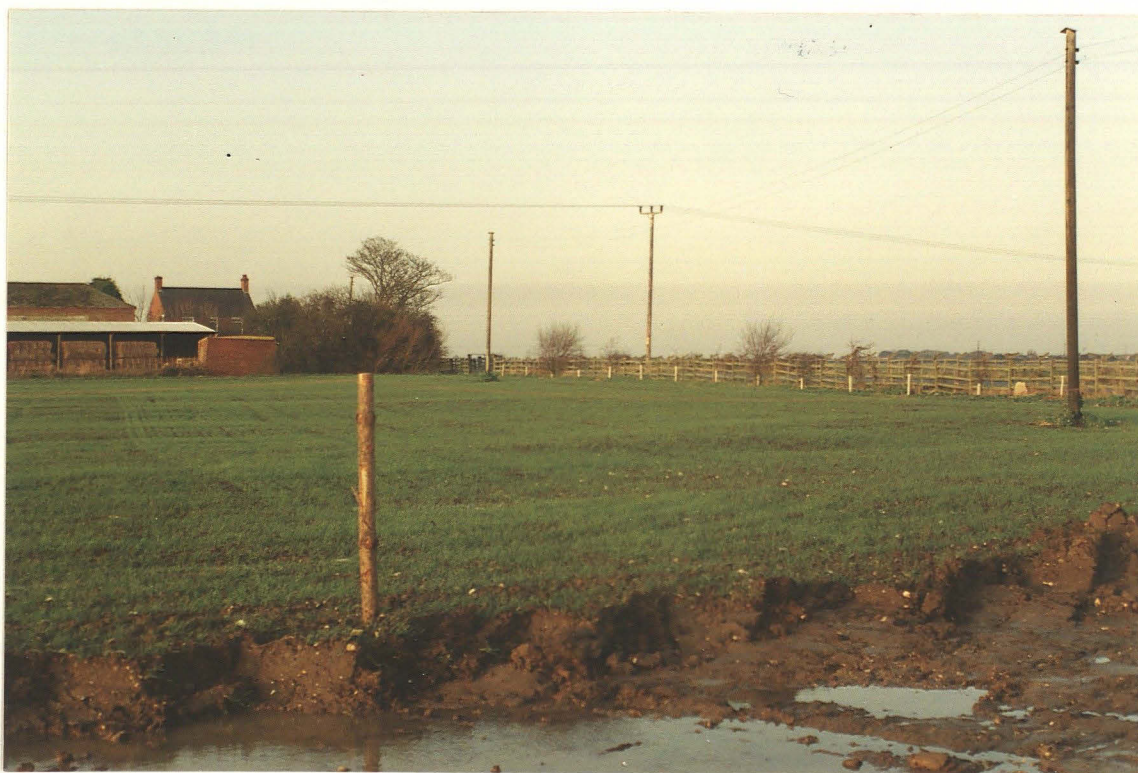
Pl.4 Field 25. Possible building platforms north of the easement

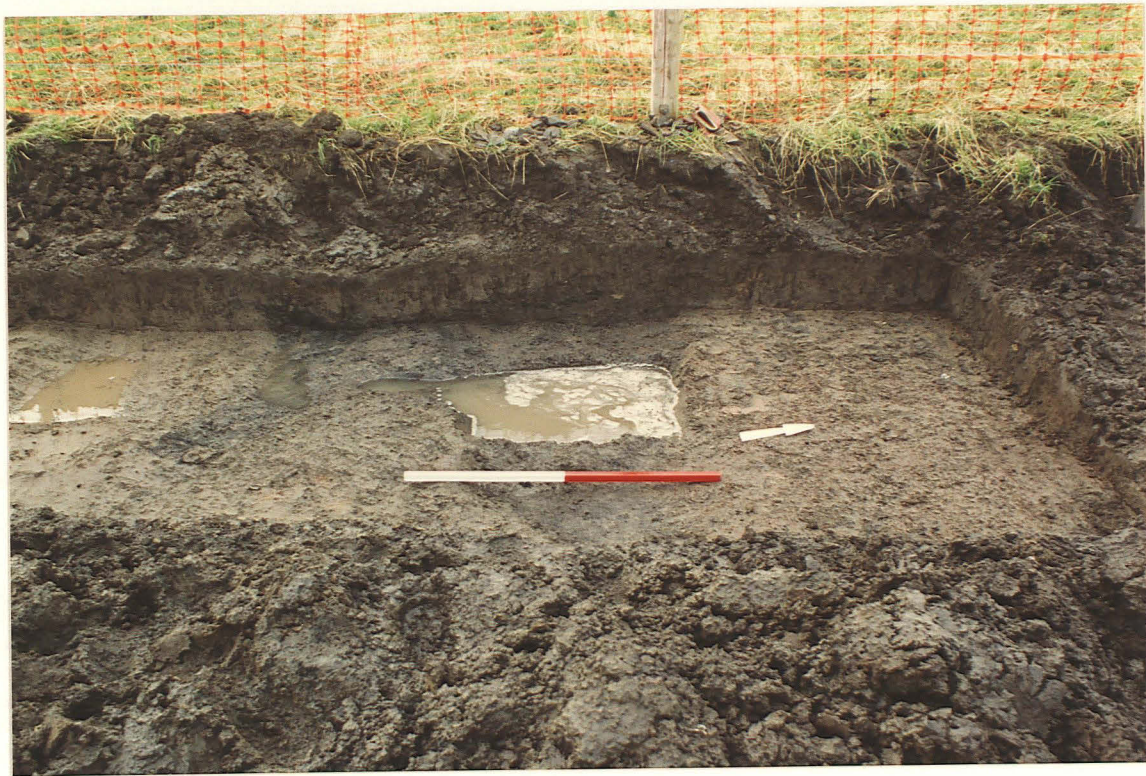
Pl.5 Field 9. Ditch 11, prior to excavation

An excavation area 6.3m N-S and 1.6m E-W was opened in Field 9 at 103m to the north of the road. This was positioned over a larger spread of dark soil and revealed three ditches (Contexts 8, 9 and 11) and a pit (Context 7) (Plates 5 and 6; Fig. 3).

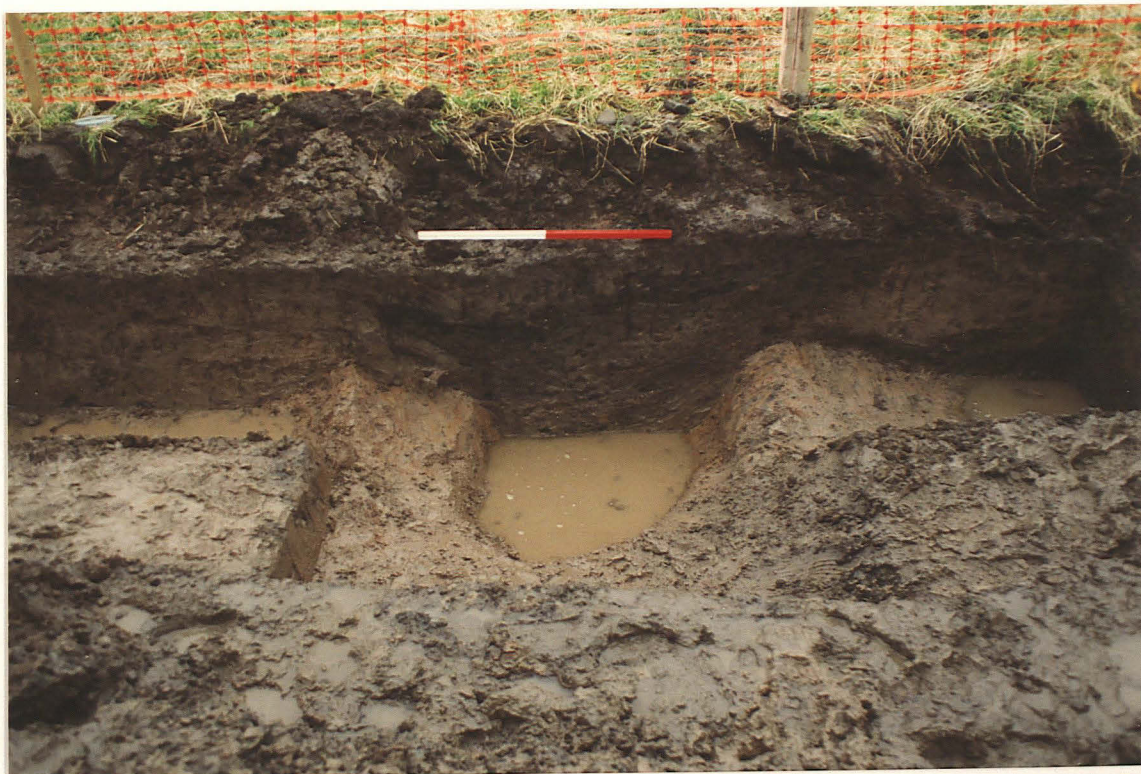
Pl.6 Field 9. Ditch 11, excavated, showing deeper pit, 7

At the west edge of the trench was part of a pit (or the butt-end of a ditch) exposed below Ditch 11. Its width was 1m and it had been dug to 1.05m below the easement surface. The sides tapered at an angle of 45-50 degrees, easing gradually into a rounded base. The fill was a dark yellow-grey silty clay with charcoal flecks and some evidence for banding suggested a gradual infilling process.

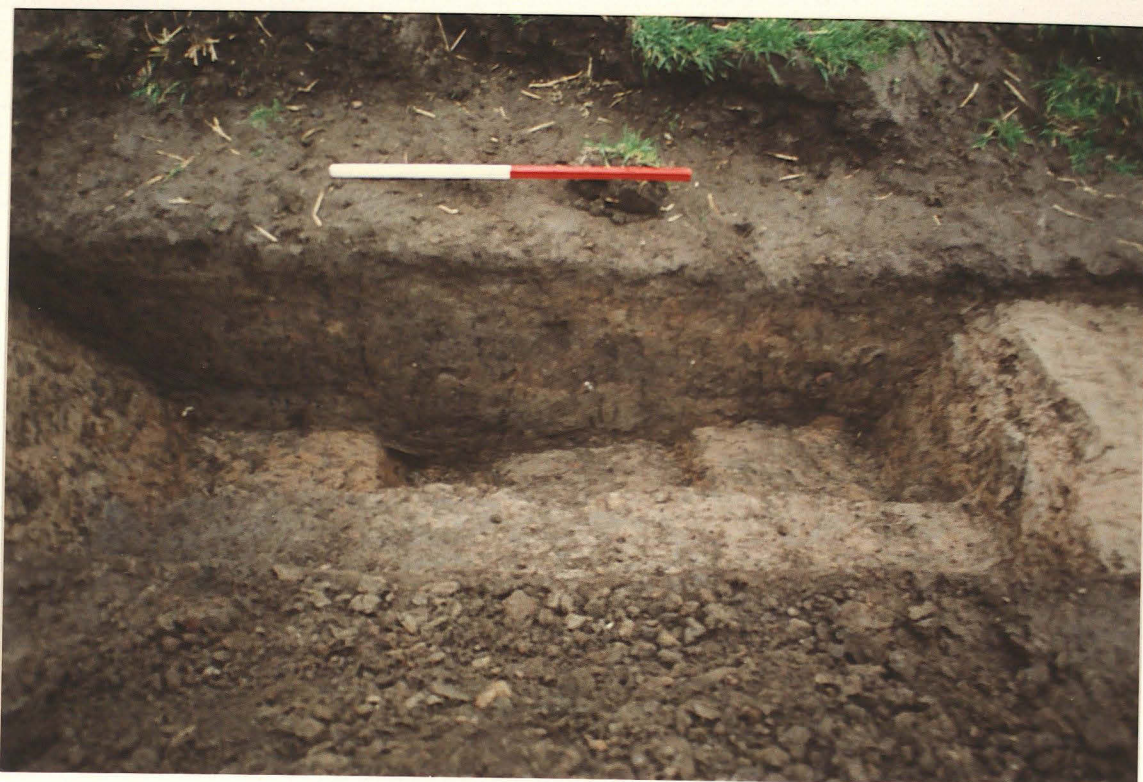
Pl.7 Field 10. Ditch 20

A second excavation area was opened 216m north of the road. This examined another ditch which crossed the easement from west to east. It was 2.8m wide and cut 0.95m below the easement surface. Its profile was very different to those to the south, with its sides sloping at an angle of 65-70 degrees to a mostly flat base. A slight shelf 0.1m above the base may have been the result of ditch cleaning. The ditch seemed to have been in use for only a short time before it was backfilled and a substantial deposit of yellow clay near to the top may have been redeposited from the upcast bank. Perhaps fortuitously this was the least wet of all those features examined.

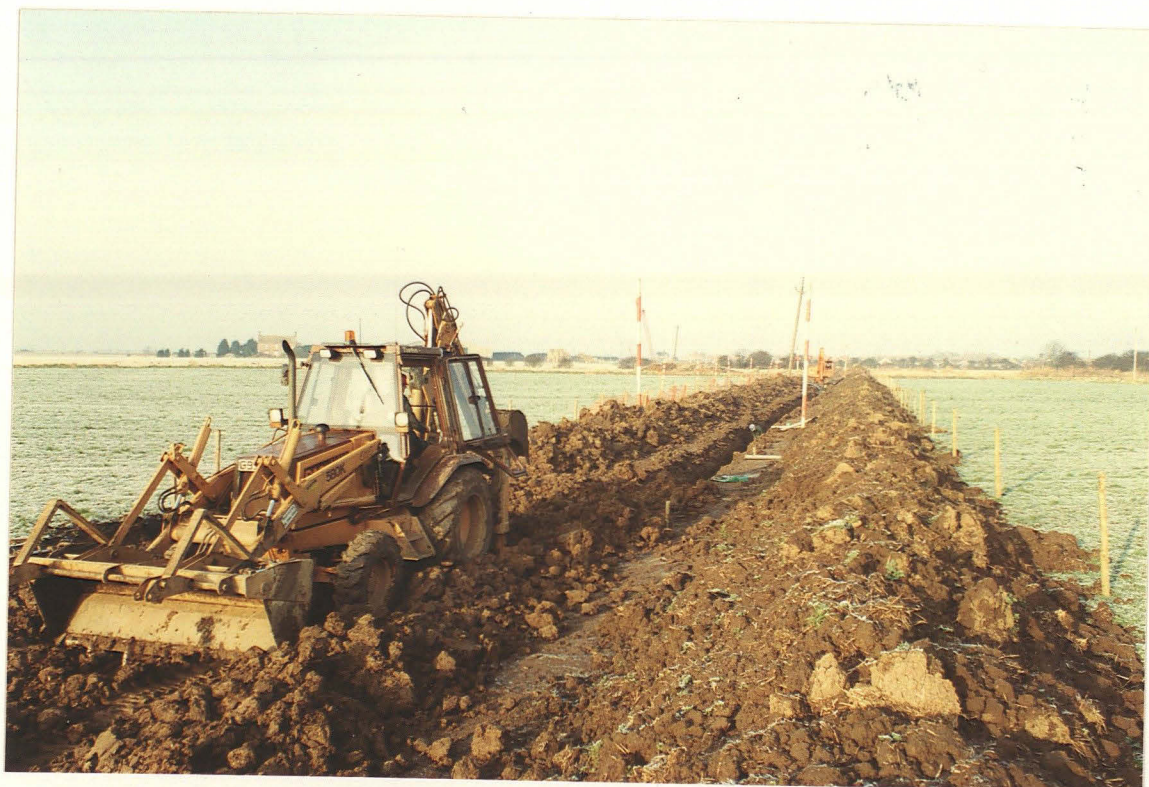
Pl.8 Pipe trench excavation in progress

The pipe-trench was excavated in early 1993 and parts of the operation were monitored (Plate 8). It was found that the flood deposit was thicker than the trench depth, so no buried former land surface was revealed (Plate 9). Close observation was restricted to Field 9 where the excavation of ditches and pits had taken place.

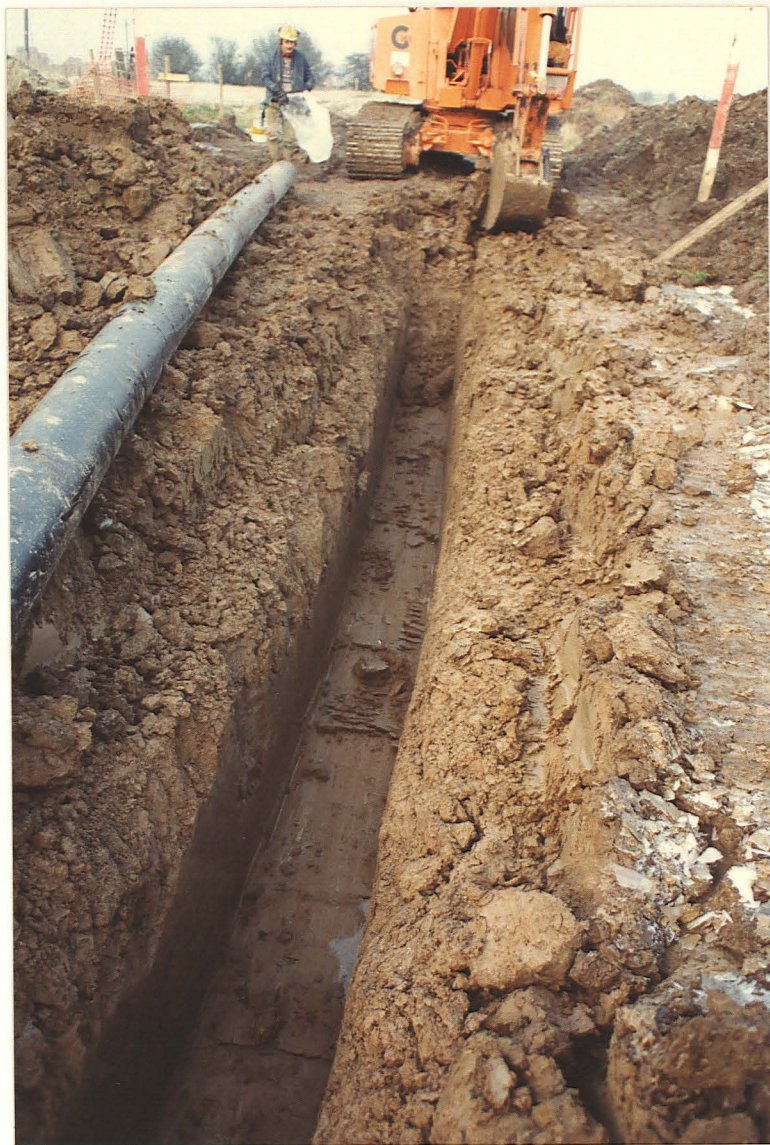
Pl.9 Marine silts, characteristic of whole route, exposed during trench cutting

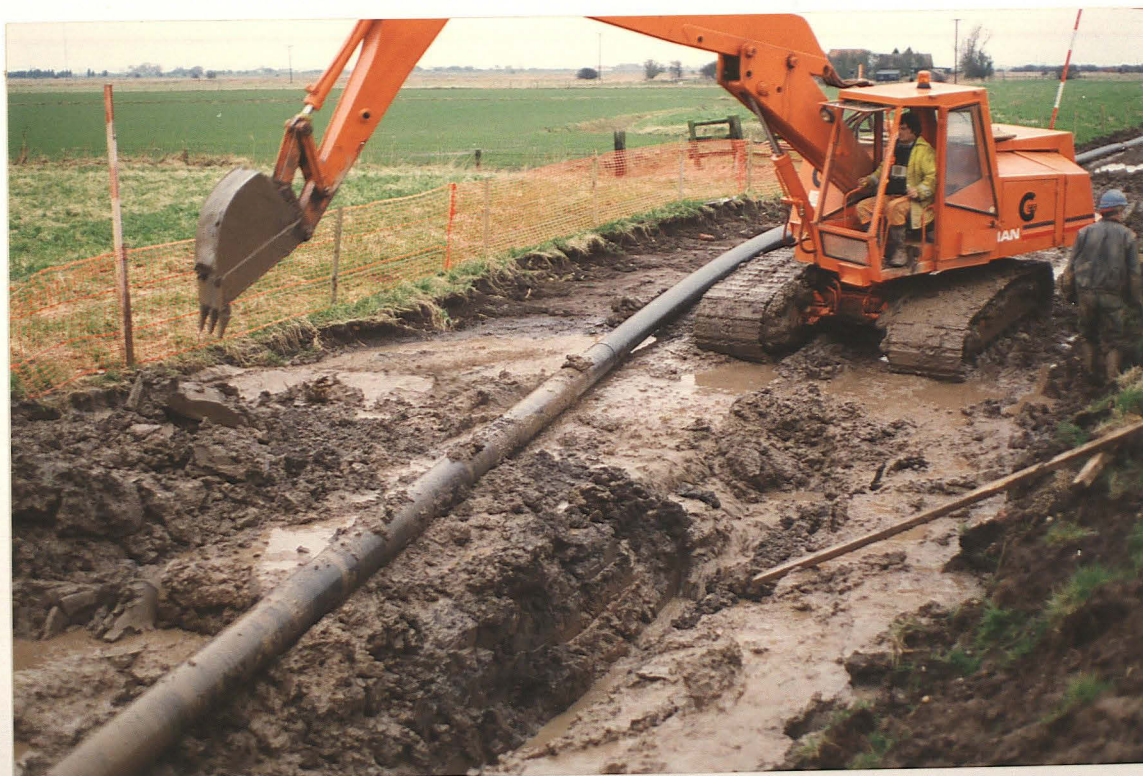
Pl. 10 Field 9. Archaeological features revealed in pipe trench, despite poor ground conditions

This second phase of the watching brief produced evidence of a number of minor ditches crossing the easement, mostly apparently in a SW-NE direction. Slight surface indications of some of these had been present on the stripped surface but ground conditions had prevented further investigation. The trench was excavated after several days of rain and the consequent muddy conditions again obscured the detail of the trench sides (Plate 10). No stratified finds were recovered from the minor ditches but the quantities of pottery in the adjacent topsoil heap indicated a medieval date for most.

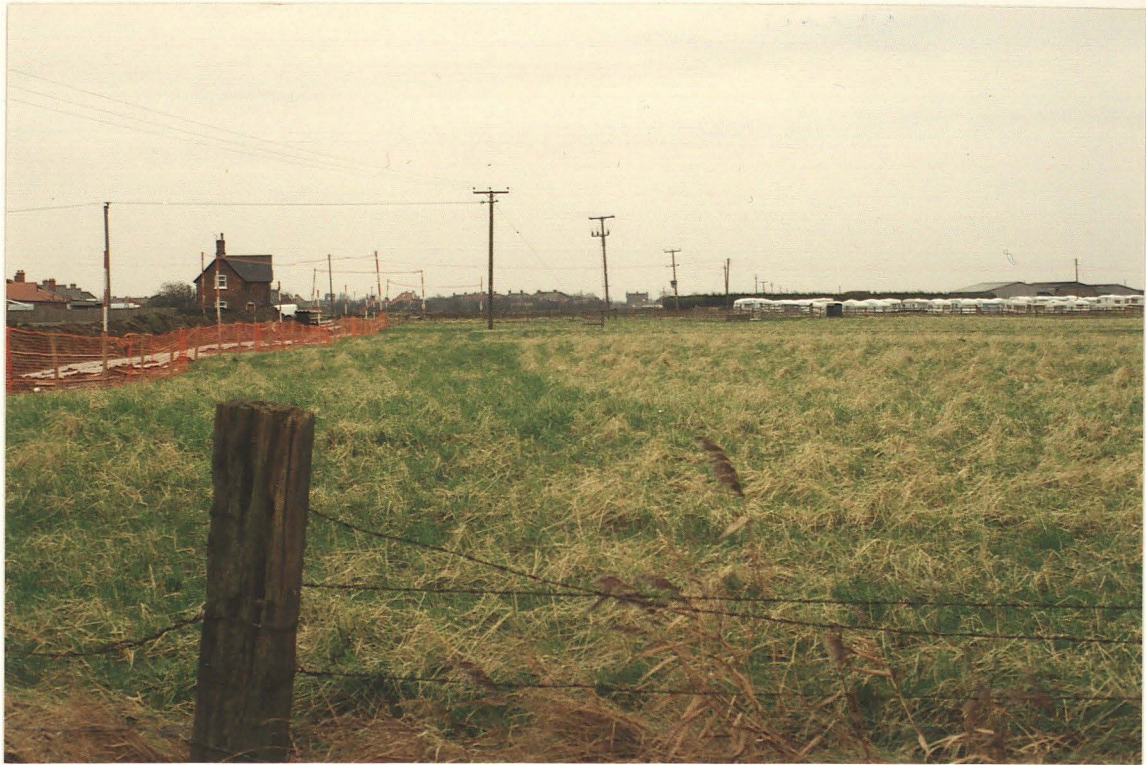
Pl.11 Field 9. Ditch 24 west of pipeline easement, visible as depression in the middle background, running L-R.

- 22 Ditch, 1.25m wide, 0.80-1.0m deep.
- 23 Ditch, 2m wide, 0.3m deep; light grey silty clay fill.
- 24 ?Ditch, 1m wide, 1.25m deep; black silt and grey clay fill; pieces of modern brick in upper fill: apparently recently back-filled. Interpreted as a field ditch or drain associated with railway (now removed). Cropmarks of a field subdivision to the W of the railway line at this point have been noted on air photographs.

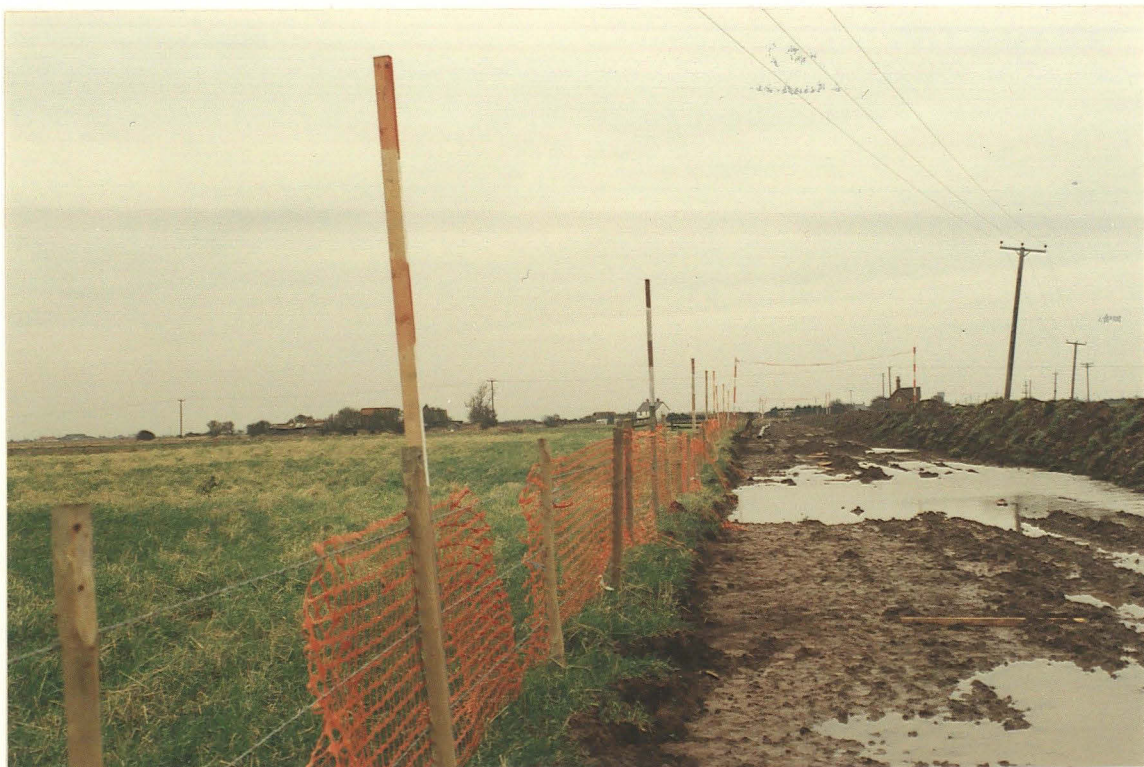
Pl.12 Field 9. Ditch 24 crossing easement, filled with rainwater
