## **HISTORIC BUILDING REPORT**

**Holland House  
Hipper Lane  
Wigtoft  
Lincolnshire**

**June 1991**

SUMMARY

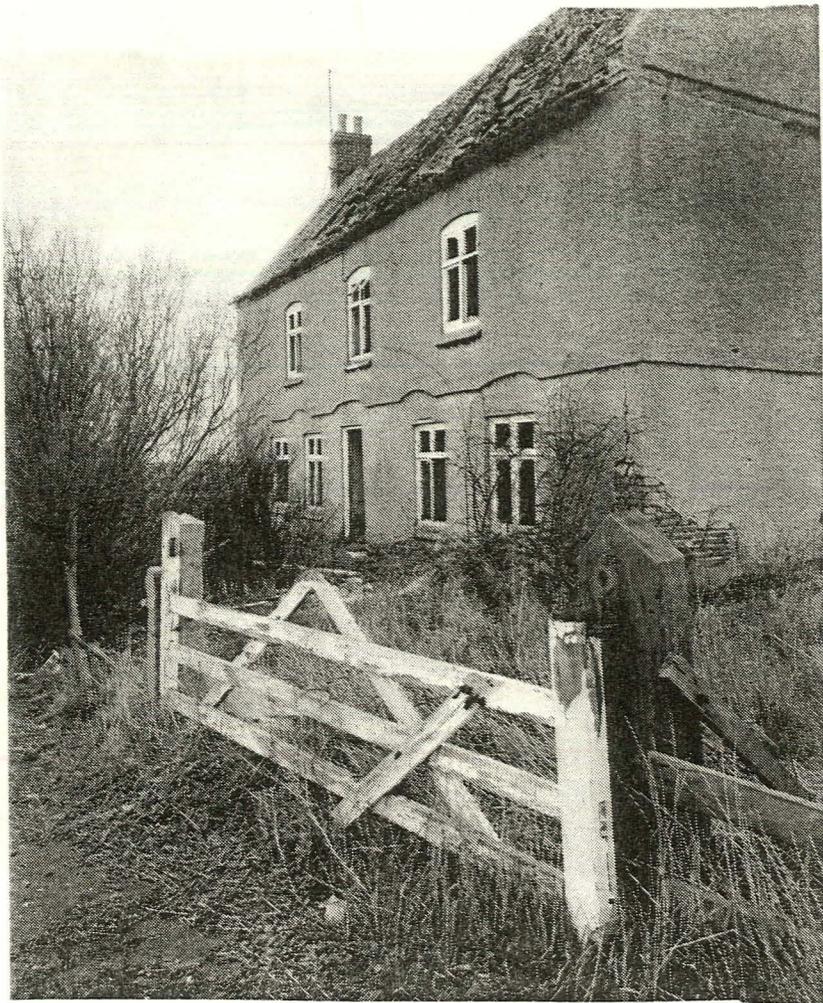
The first phase of Holland House is represented by the present eastern range. This is a five-bay brick structure of two storeys and an attic and with stacks on north and south gables. Pebble-dashing obscures the details of brickwork bond and of the original openings. There are projecting brick bands over the ground floor on the east front and over ground and first floors on the north gable, and over the east front is an eaves cornice of diagonally-set bricks. The north gable shows tumbled brickwork internally and has iron tie-rods in the shape of the initials IH (perhaps of the builder or of a descendant, possibly named Holland?). The positions of the original ground-floor openings on the south front are shown by the form of the brick band, which rises at regular intervals to give five segmental arches. The facade was symmetrical, with two windows either side of a central doorway; the southern jamb of the doorway is exposed in part.

View from north-east

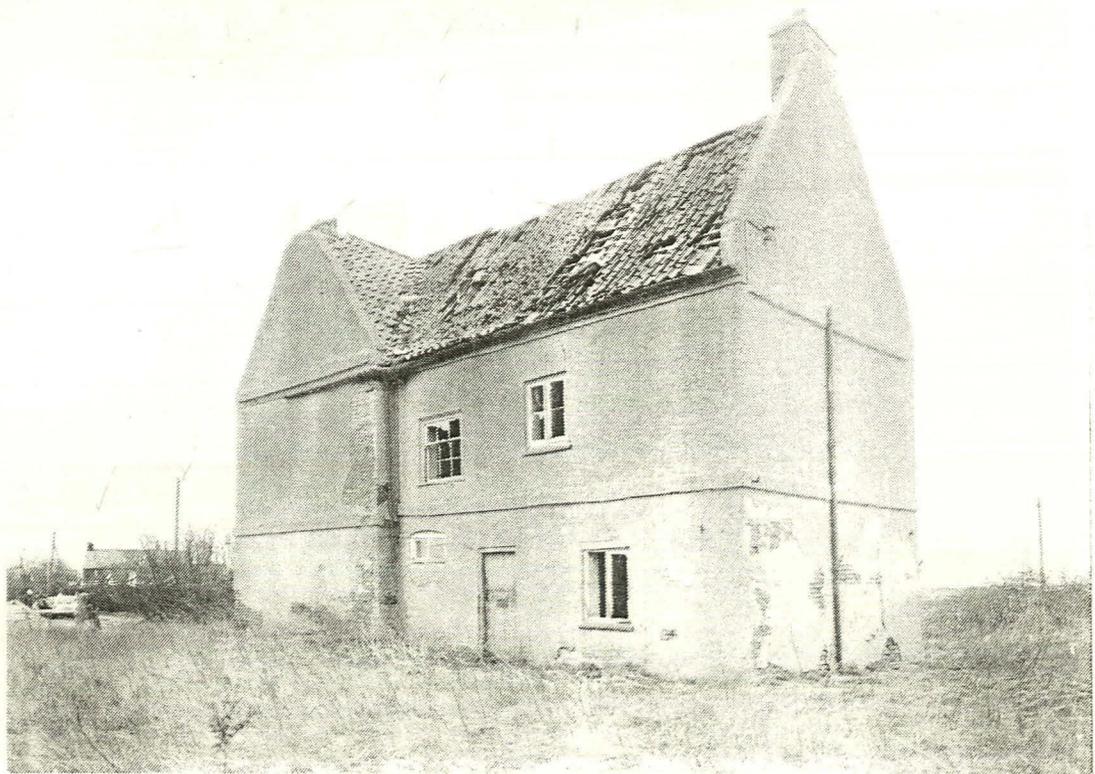
In the early 18th century the house was enlarged by the addition at the rear of the main range of a brick wing of two storeys and attic. The wing is pebble-dashed externally and has brick bands over the north and south walls above ground level and at two levels on the west gable. The gable coping rises high above the

The new wing probably provided a kitchen on the ground floor. The stack on the west gable contains a cooking range of 19th century date, and it is probable that the room was used for cooking originally. Visible externally on this wall are small blocked segmental-arched windows either side of the stack. These resemble that noted on the first floor of the main range north gable. The southern window is now obscured internally by a narrow

View from north-west

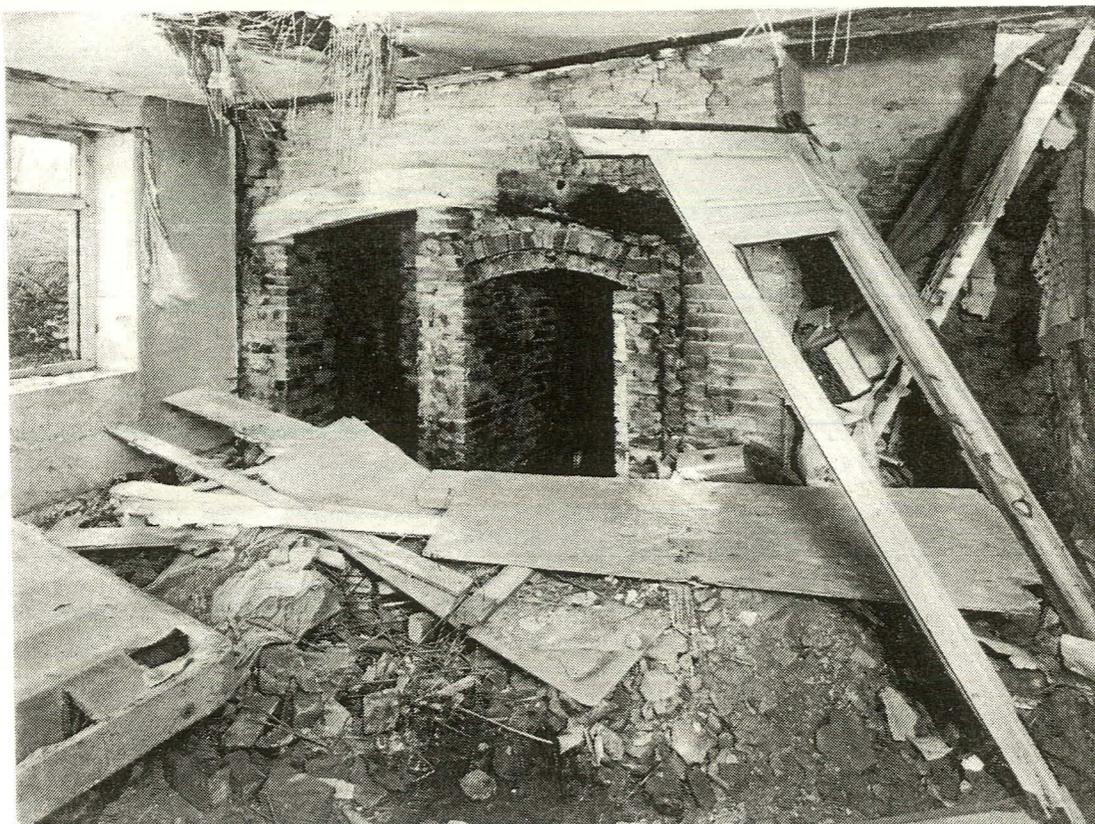
The addition of the wing appears to have been accompanied by a refurbishment within the old house. Hall, parlour and parlour chamber all retain panelled screens of pine on the fireplace walls, creating cupboard recesses either side of the stacks. In the hall the screen has raised and fielded panels and the inclusion of two doors in the screen indicates that the original large fireplace opening was partially blocked to give a smaller opening flanked by cupboards. The screen in the hall has been largely removed and broken up, but pieces survive in the room. The screens in the parlour and parlour chamber survive fragmentarily in situ.

Hall from north-west, showing part of removed screen

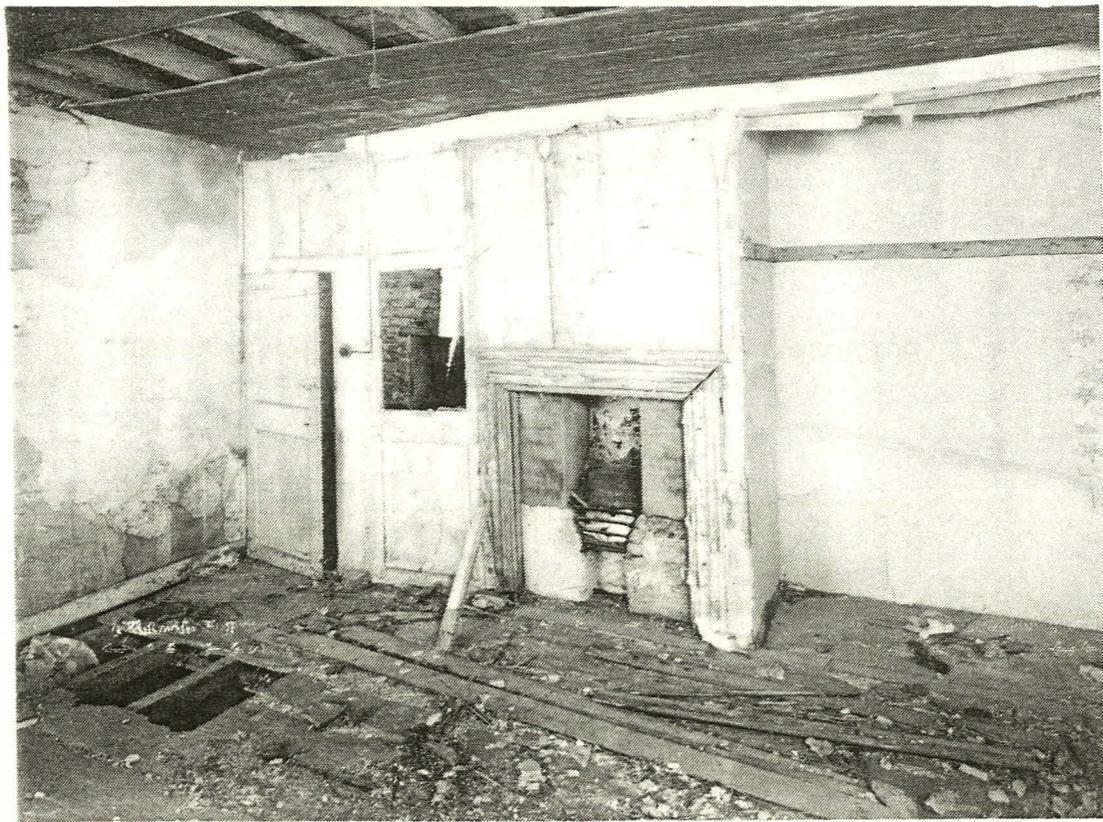
The first floor of the wing has a large room, originally screened from the stair hall by a brick wall. The west wall of the room retains large rectangular panelling in pine and a pine bolection-moulded fireplace surround. The style suggests that this work is original to the wing, and the existence of the fireplace surround in particular indicates that the room was a good-quality chamber. The provision of a doorway within the panelled screen may have been intended simply to give access to a cupboard. If, however, the stair in the south-west corner of the kitchen is original, access was gained to the chamber by means of this doorway. The attic room has a blocked fireplace, but the stack here is in later brickwork and it is probable that the original attic was unheated. The roof of the wing is of the same form as that of the main range, confirming the idea that the wing is an early addition. The roof retains the same evidence for dormer windows as described in the main range.

Rear wing, first floor; view showing fireplace  
and door to stair

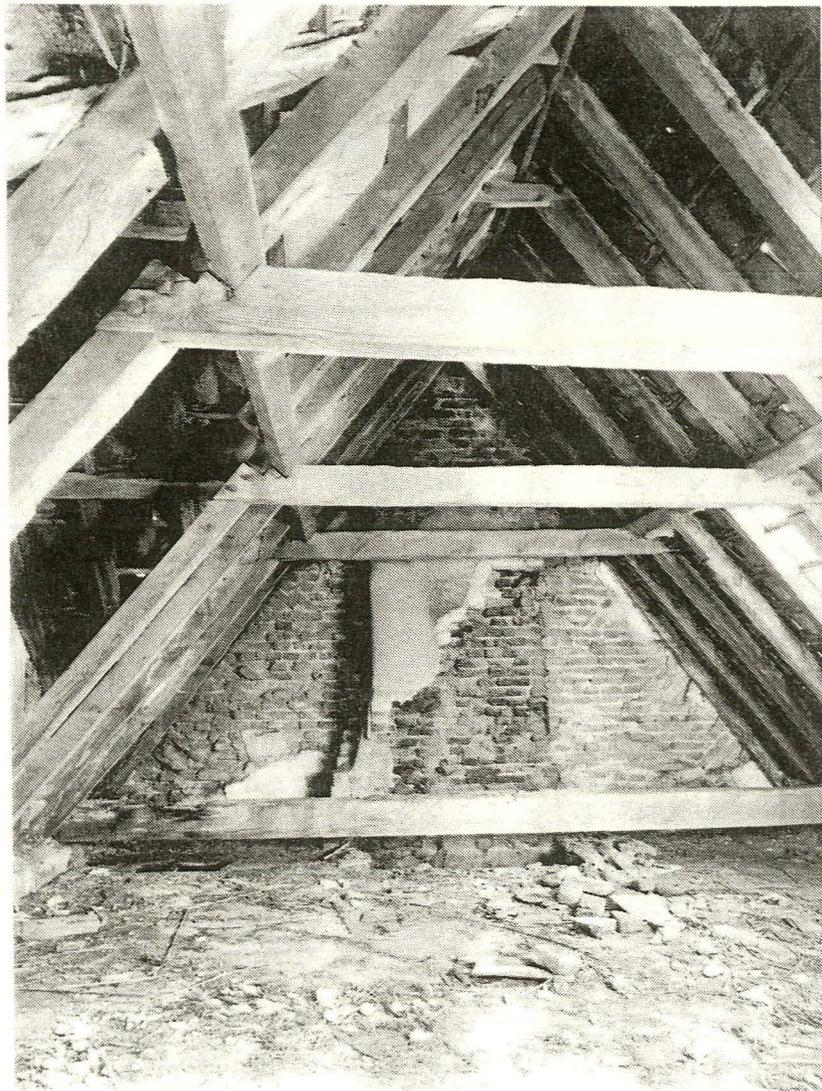
The first floor originally provided two chambers and a central landing. Both chambers appear to have been unheated originally. The northern room has the same small cupboards flanking the stack as noted in the parlour below, and at this level partially-visible straight joints in the external brickwork indicate that the cupboards have been converted from small windows. The stair continues to attic level, where the central bay is closed by brick walls above tie-beams. There are attic rooms to north and south. The roof is of common-rafter form, every third set of rafters being of heavier scantling and having a halved-over collar clasping a side purlin. At intervals in the roof are tie-beams linking the wall-plates but not jointed into the members of the roof itself. All roof timbers are of pine but may well be original since there is no evidence for earlier trusses. The height of the roof in relation to the brick gable walls, which do not rise above it in the form of a high coping or parapet, suggests that the original roof covering was pantile rather than thatch. The roof timbers of the east slope show evidence for dormer windows lighting the attic rooms; two pairs of the heavier rafters have notches near their foot for a window sill, and the area of the former windows is infilled with three rafters of slighter scantling than other rafters in the roof, these rafters terminating just above the side purlin.

Roof structure in main range; view showing  
tumbled brickwork in gable
