HISTORIC BUILDING REPORT

**Suffolk House
Off Wash Road
Fosdyke
Lincolnshire**

June 1991

SUMMARY

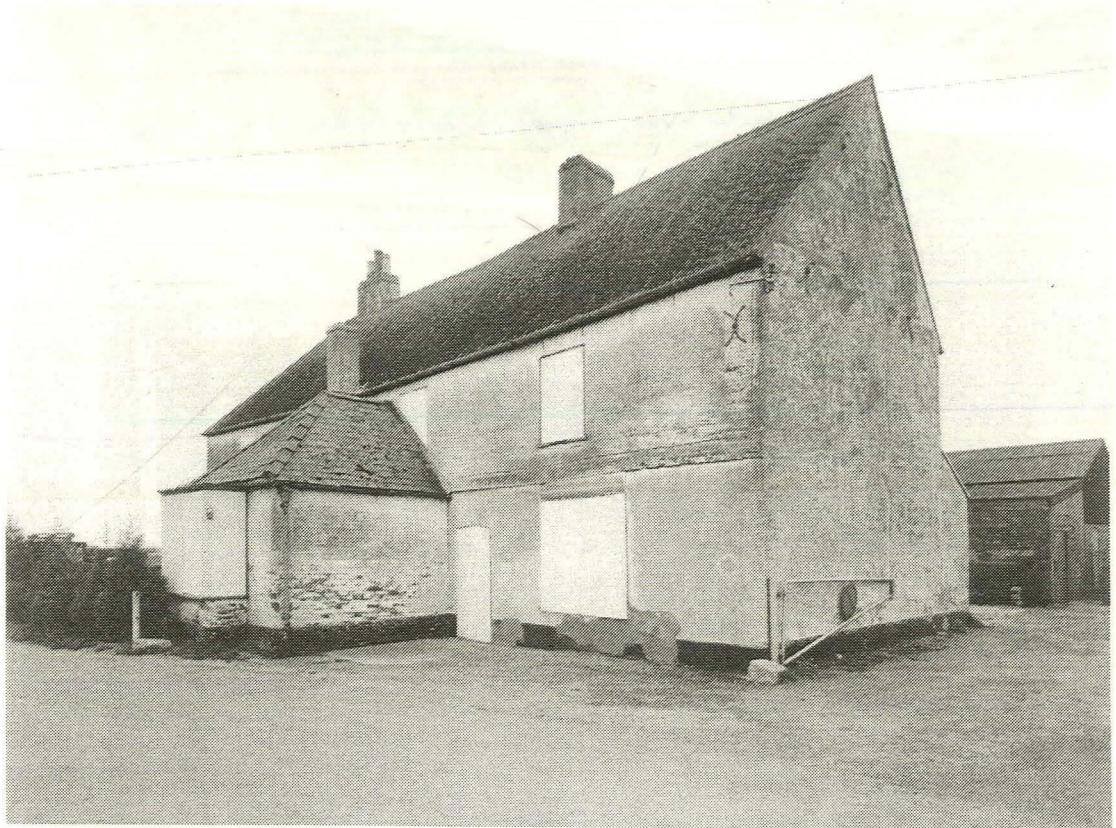
View from south-west

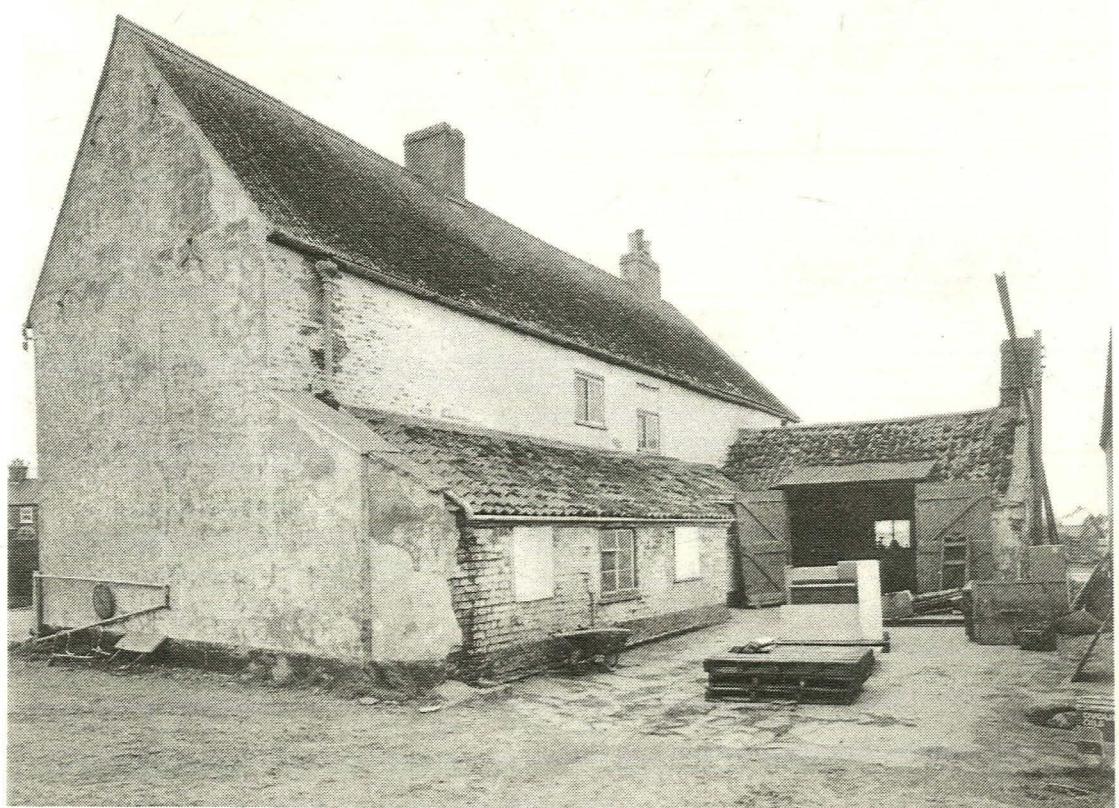
View from south-east showing added kitchen wing

In perhaps the late 18th or early 19th century the building was enlarged through the addition of a single-storeyed wing to the rear. The wing is of brick and has a pantile roof; brickwork is in English Garden Wall bond. The gable fireplace survives and has a large opening beneath a timber bressumer. The bressumer supports the tapering brick stack. Part of the fire area is occupied by an oven. The wing thus provided a cooking hearth and formed either the main kitchen or a back kitchen, bakehouse and brewhouse.

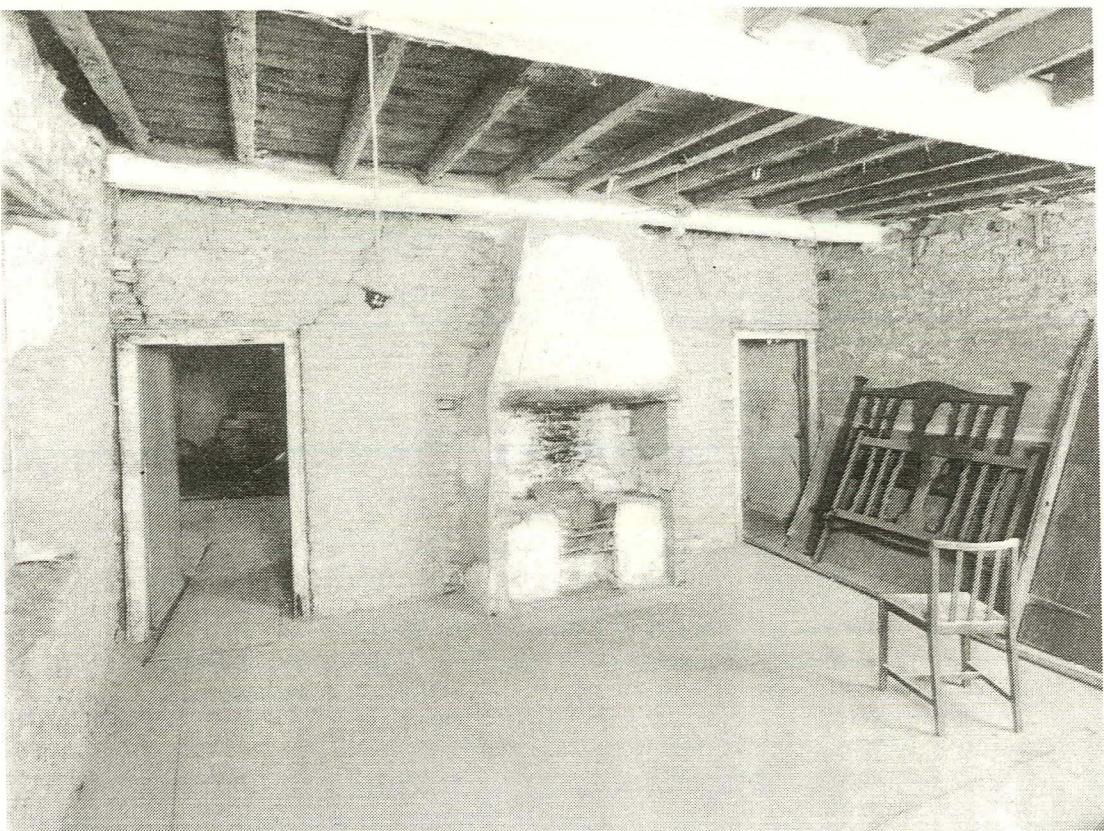
First floor, central room, view to north

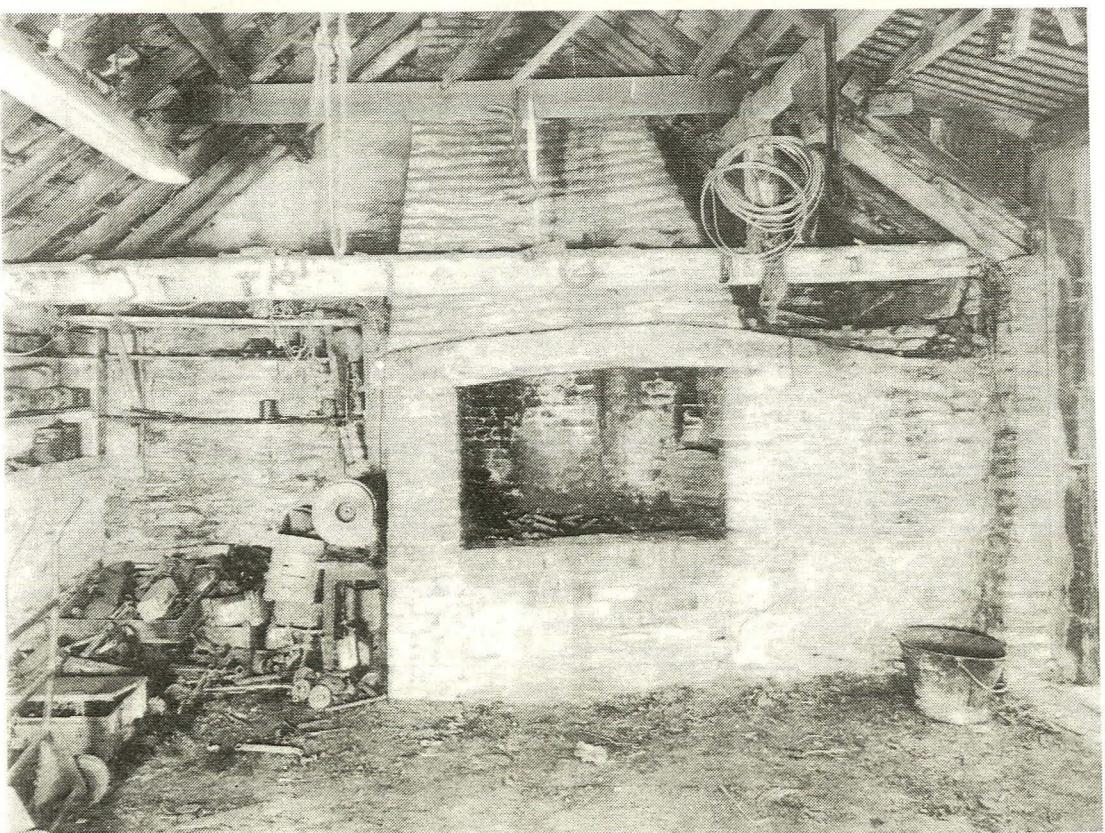
View of kitchen wing showing fireplace, oven and
later forge fittings

Various later additions and alterations have been made to the building. The kitchen wing was converted to a forge, perhaps in the late 19th century; part of the bellows mechanism survives next to the stack. Also probably in the late 19th century, a single-storeyed addition was made at the front, probably blocking the original doorway and necessitating the creation of a new entrance. The addition is of brick and provides a single room heated by a fireplace and lit by a bay window. It may have been built as an office. At the rear a small single-storeyed lean-to was built at the south end of the building probably in the 20th century to provide extra service space.

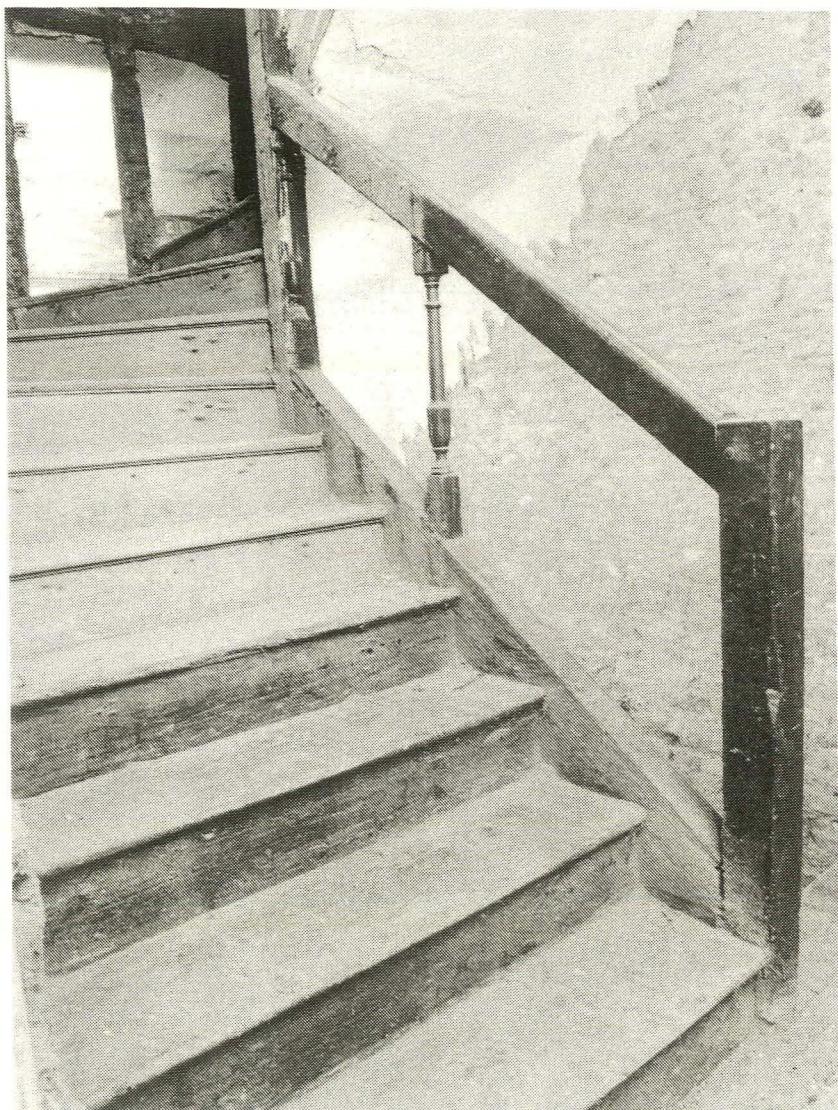
View of stair, ground floor

Between the southern parlour and the hall lies the stair. This occupies the western two-thirds of a narrow bay, the remainder forming a small closet. The stair is of dog-leg form and has square newels, closed string, moulded handrail and turned balusters, most now removed; the balusters have a plain tapering shaft above an urn. The stair appears to fit well within the stair bay and may be presumed to be in its original position. The fact that it occupies only part of the bay precluded lighting from the east, and thus the stair hall must originally have been lit from the west. On the ground floor this may have been by means of a fanlight over the doorway, but on the first floor an oak-framed cross window survives on the landing.
