1 ARCHAEOLOGY FROM AERIAL PHOTOGRAPHS

1.1 Method of photo-examination

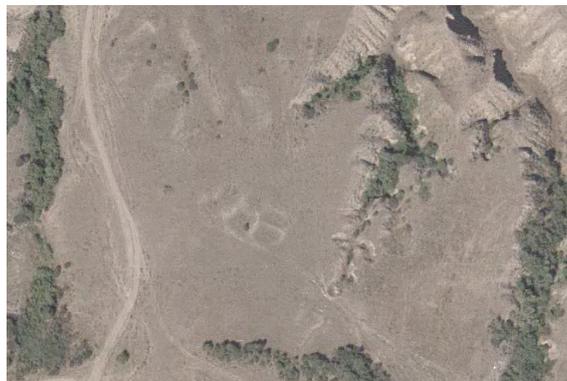
Site 8543/1 comprises a group of at least three adjoining walled or embanked enclosures on locally high ground. The site is coincident with NB75.

Fig 1.1. Archaeological site 8543/1. Walled or embanked enclosures on high ground. Site NB75. Source photograph: 6126.

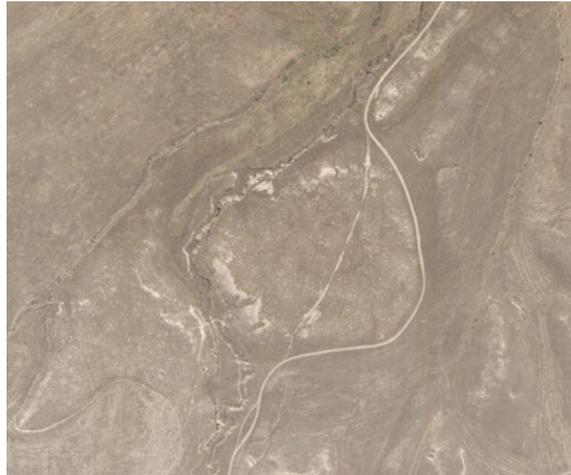
Site 8575/1 was identified as an isolated mound with parts of a possible enclosing wall and an irregular internal surface. On the basis of the air photo evidence it was suggested to be a settlement. It coincides with known site NB56.

Fig 1.2. Archaeological site 8575/1. An isolated mound that appears to have parts of an enclosing wall. Site NB56. Source photograph: 6075.

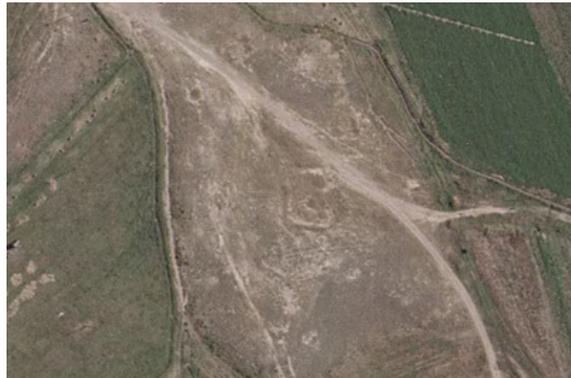
Site 8585/2 is a rectangular walled or embanked enclosure with internal features. It is likely to be a settlement site and its eroded appearance suggests it to be of some antiquity.

Fig 1.3. Archaeological site 8585/2. A rectangular embanked or walled enclosure with internal features that may indicate that the site was a settlement. Source photograph: 6056.

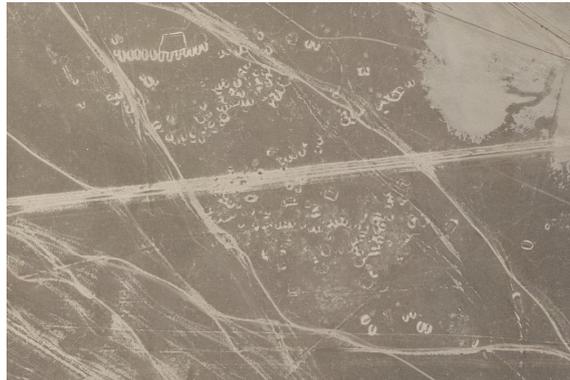
Fig 1.4. Site 8813/2 and 3. The left-right line on the print is the WREP route. In this area, the BTC pipeline will be some 70m to its north (bottom) and cuts through a densely-packed area of features of various forms. This group (8813/2) comprises mostly sub-rectangular features but includes some of rectangular form and a number of small circular or near-circular enclosures. Group 8813/3, at the top of the figure, includes a line of sub-rectangular features, all with 'entrances' on the south side, and some of which abut larger trapezoid enclosures that may be for stock. Source photograph: 6230.

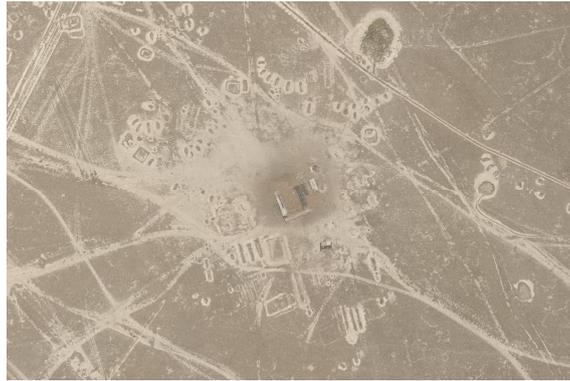
Fig 1.5. This figure is to illustrate the apparent clustering of sub-rectangular features around modern buildings or sites of buildings. The photograph also shows some of the groupings and forms of design of these features. At the upper right centre of the photograph is a pond. This group of features is in easting 8813 and the central buildings are some 600m south of the pipeline. Source photograph: 6230.

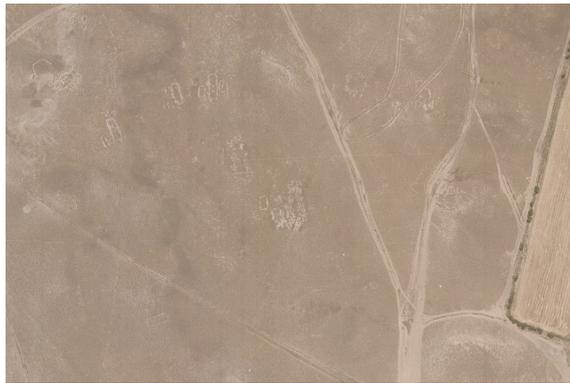
Fig 1.6. Site 8619/3. The figure includes several listed sites of which 8619/3 is near the left-centre of the frame and provides an example of eroded rectangular features. This site is very close to the pipeline route. Just left of the upper centre is 8619/12 which shows the pairing of large with small rectangular features that can also be seen elsewhere. Source photograph: 6412.

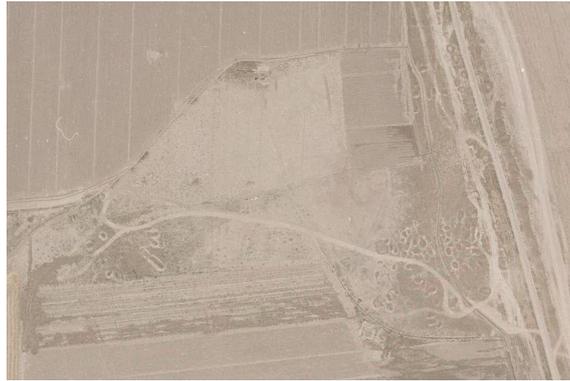
Fig 1.7. Sites 8777/2 and 3. The group of features on the right of the photograph includes 'scoops' (so-called because their raised edges almost surround the interior) and somewhat eroded rectangular features. Some superimposition of features can be seen in this group and the modern track overlays or abuts others. The smaller group on the left of the photograph also includes both types of feature. Details of both sites are surveyed on the 1:10000 map suggesting they are of some antiquity. Source photograph: 6289.

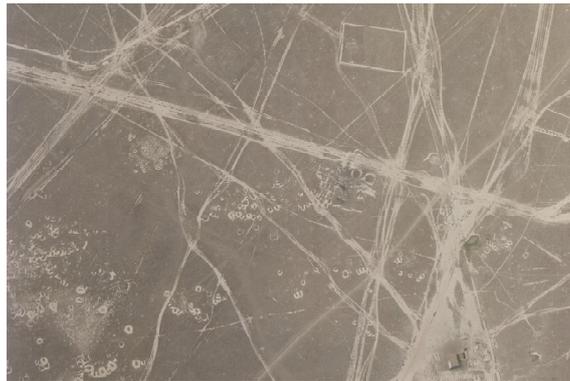
Fig 1.8. Part of Site 8815/1. This further illustrates the range of shapes and groupings of the sub-rectangular features and their associated enclosures. It also shows some of the stages of decay that occur after abandonment of the temporary structures. Of interest near the top of this figure is the walled or embanked rectangular enclosure with its cultivated land within. The walls, it may be suggested, are to exclude stock. This enclosure and its approach track are mapped at 1:10000 as are many of the sub-rectangular features. Source photograph: 6230.

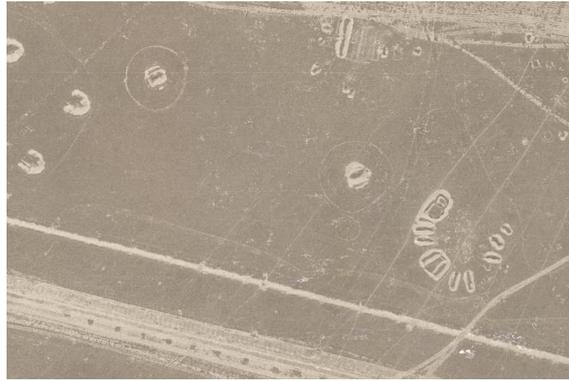
Fig 1.9. Sites 8816/1-3. The arc of sub-rectangular features and variants on the right of the photograph (8816/1) surrounds an area of lighter ground, possibly indicating wear from stock. Left of that site are two enclosures or features each within a slight circular enclosure. A smaller circular enclosure, with no internal structure, is immediately below the more centrally placed circle (8816/2). On the left of the figure is one end of an arc of wide-spaced features (see Fig 1.10, 8816/4). Source photograph: 6228.

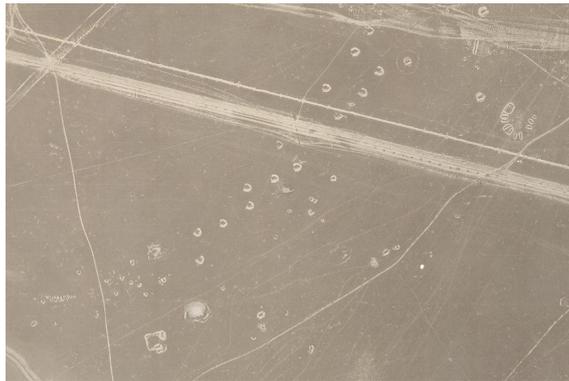
Fig 1.10. Sites 8816/1-5, 8817/1. This figure shows a broader context to sites in the previous figure (seen here at the upper right). The line of wide-spaced sub-rectangular features (8816/4) extends from the vicinity of 8816/3 (upper right centre) and appears to end by a cluster and line of smaller variants on the left of the photograph. This line of features has been cut by the WREP pipeline, and the BTC pipeline will lay parallel to this and about 100m north. Site 8817/1 is a double walled square enclosure (or three sides of an enclosure) with sub-rectangular features at its open end. This has been listed as 'archaeological' but the freshness of the walls suggest it may be somewhat recent in origin. The more degraded feature of similar size to the right of 8817/1 may be the remains of an earlier and similar enclosure. Source photograph: 6228.

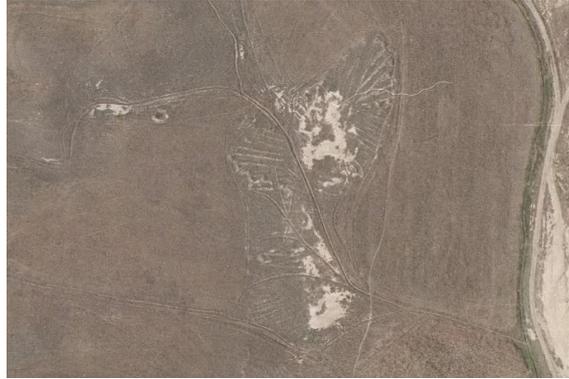
Fig 1.11. Site 8566/1. An area of conjoined long rectangular features showing as possible scoops with raised or embanked edges. Each has an open end facing a modern track and they are likely to be recent in date. Areas of light colour may indicate worn ground or levelled features. Source photograph: 6114.

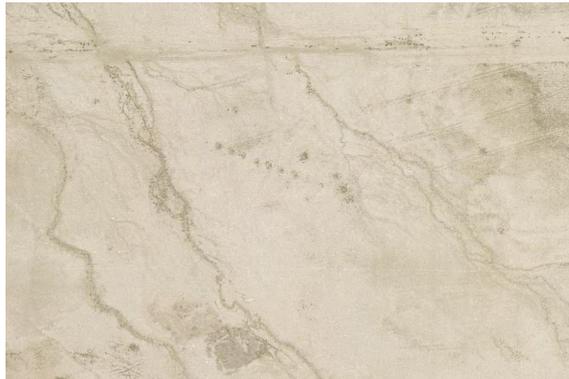
Fig 1.12. Site 8863/1. One of several rows of 'spots' identified during photo examination. No explanation can be given for these features. Source photograph: 6189.

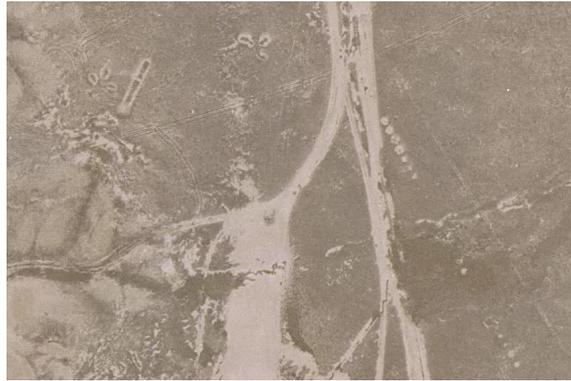
Fig 1.13. Site 8869/5. Part of a long straight row of 'spots' that appears to lay parallel to a linear feature – although the latter may be a vehicle track. The cause or purpose of the spots is unknown. Source photograph: 6177.

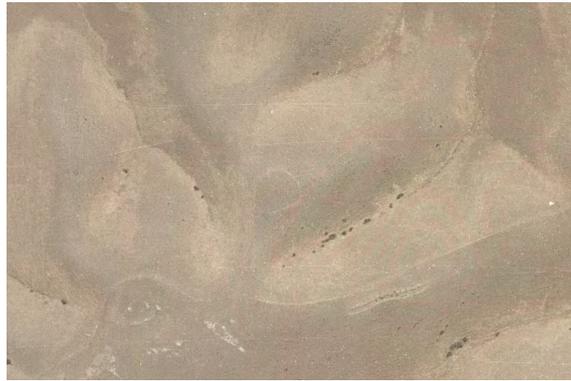
Fig 1.14. Site 8525/1. Walled curvilinear enclosure on locally high ground. Possible occupation site. Source photograph: 6024.

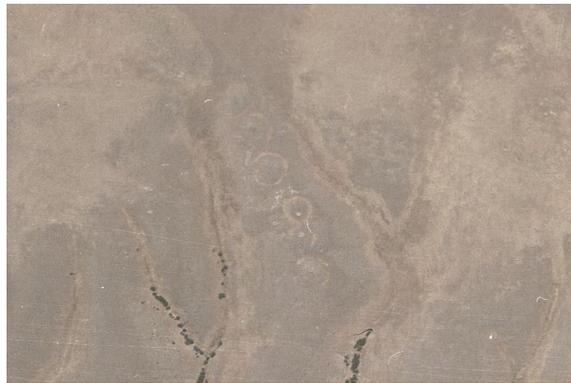
Fig 1.15. Site 8528/1. Five or more small circles on high ground between two watercourses. Possible occupation or burial sites. Source photograph: 6026.

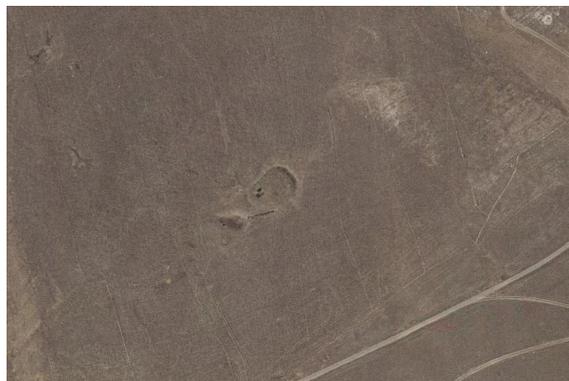
Fig 1.17. Site 8530/2. Walled curvilinear enclosure, possibly a pond rather than occupation? Source photograph: 6030.

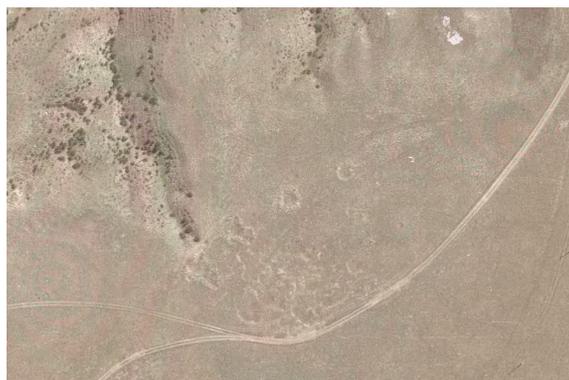
Fig 1.18. Site 8533/6. Two (possibly more) small circles adjacent to a disturbed area that may indicate quarrying. Source photograph: 6032.

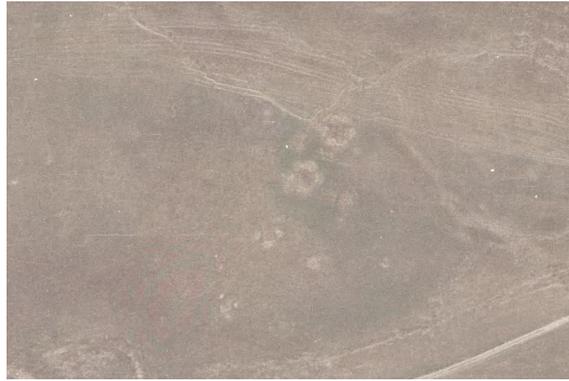
Fig 1.19. Site 8535/1. A row of at least three small circles. Their eroded appearance may suggest them to be archaeological but other similar sites in the vicinity (eg 8535/2, 8536/1) appear more recently made. Possibly burial sites, but very uncertain. Source photograph: 6032.

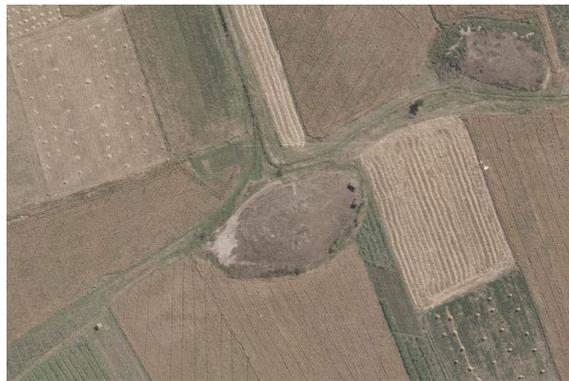
Fig 1.20. Site 8540/4. An oval mound of bare soil with surface irregularities. This is similar in appearance to known occupation sites but the presence of a second such mound in the upper right corner suggests they may be associated with modern farming. Source photograph: 6130.

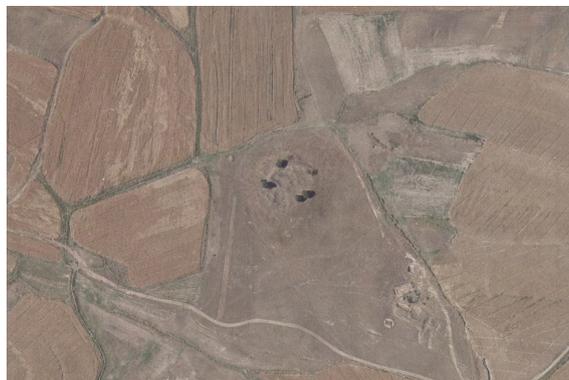
Fig 1.21. Site X3. A mound surmounted by a circular rampart within which is uneven ground. This is likely to be a settlement site. Source photograph: 6108.

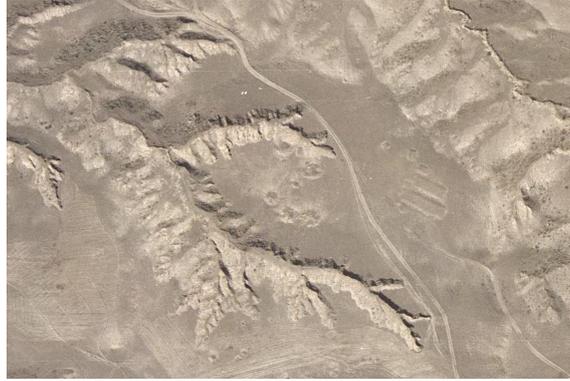
Fig 1.22. Site 8560/1. A group of circular features on high ground between watercourses. Possibly occupation sites. The rectangular features to their right are similar to others associated with shepherds' camps (see Figs 1.5, 1.6). Figure 1.23 overlaps the lower part of this photograph. Source photograph: 6091.

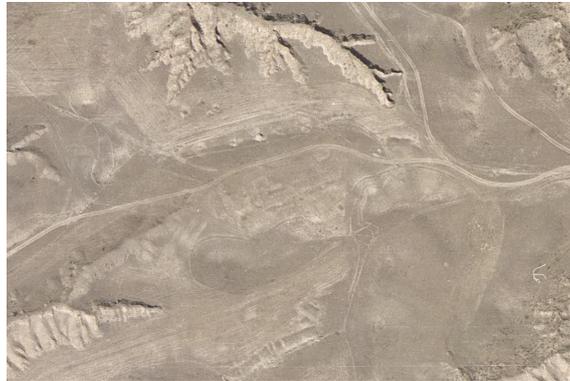
Fig 1.23. Site 8560/2. An area of slight rectangular features, possibly indicating a settlement site. Figure 1.22 overlaps the upper part of this photograph. Source photograph: 6091.

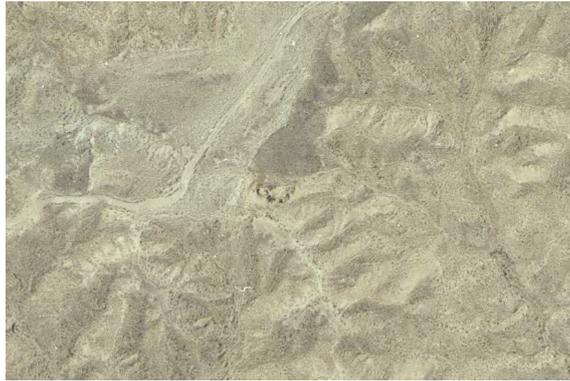
Fig 1.24. Site X4. A walled enclosure on high ground in a fairly mountainous area. Source photograph: 5569.

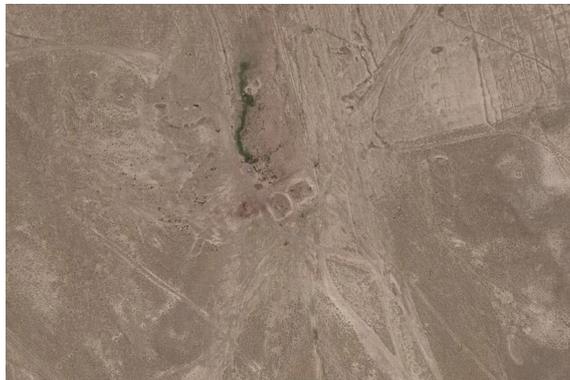
Fig 1.25. Site 8618/4. Two D-shaped conjoined enclosures at the foot of an escarpment overlooking a watercourse. Possibly an occupation site, more probably recent. Source photograph: 6412.

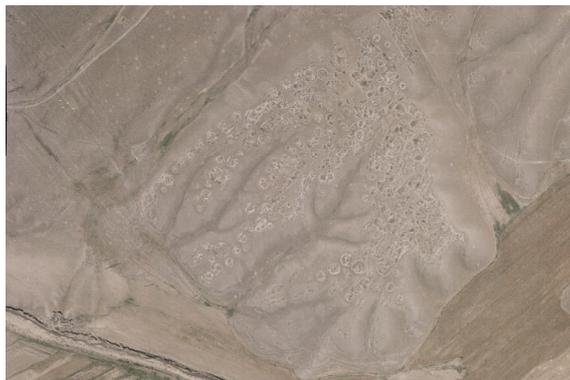
Fig 1.26. Site 8641/1. Local outcrop with many circular and other features that may indicate burials or may result from localised erosion. A part-enlargement is below as Fig 1.27. Some 1.5km to the

north is a similar, but larger, outcrop (site 8640/2).
Source photograph: 6384.

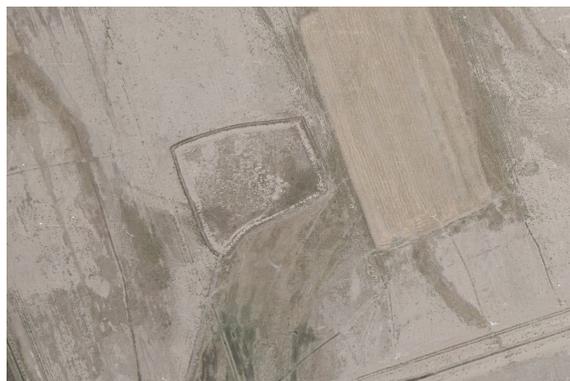
Fig 1.28. Site 8735/1. An embanked or walled enclosure with internal structures. Located at the confluence of two extinct rivers. Source photograph: 6272.

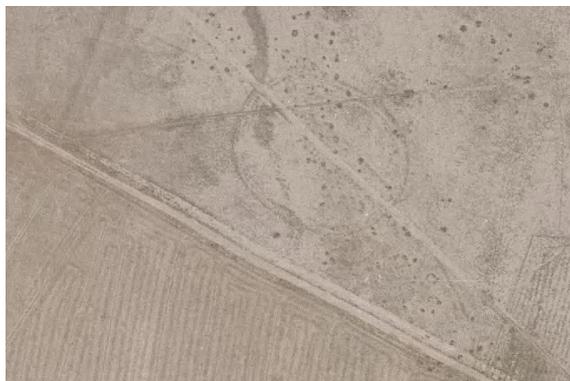
Fig 1.29. Site 8775/2. A ditched curvilinear (oval) enclosure with traces of an internal bank. Two linears cross over the enclosure and the unidentified dark spots also seem to post-date it. In the lower right corner of the figure is some ridged cultivation that possibly indicates the most recent activity in this figure. Source photograph: 6288.

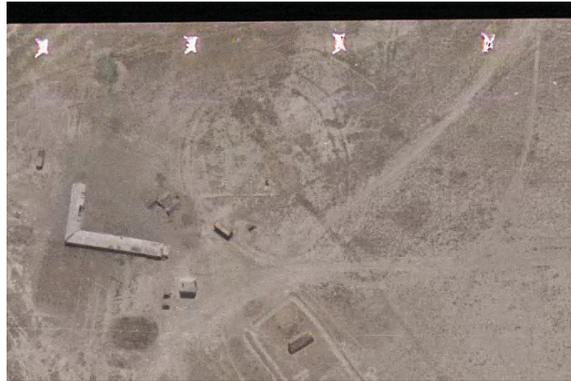
Fig 1.30. Site X5. A double-ditched curvilinear (oval) enclosure with possible internal and external features. A modern hut has been placed between the two ditches suggesting that they are visible on the ground. Several tracks cross the enclosure. Source photograph: 6288.

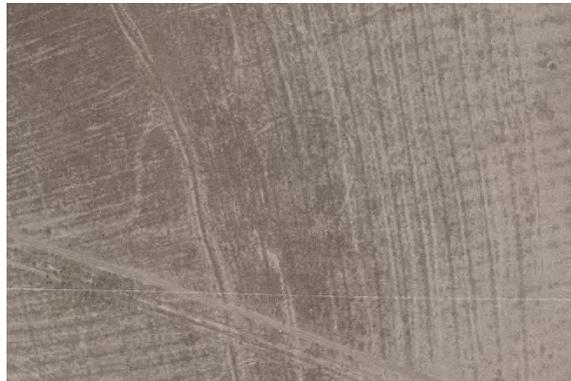
Fig 1.31. Site 8777/5. A ditched curvilinear enclosure with superimposed cultivation. Source photograph: 6289.

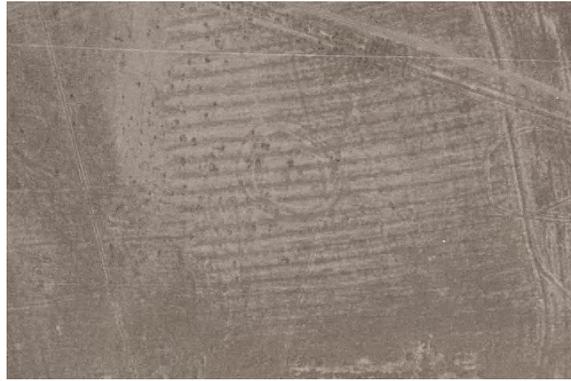
Fig 1.32. Site 8778/1. This photograph may illustrate three phases of activity. Ridged cultivation and a ditched curvilinear enclosure are superimposed in a manner which makes it difficult to identify which was earlier. Above both of these is a curvilinear wall or bank that was constructed within, but not concentric to, the ditched enclosure. Source photograph: 6289.

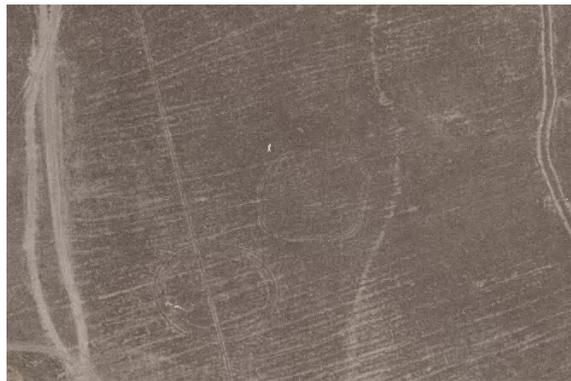
Fig 1.33. Site 8778/4. Central to the figure is a ditched sub-rectangular enclosure and to its lower left an oval enclosure with concentric double-ditches. Ridged cultivation appears to overlay both. Source photograph: 6289.

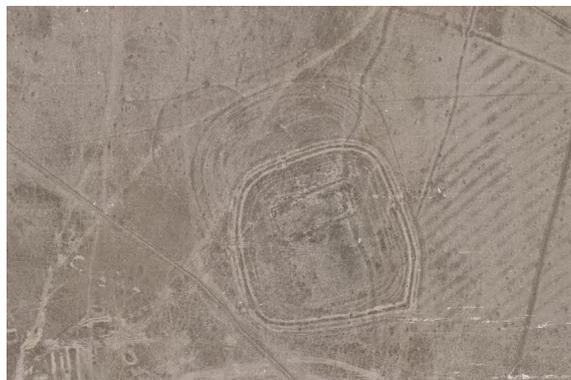
Fig 1.34. Site X8. Two superimposed multivallate enclosures that overlay a single ditched enclosure. Ridged cultivation on the right side of the figure may be overlain by the most recent enclosure. Source photograph: 6289.

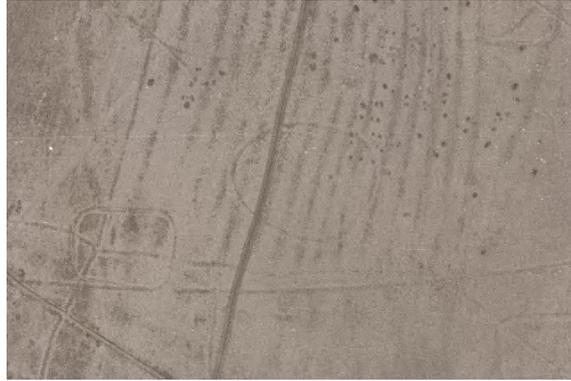
Fig 1.35. Site X13. Central to the figure is a ditched oval enclosure that is probably overlain by ridged cultivation. The rectangular enclosure (X10) on the left of the figure has a less clear relationship to the cultivation, but appears to overlay the dark-toned linear features (?ditches) that cross within it. X10 may also overlay the curving linear ditch that crosses the figure. Source photograph: 6289.

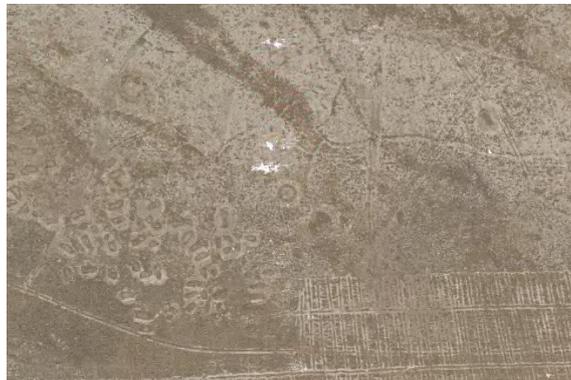
Fig 1.36. Site 8799/2. In the centre of the figure is a small circular feature comprising an external bank, a possible ditch and a central mound or platform within which there is a pit. This may indicate a burial monument. To the left are several phases of sub-rectangular features remaining from shepherds' camps. Source photograph: 6240.

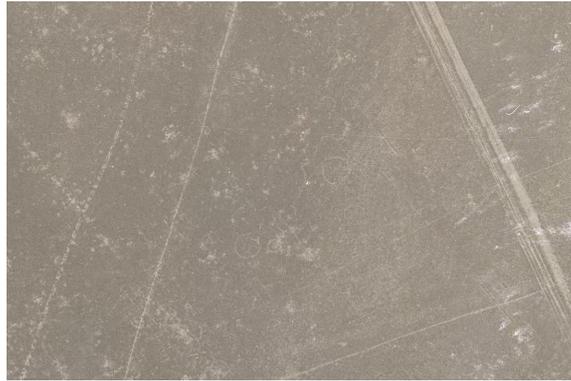
Fig 1.37. Site 8818/1. Seven, possibly more, slight walled enclosures in a range of sizes. Similar enclosing walls have been noted in areas frequented by shepherds (see fig 1.9), but there are none of their usual structures in this vicinity. Source photograph: 6228.
