Land to the rear of Pydar Mews, Truro, Cornwall;
Archaeological Watching Brief

Cornwall Archaeological Unit

Report No: 2017R077

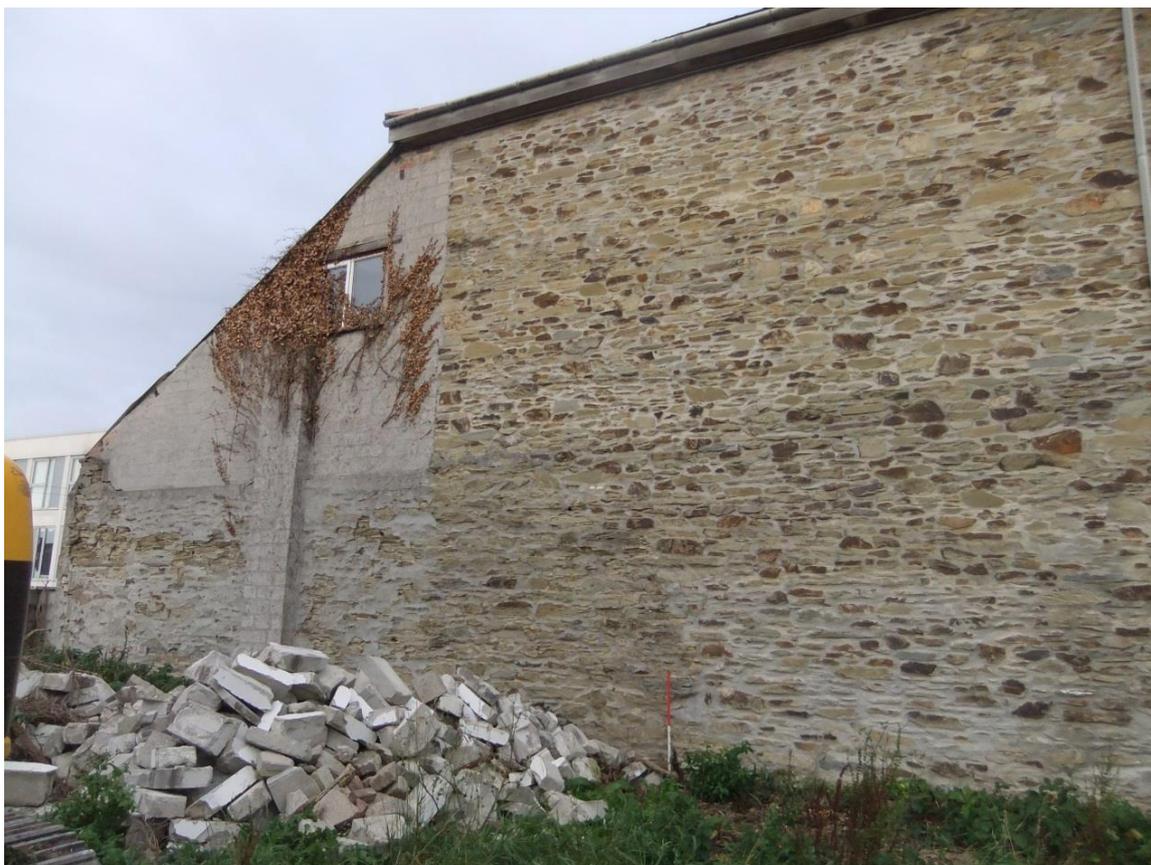
Fig 9 Possible early property wall Feature A incorporated in People's Palace left of scale.

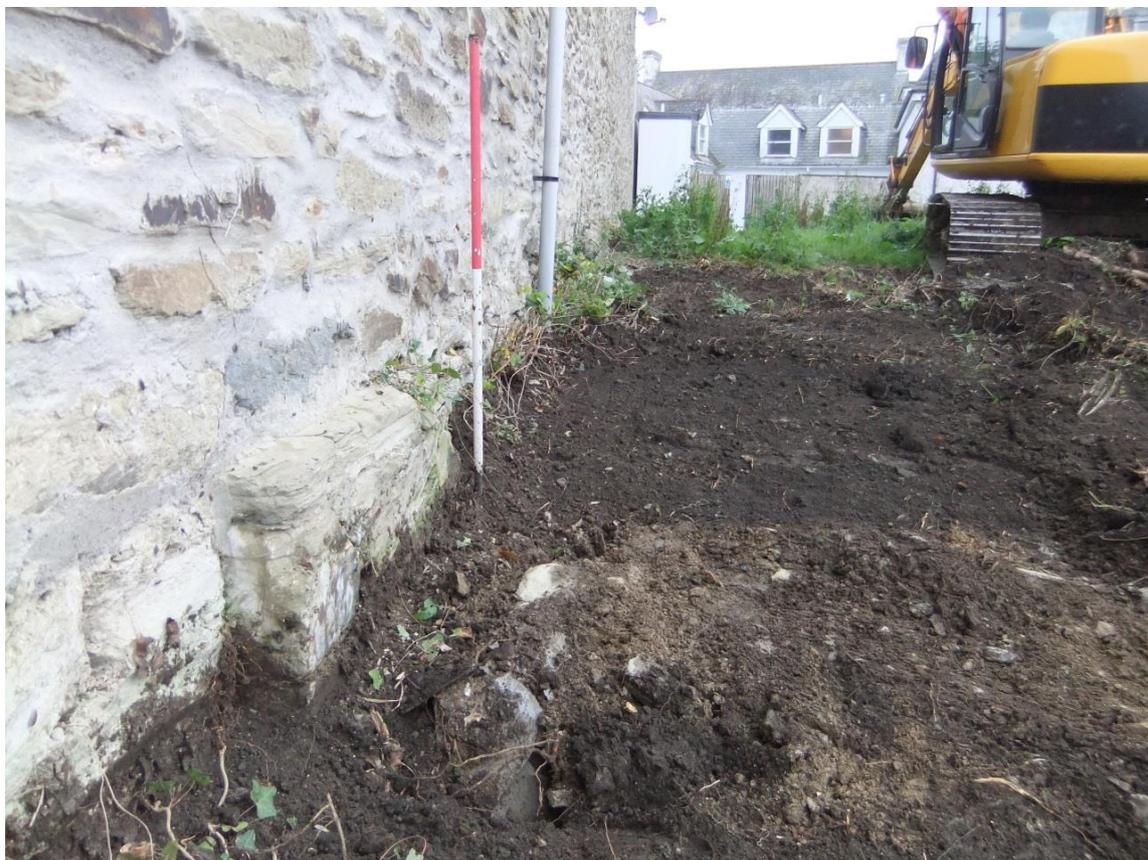
Fig 10 Stub of wall protruding from the People's Palace, Feature B, looking north.

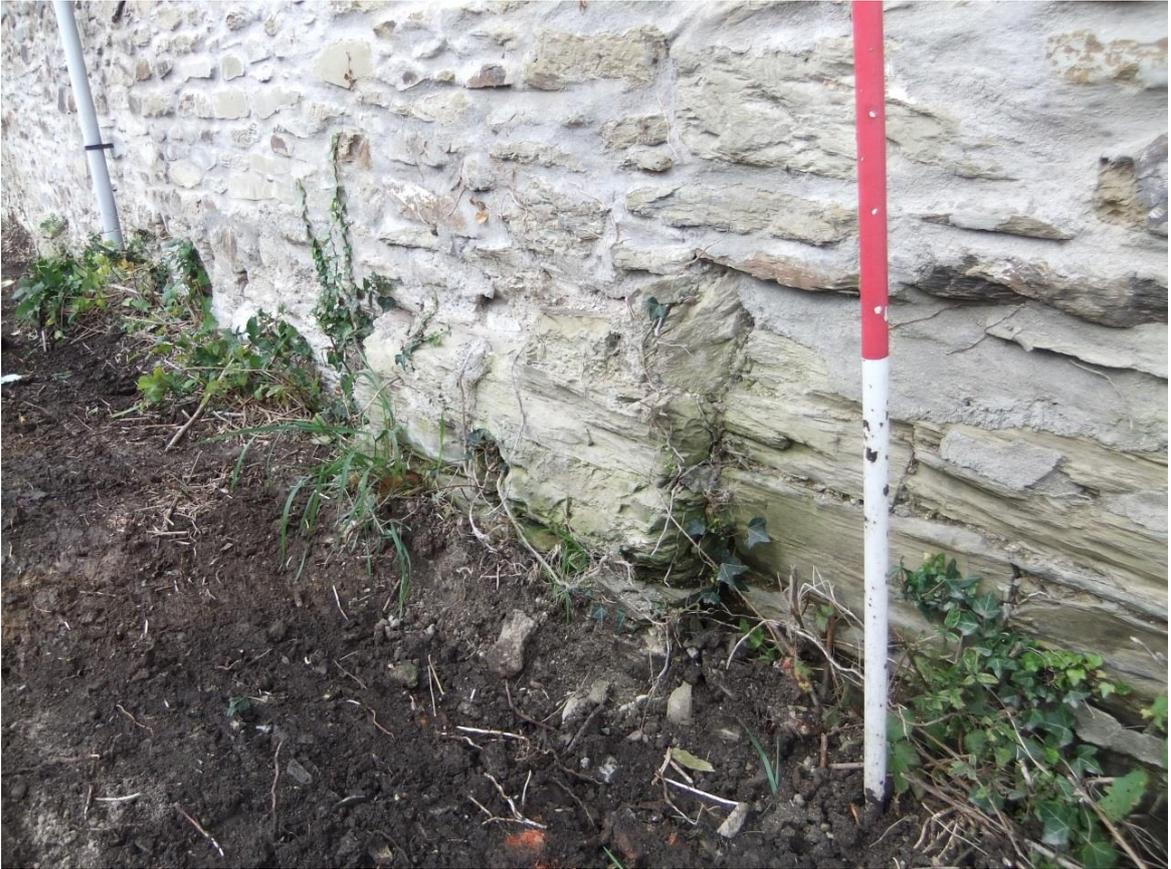
Fig 11 Further stub protruding from the People's Palace, Feature C, looking south west.

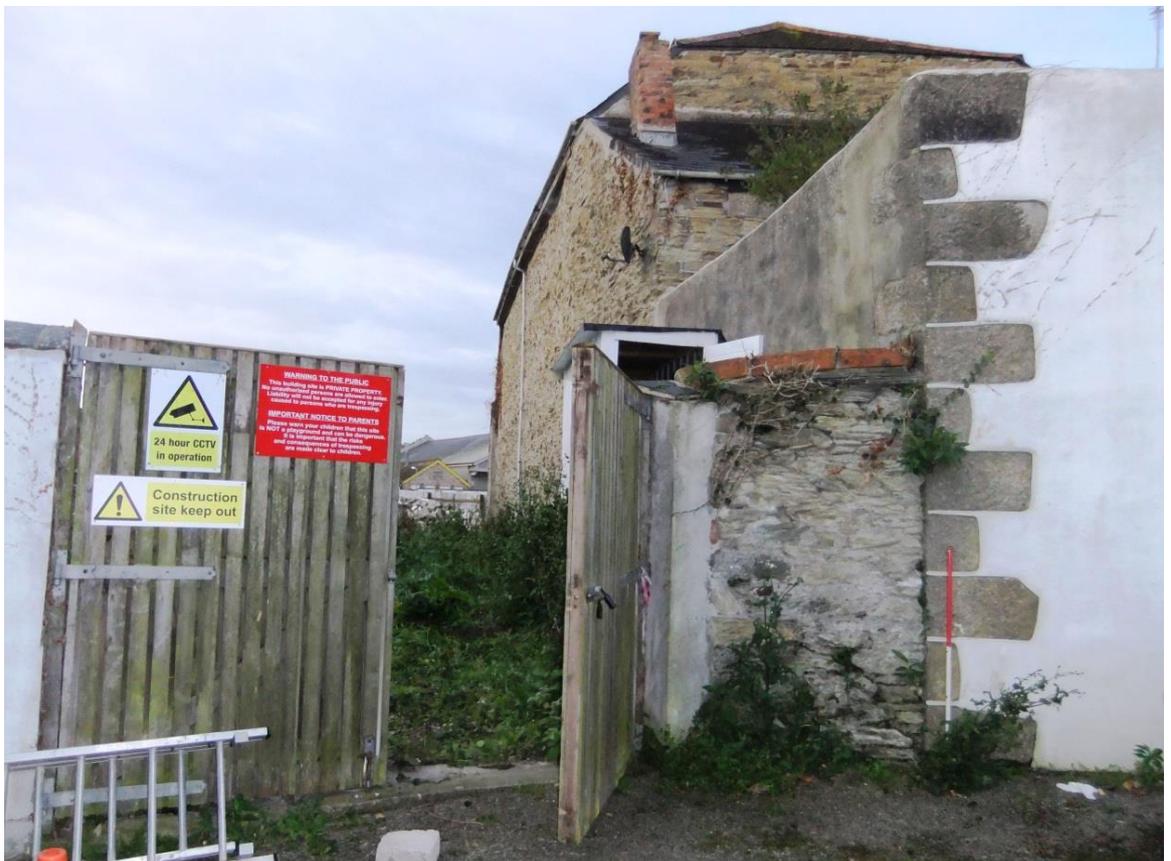
Fig 12 Looking into site through north west gateway with old walling on its west side.

Feature E is a truncated standing wall running out from the People's Palace to bound the other, inner end of the trapezoidal enclosure shown on the 1841 survey, retained to serve as part of the present property boundary (Fig 12). It is c0.8m wide and 2m high, and survives to a length of 1m. The wall faces are of the local rubble stone, with one brick and a reused roughly shaped granite also visible. Lime mortar is used (obscuring a wall core of clayey subsoil, not visible here but found in the buried base of the former eastern part of the same wall, Feature 8, described below). The wall coping is of slate topped with red clay ridge tiles bearing maker's stamps (not legible from ground level at the time of the fieldwork). The height and style of this structure are consistent with the interpretation of the trapezoidal feature as an enclosure, possibly a kitchen garden for one of the houses in the Pydar Street frontage (see Sections 3 and 4, and Fig 2).

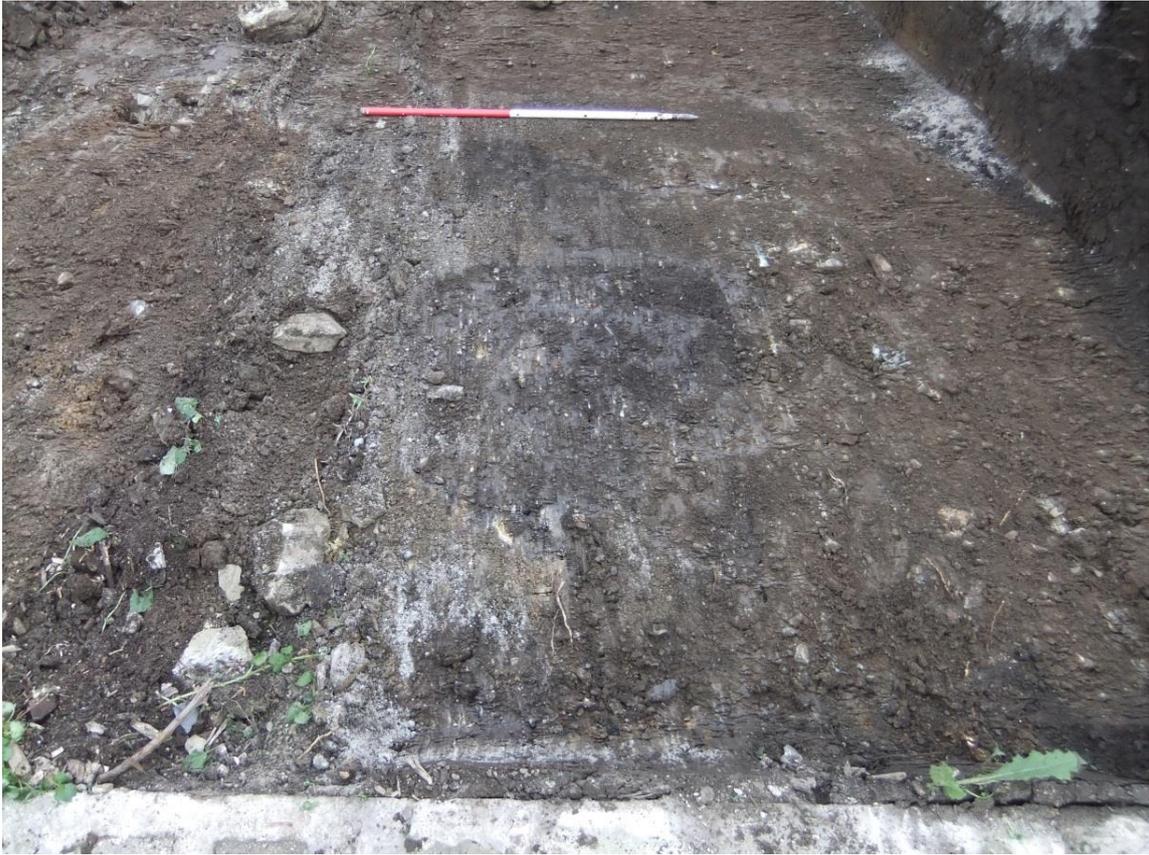
Fig 13 Feature 1 appears as a darker area in the subsoil, pre-excavation, looking north.

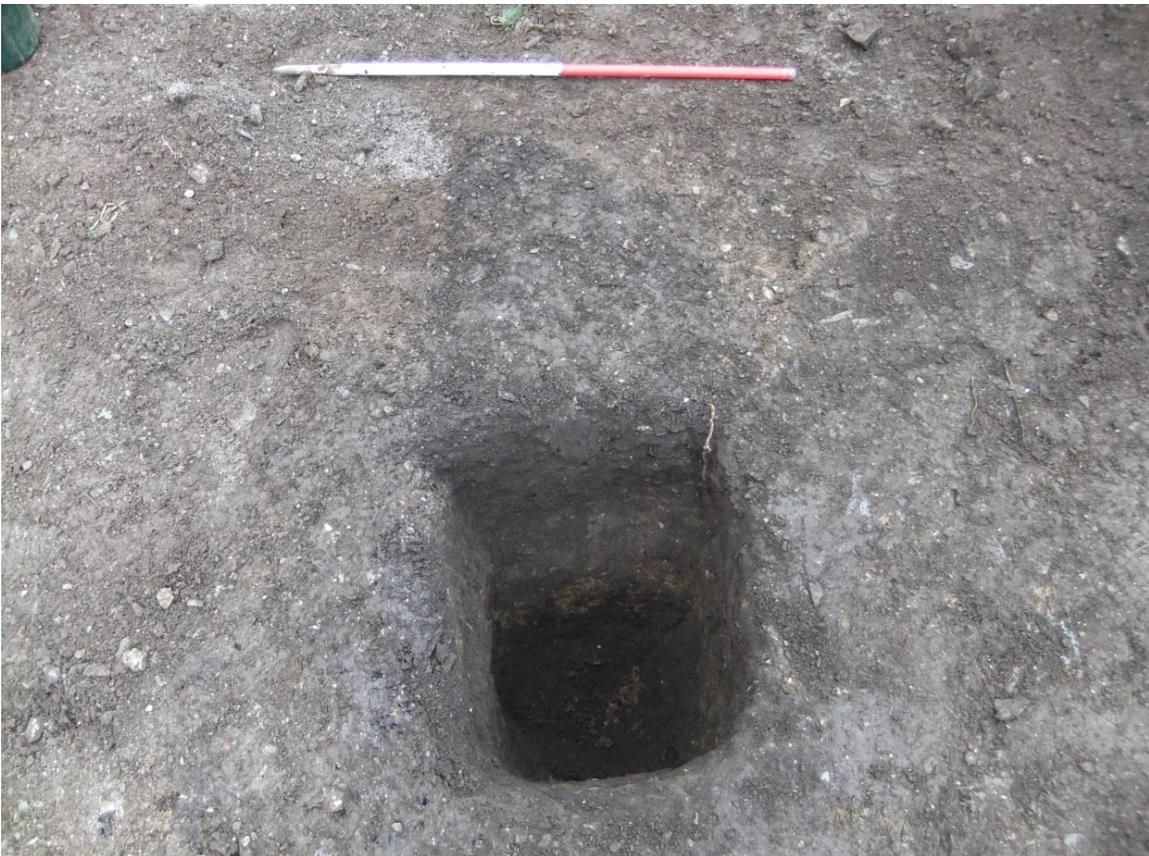
Fig 14 Feature 1 looking north, half-sectioning revealing all of its deeper southern end.

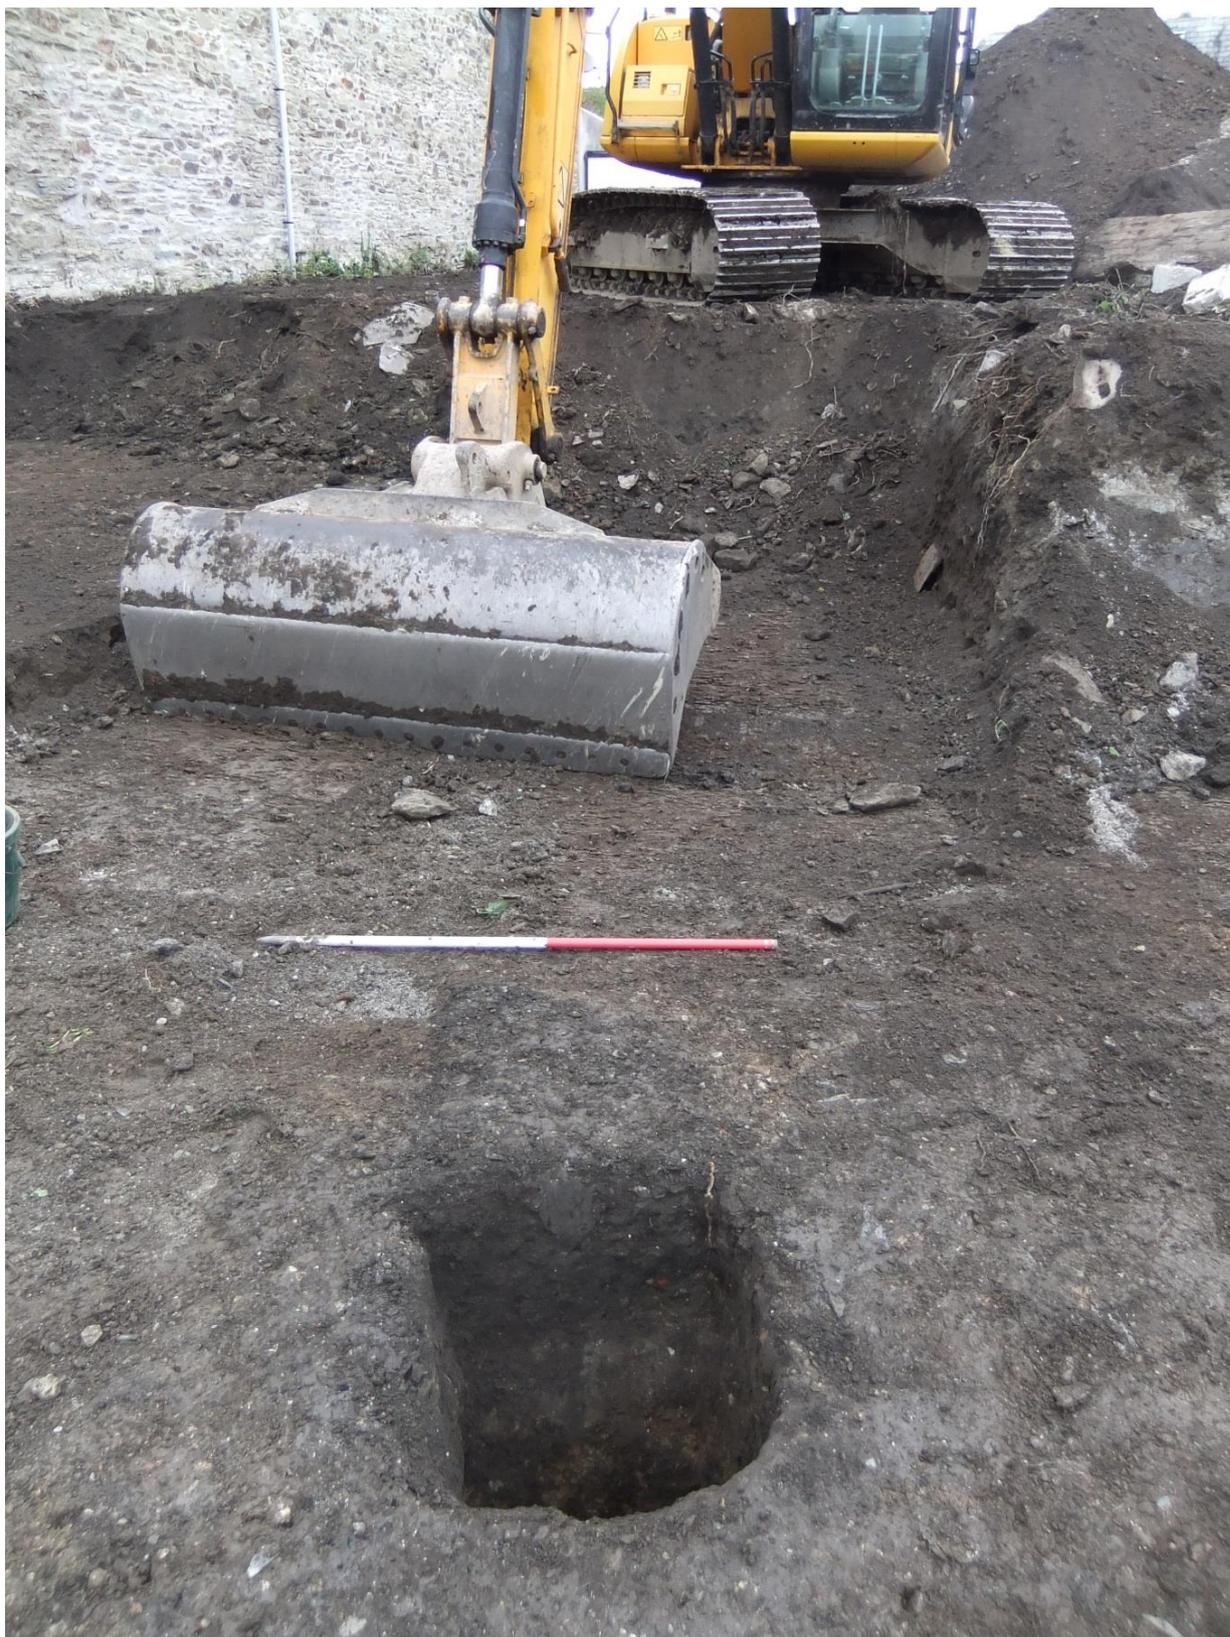
Fig 15 Feature 1 post-excavation, looking north towards typical rubbly topsoil layer.

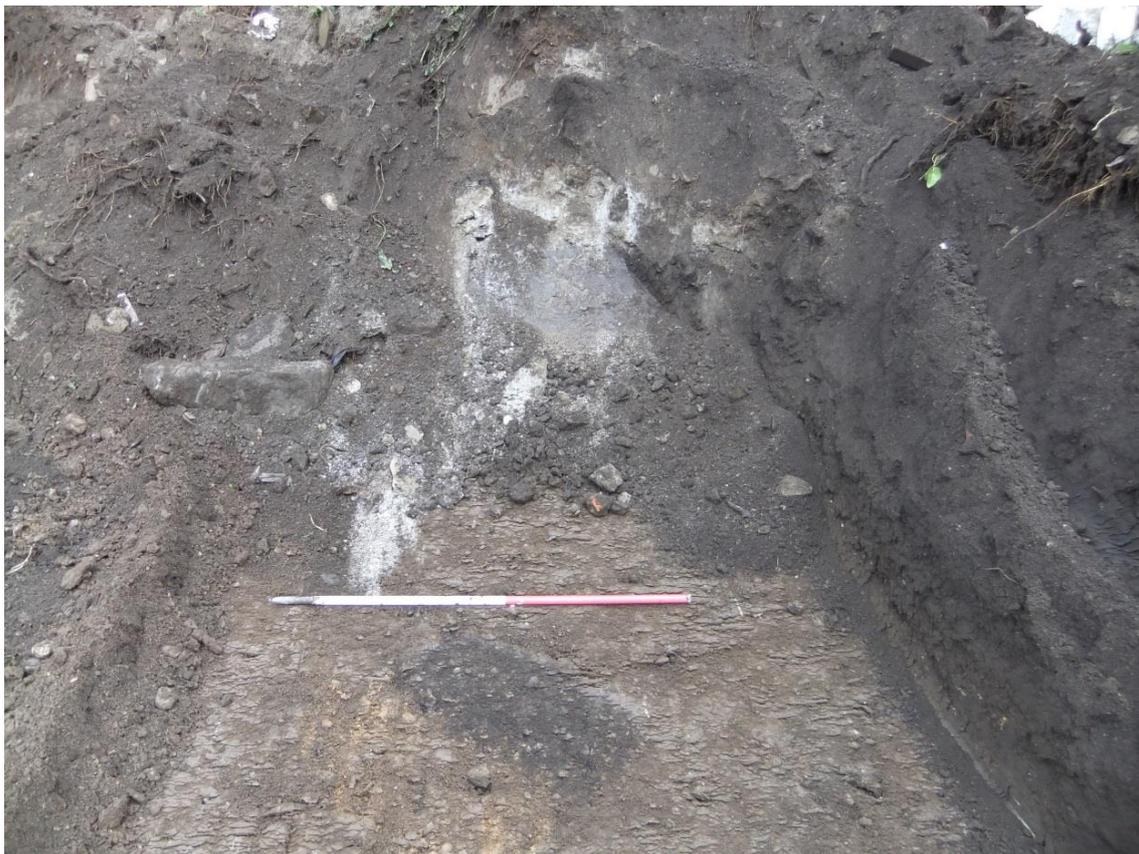
Fig 16 Feature 2 appears beneath soil with cement and other debris, looking north.

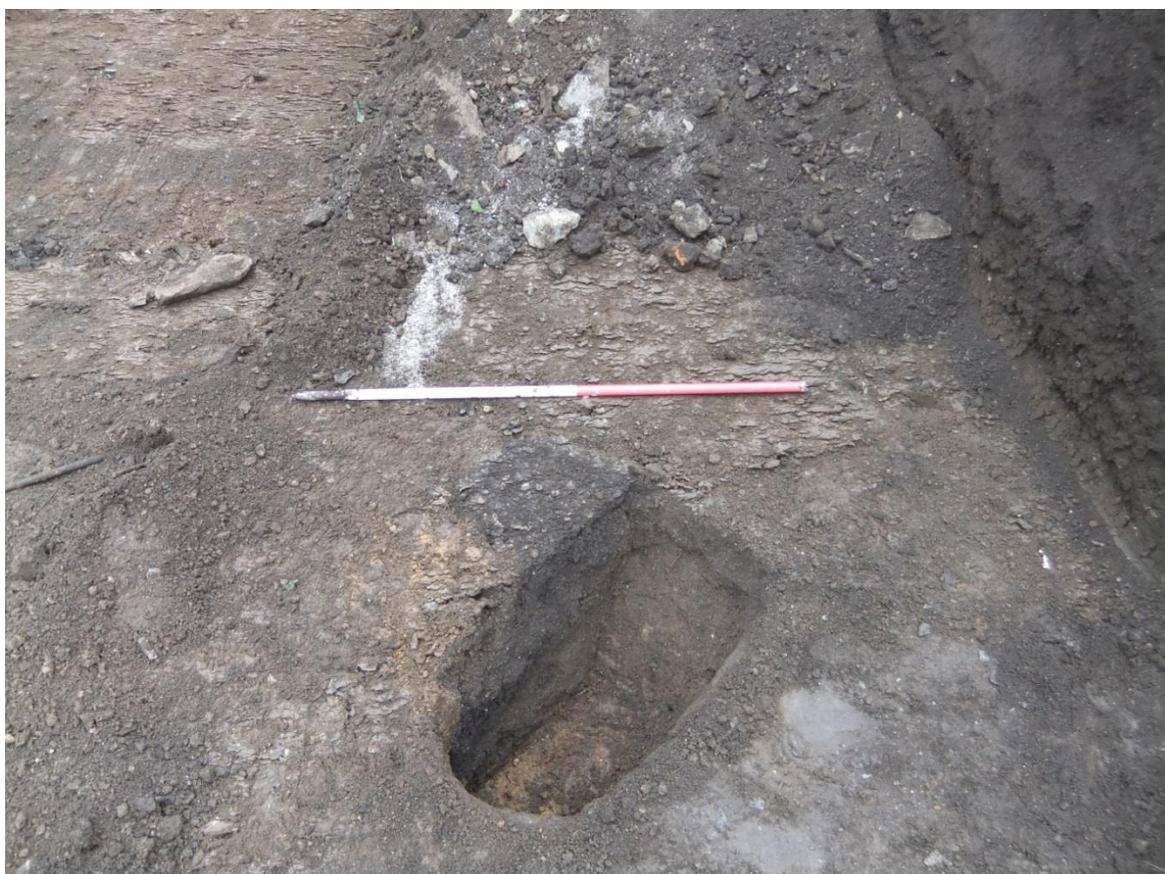
Fig 17 Feature 2 with section showing clayey (left) and darker, earthier fill, looking N.

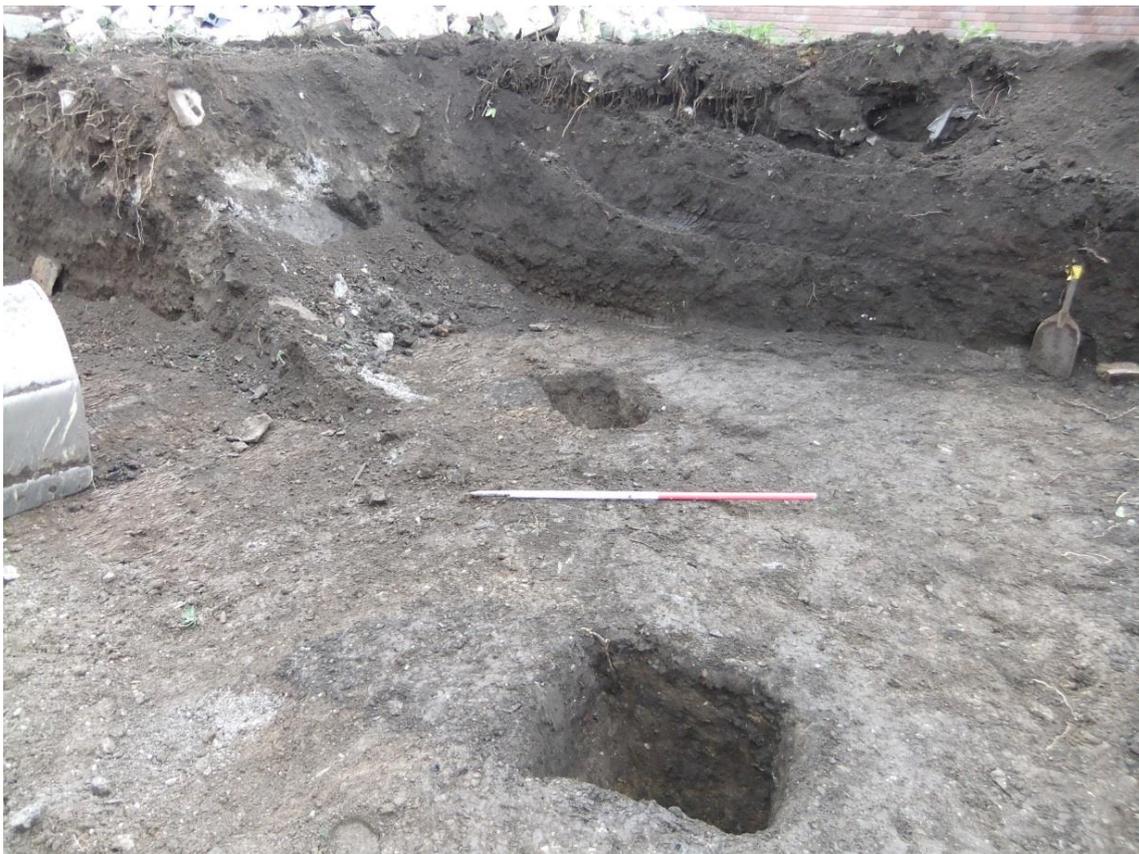
Fig 18 Excavated Features 1 and 2, showing different orientations, looking north east.

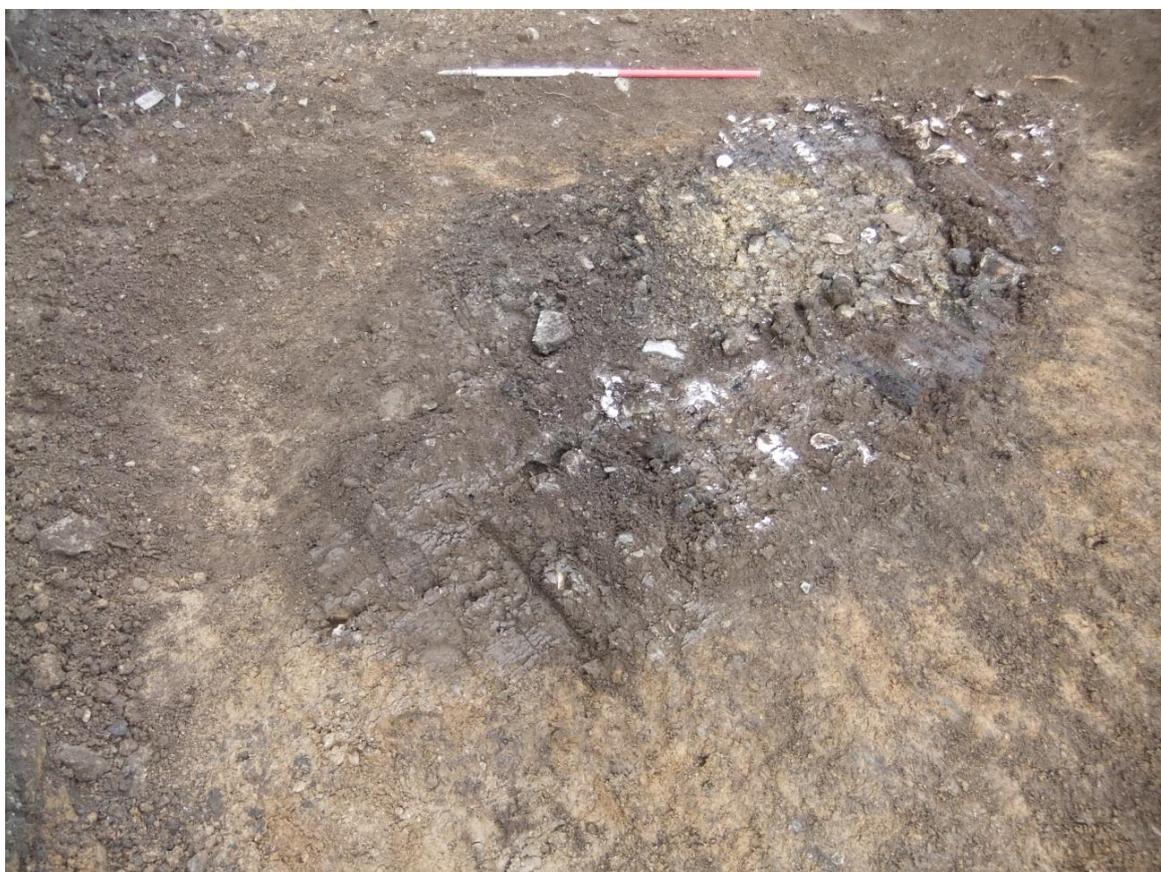
Fig 19 Feature 4 from the south pre-excitation, colours indicating several distinct fills.

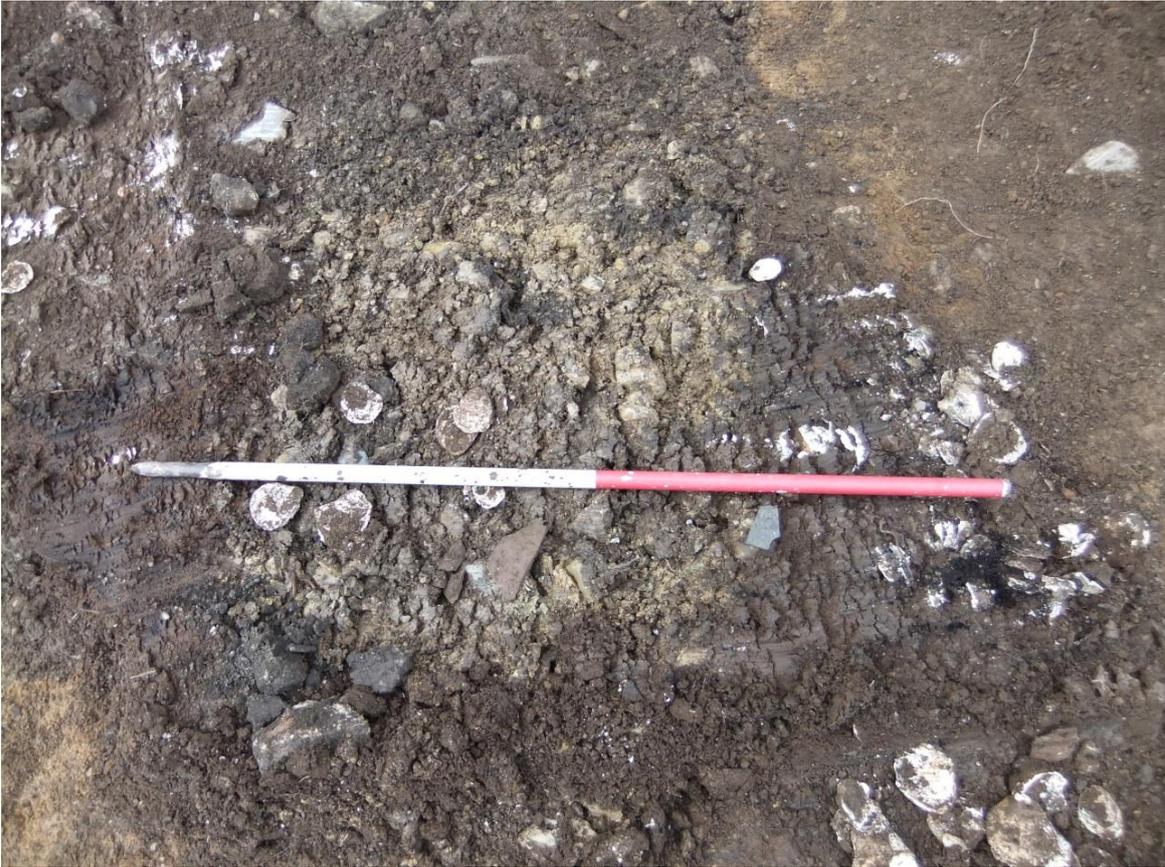
Fig 20 Centre of Feature 4 pre-excavation, with numerous shells, looking south west.

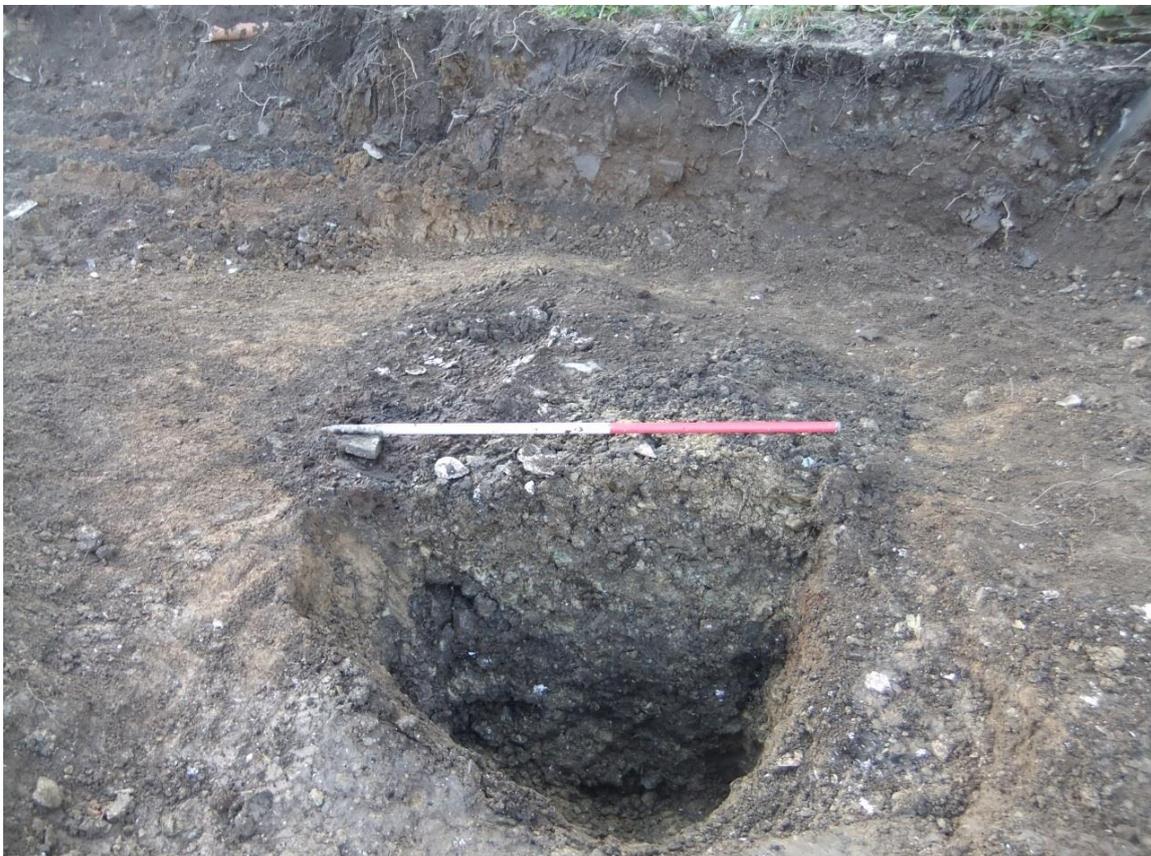
Fig 21 Feature 4 sectioned, showing lower fill with 14C to 16C pottery; looking WSW.

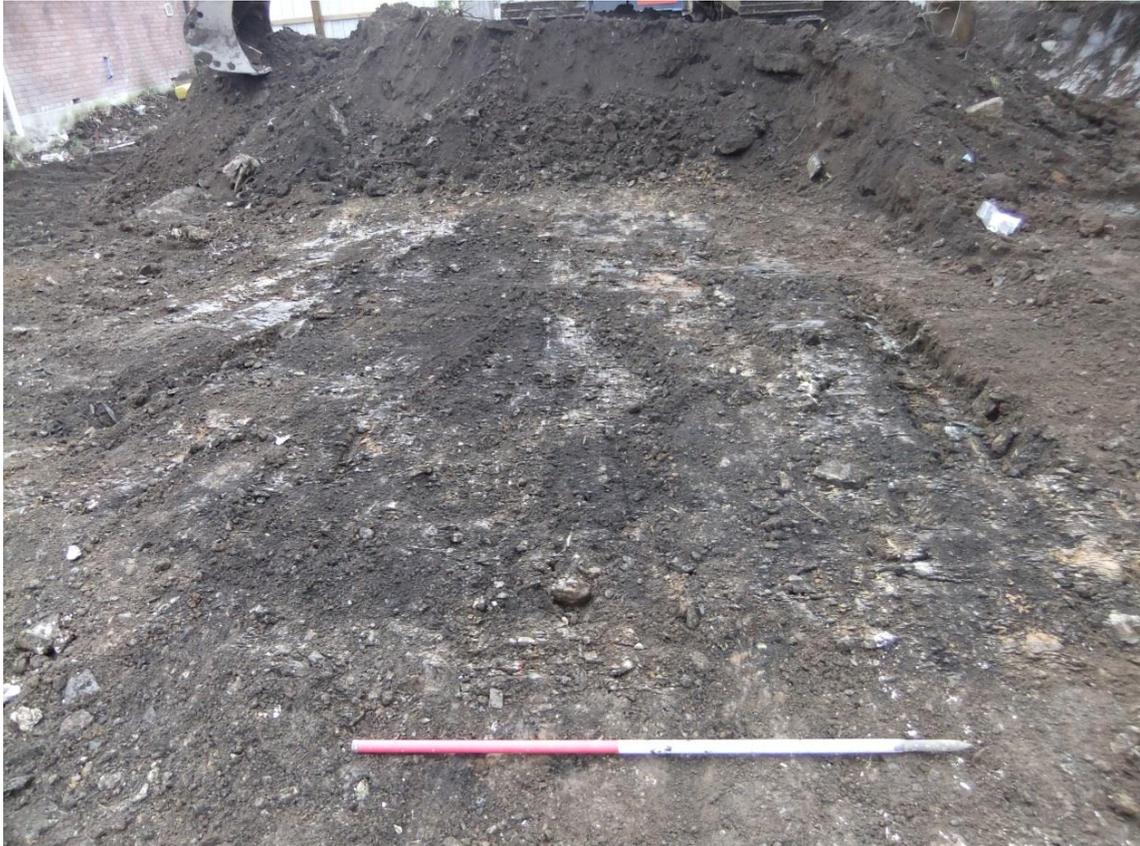
Fig 22 Feature 5 pre-excavation, looking south, showing its sub-triangular surface plan.

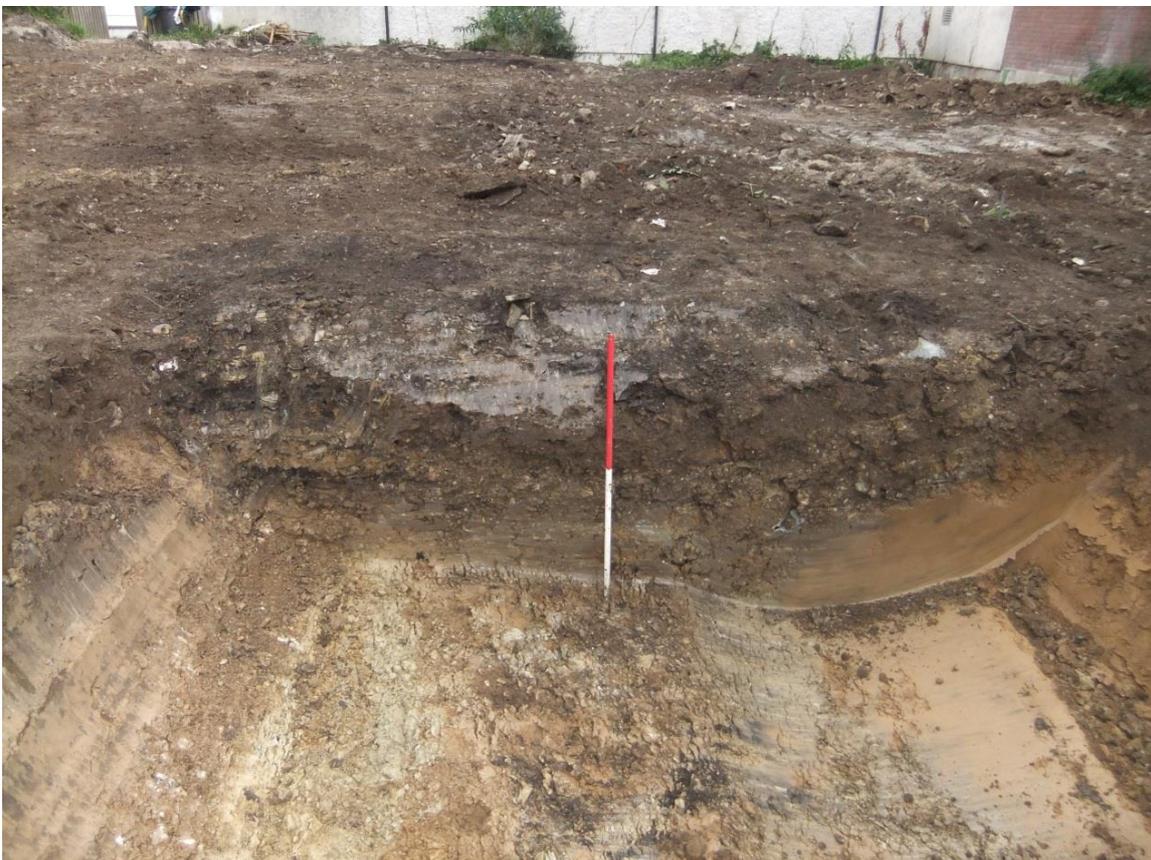
Fig 23 Feature 5, sectioned, with compact mixed dense stony fills, looking north east.

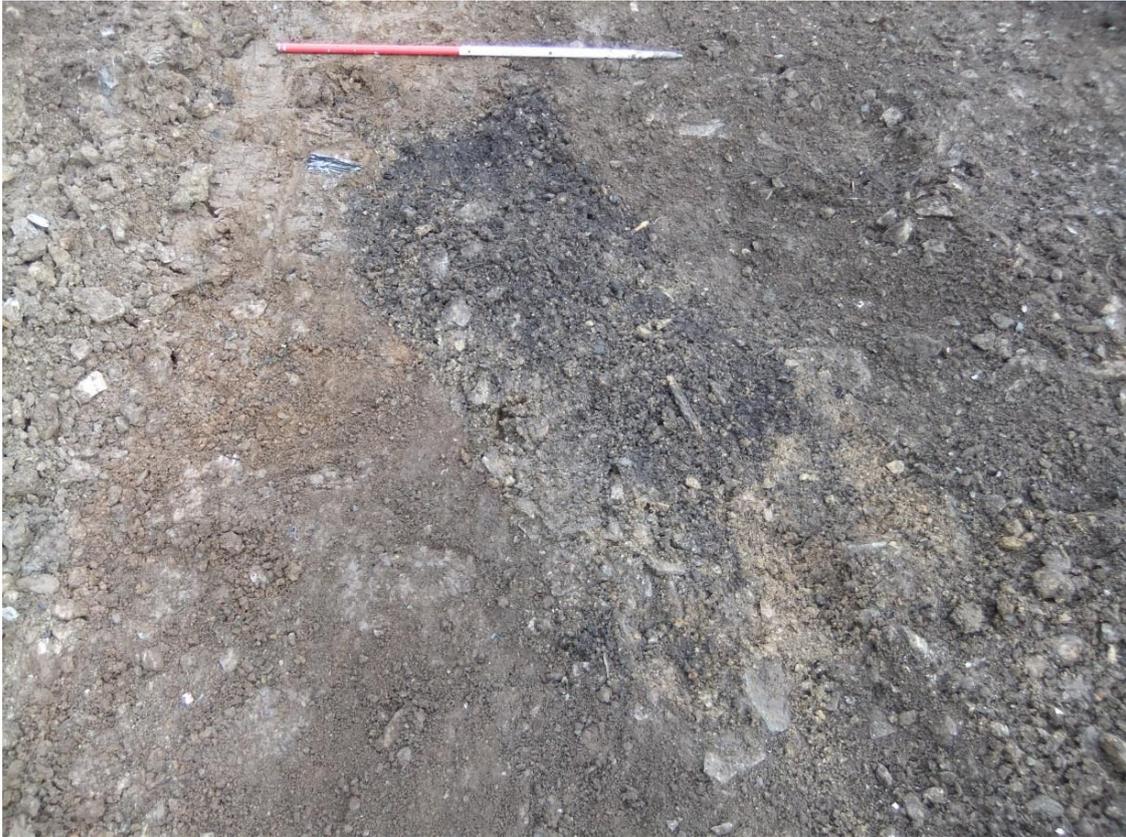
Fig 24 Feature 6 as first exposed with its very soft though gritty dark fill, looking north.

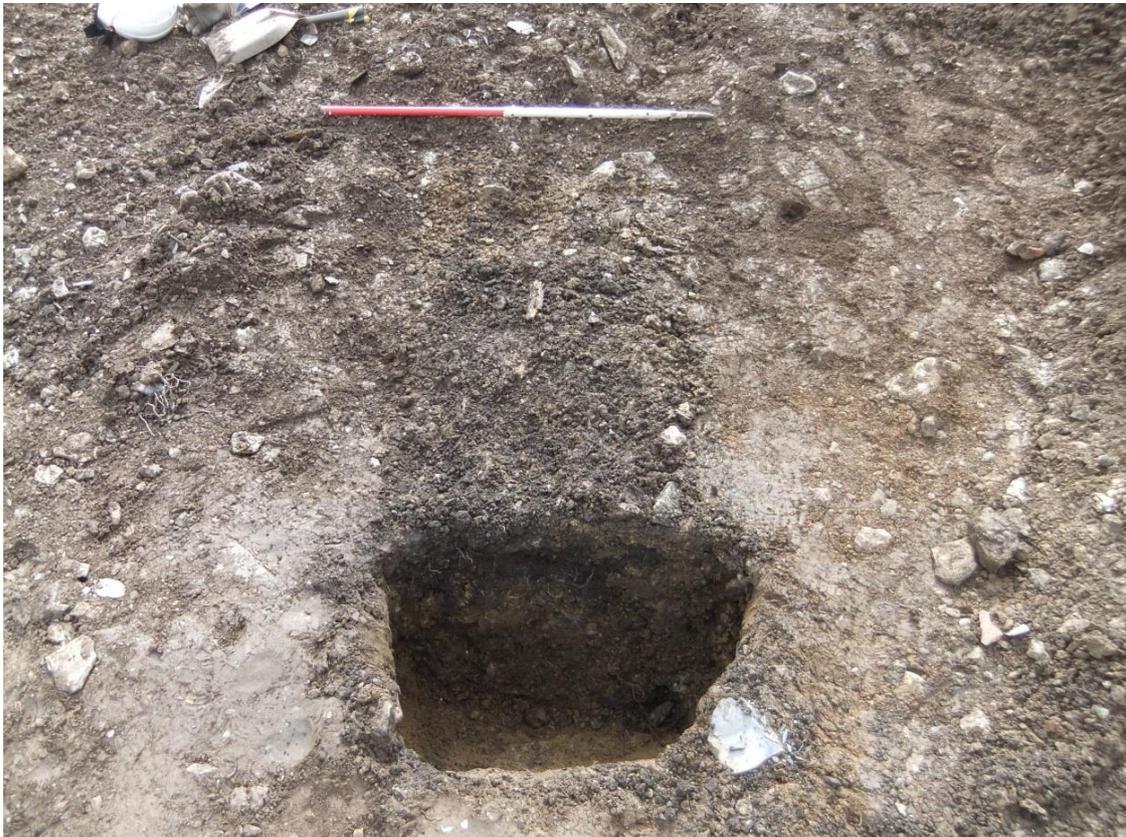
Fig 25 Looking SSW at the section of Feature 6, which produced 17th-18th century clay pipes.

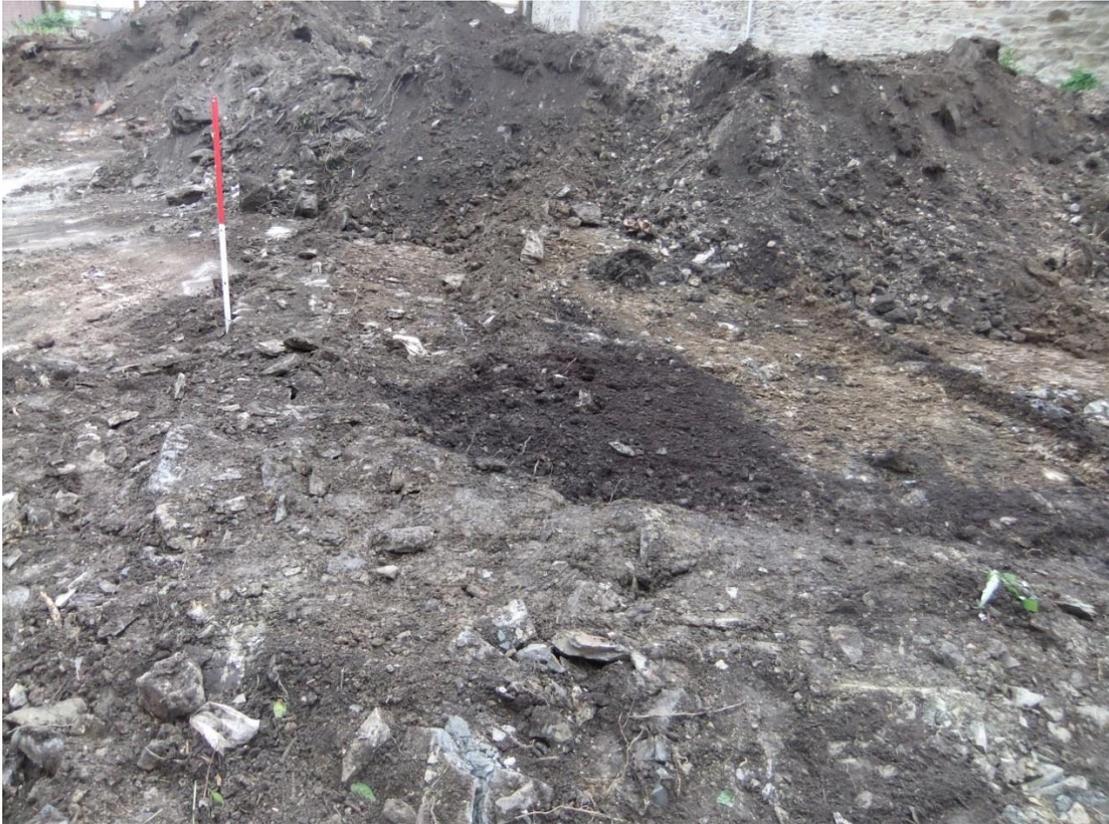
Fig 26 East corner of wall Feature 8 (running across foreground, and to right of scale), with well-defined dark spread marking burnt Feature 7 on the inside of the corner.

Also at the inner end of the old garden was Feature 7 (Figs 26 and 27), the buried site of a bonfire with a single layer of burnt or charred material and artefacts, mostly potsherds of 18th or 19th century type and butchered bones (121). Reddening of the inner side of garden wall beside Feature 8 demonstrated that the material in (121) was burnt *in situ*, and the fire probably dates from the period of use of the garden.

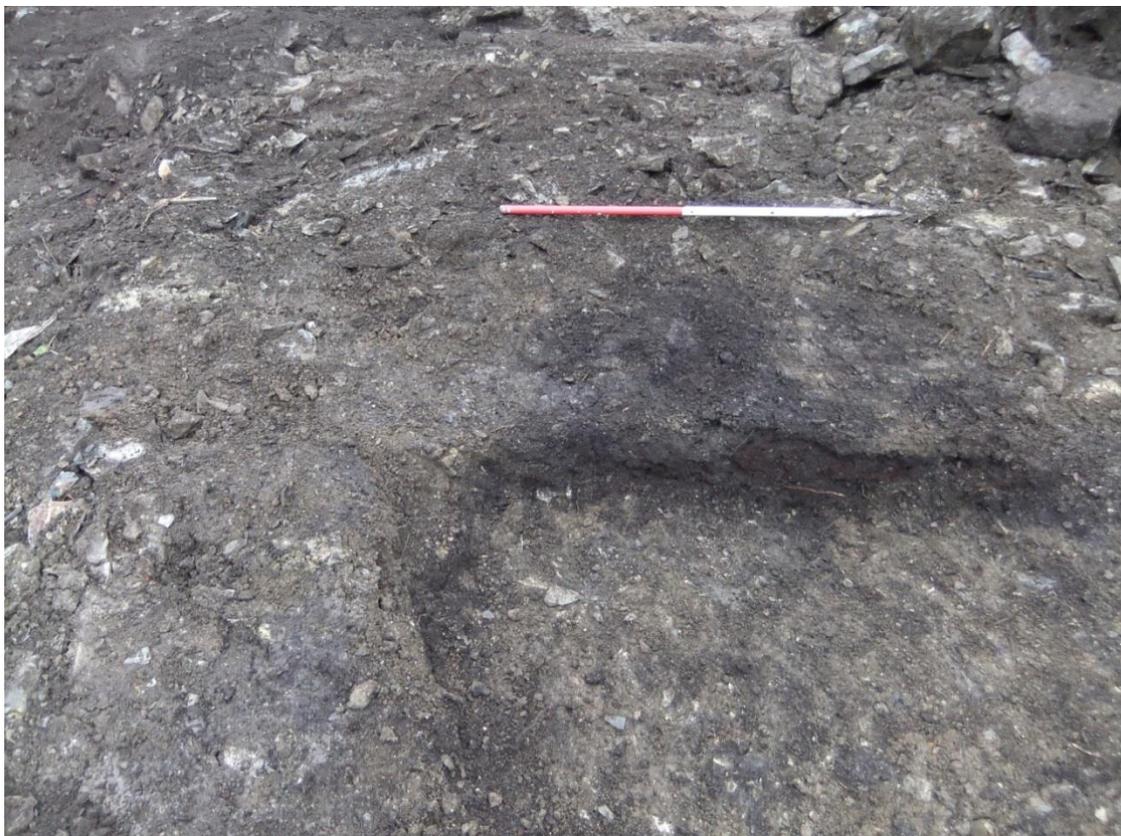
Fig 27 Feature 7, material burnt in situ in the corner formed by wall Feature 8, after cross-sectioning, looking SE. The wall runs along left and rear ground of photo.

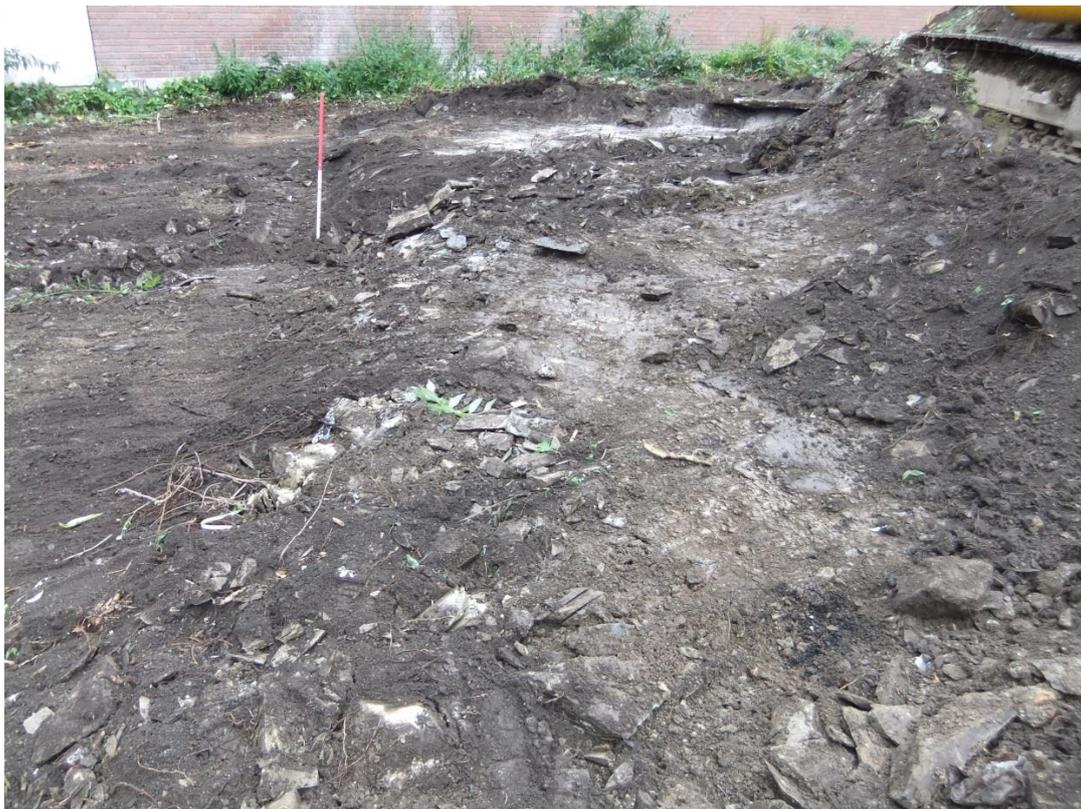
Fig 28 Looking south east along the remains of (previously demolished) wall Feature 8 (centre), to its north east corner beside the scale pole. A dump of cement overlying the cobbled floor at Feature 9 can be seen to the rear beyond the wall corner.

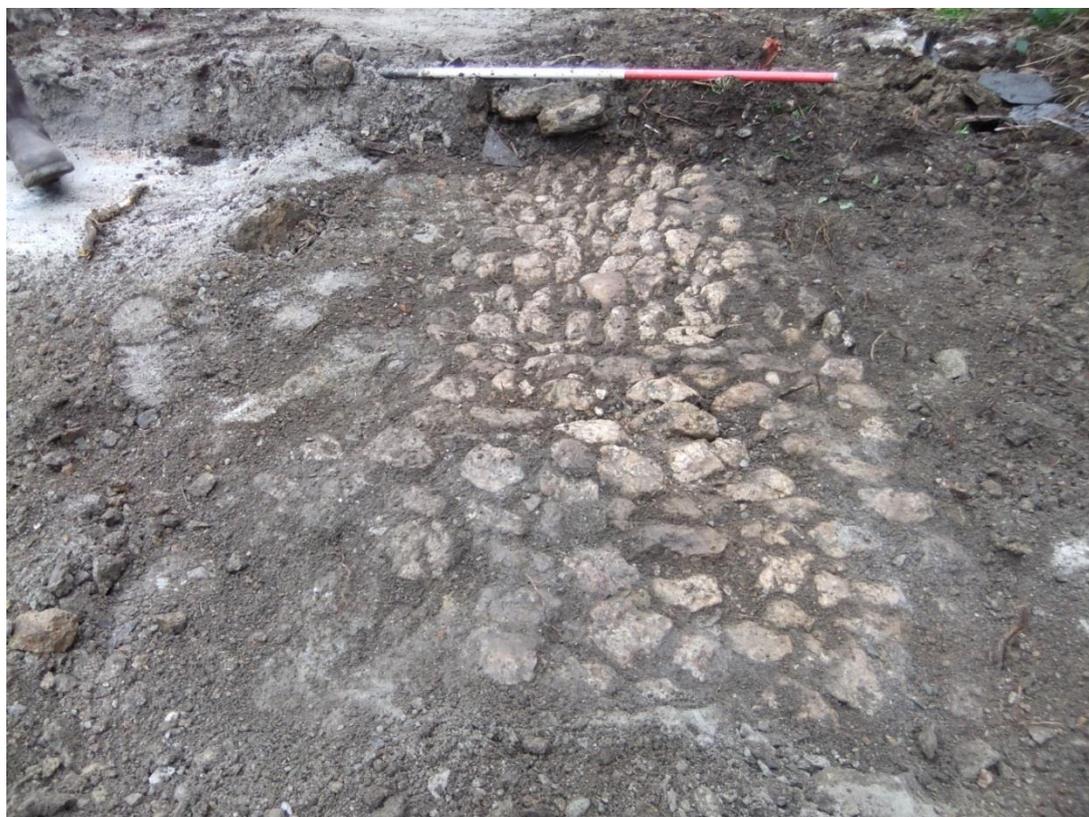
Fig 29 Sample of quartz cobble flooring, Feature 9, before part excavation, from SSW. Note the pitched slab, remains of low edging, below the left hand end of the scale.
