Land to the rear of Pydar Mews, Truro, Cornwall;
Archaeological Watching Brief

Cornwall Archaeological Unit

Report No: 2017R077

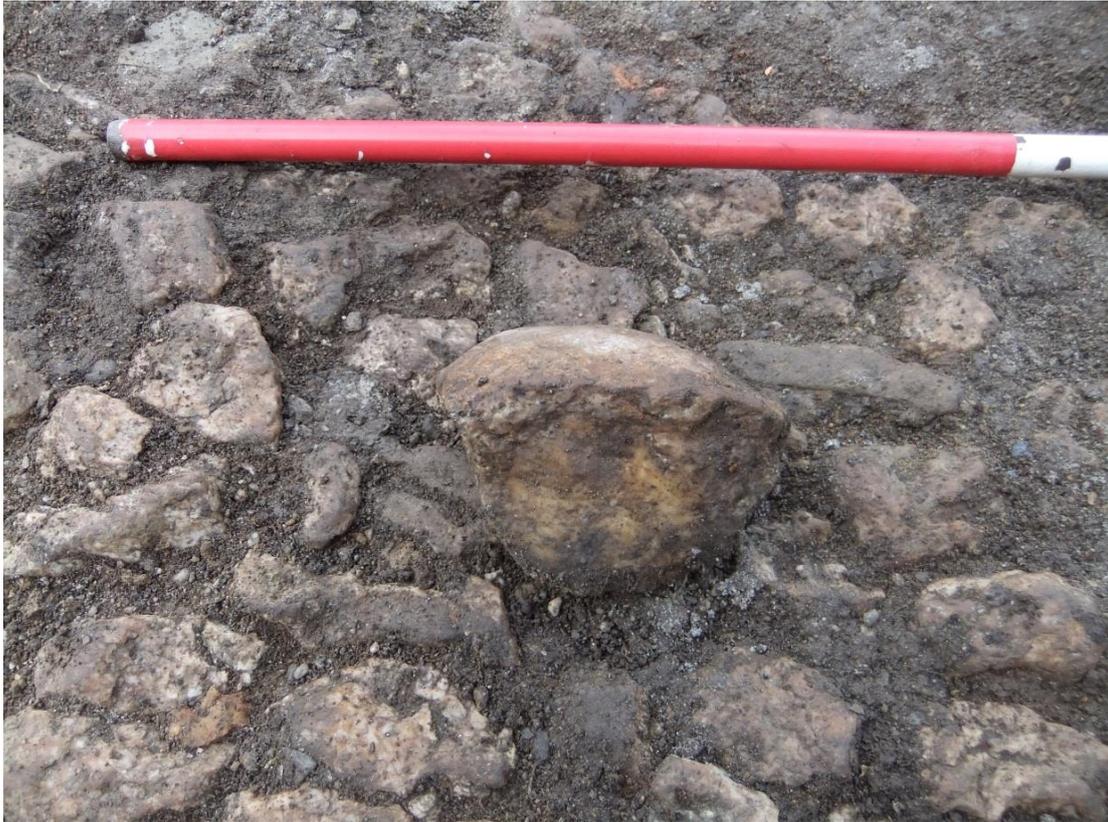
Fig 30 Cobbles at Feature 9; one lifted to show wear to its top possibly indicating re-use in this context where other cobbles are generally rougher (looking north west).

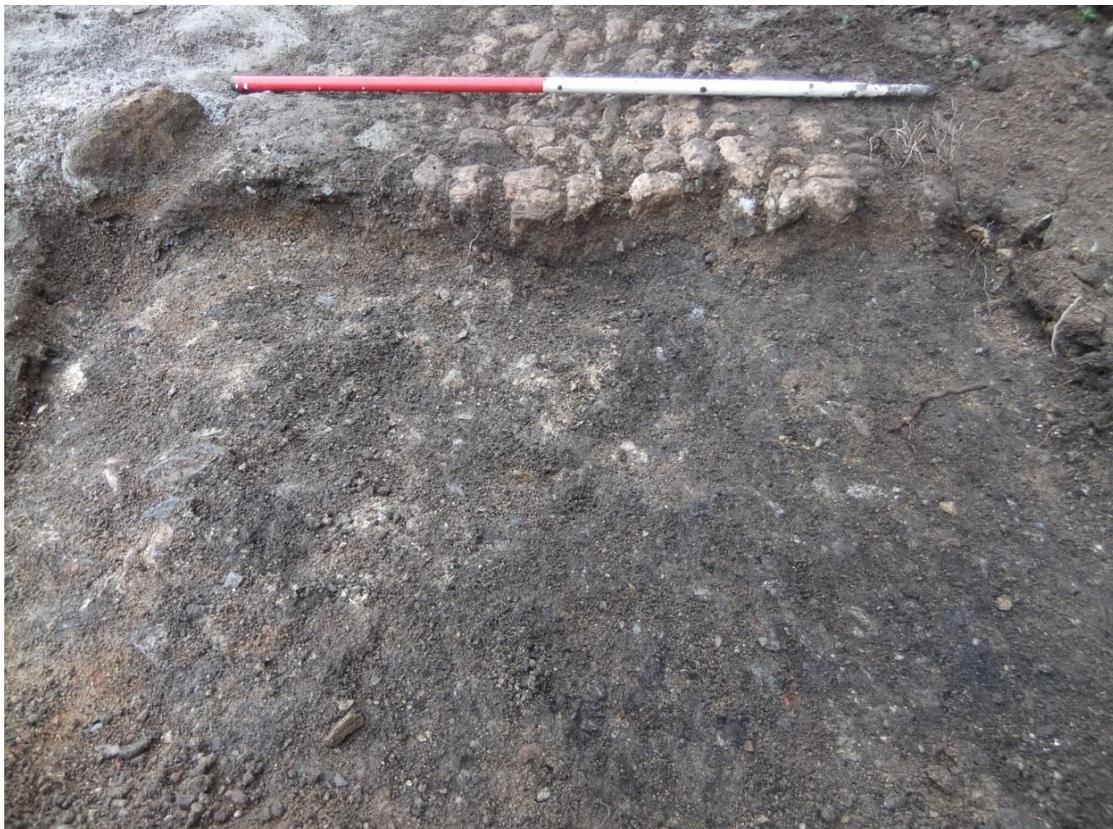
Fig 31 Feature 9, following part cross-sectioning of the cobbling, exposing a dark clayey base layer in which the edging slab (left of scale) was embedded (looking NNE).

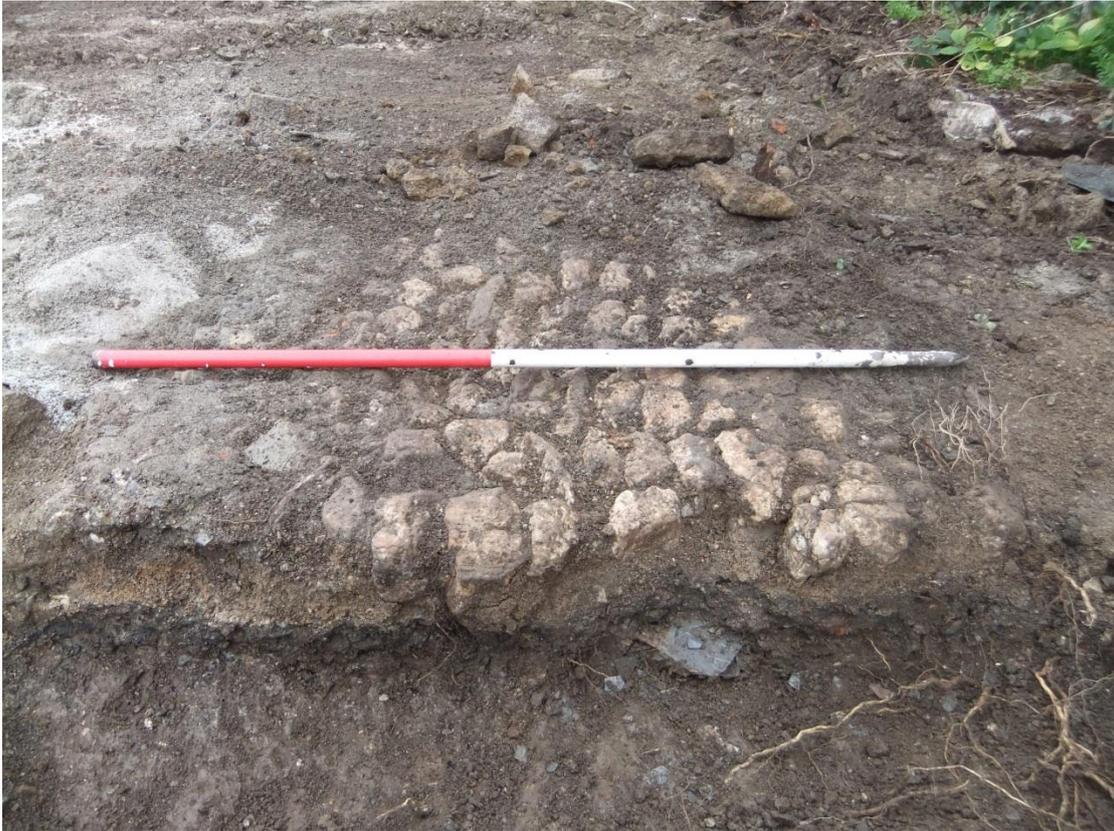
Fig 32 Detail of Feature 9 cross-sectioned, showing the cobbles set in a sandy matrix, and the dark clayey layer of similar depth beneath, over the sub-soil (looking NNE).

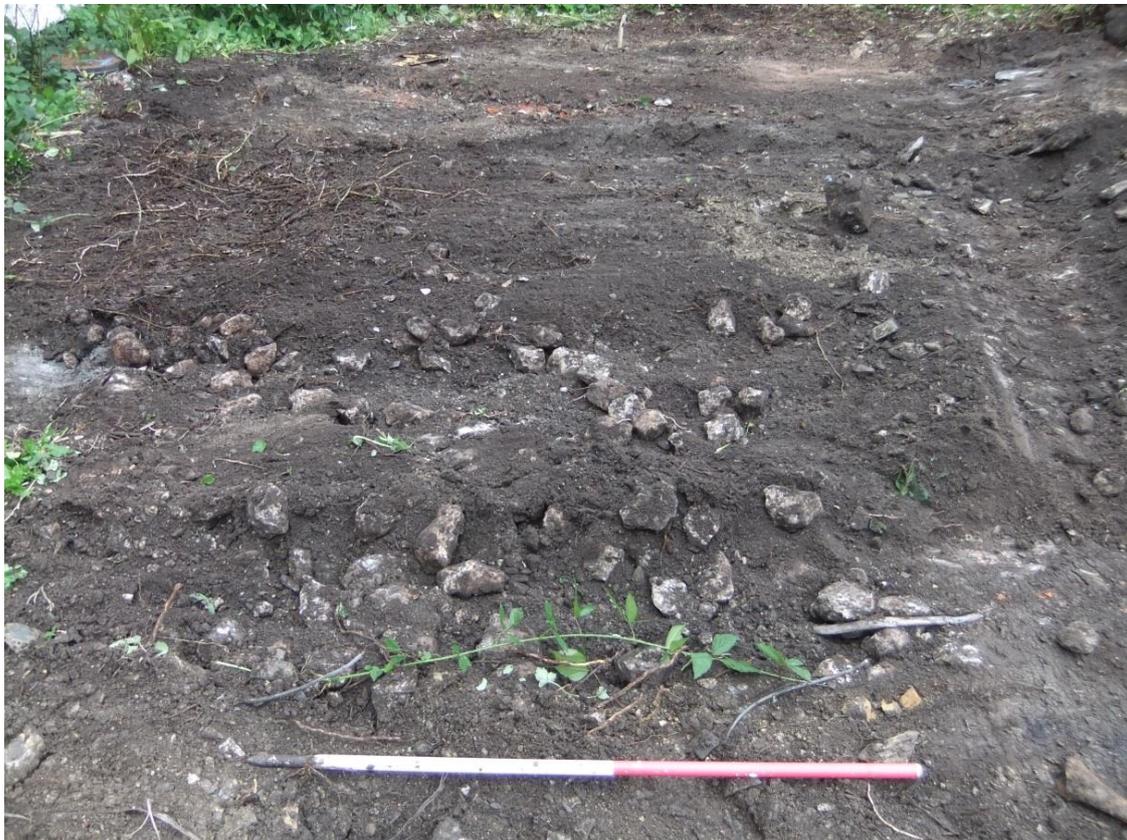
Fig 33 Previously-disturbed cobbles in lower part of topsoil, Feature 10, looking east.

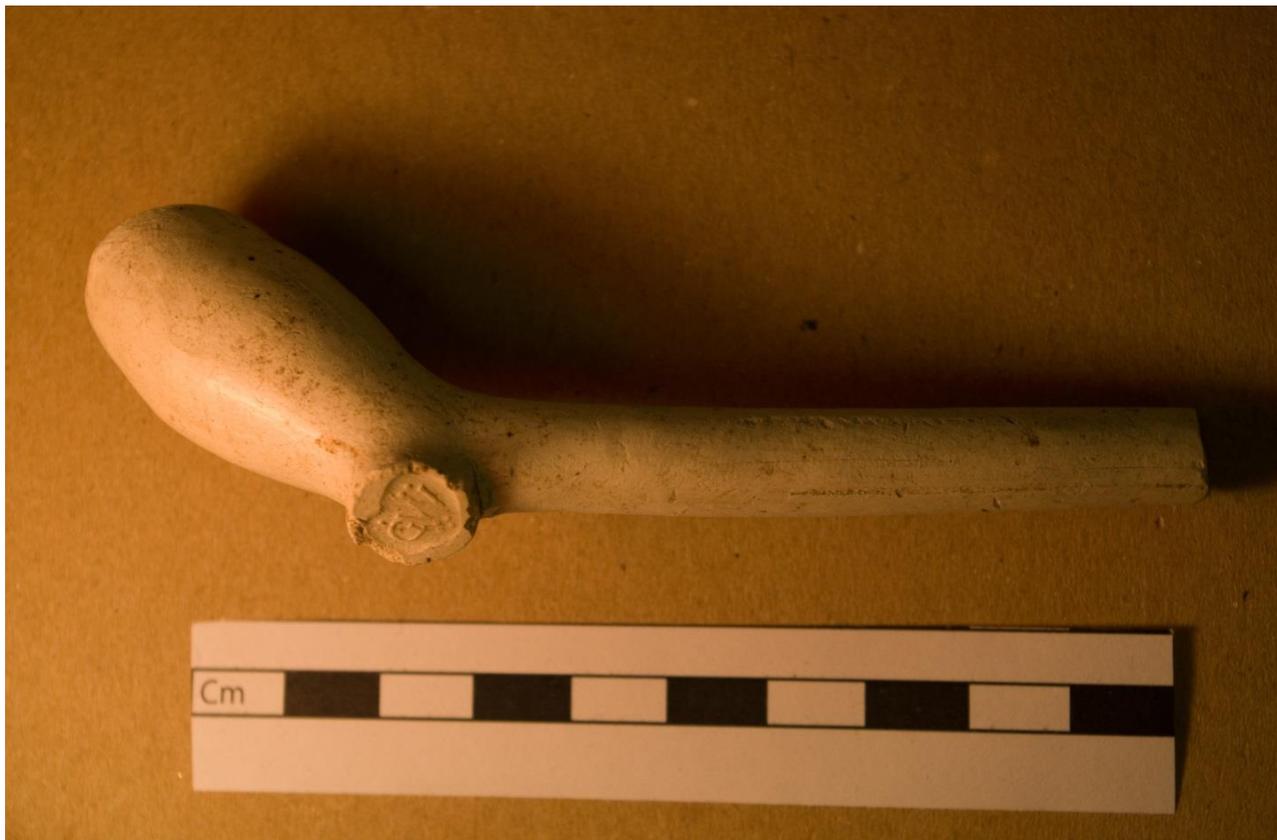
Fig 34 Clay pipe, from fill (118) with 15th to 20th century artefacts, in pit [116], at Feature 6.

One pipe from fill (118), with a length of stem attached, has been dated by typology to c1715 (Carl Thorpe pers comm). It bears the maker's mark GW (Figs 34 and 35). A clay pipe from North Street in Exeter, with the same mark rendered in a different style, is dated c1660-1680 (Allan 1984, 283, 285); possibly the GW manufactory was in Exeter and the pipe found in Truro came from there, but this is not known at present.

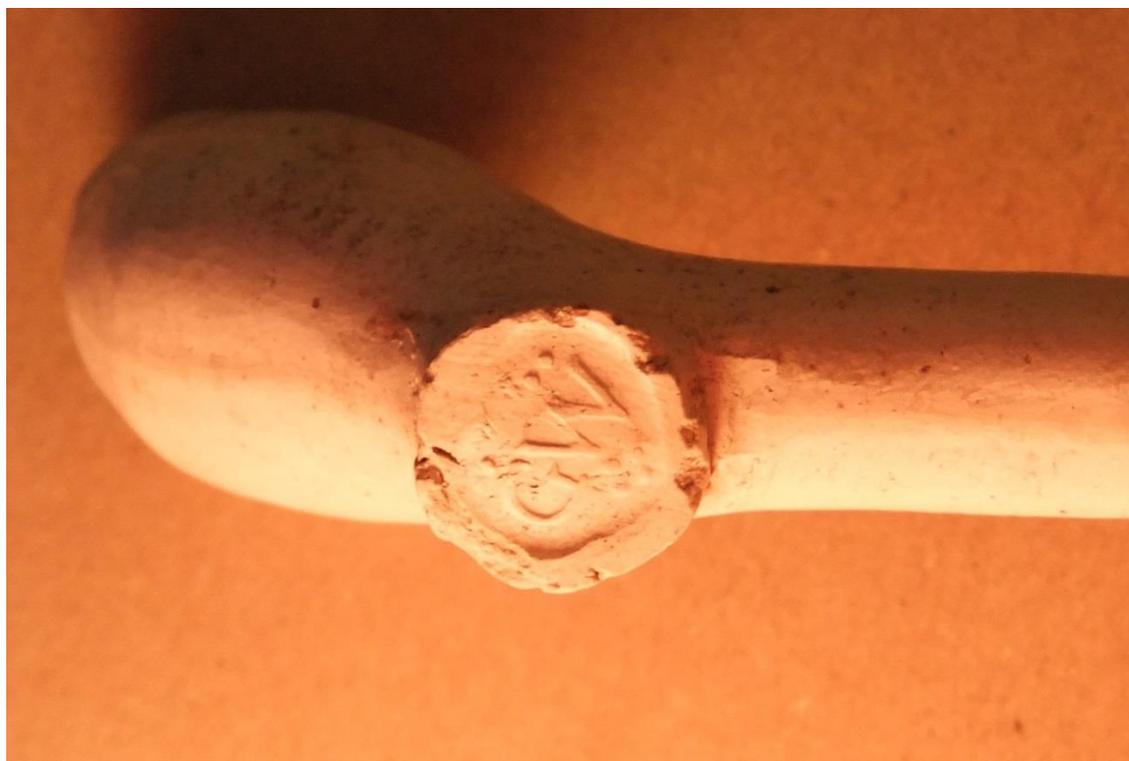
Fig 35 Maker's mark featuring initials GW with dots, on heel of clay pipe seen in Fig 34.

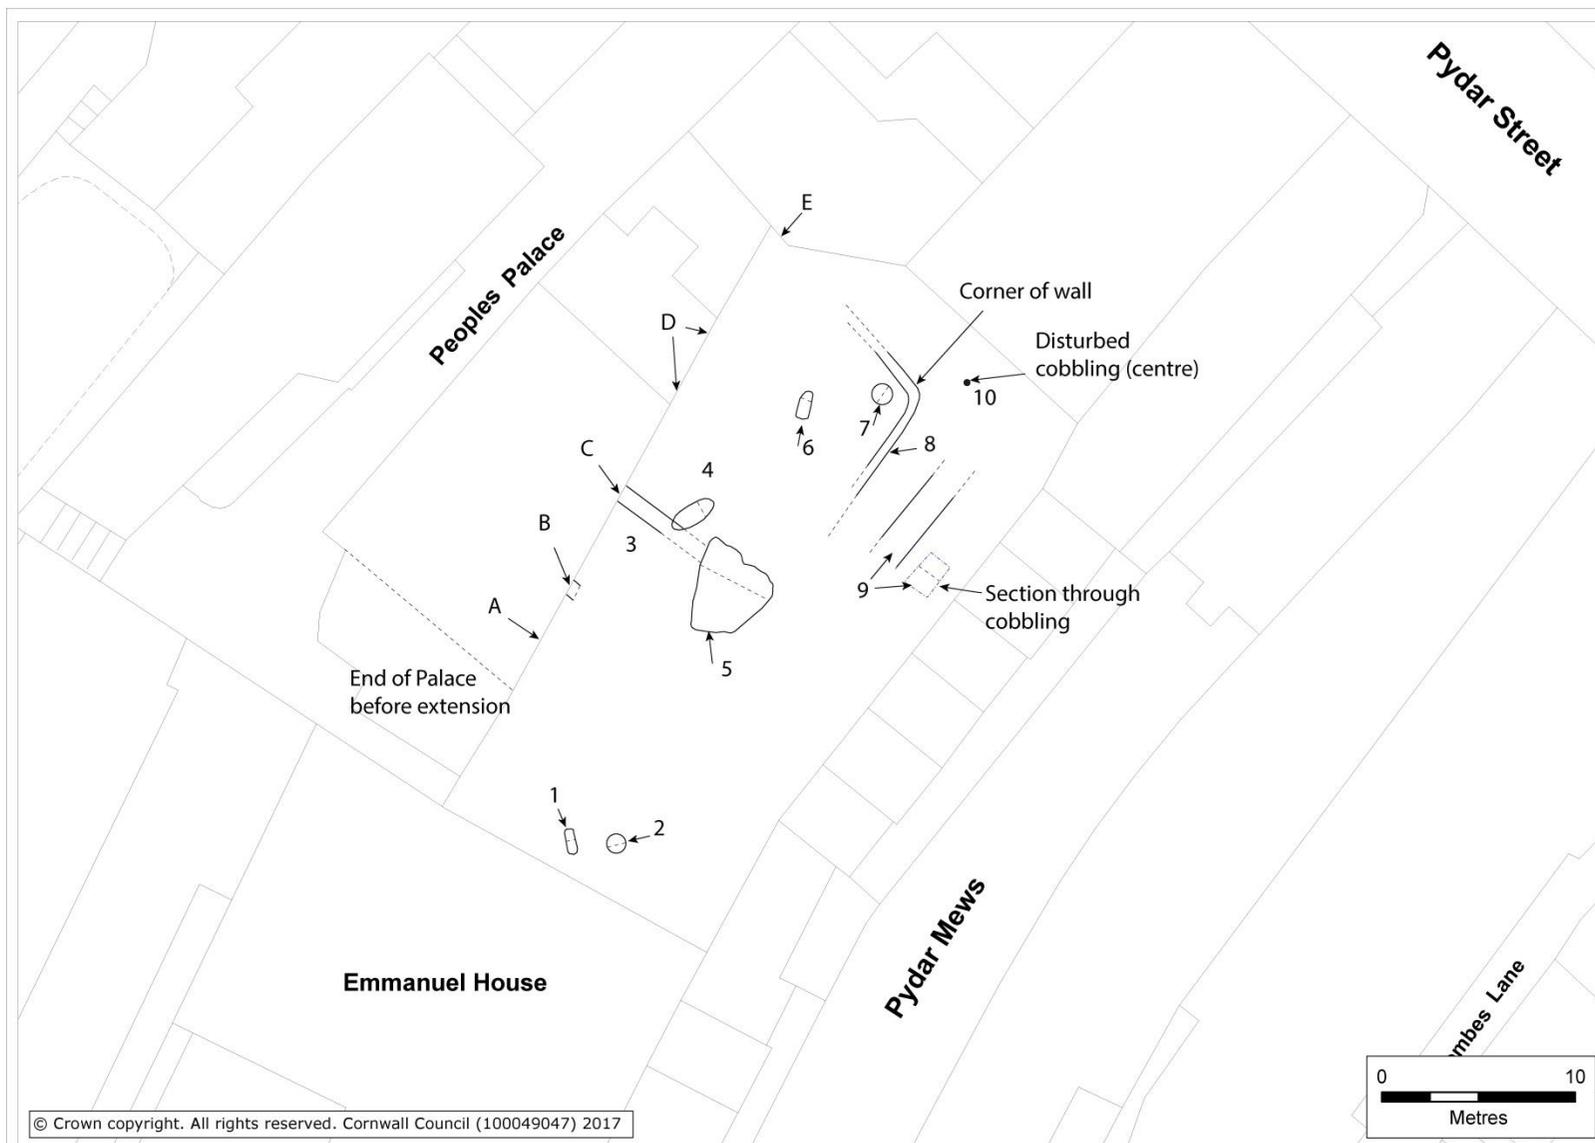
Fig 38 Site plan showing buried Features 1-10, and points of interest A-E in walling on the north west, on modern map base.

Figures 38 and 39. The context numbers start at 100, to avoid any confusion with the Features, numbered from 1 to 10. Also shown on Figures 38 and 39 are other locations distinguished by letters; these mark upstanding historic building fabric or features noted at the commencement of the project (Feature A to Feature E). Each sequence of references runs from south to north and west to east across the site.

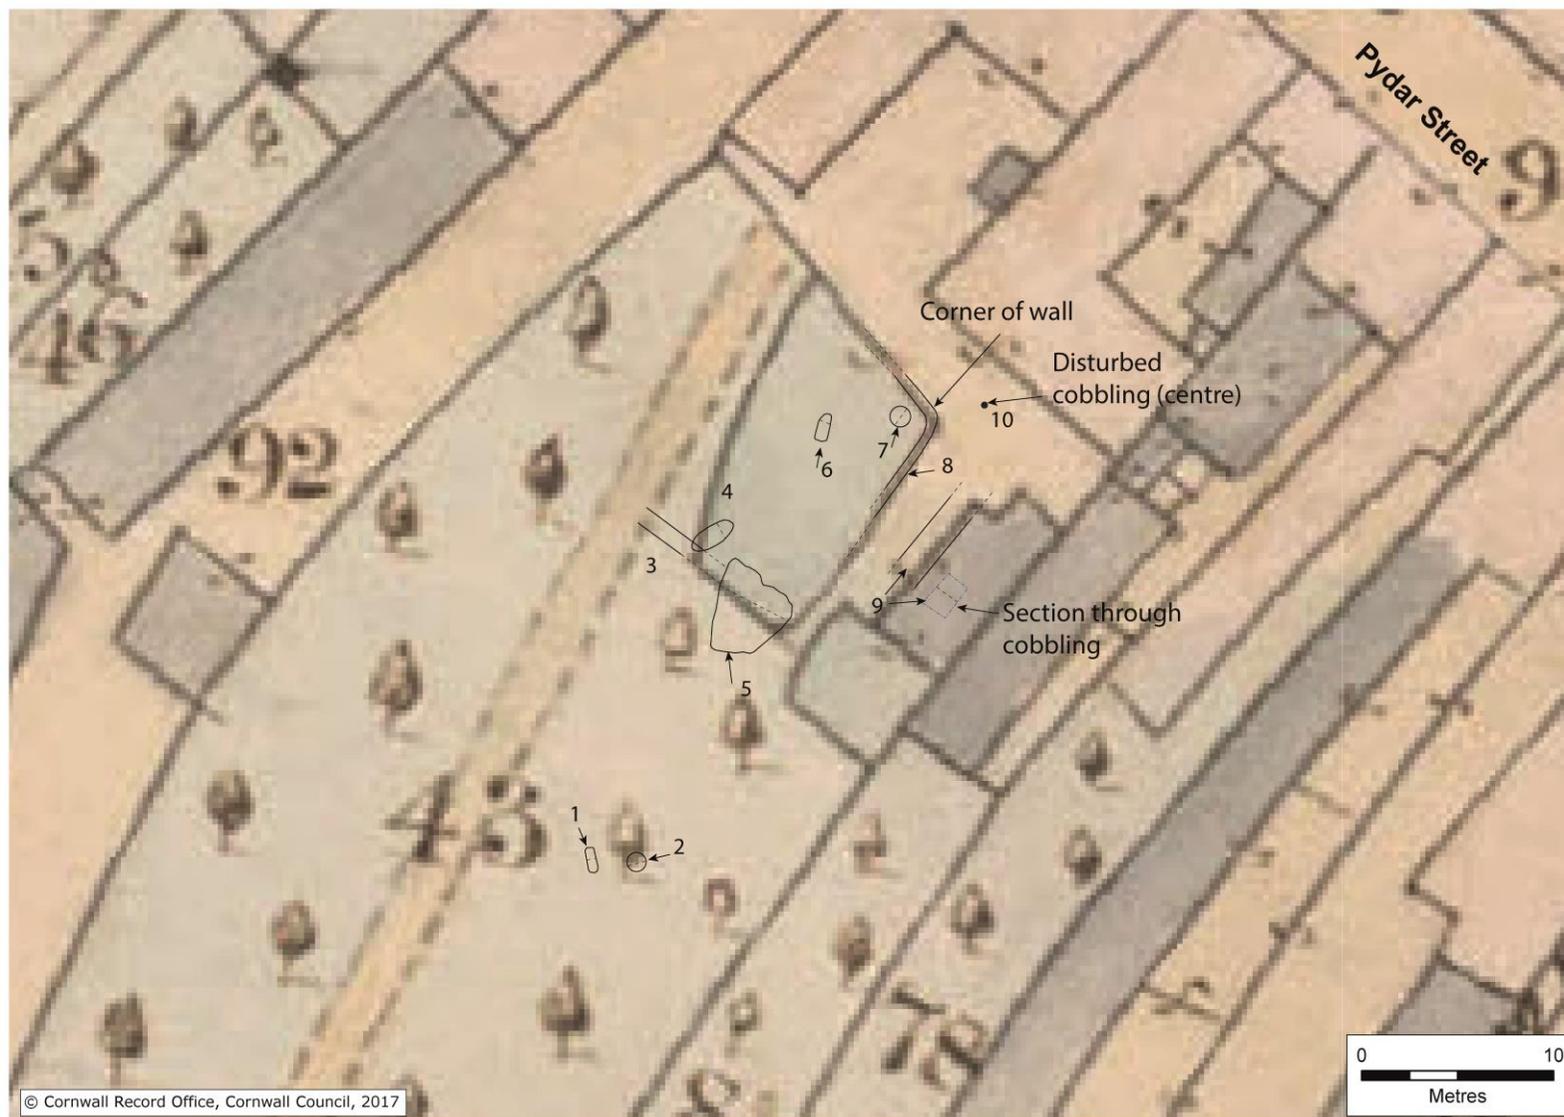
Fig 39 Site plan showing buried Features 1-10, and points of interest A-E in walling on the north west, on 1841 Tithe map base.
