SOUTHERN **ARCHAEOLOGICAL** SERVICES LTD

REPORT ON BUILDING RECORDING AT
THE 'COACH HOUSE', THE NEW INN,
BEVOIS VALLEY ROAD, SOUTHAMPTON
SAS 427 SOU1516
A.2009.25

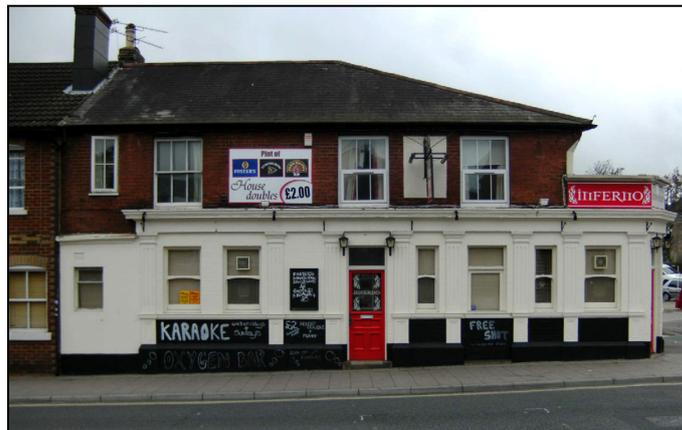
The exterior of the New Inn shows a typical late Victorian/Edwardian public house frontage, consistent in style with the 1910 extension added to the southwest corner (ground floor only). The ground floor has a stuccoed façade with eight pilasters rising from a plinth and an architrave above, although this does not extend all the way to the boundary with no 18, leaving a plain narrow frontage in the gap, probably initially to allow access to no 17, which was a separate property before 1910. After that date it may have been used for access to separate living quarters on the upper floor. The frontage is asymmetric, with the main door roughly central and three pilasters to the left, making one narrow, windowless bay and one wider bay with two single-light sash windows; and five pilasters to the right making four bays with alternate narrow and wide single light sash windows. The first wide window is of a different, non-sash design, and there is a break in the plinth in this bay and evidence of unkeyed brickwork, suggesting a blocked doorway. The single window at the far left is placed close to the boundary with no 18, and is a small, two-light, frosted glass window (now the Ladies WC). Two of the front windows are frosted glass, engraved with George Gale & Co's portcullis symbol. The last bay on the right is part of the 1910 extension. This extension has a door cutting the corner and three pilasters making two bays to the right, the first with a two light sash window and the second with a break in the plinth, unkeyed brickwork and a different window (but matching the odd one at the front, so possibly another blocked doorway). The upper floor has a pair of six-light sash windows either side of the pub sign in a plain brick wall (mainly flemish bond) with room for another window in the gap between these and the third similar one, and a smaller four-light casement window at the far left.

Plate 1. New Inn frontage, looking SE (Photo 4/2)

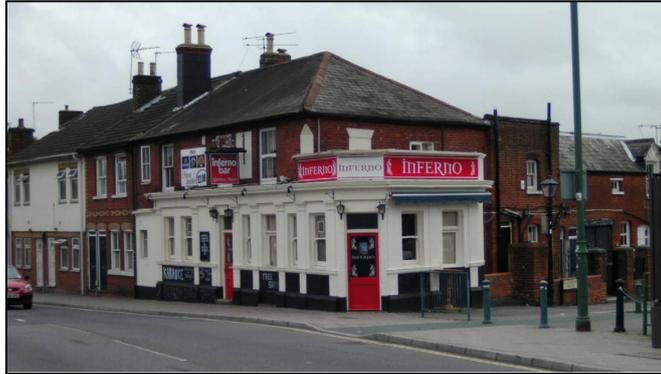
The elevation facing Blackberry Terrace has one blocked window above the 1910 extension and a casement window to the right. The roof is hipped, of slate with ceramic ridge tiles, and shares two chimney stacks with no 18. Attached to the rear of the original end of terrace house is a block in similar brickwork, but with smaller six-light sash windows (one on each floor), a windowless door with fanlight

and a 'Gales' carriage lantern above the space between door and window. This extension projects 0.18m from the building line and has a slate lean-to roof facing away from Blackberry Terrace and a flat roof beyond that, as can be seen on satellite imagery. Around the edge of the property is a brick wall with piers, most of which has been rebuilt, but a small section of low wall with brick coping adjoining the 'Coach House' double door and the easternmost pier and end wall could be original. The original boundary wall was 1½ bricks thick, but two of the rebuilds (in front of the rear extension to the pub, and in front of the east end of the 'Coach House' were built in double brick thickness, causing the wall to project 6-7cm forward of the piers at either end.

Plate 2. New Inn with rest of terrace and 'Coach House', looking E (Photo 4/3)

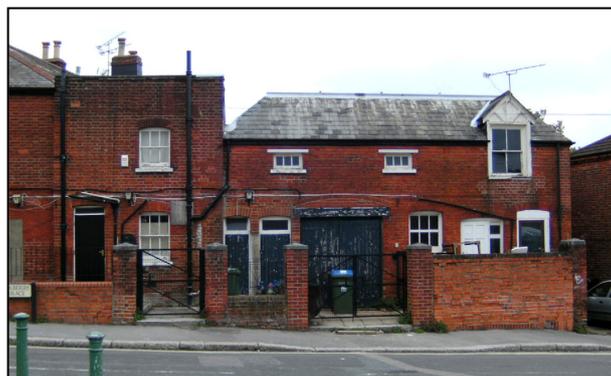
The only visible external frontage of the 'Coach House' is on Blackberry Terrace. The walls are of brick and in a similar bond (mainly Flemish bond). The double door entrance is asymmetrically placed, with a large timber lintel and brick relieving arch above. To the left of the entrance are two single ledge and brace doors of differing widths, with fanlights and relieving arches (presumably for outside toilets, although access to these was not available during the survey). There is a 'Gales' carriage lantern above these. On the other side of the double door is a six-light sash window with relieving arch and then a wider opening with a panelled door and a narrow window with wooden surround to its right - the relieving arch for this opening is both wider and flatter than the others. Near the southeast corner is another doorway with a glass-panelled door set into an opening slightly larger than it and a relieving arch that matches that for the window. On the upper floor there are three evenly-spaced windows visible: two are small three-light louvre windows with white-painted wooden lintels and sills and the third is a four-light gabled dormer sash window with a slate roof with lead flashing along the junction, and ceramic ridge tiles. There is a gutter with a downpipe at each end, that on the left joining a soil pipe attached to the adjoining extension. The end wall in Blackberry Terrace is plain brick with no windows or other detail visible, apart from a damp proof course. The roof is slate with lead flashing over ridge tiles along the ridge, except where it extends back from the road and over the dormer window, where it has ceramic ridge tiles instead. Satellite imagery shows that the ridge widens to a flat triangular shape sheathed with lead flashing, presumably to reduce leaks

Plate 3. Rear of New Inn with 'Coach House', looking NE (Photo 4/5)

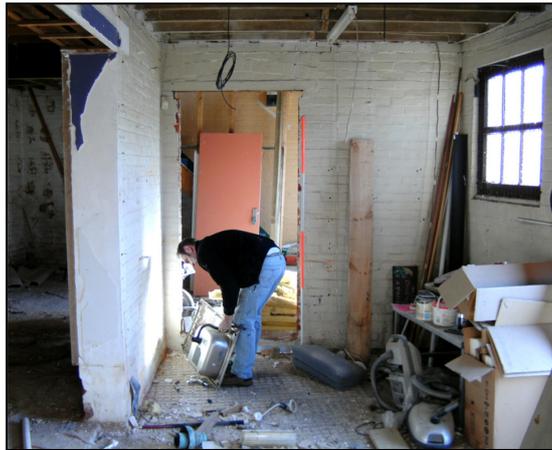
Room A/D is marked on the 1868-70 OS map as separate from room B/D, but there is evidence to suggest that they were built as one, as the dividing wall between A and B is a single brick (header) wide and looks original, whereas the external walls and those dividing rooms A and B from the former yard (C) are double-skin cavity walls and incorporate ventilation grilles. The floor is made of square-embossed engineering bricks, apart from the area behind the outside toilets, which has a stepped-up (0.1m) floor of smooth (possibly inverted) engineering bricks, and there is a small circular drain set into the middle of the floor, which is consistent with former use as a stable. The outward-opening double wooden ledge and brace door has a substantial 0.23m thick timber lintel above. Photo 4/28 shows that the brick relieving arch can be seen only in the external brickwork, as the inner skin has one course of brickwork and then a wooden beam supporting the joists and herring-bone strutting (running northeast-southwest) that support the upper floor.

Plate 4. Room A, looking SE, scale 2m
(Photo 4/16)

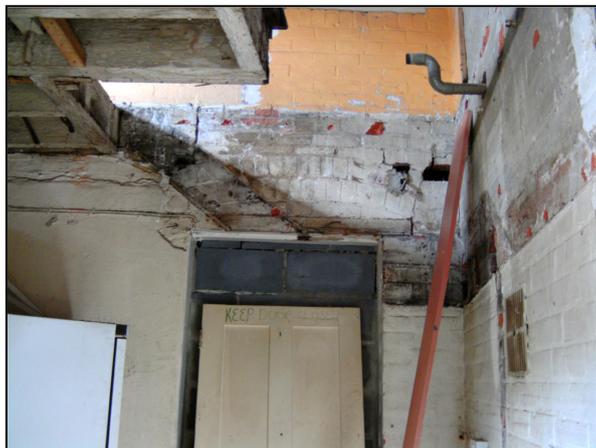
The walls are mainly whitewashed brick in running bond, with a small area of render and a painted area next to the door leading through to the pub (now blocked with a breezeblock wall). This area also shows the scar of a staircase that was obviously inserted at some point, as it cuts the corner of the doorway, and the absence of render here allows the wooden lintel and relieving arch above it to be seen (Plate 5). There is one wooden framed window with a wooden lintel looking out onto Blackberry Terrace. There is a gap through to room C here, spanned by a pair of rolled steel joists (RSJs) resting on the brick cavity wall, and the floor steps up 0.05m. A doorway with wooden lintel and brick relieving arch leads into room B, but the door and frame had been removed before the survey. The floor also steps up 0.14m at this doorway.

Plt 5. Detail of removed staircase & blocked doorway, looking NW (Photo 4/21)

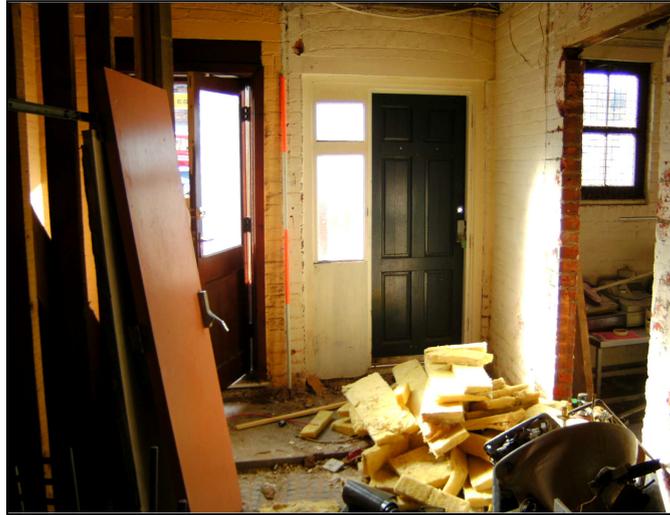
Room B has an embossed engineering brick floor with another probable stable feature - a semicircular gutter (T-shaped in plan) that runs across the centre of the room (Plate 7). There was probably a drain originally associated with this gutter, but it is probably now covered by Modern concrete near the front doors, where the floor is raised 0.05m. There is also a concrete step at the bottom of the staircase. The walls are of brick, and had been whitewashed and/or rendered. Access to room A is via the doorway in the single skin brick wall, and access to room C is via a gap spanned by two RSJs set at slightly different heights (0.1m different).

Plate 6. Room B, looking SW, scale 2m (Photo 4/15)

The only window now present is a narrow double deadlight adjoining one of the external doors, which had a fire escape fitting still in place on the door. The window is set in a wooden panel and fills up the space in an obviously larger doorway, so has probably been inserted to replace a wider door, while an extra lintel has been added above the door at the bottom of the stairs to fill the gap. The lintel and relieving arch here match the window in room A, so this doorway was probably originally a window. The staircase to room D is also inserted, and was built onto a stud wall, part of which remained in place on the first visit. The ceiling is of similar construction to that of room A, but the joists run northwest-southeast instead, and it is pierced by three hatches, two at the back and one at the front. The front hatch is larger and boxed round, and the rear two are also boxed, but show more careful joinery (Photos 4/25-26), and are presumably intended to be seen (see also room D).

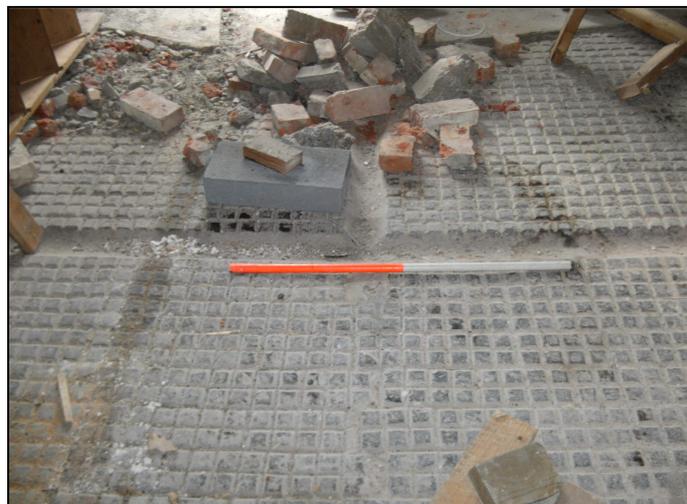
Plate 7. Detail of engineering brick floor with gutter, looking SW, scale 1m (Photo 4/23)

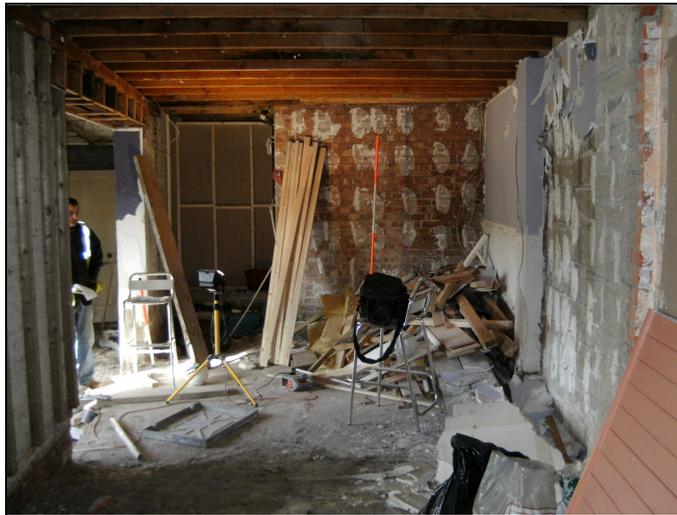
Room C was originally the backyard, as is shown by the presence of a frosted glass window (to the Gents WC), downpipe and small drain grating and a vent in the wall dividing rooms A and C. The floor level at this point is 0.36m higher than the rest of room C, which has a plain concrete floor, although in places the floor was obscured by rubble from the recent works. Two large cast iron covers give access to the foul drain, another indication that this was previously the backyard. Access to the pub is now blocked by a recently installed plasterboard partition wall, and the rear wall of the pub toilet is built of newer bricks than the rest of the building, laid in a modified running bond. Part of the boundary wall is still covered in plasterboard, but about half has been removed, exposing a Modern breezeblock wall with a central buttress, the purpose of which is not immediately obvious. A second breezeblock buttress has been inserted in place of the outer skin of room B's brick wall, to support the higher of the two RSJs between rooms B and C, the other end being supported by the original brick external wall of room B. The roof is flat, consisting of plywood sheets supported on pine joists running northeast-southwest, and was installed by a previous tenant of the pub (within the last ten years). Presumably the access to room B was inserted at the same time, but the opening into room A looks like it may have been in place for longer, being painted and partially wallpapered.

Plate 8. Room C, looking NW, scale 2m (Photo 4/12)

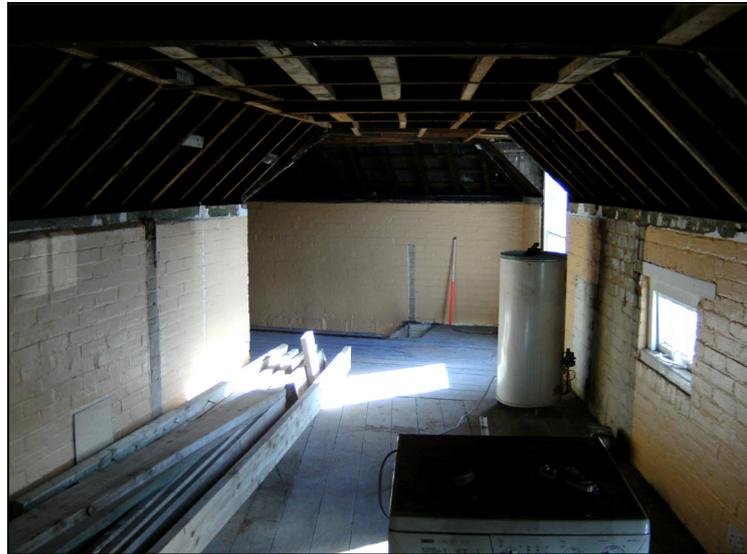
Room D occupies the entire first floor, although there are indications that it had previously been subdivided by partition walls. There was, however, no sign that there had ever been a dividing wall between the equivalent of rooms A and B, so it seems likely that the two buildings were built as one. Access was by a staircase from room B on the east wall (by ladder on the second visit), but there was also a staircase from room A (now removed), although both appear to have been inserted by cutting the floorboards and joists, so originally access was probably via the larger hatch in the southeast corner. The other two hatches are evenly spaced by the northeast wall and may have been used for some kind of pulley system for lifting goods, although their dimensions (0.61m x 0.59m) would limit the size of the objects that could be lifted. The walls are painted brick in running bond and are 1.38m high, with 0.08m thick timbers above supporting the roof structure. There are five windows: one gabled dormer sash window at the southeast corner and four small three-light louvres: two in the same wall, one overlooking the lean-to roof of the adjacent pub extension and the fourth overlooking the flat roof over the former backyard. The dormer window may be inserted, as the external brickwork shows signs of a rebuild and there is a wooden panel below the window instead of brickwork on the inside, but the internal timber work looks compatible with the rest of the roof, so if it did replace an earlier window (presumably matching the others) it was probably done fairly soon after the building was erected. It is also possible that there was originally a hoist of some sort at this point, later replaced by the dormer window. A plastic waste pipe is

located in the southwest corner and scars on the adjacent walls show where a WC had formerly been installed. There is another wall scar adjacent to the middle window, with one roughly opposite, presumably from a former subdivision of the upper floor. Other scars show the location of banisters since removed from the staircases. A disconnected boiler and washing machine indicate that part of room D may have been recently used as a laundry room.

Plate 9. Room D, looking SE, scale 1m (Photo 4/19)

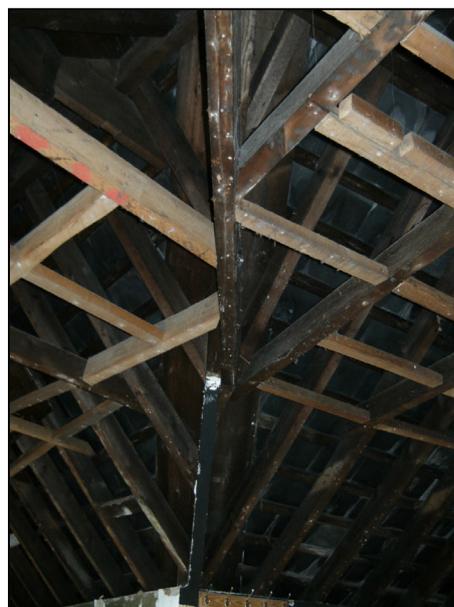
There was no ceiling in room D when the survey was carried out, so the roof structure was clearly visible. It is a simple pine roof with rafters mounted on wall plates and braced by tie-beams set about half way up the rafters, so that there is at least 2m headroom, despite the low wall height. Because the ground plan is not rectangular but tapers to the southeast, the ridge in the main part of room D divides in two, which then diverge so the rafters do not meet at the northwestern end, forming a triangle. This has been panelled, probably when the roof was erected, as the wood and workmanship looks similar to the rest of the roof. Chipboard panels have been attached to the tie-beams near the northwestern end to support a water tank. The roof slates are laid directly on battens nailed to the rafters, so they are visible from inside.

Plate 10. Detail of roof timbers, looking N (Photo 4/44)

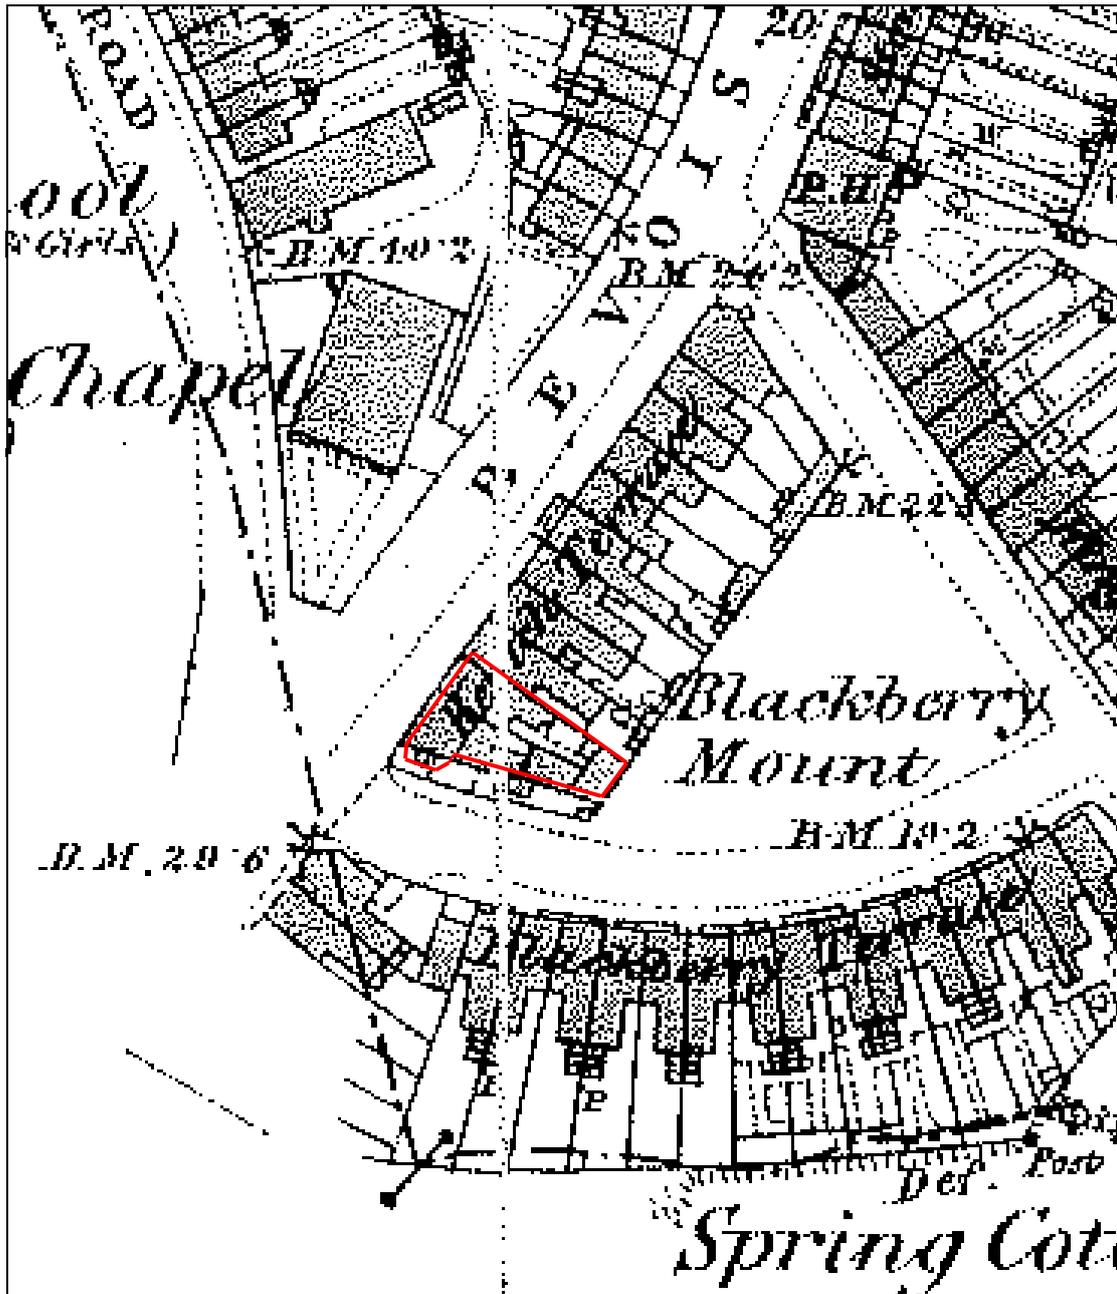
Figure 6. OS 25" First Edition Sheet LXV.7 1868-70 (scale x3)

The first cartographic depiction of the site is on the 1868-70 OS First Edition 25" map (Figure 6), which shows how much development had happened since 1846: the road layout is very similar to today, with the Methodist Chapel (now a Gurdwara) on the corner of Peterborough Road and houses along most of Mount Pleasant, Bevois Valley Road and Blackberry Terrace (south side). The site itself is made up of the two end houses in 'Kertch Terrace', with two outbuildings at the back forming an 'L' shape. The

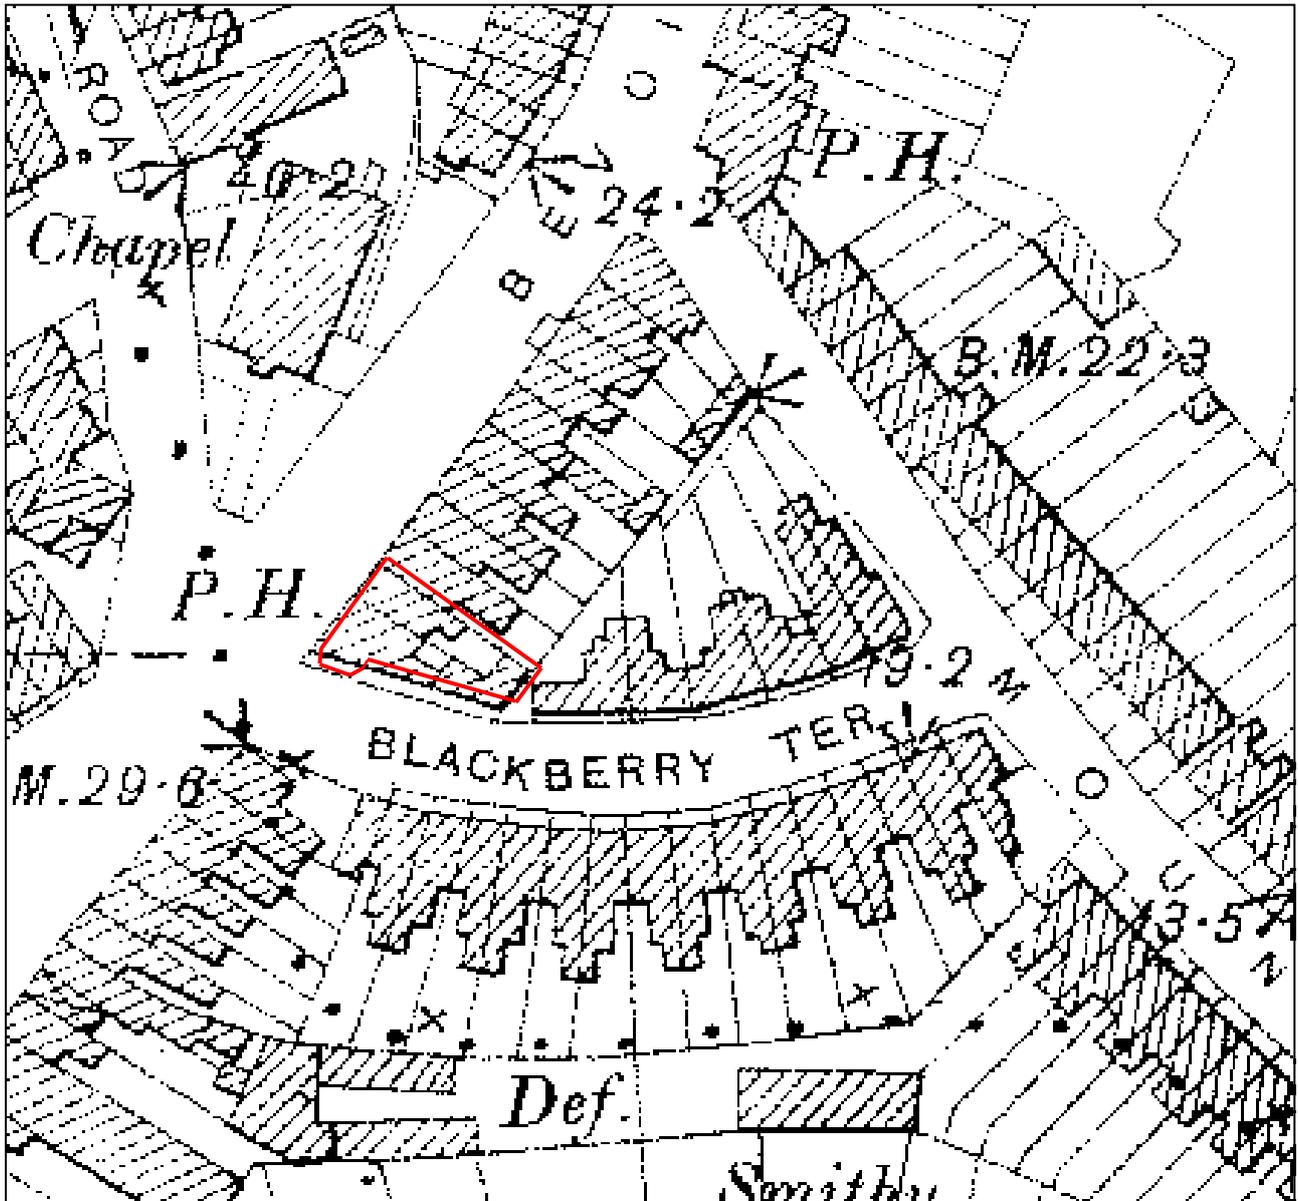
Figure 7. OS 25" Second Edition Sheet LXV.7 1897 (scale x3)

corresponding map for 1897 (Figure 7) shows the development of the north side of Blackberry Terrace and the amalgamation of the two outbuildings. By 1910 (Figure 8) the two houses and outbuildings are marked as one property, a small extension has been built on the southwest corner and it is marked as a Public House. The 1941-3 map (Figure 9, produced for Southampton Borough at a reduced scale of 12½" to the mile) shows the site almost unchanged, apart from a very minor change in the small area of no 16's backyard shown in 1910 being now built over. The end of the terrace at the junction with Mount Pleasant Road (now car sales and repair) is empty, presumably as a result of bomb damage. Current OS 1:1250 digital mapping (Figure 1) shows that the footprint of the building has not changed significantly since 1910, although satellite imagery from Google and the survey both confirmed the author's (and other former locals') memory - that the small area of no 17's backyard shown as open on the current OS map was roofed over within the last decade.
