NEW FARM, WESTON WAY, BALDOCK HERTFORDSHIRE

AN HISTORIC BUILDING SURVEY

September 2005

Project No: 33.61

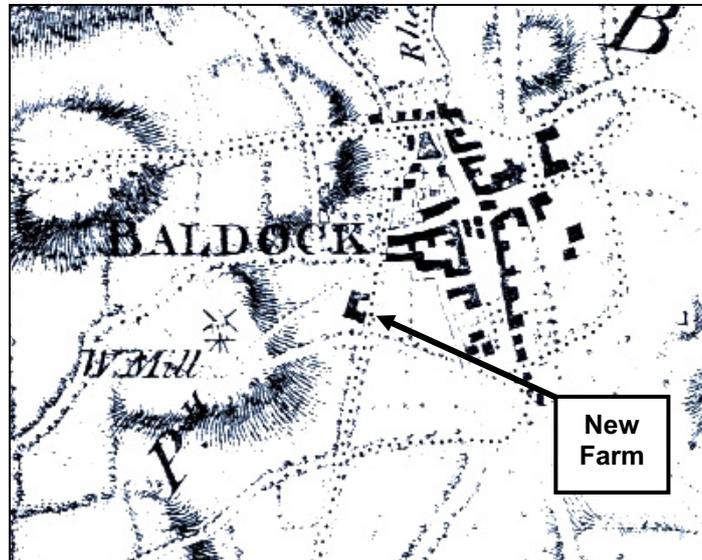
Figure 4: 1766 Dury and Andrews Map

A map dating to 1766 shows a building or series of buildings roughly in the location of the current farm buildings (Fig. 4). They are three sided in plan and lie along the side of the road / track that led south to Weston. No other information could be obtained and it is possible that this structure pre-dates any of the current buildings on site.

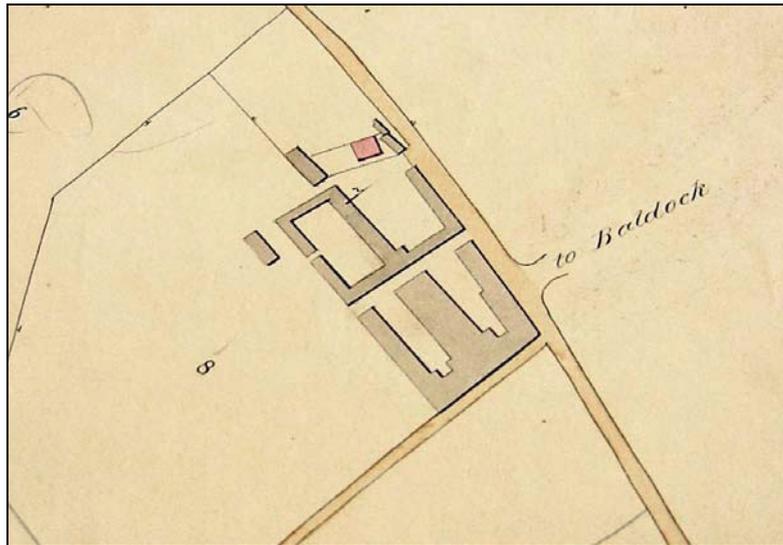
Figure 5: 1839 Willian Tith Map (HALS DSA4/119/2)

By 1839 the plan of New Farm appears clearly upon the William Tithe Map and is different in its arrangement (Fig. 5). It comprises three distinct parts;

- a small farmhouse (shown in red) with outbuildings and a garden/orchard at the northern edge of the site,
- a series of farm buildings south of the farmhouse forming an almost enclosed farmyard on the west side (the long building on the west range has opposed doorways), and there is a long 'L' shaped building that forms the east and south ranges,
- a malt house with an 'E' shaped plan south of the farm buildings, which may also date to the early 19th century.

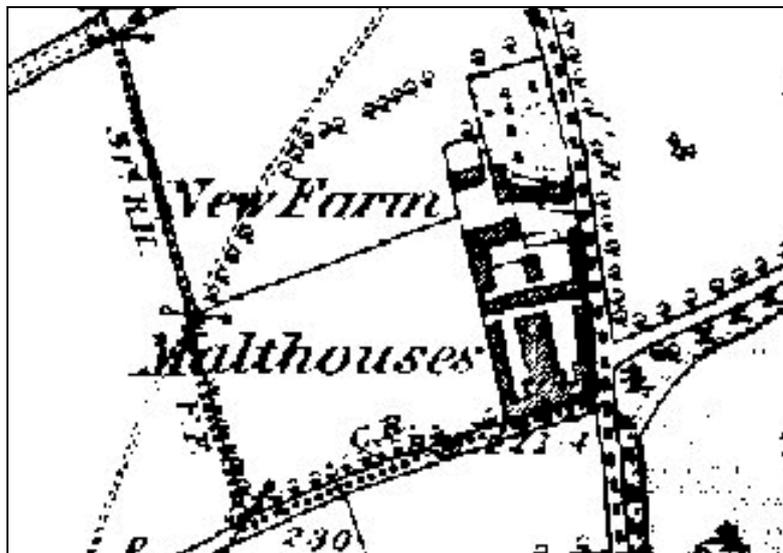
Figure 6: 1884 Ordnance Survey Map

By the 1880s the plan of New Farm had changed as had its ownership. While the south, east, north and west ranges of the farm buildings remained, a central wing that had projected out into the yard from the south range had been removed (Fig. 6). This was either replaced by or reduced in size to a much smaller single building between 1839 and 1884. In addition a small (unshaded) building/pen appears at the north east corner of the farmyard.

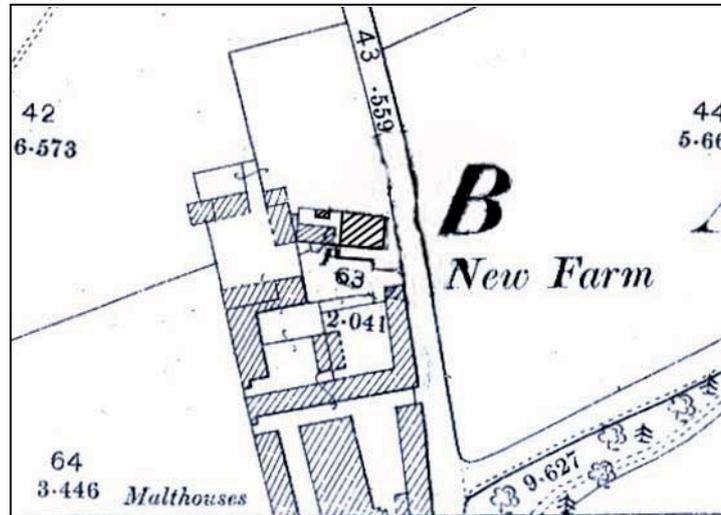
Figure 7: 1898 Ordnance Survey Map

By the late 19th century the plan of the farm and its maltings seems to have remained unchanged (Fig. 7).

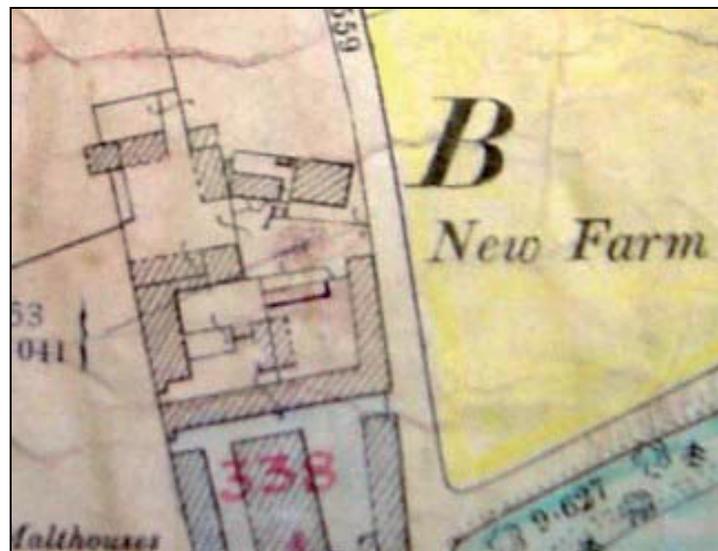
Figure 8: 1910 Inland Revenue Map (HALS IR2 10/1)

The Inland Revenue Map showing New Farm suggests that between the 1880s and 1910 two structures have been added to the plan of the farmyard (Fig. 8). These were a building that stood alone toward the north east corner of the farmyard in front of the building/pen near the 'L' shaped building, and another that had been constructed on the east side of the large building on the west range. Both are shown only in outline.

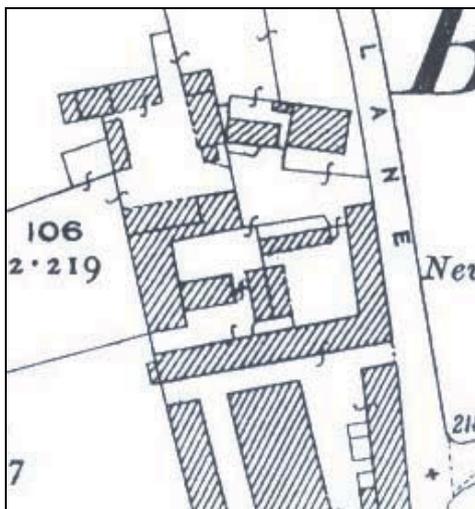
Figure 10: 1922 Ordnance Survey Map

The plan of the buildings at New Farm appeared unchanged in 1922, although the two buildings previously outlined on the 1898 and 1910 Ordnance Survey maps are shown more clearly (Fig. 10). By 1937 an additional structure had been erected in the centre of the courtyard (Fig. 11).

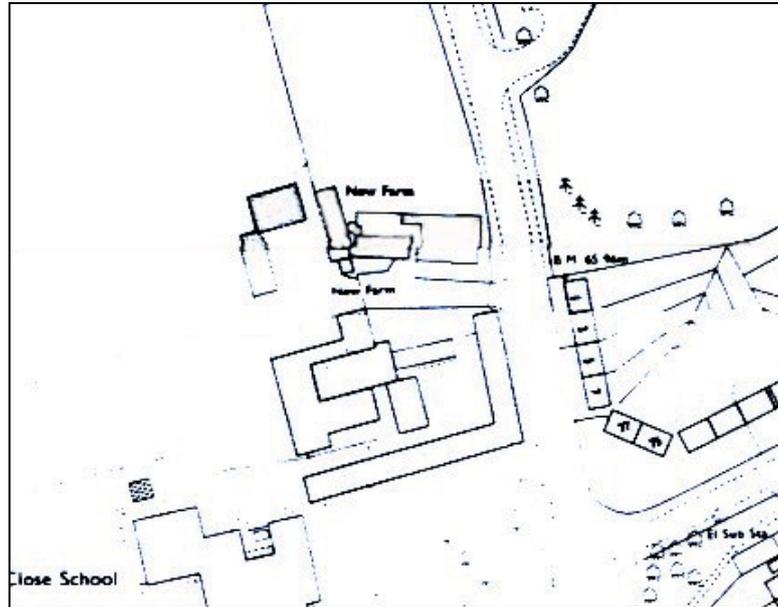
Figure 14: 1974 Ordnance Survey Map

The plan of New Farm appears to have remained unchanged from 1937 through to 1974. However New Farm Maltings had been demolished by 1974 (Fig. 14). This probably occurred during the 1950s/1960s.

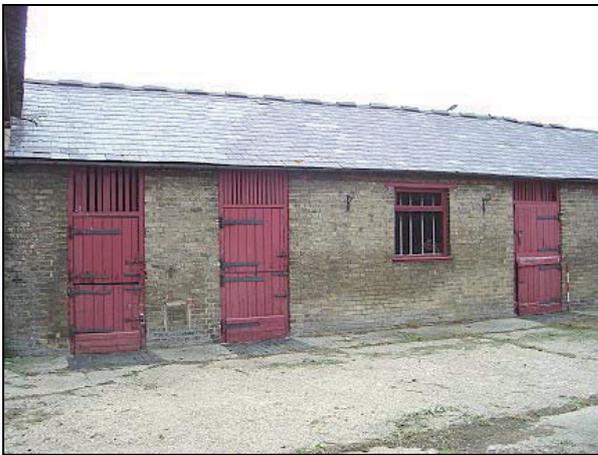
Figure 17: building 1, west elevation

The stable block along the remainder of the east wing has four doorways along its west elevation, three are traditional stable doors with metal gothic style hinges and have timber slatted ventilation head panels. Each of these three doors enters into a single room, none of which interconnect. In front of the three doorways is a small area comprising individually laid small square brick/concrete block work. The doorway at the south end of the stable block has been replaced (forms part of the building used by the school). There are also two timber casement windows either side of one of the doors at the southern end of the wing with timber sills.

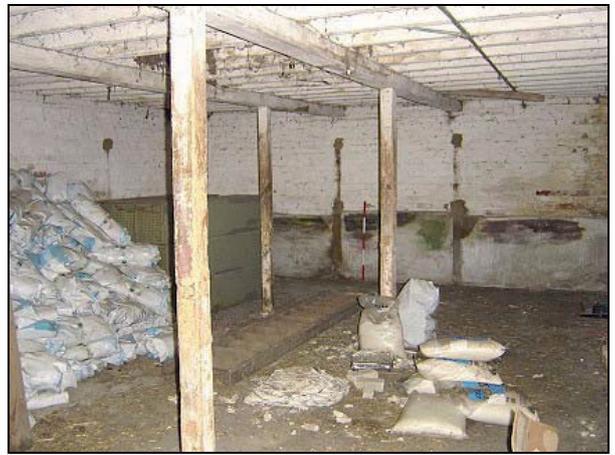
Figure 18: building 1, room 1, NW – SE view

Ground floor. White washed brick walls to all elevations. The casement windows have a series of panes with timber ovolo glazing bars and are boarded over. Metal security bars to window interior. Exposed timber joist ceiling (east to west) with lath and plaster to underside of floorboards above. Joists rest on two beams (north to south) that are supported on four timber posts. Concrete floor with evidence of possible grain bins now removed.

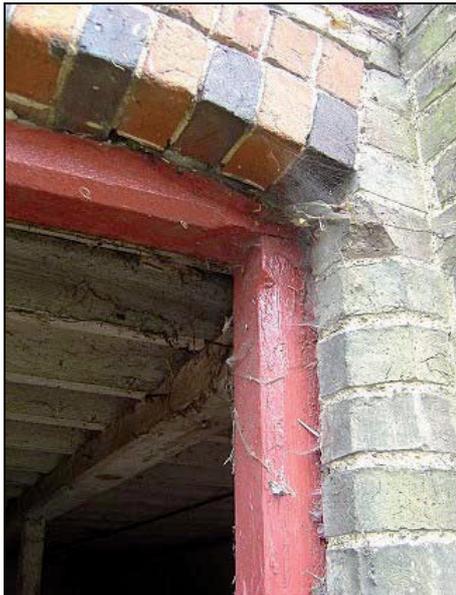
The north end of the east wing has a ground floor doorway that leads into a store with chamfered brick reveals that are stopped at the top of the opening. Its segmental brick arch above comprises a row of red brick voussoirs with a row of alternate black and red brick voussoirs below. The door frame is also chamfered and stopped on its external inner side and has a tongue and groove timber panelled door. The two ground floor windows set either side of the doorway are set within two storey blind arcading with rounded heads comprising a row of alternate black and red brick voussoirs with a row of red brick voussoirs below. Above each window is a brick segmental arch also comprising a row of red brick voussoirs with a row of alternate black and red brick voussoirs above. Both window openings have timber sills and chamfered brick reveals which are stopped at the top of their openings. The doorway on the first floor of the north elevation has chamfered brick reveals and a timber panelled door. It leads into the granary that would be accessed by an external ladder (found lying inside the room). To the right of the door is metal hoist with a curved brace. The east elevation has two decorative metal grills for ventilation.

Figure 19: building 1, chamfered and stopped doorway reveal and door frame

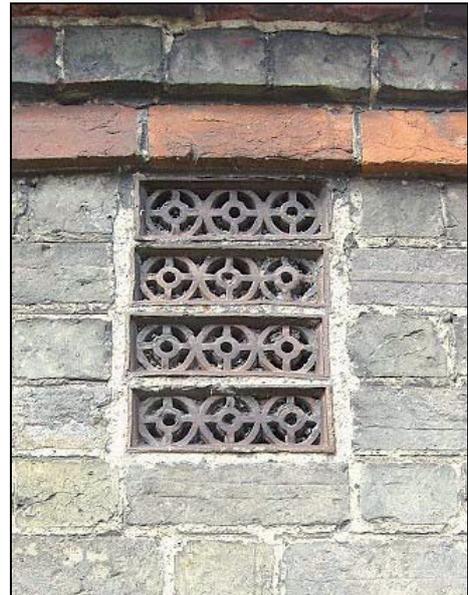
Figure 20: building 1, ventilation grill

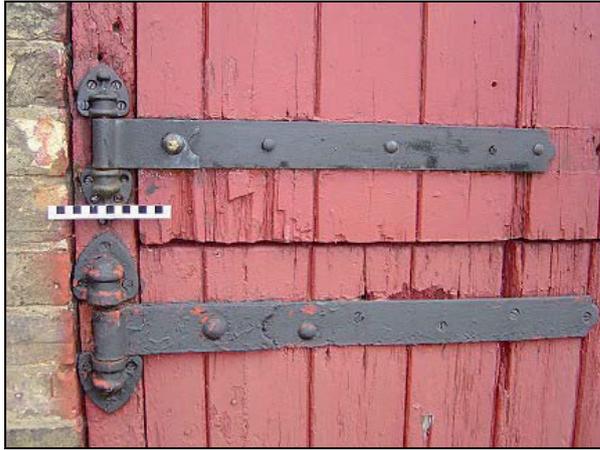
Figure 21: building 1, gothic door hinges

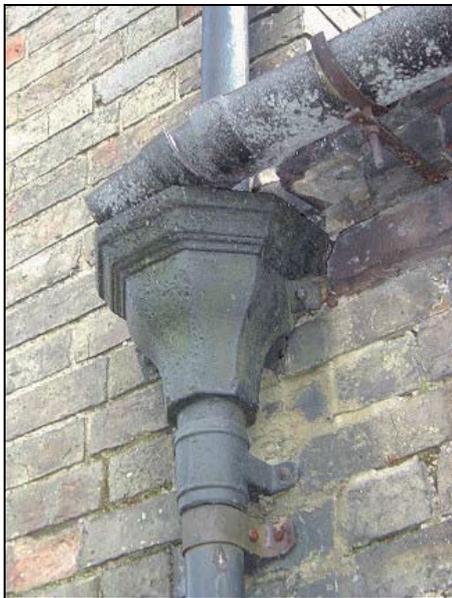
Some cast iron guttering remains. The main rainwater head is a five-sided cast iron design located on the west elevation at the corner of the eave of the granary.

Figure 23: building 1, cast iron rainwater head

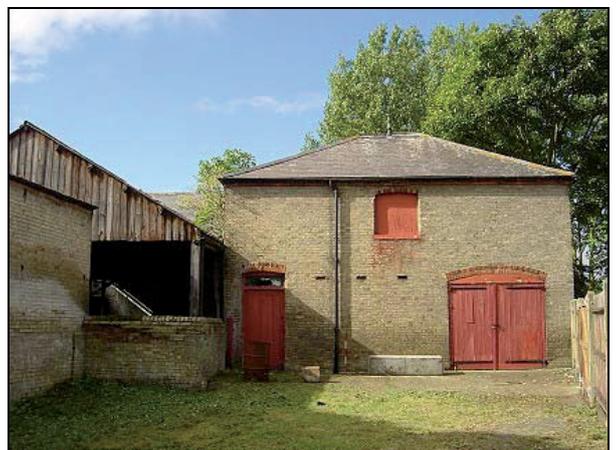
Figure 26: building 2, east elevation

The north side of the east elevation has a ground floor doorway that leads into the cartshed. It has a timber panel between the top of the door and the head of the doorway arch. The brick segmental arch above the doorway comprises a row of red brick voussoirs with a row of alternate black and red brick voussoirs below. Timber panelled double doors (probably replaced a pair of arch headed double doors). To the south is a single doorway leading into a store area with a brick segmental arch above comprising a row of red brick voussoirs with a row of alternate black and red brick voussoirs below. The doorway has chamfered brick reveals and a timber panelled

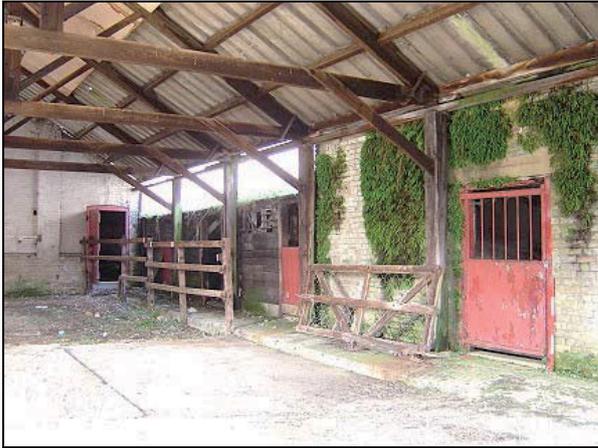
Figure 27: building 2, south elevation and building 3, south elevation

Each of the three rooms has its own door along the south elevation with a half stable door. Brick feeding troughs with tethering rings located along the north wall of each room are found throughout. They are constructed in stretcher bond and covered with concrete. The floor is built of brick and a gulley runs along the south side of the length of the building into a drain at the south east corner. It is likely that it functioned as a cowhouse/shelter and later as a stable.

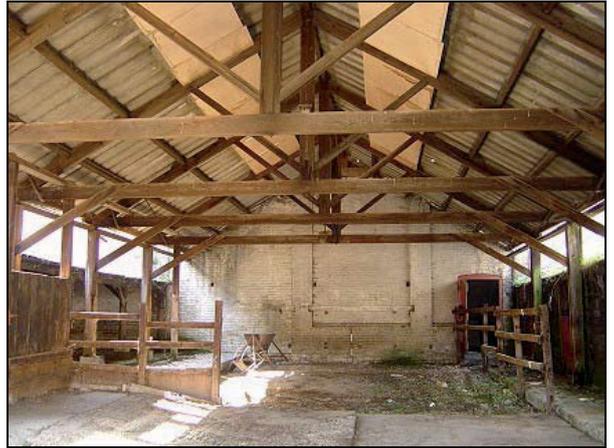
Building 8 is an open sided structure of six bays comprising six pairs of timber posts most of which are set in the concrete floor (two are on concrete plinths along the south side). It abuts building 5 to the west and also building 6 to the south. The floor is largely level in the centre with a step up to the north, east and south. The ground rises slightly to the east and there is a sharper slope to the south towards the extended animal pen of building 6. There are six king post roof trusses with metal ties through the main post up to the ridge piece and the roof is constructed of corrugated iron. Each tiebeam is braced into each post and also joined to a principal rafter. There are also four through purlins to each side of the roof that support the corrugated iron covering.

Figure 34: building 5, east elevation and building 8 E – W view

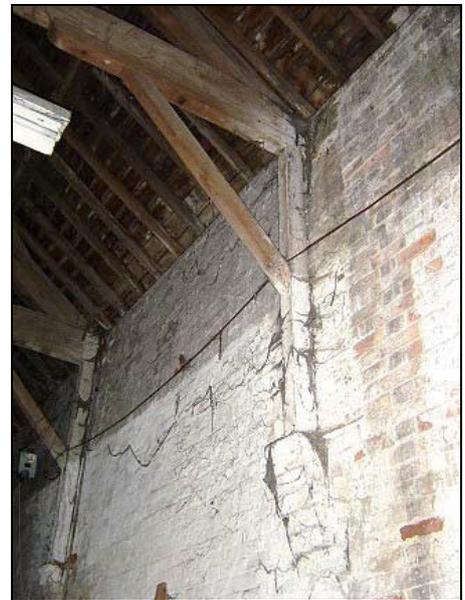
Figure 36: building 5, roof truss and corbel

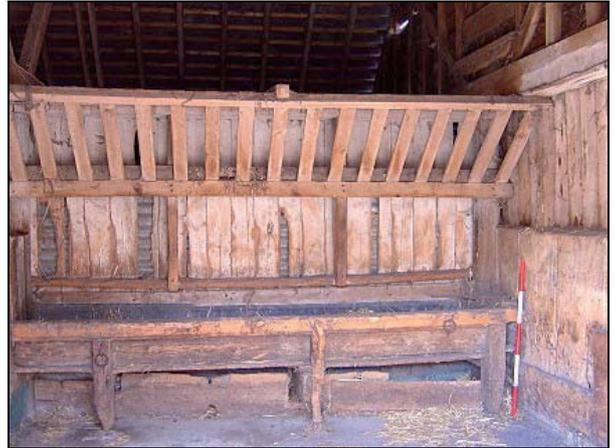
Figure 40: building 6, room 3, N – S view

Rooms 3, 4, 5 and 6 lie along the south side of the building and are roughly equal in size. Each are access by a timber panelled stable door. The lower halves of the doors have gothic style hinges, while the upper halves have been added or replaced at a later date. Rooms 3 and 4 have a timber feeding trough with tethering rings on the north elevation and there is a further timber trough above. Room 5 has had its timber feeding trough with tethering rings removed and only the timber trough above remains. Access was not gained into room 6.

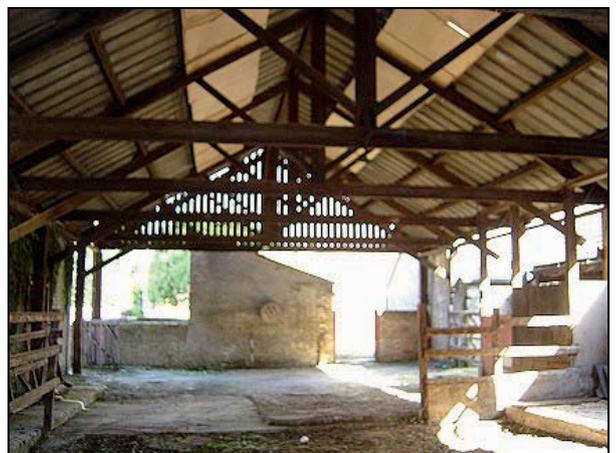
Figure 44: building 8, W - E view

There are a number of carpenter's marks along the wall plates, tiebeams and braces of building 8. Some are construction markings in Roman numerals, others are length measurements of certain timbers. All marks appear on different faces of each timber and are not always in numerical order. However, roman numeral markings on the wall plate at the point where the post and tiebeam meet (sometimes partly hidden) are suspected to start along the north side at the north east corner, run west (I, II, III, IV, V & VI) and return along the south side (VII, VIII, VIII, X, XI & XII) to the south east corner.

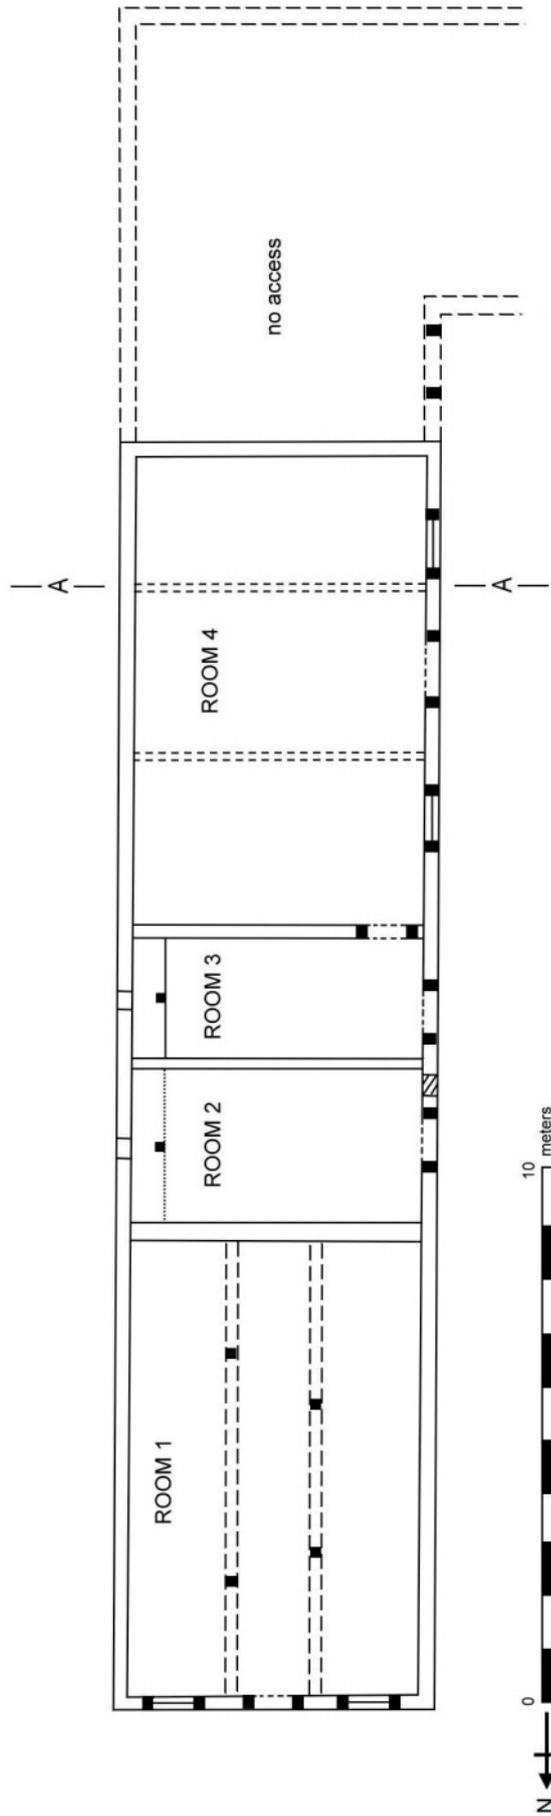
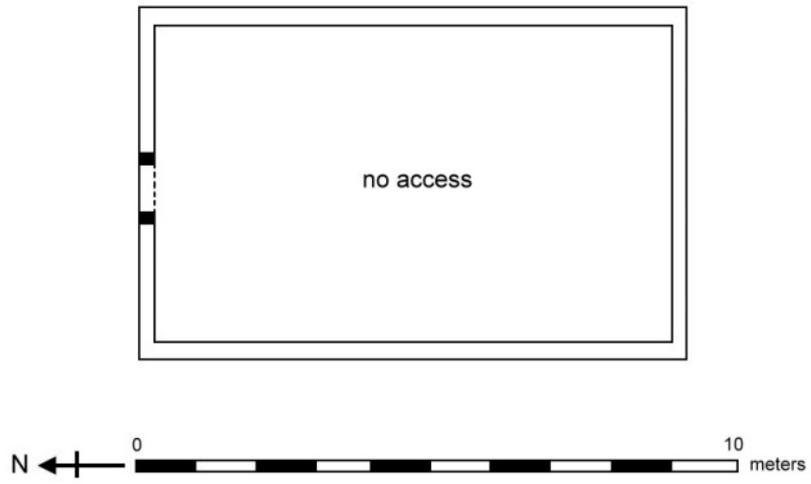
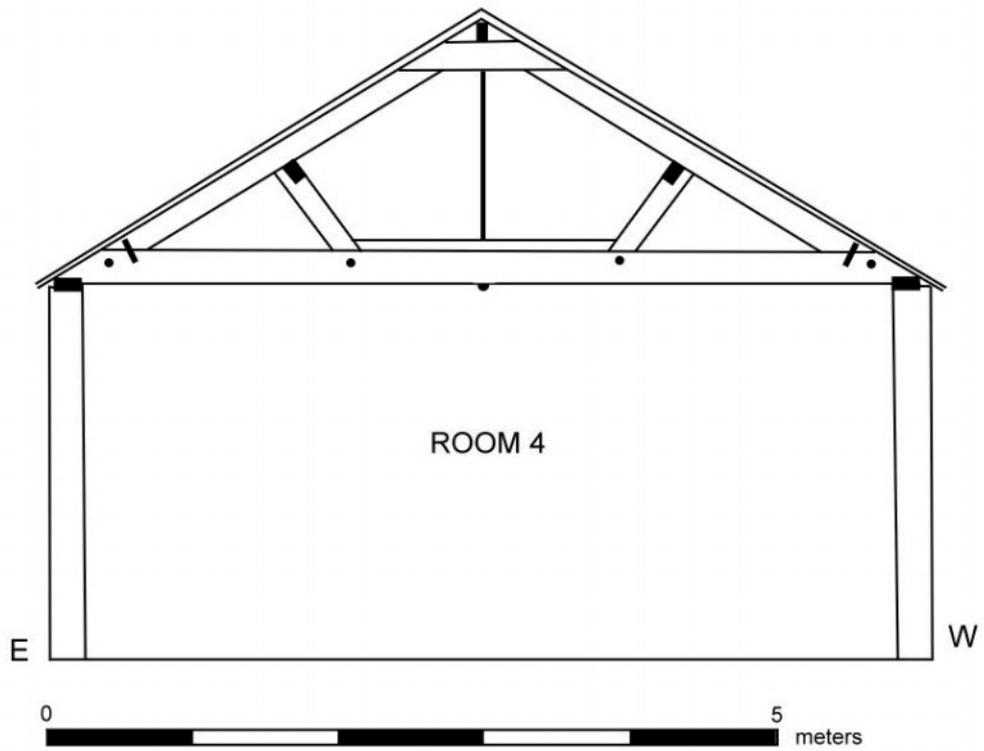
Figure 45: building 1 ground floor plan

Building 1 is 'L' shaped, constructed of yellow brick in Flemish bond with a hipped slate roof and a row of red brick along the eaves to all elevations. The two storey north end of the east wing has a store on the ground floor and a granary above and is joined to the single storey stabling block to the south which forms part of the east and south wings of the building (the south wing was not recorded – several windows and doorways have been inserted along its north and south elevations).

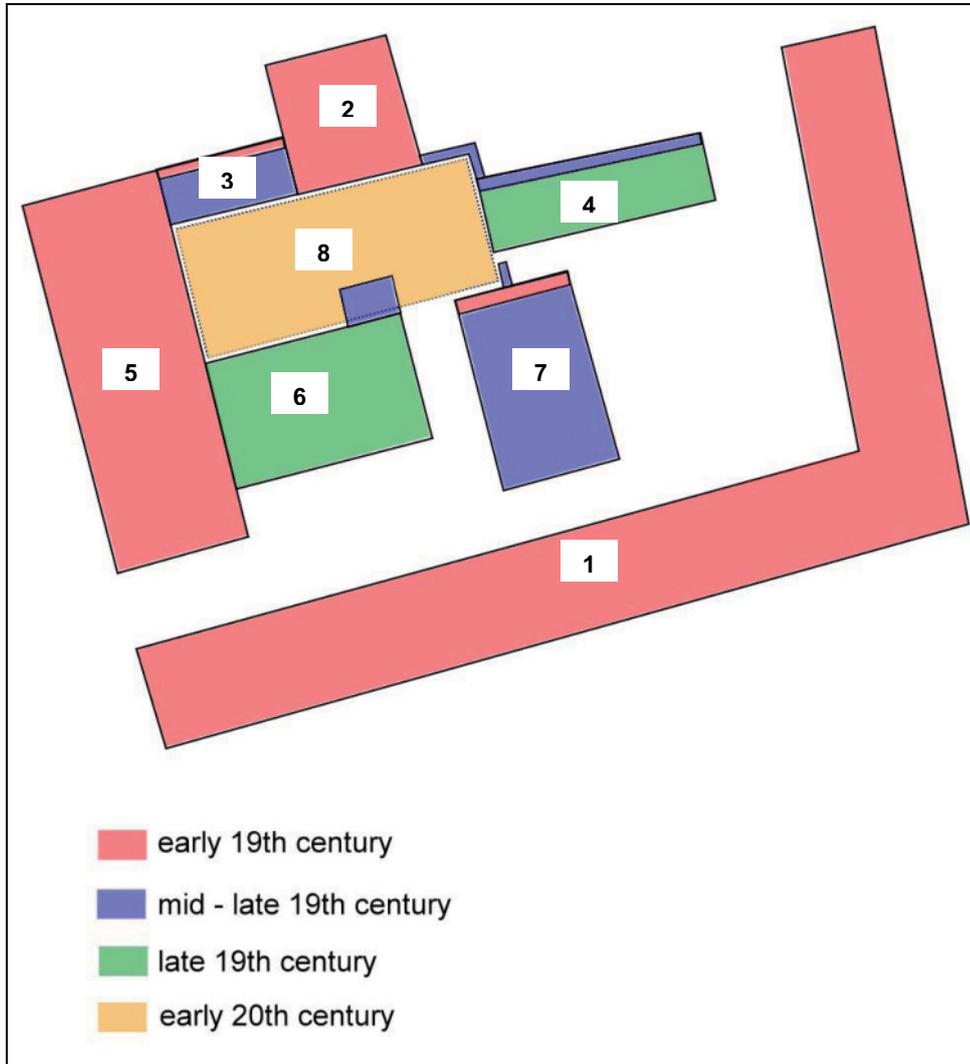
6.3 Other later buildings in the farmyard date to the mid – late and late 19th century, and the early 20th century and are constructed of timber posts on concrete plinths/concrete floor with external weatherboarding (buildings 3, 4, 6 and 7; Fig. 63). Within some buildings are the remains of earlier brick structures. Building 3 is a mid - late 19th century lean-to that abuts a wall to the north, which is probably a re-built wall of an early 19th century structure formerly on site with buttresses. Building 4 is a late 19th century cowshed/milking shed that has an earlier buttressed brick wall to the north which formed part of a mid-late 19th century structure. Building 6 may have been an open sided cowshed on its north side until the extension of room 1 to make another bull pen prior to the erection of building 8. The most recent building on the site is building 8 which probably dates to the 1920s/1930s and provided a covered area for cattle at night (Fig. 63). In addition to the buildings, there were at least two walls that were built to enclose the farmyard and probably date to the change from arable to mixed farming. These abut buildings 2, 4 and 7 (Fig. 63).

Figure 63: phased plan of the farm buildings (1 - 8) and farmyard at New Farm
