6 Argyle Street, Dornoch

Building Recording and Archaeological Evaluation

Report

Site Number	AN4
OS Grid Reference	NH 8003 8965
Author	Pete Higgins
Date Produced	13 August 2010
Date revised	4 September 2010

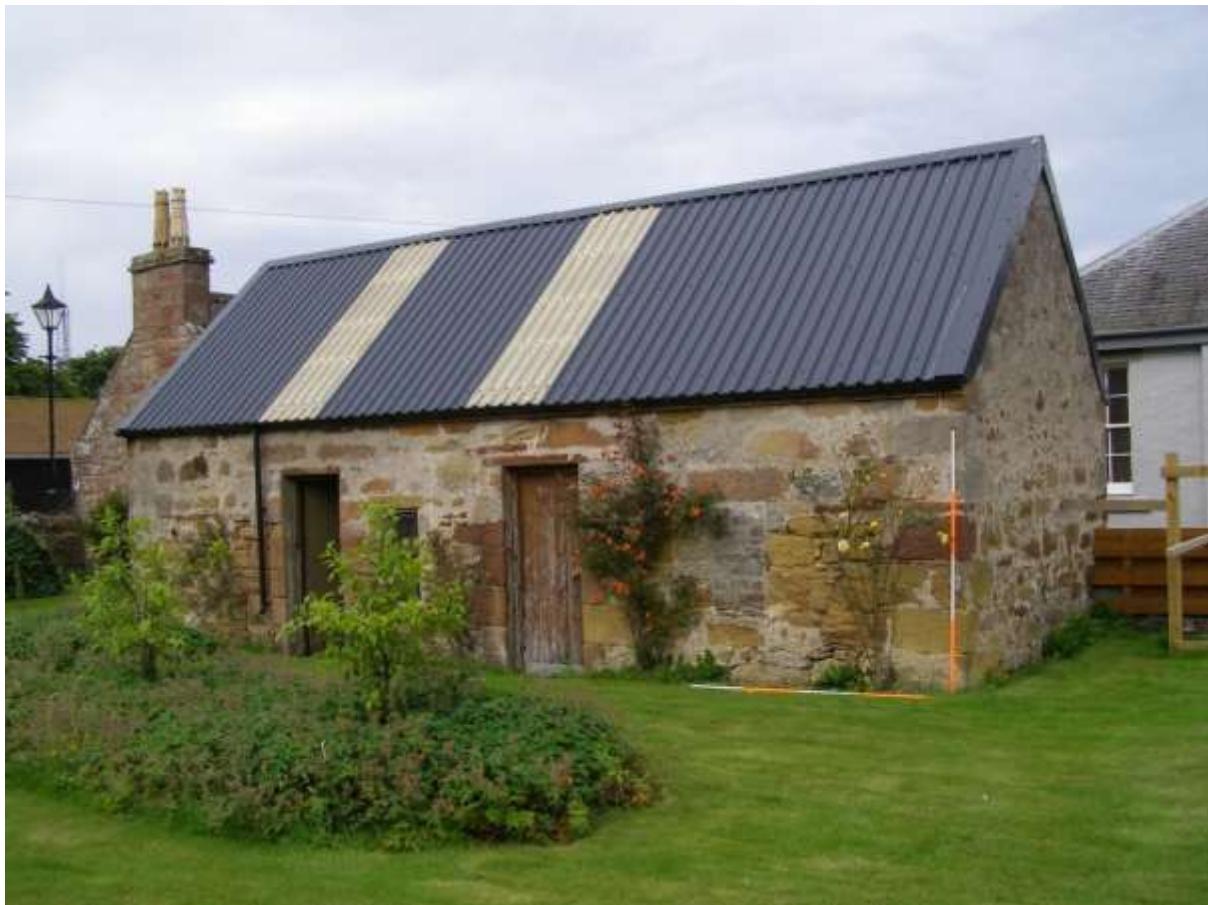
Photograph is of east elevation of building

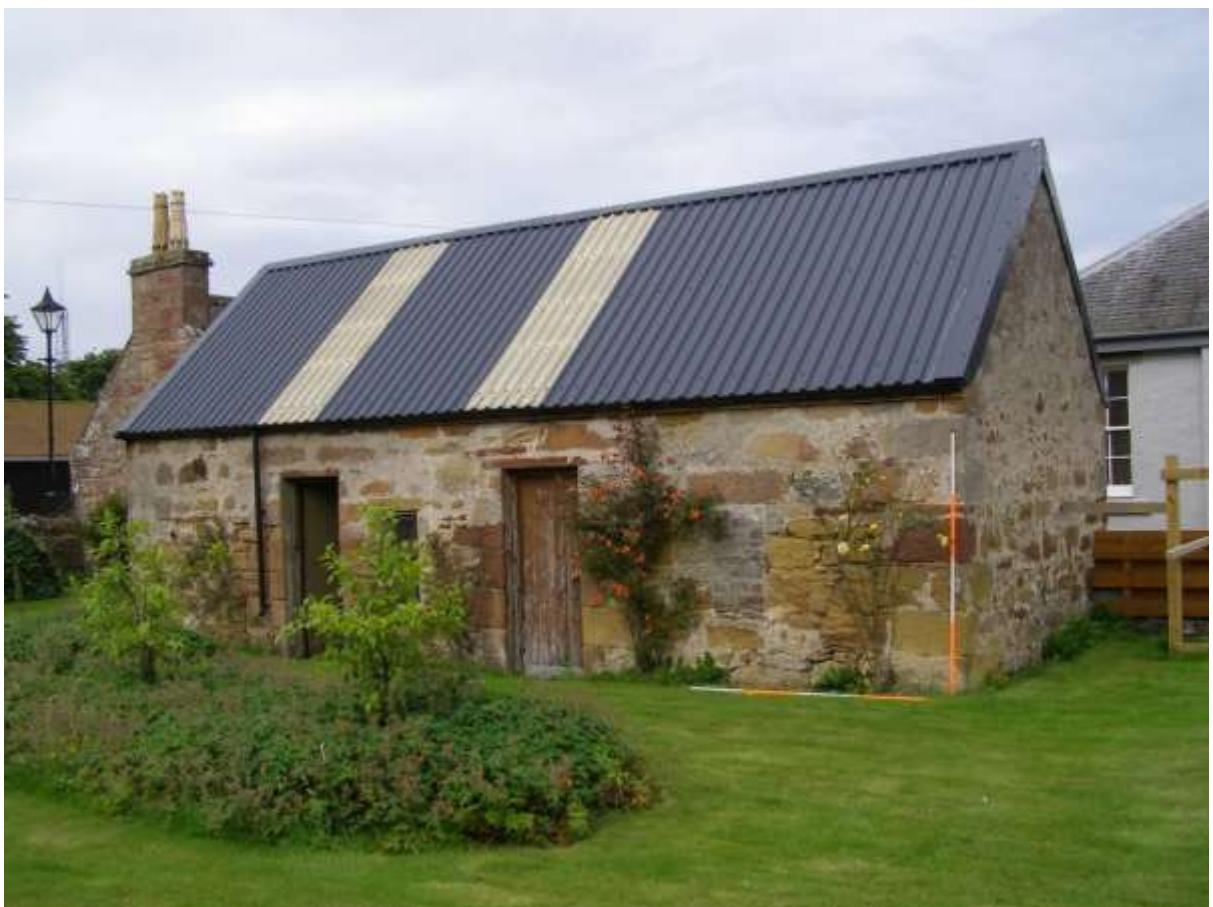
Figure 3 East elevation of building. Scales 2 x 2m.

A window in the west elevation, and a window and door in the east elevation are probably from this period. They are all simple rectangular openings, with no splay. The external lintels of the windows are of yellow sandstone, as are the quoins.

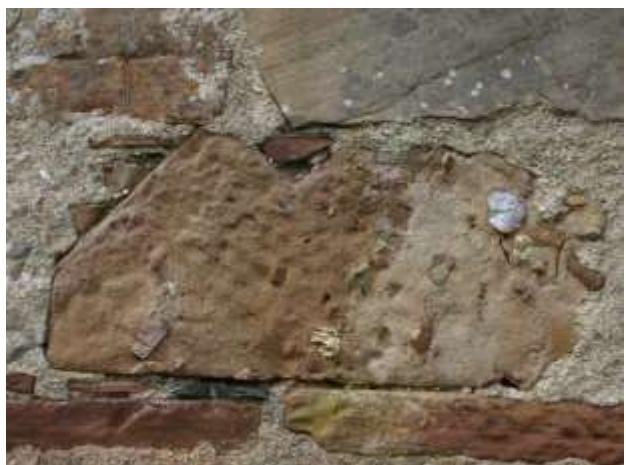
Figure 4 Shaped stone in north end of east elevation

Three stones of unusual shape have been placed in this phase (figures 4 & 5). All are located at approximately the same height and distance from corners, and two (in the

north end of the east and west elevations) are opposite each other. The third stone is in a similar position in the south end of the west elevation, but its possible corresponding partner in the east elevation is largely obscured by cement mortar and harling. These stones appear notched in their upper surface, as though to accept sloping timber, and they are likely to be gable stones relocated from the gable end to the side elevations, presumably during this phase.

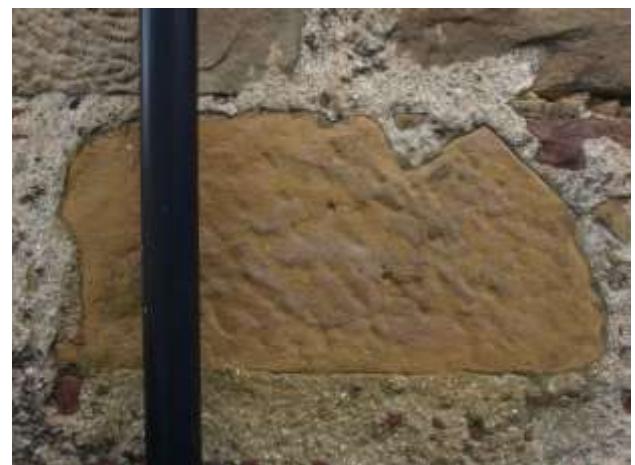
Figure 5 Shaped stone in north end of west elevation

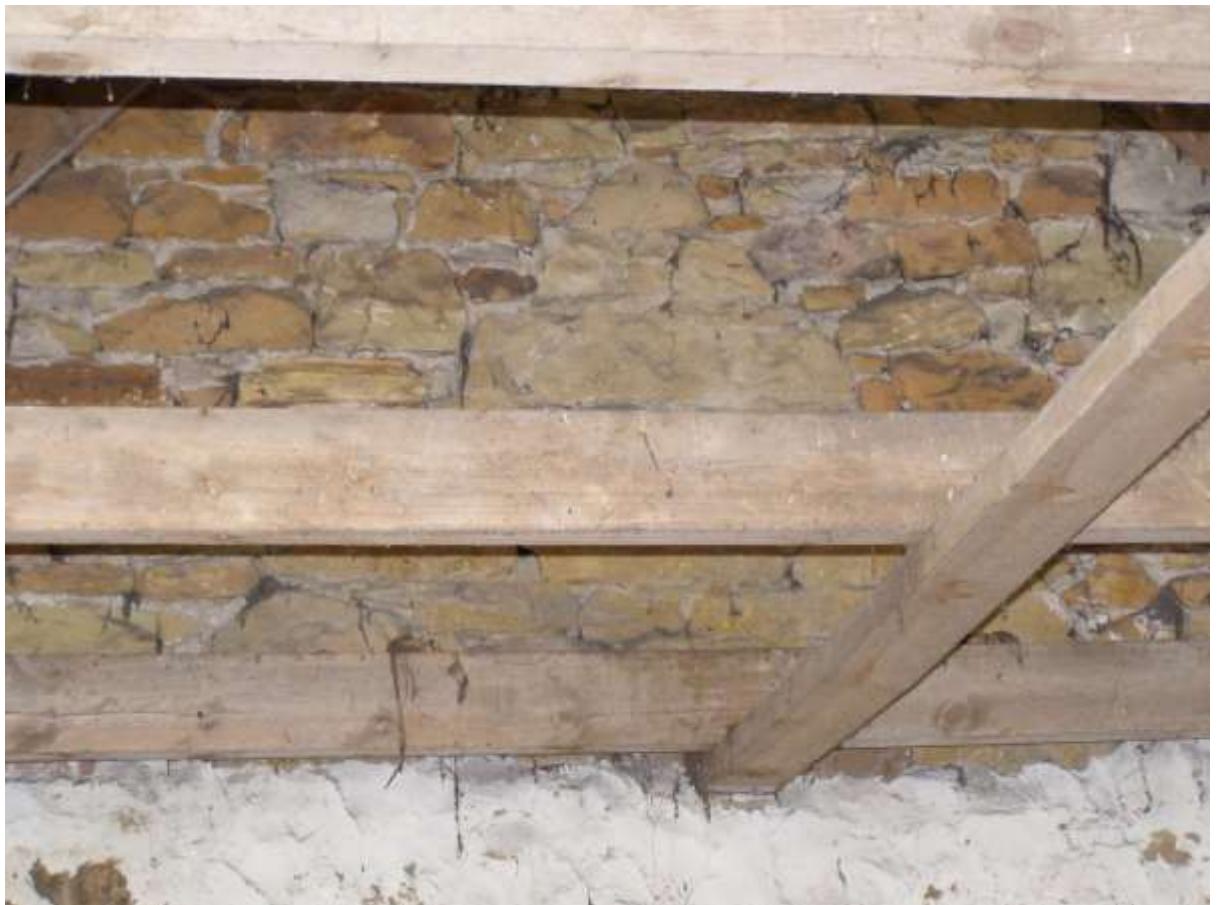
Figure 6 Internal south elevation, showing raised gable and differing stonework

7.2. **Phase 2. Late 19th century.** In this phase the roof is raised, the walls increasing in height to 2.8m and the gable ends to 4.9m. Red, dark red and grey sand stone, and granite, are all used, together with some probably re-used yellow sandstone. The provenance of the later sandstones is uncertain. Bonding is of lime mortar.

The gable walls of this phase are c0.4m thick, leaving an offset visible internally. Another window is inserted in the east elevation, together with another door, both with at least one side splayed. The first phase window in the east elevation is partly rebuilt, with pecked grey sandstone inserted in the southern jamb, forming a splay on that side; the northern jamb is untouched.

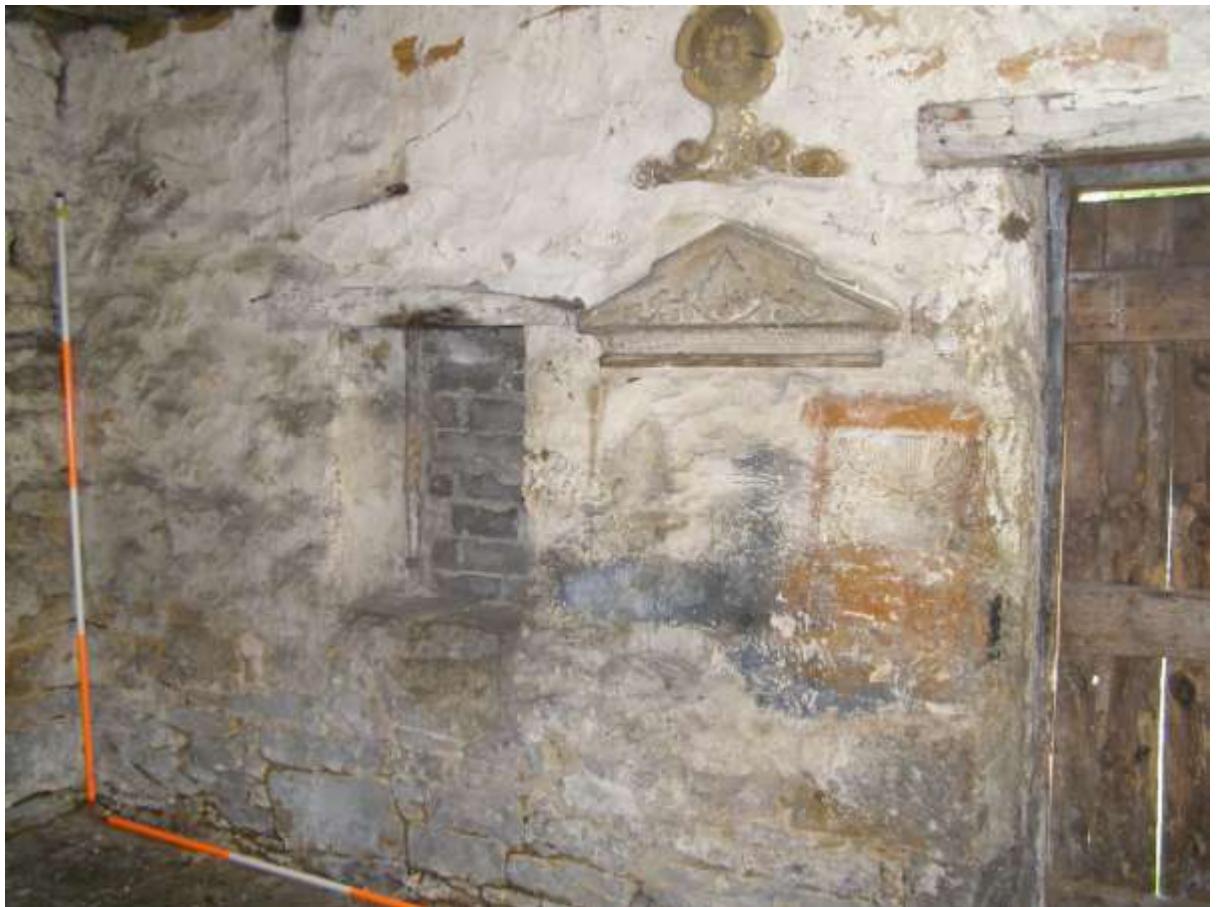
Figure 7 Scales 2 x 2m

- 6 Internal south elevation, showing raised gable and differing stonework
- 7 Northern end of east elevation, internal, showing carved quoin (see figure 7) and re-used stonework.

- 10.1.4. The three carved stones in the internal east elevation comprise two inserted, re-used monumental stones and a quoin, already in situ when carved and signed 'James Munro'. A William Munro is listed in burgh records held at Historylinks Museum as leasing a building lot in Dornoch in 1885 and is recorded as still working in 1905 (Dornoch Burgh records, Leases 2004, held in Historylinks Museum). There is nothing, however, to link him definitively with the Argyle Street site. The census return for 1901, which for the first time lists the streets and house numbers of the burgh's inhabitants provides the first firm evidence that a mason lived, and presumably worked, at 7 Argyle Street. David Munro, aged 48, gives his occupation as mason. He is also listed in the census of 1891. None of David's three sons were named James but it is possible that James Munro was David's father or brother. The 1930 valuation roll for the burgh¹⁸ which records the residents of Argyle Street but does not identify street numbers or house names lists a byre as the property of a Kenneth Macgregor, from which entry it may be assumed that the Munro family were no longer resident on the street.

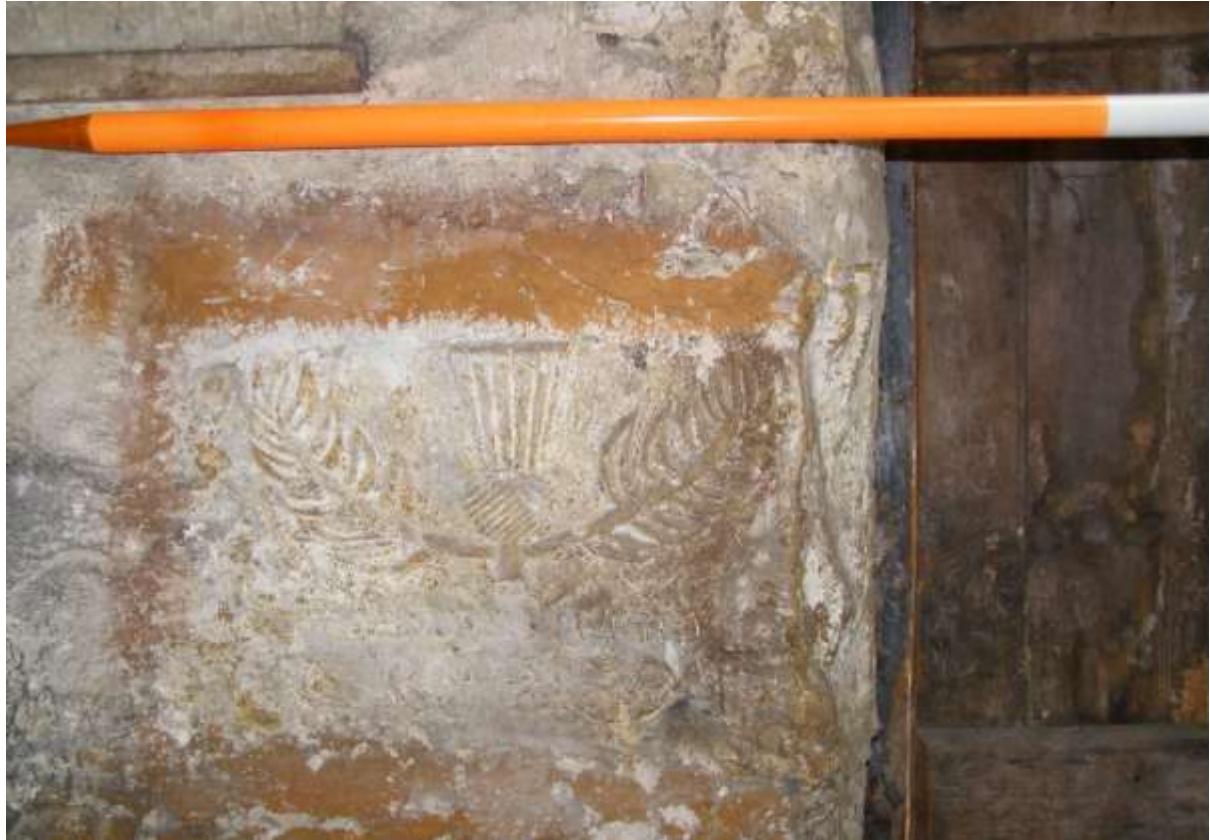
Figure 8 Carved quoin by westernmost door in north elevation, internal. Inscription reads 'James Munro, Mason'.
Scale 1m

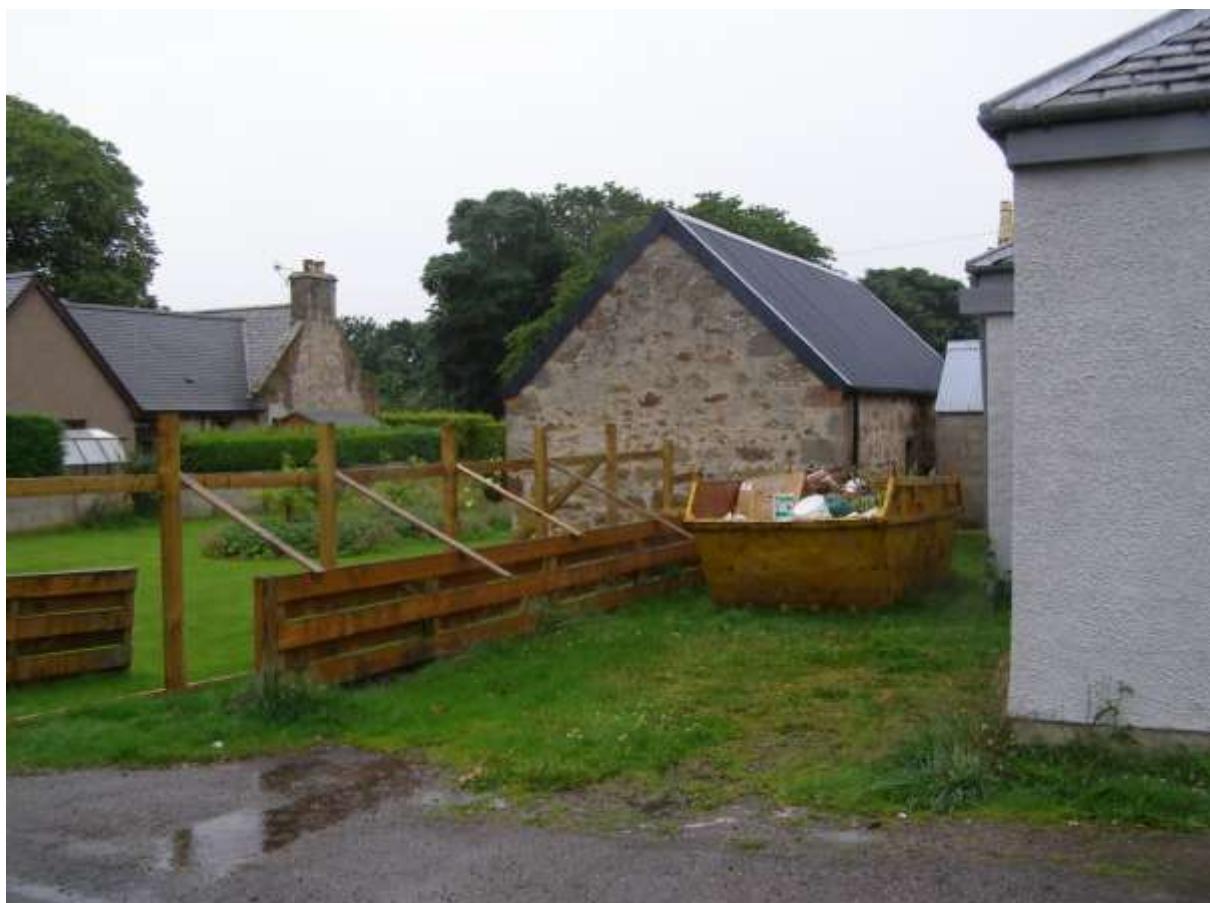
Figure 9 North elevation. The building in the right foreground is The Coach House

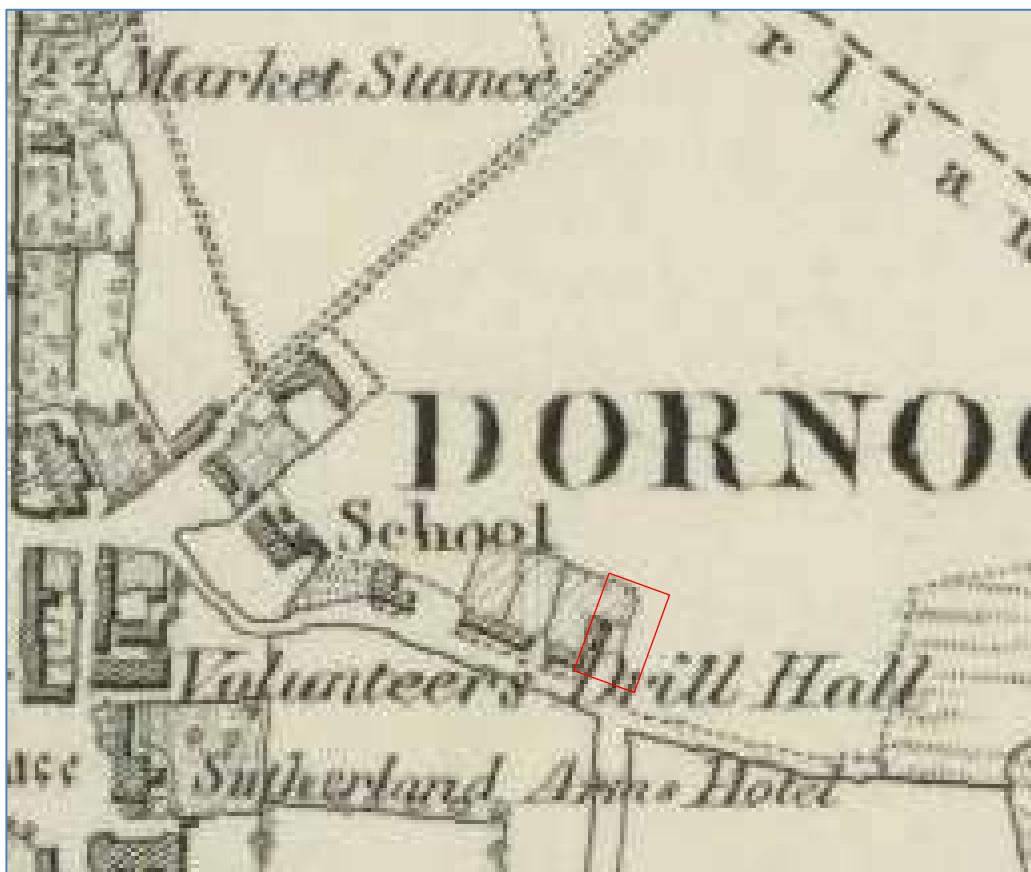
Figure 10 The site on the OS 1st edition map, surveyed 1874. Site area outlined in red.

By the time of the first Ordnance Survey of the area, in 1874¹⁵ Argyle Street is marked branching off from Schoolhill and extending northwards. This map also provides the first representation of three enclosed plots, see figure 10, with roofed buildings on the street frontage, at the northern end of the street and shows clearly the byre under investigation at right angles to the street frontage. The northernmost plot appears to be almost of double the width to the two plots to its south and also shows an unroofed building on the street frontage. The implication is that this wider plot was later subdivided, the four plots eventually becoming known as nos 4-7 Argyle

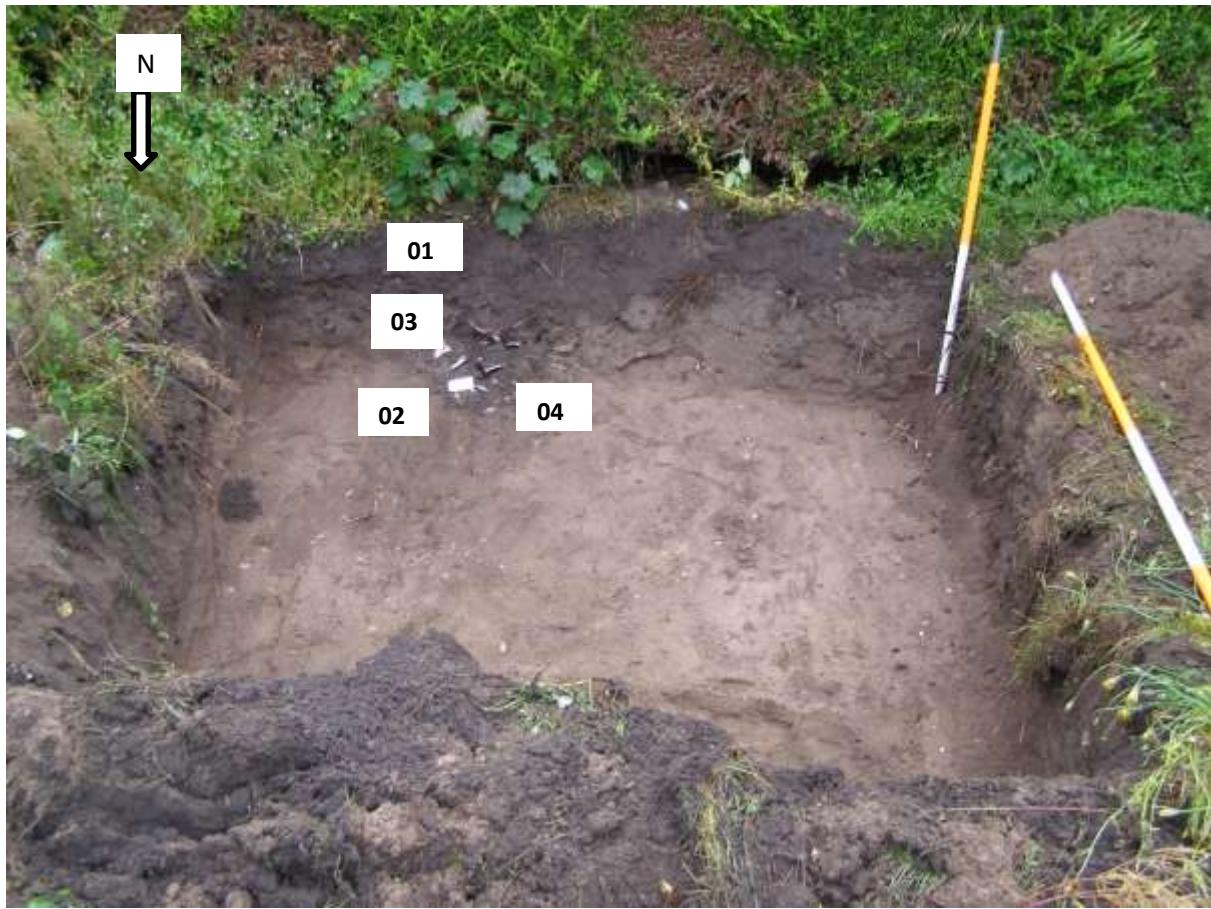
Figure 12 Trench 1 excavated. Scale 2 x 1m

- 10.2.1. The topsoil, identified as 1, **201** and **301**, was a thick, very well mixed and highly humic topsoil. This topsoil was effectively identical to that across the rest of the site, although the humic content was higher in Trench 1, which lay in a vegetable plot.

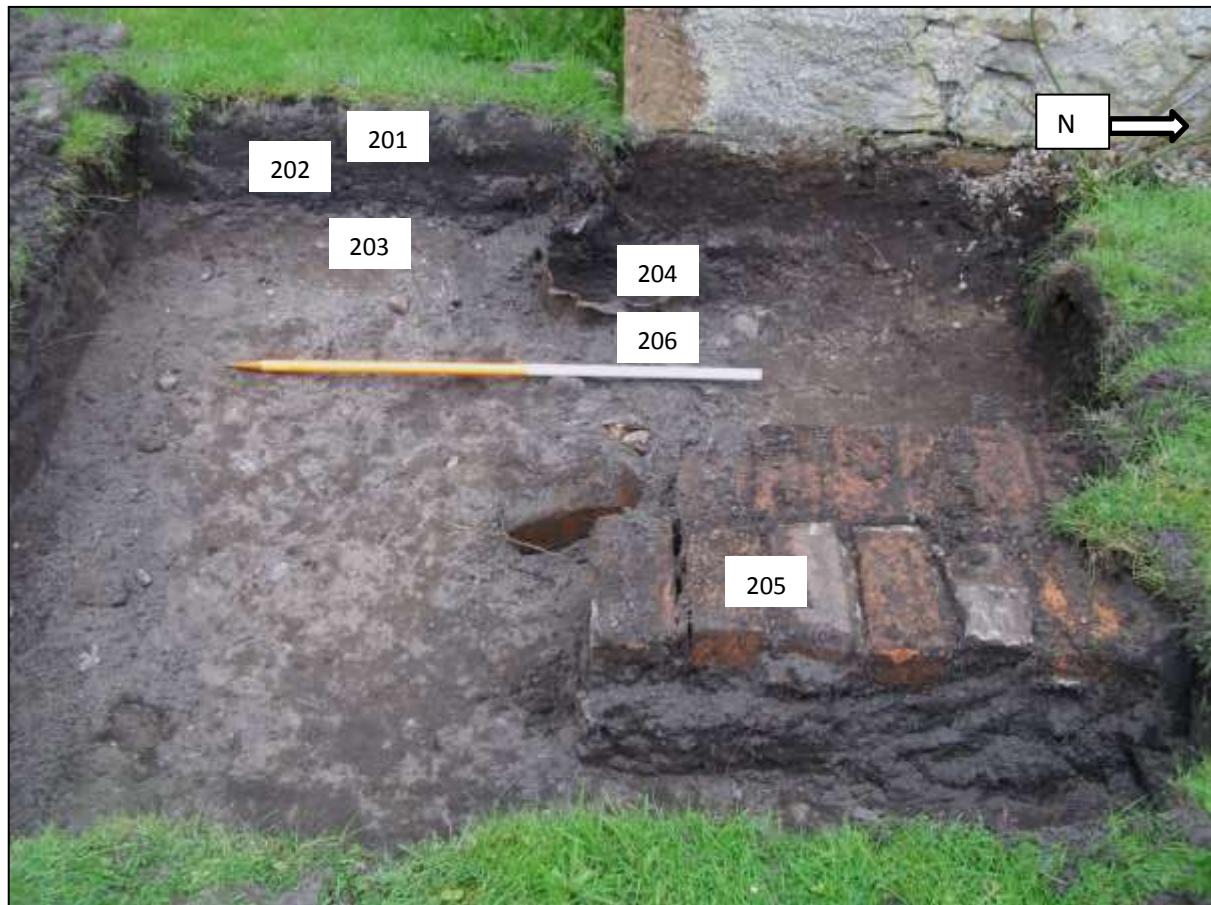
Figure 13 Trench 2 Excavated. Scale 1 x 1m

- 10.2.2. Trench 2 found evidence of garden paths, **202** and **205**, together with a construction layer, **203** and soakaway, **204**. The latter were presumably associated with the byre, and the presence of cement mortar dates **203** to later than *Phase 1*.

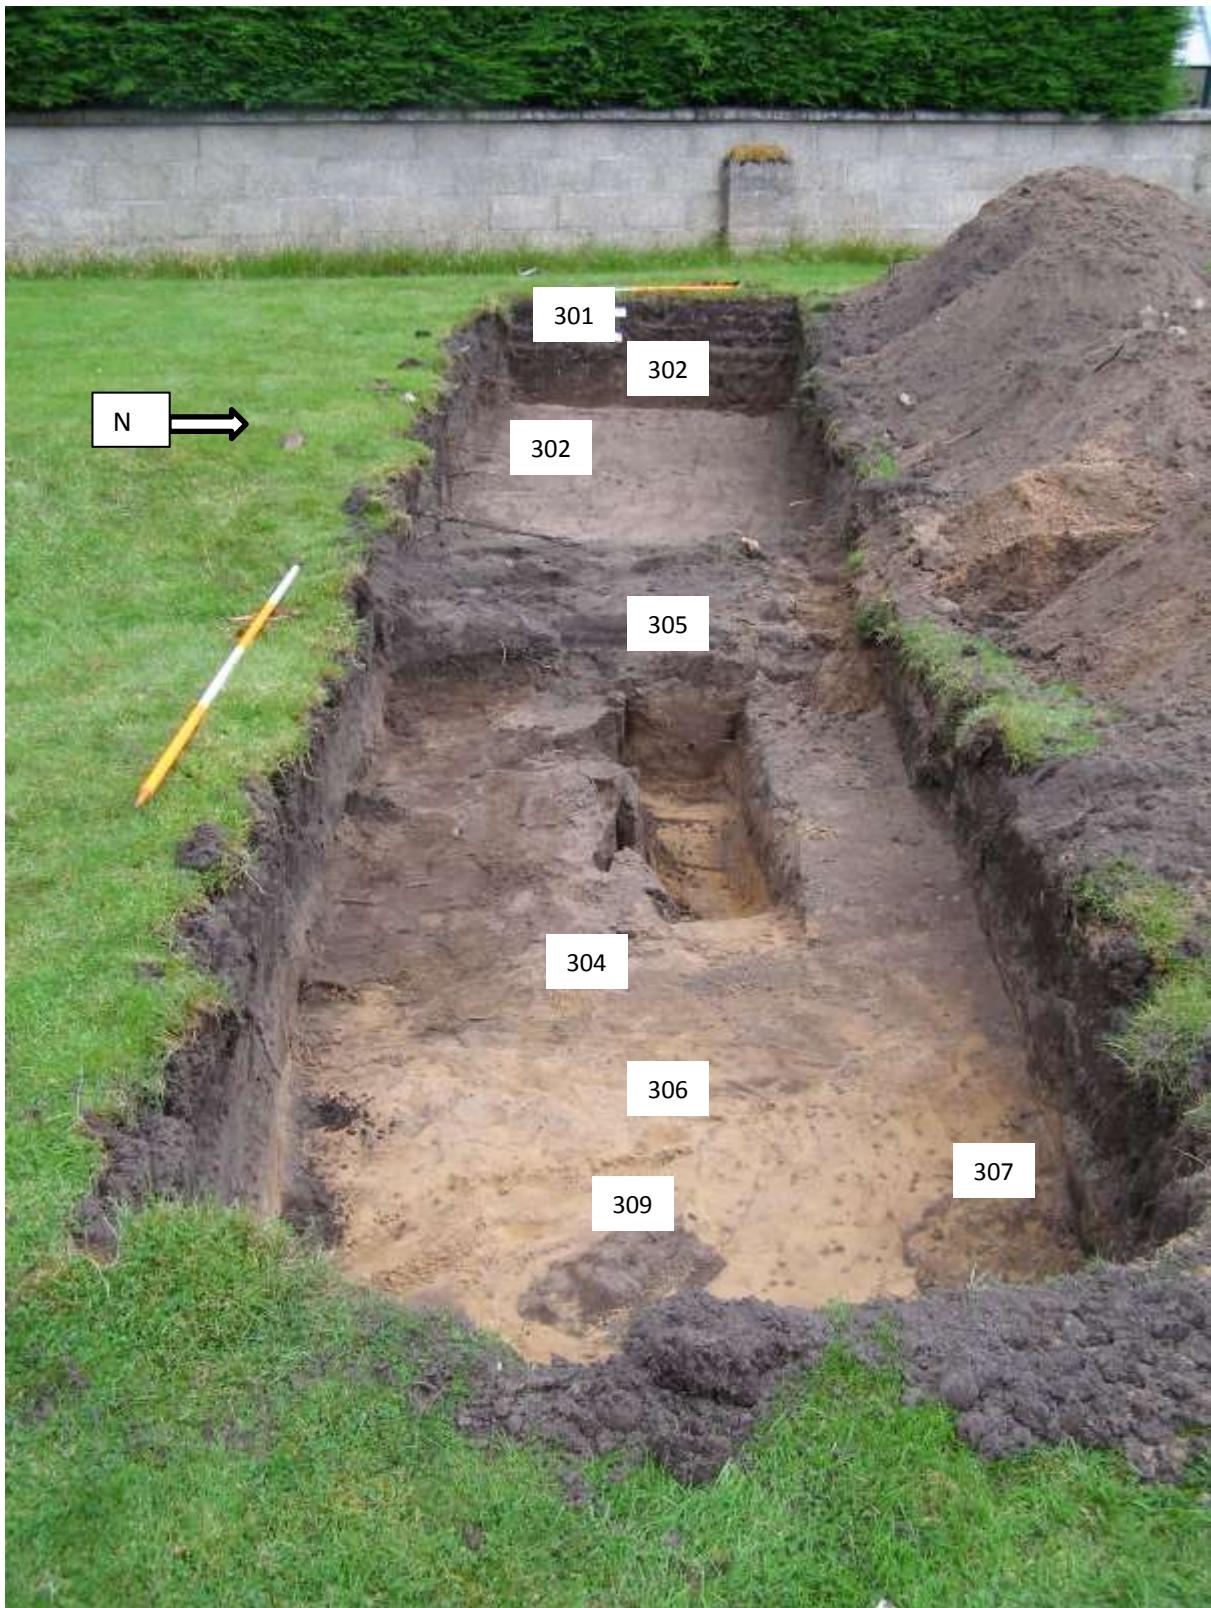
Figure 15 Trench 3 Excavated. Scale 1 x 2m

- 10.2.3. The service trench, **305**, in trench 3 seems overly large for the purpose ascribed to it, and coincides with the eastern property boundary shown on the 1874 map. Other property boundaries in the vicinity of the site are defined with stone walls and **305** is therefore interpreted as a robber trench, dug to remove a stone wall. No sign of a recut was noted, and it is possible that the service pipe was laid in the open robber trench.

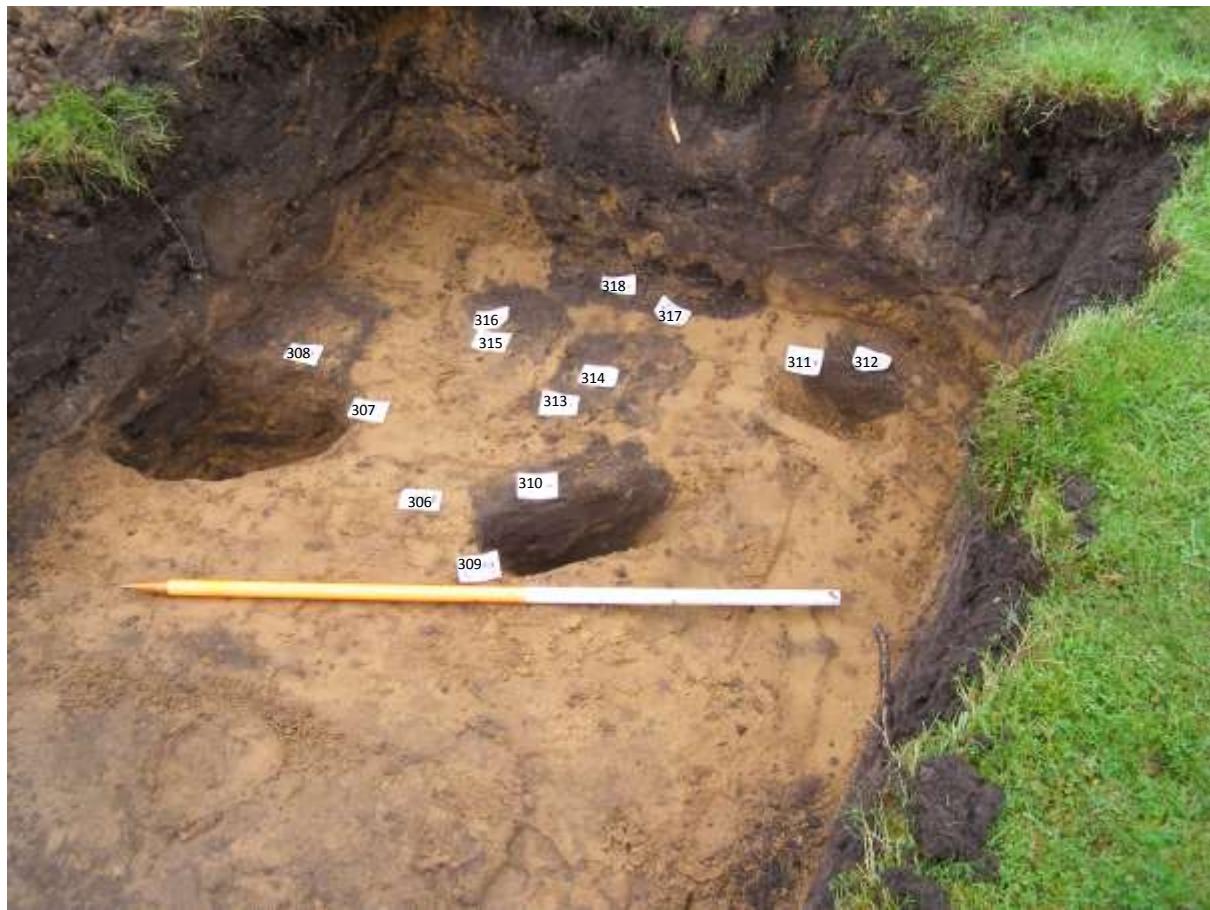
Figure 17 West end of Trench 3, showing cluster of postholes Scale 1m

- 10.2.4. The features in the western end of trench 3 are filled by fills indistinguishable from each other, suggesting a contemporaneous origin. The fills have a very slightly lower humic content than the topsoil, and all the features are truncated. No silting was noted in any of the features. This is consistent with the features being back-filled, soon after cutting, with garden topsoil. The back-filling would have occurred at a point sufficiently long ago to allow the topsoil to diverge from the fills by more intensive cultivation (increased humic content) but sufficiently recent for the divergence to be small. All these features have the same stratigraphic relationships, similar dimensions, are of similar depth, and only differ in their plans. Three – **309**, **313**, and **315** – are rectilinear in plan, have flat bases, and are probably post-holes. The other three – **307**, **311**, and **317** – are less regular in plan and have sloping bases, a shape common to planting holes for small rooted plants. Since the features are effectively filled with cultivated topsoil, lie within an area not known to be used for any purpose other than as a garden, and are explicable in terms of gardening, they are assumed to be garden features.

- 10.2.5. The only dating evidence recovered consisted of a single flat-headed nail of mid to late 20th century type from the base of **307**, providing a secure dating for that feature, and by extension of the reasoning above, for the other features.

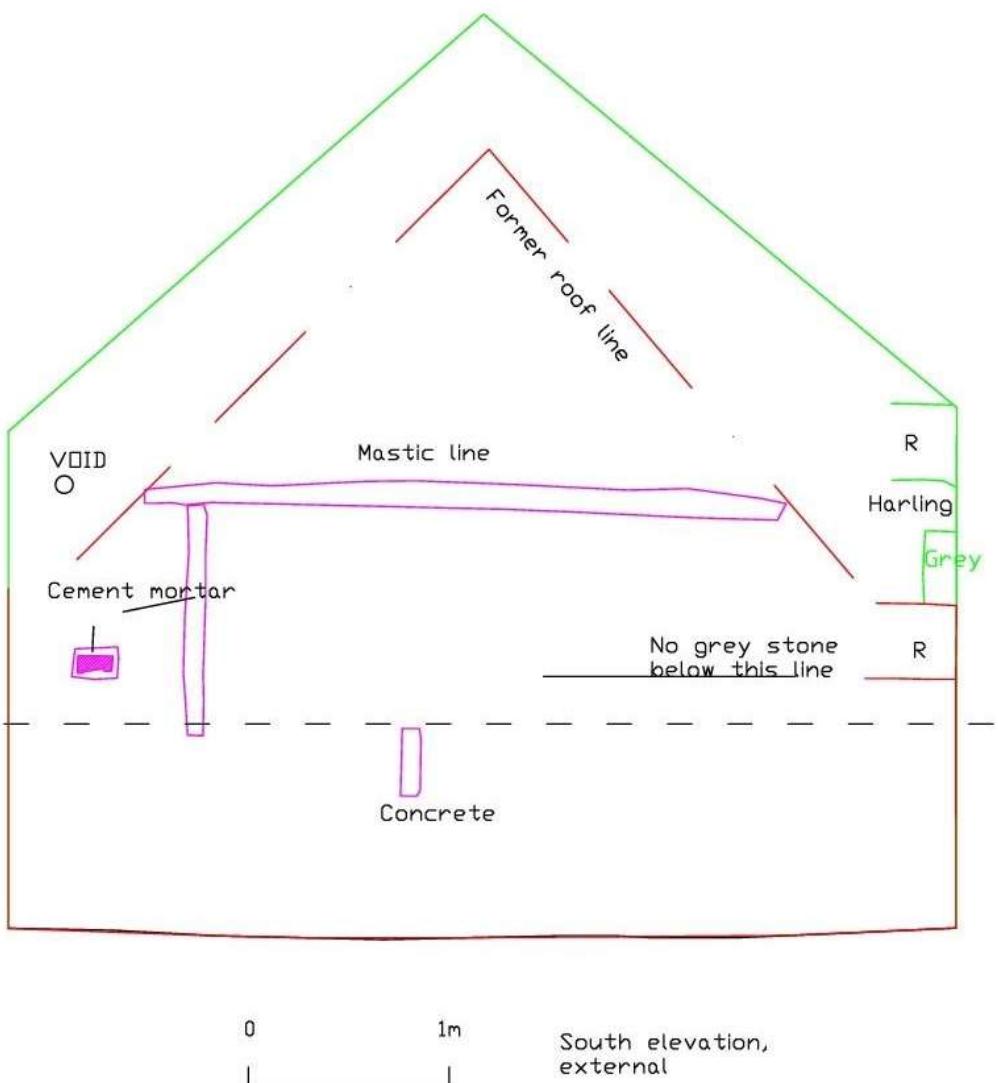
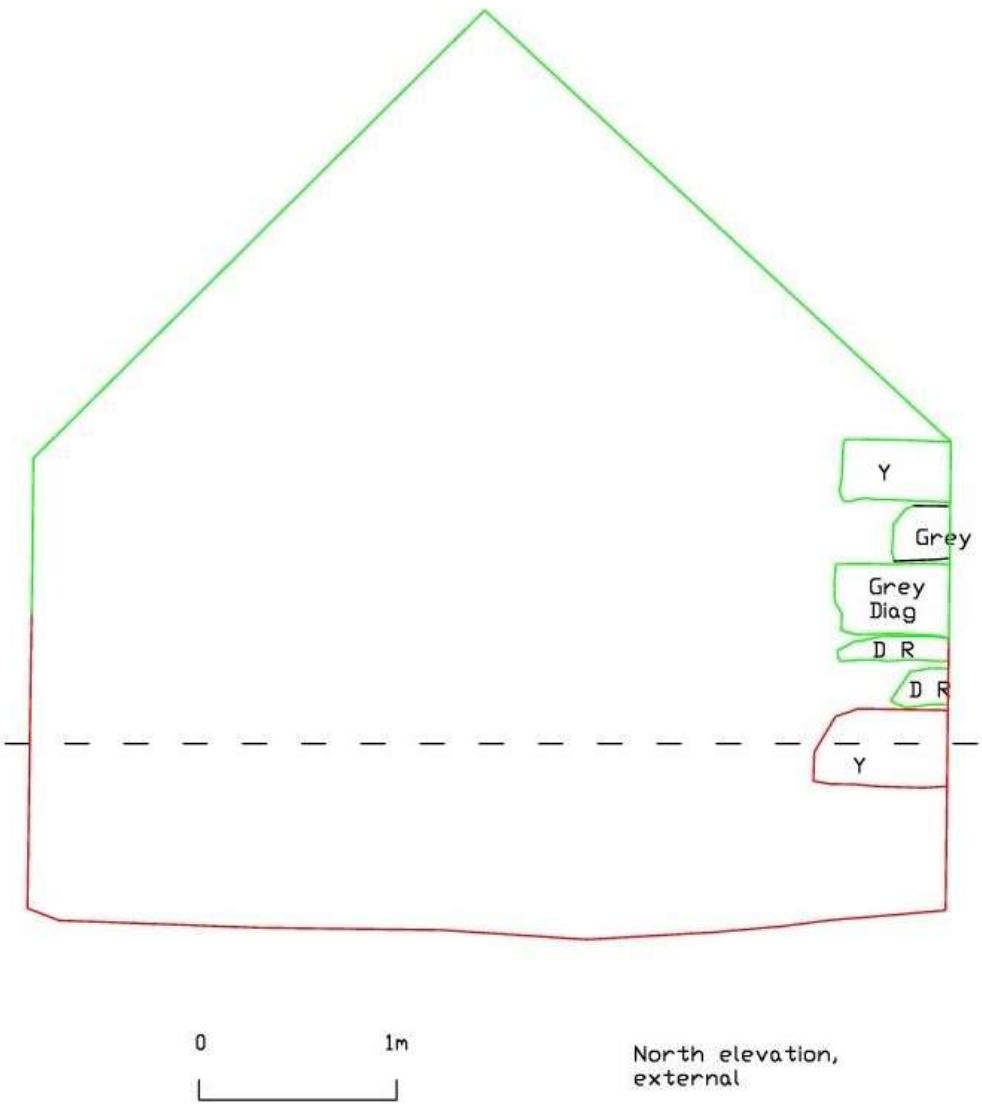
Figure 19 South and north external elevations

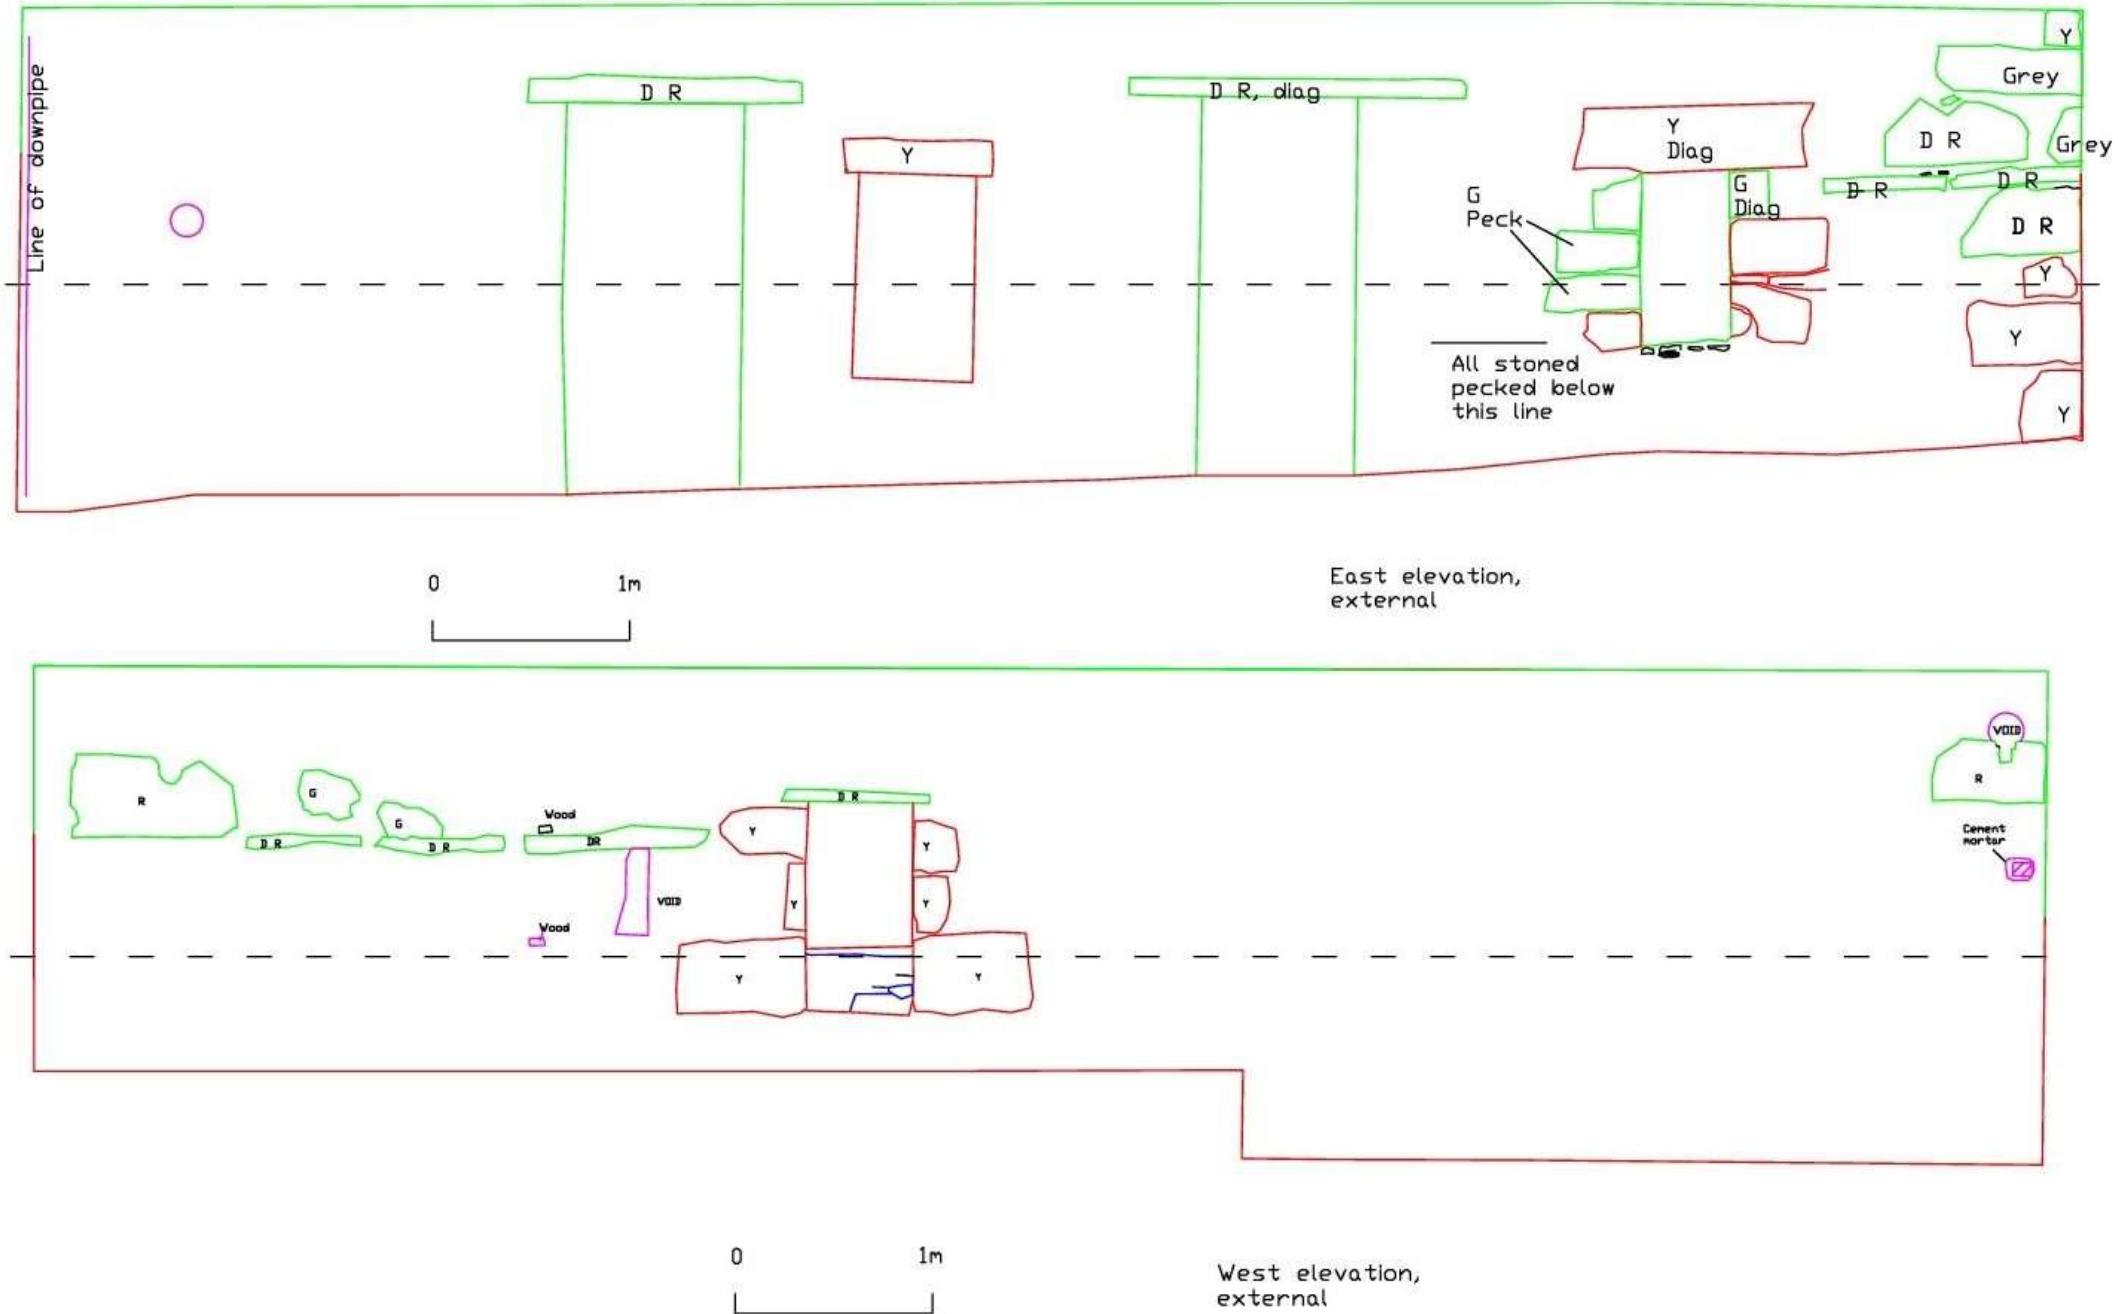
Figure 20 East and west external elevations

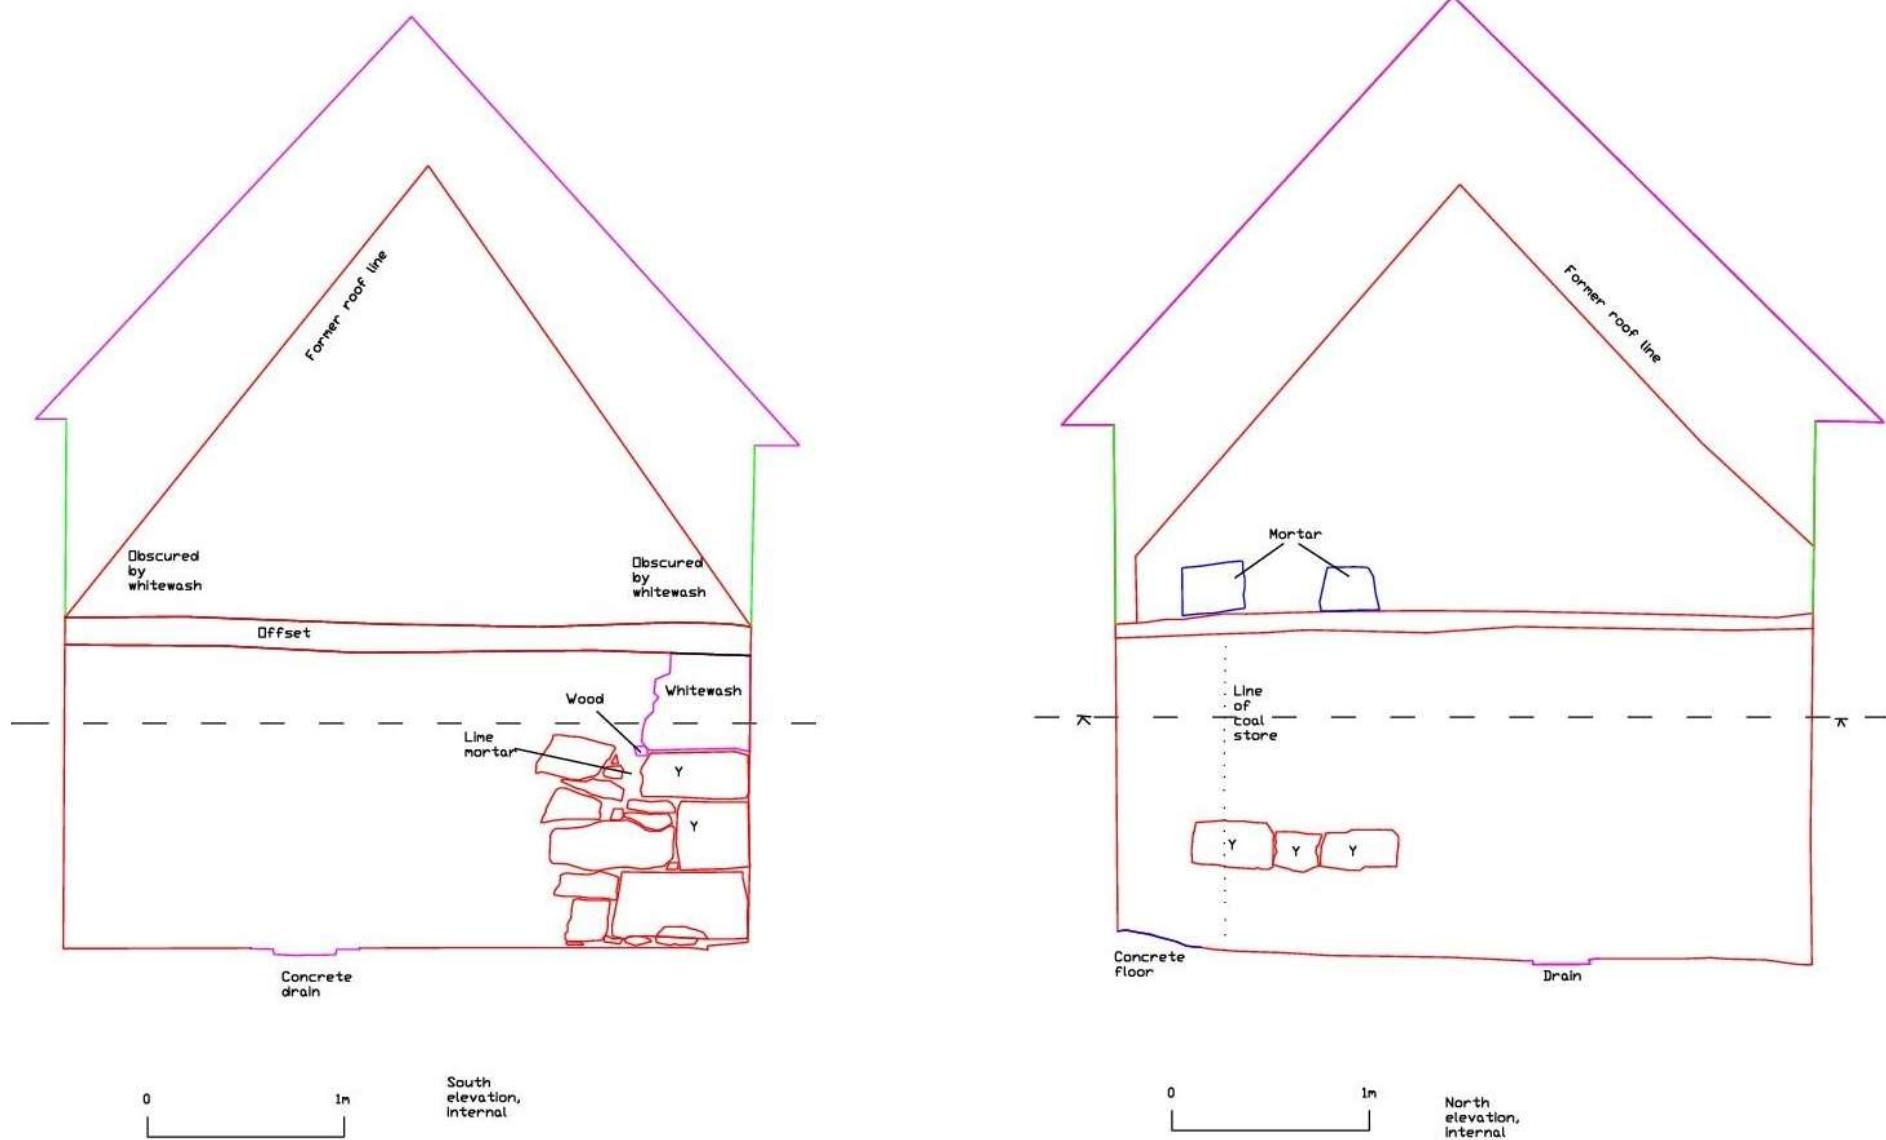
Figure 41 South and north internal elevations
