6 Argyle Street, Dornoch

Building Recording and Archaeological Evaluation

Report

Site Number	AN4
OS Grid Reference	NH 8003 8965
Author	Pete Higgins
Date Produced	13 August 2010
Date revised	4 September 2010

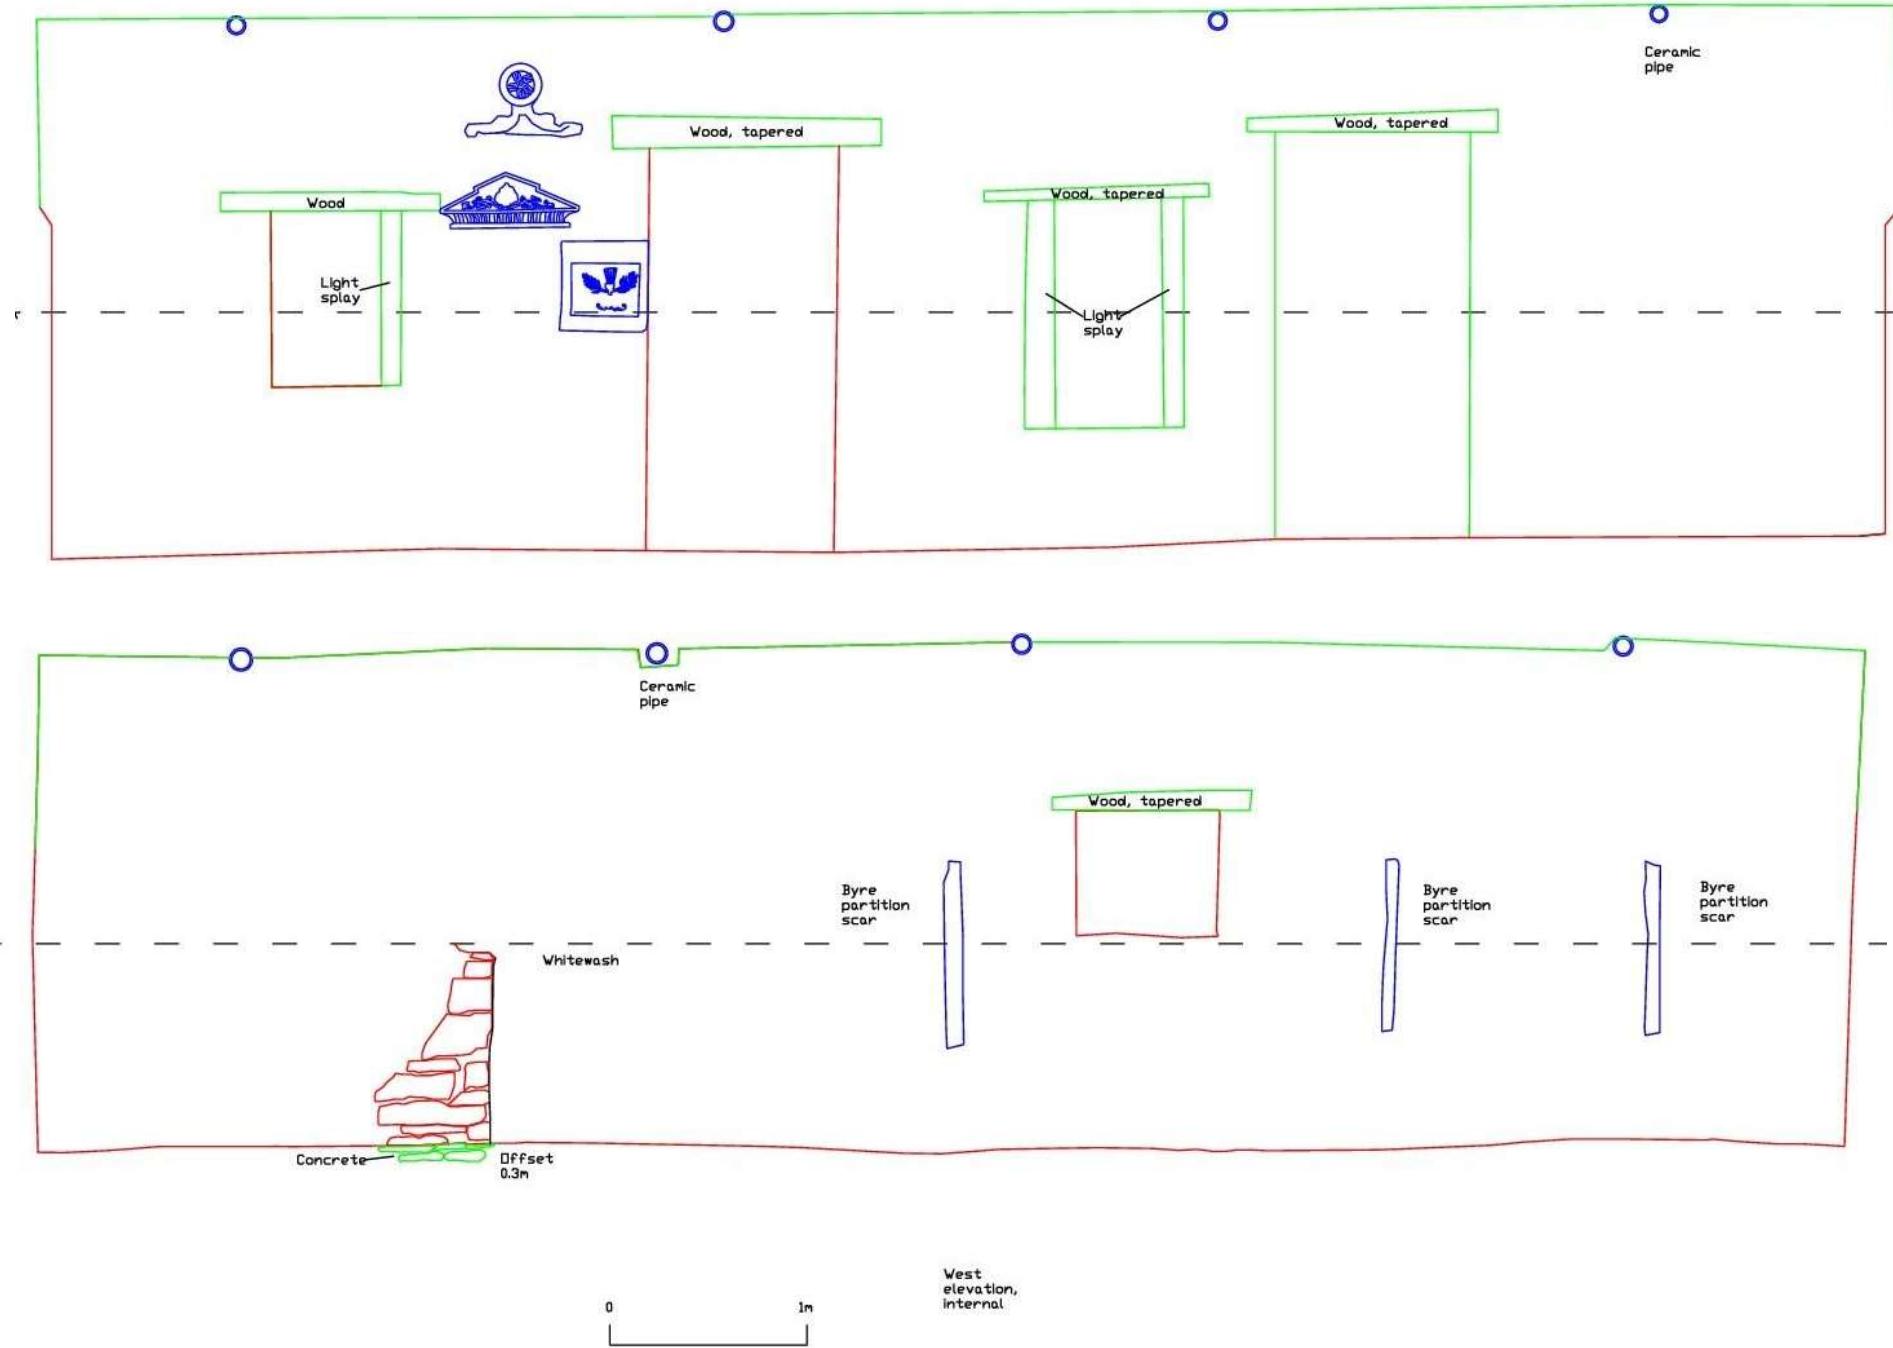
Figure 22 East and west internal elevations
