# Plot 2, East Birchwood, Migdale

## Archaeological Watching Brief

### Report

Site Number	AN2
OS Grid Reference	NH63207 91960
Author	Pete Higgins with a contribution by Anne Johnston
Date Produced	19/10/10
Date revised

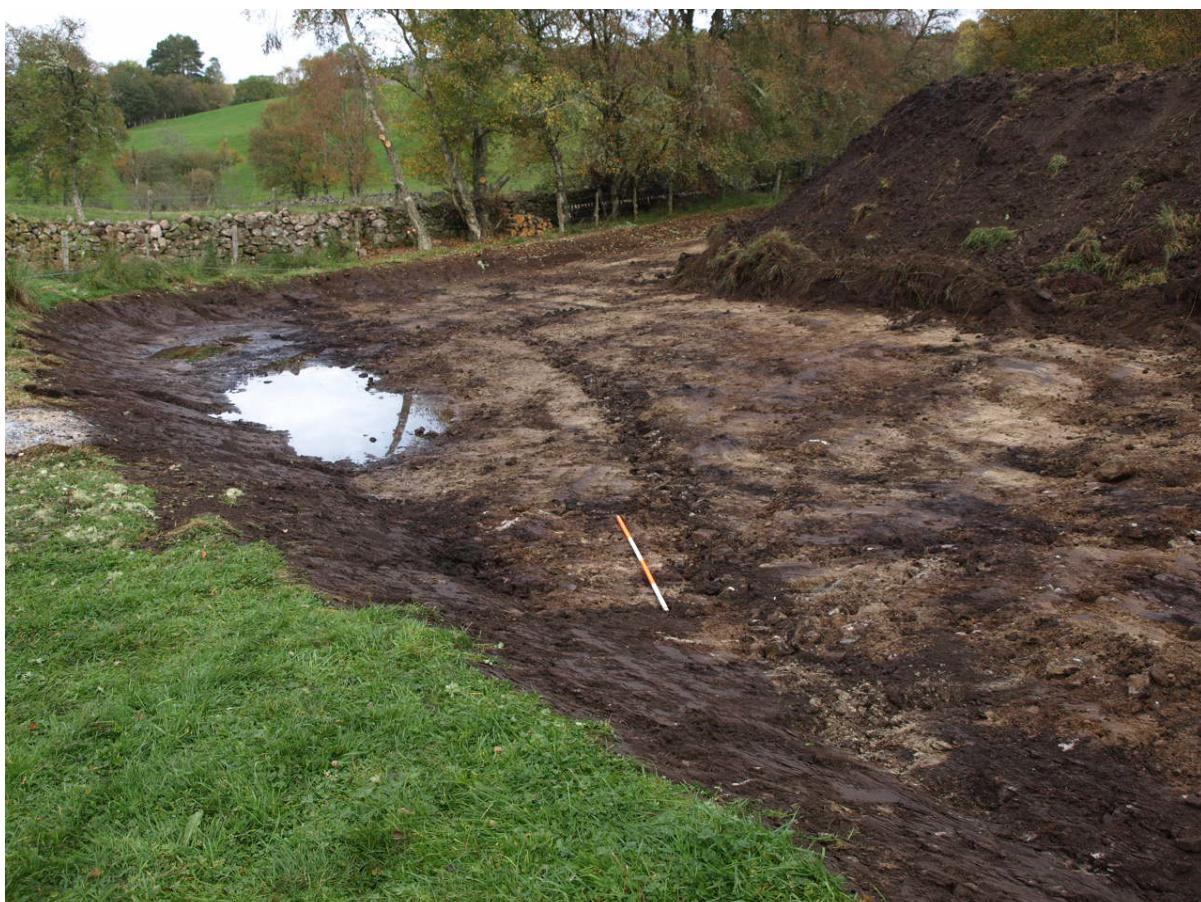
Photograph shows the French drain in the north of the site

6.2.5. A French drain, **07**, was found in the centre of the site, running along the eastern side of the marshy area, see cover photograph and figure 4. It was filled with stones, **08**, and presumably acted as both interceptor and dispensor, taking the runoff from the slope to the east and diverting it to the north. At the southern end of this curved drain three smaller, similar drains formed a small herring bone pattern, possibly part of a larger pattern concealed beneath the baulk.

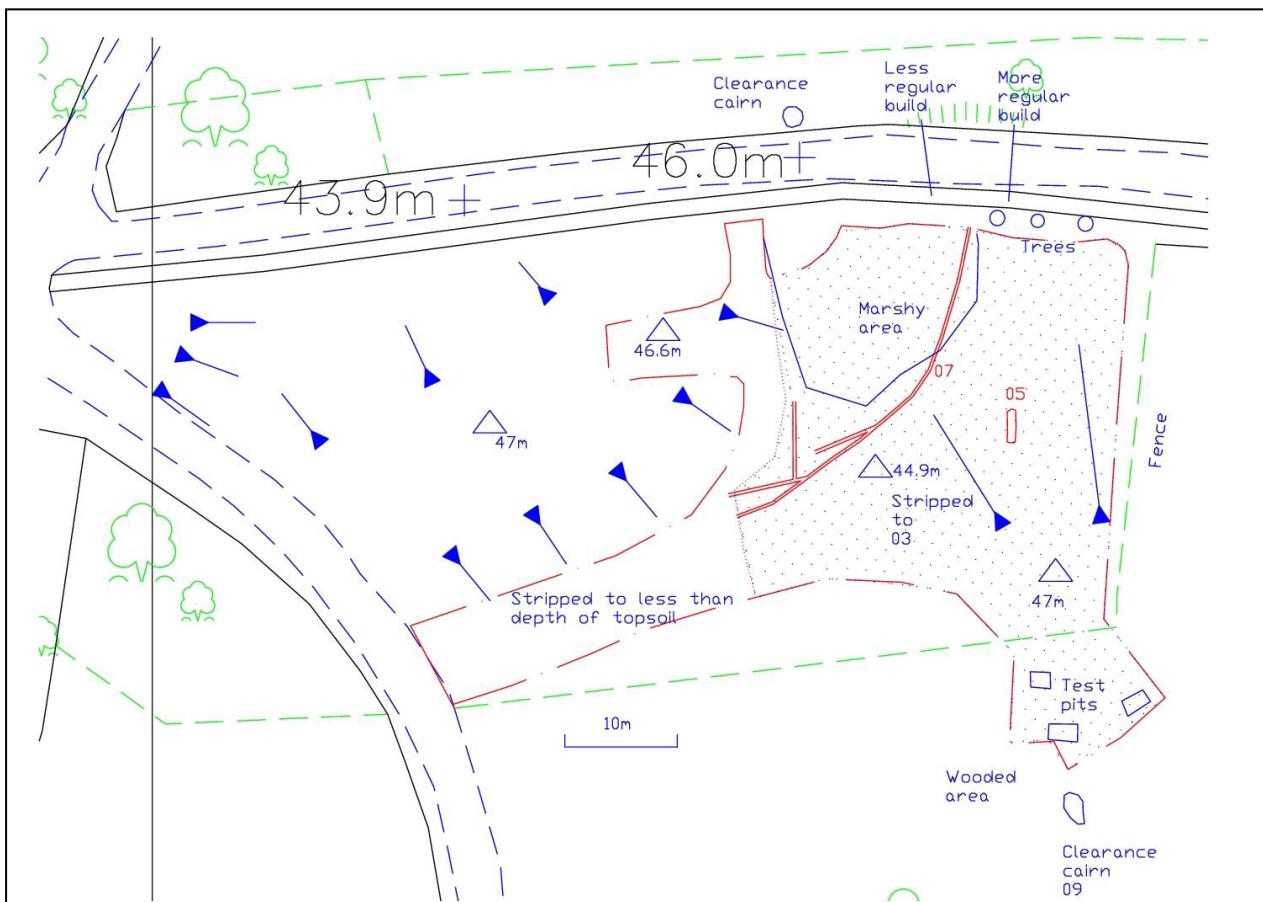
Figure 4 Plan of site, showing archaeological and other features.

Note the hachures denote slope before stripping, although the underlying natural deposits generally conformed to the same degree and direction of slope. For explanation of other annotations, see text.

Table 1 lists the contexts recorded, together with their descriptions and interpretations. Their position is plotted on figure 4. The lowest point of the site lies at 45.4m aOD, rising to 47m aOD at the top of the two high points, see figure 4.

6.2.6. Two small cairns were noted in and around the site, see figure 4. The stones were mostly small (50 - 200mm), although larger stones up to 350mm were present in cairn 09. These are probably clearance cairns, albeit very small ones.

- 7.3. The French drain, **07**, is located across a slope just above the marshy area, see figure 4, and appears to be an attempt to reduce waterlogging. The fact that the drain was still functioning, even in a dry spell, suggests both that it had been at least partly effective and that it was much needed. It branched towards the southern part of the stripped area, and it is probable that the branches formed part of a wider pattern. It is worthy of note that the drain fell towards the north, carrying the drained water to a confluence with channels gathering water to feed the nearby mill pond. Many similar small channels do the same, demonstrating the wide effect the construction of the mill had on the neighbouring landscape.

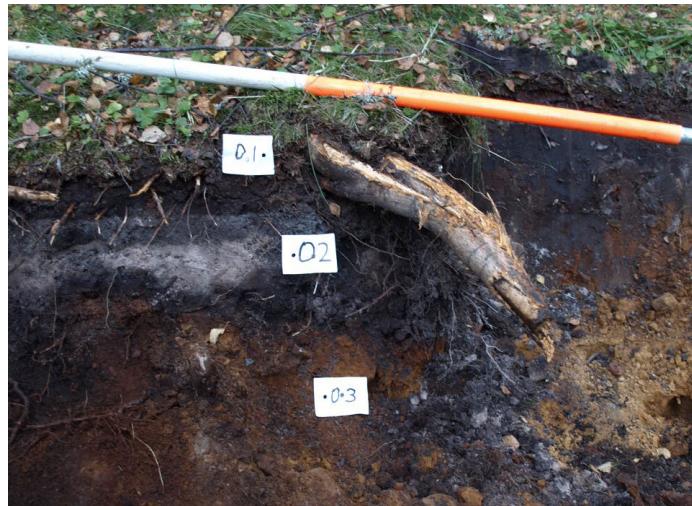
6.2.1. The topsoil in the wooded area in the southeast corner of the site, **01**, appears to be a forest soil in process of formation, with a large A horizon of leaf litter from the deciduous woodland. It lies directly above a well-developed podzol, **02**.

Figure 5 North-facing section through woodland area soils.

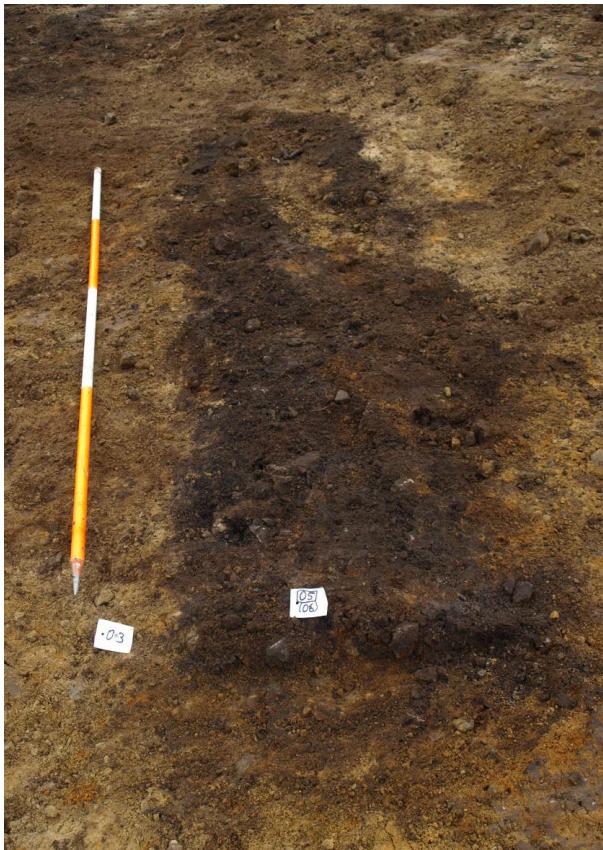
6.2.4. A rectilinear feature, **05**, with its long axis more or less northwest/southeast, was found lying along the contours of the west-facing slope in the east of the site. It was very shallow, and had probably been truncated by ploughing. The southern terminus was present but the northern end appeared truncated; the bottom of the feature was stained darker than the

surrounding soils. The fill, **06**, was siltier than, but otherwise similar to, **04**. The function of this feature is not known, although it was noted that it was oriented almost directly with a change in build of the northern boundary dyke.

Figure 6 Feature **05**, looking north

- 7.4. Where the projected line of the drain **07** met the northern dyke there appeared to be a change in build of the dyke, with a stretch of some four metres being of a less regular construction than the majority, suggesting a repair. Feature **05** was also oriented with its long axis aligned with this point (though the stripped area did not extend far enough to reveal any conjunction with either **05** or **07**). It is probable that part of the dyke was demolished to allow construction of the drain, which therefore postdates the dyke. Taking into consideration the post and wire boundaries, and assuming the dyke dates from late 18<sup>th</sup> and early 19<sup>th</sup> century improvements by the landowner, Sir George Dempster, see the Documentary background, above, then it seems likely that the grassed enclosure and drain are of a later date, possibly carved out of a wooded enclosure. The grassed enclosure appears on the 1874 map.

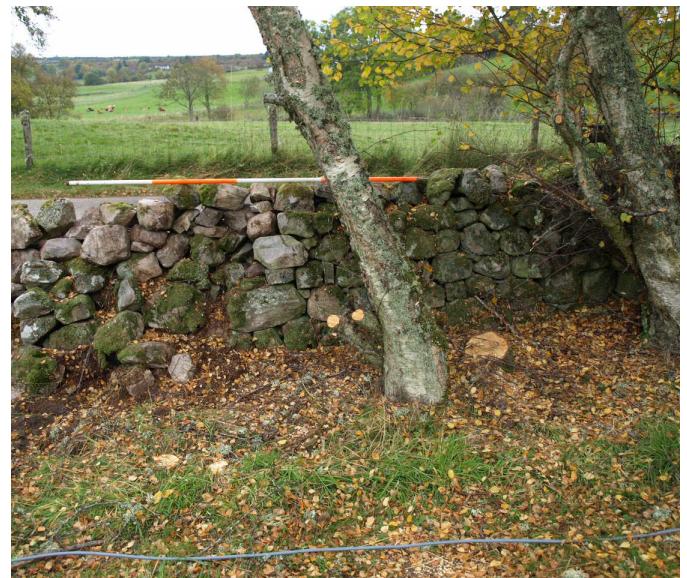
Figure 7 Change in build in northern boundary dyke

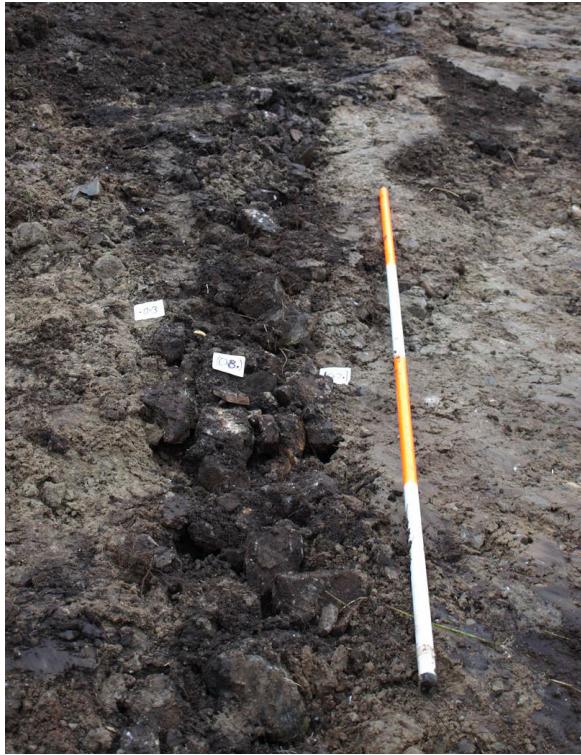
Figure 8 French drain, 07

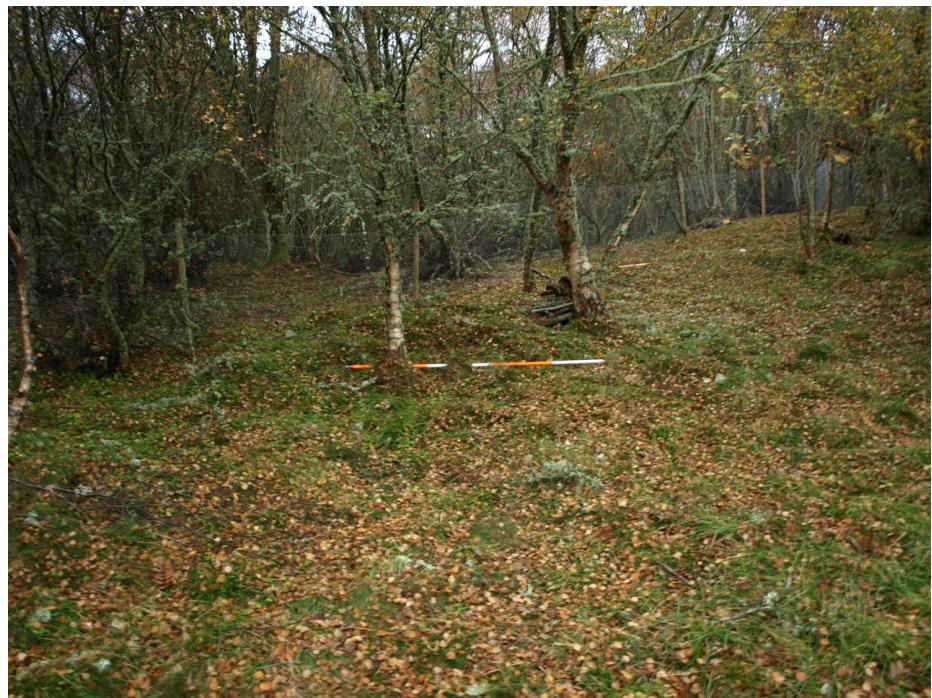
Figure 8 Clearance cairn 09, in wooded area.

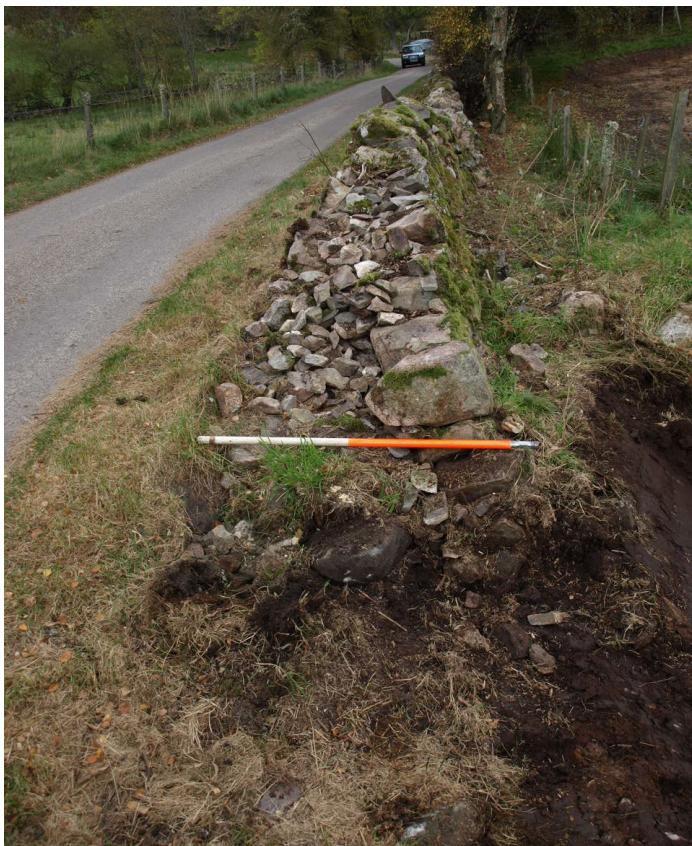
6.3. The dyke along the north of the site had earlier been pierced to allow a new access, so the opportunity was taken to photograph its construction, see figure 9. It extends to the east, outwith the area of the site and is of similar construction to many in the area, all thought to date from the late 18<sup>th</sup> and early 19<sup>th</sup> centuries.

Figure 9 West facing section through northern boundary dyke

- 7.2. It is likely that the northern boundary wall, which continues along the western boundary, dates from the period of improvements made by Sir George Dempster in the late 18<sup>th</sup> and early 19<sup>th</sup> centuries. It was noted that the other boundaries were marked only by post and wire fence and it is possible that the dyke predates the formation of the enclosure.

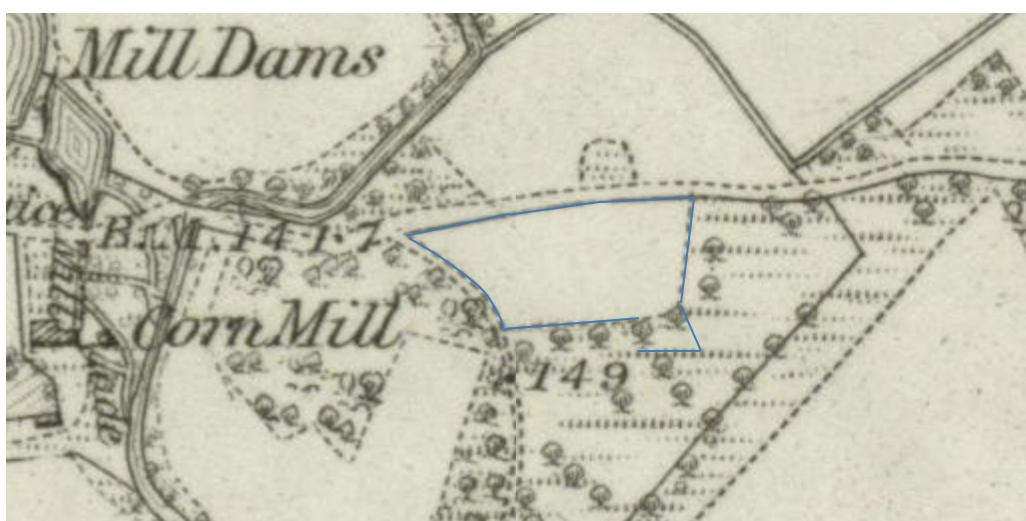
Figure 10 The site located on the 1874 OS 1<sup>st</sup> edition map

- 7.1. The podzol, **02**, was found intact only below the developing woodland topsoil in the wooded area, and had been destroyed, presumably by ploughing, over most of the rest of the site. Its absence coincides with the area marked as enclosed on the 1874 map, and demonstrates the transition from heathland to pasture caused by the improvement of the land by enclosure and draining.
