## **ARCHAEOLOGICAL TRIAL TRENCHING AT KEDLESTON HALL SAW MILL, DERBYSHIRE**

*EVALUATION REPORT*

Report Number 2011/45    July 2011

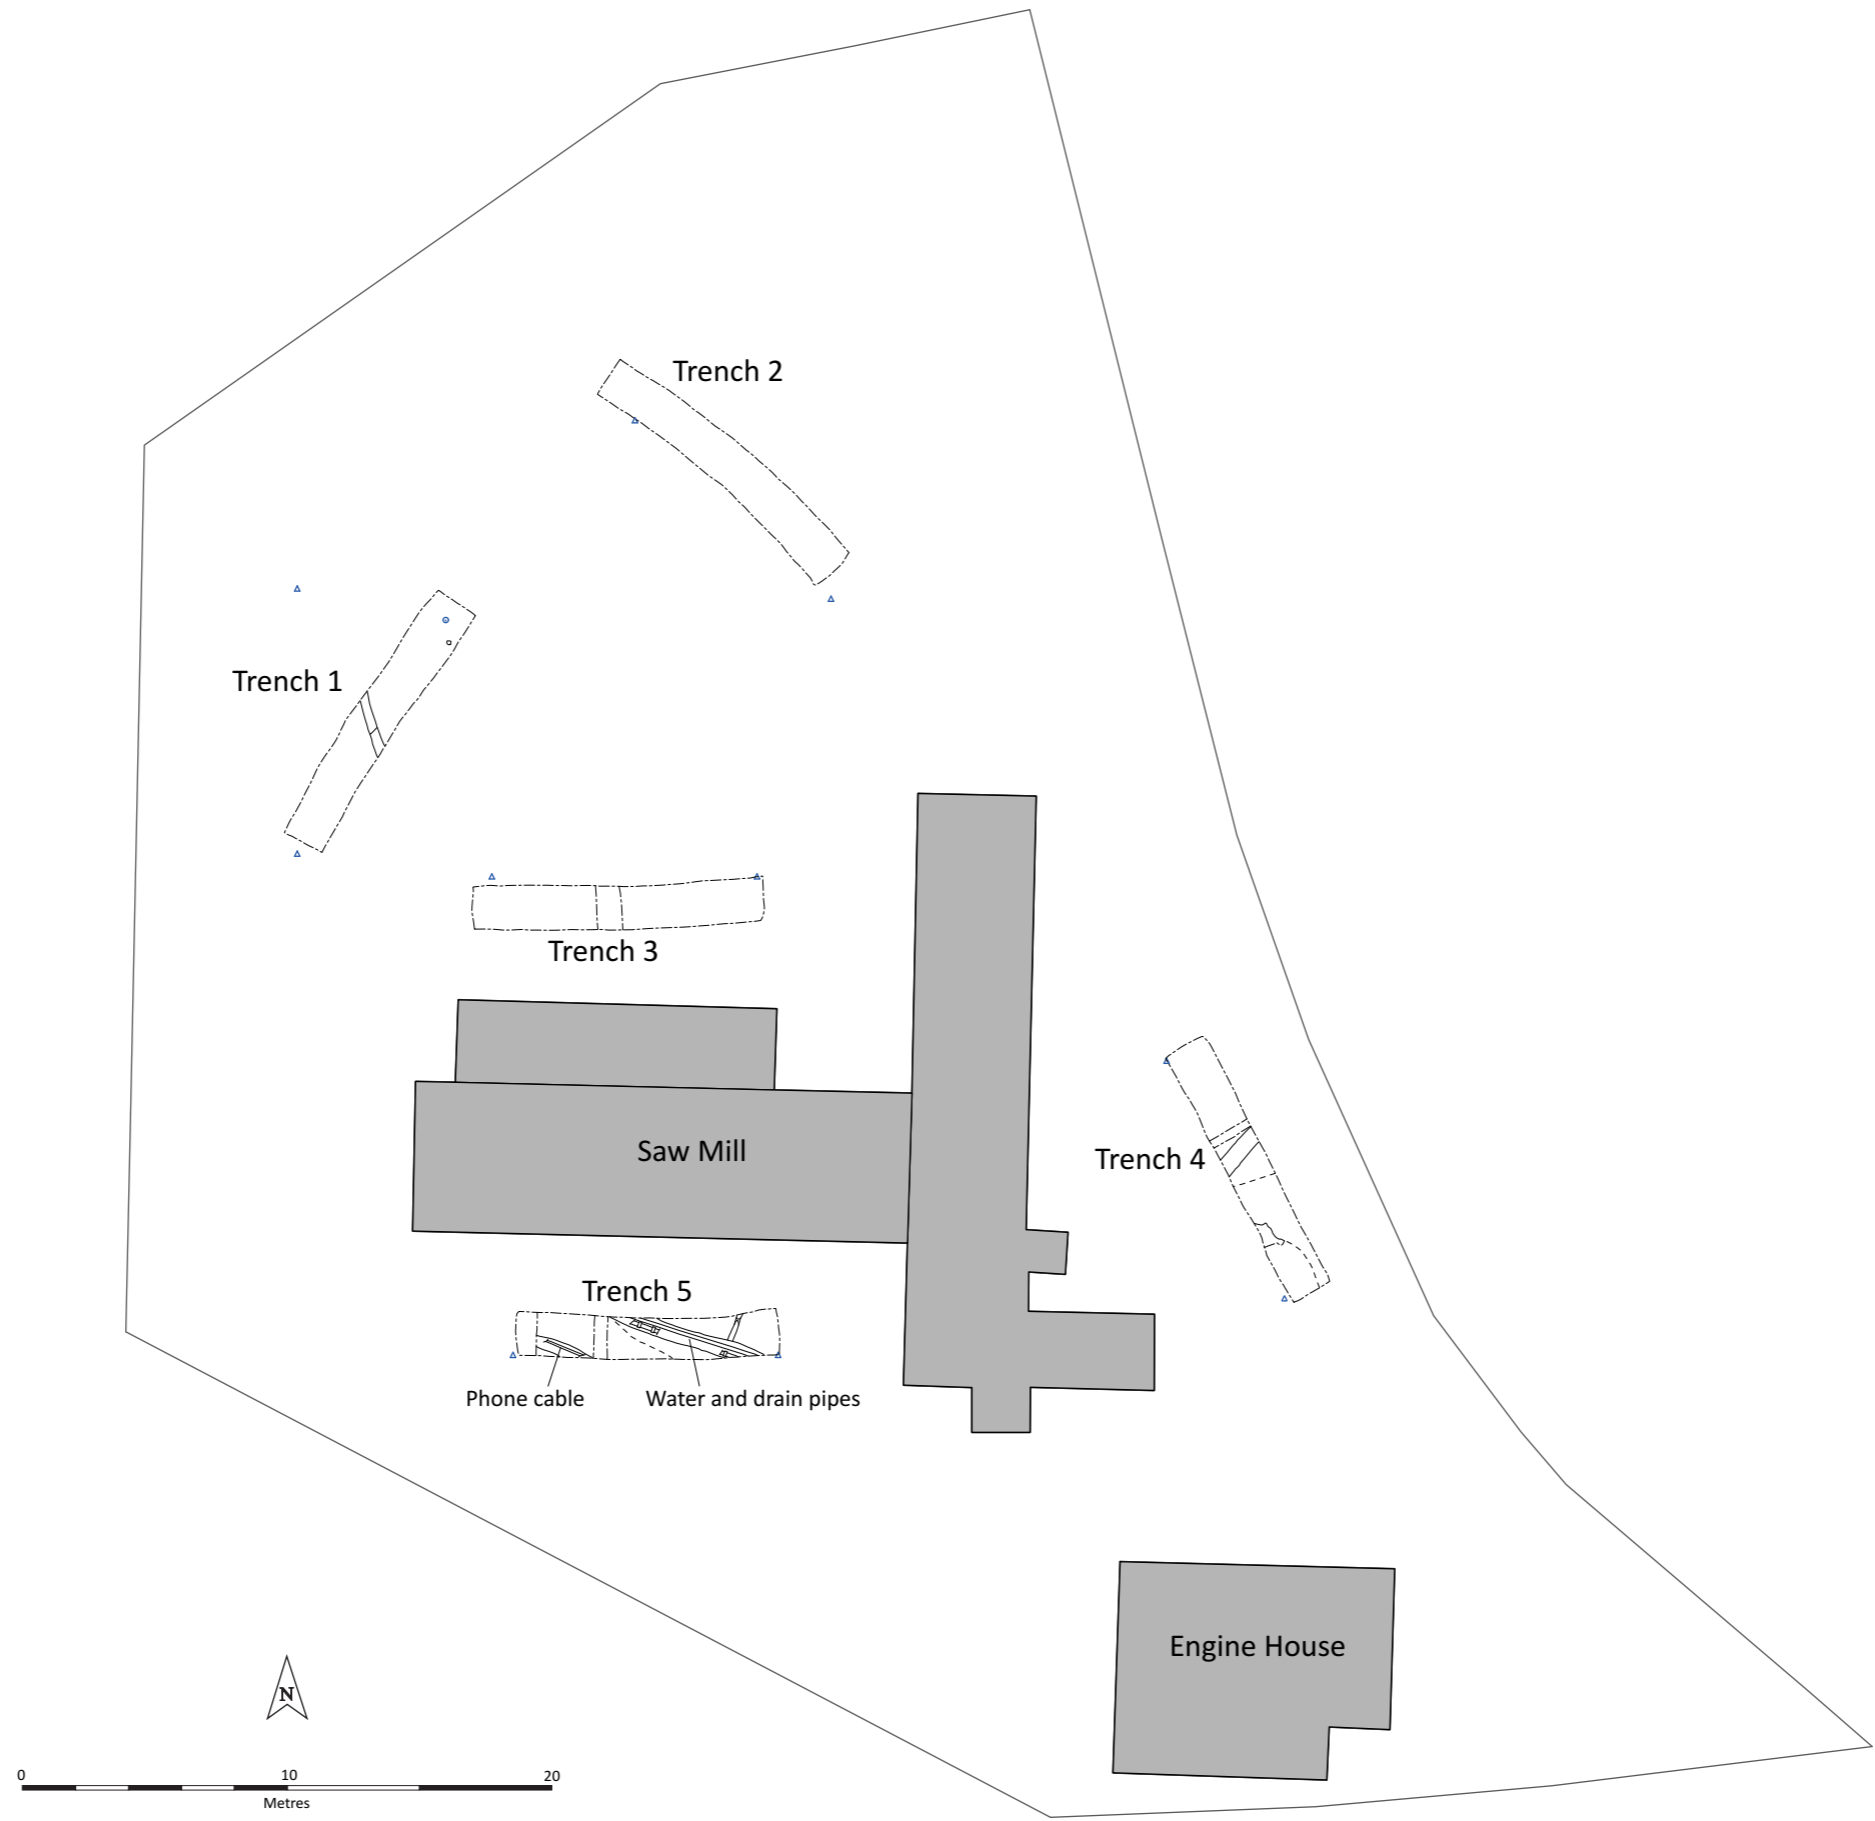
Trench 1 plan

In the central area of the trench was a linear cut feature, 105 (Plate 1). This was cut from just below the hardcore yard surface, and had very straight sides, 30cm wide (Plate 2). It crossed the trench on a northwest-southeast alignment. It was excavated to a depth of 54cm, where a compacted clay layer was reached. No pipe or cable was found in the trench, but it appeared to be characteristic of a relatively modern service trench. The fill, 106, comprised a mid-brown/orange mixture of clay and pebbly sand, with occasional inclusions of brick and wood fragments.

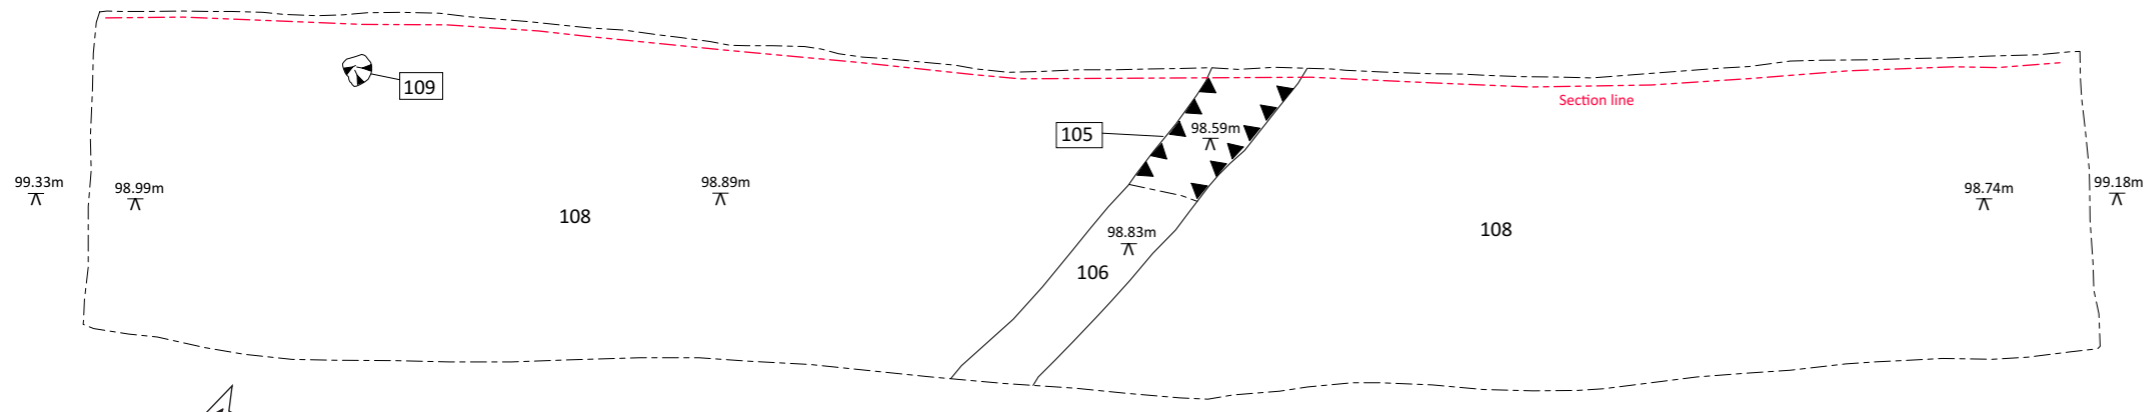
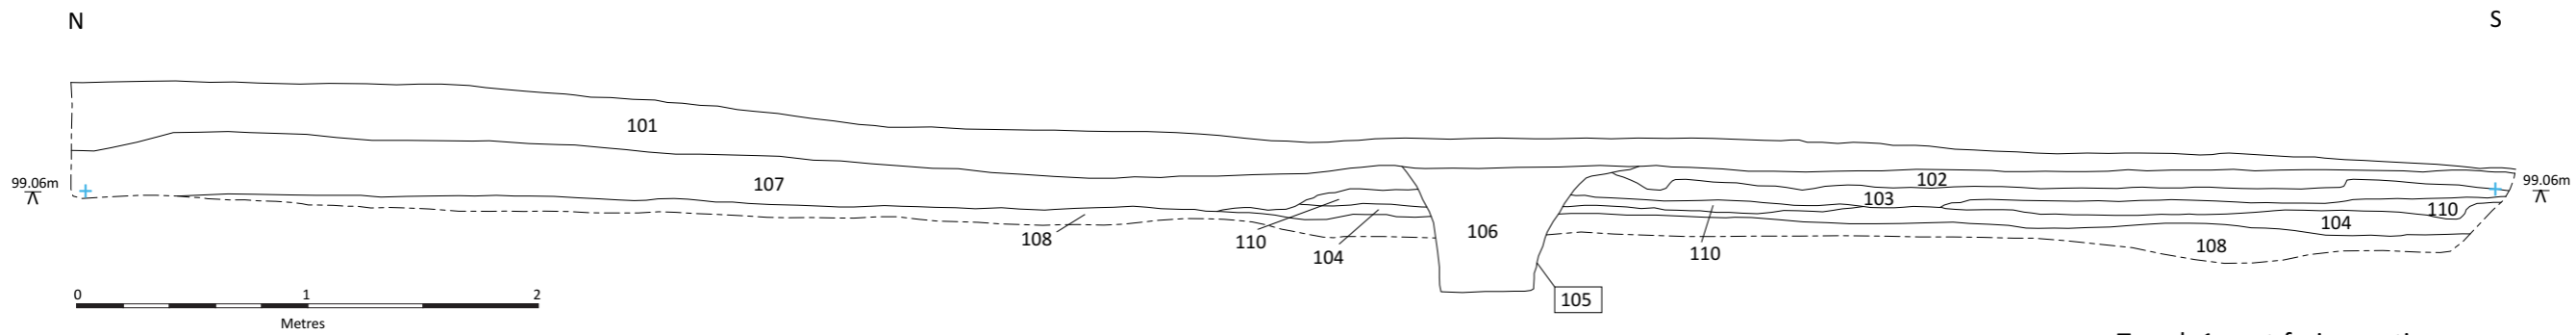
Trench 1 was located along the western boundary of the yard, to the north of the Saw Mill building. The trench was excavated at an angle to the proposed location, due to the presence of scrap material and trees along the edge of the site. The trench was aligned northeast-southwest. The plan and section of Trench 1 are shown in Figure 5.

Trench 1 west-facing section

The upper layer of the trench comprised a grey-brown pebbly hardcore layer (101), 7-14cm thick, which formed the surface of the yard (Plate 3). The underlying deposits were different at

the north and south ends of the trench. Towards the south end of the trench, the hardcore overlay a pale sandy levelling layer, 102, which was 10cm deep (Plate 4). This was underlain by a dark brown silty soil deposit, 103, 5-8cm thick, which appeared to be related to root action or a remnant topsoil layer. This was only visible in the south end of the trench. Below this was a yellow sandy silt layer, 110, which was not continuous but survived in several fragments, up to 8cm thick, and may have been a redeposited natural subsoil. Below 110 was a firm, dark brown pebbly deposit in a sandy-silt matrix, 104, with occasional red brick fragments and relatively small pieces of a vitreous slag that is probably waste material from a blast furnace. The layer was 6-10cm deep. No ceramics or other cultural material were noted in this deposit, which appears to be a levelling layer. The presence of brick and blast furnace slag suggests that the levelling material was brought in from elsewhere in the region, and is probably associated with the creation of the yard and construction of the Saw Mill in the mid-19<sup>th</sup> century. Layer 104 overlay a firm, orange-brown silty clay, 108, which was interpreted as the natural subsoil.

At the northern end of the trench, the hardcore 101 directly overlay a thick made ground deposit, 107, between 10 and 25cm deep. This deposit comprised a black-brown gritty silt with a high rubble content, and was very compacted (Plate 3). The rubble included a high proportion of vitrified slag, sandstone, red and yellow bricks, and cinder/coke. No ceramics were observed. As with that in 104, the slag appeared to be blast furnace waste, and the bricks, many of which were relatively narrow and probably hand-made, may also have been related to industrial structures. The brick and slag fragments were larger than those in deposit 104, up to 20cm in size. It appears likely that the material was imported to the site for use as a levelling layer to form an even yard surface. Blast furnace slag was commonly used as hardcore (Bayley et al 2008, 13). The deposit was directly overlying the natural subsoil 108.

Towards the north end of the trench was a small circular feature, 109, c.10cm in diameter. It was cut into the natural and underlay 107. On excavation, this feature appeared to be an animal burrow, as it proceeded downwards at an angle of c.45 degrees and was relatively uneven. The fill appeared to be a mixture of redeposited natural and material from 107. It was excavated to a depth of 12cm (Plate 3).

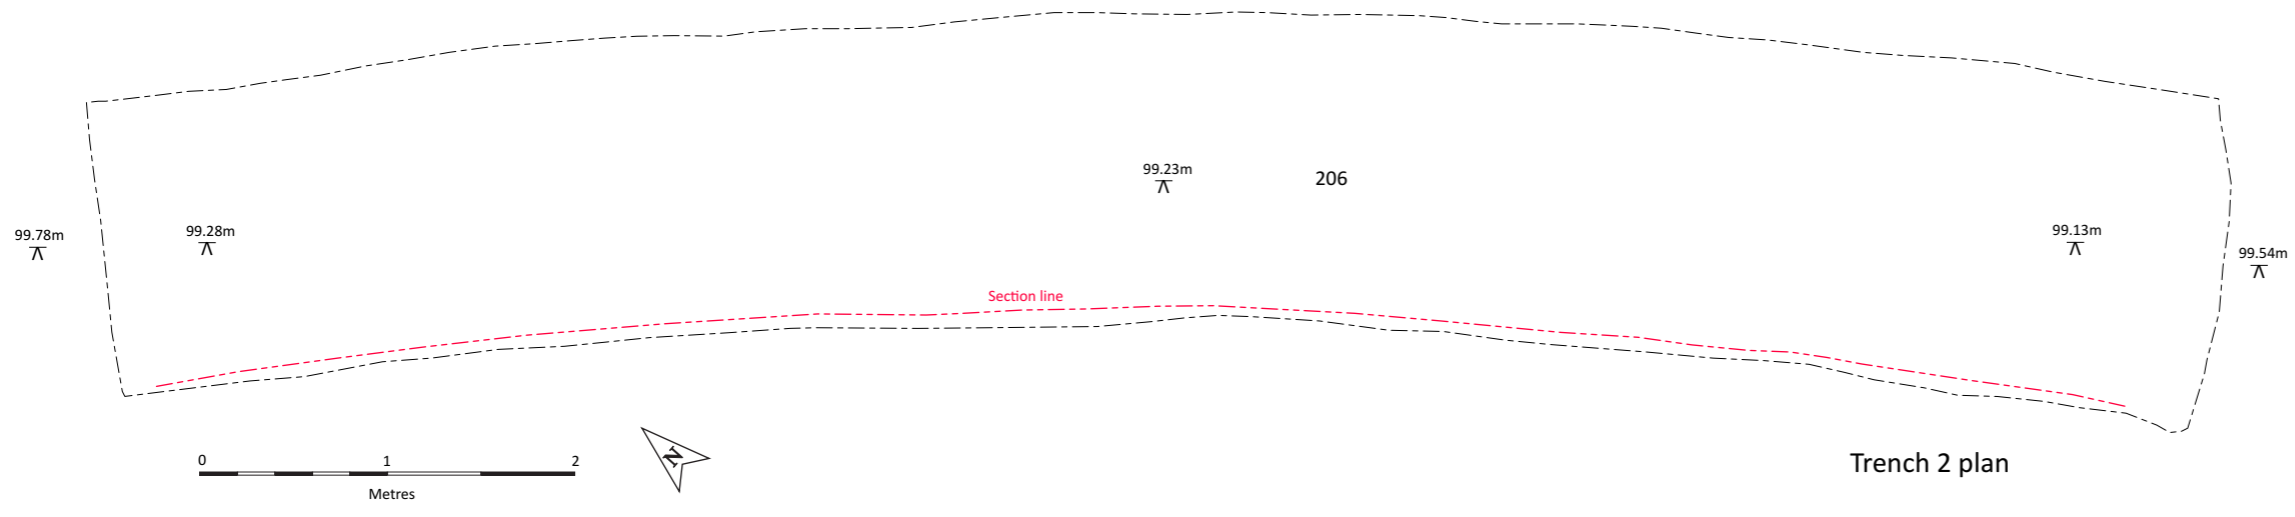
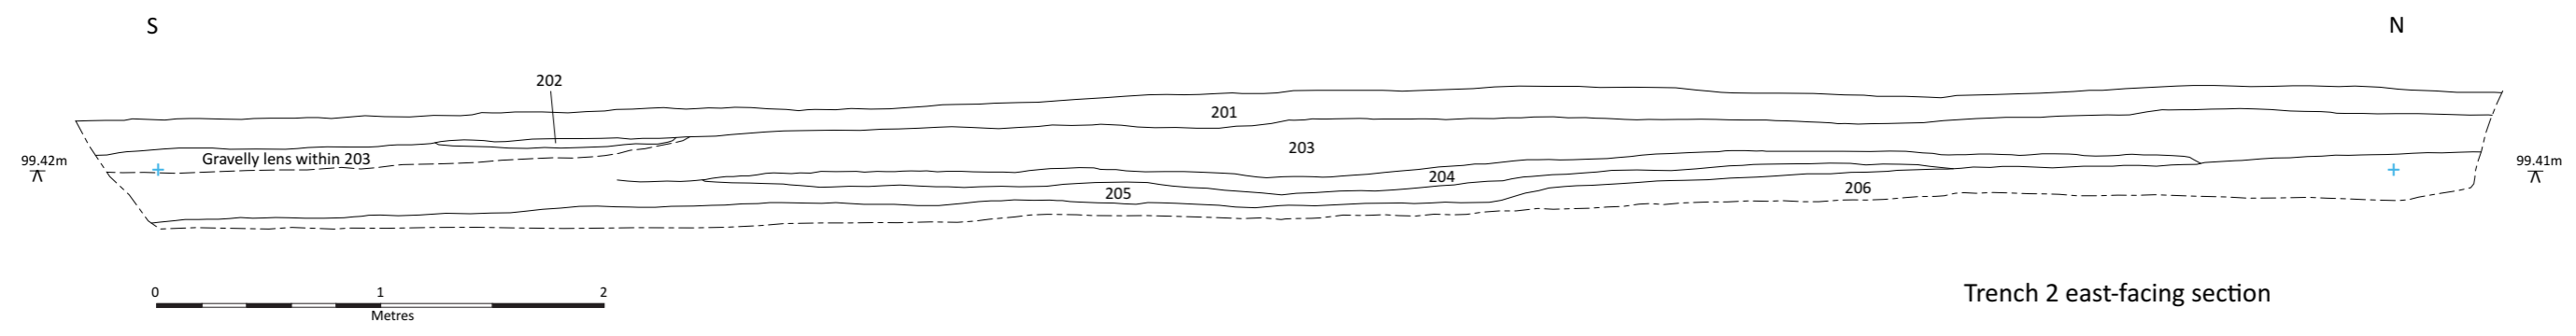
Trench 2 plan

Trench 2 was located at the north side of the yard, to the north of the Saw Mill, and was aligned northwest-southeast. The trench was moved c.1m to the northwest of the proposed location to facilitate access to a rubbish skip. The plan and section are shown in Figure 5.

Trench 2 east-facing section

As with Trench 1, the upper layer consisted of a grey-brown pebbly hardcore, 201, 18-20cm thick, forming the yard surface (Plate 6). This overlay a compact, dark blackish gritty sand layer, 203, up to 20cm thick with a high rubble content. The rubble included slag, bricks (whole

and fragmentary), slate and sandstone, suggesting that it had been imported to the site for use as a levelling deposit. There was a lens of more pebbly material at the south end of the trench, which was counted as being part of 203. A fragmentary pale sandy deposit (202) was visible in a small spread towards the south end, up to 5cm deep, lying between 201 and 203. This was interpreted as a bedding layer for the hardcore, and was analogous to 102. Underlying the rubble deposit 203 was a compact layer of reddish brick rubble in a sandy matrix (204). The brick was mainly fragmentary, up to 6cm in size, and there were also mortar fragments. This layer was up to 8cm thick, and was not visible for the full length of the trench, but divided 203 and 205 in the central area. It may represent a lens within a single levelling episode (with 203 and 205), and disappeared towards the north end of the trench, where the natural subsoil was higher (Plate 7). Deposit 205 was a compact dark black rubble layer in a gritty sand matrix, c.10cm thick, similar to 203 and indistinguishable at the south end of the trench where the intervening layer 204 was not present. Inclusions comprised frequent brick fragments, including whole bricks, shards of clear window glass and slag. This again appeared to be a made ground deposit imported to the site for levelling the yard surface. It was not present at the north end of the trench. Layer 205 directly overlay the natural orange-brown silty clay subsoil, 206, with layers 204 and 203 overlying 206 at the north end of the trench. No cut features were found within the trench (Plate 5).

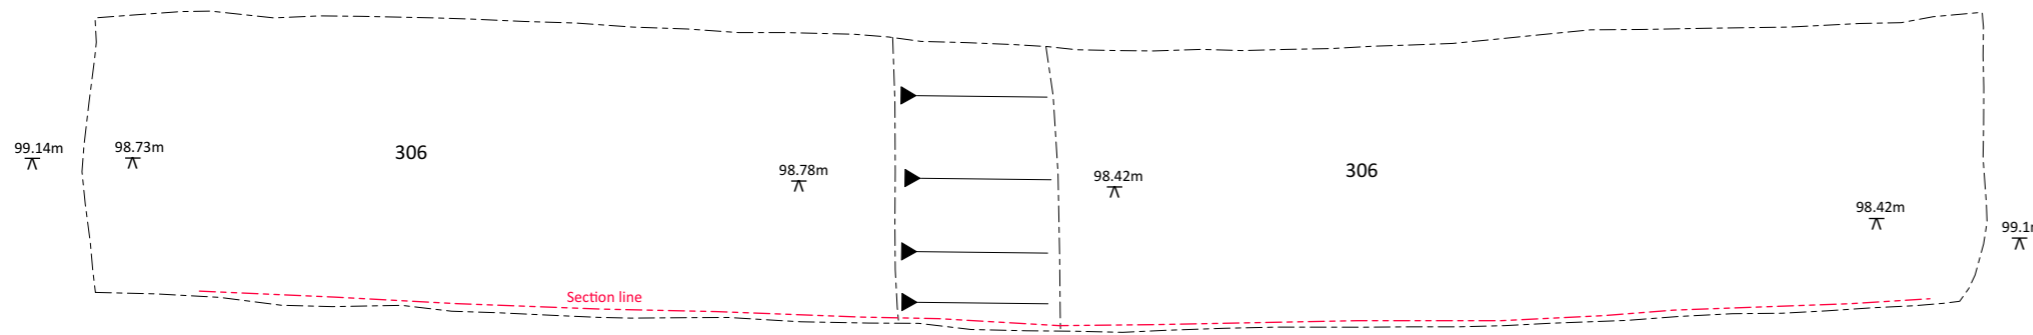
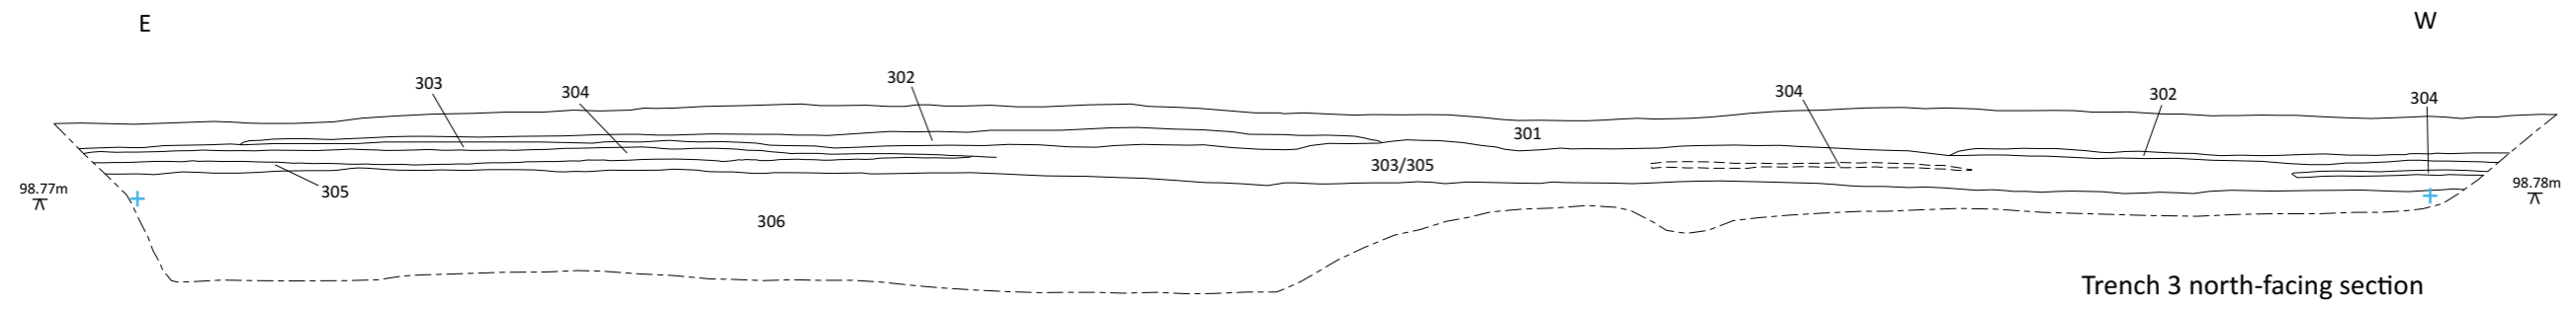
Trench 3 plan

Trench 3 was located to the north of and parallel with the main Saw Mill building, within the yard area. It was aligned east-west. The trench was excavated 1m to the south of the proposed location to enable vehicular access to the yard during the fieldwork. The plan and section of Trench 3 are shown in Figure 6.

Trench 3 north-facing section

The upper layer of the trench comprised the grey-brown pebbly hardcore yard surface, 301, 12-15cm thick in this area. This overlay a pale gritty sand deposit, 302, 8cm thick, interpreted as a bedding layer for the hardcore. It was analogous to 102 and 202, and was present across most of the trench, with some gaps. Underlying 301 and 302 were a series of levelling layers, 303-305. Upper deposit 303 comprised a thin layer of black gritty sand, with frequent clinker and occasional small brick fragments and gravel inclusions. This layer was 3cm thick, and merged with the lower black gritty layer 305 across much of the trench (Plate 9). The two were divided in some areas by a yellow-brown gravelly layer, 304, 2-8cm thick, which survived in several lenses across the trench, the main concentration being at the east end (Plate 10). The fragmentary nature of this layer suggests the three made ground layers may all have been deposited as a single levelling phase. The lower layer 305 was between 4 and 18cm thick and contained frequent brick fragments, including whole bricks and fragments less than 1cm in size, clinker, and occasional ceramic. Three ceramic sherds in a hard white fabric with white glaze were recovered, probably 19<sup>th</sup>- to early 20<sup>th</sup>-century Whiteware. Deposit 305 overlay firm orange-brown silty clay 306. This was excavated to a maximum depth of 0.54m, with no disturbance noted, and was concluded to be the natural subsoil, analogous to 108 and 206.

The levelling deposits in Trench 3 were less compacted and had a lower rubble content than the lower layers in Trenches 1 and 2. The blast furnace slag was not noted in the rubble in Trench 3, suggesting that a number of deposits from different sources were used in the levelling of the yard. No cut features were noted within the trench (Plate 8).

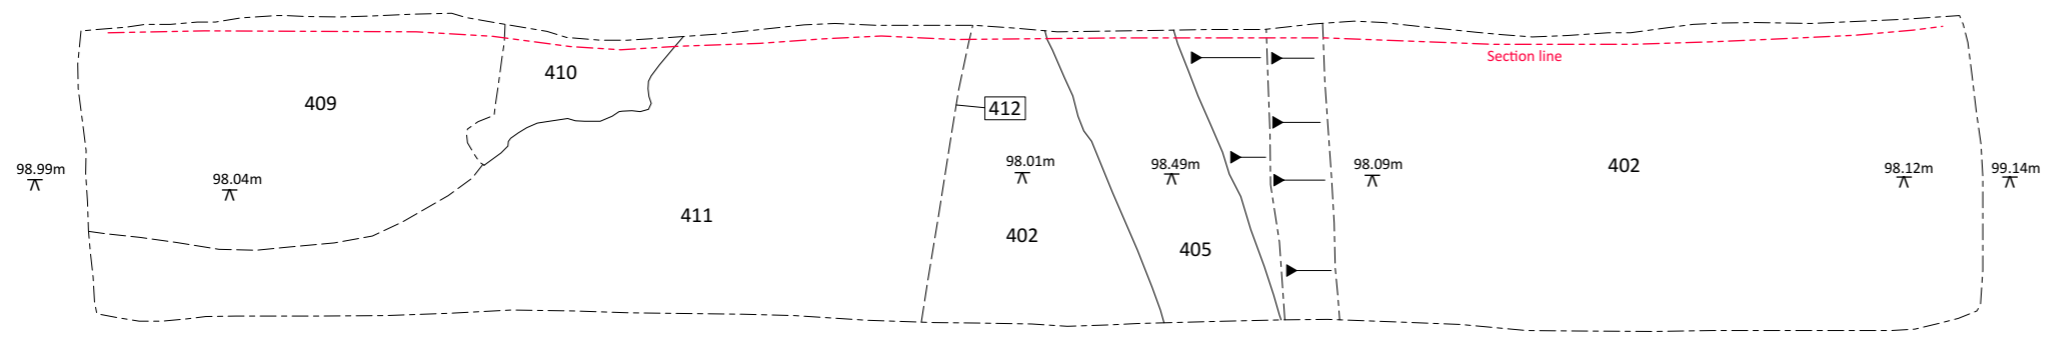
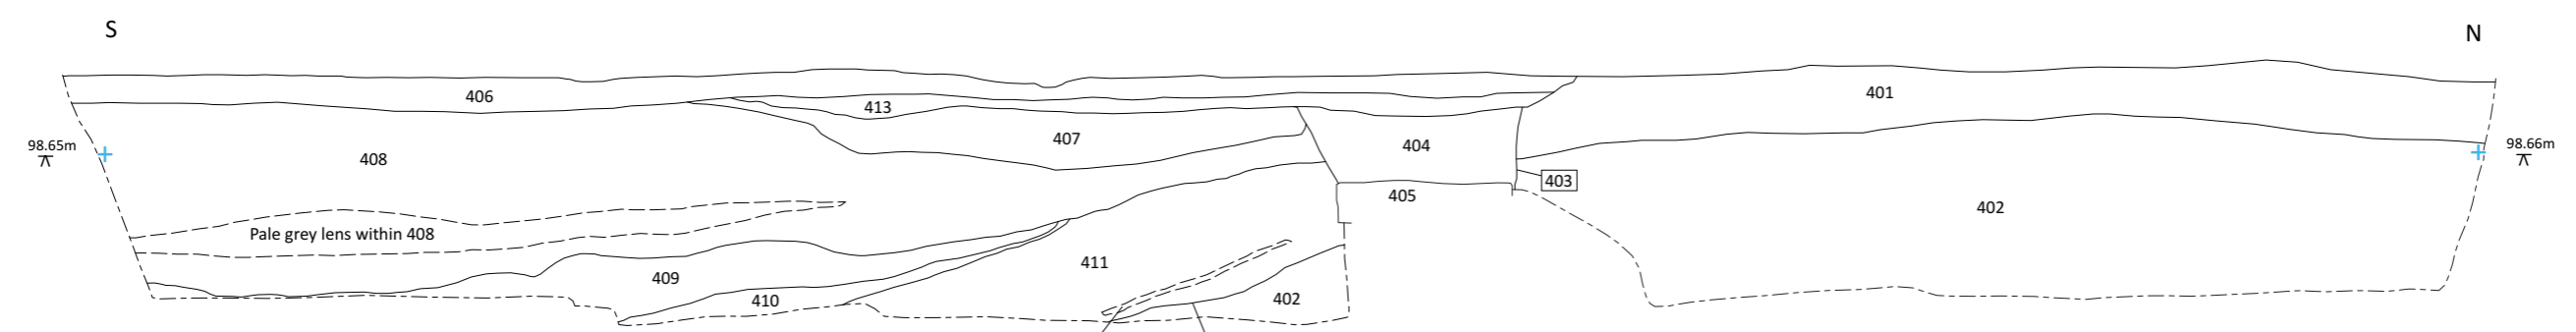
Trench 4 plan

Trench 4 was located to the east of the Saw Mill buildings, in an area of predominantly waste ground which had been used as a track. The trench was aligned northwest-southeast. The plan and section are shown in Figure 6.

Trench 4 east-facing section

The deposits within this trench were noticeably different at the north and south ends. At the north end, the upper layer comprised a mid-brown silty topsoil with some clay (401), up to 25cm thick. Fragments of broken-up tarmac were found within this layer, and there was a thin pebbly deposit at the interface with the natural subsoil. The topsoil 401 directly overlay the natural silty-clay subsoil, 402 (Plate 14).

At the south end of the trench the upper layer consisted of a pale hardcore layer (406). As with 401, some lumps of broken tarmac had been dumped on and within the hardcore. In the central part of the trench 406 overlay a thin layer of crushed limestone, 413, probably a bedding deposit for the hardcore. 413 and 406 overlay a series of deposits at the south end of the trench which appeared to be infilling a large cut feature, 412. This feature occupied slightly over half of the width of the trench. The cut was visible in the west and south sections (Plates 11 and 12). In the west section, it sloped at a shallow angle downwards from north to south. In the south section a steeper, convex slope was visible, terminating before the east side of the trench. The base of the cut was not reached within the trench, and further excavation was not undertaken due to the depth of the trench. It was not visible in the eastern section.

The upper fill of the feature comprised an orange-brown silty clay, 407, which appeared to represent redeposited natural subsoil. This was present over the northern side of the feature. 407 overlay a series of gritty dark grey to black dump layers, forming thin beds dipping towards the south, where the combined deposits were 0.75m wide. The deposits were given a single context number, 408, and overlay a second layer of redeposited natural, 409, up to 25cm thick. Below 409 was a back ashy grit deposit, 410, from 2cm to 10cm in thickness, the base of which was not reached in the southern end of the trench. 410 overlay another layer of redeposited natural subsoil, 411, up to 30cm thick. There was a lens of yellow-brown sandy clay near the base of this layer, not given a separate context number (Plate 13). Layer 411 appeared to be the basal layer within cut 412, overlying an orange-brown silty-clay which appeared to be natural subsoil 402, though only a small patch of this was seen.

In the centre of the trench was a modern linear cut, 403, crossing the trench at a diagonal angle aligned approximately northeast-southwest. This cut held a concrete beam, 405, c.70cm wide and 20cm deep, which may have been cast *in situ* (Plate 11). The concrete beam was at a depth of 0.46m below the ground surface. Cut 403 appeared to cut the topsoil 401 and natural 402 to the north and the fills of 412 to the south (Plate 13). The fill of cut 403 was a mixture of topsoil and redeposited clay derived from the surrounding natural, 404, with occasional rounded pebble inclusions that was observed above 405. 405 was overlain by hardcore 401 and the bedding layer 413. The purpose of the concrete beam was unclear; it may have covered a service pipe, or have been associated with an earlier foundation.

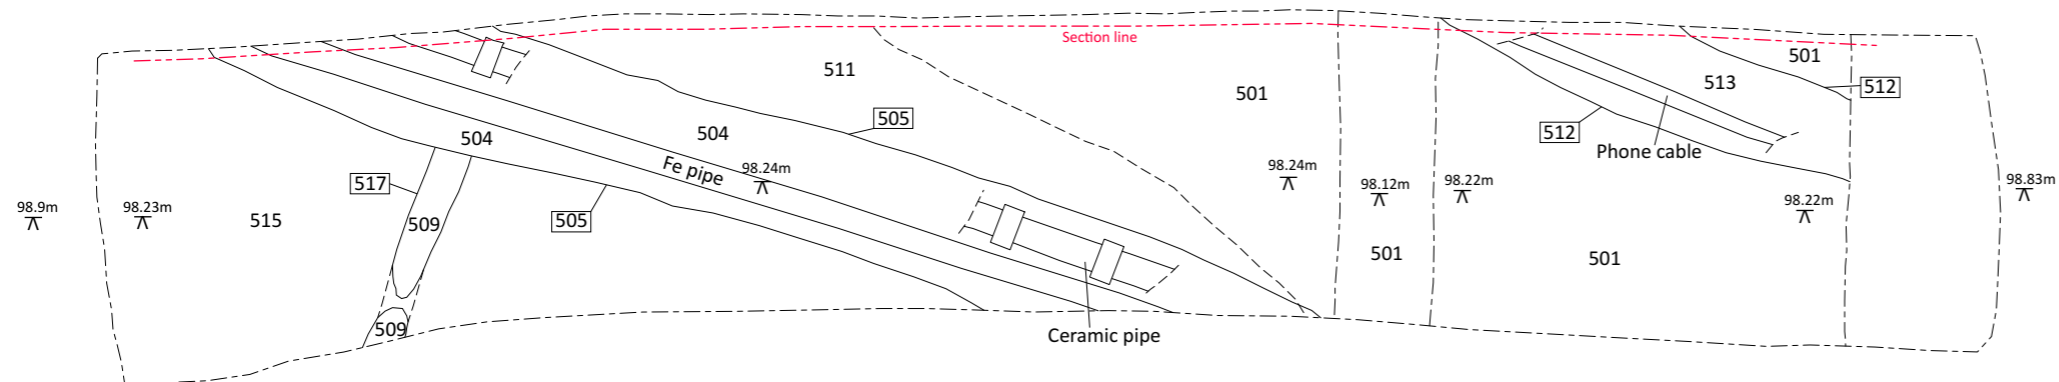
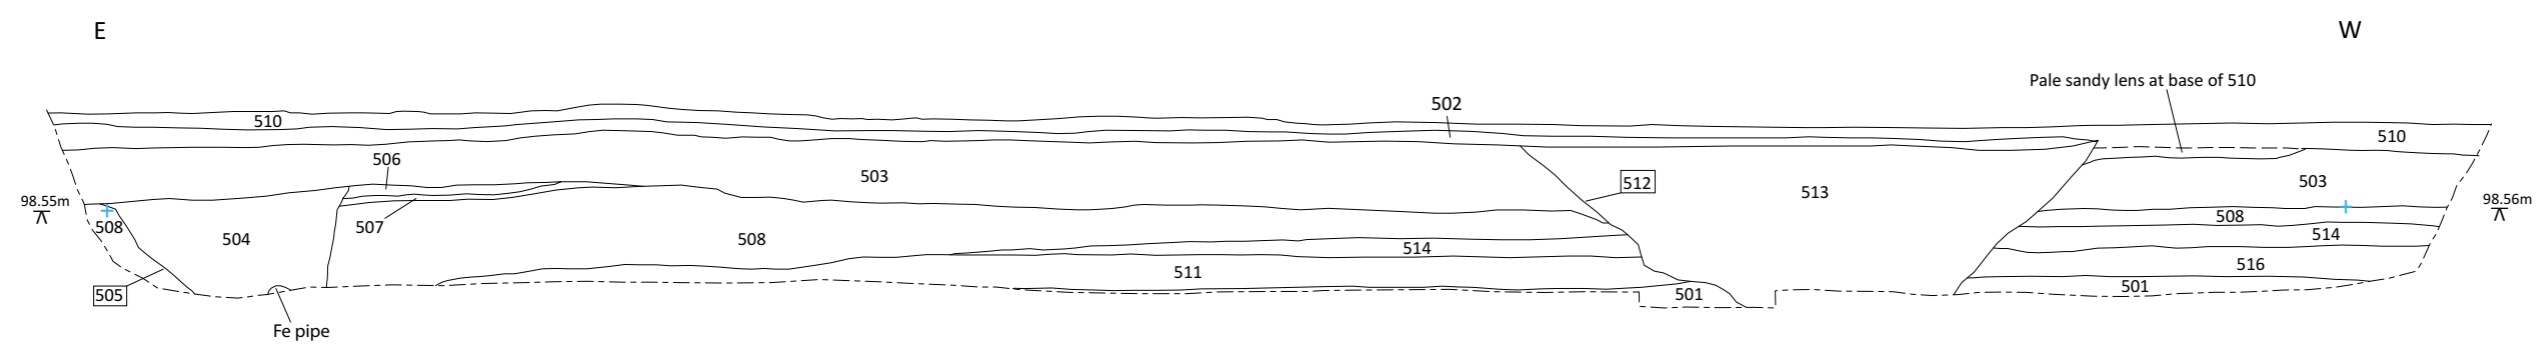
Trench 5 plan

depth of 0.80m due to the presence of services (Plate 15). The plan and section are shown in Figure 7.

Trench 5 north-facing section

The upper layer of the trench comprised a gravelly hardcore deposit, 510, forming the surface of the southern yard. This layer varied in depth between 5 and 10cm. For most of the trench, it overlay a thin layer of reddish angular gravel fragments, 502, possibly a former yard surface (Plate 16). This overlay a levelling deposit of a black-brown ashy grit, 503, up to 25cm thick. Below this was an orange-brown silty clay layer, with inclusions of rounded pebbles and brick fragments, 508, which varied in depth between 6 and 30cm. In the central and western part of the trench this overlay a thin layer of orange-brown silty clay, 514, probably representing redeposited natural, with dark grey silty clay layer 511 below. Layer 511 may have been a disturbed upper part of underlying grey silty clay 501, which contained frequent fragments of sawn wood and wood chips, interpreted as waste from the Saw Mill. The layer contained one handle sherd of brown-glazed earthenware of 18<sup>th</sup>- to mid-19<sup>th</sup>-century date.

In the eastern end of the trench was a linear cut, 505, which held a metal water pipe and ceramic drain pipe, running parallel in a northwest-southeast alignment. The fill of the cut, 504, was blackish-brown silty sand with pebbles and brick fragments in a series of lenses (Plate 16). It underlay levelling layer 503. To the immediate west of the cut were two narrow lenses lying between 503 and 508. The upper lens, 506, comprised red-brown sand containing small brick fragments, and overlay dark brown sandy clay 507. It was unclear if these related to the backfilling of the cut, but they were not visible elsewhere in the trench. To the northeast of the cut, at the base of the trench, was a deposit of brown clay, 515, with occasional patches of reddish staining. This deposit was cut by 505. To the north of the cut was a further shallow linear feature, 517, aligned northeast-southwest. It was unclear if this was cut by the pipe trench 505, connected with it, or cut it. The shallow feature had a rounded base, and was approximately 0.3m wide. No service pipes or cables were found within the feature, though it appeared likely to have been a service trench. It was filled by a mixed gritty black-brown deposit, 509, with rubble inclusions.

At the western end of the trench was a further cut, 512, containing a telephone cable in plastic ducting (Plate 17). The cut and cable were on a northwest-southeast alignment. The fill, 513, comprised a black/brown mixture of grit and silty soils, with fragments of brick and stone rubble. The cut and fill underlay the hardcore 510 and possible surface 502, and cut through all of the levelling deposits at the west end of the trench. To the west of cut 512 was a layer of yellow-brown sandy gravel, 516, which lay between deposits 514 and 501. This was only seen at this end of the trench. The rounded gravel inclusions varied in size between 2 and 10cm. This was interpreted as another levelling layer.

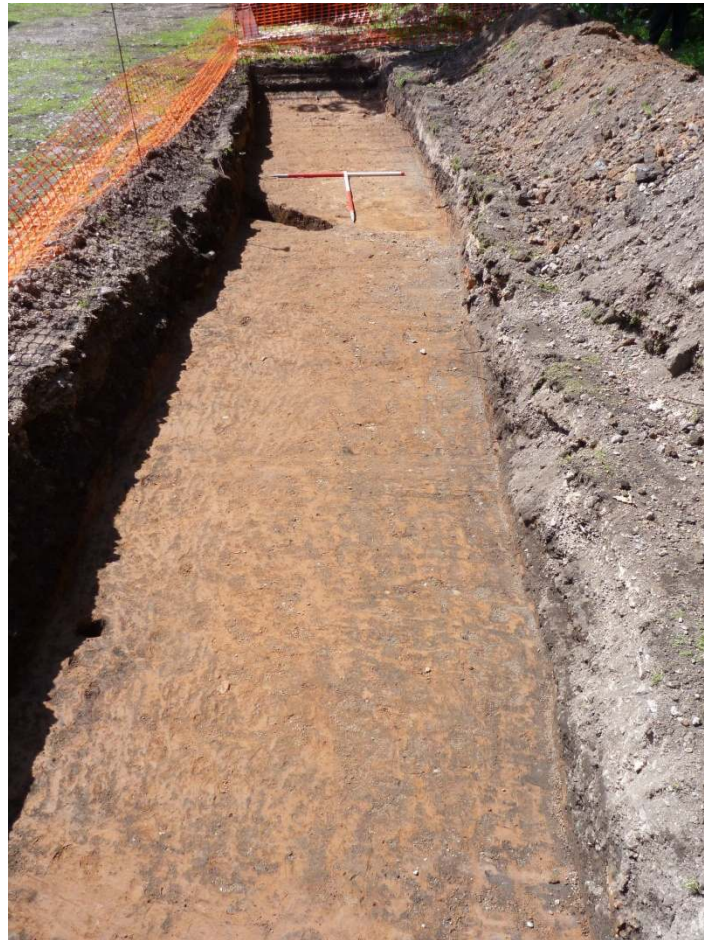
Plate 1: Plan view of Trench 1, facing southwest

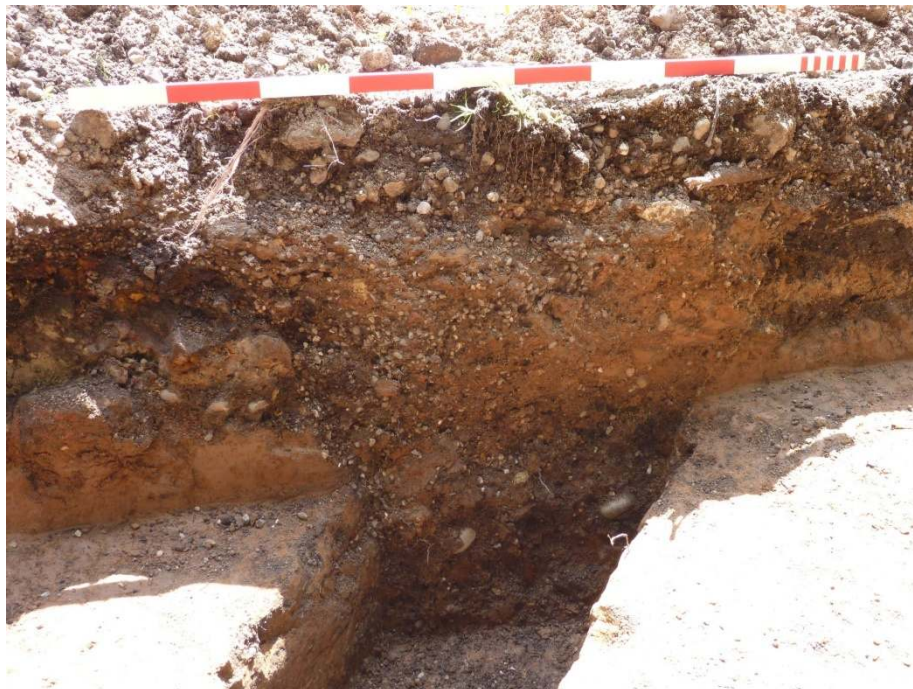
Plate 2: Detail of Trench 1 section showing cut 105, viewed facing southeast

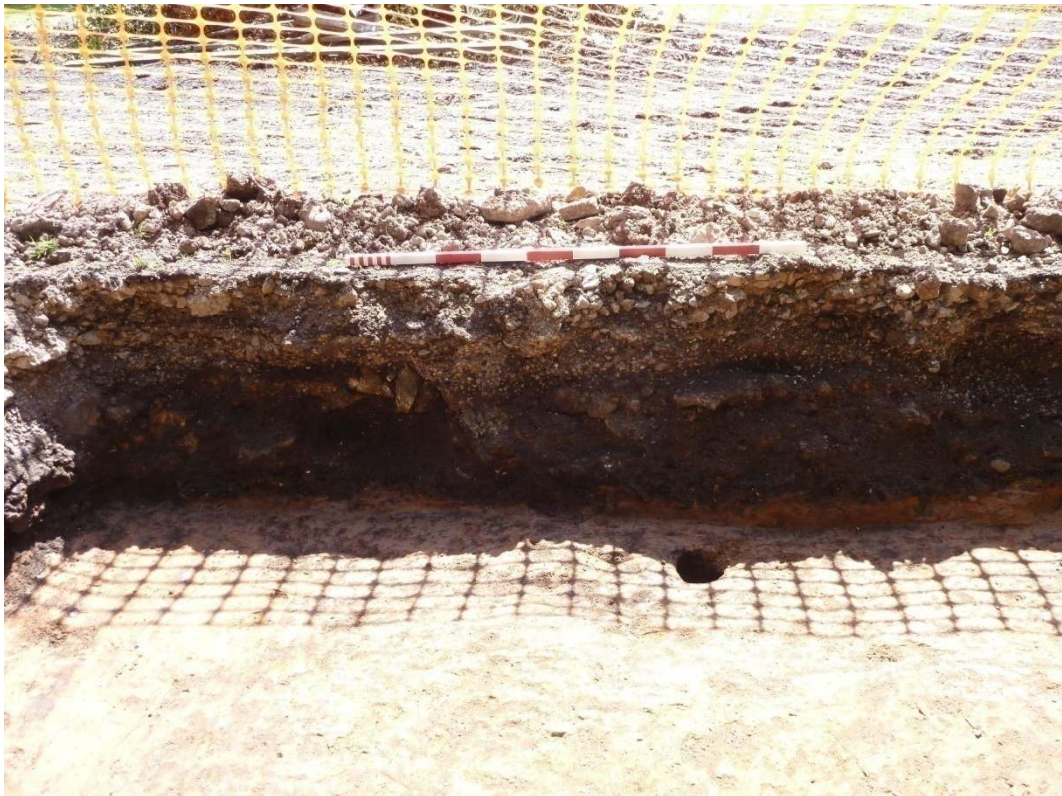
**Plate 3: Section of Trench 1, north end, showing made ground layers, viewed facing southeast**

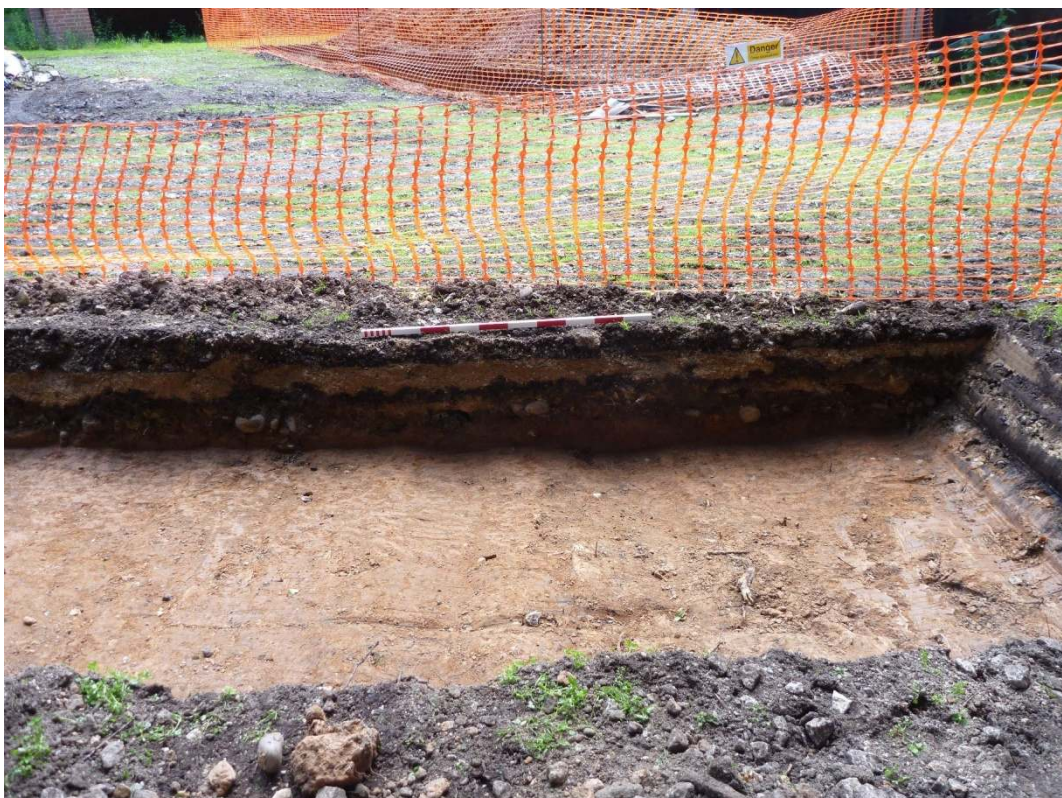
**Plate 4: Section of Trench 1, south end, viewed facing southeast**

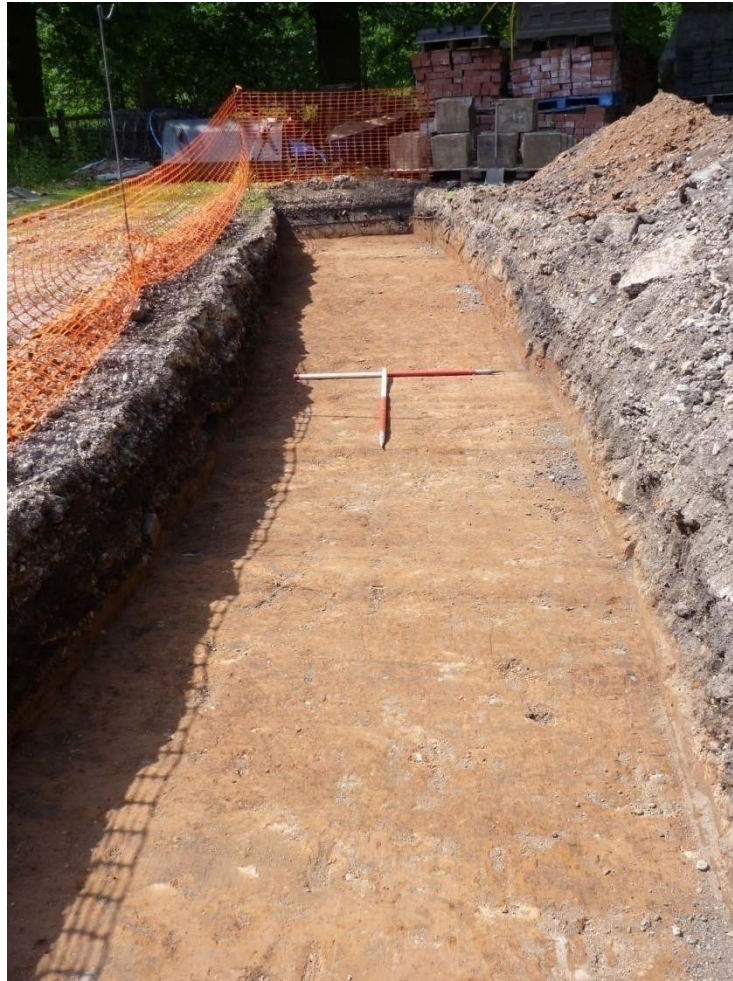
**Plate 5: Plan view of Trench 2, viewed facing northwest**

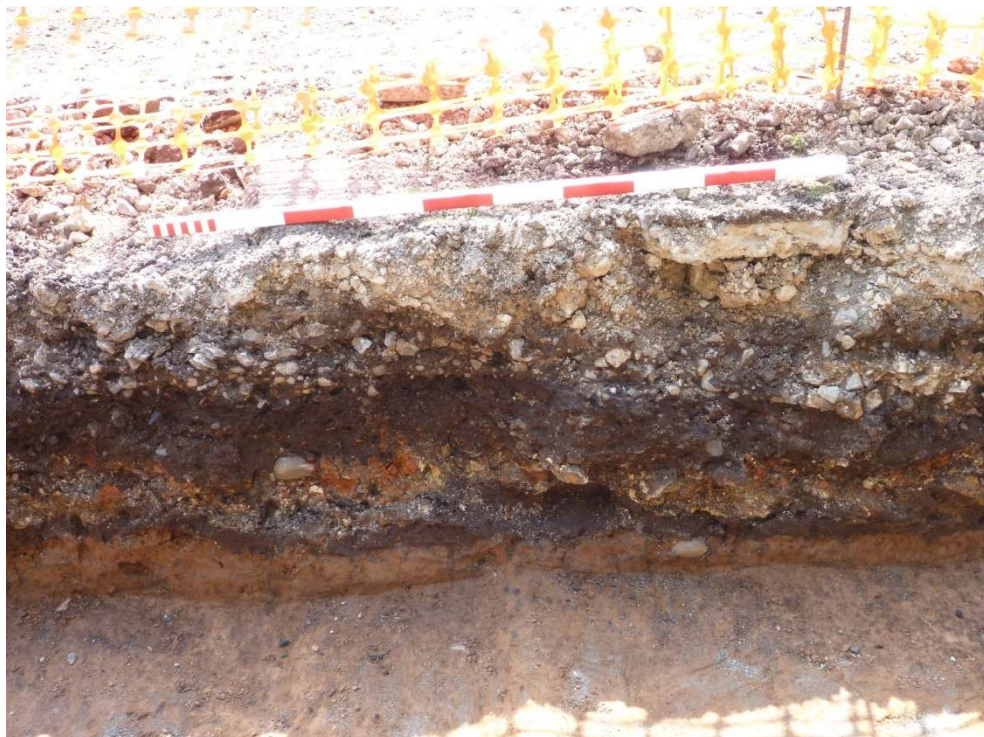
**Plate 6: Section of Trench 2, south end, showing made ground layers, viewed facing southwest**

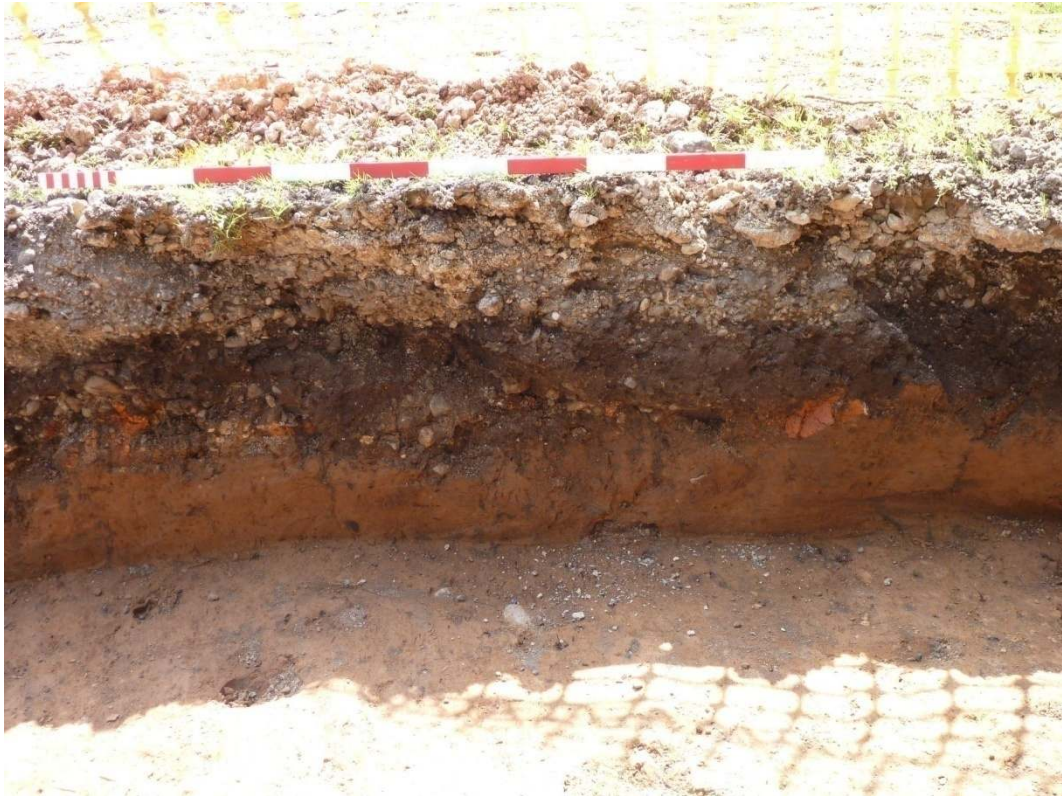
**Plate 7: Section of Trench 2, north end, viewed facing southwest**

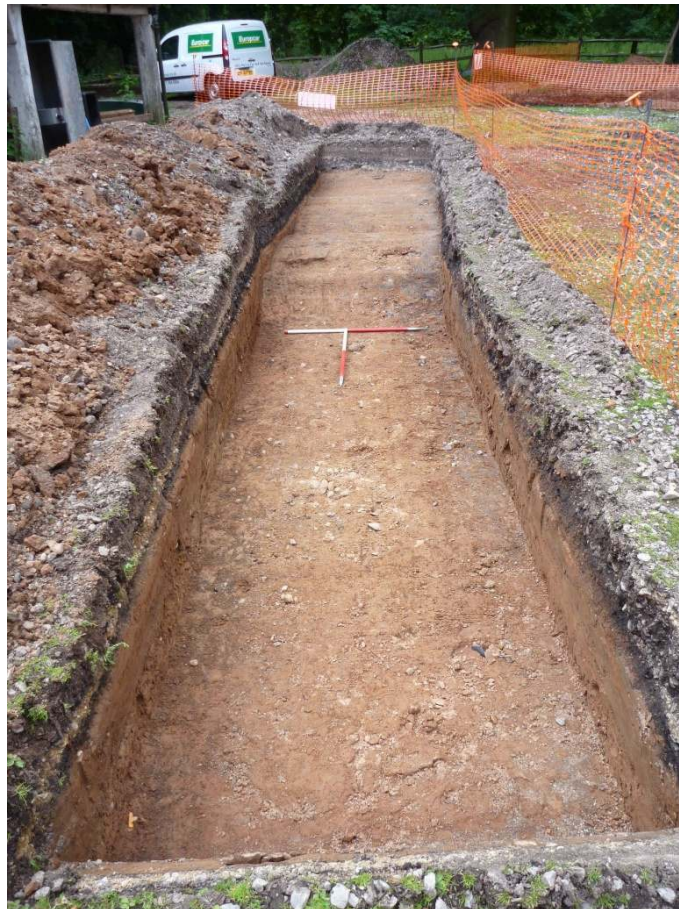
**Plate 8: Plan view of Trench 3, viewed facing west**

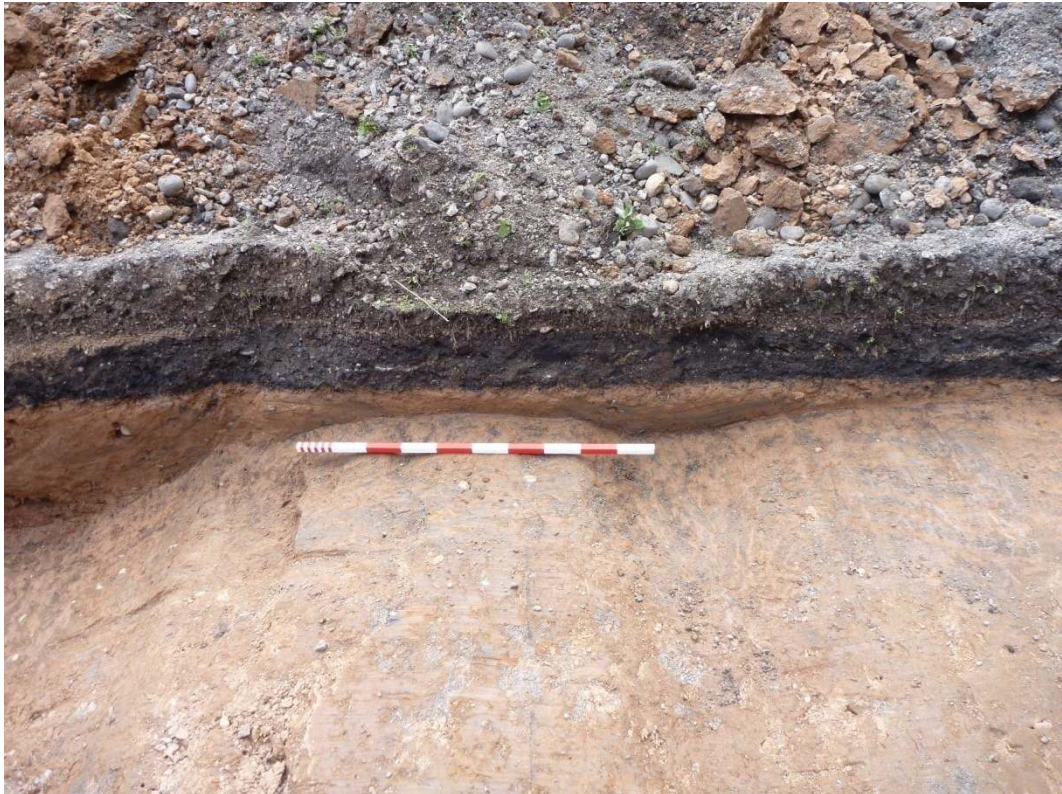
**Plate 9: Section of Trench 3, central area, viewed facing south**
