## **ARCHAEOLOGICAL TRIAL TRENCHING AT KEDLESTON HALL SAW MILL, DERBYSHIRE**

*EVALUATION REPORT*

Report Number 2011/45    July 2011

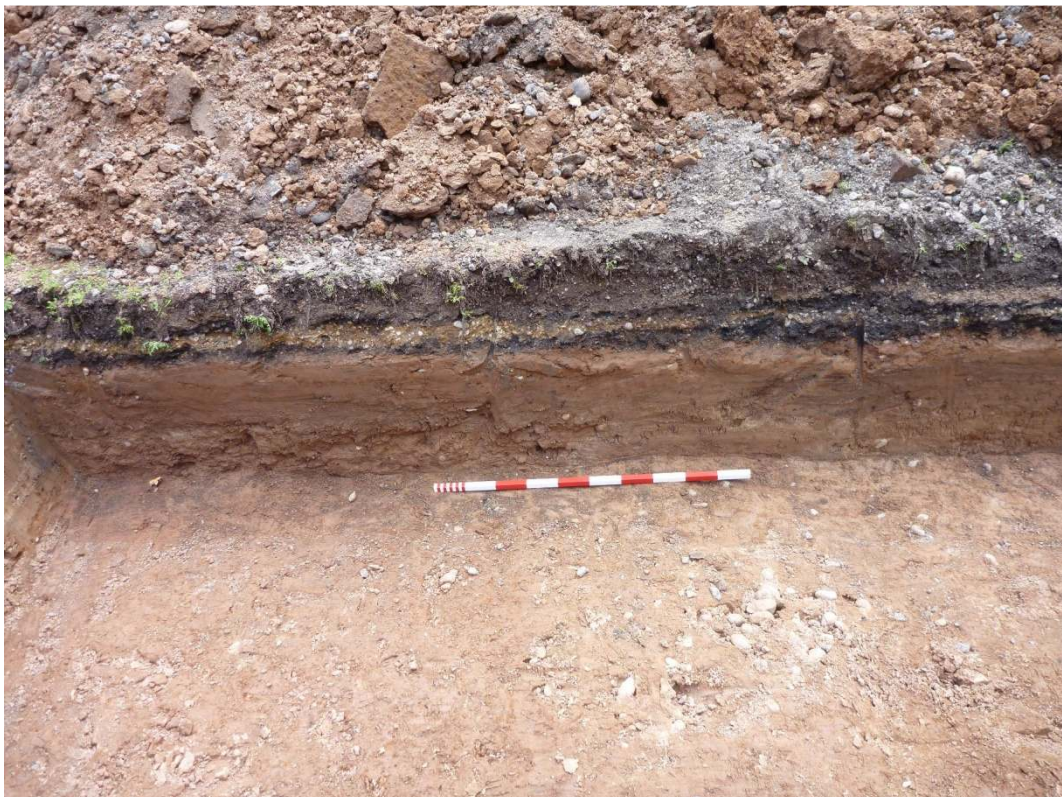
**Plate 10: Section of Trench 3, east end, viewed facing south**

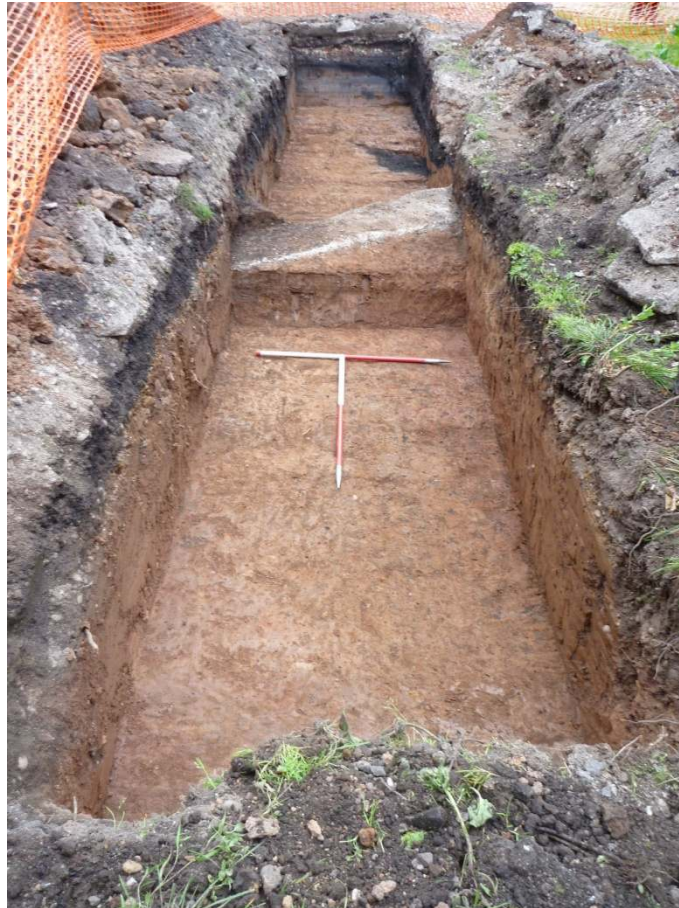
**Plate 11: Plan view of Trench 4, viewed facing northwest**

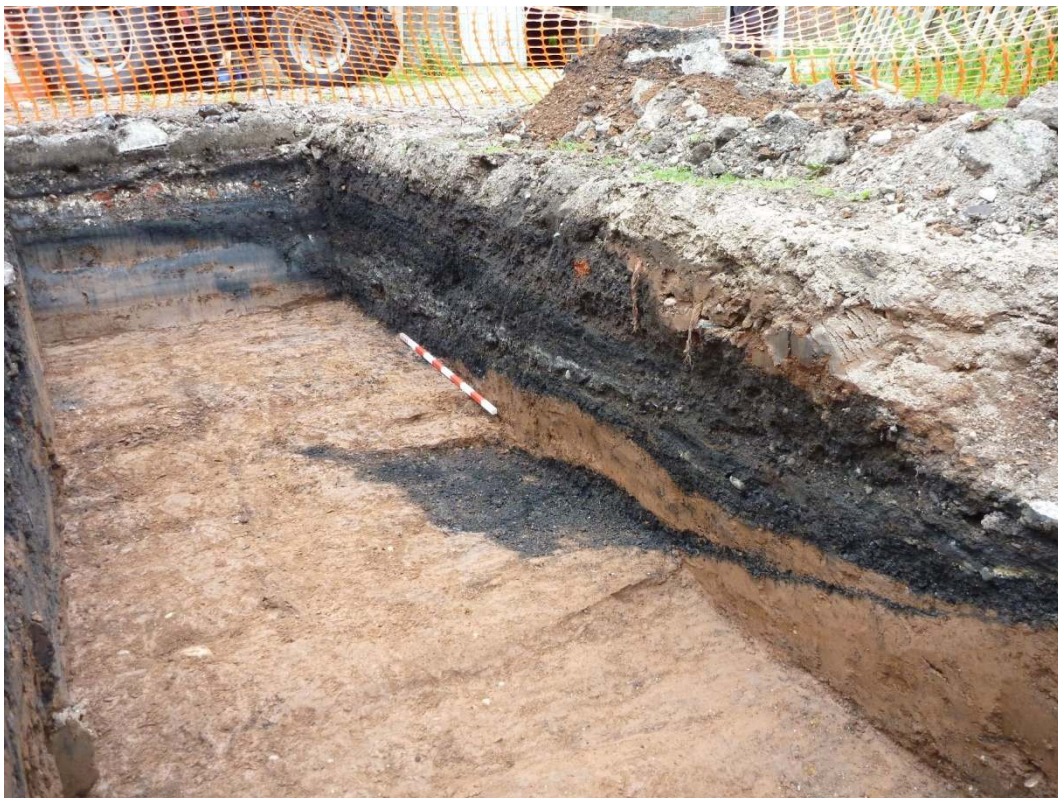
**Plate 12: Section of Trench 4, south end, showing large feature 412, viewed facing south**

At the south end of the trench the upper layer consisted of a pale hardcore layer (406). As with 401, some lumps of broken tarmac had been dumped on and within the hardcore. In the central part of the trench 406 overlay a thin layer of crushed limestone, 413, probably a bedding deposit for the hardcore. 413 and 406 overlay a series of deposits at the south end of the trench which appeared to be infilling a large cut feature, 412. This feature occupied slightly over half of the width of the trench. The cut was visible in the west and south sections (Plates 11 and 12). In the west section, it sloped at a shallow angle downwards from north to south. In the south section a steeper, convex slope was visible, terminating before the east side of the trench. The base of the cut was not reached within the trench, and further excavation was not undertaken due to the depth of the trench. It was not visible in the eastern section.

The upper fill of the feature comprised an orange-brown silty clay, 407, which appeared to represent redeposited natural subsoil. This was present over the northern side of the feature. 407 overlay a series of gritty dark grey to black dump layers, forming thin beds dipping towards the south, where the combined deposits were 0.75m wide. The deposits were given a single context number, 408, and overlay a second layer of redeposited natural, 409, up to 25cm thick. Below 409 was a back ashy grit deposit, 410, from 2cm to 10cm in thickness, the base of which was not reached in the southern end of the trench. 410 overlay another layer of redeposited natural subsoil, 411, up to 30cm thick. There was a lens of yellow-brown sandy clay near the base of this layer, not given a separate context number (Plate 13). Layer 411 appeared to be the basal layer within cut 412, overlying an orange-brown silty-clay which appeared to be natural subsoil 402, though only a small patch of this was seen.

A large cut feature, 412, in Trench 4, to the east of the sawmill, is of unknown function and date. The base of the feature was not reached in the trench. It is possible that it may relate to the excavation of foundations or flues for the freestanding chimney stack that stands a short distance to the southwest, at the edge of the Saw Mill. The feature was backfilled with a series of deposits including redeposited natural and made ground similar to that found elsewhere in the yard. This was the only cut feature within the trenches that did not appear to relate to modern activity or services.

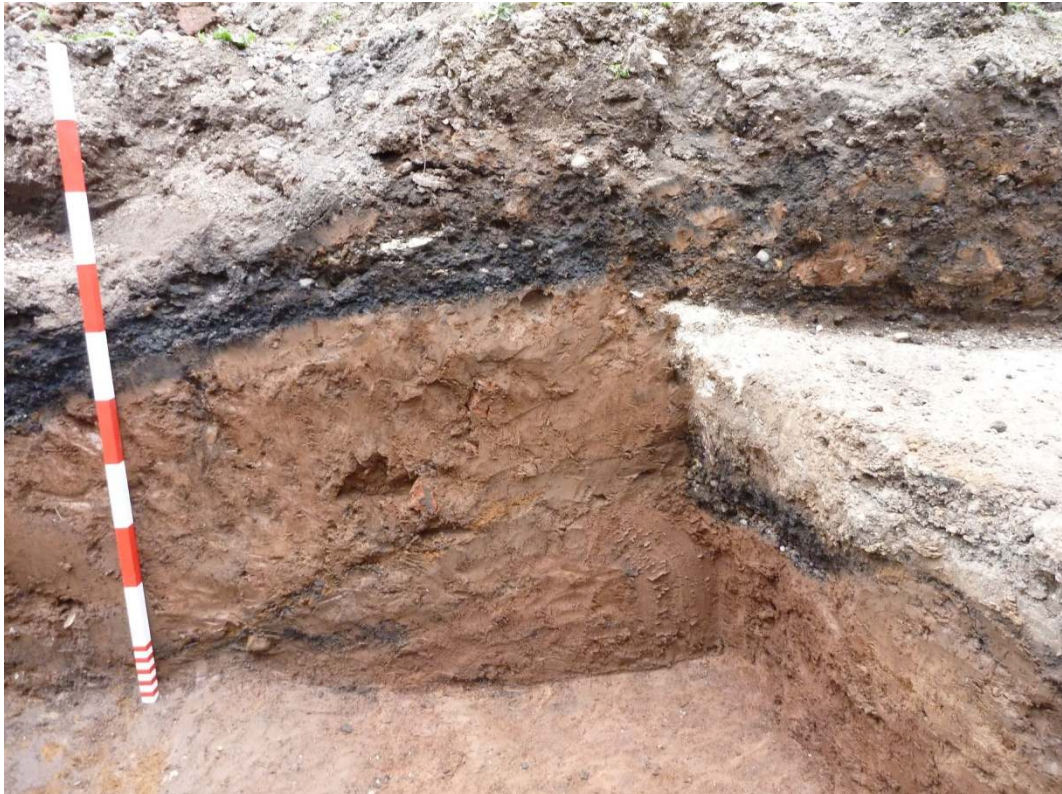
**Plate 13: Section of Trench 4, showing cut for concrete beam 405 and edge of cut 412, viewed facing southwest**

In the centre of the trench was a modern linear cut, 403, crossing the trench at a diagonal angle aligned approximately northeast-southwest. This cut held a concrete beam, 405, c.70cm wide and 20cm deep, which may have been cast *in situ* (Plate 11). The concrete beam was at a depth of 0.46m below the ground surface. Cut 403 appeared to cut the topsoil 401 and natural 402 to the north and the fills of 412 to the south (Plate 13). The fill of cut 403 was a mixture of topsoil and redeposited clay derived from the surrounding natural, 404, with occasional rounded pebble inclusions that was observed above 405. 405 was overlain by hardcore 401 and the bedding layer 413. The purpose of the concrete beam was unclear; it may have covered a service pipe, or have been associated with an earlier foundation.

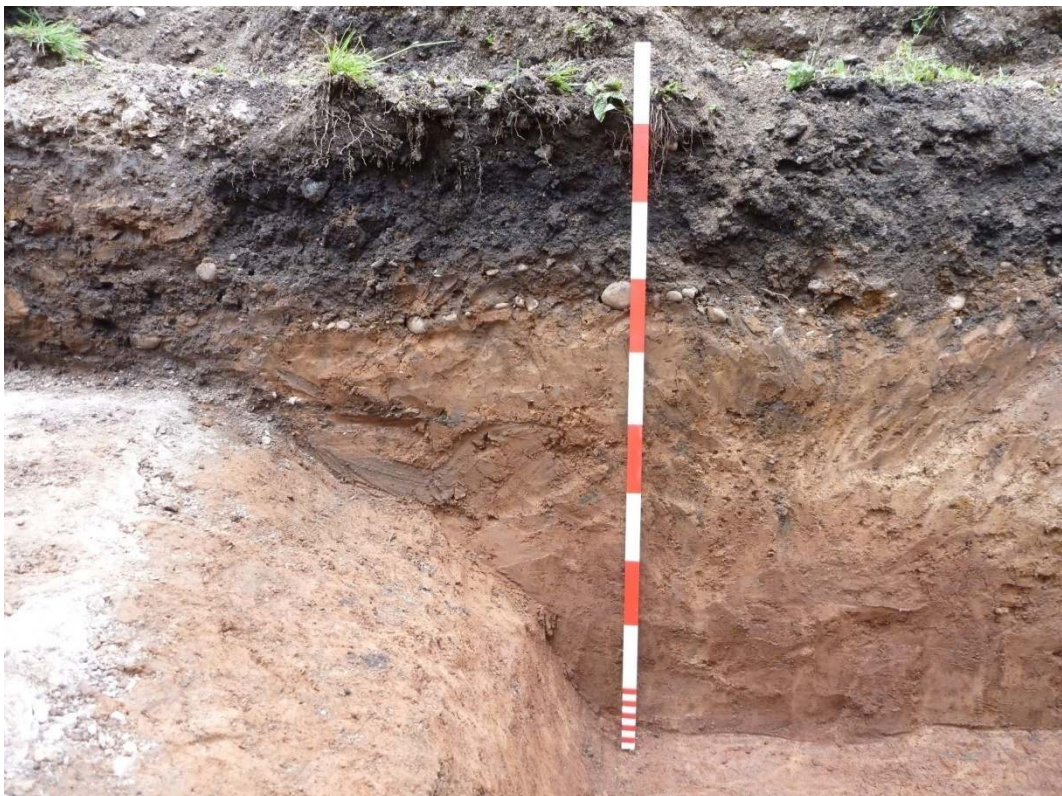
**Plate 14: Section of Trench 4, north end showing cut for 405 and topsoil 401, viewed facing southwest**

The deposits within this trench were noticeably different at the north and south ends. At the north end, the upper layer comprised a mid-brown silty topsoil with some clay (401), up to 25cm thick. Fragments of broken-up tarmac were found within this layer, and there was a thin pebbly deposit at the interface with the natural subsoil. The topsoil 401 directly overlay the natural silty-clay subsoil, 402 (Plate 14).

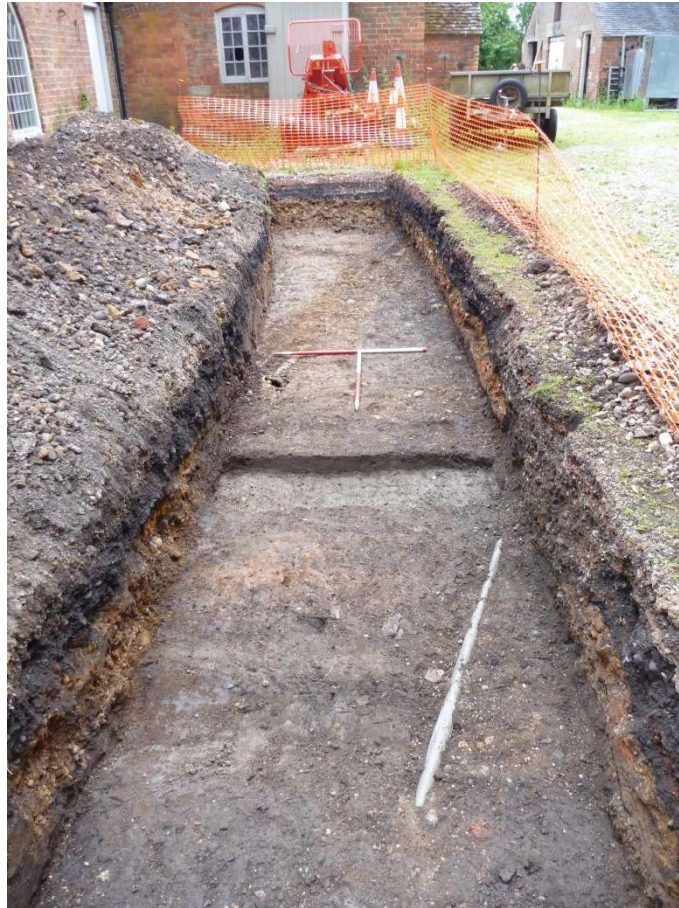
**Plate 15: Plan view of Trench 5, viewed facing east**

Trench 5 was located to the south of and parallel with the main Saw Mill building. It was aligned east-west. Natural subsoil was not reached in this trench, and excavation ceased at a

depth of 0.80m due to the presence of services (Plate 15). The plan and section are shown in Figure 7.

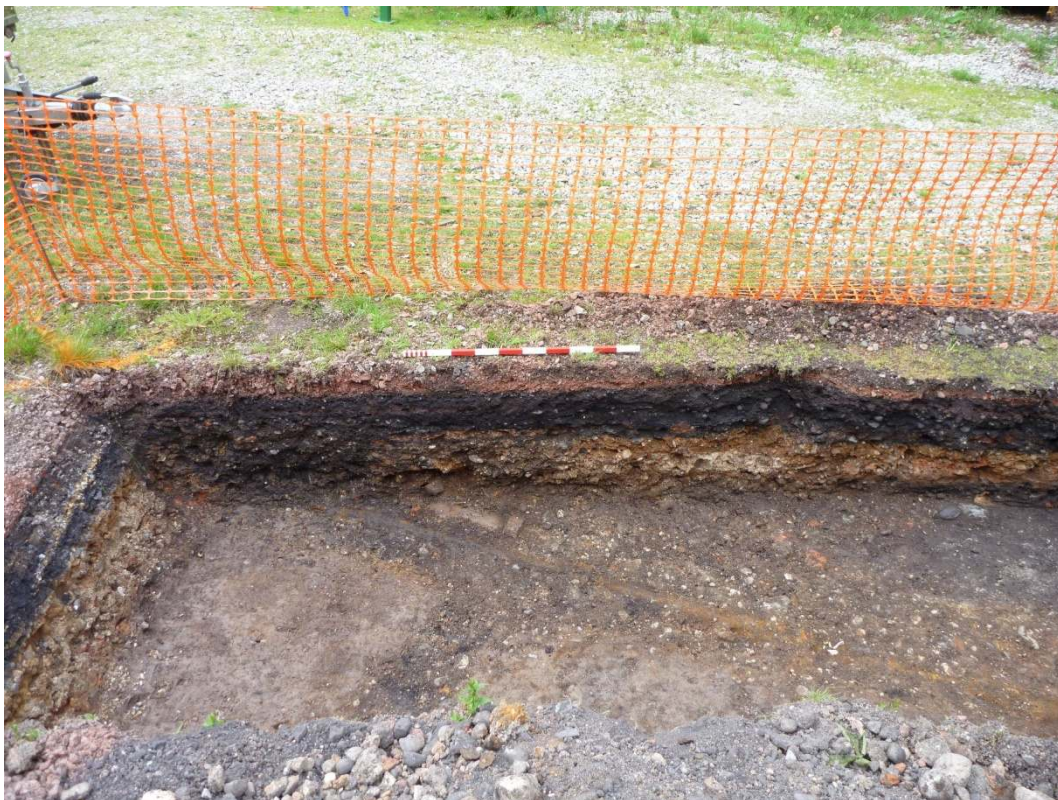
**Plate 16: Section of Trench 5, east end, showing cut 505 for pipe trench, viewed facing south**

In the eastern end of the trench was a linear cut, 505, which held a metal water pipe and ceramic drain pipe, running parallel in a northwest-southeast alignment. The fill of the cut, 504, was blackish-brown silty sand with pebbles and brick fragments in a series of lenses (Plate 16). It underlay levelling layer 503. To the immediate west of the cut were two narrow lenses lying between 503 and 508. The upper lens, 506, comprised red-brown sand containing small brick fragments, and overlay dark brown sandy clay 507. It was unclear if these related to the backfilling of the cut, but they were not visible elsewhere in the trench. To the northeast of the cut, at the base of the trench, was a deposit of brown clay, 515, with occasional patches of reddish staining. This deposit was cut by 505. To the north of the cut was a further shallow linear feature, 517, aligned northeast-southwest. It was unclear if this was cut by the pipe trench 505, connected with it, or cut it. The shallow feature had a rounded base, and was approximately 0.3m wide. No service pipes or cables were found within the feature, though it appeared likely to have been a service trench. It was filled by a mixed gritty black-brown deposit, 509, with rubble inclusions.

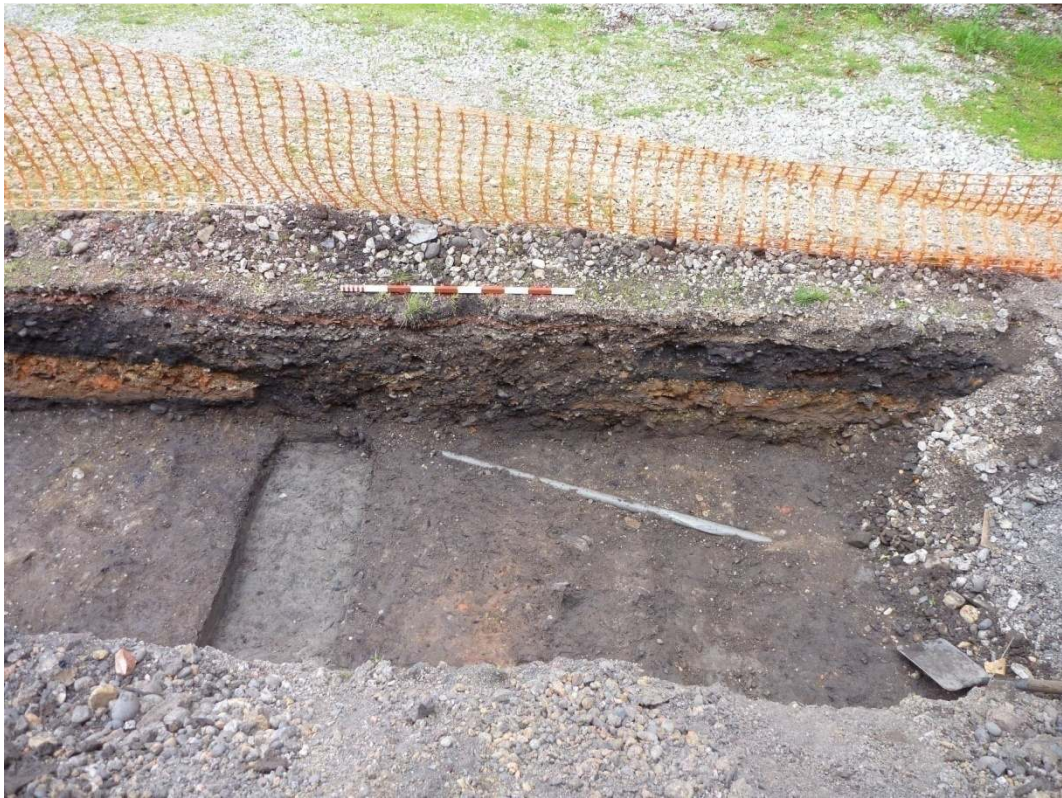
**Plate 17: Section of Trench 5, west end, showing sondage into 501 and cut 512 for phone cable, viewed facing south**

At the western end of the trench was a further cut, 512, containing a telephone cable in plastic ducting (Plate 17). The cut and cable were on a northwest-southeast alignment. The fill, 513, comprised a black/brown mixture of grit and silty soils, with fragments of brick and stone rubble. The cut and fill underlay the hardcore 510 and possible surface 502, and cut through all of the levelling deposits at the west end of the trench. To the west of cut 512 was a layer of yellow-brown sandy gravel, 516, which lay between deposits 514 and 501. This was only seen at this end of the trench. The rounded gravel inclusions varied in size between 2 and 10cm. This was interpreted as another levelling layer.
