**SYLVESTER STREET, SHEFFIELD, SOUTH YORKSHIRE  
SITES B & D - EVALUATION REPORT**

**Report Number 2010/80**

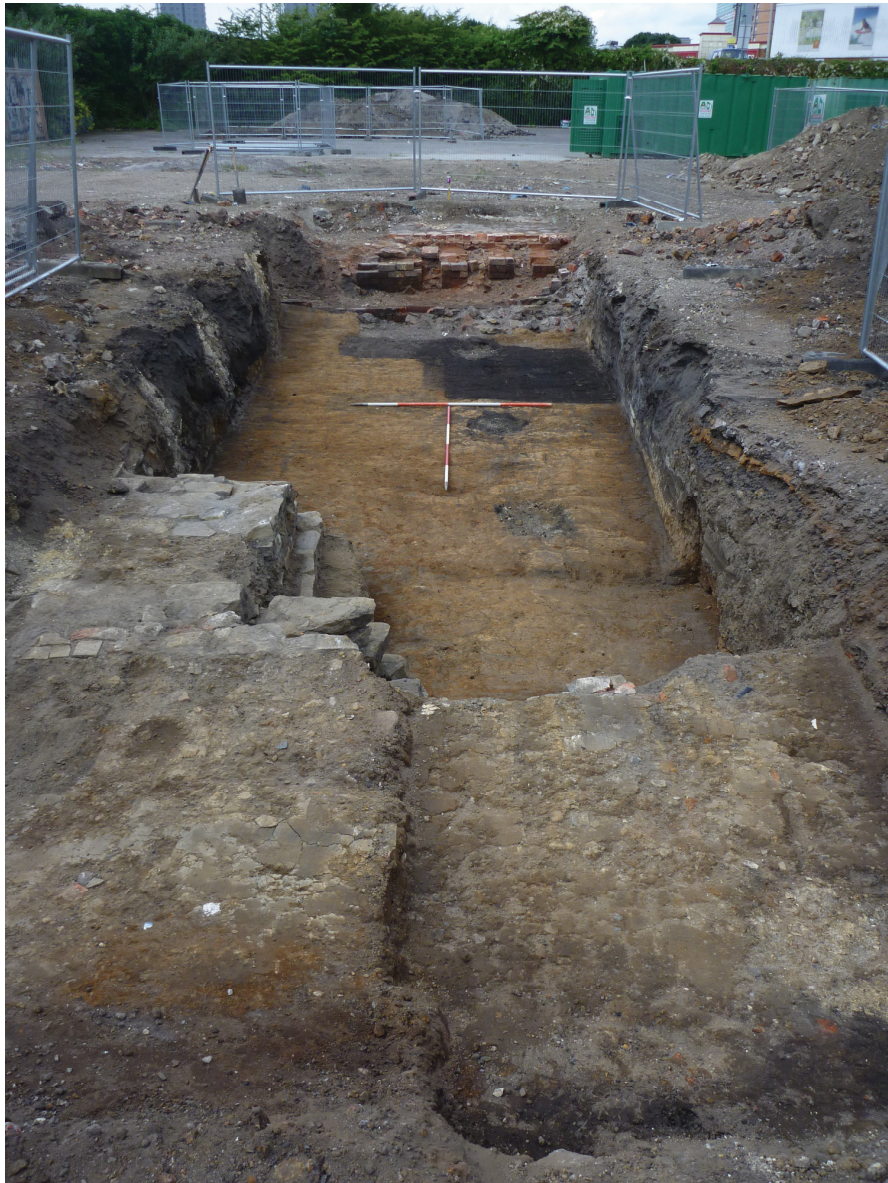
Cover: Trench 4, crucible furnace bases, looking north-west. 2m scale

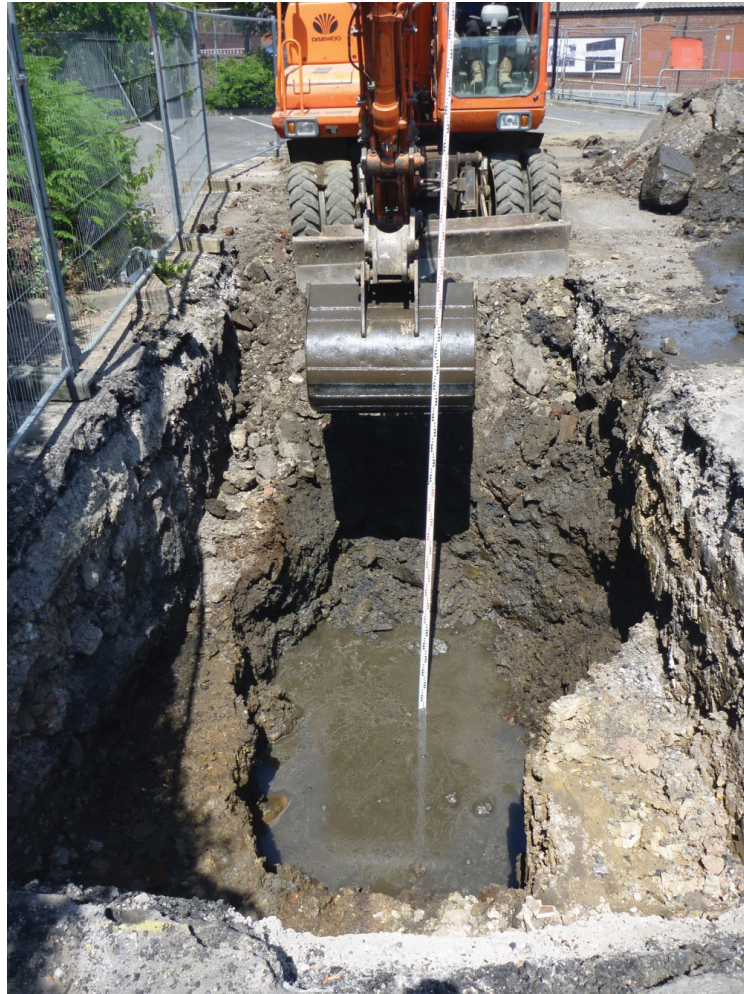
*Plate 1 Working shot of machine excavation of palaeochannel (1011)*

Trench 1 was located in the north-west corner of Site D (figure 1), within the tarmac car-park of the recently demolished retail outlet. The car park surface sloped gently from North to south, or from 63.78 – 63.47m AOD. Trench 1 was north – south aligned, 15m long and 3m wide (Figure 2). The northern half was machine excavated to a depth of 1m BGL, or 62.13m AOD, whereas the southern half was reduced to c.1.44m BGL, to 62.13m AOD, over much of its area. The exception was located within the south-west corner of the southern half of the trench, where a 3.78m long, 2.16m wide and 1.66m deep slot (Increased depth dig) was cut into the base of the trench to investigate the course of a river channel. In this instance excavation was halted at c.3.10m BGL, or 60.47m AOD.

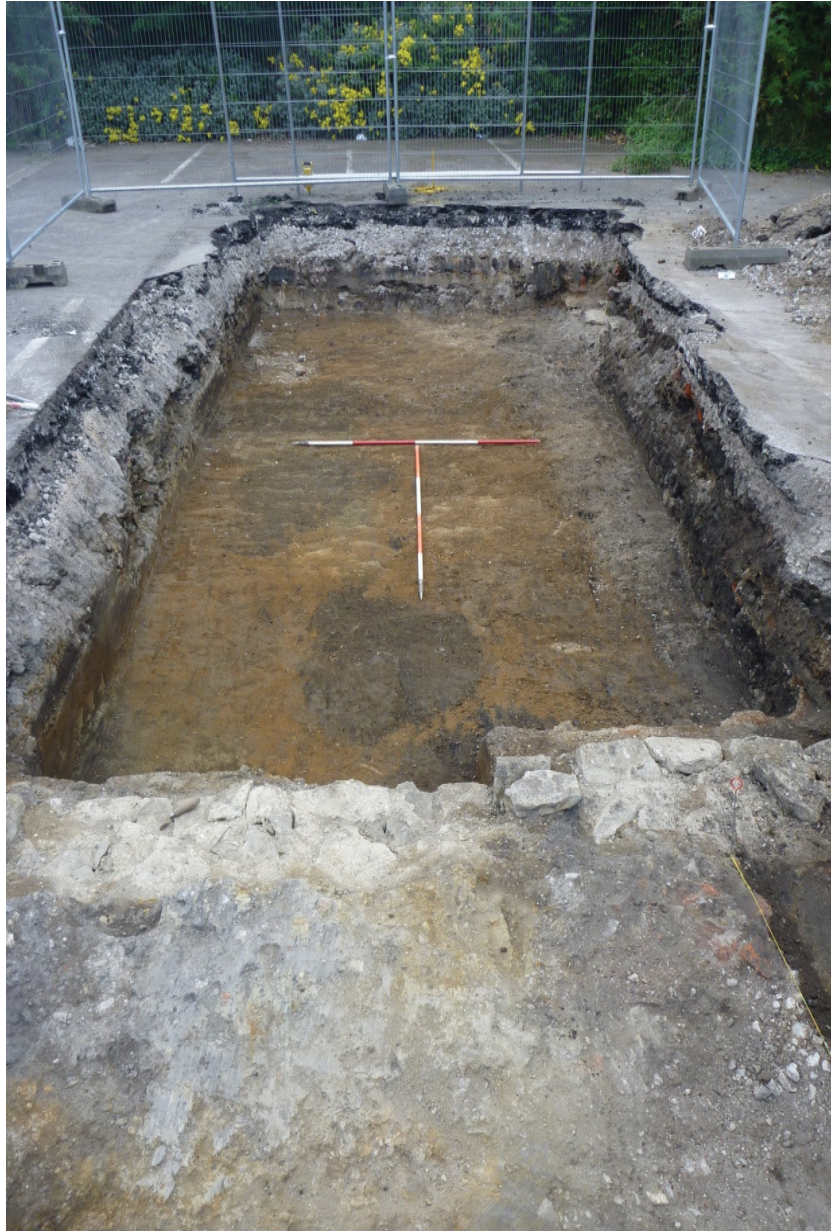
*Plate 2 Pre-excitation shot of Trench 2 looking south-south-east. 0.50m scale units*

This trench (Figure 1) was located towards the southern site boundary, within the tarmac car park. It was aligned north-north-west – south-south-east and was 10m long, 4m wide and up to 1.15m deep. At the northern end of the trench a 3.04m wide block of material was retained due to the presence of a sandstone wall. This extended across the full width of the trench and was up to 0.39m deep (Figure 3, Plate 2).

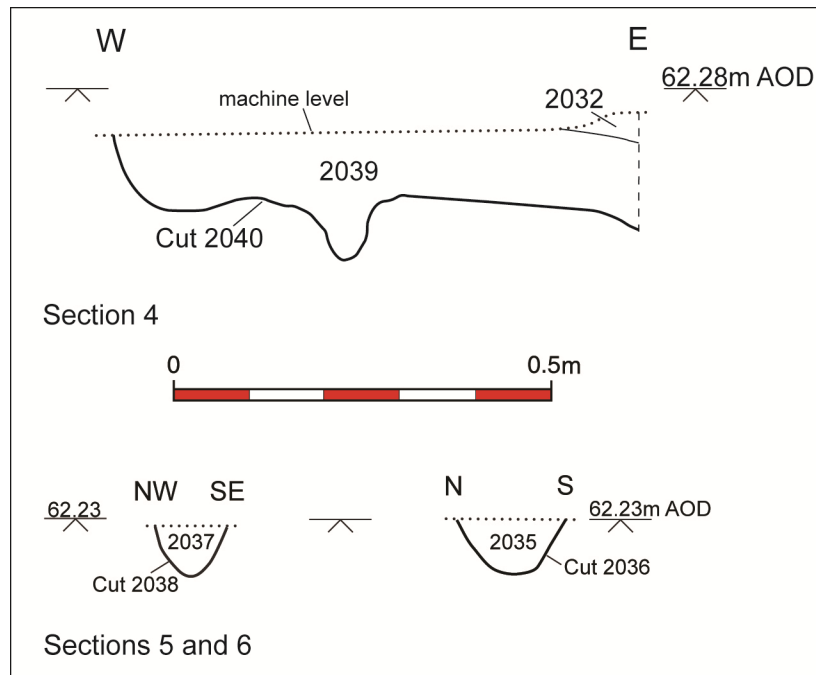
Figure 4 Section no's.4, 5 and 6

The earliest deposits in Trench 2 were observed at 62.09m AOD (1.15m BGL) and comprised a banded sequence of alluvial sand silts (2043) which were thought to have represented the fills of several natural water courses. Although these remained un-excavated a general north-west – south-east observed trend suggests they flowed down from the slightly higher ground to the north. The top of (2043) was cut into by a small pit (2040) and a pair of possible post-holes (2036 and 2038; Figure 3 and 4)

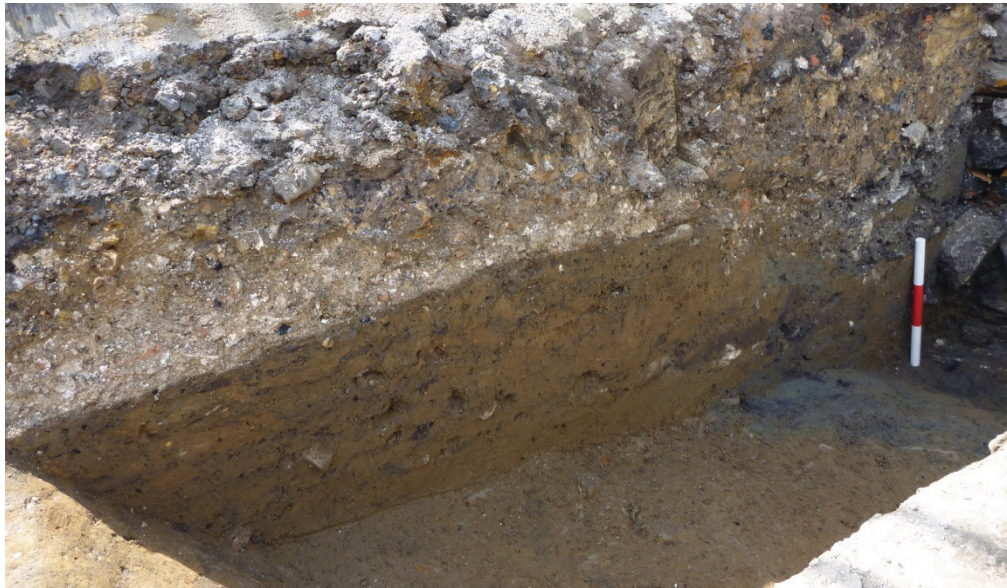
*Plate 3 Cut 2031(Cut 2032 top right of shot) looking south. 0.20m scale units*

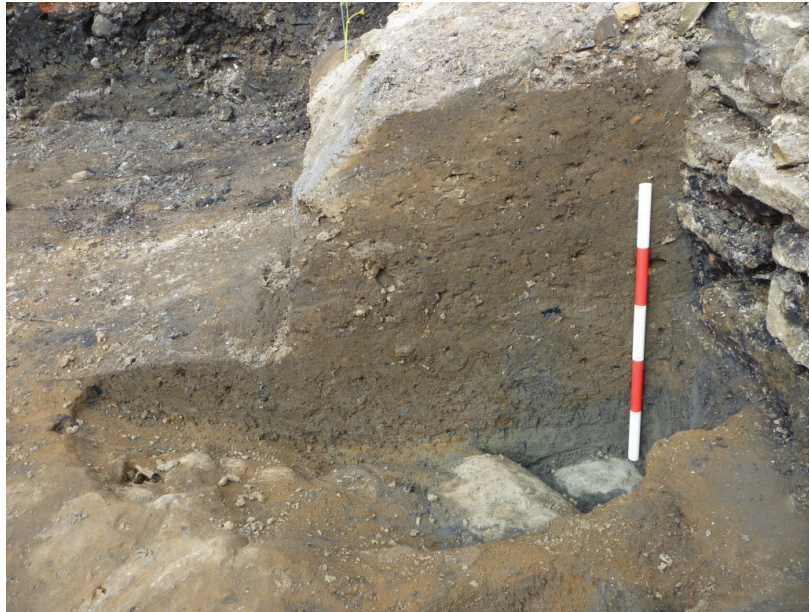
Plate 4 North-east facing section of Pit 2005 (Construction cut (2007) and wall (2012) to right of 0.50m scale)

Only a small part of the construction cut (1007; Figure 3 and 6) for wall (2012) was observed where it had been cut through the north side of the fill (2006) of Pit 2005 (plate 4). In this location it showed that the south side of the cut was vertical, in excess of 0.60m deep (the base was not reached). The northern extent of (2006) was not established. It must have followed the same west-south-west – east-north-east alignment as wall (2012), as it had had been built hard up against it. Cut (1007) also appeared to have truncated the backfill (2004) of

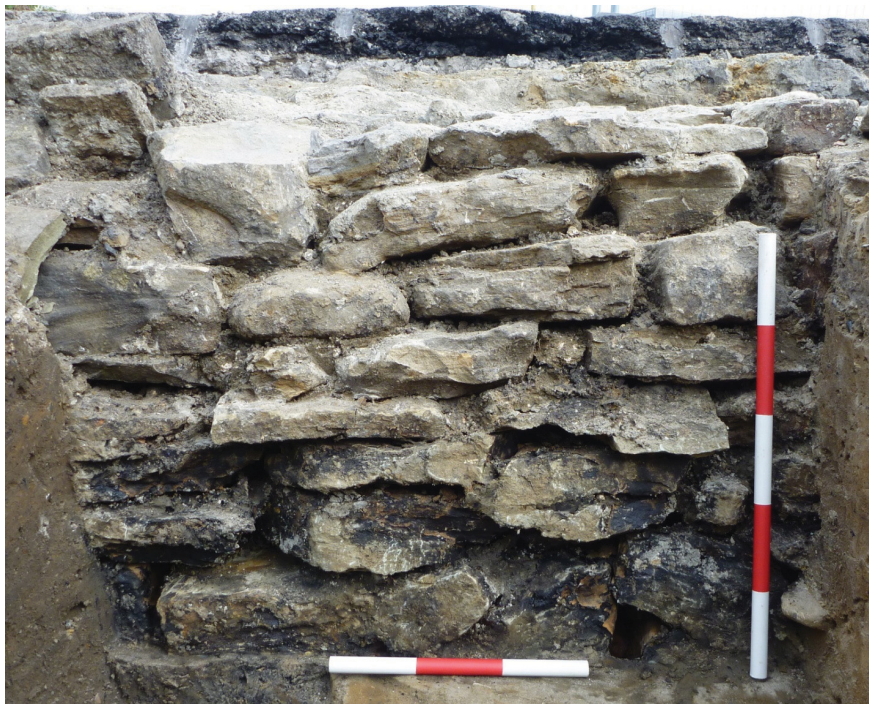
*Plate 5 South face of wall 2012. 0.3 and 0.5m scales*

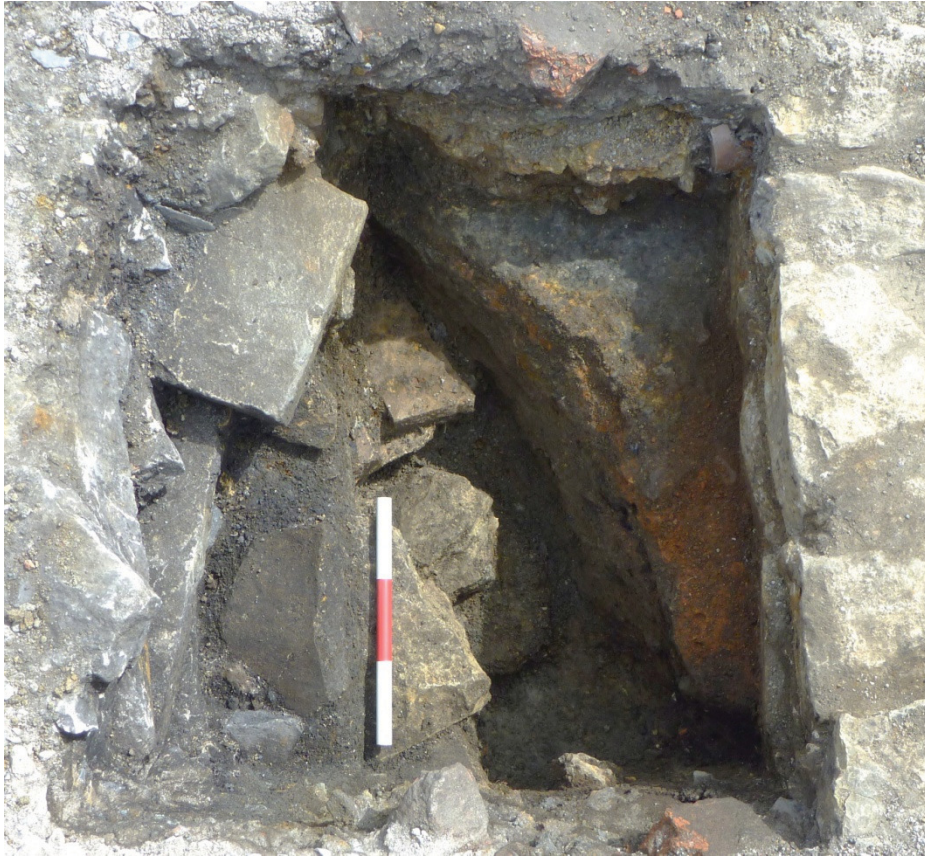
*Plate 6 Vertical shot of trial trench, North face of Wall 2012 to right, South side of Wall 2013 centre left. Floor 2014 can be seen abutting north face of Wall 2012. 0.3m scale.*

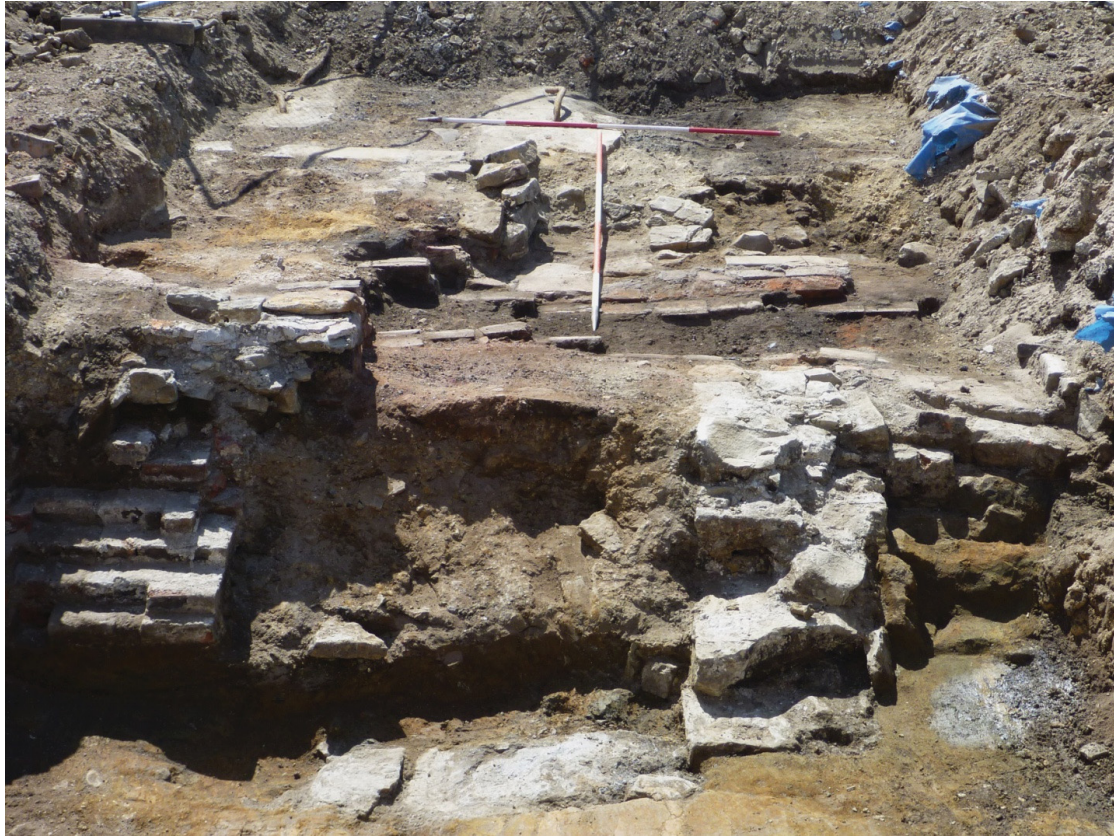
*Plate 7 Trench 3, pre-excavation shot looking south. 2m scales*

The northern-most 4m of the trench had been reduced to c.1.46m BGL (probably when the retail outlet was cleared) cutting well down into the clay natural (3027) and removing all the archaeological features and deposits. In the remainder of the trench there was a complex of building remains (plate 7).

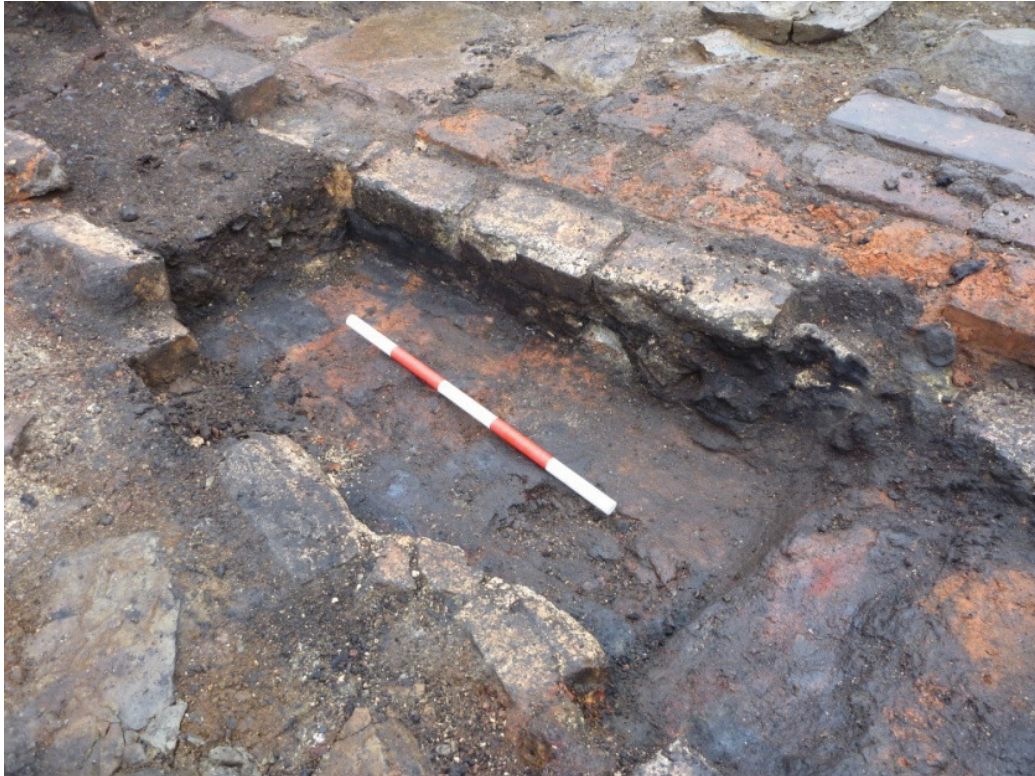
*Plate 8 Flue 3001 looking east. 0.5m scale laid on original base (3018).  
Brick infill of Wall 3007 top left*

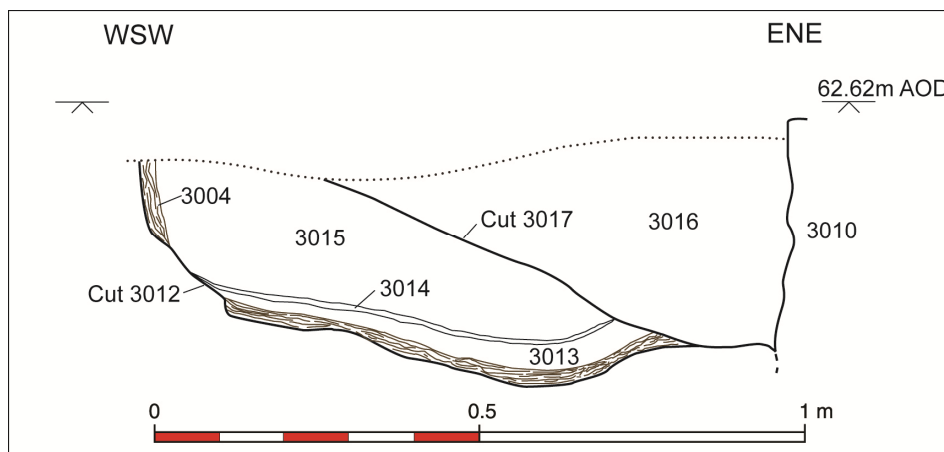
Figure 16 South-south-east facing section no.13

A metal lined tank, (3004) (Figure 16, plate 9) was observed against the southern limit of excavation. It was aligned south-south-east – north-north-west and projected into the trench by 1.80m, was up to 0.36m deep and would have been over 1.02m wide, had its eastern edge not been truncated by later activity. The relationship between the tank and the aforementioned structures was not evident.

The cut (3012) had been excavated to the size of the tank before it was set into the ground. All that survived of the tank (3004) was a laminated corrosion scale, up to 30mm thick, which lined the sides and base of (3012). The base undulated due to ground settlement, exacerbated

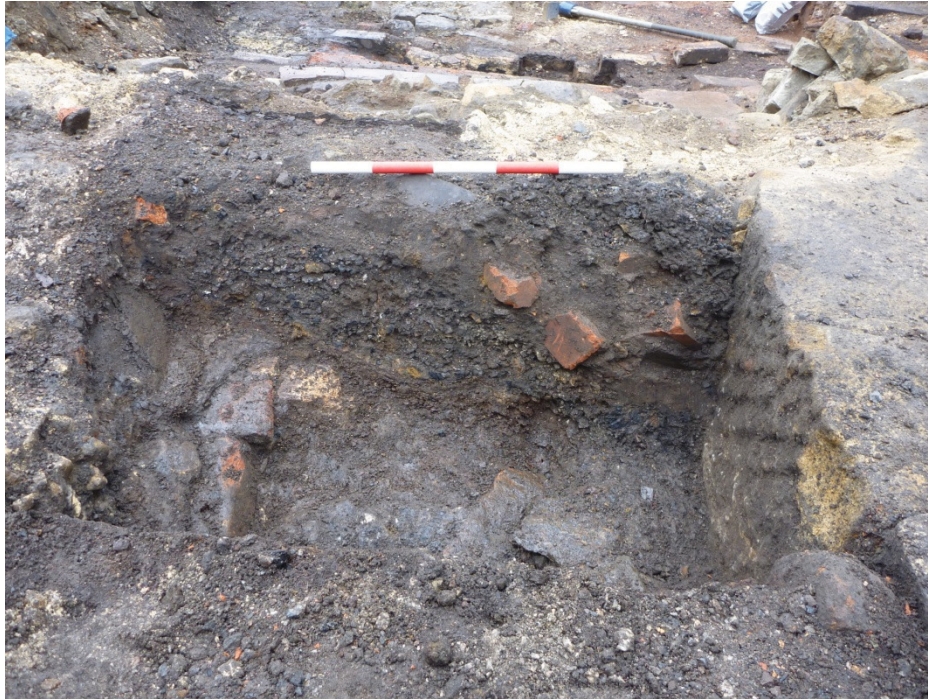
*Plate 9 Section No.13 looking north-north-west. Engine/machine base 3010 far right.*

Wall (3005) appeared to have been demolished and reduced in height, down to 62.53m AOD, for the insertion of massive sandstone block bases (3010, Figure 13), part of which (3019) overlay the south-east face of wall (3005). The clearance cut (3017) for the blocks was only observed where it had truncated the upper fill (3015, plate 9) of iron tank (3004). The back fill (3016) of cut (3017), a loose, grey brown silt sand with moderate brick and stone rubble, failed to produce any dateable artefacts. A series of large iron floor bolts, inserted into the top of the blocks suggests they had functioned as the base for an engine or large piece of machinery such as a press or hammer.

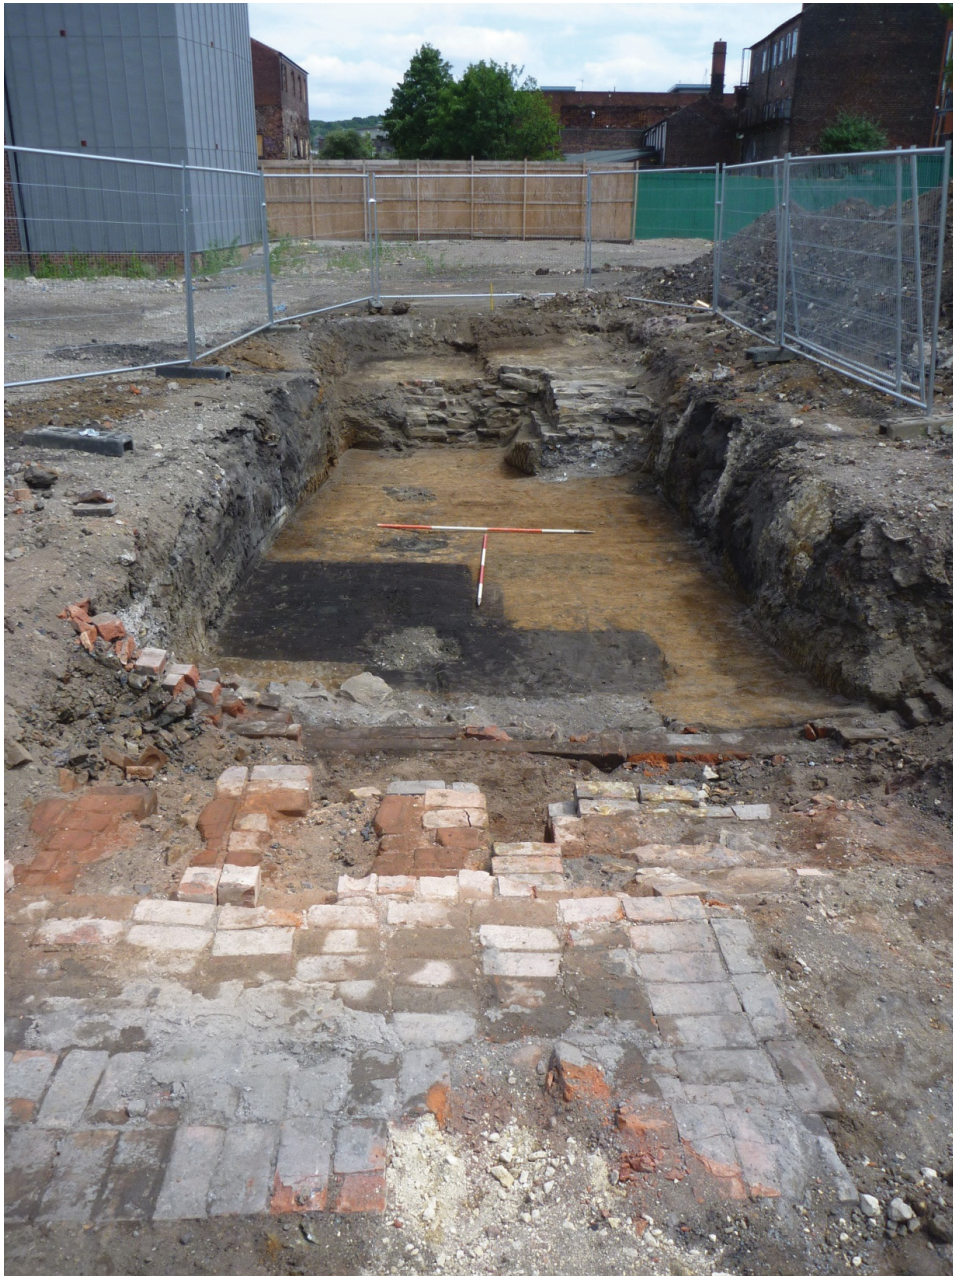
*Plate 10 Pre-excavation shot of Trench 4, looking west-south-west. 2m scales*

Trench 4 (Figure 2) was east-north-east – west-south-west aligned, 15m long, 3m wide and was machine excavated to a maximum depth of 1.26m, or to 61.62m AOD (Figure 17, Plate 10).

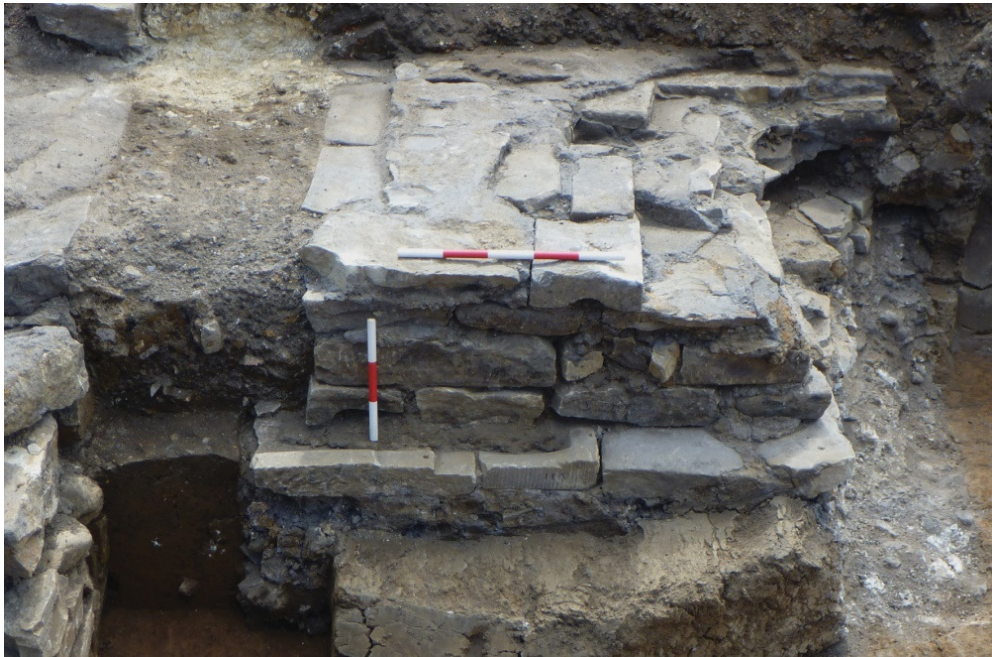
*Plate 12 Wall / footing 4026 looking south. 0.30 and 0.50m scales*

(4026) was located to the west of wall (4023) (Figure 17 and 18) and was 1.30m wide, 0.52m high. As only 1.13m of it projected from the southern trench edge its true dimensions could not be established. What was exposed comprised c. 5 courses of mixed, large random sandstone rubble and large sandstone blocks, some re-used, bonded with a pale – mid grey ash mortar (Plate 12). The 0.52m gap between walls (4026) and (4023) was in-filled and levelled with a 0.40m thick deposit of compacted, crushed, mid grey- black ash cindery slag (4025). It could not be ascertained if this was an associated floor level or part of the later demolition works as it had been truncated at the same level as the top of the walls, at c.62.45m AOD (Plate 12).

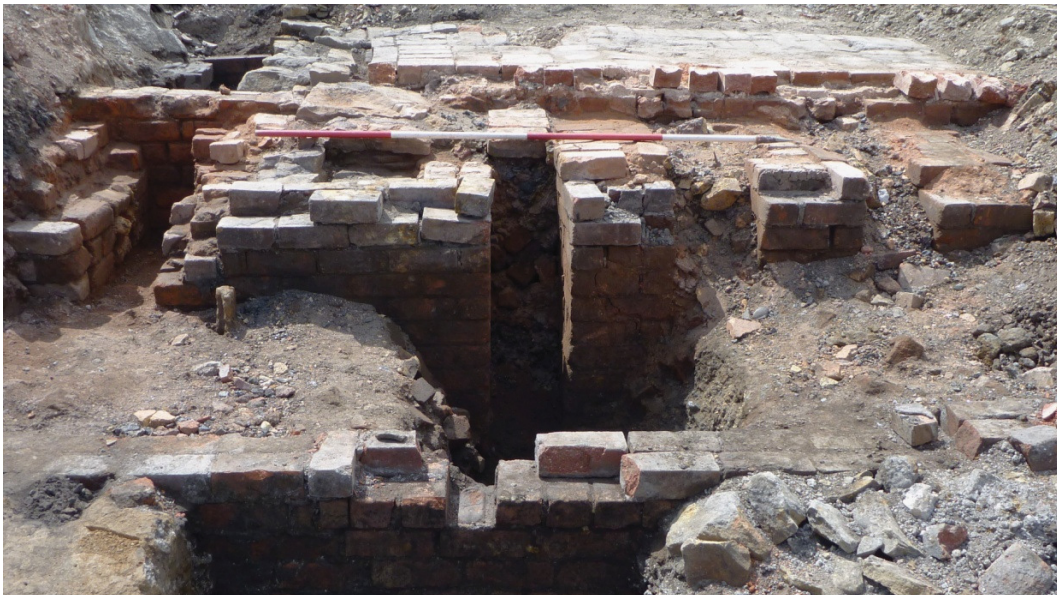
Plate 13 Elevation of furnace bases with Wall 4000 running across bottom of shot, Wall 4018 to top. 2m scale

A series of crucible furnace bases, 4 or 5 in number (4037), were located against the eastern face of wall (4018). It was not possible to determine whether (4018) and (4037) represent a single phase of construction, or if the furnace bases were added later. The openings to the furnace bases all faced east-south-east. One was partially excavated, showing that it was 0.86m in length, 0.26m wide and had vertical side walls, 1.22m high. Access was gained to the base of the furnaces by a brick floored (4036, Figure 19) passageway, 0.93m wide, with the eastern side of it delineated by a 0.23m wide, 0.75m deep brick wall (4000). This wall (4000) was aligned parallel to the furnace bases and ran across the full width of the trench (Plate 13). Its construction cut (4010) had truncated the top of natural (4030), neither the cut or its backfill (4011) were excavated.

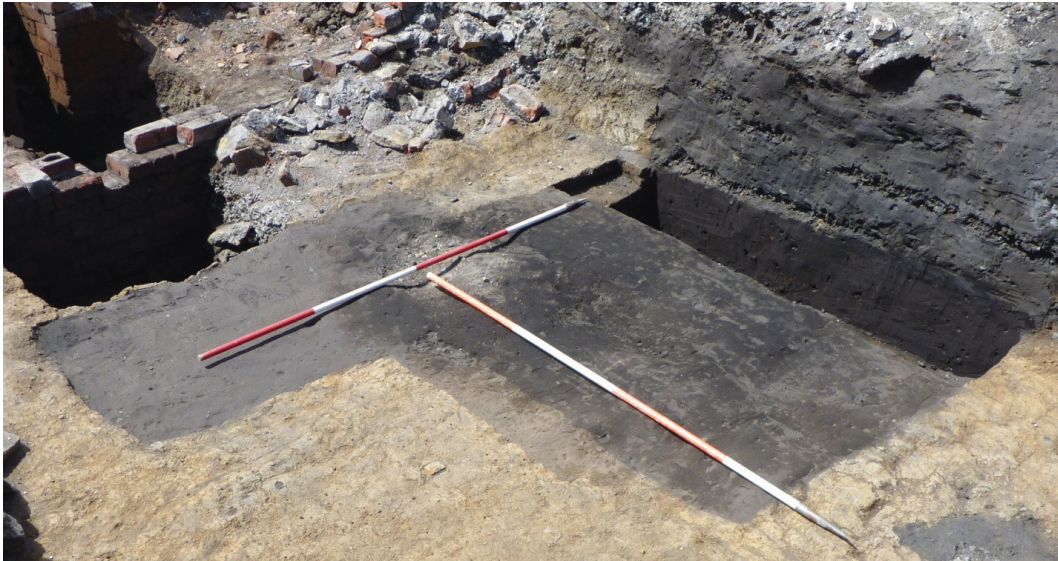
*Plate 14 Pit group to east of furnace bases (top left) looking west. Section cut through Pit 4016. 2m scales*

A series of pits (Plate 14) were observed just to the east of the crucible bases. The earliest of these were cuts (4039) and (4015), which contained similar fills (4038 and 4014, respectively). (4039) and (4015) were cut into the top of natural (4030). Only cut (4015) was half sectioned

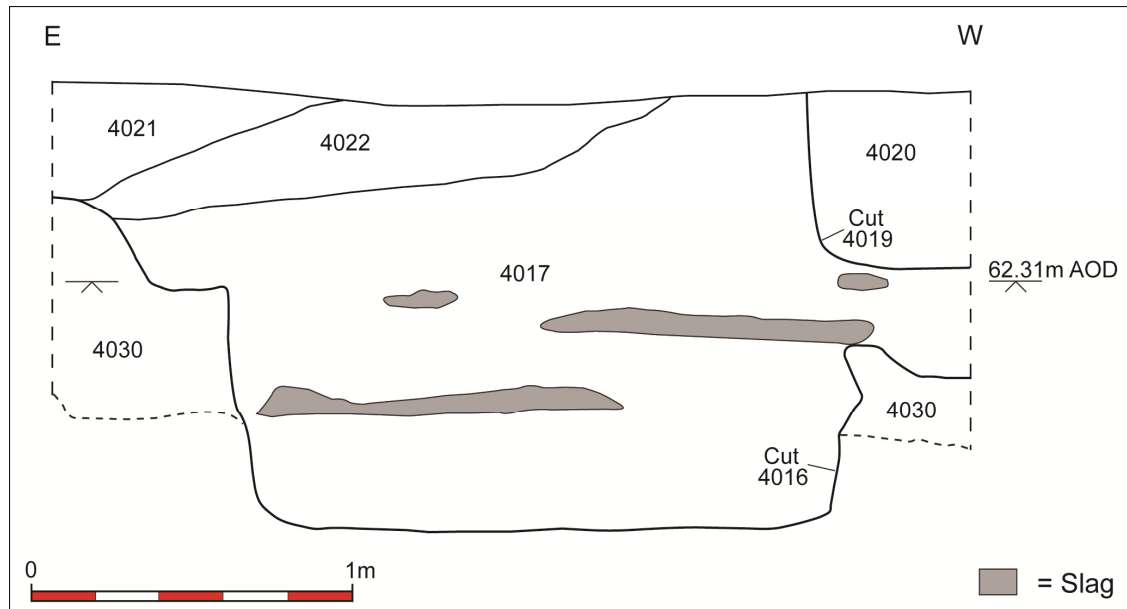
Figure 21 South facing section no.20

Its full depth, 1.08m, was recorded in the northern trench edge (Figure 21). Its backfill (4016) comprised a compacted, loose, fine grained black sand, with occasional interrupted lenses of slag, which over-spilled the west edge of the pit. This may suggest that it would have originally had a stepped profile. The form and fills of pits (4008) and (4016) (and their proximity to the furnace bases) suggests that they had functioned as sand casting pits. The western edge of (4017) was truncated by a steep sided flat based service, cut (4019), which was backfilled with a dark grey sand with several fragments of salt glazed sewer pipe. On its eastern side deposit 4017 was sealed primarily by, deposits (4022) and (4021). Deposit 4022 comprised a dump of iron stained slag fragments, whereas 4021 comprised demolition rubble in a matrix of light brown grey silt sand. Together with deposit (4040) (Figure 17), (4022) and (4021) were thought to represent post demolition levelling of the site, forming the ground level at c.62.88m AOD.

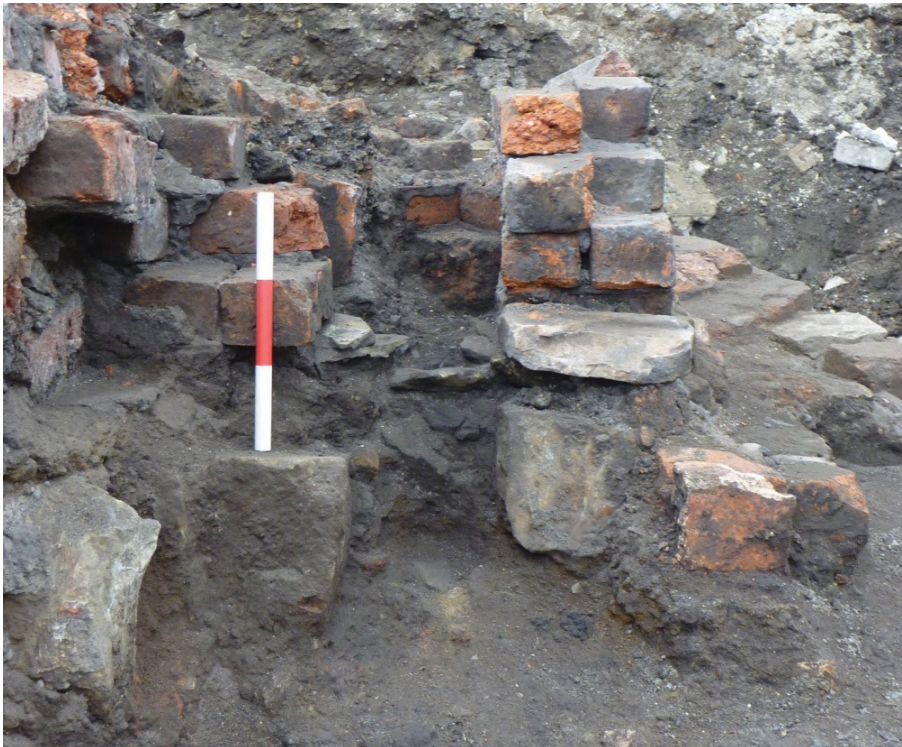
*Plate 15 Elevation of Walls 5018 (right), west end of wall (5022) (under scale) and wall (5005) (extreme left) after deposit (5017) removed, looking south. 0.3m scale*

The east side of the basement/boiler room was most likely delineated by a badly damaged brick wall. Small parts of the brick foundation course of this wall were recorded (5010 and 5019, Figure 25). The foundation cut was not observed. The upper build (5004 and 5018) was constructed from brick and it would have originally been north-north-west – south-south-east aligned, over 4.30m long (it ran beyond the north trench edge) and c. 0.40m wide. A single course wide skin of fire brick was noted on its western (internal?) face. The most intact part of it (5004) was 0.76m tall and had been demolished and reduced in height, to 61.94m AOD. The southern element, (5018), had been founded on top of brickwork (5012). It had been reduced to 61.78 m AOD by later activity. One of the bricks used in the build suggested a date of the late 19<sup>th</sup>-20<sup>th</sup> century for its construction. An east west aligned brick wall (5022) may also have been integral, forming a 'T' junction with the east face of wall (5022), this could not be ascertained as the connection was severed by a later build. Wall (5022) was only seen in plan and it was 0.90m long, 0.26m wide and comprised two courses wide of brick stretchers. All that can be said is that a later build (see 5005, below) appeared to have incorporated part of the foundations of wall (5022) as its own.

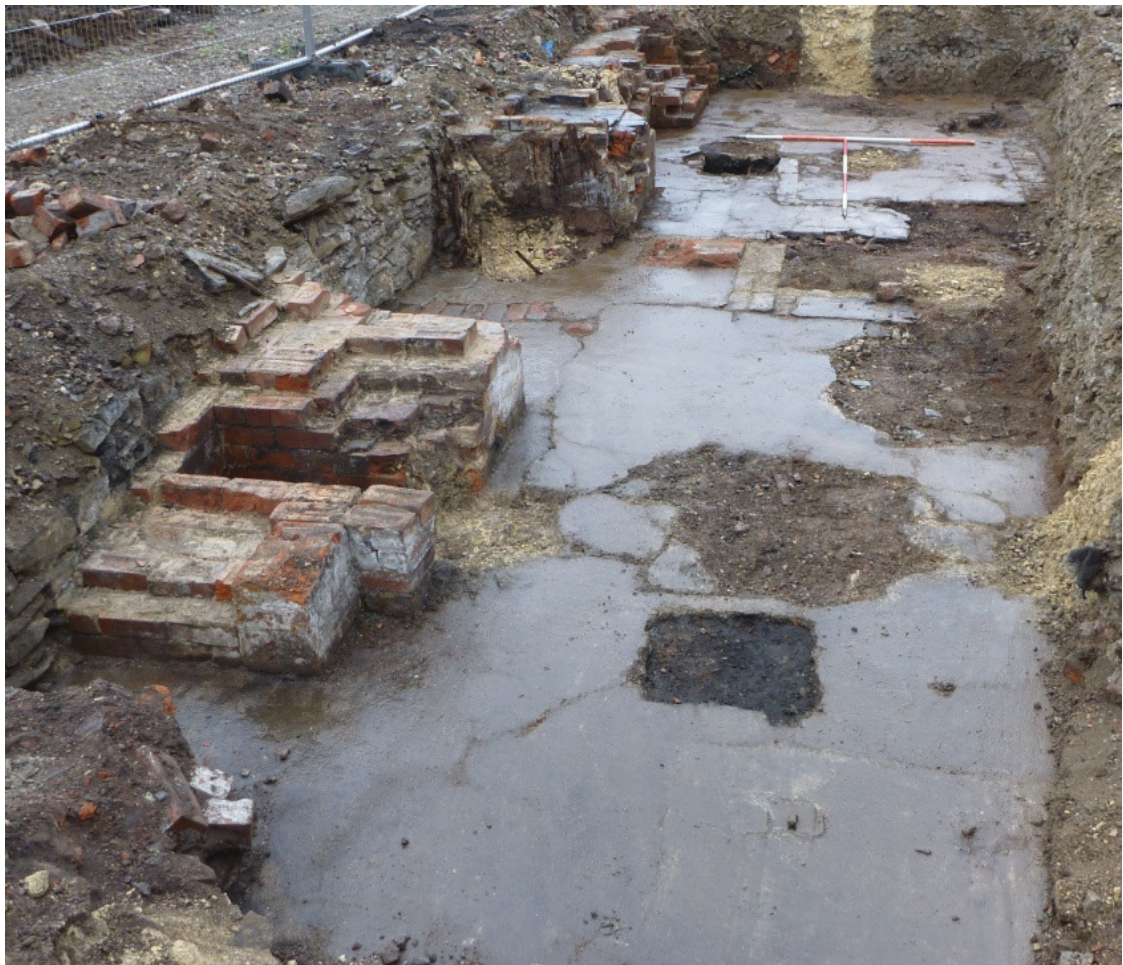
*Plate 16 Trench 7 looking west. 2m scales*

Wall (7010) was aligned east – west, and ran for 4.7m from the eastern trench edge, before veering towards the southern trench edge and running beyond it (its full width was not visible as the majority of it lay outside the same). It had been demolished and reduced to 62.82m AOD, leaving only 0.64m still standing. The wall was constructed from c.11 courses of random sized ‘slabby’ sandstone fragments bonded with a soft pale brown gritty lime mortar (Plate 16).

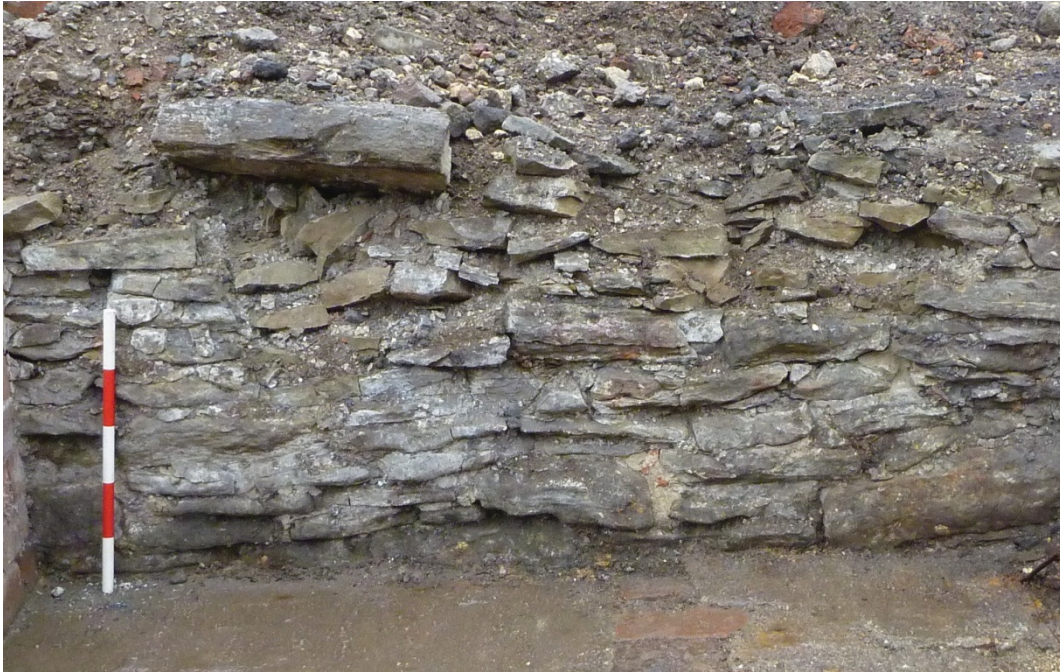
*Plate 17 Elevation of north face of Wall 7010. 0.50m scale*

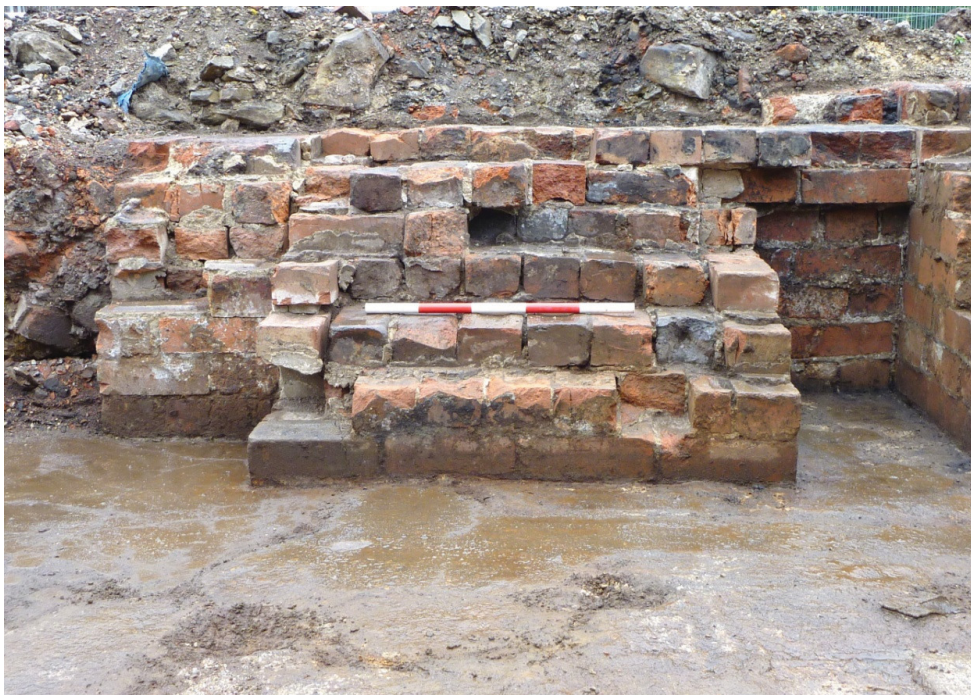
*Plate 18 H1 (7003) looking south with Wall 7010 behind. 0.30 and 0.50m scales.*

Hearth 1 (plate 17) was located towards the eastern end of the trench and protruded 1m from the face of wall (7010). Hearth 1 was 1.98m wide and survived to a height of 0.52m, or to 62.71m AOD. A 0.32m wide, 0.9m long alcove was formed some 0.60m from its eastern extremity. This most likely functioned as a store for coal or coke to fuel the hearth. The working surface of this forge had been removed.

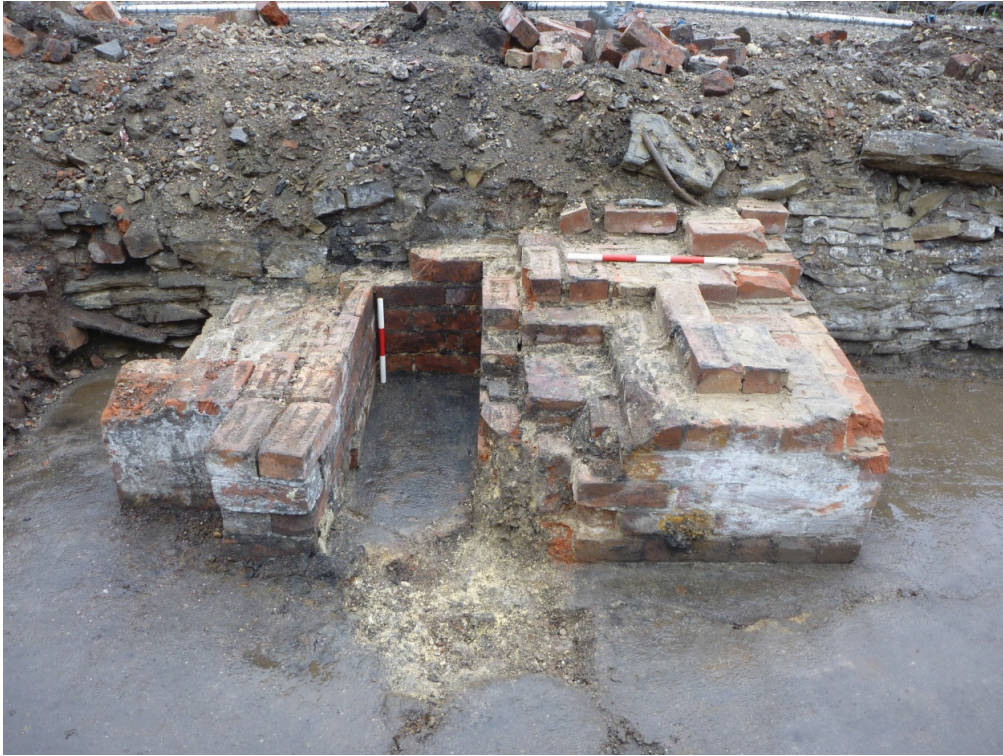
*Plate 19 H3 (7001) looking south. 0.50m scale.*

H3 (Plate 18) was located at the western end of the trench and was also built directly on top of floor (7004). At 1.92m wide it was almost the same width and plan shape as H1, with the alcove located at the opposite side, some 0.20m from its western edge. The alcove was, at 0.72m deep and 0.36m wide, smaller than that of H1, it had the remnants of a unitary brick cover remaining. Despite these differences it was also thought to have been a fuel store. It survived to a height of 0.56 m, to 62.81m AOD, also had its working surface removed.

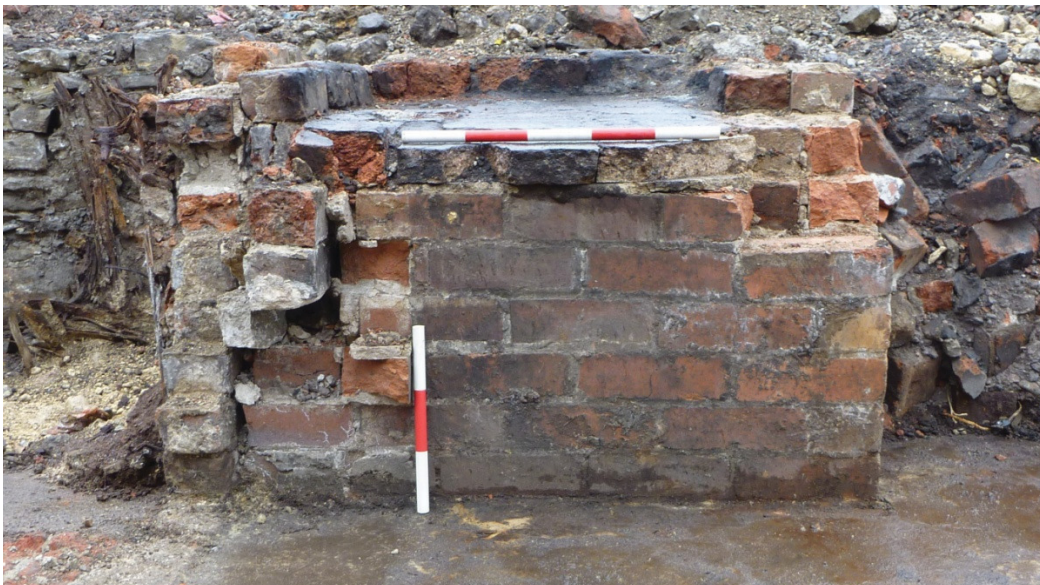
*Plate 20 H2 (7002) looking south. Wall 7009 on left side of hearth. 0.30 and 0.50m scales*
