**Stronvar Garden Cottage,
Stronvar, Balquhidder**

**Planning Application Reference:
2012/0239/DET**

**Report on Archaeological
Standing Building Recording**

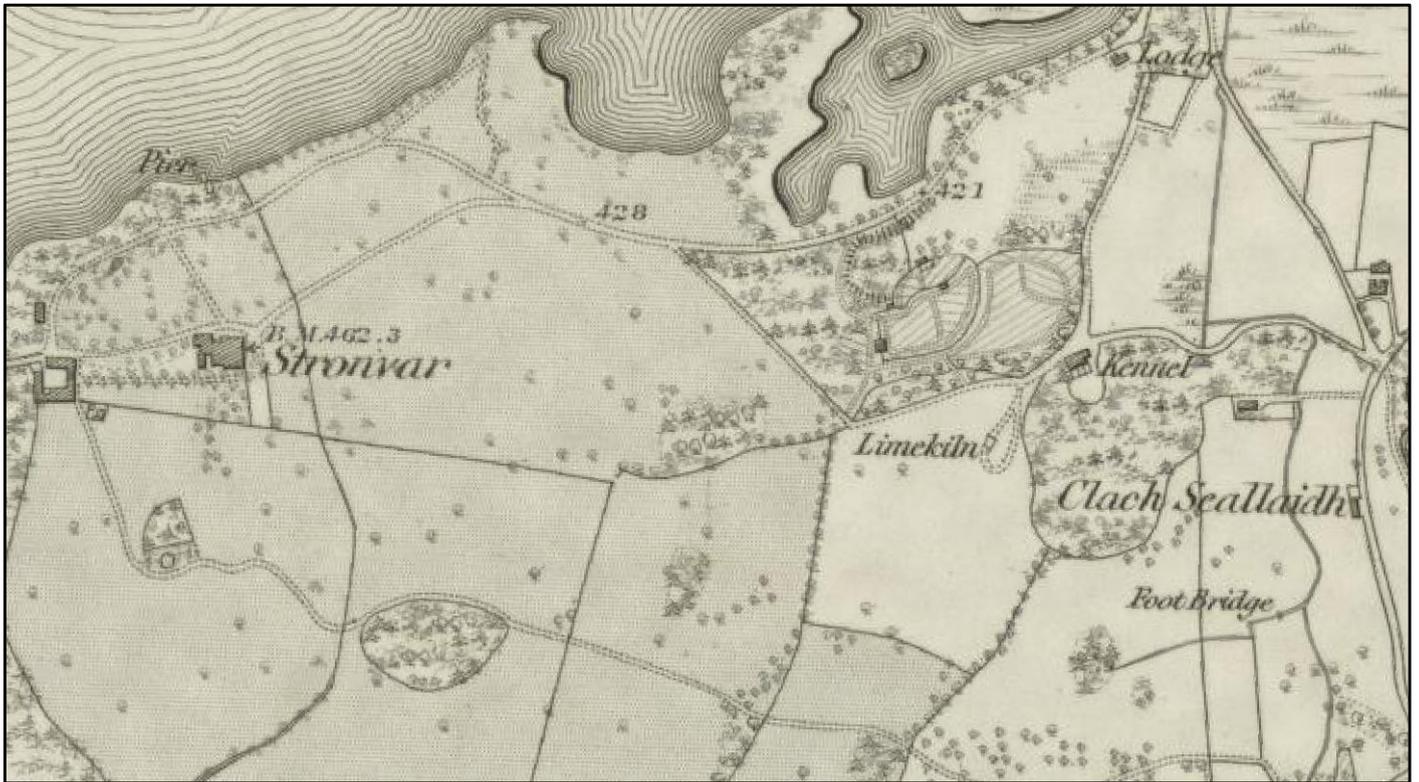
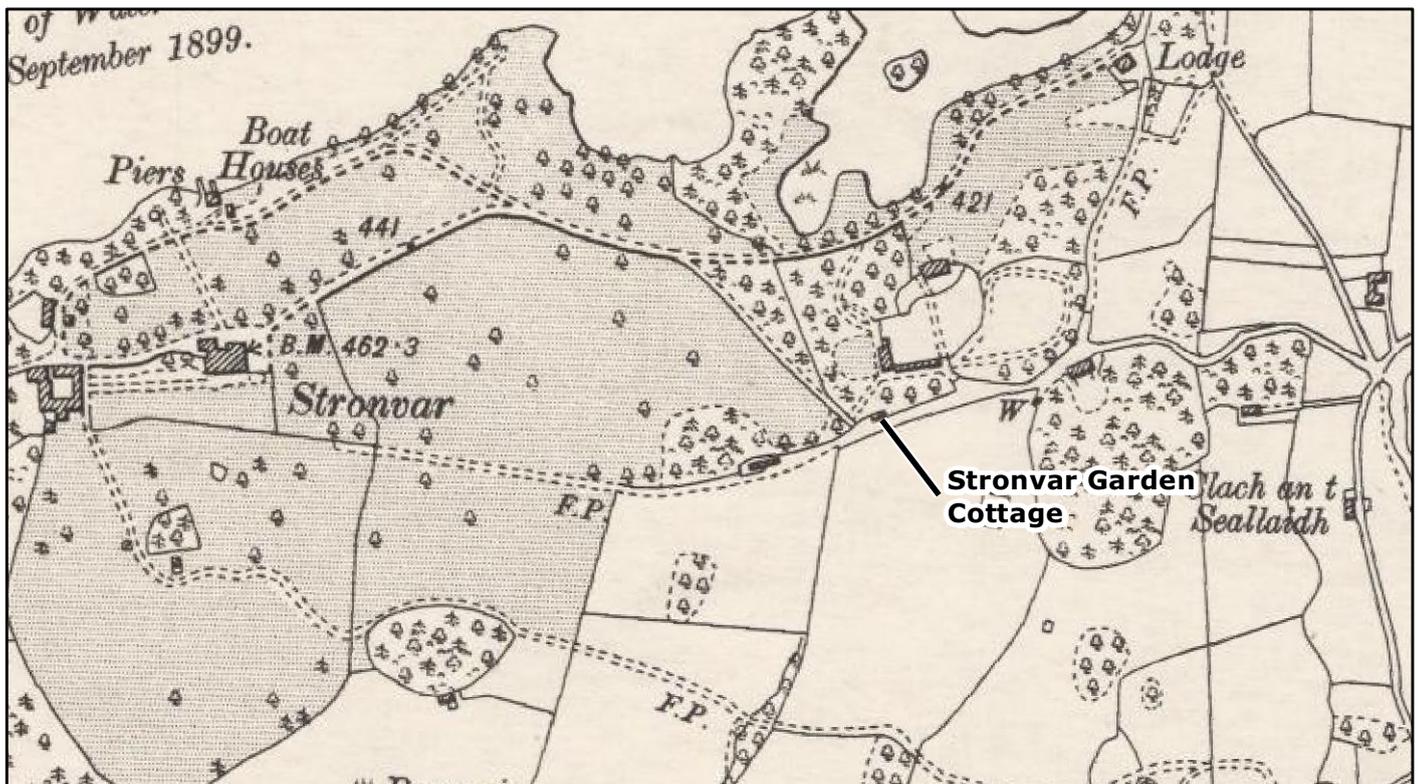
Figure 2: Map regression

1866 Ordnance Survey map

1901 Ordnance Survey map

- 3.5 At the time of the Ordnance Survey revision in 1898 (Figure 2), the structure is shown with a simple rectangular footprint immediately fronting a track with no garden plot; the neighbouring structure to the north-east has been remodelled, the limekiln has been removed, a larger building has been constructed to the west and the kennels are no longer named as such.

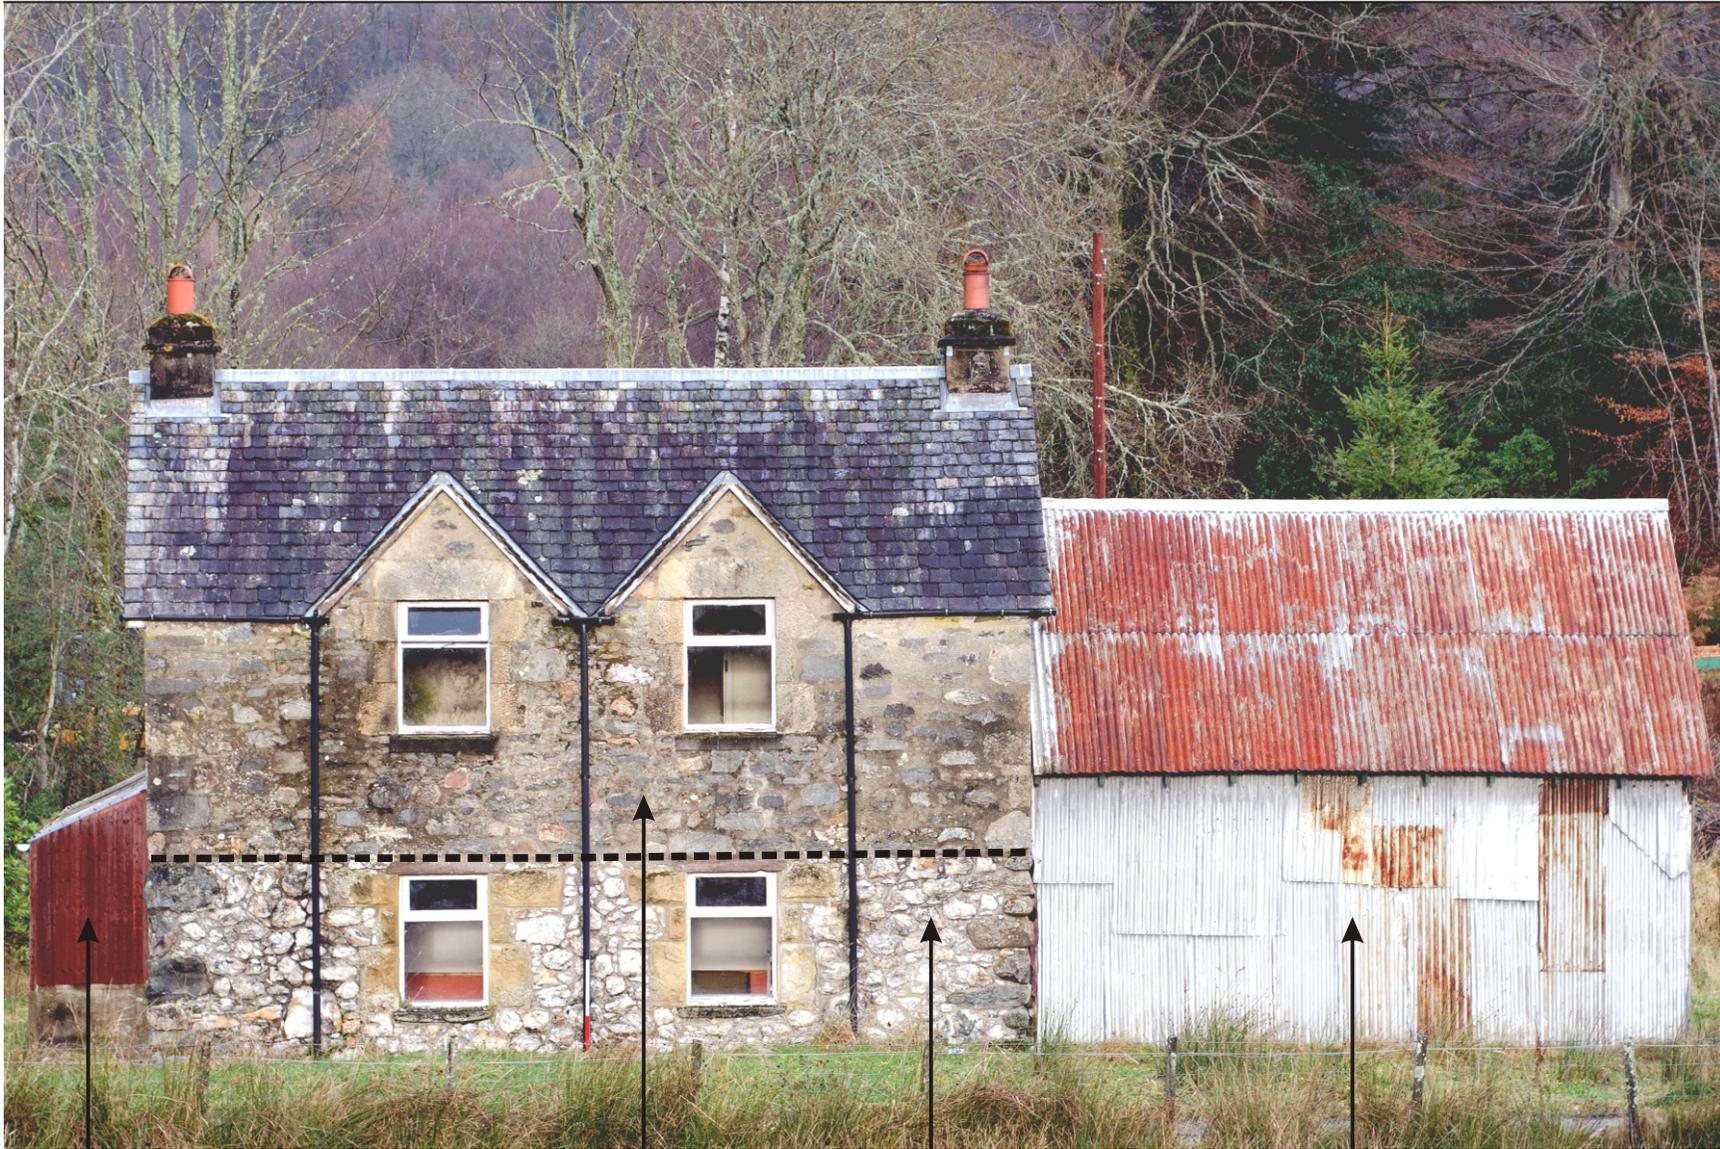
Figure 3: South elevation showing phases

Phase 3

Phase 2

Phase 1

Phase 4

- 5.1 Stronvar Garden Cottage was subject to a Level 2 record (RCHME 1996); it included DSLR photographs of external elevations, which have been marked-up to illustrate the phased development of the building (Figures 3 & 4).

- 7.7 An upper floor was added to the primary building (Figure 3). This was also of randomly coursed, mainly sandstone, rubble. It was mostly obscured by cement render but it was plain that the use of quartz in the Phase 1 south elevation had not been replicated. Again there were two symmetrically placed window openings, directly above those in the ground floor and original to this phase. These were surrounded by honey-coloured sandstone rybats and lintel, the hammer-dressing was again rough, but smoother than in Phase 1 and with no margin (Plate 5). The lintels were much larger than in Phase 1 and the sills were of concrete.

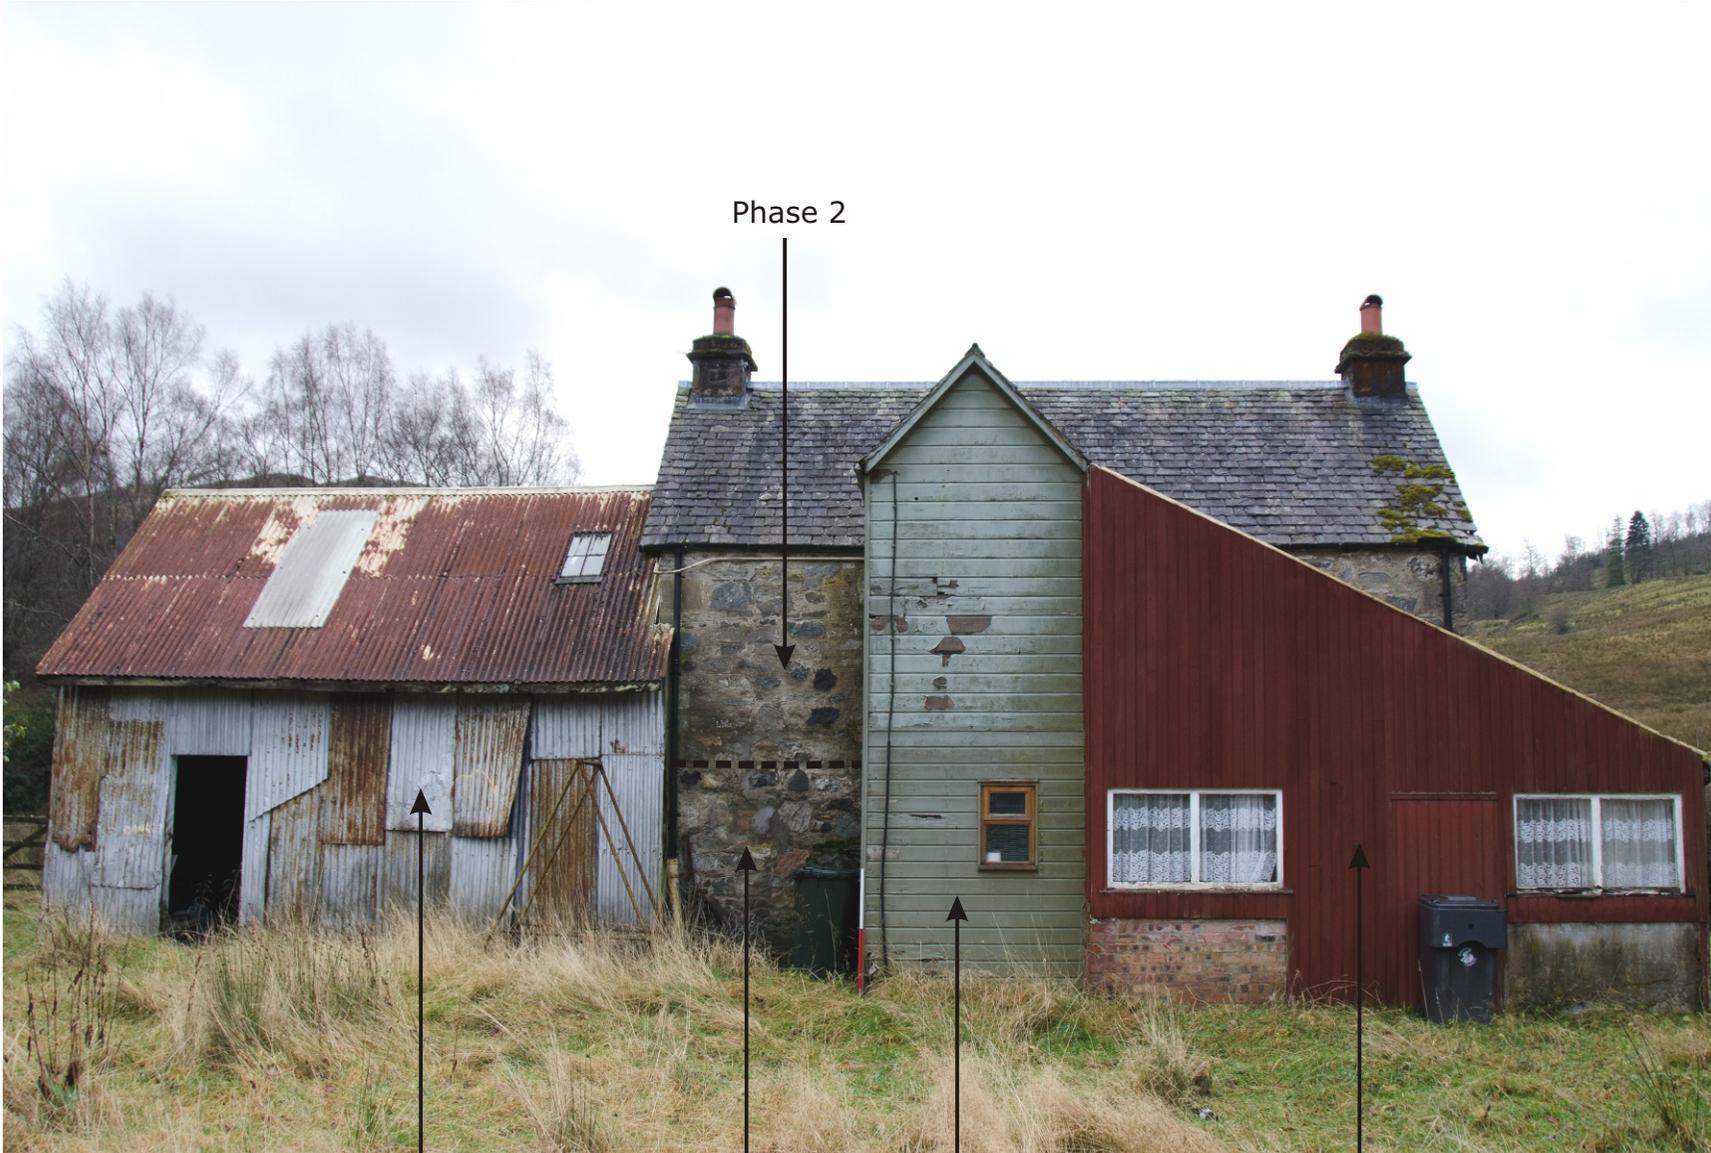
Figure 4: North elevation showing phases

Phase 4

Phase 1

Phase 2

Phase 3

- 7.10 The upper floor was accessed by a timber stair leading to a vertical plank door at the extension's first floor level on its western side (Plate 7). A scar to the left of this door indicated that the stair in use latterly was not original. The lower part of the extension's western wall had been replaced and the whole side painted dark green (apart from the first floor door which was white). Elsewhere the extension was covered with weathered and peeling, originally green, paint (Figure 4).

- 7.19 Externally, the timber of this extension had been treated with red-brown sealant. The brick or concrete was left exposed. There was one 2-pane window, 1.5m wide and 0.8m high, in the west elevation (Plate 14) and two similar in the north (Figure 4). Also in the west elevation was the current door (Plate 14); painted white plywood with central letterbox and plastic handle. In the north elevation, between the two windows, was a former door opening. The extension was built to cover the stair up to the 1st floor so rose in height from 2.2m in the west to above the eaves of the Phase 2 stone building (Figure 4).

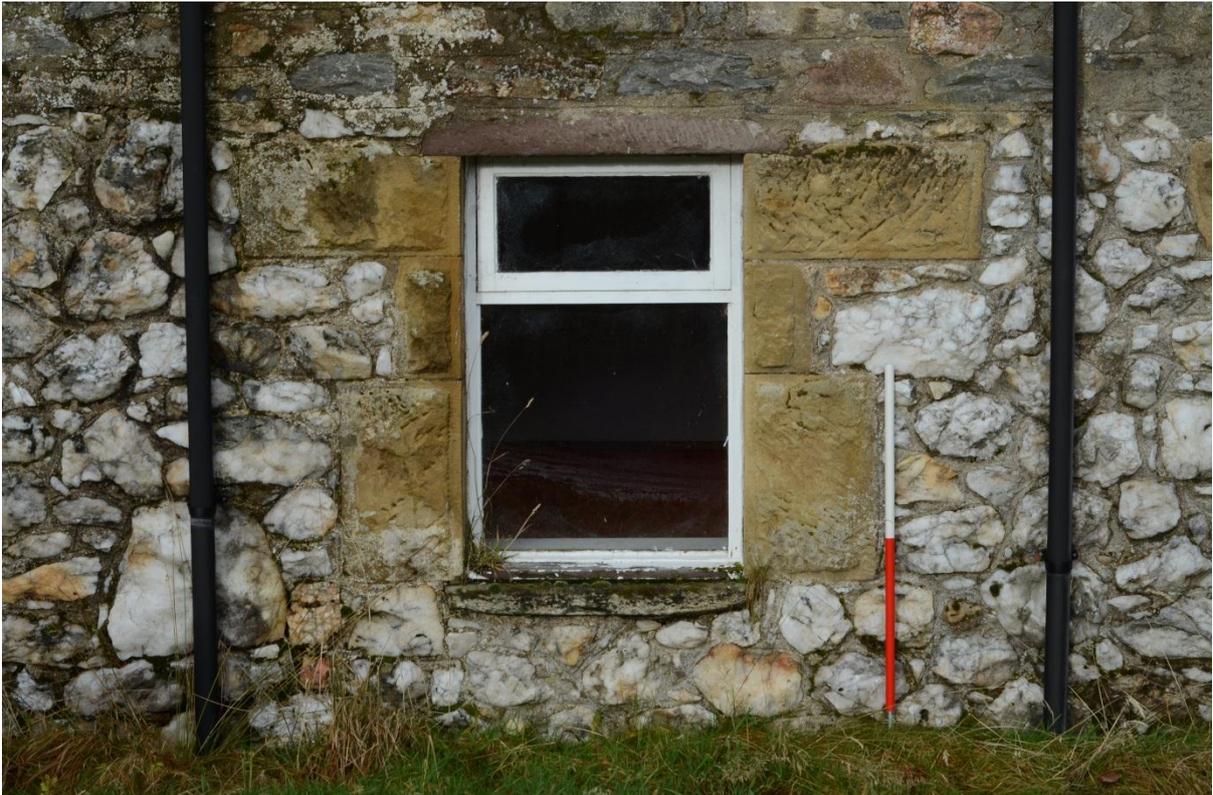
Plate 1: Phase 1 western window exterior (Shot 41)

- 7.3 The south elevation was of random rubble build and coursing using white quartz boulders bonded by an off-white lime mortar with grit. The use of quartz was rare in the other elevations and this appears to have been a deliberately decorative use of material along the building's most visible aspect. This is presumably the reason the lower part of the elevation was not covered in a later cement render. At the corners were large, unworked sandstone boulders used as quoins (six to east and seven to west). There were two original window openings set symmetrically and placed 2.3m from each corner with an external width of 0.8m and a height off current ground of 1.25m. Both had honey-coloured sandstone rybats (roughly hammer-dressed with flattened chiselled margins) to either side, roughly worked pinkish sandstone lintels and grey sandstone sills (Plate 1). The matching of colours in both windows appeared to be deliberate and presumably for decoration.

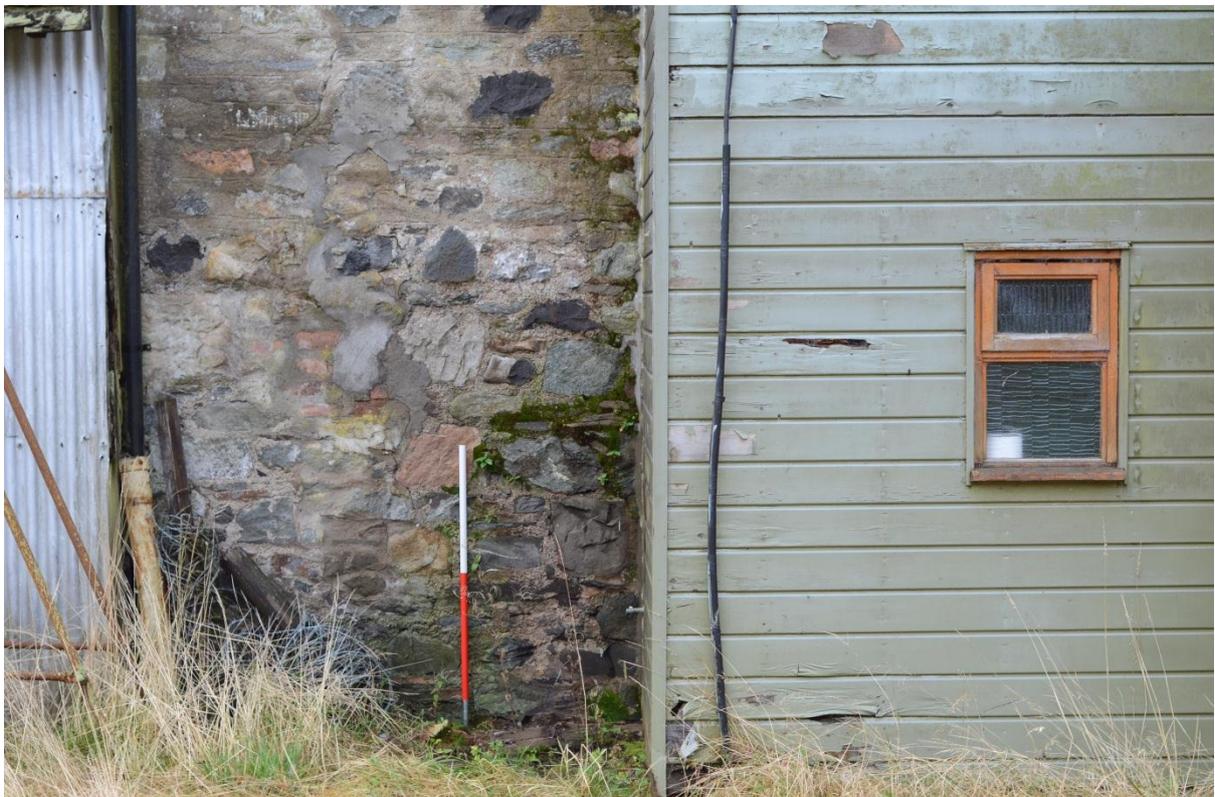
Plate 2: North-east corner showing variation in quoins between Phase 1 & 2; Phase 2 window exterior in Room 3 (Shot 47)

- 7.4 All the other Phase 1 elevations had been subject to cement rendering to at least some degree, but it remained possible to note where the Phase 2 upper storey had been added, by a variation in both the amount of render (it had been more liberally applied to the upper storey) and also the style of corner quoins (Figure 4; Plate 2 & 3). The doorway into the cottage was in the south end of the west elevation behind a later extension (Figure 5); 1.06m wide and 2m high. Roughly-faced sandstone lintel and rybats of various colours were visible through the render. No original door or frame survived and the replacement was plywood with glass. No other external features were apparent; and it seems likely there were none. There was some structural cracking and patching noted at several points in the north elevation. At one point, in the north-eastern corner this was with brick and concrete (Plate 2).

- 7.11 The extension had two window openings, both original and with their timber surrounds bearing the same weathered green paint. The ground floor window (Plate 2) faced north and had a width of around 0.4m and a height of 0.7m. The 2-pane pine frame and patterned glass was not original. At the first floor was a 6-pane frame facing east, 0.6m wide by 0.8m high, which was original (Plate 8).

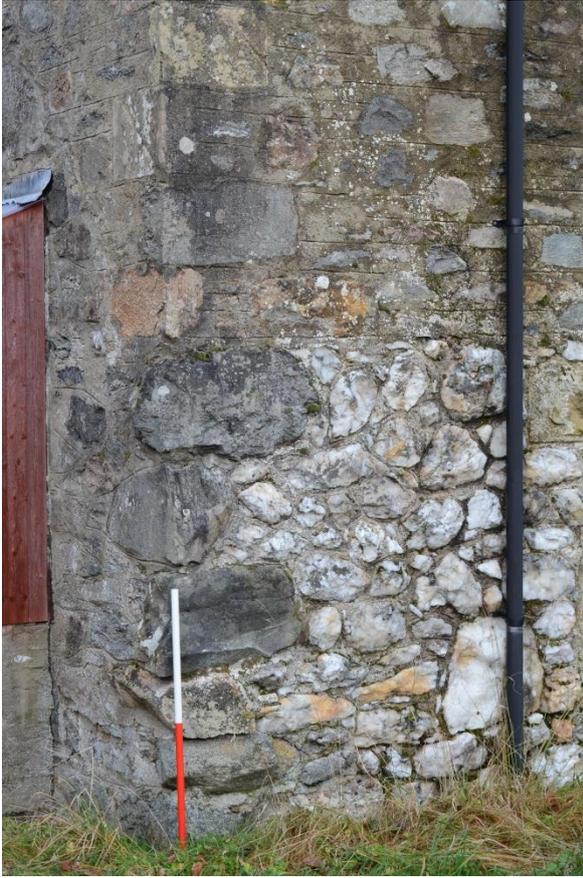
Plate 3: South-west corner showing difference in Phase 1 & 2 quoins (Shot 49)

- 7.8 The corner quoins were dressed, in contrast to those of Phase 1 (Plate 3) and were a variety of stone types and dressings, some quite fine; presumably they were recycled from elsewhere. The pitched slate roof had wall dormers above each window (Figure 3) and a chimney slightly inset and centrally placed in the east and west elevation. The chimneys were square and of faced sandstone with a decorative projecting ledge near the top and ceramic pots (Plate 6). The roof had lead flashing and plastic drainpipes around the eaves. Three plastic outflows ran down the south elevation and two down the north.

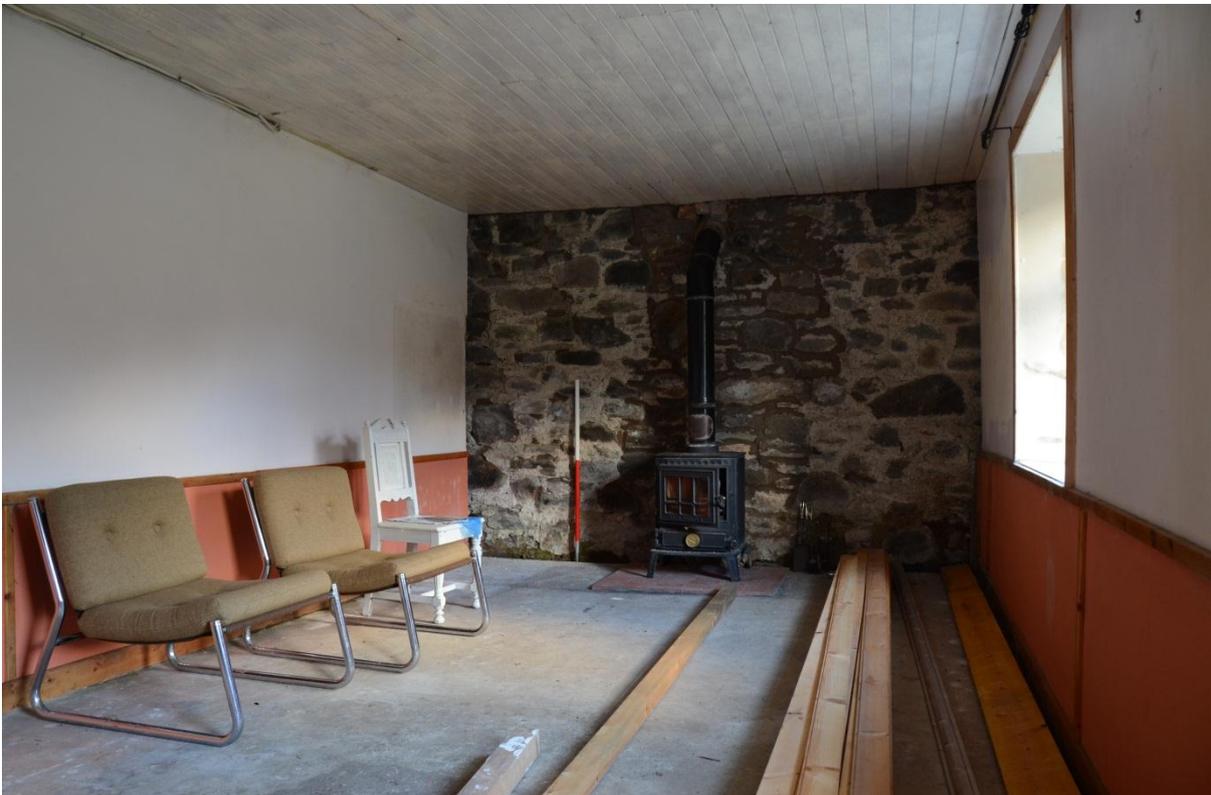
Plate 4: Room 1 showing east wall and scar (Shot 71)

- 7.5 The interior consisted of a single room (Room 1; Figure 5); measuring 7m by 3m with a height to roof of 2.25m. All walls had modern plasterboard covering apart from the east, which was exposed stone (Plate 4). Here a scar where an original fireplace had been located was noted behind a modern stove and ceramic tile stance. The floor was concrete. The two window frames were pine and 2-pane (the bottom fixed, the upper opening outward); presumably they had replaced earlier sash and case windows. The embrasures were lined in plasterboard. The roof was covered with white painted timber cladding, which presumably had replaced original plaster.

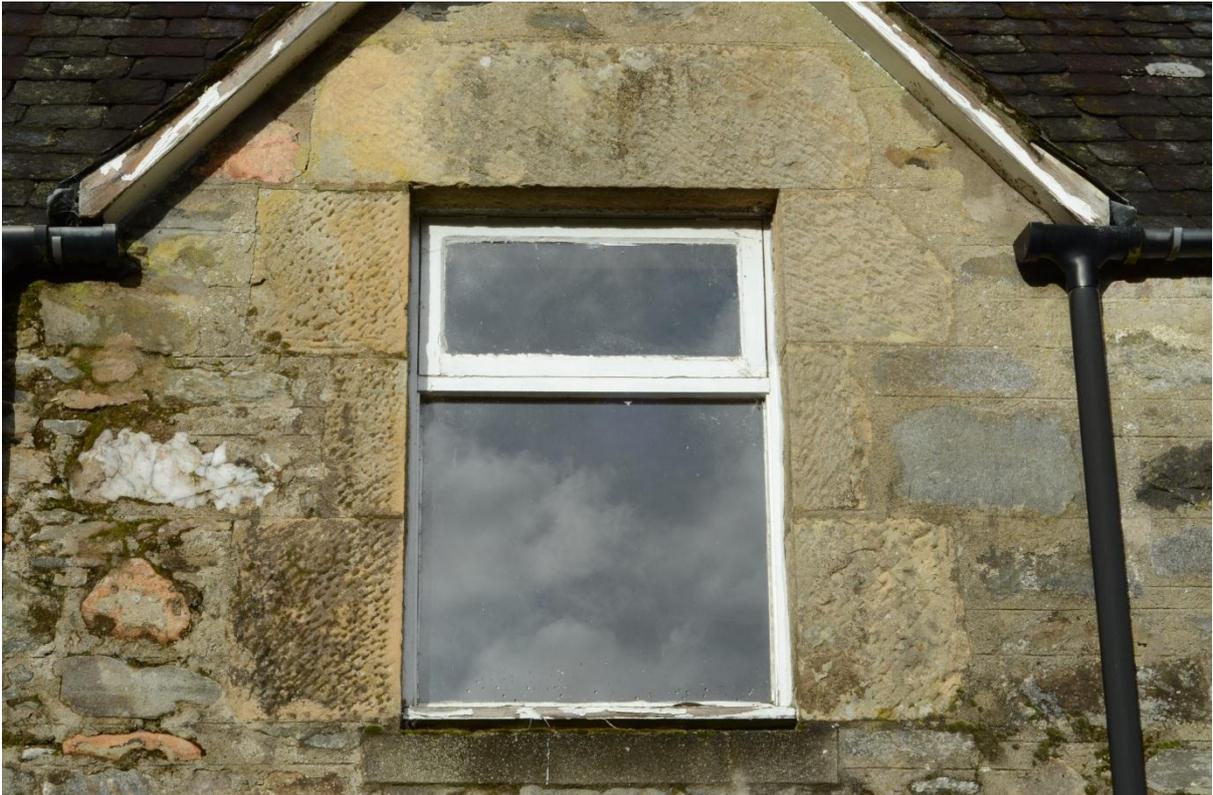
Plate 5: Phase 2 (upper floor), eastern window exterior (Shot 36)

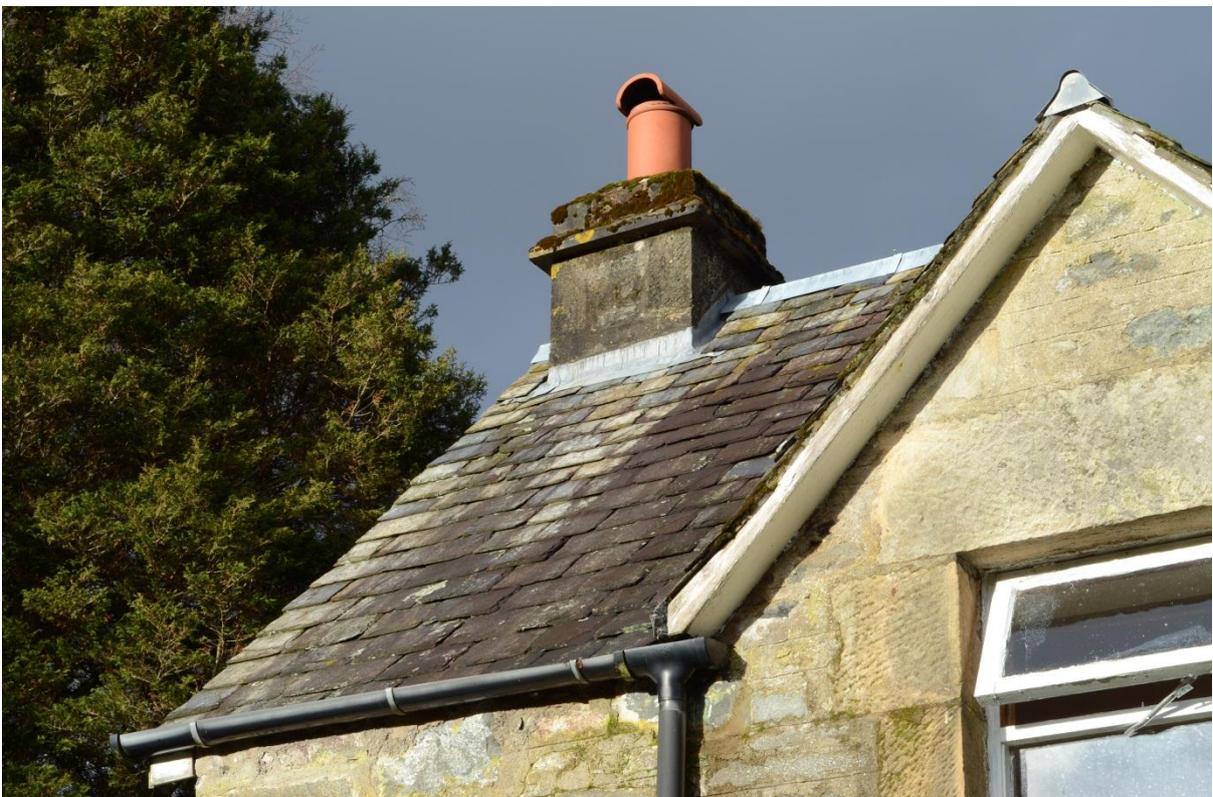
Plate 6: Phase 2 roof and chimney (Shot 40)

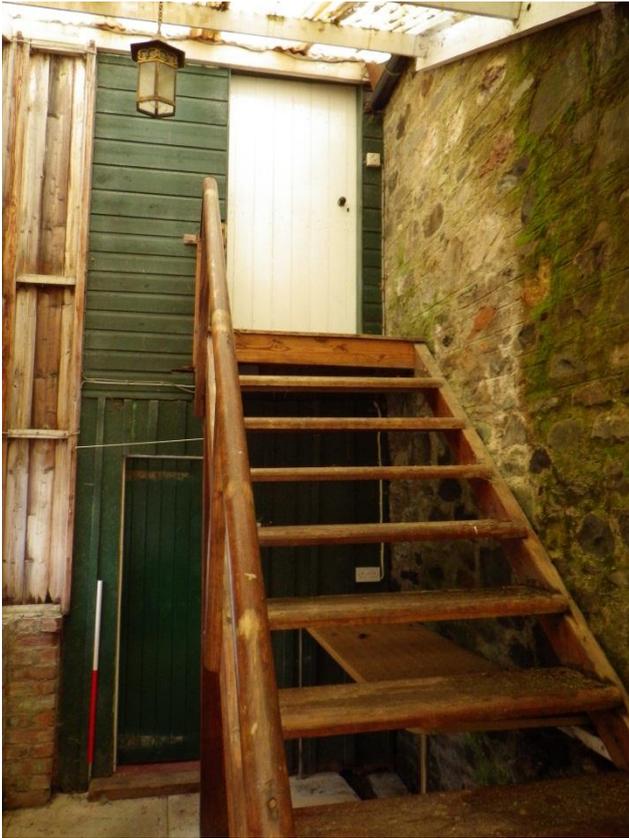
Plate 7: Entrance door (exterior) into Phase 2 upper floor and timber stair (Shot 107)

door of the same design as that seen throughout the Phase 2 upper floor (Plate 7). In the absence of any evidence otherwise, it is assumed that this small room had always been accessed through its western wall; perhaps as an external WC shared between the two properties. The room is described fully as part of Phase 3 entailed its conversion into an internal WC.

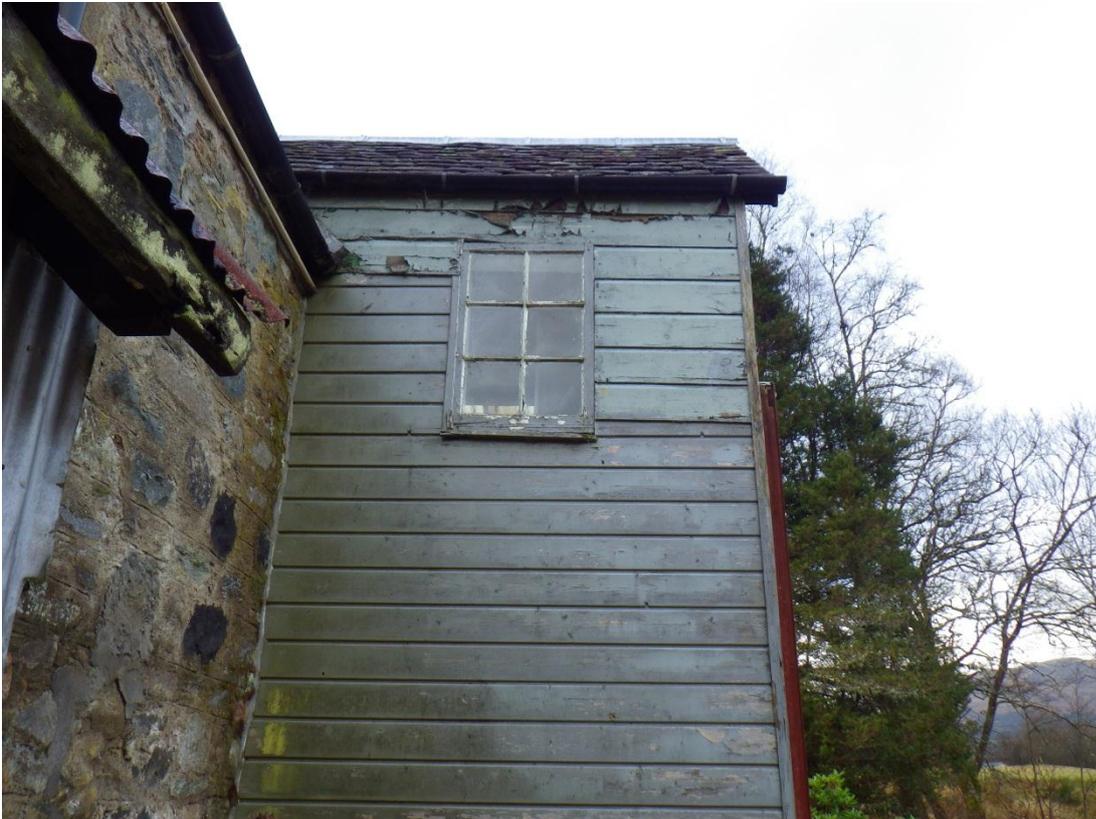
Plate 8: Phase 2 extension window in east wall (Shot 90)

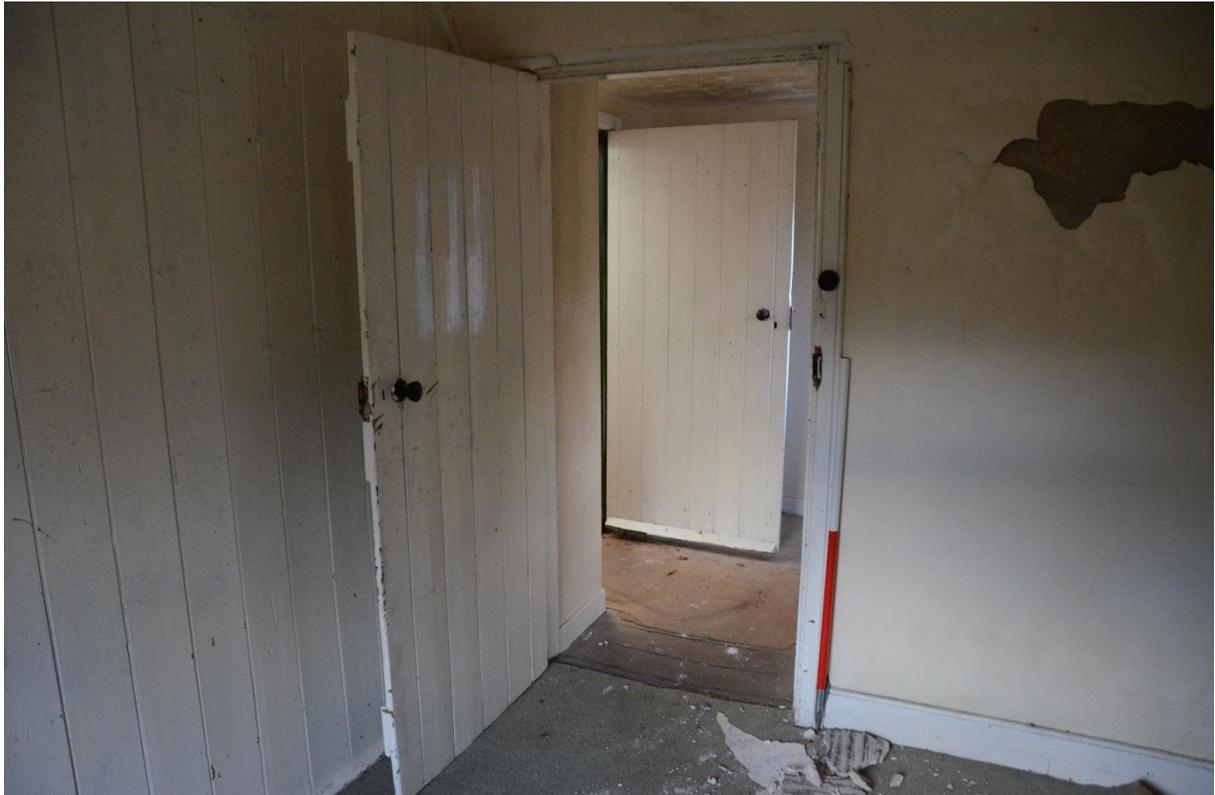
Plate 9: Room 4 door to vestibule and entrance into Phase 2 extension beyond (Shot 69)

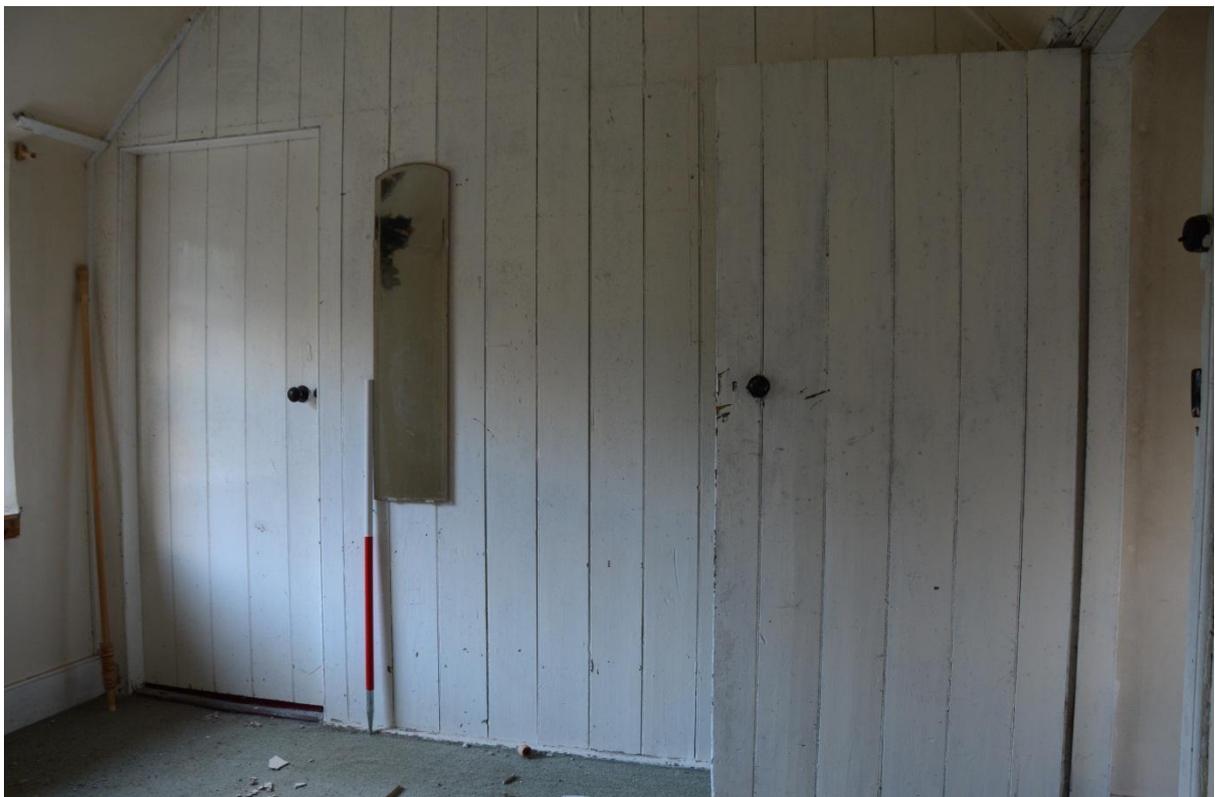
Plate 10: Room 4 door to vestibule and door to Room 5 beyond in Phase 2 upper floor (Shot 75)

7.16 The stone fireplace and exposed wall in Room 5 suggested that it may have been used latterly as a living room. A dressing mirror affixed to the wall in Room 4 (Plate 10) suggested it may have been a bedroom. In its original design it seems more likely that these uses would have been reversed; with the living space adjacent to the entrance and the bedroom in Room 5 (Figure 5).

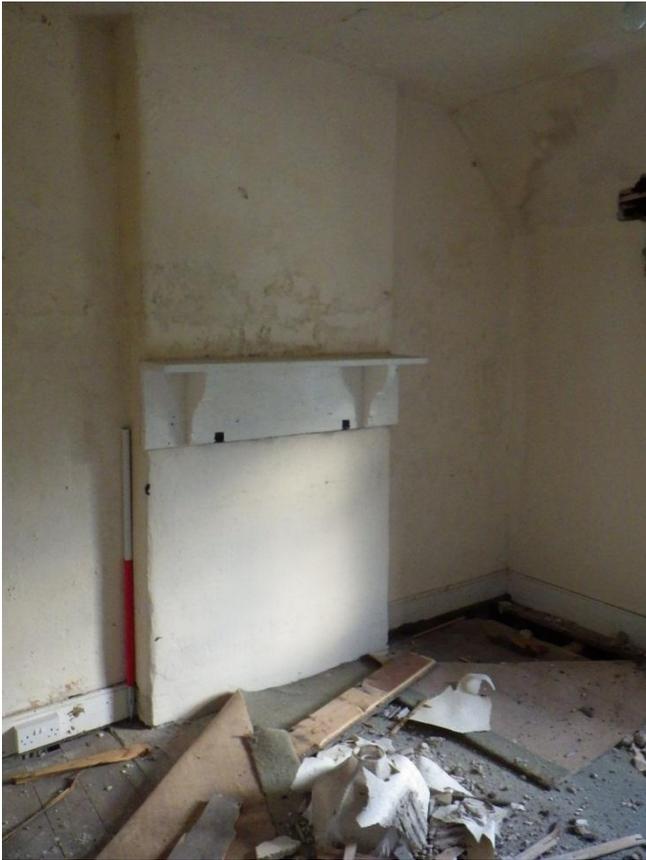
Plate 11: Chimney breast and white mantel in Room 4 (Shot 120)

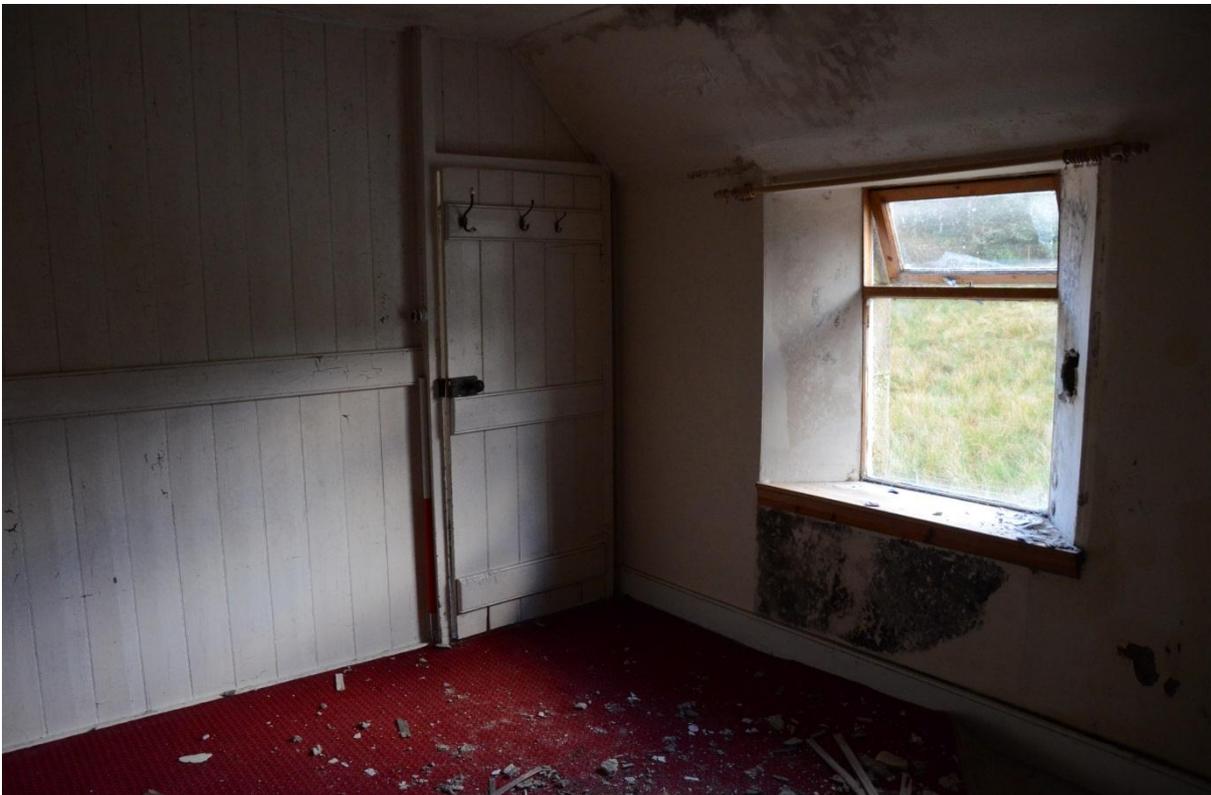
Plate 12: Room 5 window and door to Room 4 (Shot 70)

7.13 Room 4 and the vestibule are described together. The vestibule measured 1.7 by 1.7m with a height to ceiling of around 2m. The east wall had the 6-pane east-facing window noted above and a modern cupboard with electricity meter. There was a round Bakelite light switch on the door frame to the right on entry and the door opened to the left; the entrance into the main body of Room 4 was on the right. The door into Room 4 opened to the right and there was another Bakelite light switch on the door frame to the left. Room 4 was almost square (3.1m by 3.2m). The walls and ceiling were lath and plaster throughout apart from an interior wall shared with Room 5, which was vertical timber planks (Figure 5; Plate 10). There were white painted wooden skirting boards with simple decorative beading, 0.1m high in Room 4. The skirting boards were slightly lower and without beading in the vestibule; the walls were cream throughout. The ceiling was coombed with a maximum height of 2.7m and central modern light pendant. The floor was timber board mostly obscured by grey carpet. The east wall had a projecting chimney breast (Figure 5), centrally-placed and extending out from the wall by around 0.1m with a width of 1.2m. It was plain from a mostly obscured cement base in the boards, extending out some 0.8m, that a fireplace had formerly been present here and there was a wooden shelf and mantel painted white about 1m above this base (Plate 11). The window frame (2-pane and pine) fitted into the southern wall was not original and the embrasure was lined with plasterboard; identical to those in Room 1 and Room 5 (Plate 12).

7.14 The door to Room 5 was set in the south of the plank interior wall, which had reinforcing planks and door frame visible from the interior of Room 5 (Plate 13; Figure 5). The horizontal planks here had some simple decorative beading. The door opened to the left and another matching round Bakelite light switch was present to the right on entry. The room was slightly longer than Room 4 (3.8m by 3.1m) and with the same roof height. It had the same decoration as Room 4 with the exception of a deep red carpet and the west wall, which had been left as exposed stonework (Plate 13). The stonework was repointed and the fireplace was modern with artificial stone, wooden mantel, cement base and metal grate. Presumably the wall was exposed and repointed when this fireplace was fitted. The original chimney breast behind was narrower than that in Room 4 (around 0.8m wide). As noted above, the window frame fitted into the south wall, like all those in the stone structure, was not original and the embrasure was lined in plasterboard (Plate 12; Figure 5).

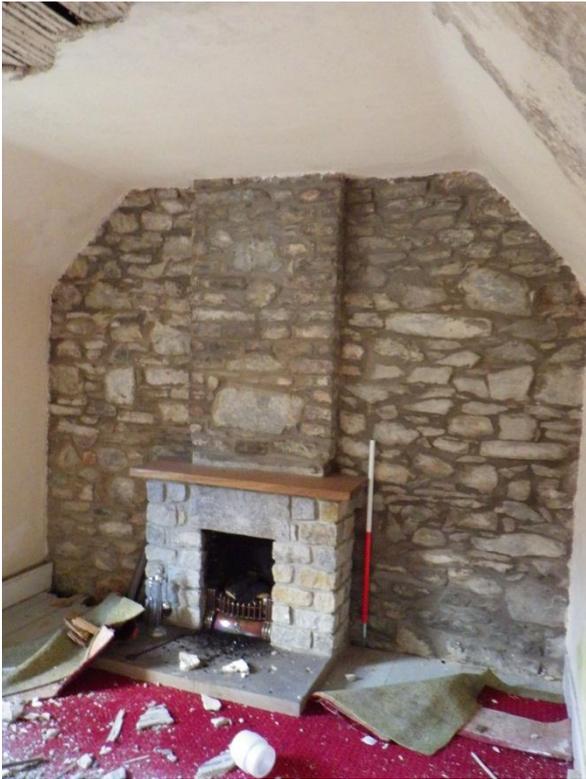
Plate 13: Room 5 western wall (Shot 122)

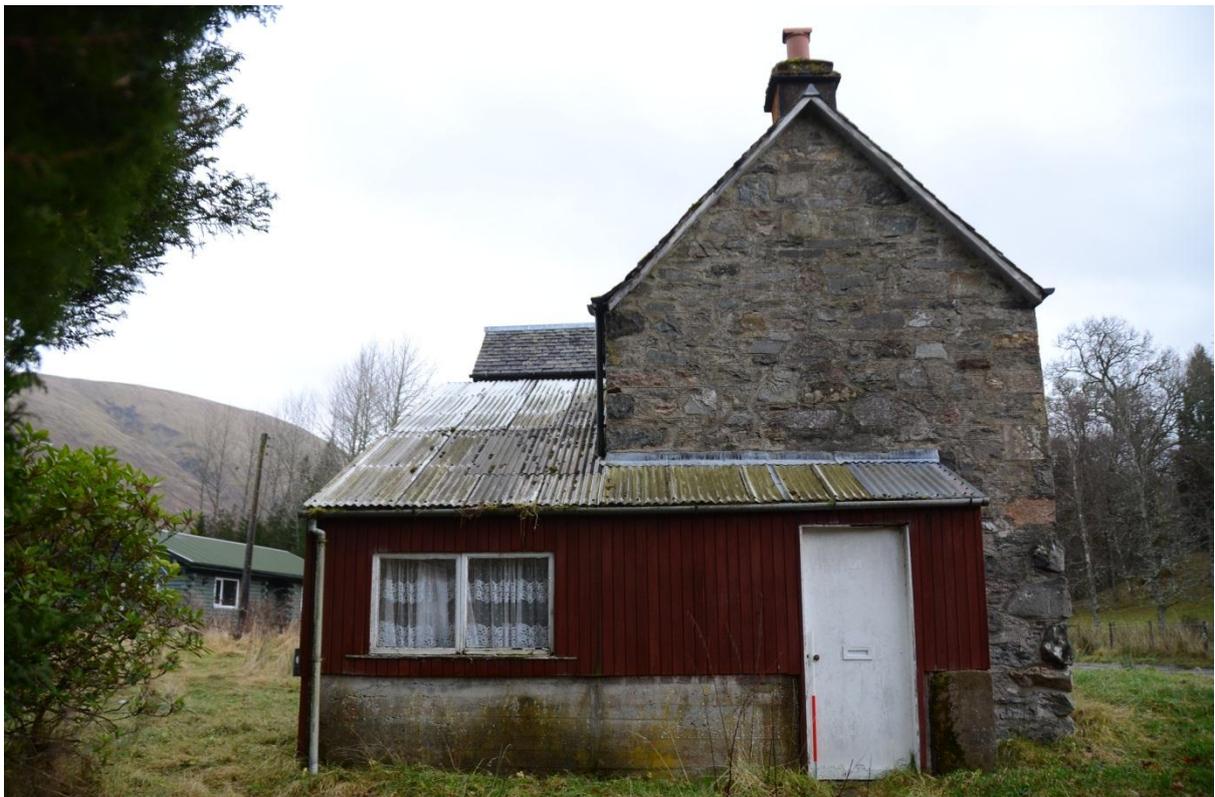
Plate 14: West elevation (Shot 23)

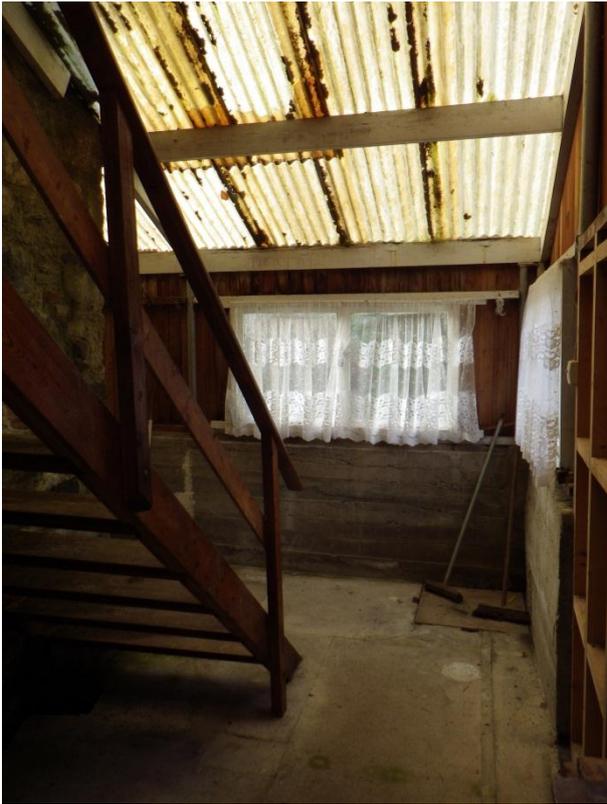
Plate 15: Room 2 general view (Shot 102)

- 7.20 Room 2 was in effect a utilitarian corridor and not a living space (Plate 15). Surfaces were bare and exposed; the floor cement. The only decoration seems to have been the painting of the former external western wall of the Phase 2 extension dark green (Plate 7). There was a laminate work-surface placed under the wooden stairs to the 1st floor. As noted above, the wooden stairs were not original and had presumably been replaced some time after the erection of the Phase 3 extension as the dark green paint noted above did not extend over the attachment scar left by the original stair.

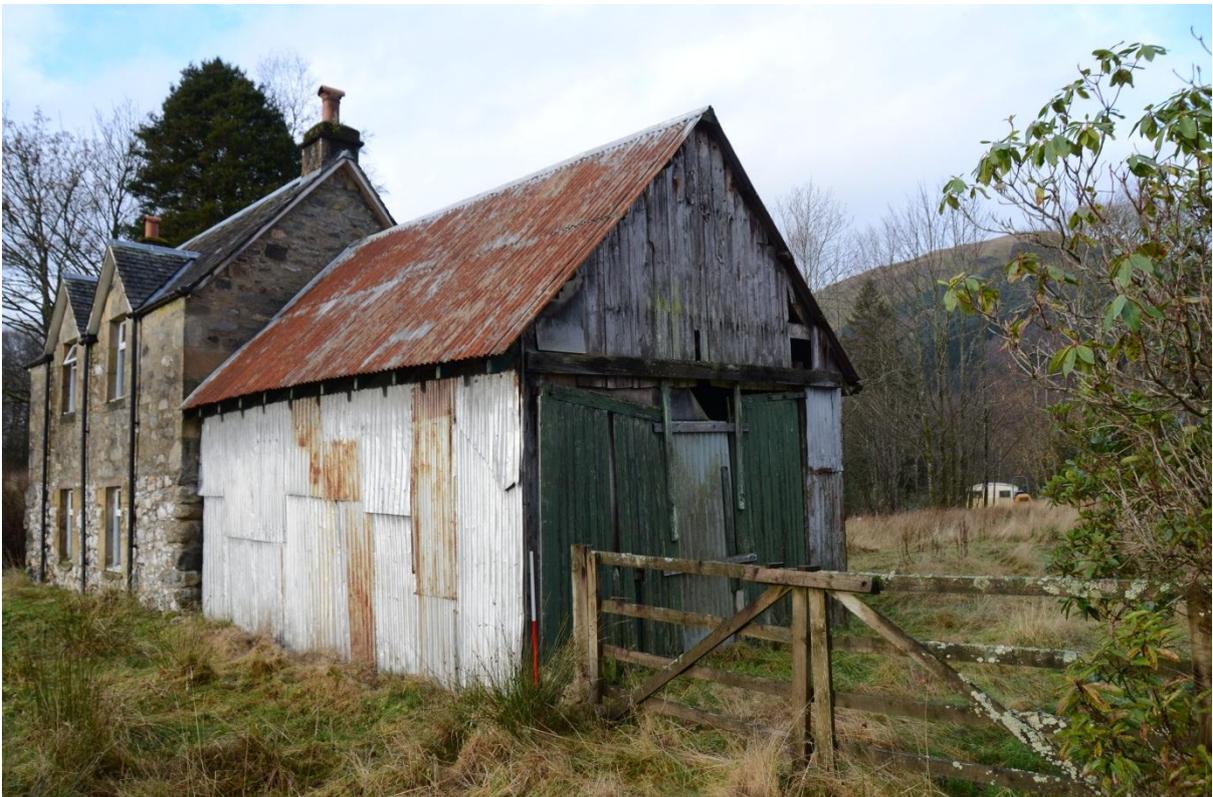
Plate 16: Phase 4 extension (Shot 28)

roof about 1 m lower and mirroring the Phase 2 roof-line (Plate 16). There was a wooden plank gable above double wooden doors to the east; the double doors had been latterly barred. The roof itself, and the remaining sides, were patched haphazardly in corrugated iron, which was presumably re-used from elsewhere. A single door allowed access to the interior on the northern side. There was a concrete floor. The walls were of vertical planks with some horizontal supports. The roof was supported on a timber A-frame.
