**Former Barnton Hotel,
562 Queensferry Road,
Edinburgh**

**Planning Application Reference:
12/01941/FUL**

**Report on Archaeological
Standing Building
Recording**

**Client: McCarthy & Stone
Retirement Lifestyles Ltd**

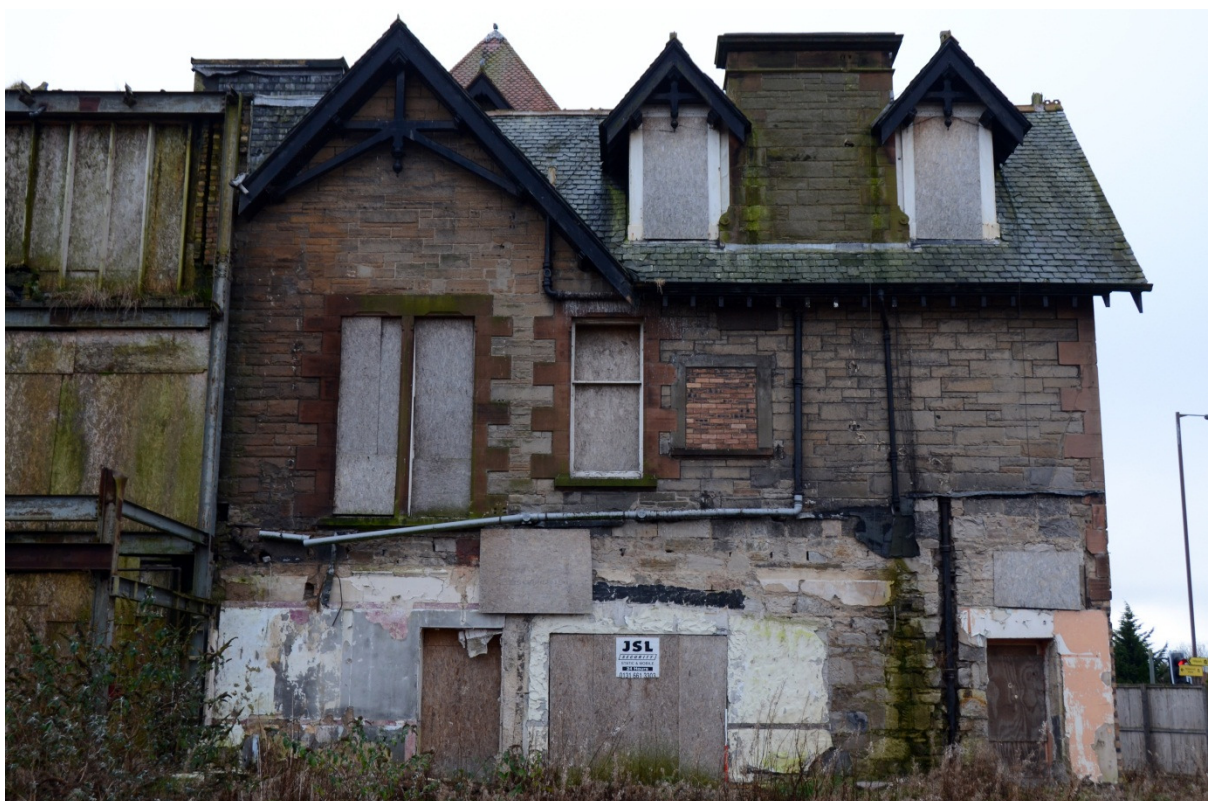
Plate 8: Visible parts of the north elevation (Shot 030)

- 7.7 A large part of the northern elevation was obscured by modern extensions when described in 2002 and 2005. The eastern part, where modern extensions had been attached to the original building, was obscured by supporting steel and boards during this survey. What was assessed in 2005 (Simpson & Brown) as an original ground floor extension at the northwest (and nothing to suggest otherwise was noted

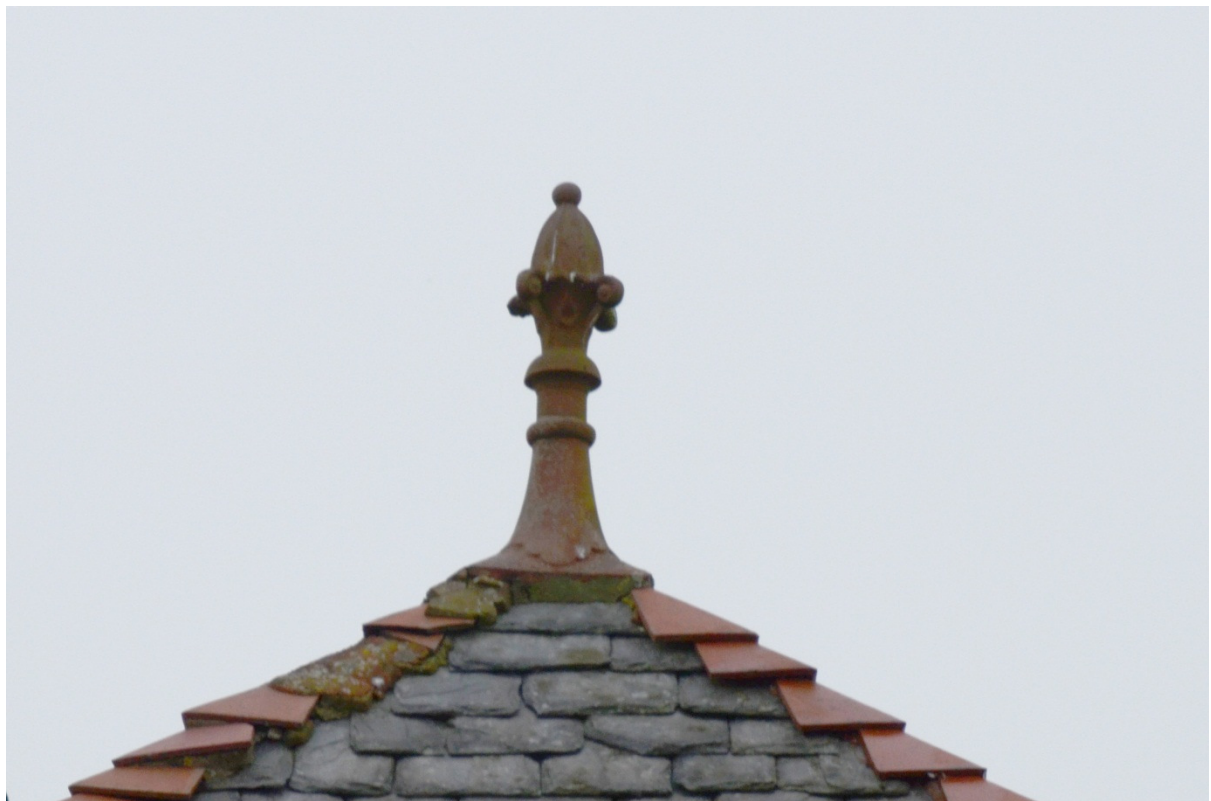
Plate 10: Surviving roof finial (Shot 038)

- 7.10 Some modifications also appear to have been effected to the two most southerly ground floor windows in this elevation. The lintel of the most southerly did not have the usual decoration and the quoins on the north side were stumpy. However, an undated photograph (Figure 2) shows this window with the usual decoration and it must simply have been repaired. The window to the north had been converted to a door (Plate 9). In contrast the first and attic storeys were well-preserved and this elevation is also of note in that it allows a glimpse of a surviving iron finial on the roof (Plate 10).

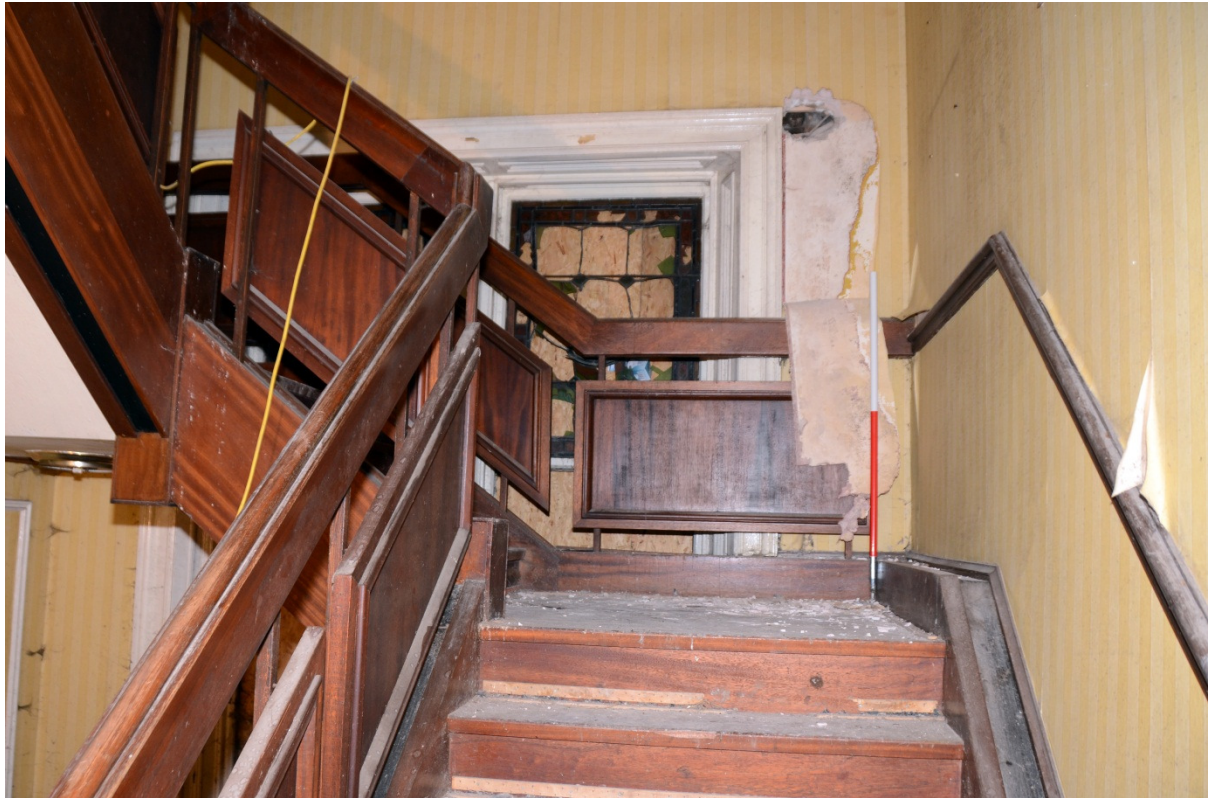
Plate 19: Stair to 2nd floor obscuring original window (Shot 086)

- 7.27 Originally the main staircase only extended from ground to 1st floor. An extension to the 2nd floor was built after 1951 (Plate 19; Figure 4.3). Although of a similar style to that from the ground floor to the first, the treads in the extension were of wood rather than stone. The bannisters were metal and dark wood throughout. The extension to the 2nd floor had obscured much of a fine, 3m-high bipartite stained glass window in the north wall. Only small parts of the upper section survived, but the design had been red at the edges with alternating designs of foliage and a four-petal flower (Plate 20). Little can be said about the main body of the window apart from that it was green and had an oval centrepiece. The panelled surround survived. The stairwell roof was white plasterboard with a central rose. The walls were covered in yellow striped wallpaper to base. The beaded surrounds of timber panels (painted white) protruded from the wallpaper from the ground to first floor but not in the extension (Plate 21). The doors to both floors were later fire doors. The balustrades at the base may be original (Plate 22).

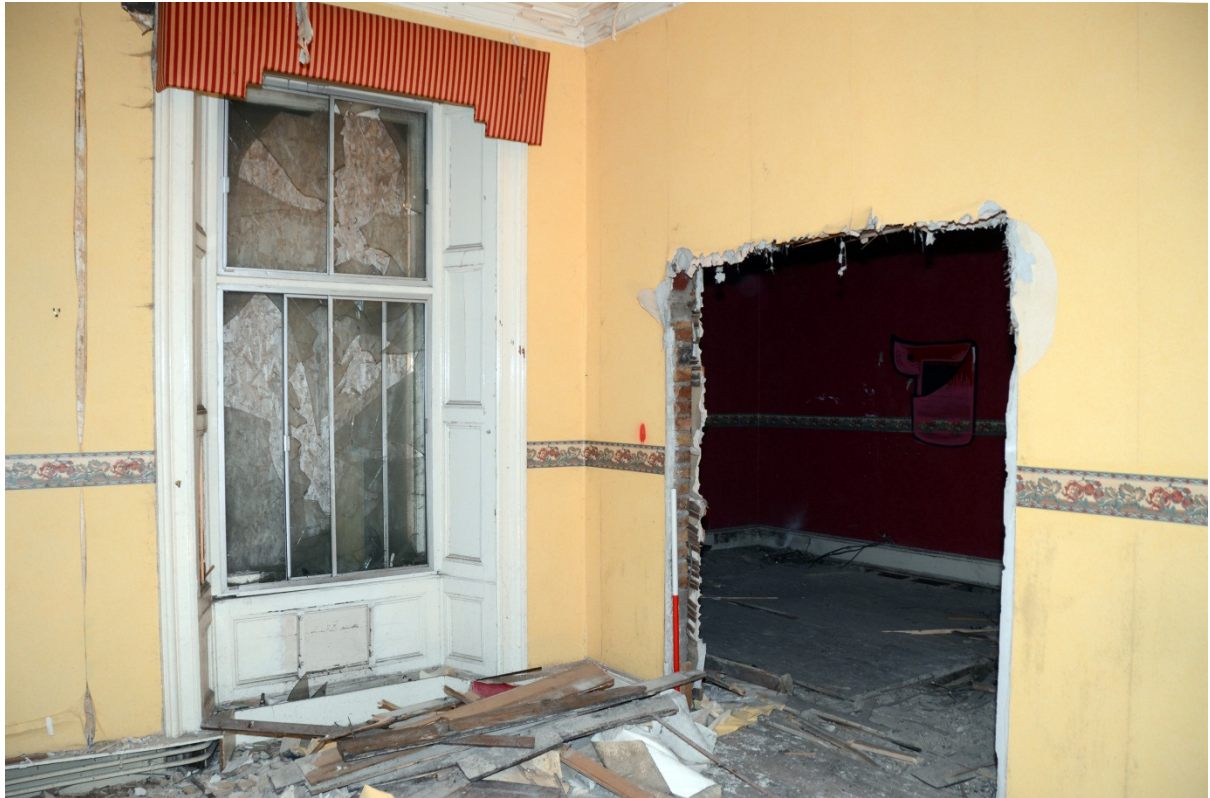
Plate 25: Room 16 showing window and toward Room 17 (Shot 103)

- 7.32 The decoration and arrangement of Rooms 16 & 17 suggested another suite here, but the entrance door was missing along with any name-plate. A double-door entry had been crudely knocked through from Room 16 to 17 to form a single space (Plate 25). The embossed floral wallpaper seen elsewhere was on the ceiling in both rooms. Room 16 had simple coving painted white and similar to that seen in Room 14 and 2 (so original; Plate 26). There was yellow wallpaper in Room 16 and red in 17 and both carried a yellow floral frieze. The press blocked in Room 15 was accessed from this room instead; an arrangement that is not original according to the plan of 1951, even though the architrave in Room 16 looked original. The white skirting boards could be original. A single window in the west wall had the usual timber panelling, painted white (Plate 25).

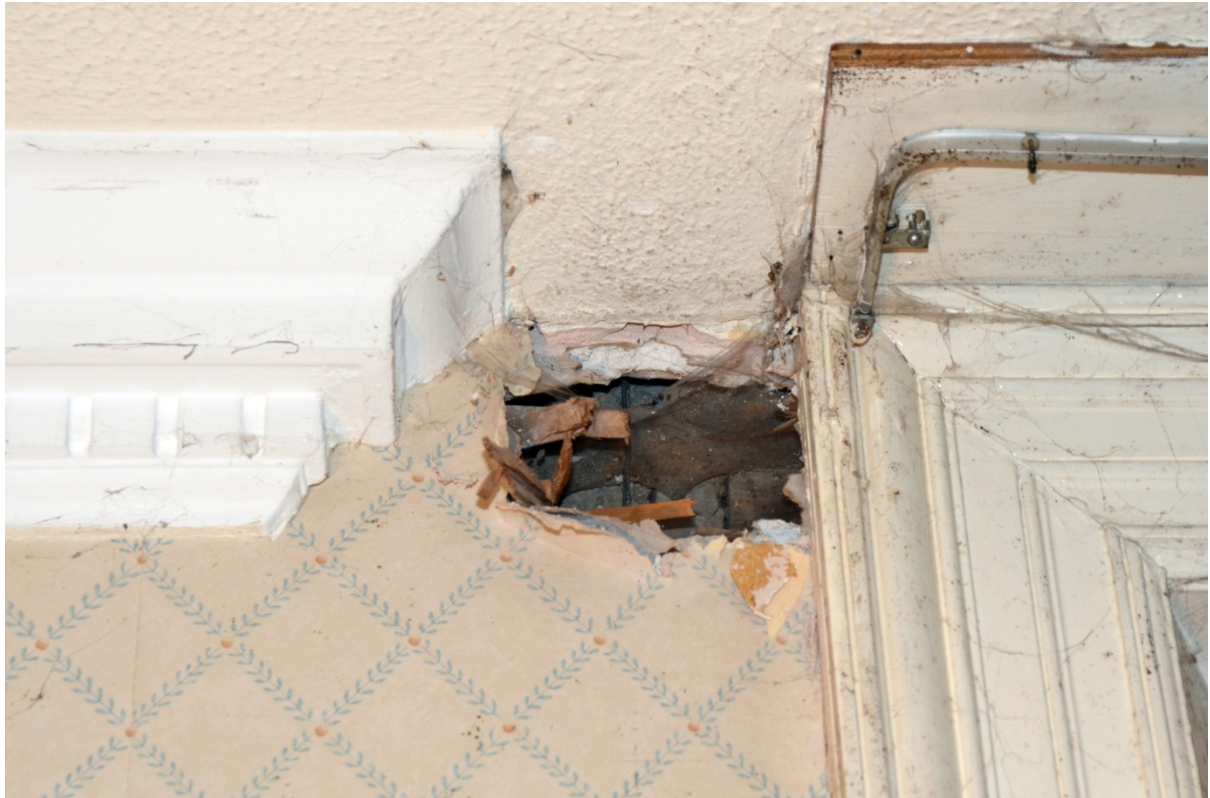
Plate 33: Late cornice in Room 20 and original window architrave (Shot 120)

- 7.36 Room 20 had a white woodchip ceiling and the same geometric cornice seen in Room 17. Here it was even clearer that the cornice was not original as it stopped short either side of an original window architrave in the east wall (Plate 33). Unusually the window embrasure did not extend to the floor. Further south was a smaller window with frosted glass and a simple vertical timber lining. In 1951 this was shown as a bathroom and the lining is probably original. The window had been latterly sealed with board and was only visible through an inspection hole. The wallpaper was a green diamond pattern and the skirting boards were not original. A double-width opening to the north led into an identically decorated space with another window in the eastern wall. This did not have an original surround and did extend to the floor. The 1951 plan (Figure 4.2) shows that this room had been formed from the amalgamation of two guest bedrooms, and the corridor extended north to access the 1966 extension. On an architects' plan of 1983 (Weddell & Thomson) this room forms part of another suite.

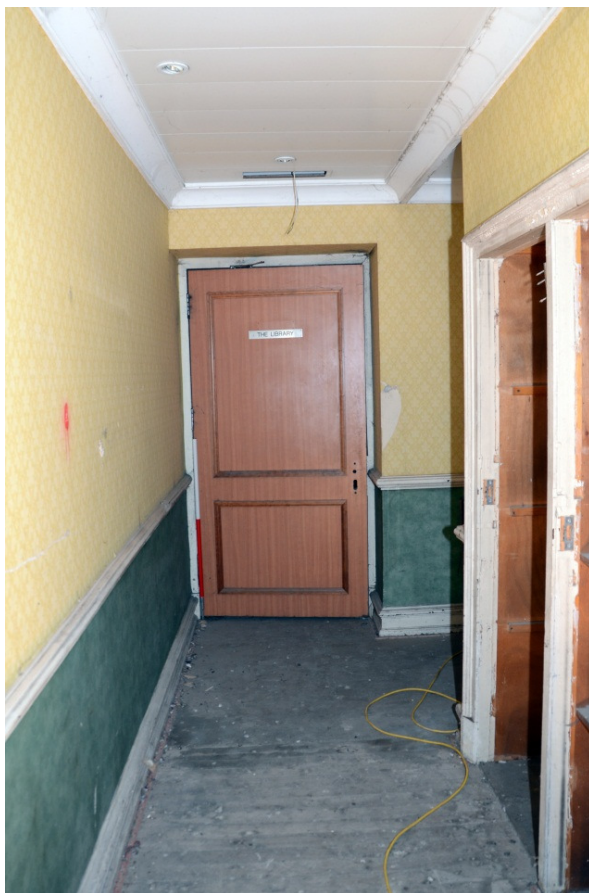
Plate 34: 1st floor hall (Room 21) toward 'The Library'/Room 19 (Shot 122)

- 7.35 This room was identified by an aluminium plaque on the laminate exterior of the door (Plate 34). The interior had the same decoration as Room 18, including the smoked mirror and wood ceiling centrepiece. The original cornice (Plate 30) was different to, and more elaborate than, that in Room 18. There was a grand sexpartite projecting window in the south wall with the usual white-painted timber panelling (Plate 31). The panelling was missing on the ceiling of the embrasure and had been replaced with plain plywood incorporating spot-lights. The projecting bay had a decorative column where it joined the main room and the original white-painted skirting boards. There was a single window overlooking the recessed bay in the west wall and a further two in the east wall. All had their panelling intact. Between the two windows in the east wall was a centrally-placed fireplace scar about 1.5m wide (Plate 32; Figure 8). The door to the hall was 6-pane dark wood on the interior, with a decorative surround; it matched those in Room 18 and was not original. With the exception of the entry to Room 18 the room had the same layout as in 1951 when it was named the 'Residents Lounge'.

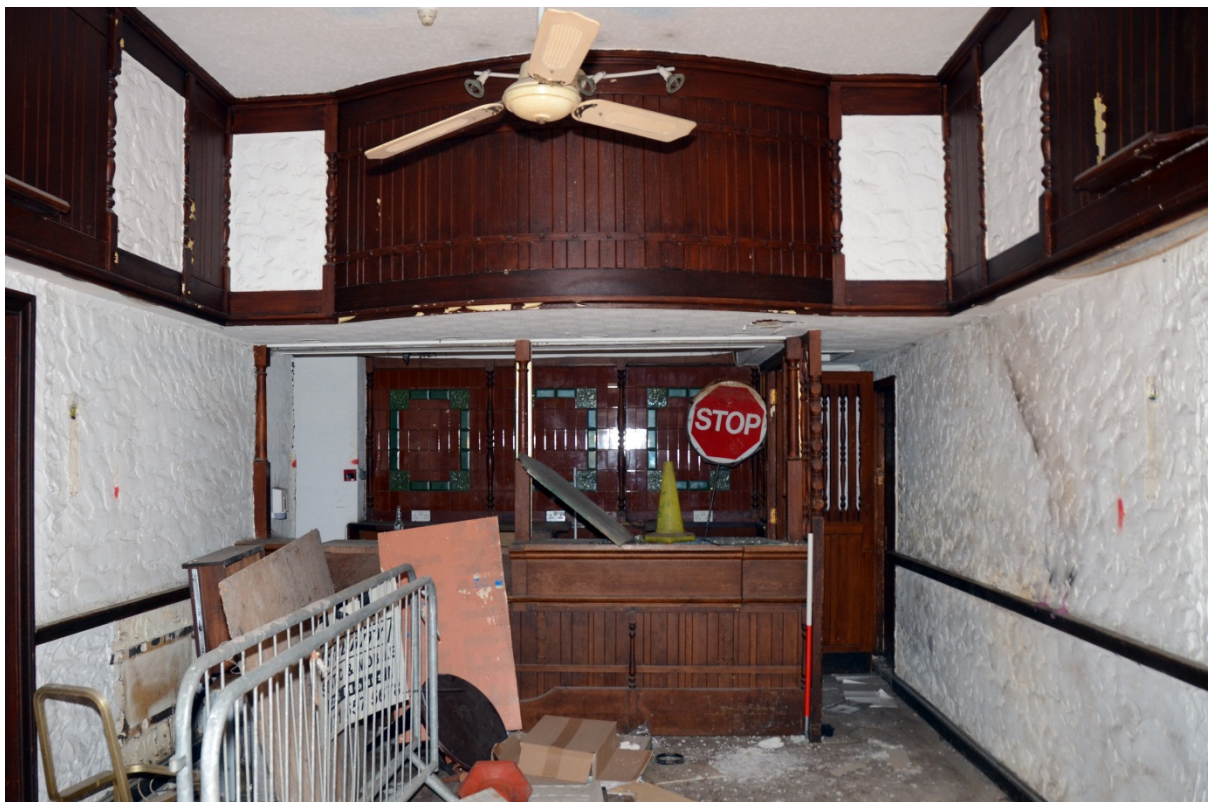
Plate 36: Room 22 looking toward the west wall and bar (Shot 136)

- 7.42 Rooms 22 and 23 functioned as one space connected by double swing doors. The northern part (Room 22; Plate 36) had a relatively recent finish (presumably toward the end of the 20th century as the style is not consistent with any of the newspaper photographs from the 1960s). There was white-painted, geometric embossed wallpaper on the ceiling and a central roof fan. The bar was against the western wall and had a projecting bay front lined in dark wood and white-painted rustic artex. The wood lining extended around the whole of the upper part of the walls, just above door height, with artex covering the lower parts of the walls. The lining consisted of vertical boards with some decorative turned poles. The lower part of the eastern wall was a partition comprising a panelled dark wood base with glazed upper section. There were nine panes of wire mesh glass to either side of a central double swing door (Plate 37). This wall is as shown on the plan of 1951 (Figure 4.1; the room was then a 'Lounge') and could be original as wire mesh glass was invented in 1892. A boxed extension to the base on the north side is not shown in 1951 and must be later. The double doors to Room 23 are of the same wood and glass, and fill an entrance shown in 1951 so may also be original (Plate 38). A folding set of doors in the north wall were not original.
